**BEFORE THE PUBLIC UTILITIES COMMISSION
OF THE STATE OF CALIFORNIA**

Order Instituting Investigation on the Commission's Own Motion into the Operations and Practices of Pacific Gas and Electric Company with Respect to Facilities Records for its Natural Gas Transmission System Pipelines.

**PREPARED DIRECT TESTIMONY OF MIKE MIKICH
ON BEHALF OF THE UNITED ASSOCIATION OF PLUMBERS, PIPE FITTERS AND
STEAMFITTERS LOCAL UNION NOS. 246 AND 342, AND THEIR INDIVIDUAL MEMBERS**

April 30, 2012

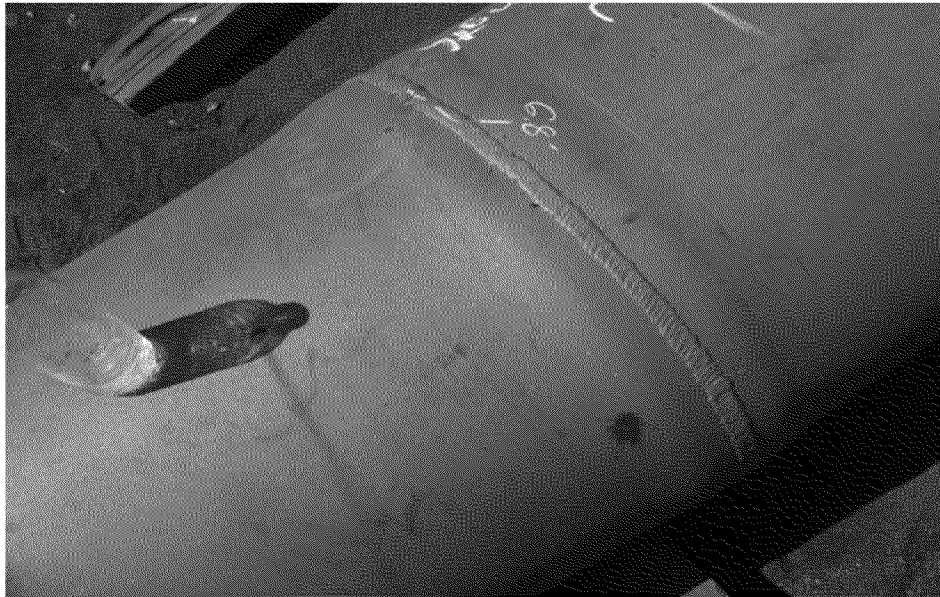
11 Illustration A: Stenciled Weld

23 Illustration A, called "Stenciled Weld," is a photograph of an old pipe joint in PG&E's existing
24 Line 132 in Redwood City. It shows several unacceptable welding practices. First, the letter "M" was
25 welded into the pipe. Welding outside the pipe joint is prohibited by PG&E's (and all other) standards.
26 Further, the weld in the joint itself is defective. It has undercuts, arc strikes and asymmetrical welds.
27 We saw many similar defects in the work we did on Line 132 and elsewhere.

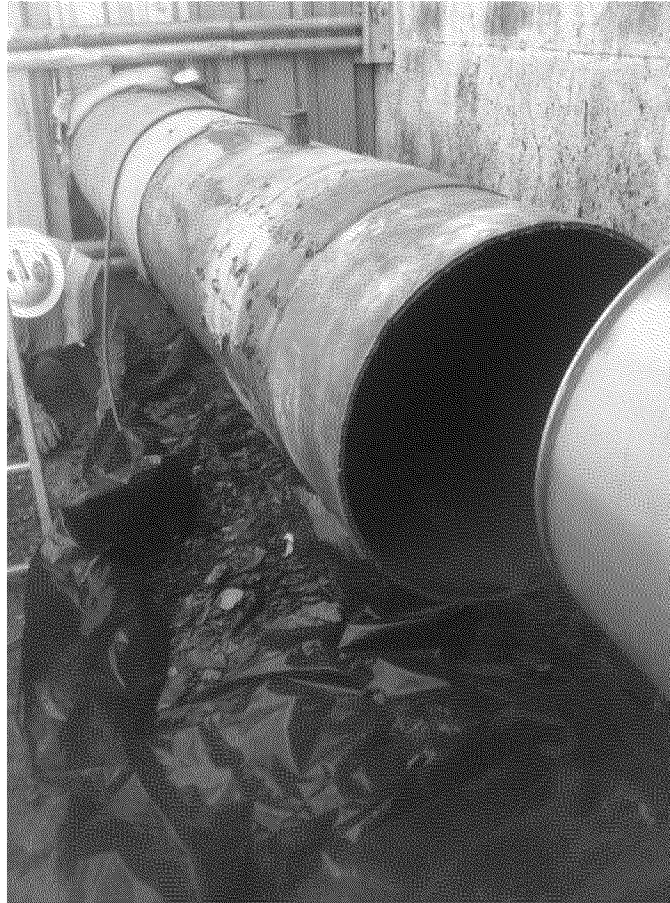
5
6
7
8
9
10
11
12
13
14
15
16
17
18
19
20
21 Illustration C: Coating Deficiencies

1 Illustration C, called “Coating Deficiencies,” is a photograph of a PG&E pipeline segment in
2 Antioch. The pipe had been cut for hydro-static testing. The photo shows that between the worker’s
3 shoulder and the open end of the pipeline, there is extensive pitting in the pipe coating on the pipe, and
4 the coating is cracked and not bonded well.
