**BEFORE THE PUBLIC UTILITIES COMMISSION
OF THE STATE OF CALIFORNIA**

Order Instituting Investigation on the Commission's Own Motion into the Operations and Practices of Pacific Gas and Electric Company with Respect to Facilities Records for its Natural Gas Transmission System Pipelines.

**PREPARED DIRECT TESTIMONY OF MIKE MIKICH
ON BEHALF OF THE UNITED ASSOCIATION OF PLUMBERS, PIPE FITTERS AND
STEAMFITTERS LOCAL UNION NOS. 246 AND 342, AND THEIR INDIVIDUAL MEMBERS**

April 30, 2012

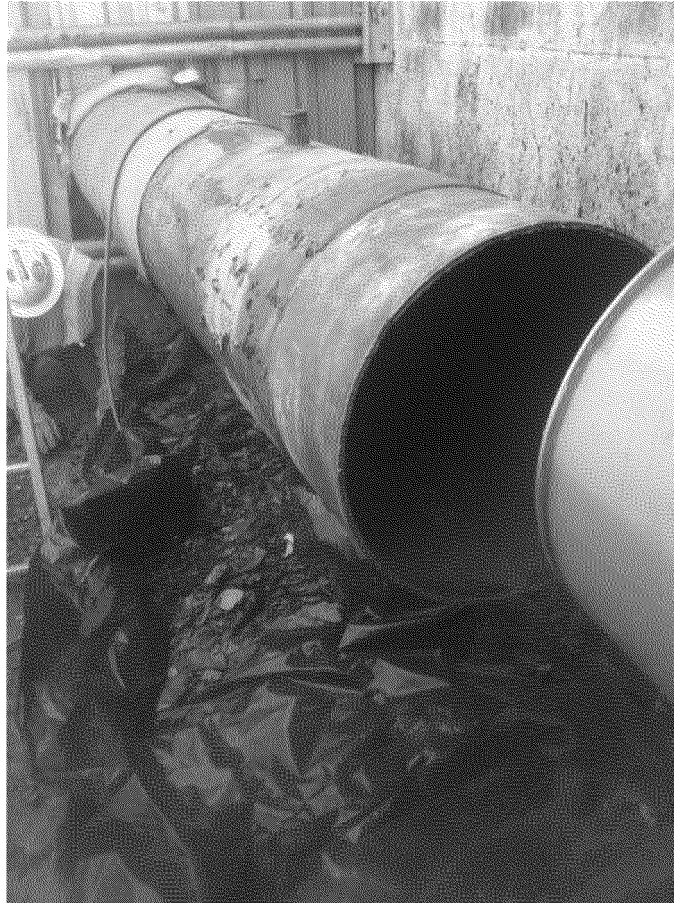
5
6
7
8
9
10
11
12
13
14
15
16
17
18
19
20
21 Illustration C: Coating Deficiencies

1 Illustration C, called “Coating Deficiencies,” is a photograph of a PG&E pipeline segment in
2 Antioch. The pipe had been cut for hydro-static testing. The photo shows that between the worker’s
3 shoulder and the open end of the pipeline, there is extensive pitting in the pipe coating on the pipe, and
4 the coating is cracked and not bonded well.
