**BEFORE THE PUBLIC UTILITIES COMMISSION  
OF THE STATE OF CALIFORNIA**

Order Instituting Investigation on the Commission's Own Motion into the Operations and Practices of Pacific Gas and Electric Company with Respect to Facilities Records for its Natural Gas Transmission System Pipelines.

**PREPARED DIRECT TESTIMONY OF MIKE MIKICH  
ON BEHALF OF THE UNITED ASSOCIATION OF PLUMBERS, PIPE FITTERS AND  
STEAMFITTERS LOCAL UNION NOS. 246 AND 342, AND THEIR INDIVIDUAL MEMBERS**

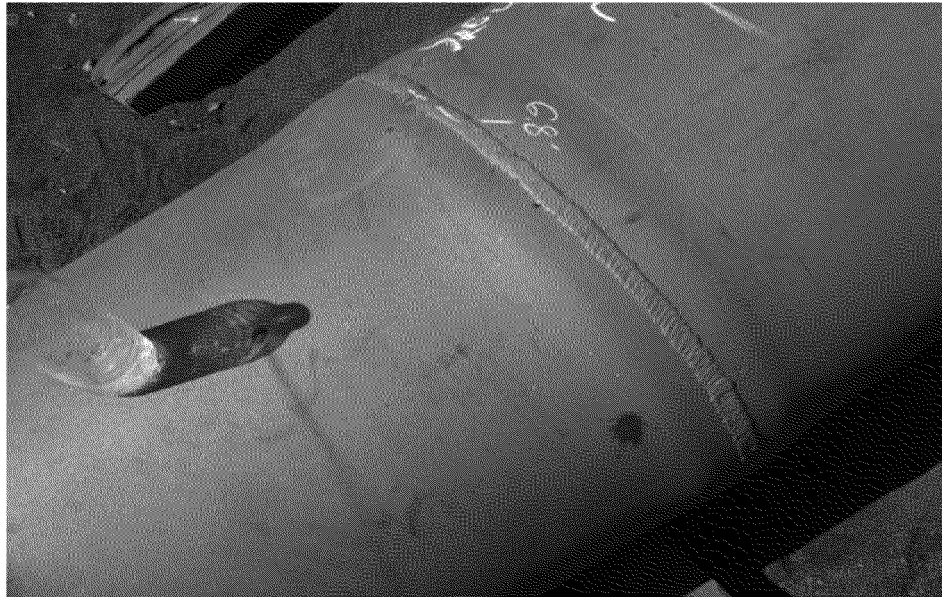
11 Illustration A: Stenciled Weld

23 Illustration A, called "Stenciled Weld," is a photograph of an old pipe joint in PG&E's existing  
24 Line 132 in Redwood City. It shows several unacceptable welding practices. First, the letter "M" was  
25 welded into the pipe. Welding outside the pipe joint is prohibited by PG&E's (and all other) standards.  
26 Further, the weld in the joint itself is defective. It has undercuts, arc strikes and asymmetrical welds.  
27 We saw many similar defects in the work we did on Line 132 and elsewhere.

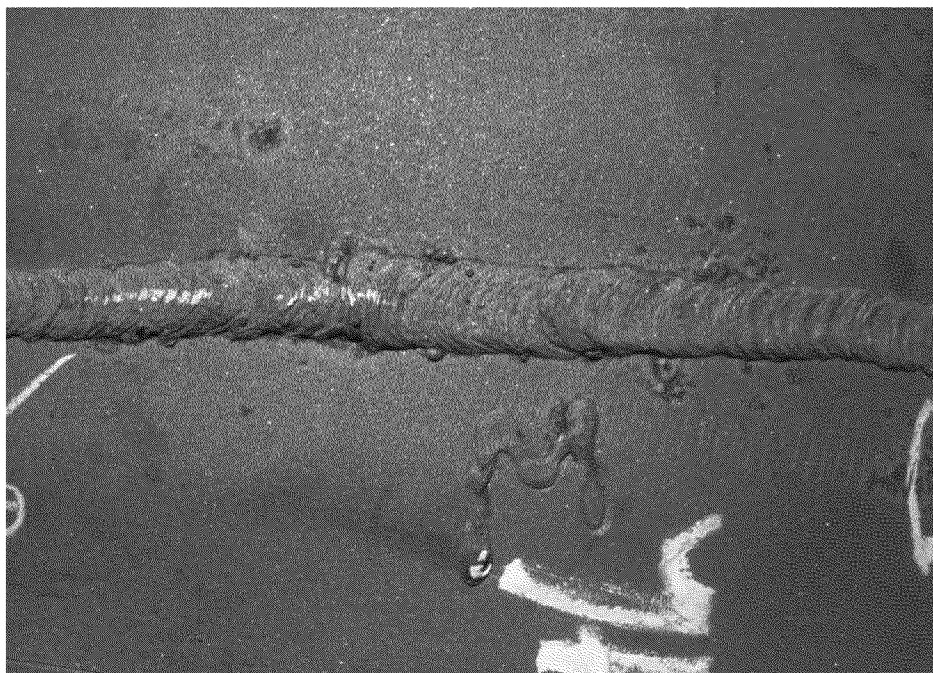
28 Illustration B: Arc Strikes

24           b. We also saw “arc marks” all along the San Bruno area of the existing pipeline. An arc  
25 mark is a burn inside a pipe, away from the welding joint. It is made by careless welding, when  
26

1 the welder lets the tip of his welding rod get outside the joint, and it burns a gouge inside the  
2 pipe. Some of the arc marks were quite deep, as much as one-sixteenth of an inch, and some  
3 were a foot long. We saw too many arc marks to count – they were in almost every piece of pipe  
4 we took out.

12 Illustration B, called “Arc Strikes,” also shows an old pipe joint on Line 132. It shows  
13 unrepaired gouges that were burned into the pipe through careless welding (see Para. 10.b. above). It  
14 reflects the same defective welding practices (except for the letter “M”) as does Illustration A. That pipe  
15 section should have been cut out and replaced.

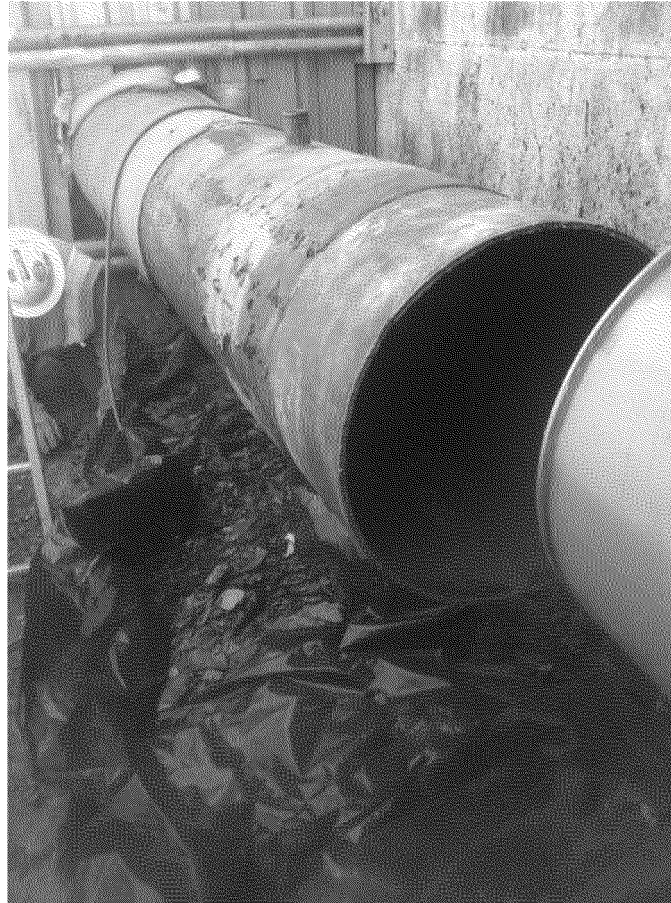
5  
6  
7  
8  
9  
10  
11  
12  
13  
14  
15  
16  
17  
18  
19  
20  
21 Illustration C: Coating Deficiencies

1 Illustration C, called “Coating Deficiencies,” is a photograph of a PG&E pipeline segment in  
2 Antioch. The pipe had been cut for hydro-static testing. The photo shows that between the worker’s  
3 shoulder and the open end of the pipeline, there is extensive pitting in the pipe coating on the pipe, and  
4 the coating is cracked and not bonded well.
