Land & Environmental Management Pilot

Gas Transmission Line 132 Encroachment Pilot Projects	
Redacted		
	· .	A THE PARTY OF THE
		The state of the s
		The second secon
		A Delining to the control of the con

Final Report: Redacted

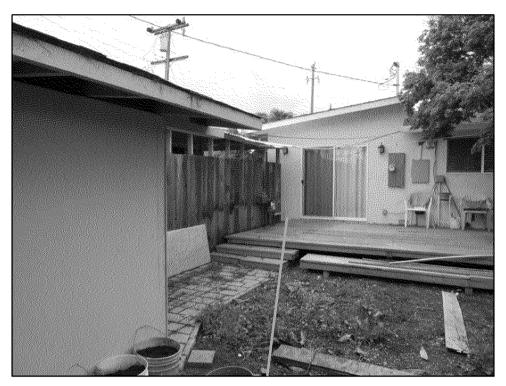
Standing on the line looking west.

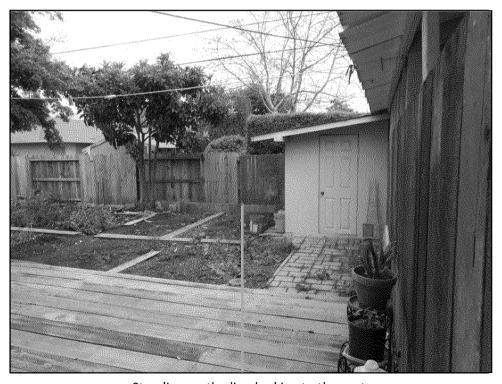
Standing on the line looking to the east.

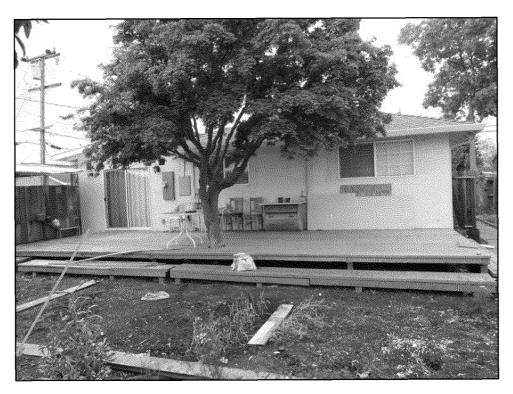
The main house is within the easement and over the pipeline. The expanded garage overhang is within the easement and appears to be over the pipeline. The small shed addition is within the easement and the overhang appears to be over the pipeline.

Main House is over the line.

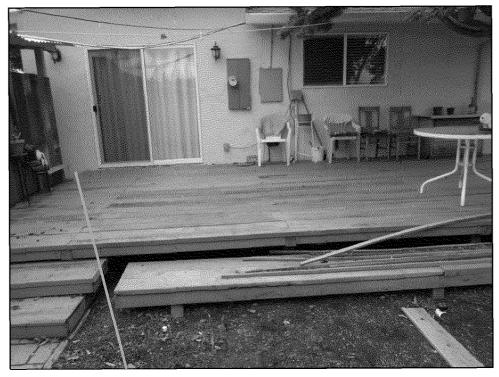
Deck is over the top of the line.

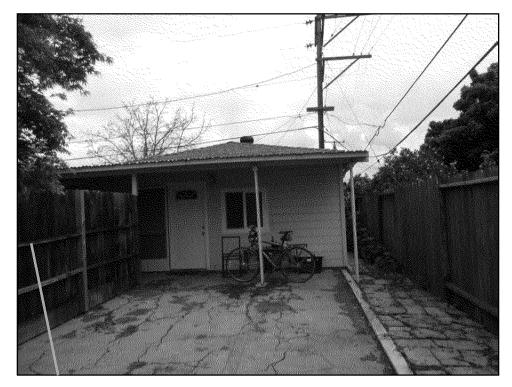
Second House (expanded garage) Overhang within the easement and over the pipe.

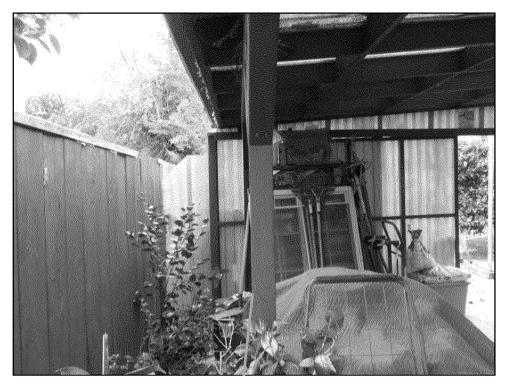
Standing on the line looking west from the covered patio

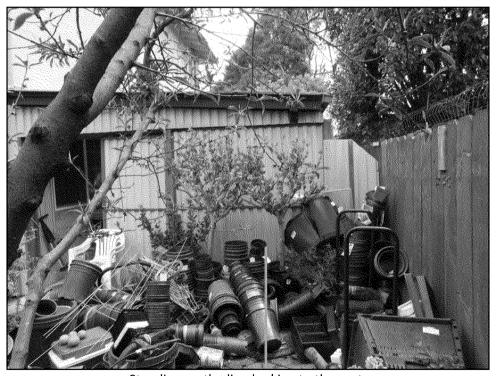
Standing on the line looking to the east.

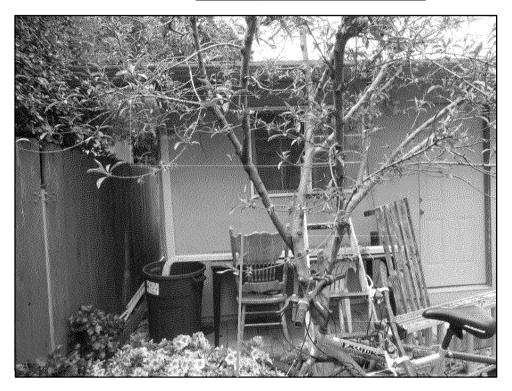
Standing on the line looking to the west.

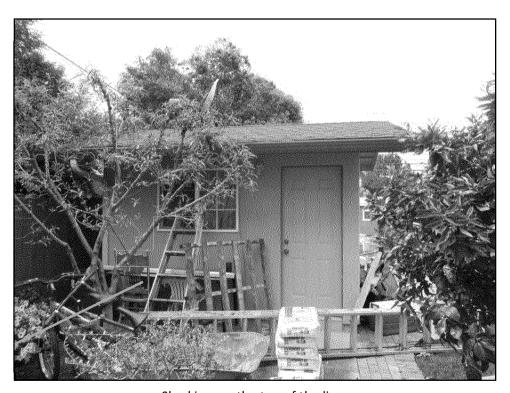
Building structure and concrete patio with cover is within easement and over pipeline.

Shed is over the top of the line.

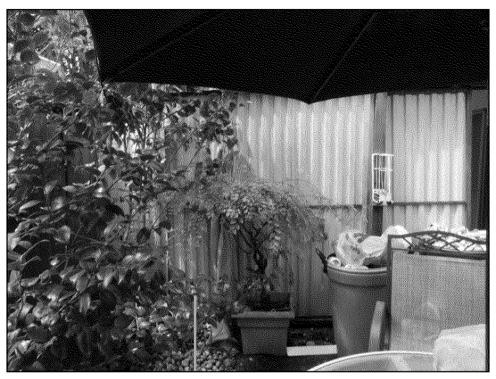
Patio with overhang is over the top of the line.

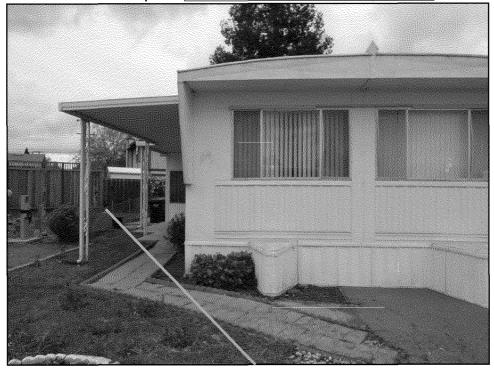
Standing on the line looking west.

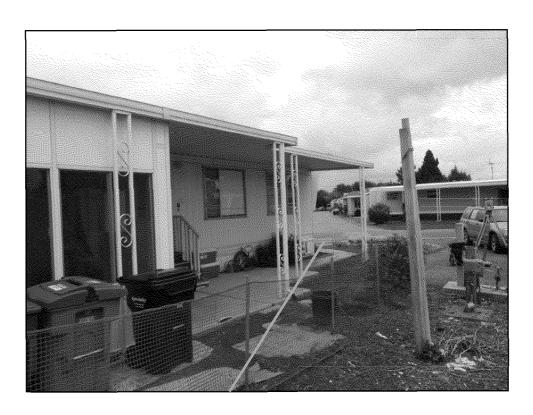
Standing on the line looking to the east.

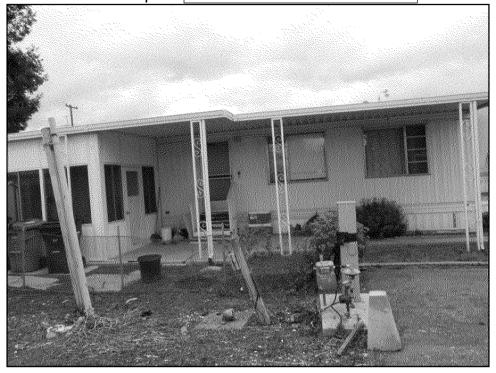
Property boundaries are not yet resolved as there is little monumentation in the area and to resolve the boundary would likely require an extensive survey of the property and surrounding areas. The easement lines are not yet shown on the map. The edge of the mobile home is .73' away from the pipeline and the concrete patio is .25' away from pipeline. There are utility hookups on the adjacent lot that may be encroaching into the easement.

Mobile home is within the easement.

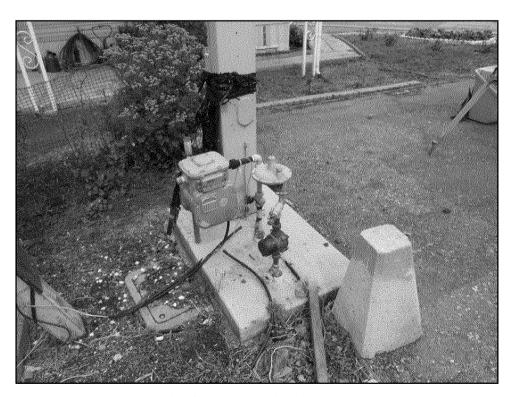
Utility hooks ups are within the easement.

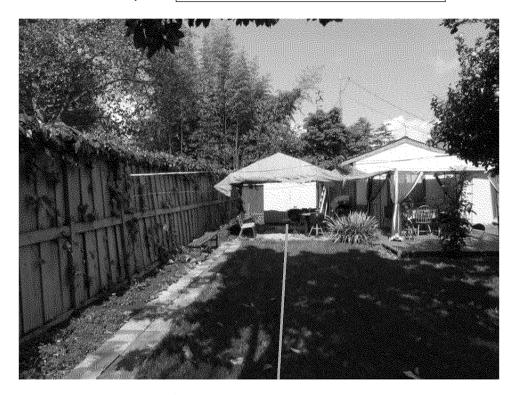
Standing on the line looking northwest

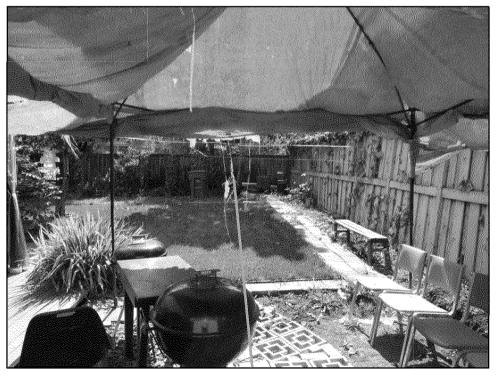
Standing on the line looking to the southeast

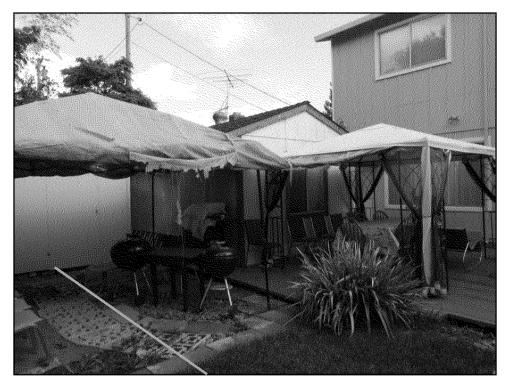
Storage shed is within the easement and over the pipeline. The edge of the house is .3' into the easement and not over the pipeline

Shed is within the easement area.

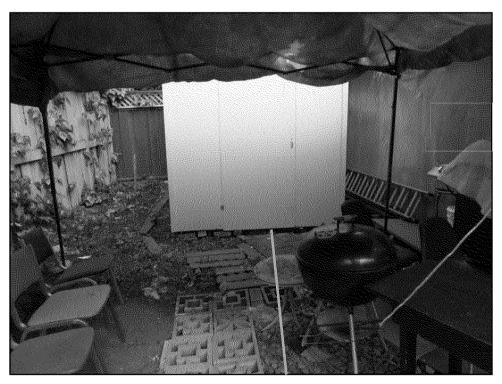
Shed is over the top of the line.

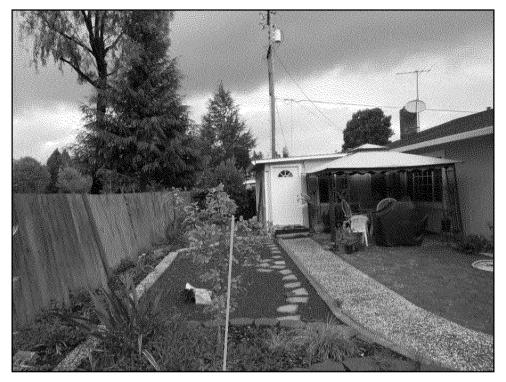
Standing on the line looking northwest

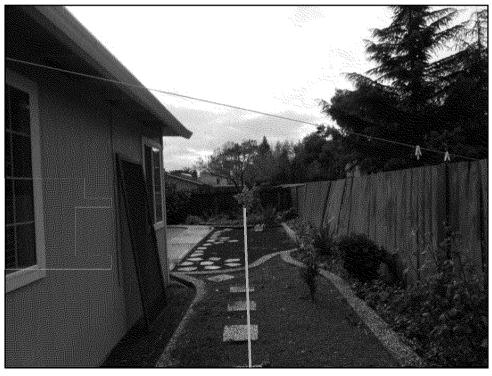
Standing on the line looking to the southeast

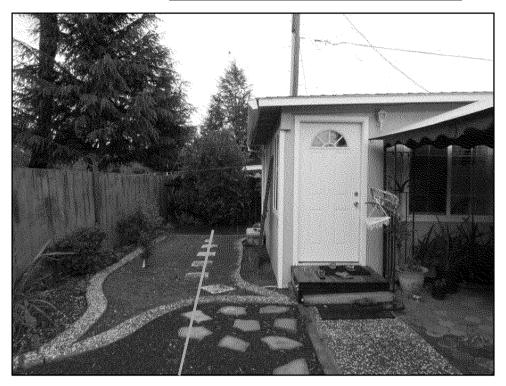
The house encroaches 1.4' into the easement and is not over the pipeline.

House, is within the easement area by 1.4'.

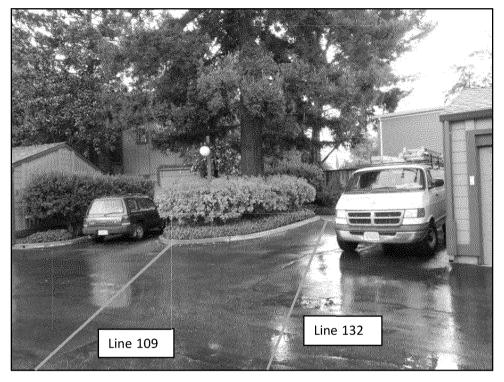
Standing on Line 132 looking to the east down the line.

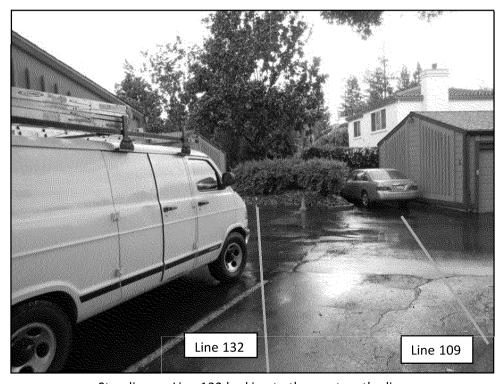
Standing on Line 132 looking to the west up the line

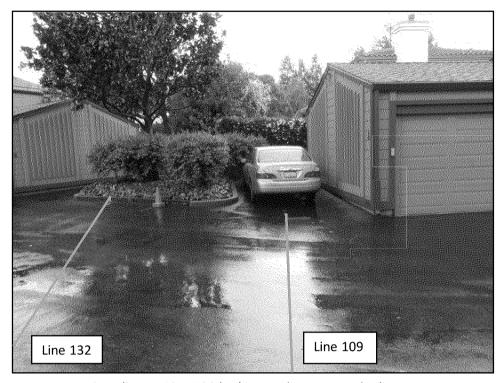
Standing on Line 109 looking to the west up the line.

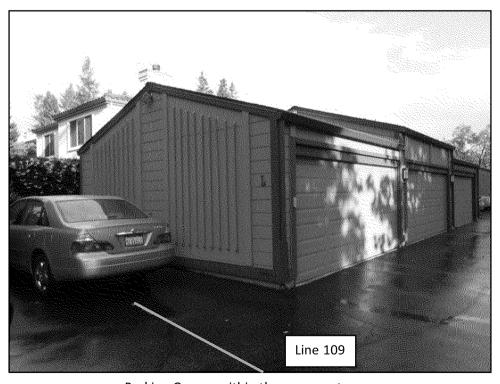
There are two garages that fall within the easement on 132 at .9' and .6', but are not over the pipeline. One garage falls into the easement on 109 at .8', but is not over the pipeline.

Parking Garage within the easement area.

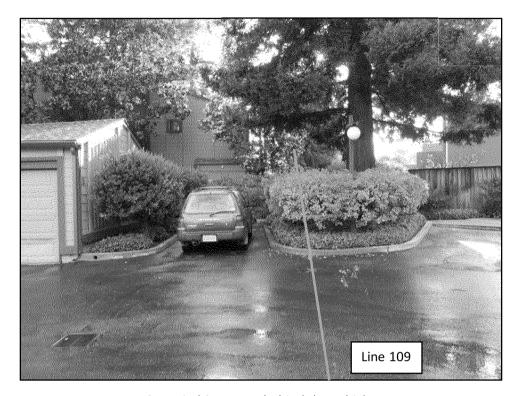
Occupied Structure behind the vehicle.

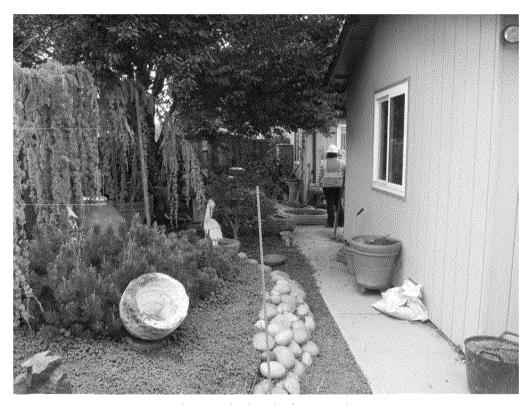
Standing on the line looking northwest

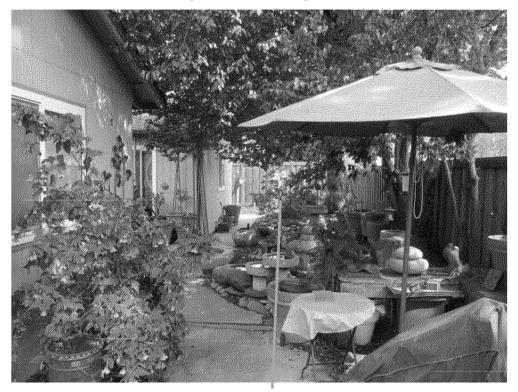
Standing on line looking southeast

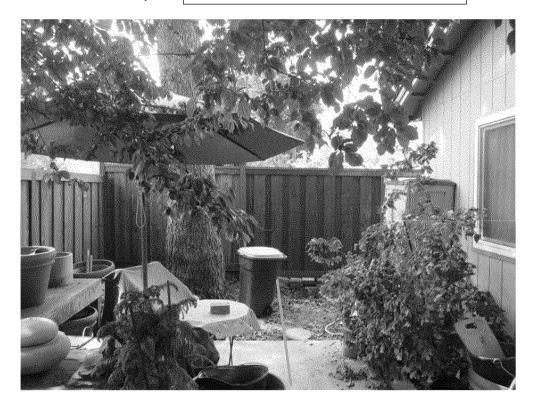
Standing on the line looking northwest

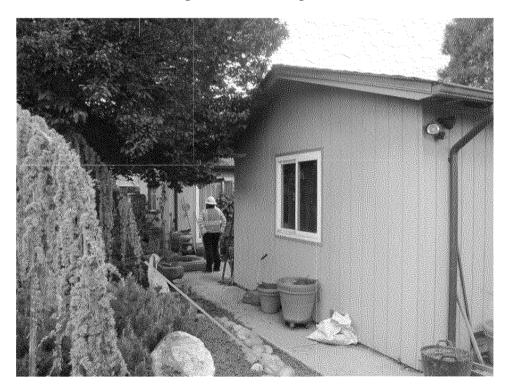
Concrete patio is over the pipeline. House is not within the easement.

House is not within the easement area.
