Encroachment Pilot Report of Findings

Gas Transmission Line 153 Encroachment Pilot Projects

Report of Findings for Line 153
Gas Pipeline Encroachment Pilot Program
Final Report: Redacted

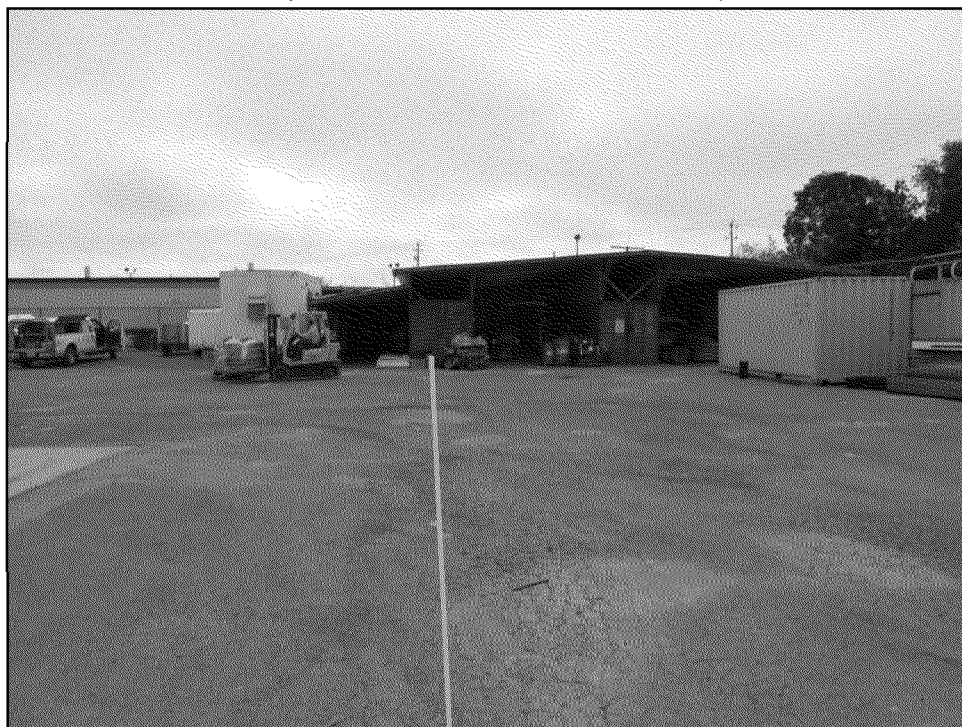
Standing on the line looking north.

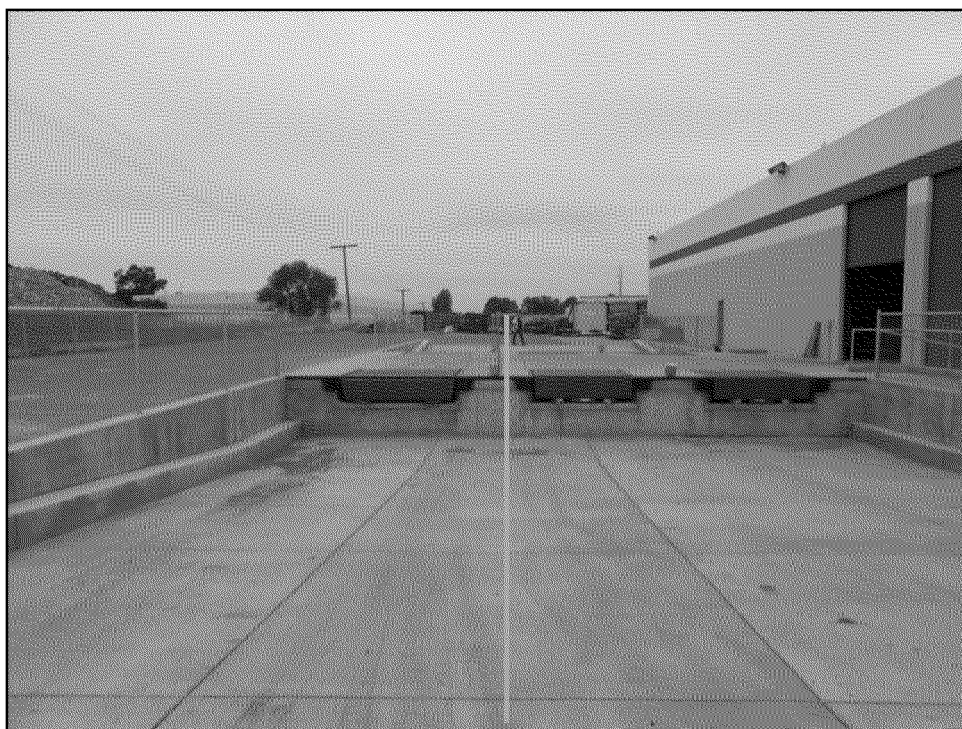
Standing on the line looking to the south.

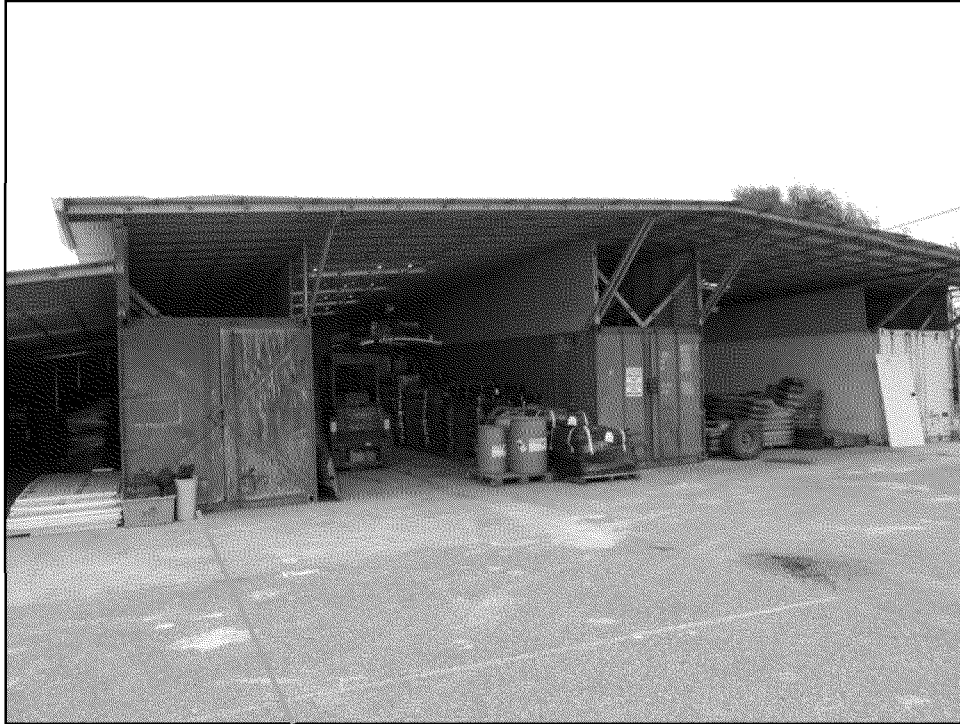
1. A portion of a storage area is directly over the gas line and within the easement area.
2. Loading docks for heavy trucks have been constructed over the gas line and within the easement. Cover over the gas line has been reduced to approximately 15 inches.

Building is over the easement.

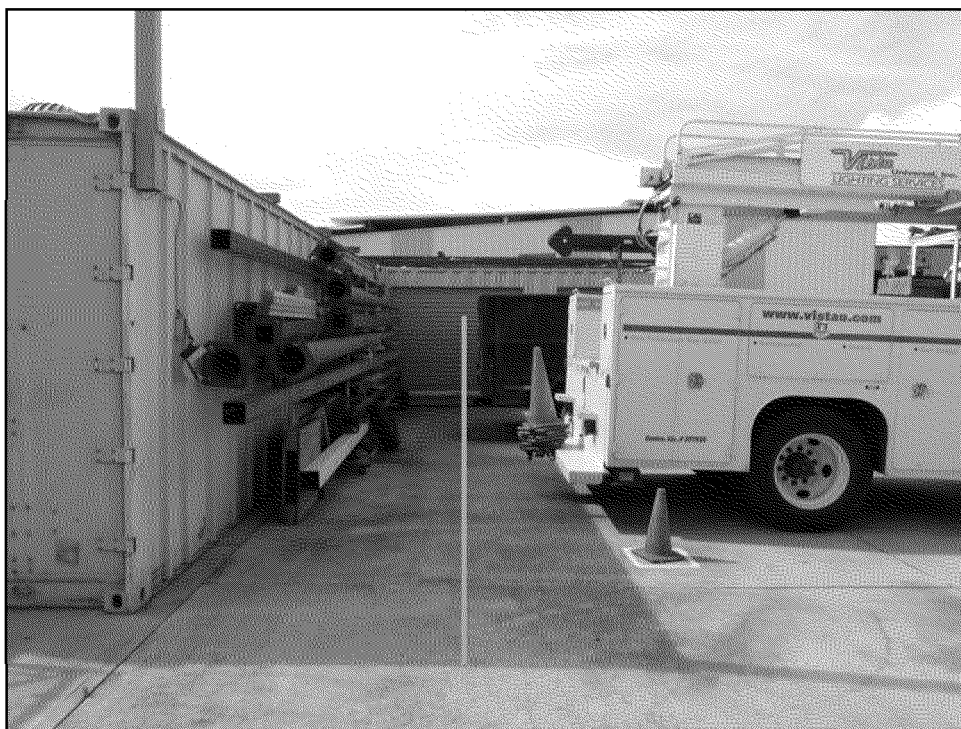
Standing on the line looking northeast.

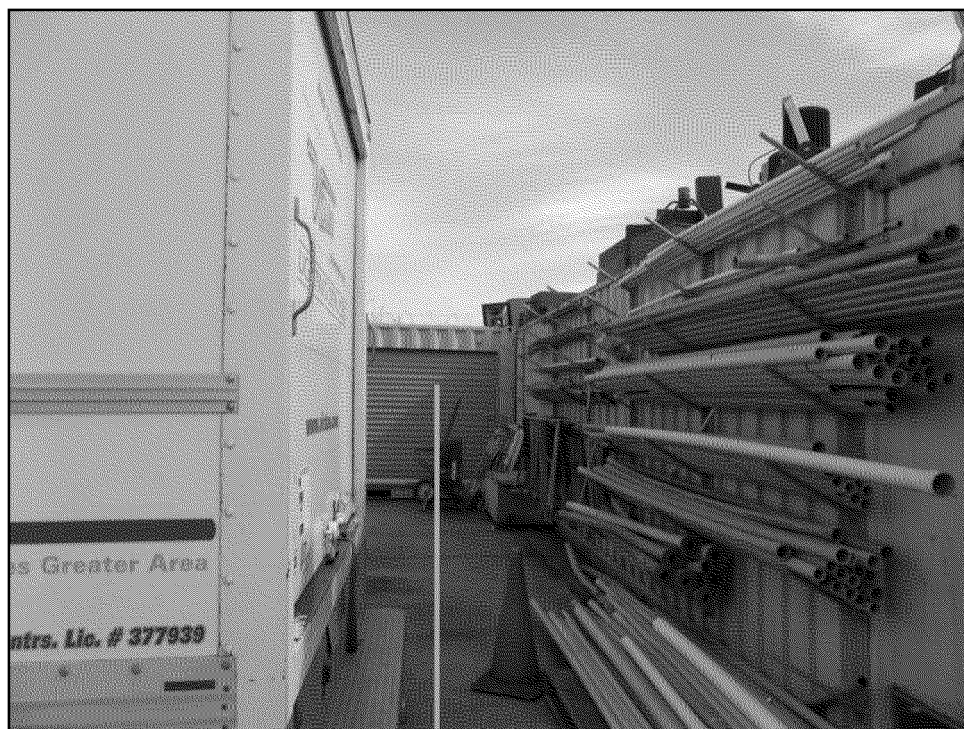
Standing on the line looking southwest.

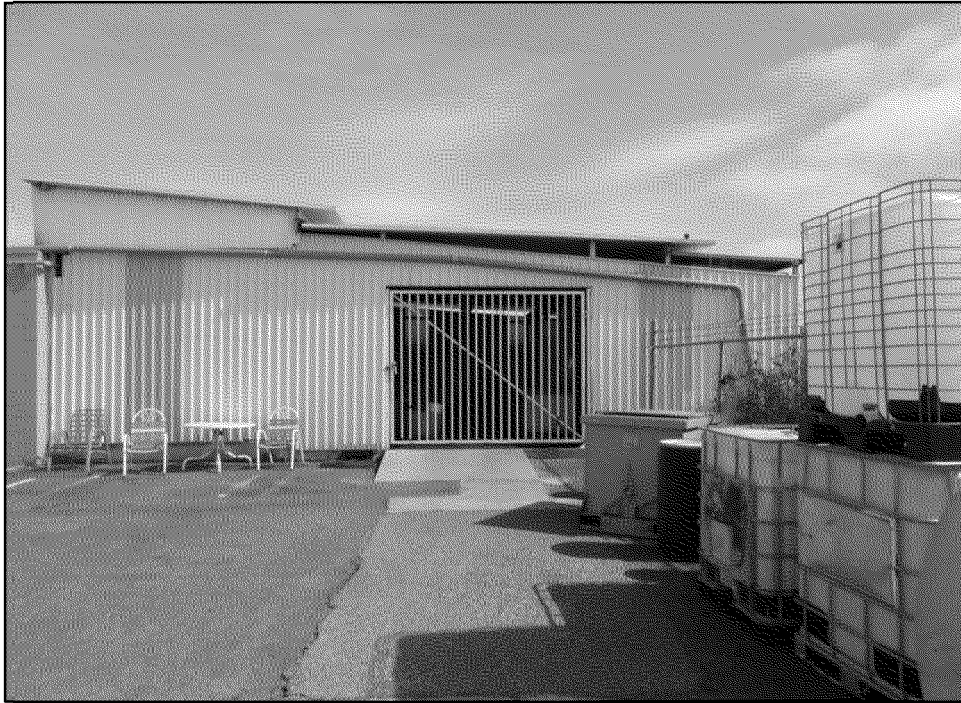
Redacted building is entirely across PG&E's easement and over the pipeline across the entire parcel.

Building is over the line.

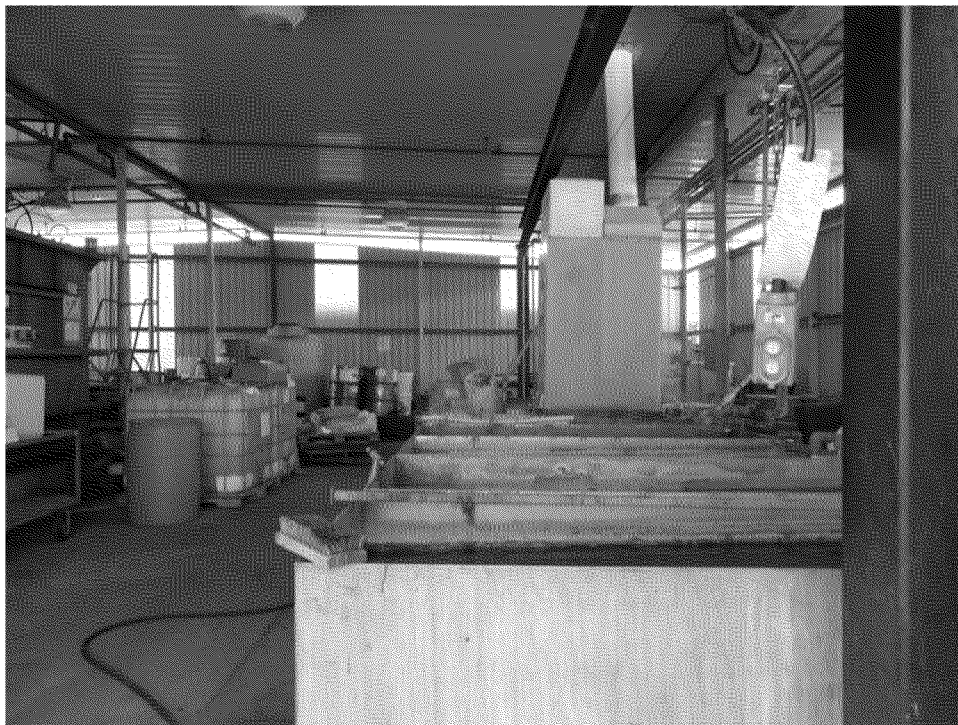
View inside the industrial shed over the line.

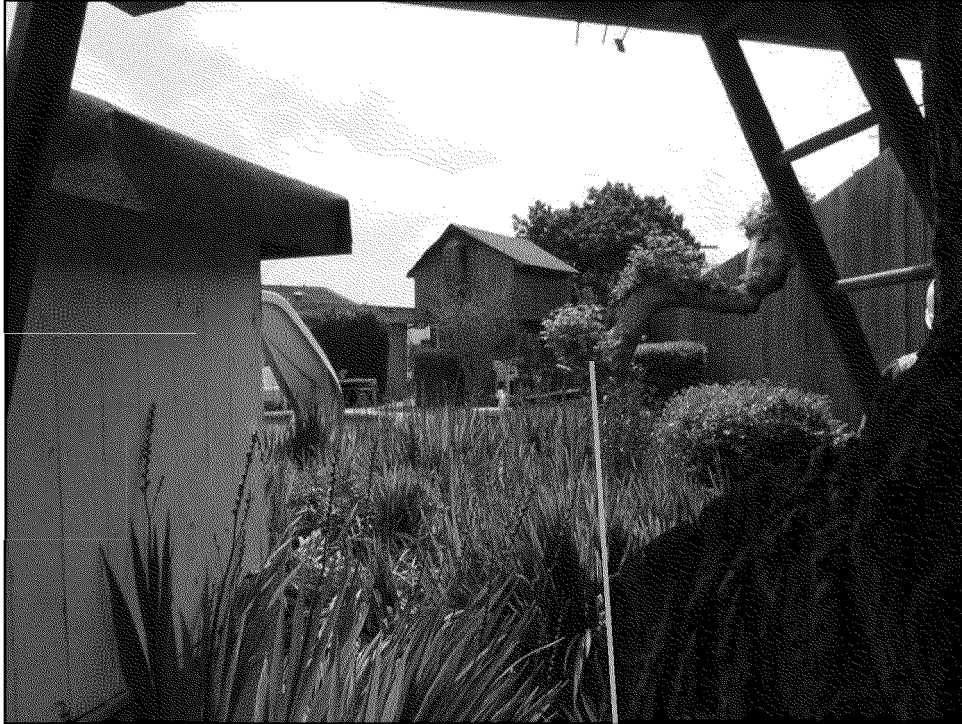
Standing on the line looking northwest.

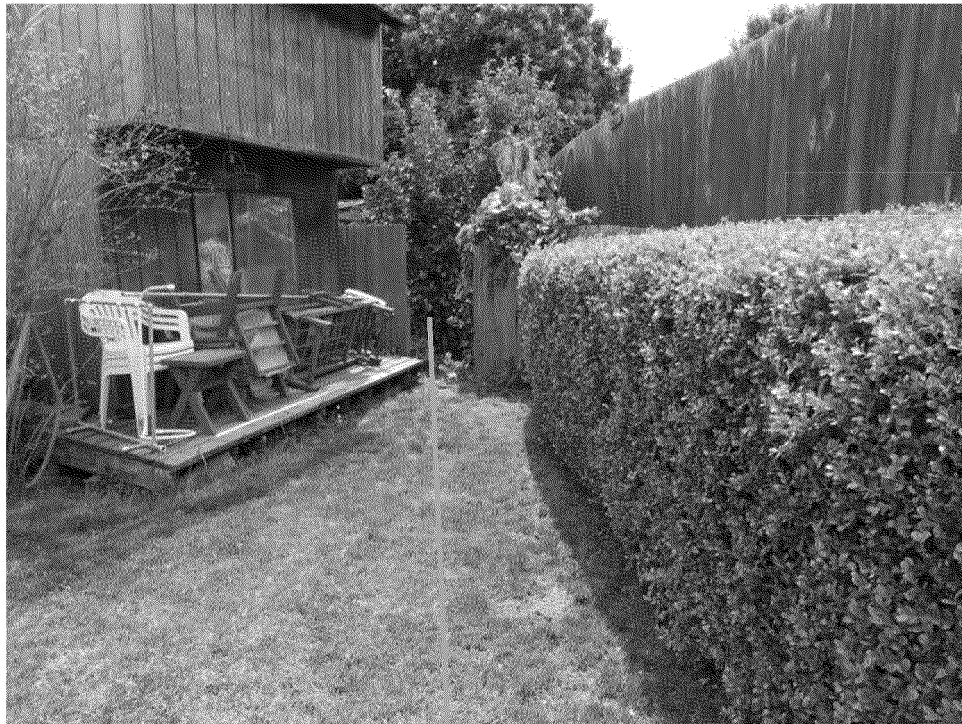
Standing on the line looking to the northwest.

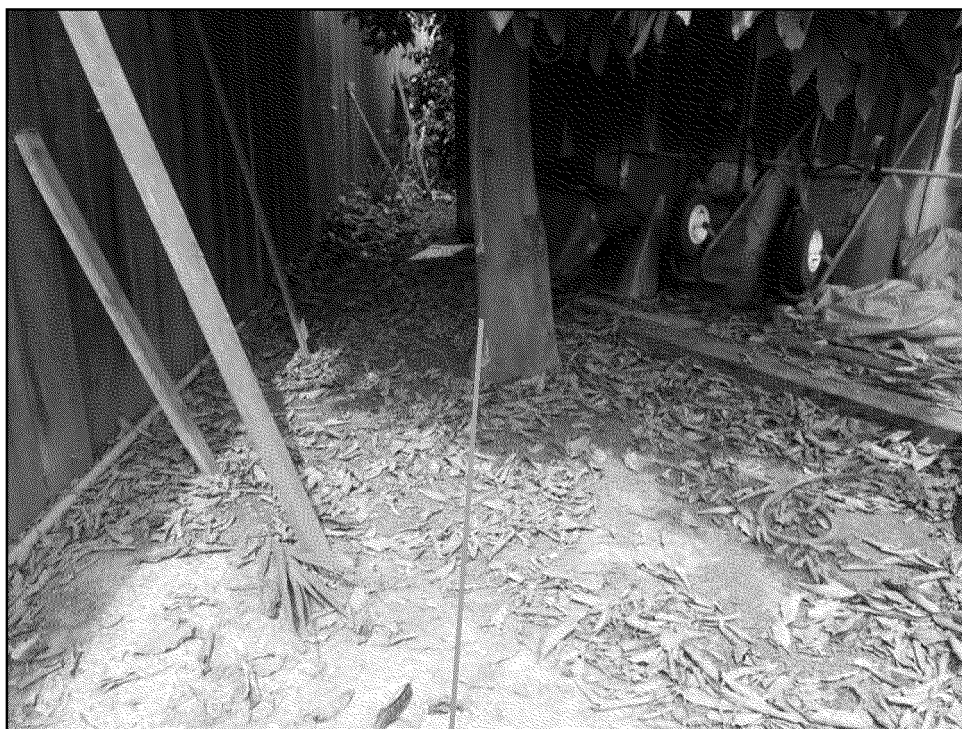
Standing on the line looking to the southeast.

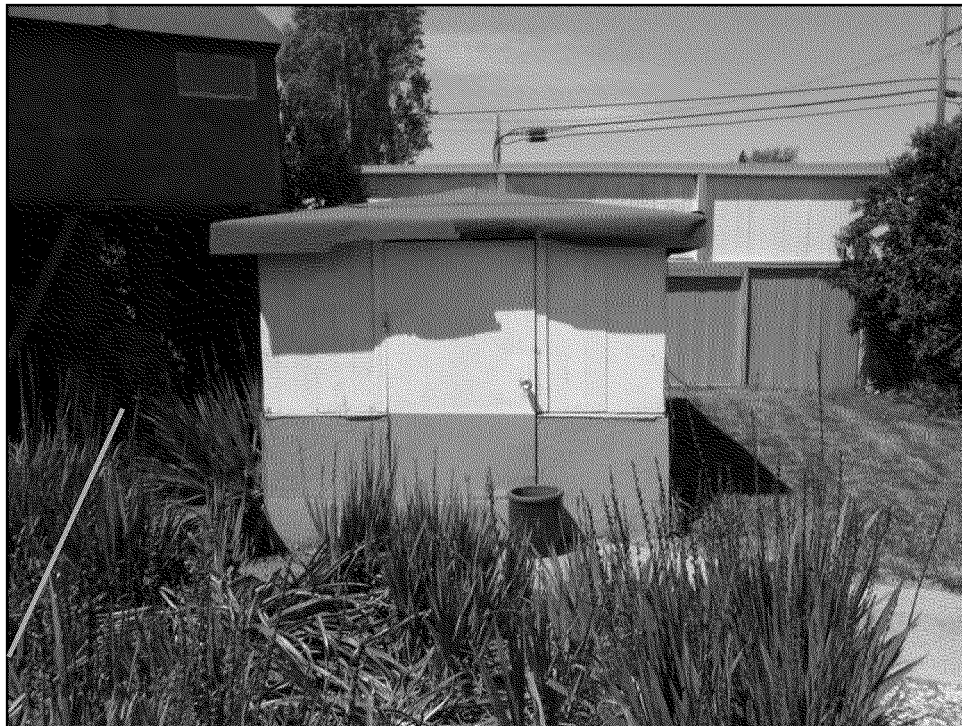
Shed within the easement area.

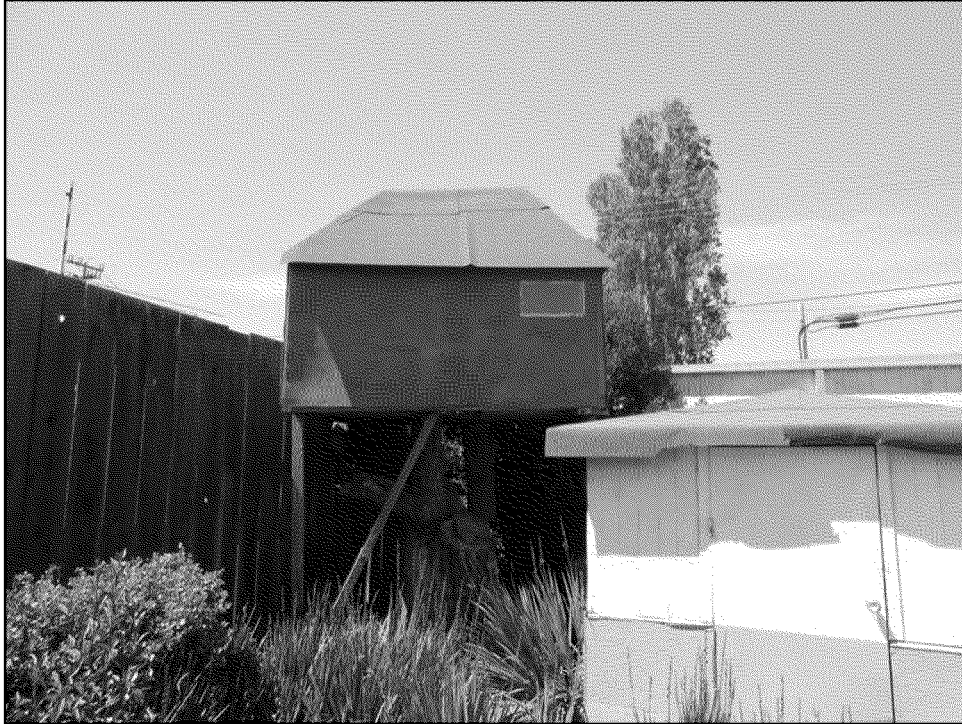
Tree house over the top of the line.

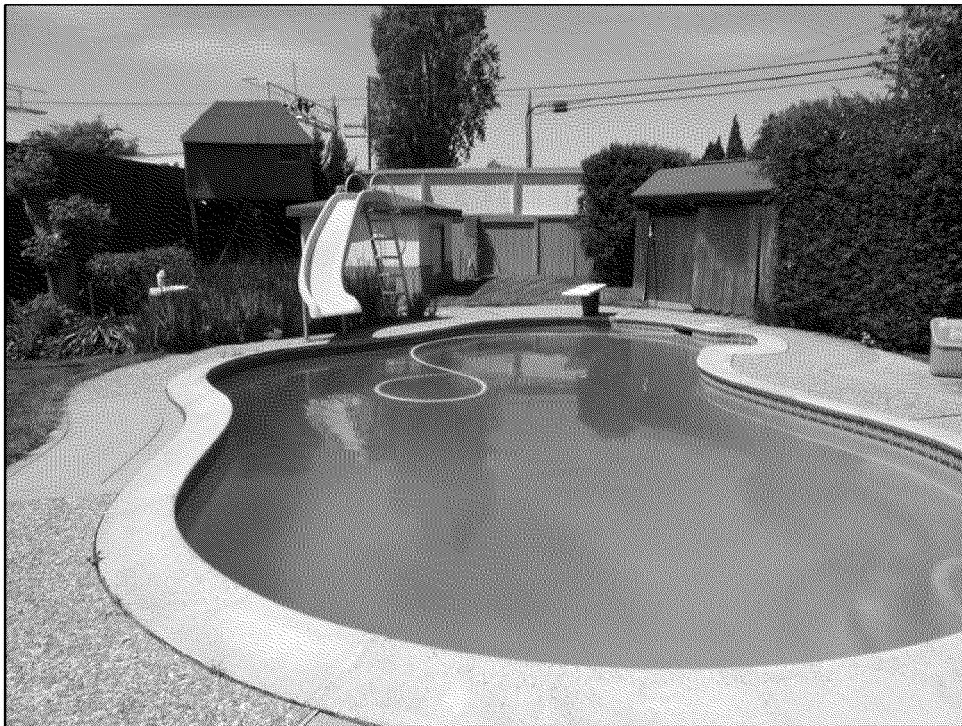
Pool deck within the easement area.

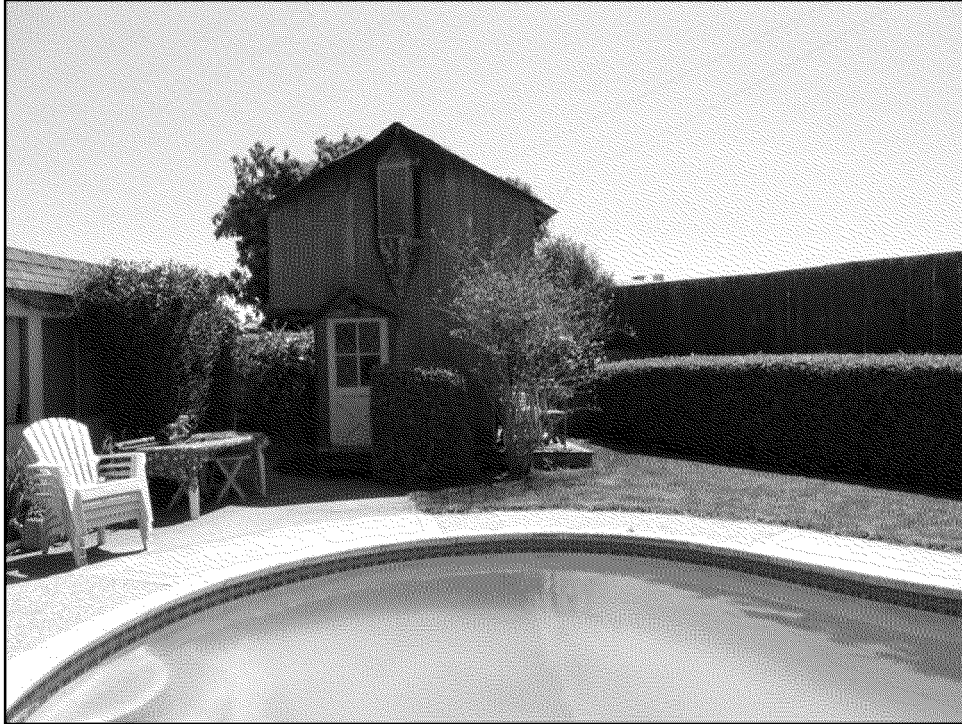
House within the easement area.

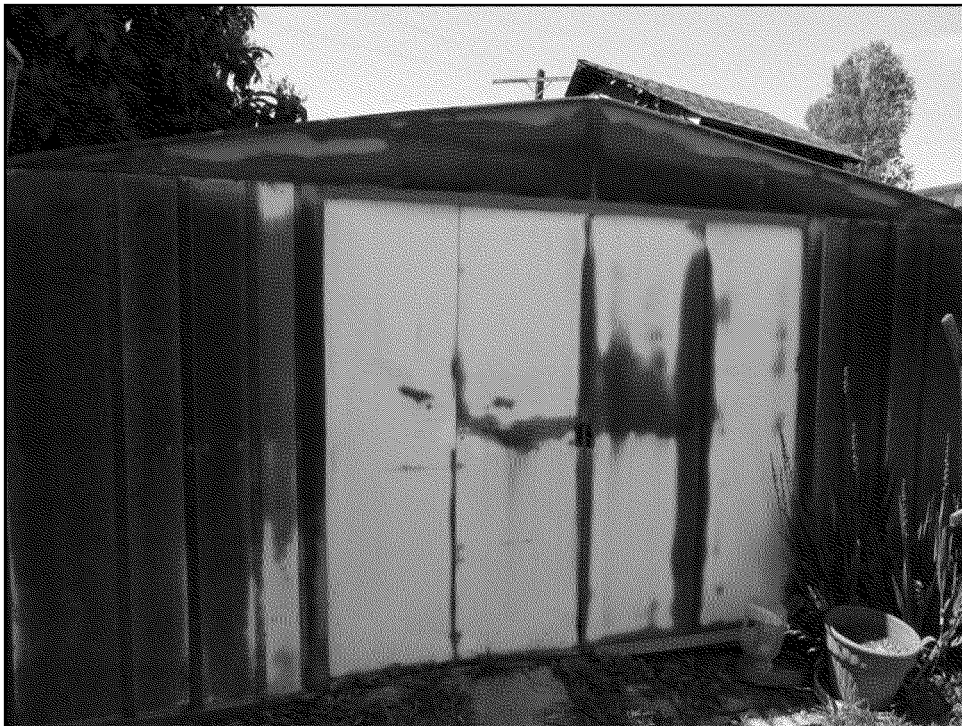
Shed within the easement area.

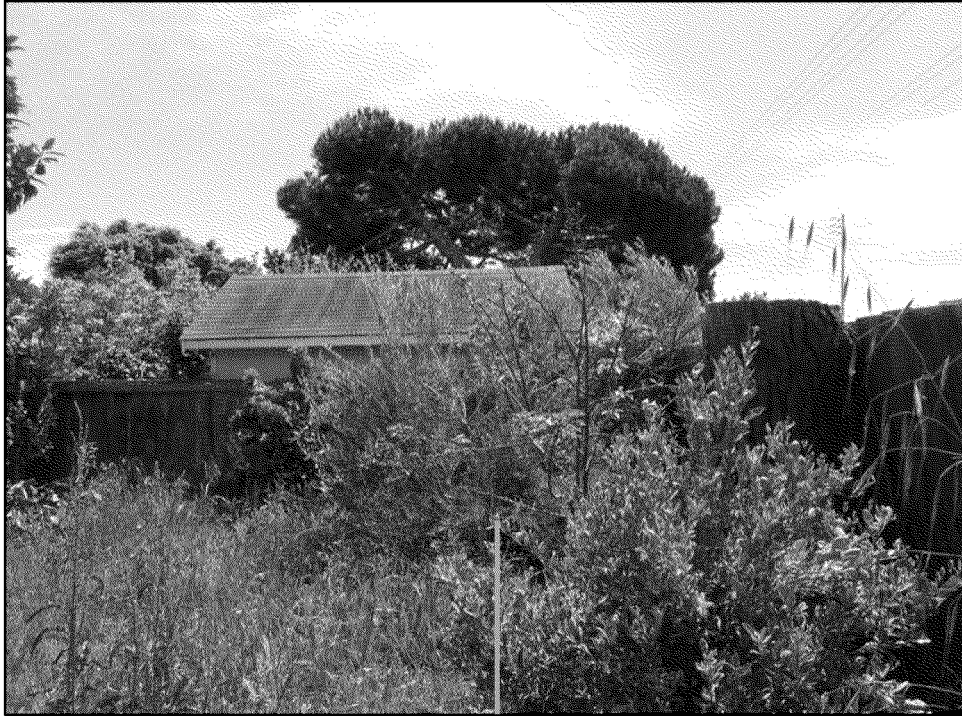
Standing on the line looking southeast.

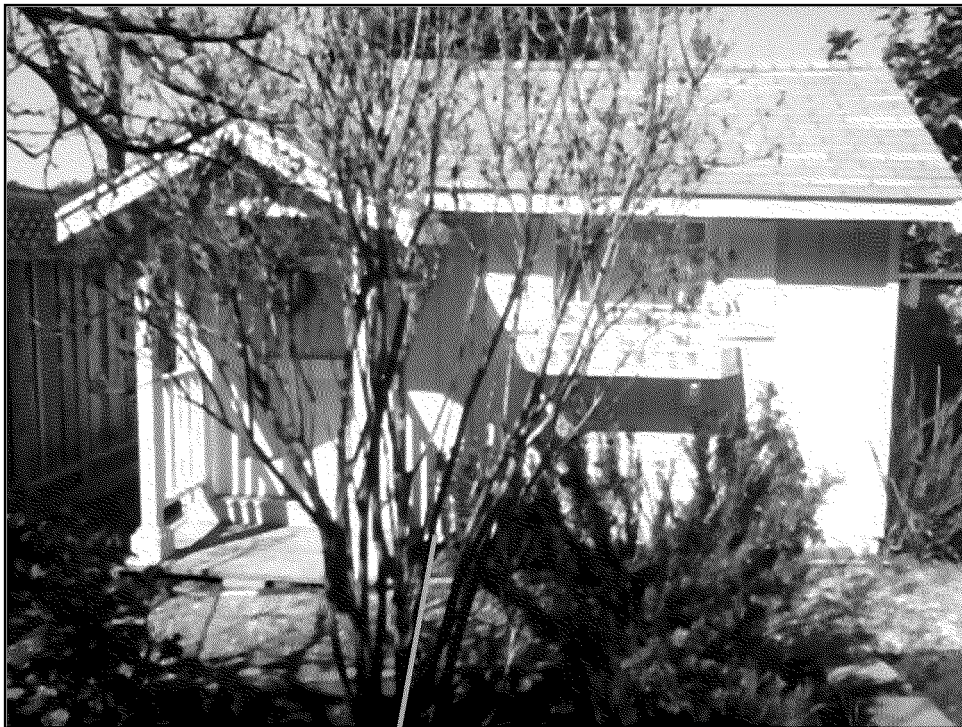
Wood Structure Playhouse is located on top of the pipe and is within the easement.

Playhouse is over the top of the line.

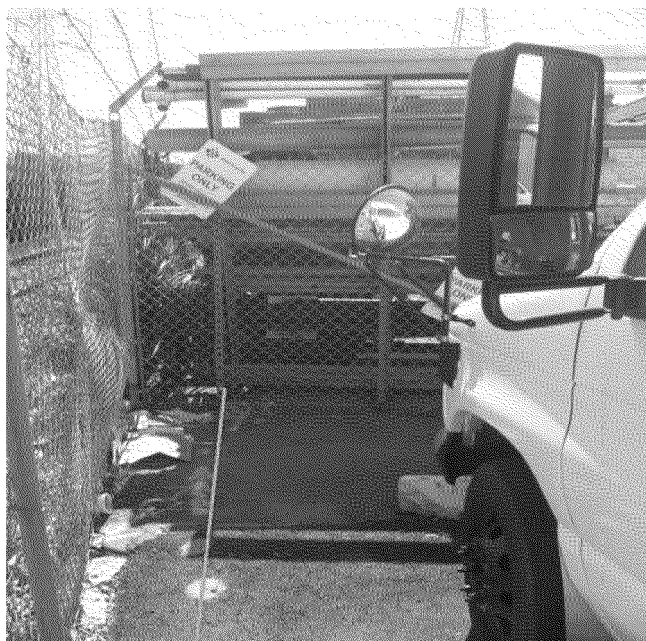
Standing on the line looking west southwest

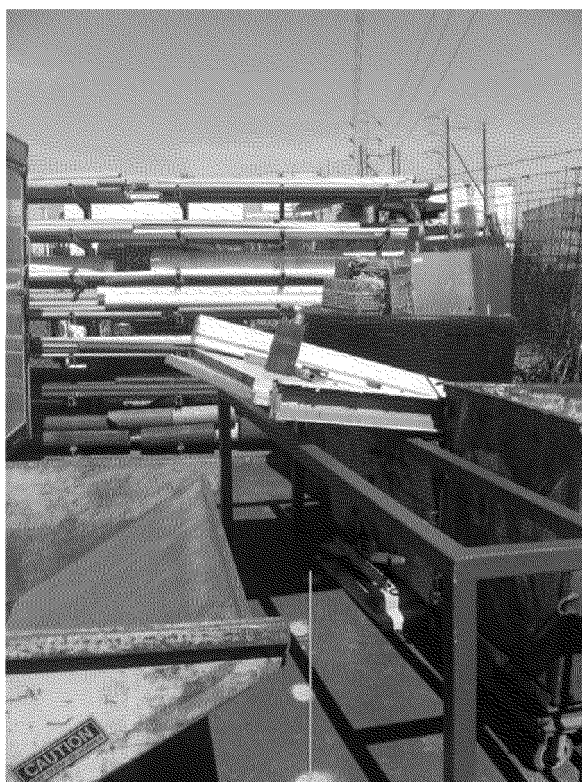
Standing on the line looking east southeast

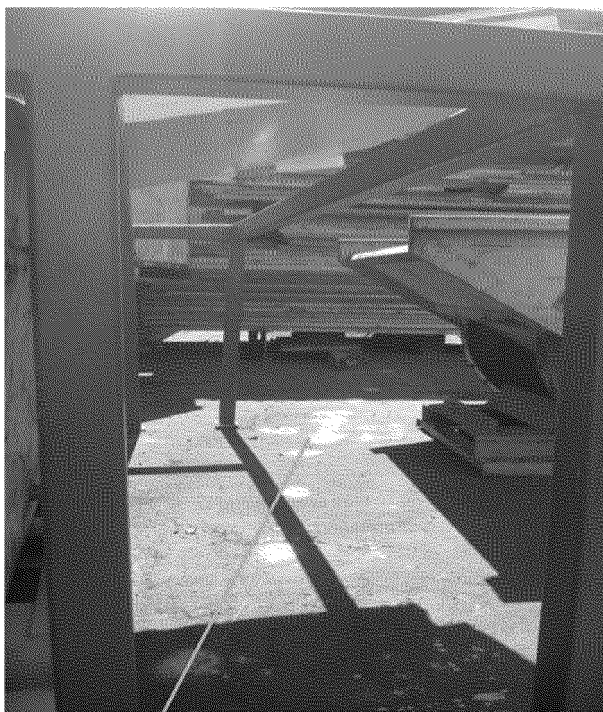
Standing on the line looking west southwest

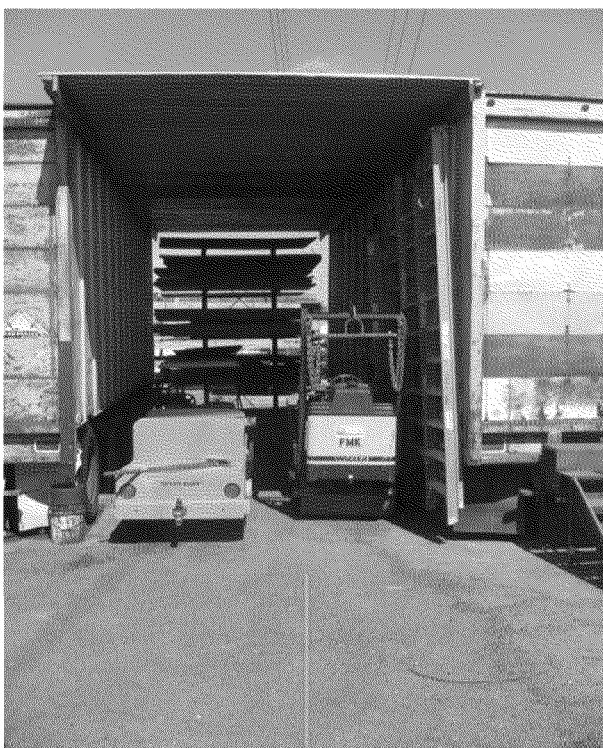
Standing on the line looking east southeast

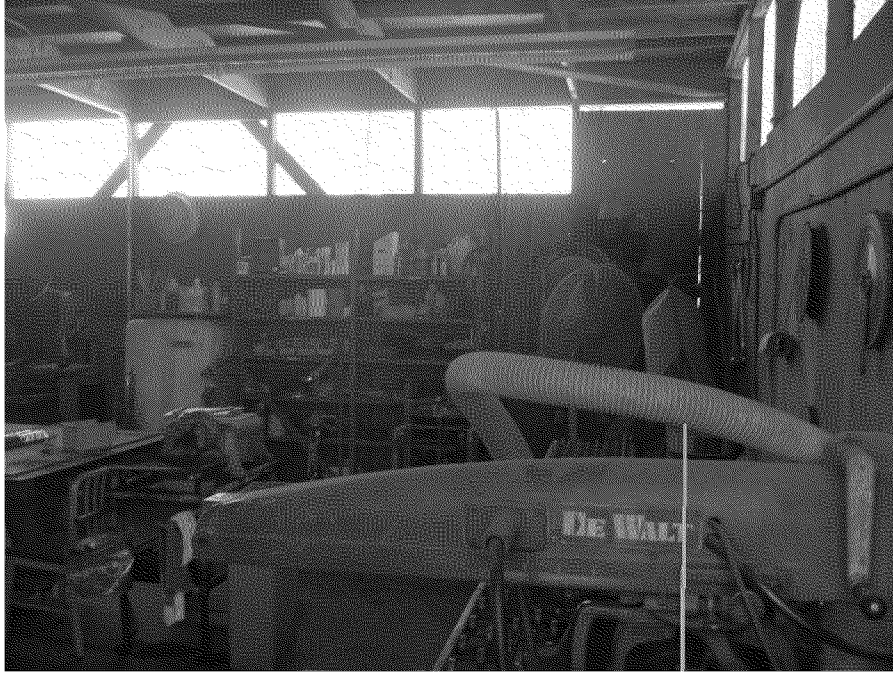
Standing on the line looking west southwest at the only non-removable structure an old shed

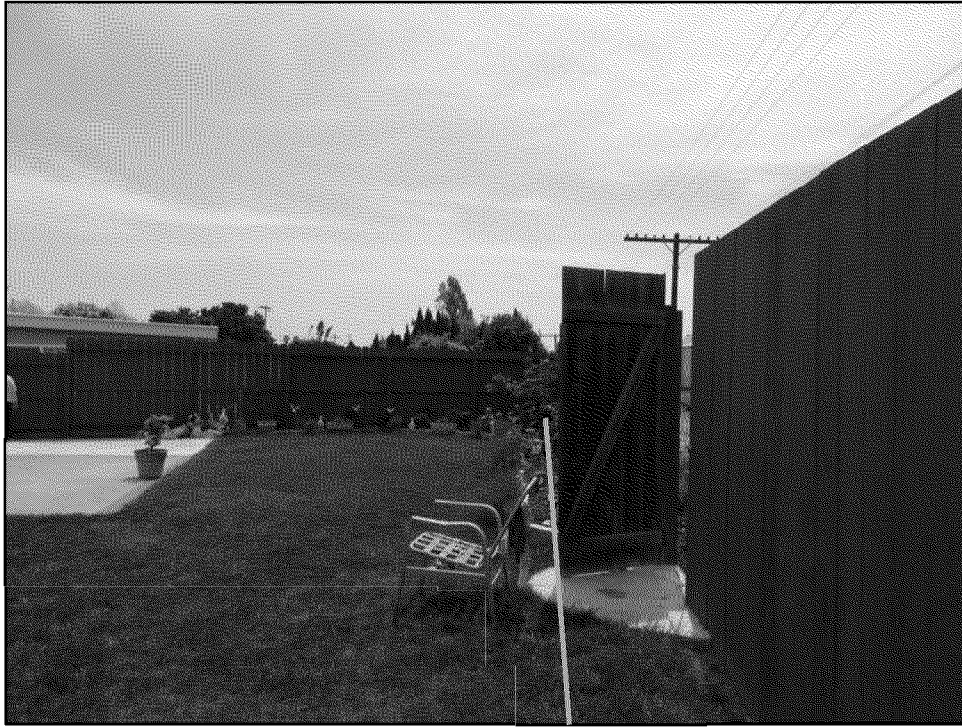
Standing on the line looking southeast.

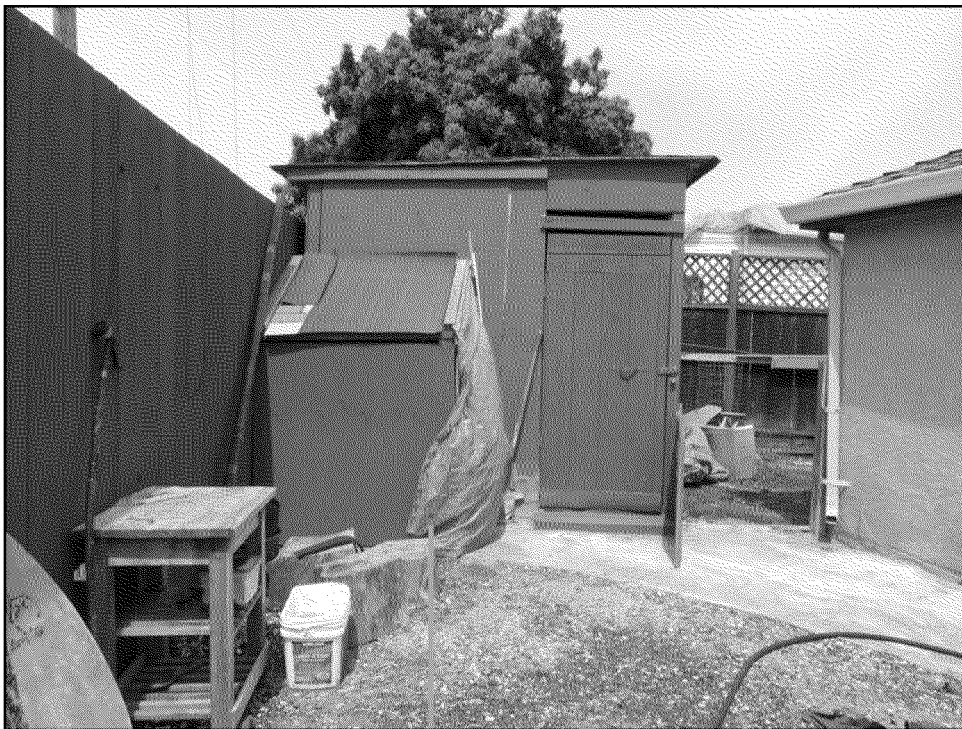
Standing on the line looking to the northwest. Shed is over the top of the line.

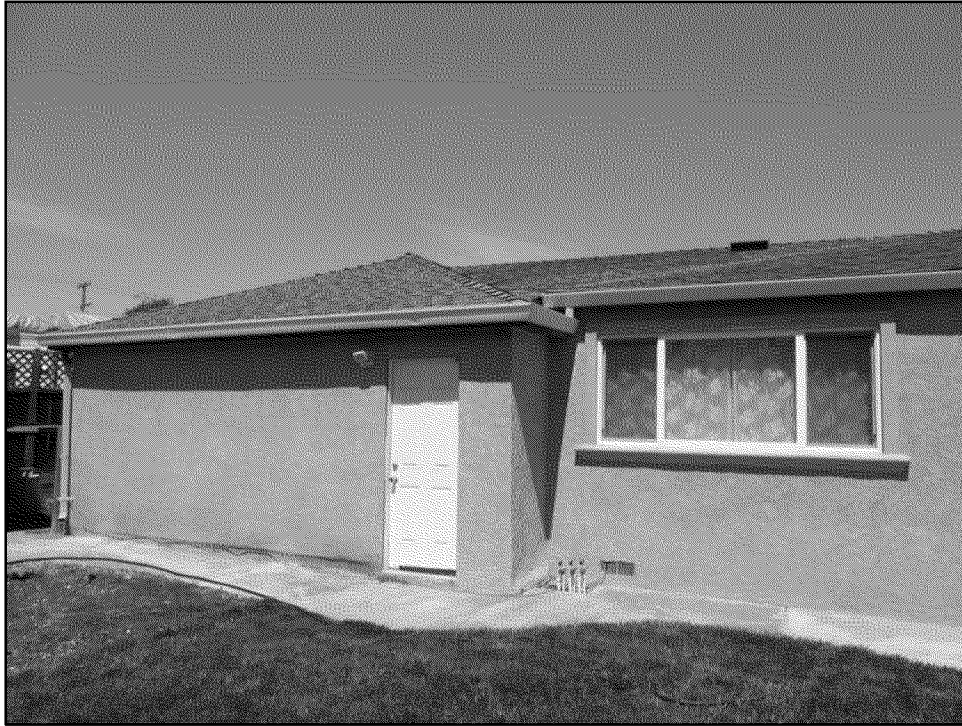
1.43' of the house is within the easement area.

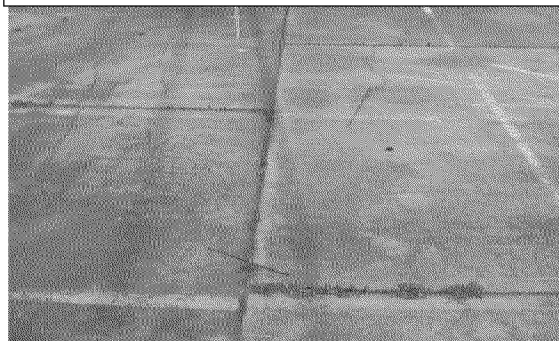
Standing on the line looking east northeast at major encroachment which is an abandoned office building

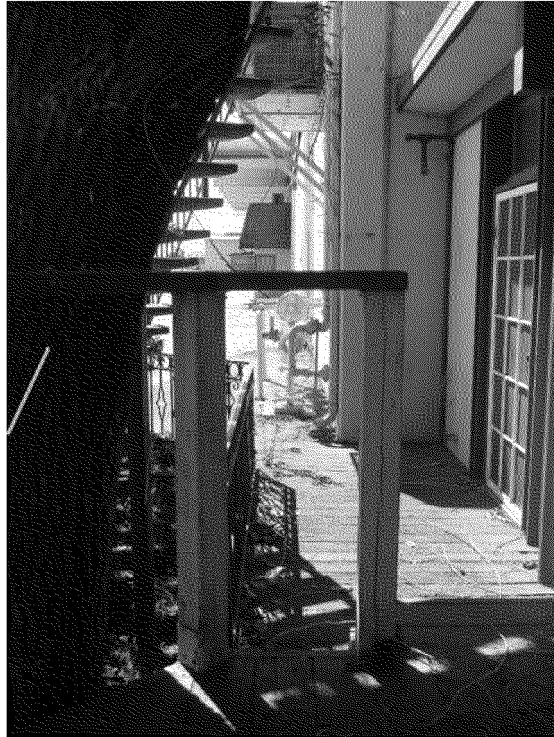
Standing to the right of the line looking southwest through the office building

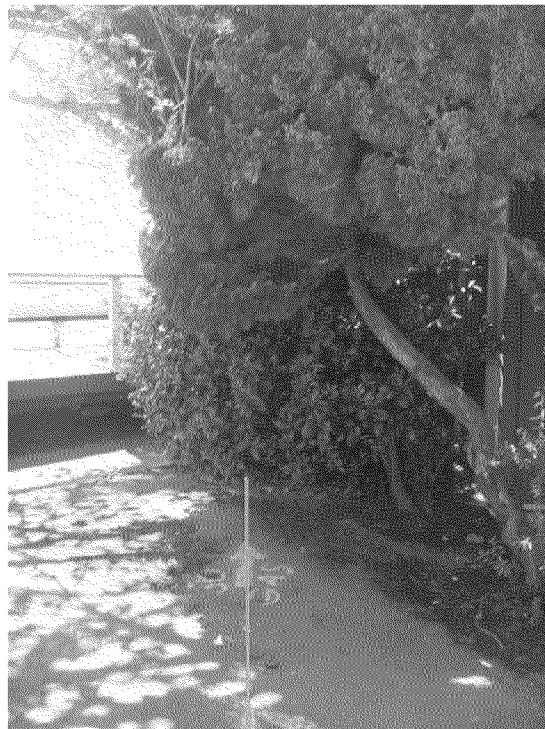
Standing on the line behind the building looking southwest there is a deck on the left

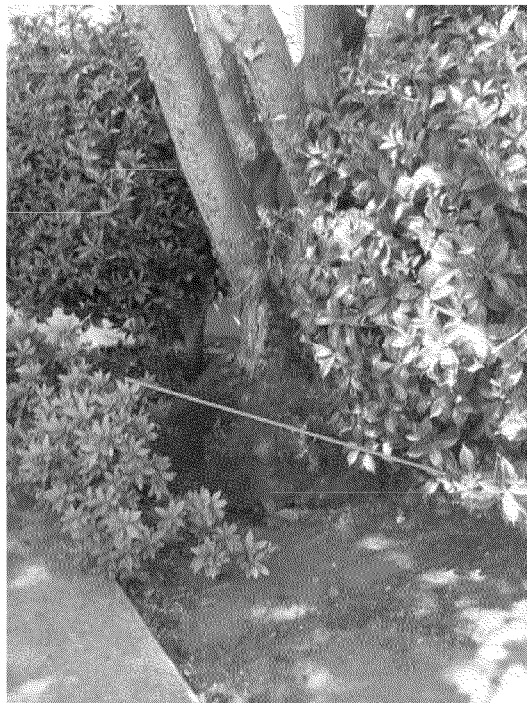
Standing behind the line looking at a cherry blossom tree that is possibly growing on top of the line

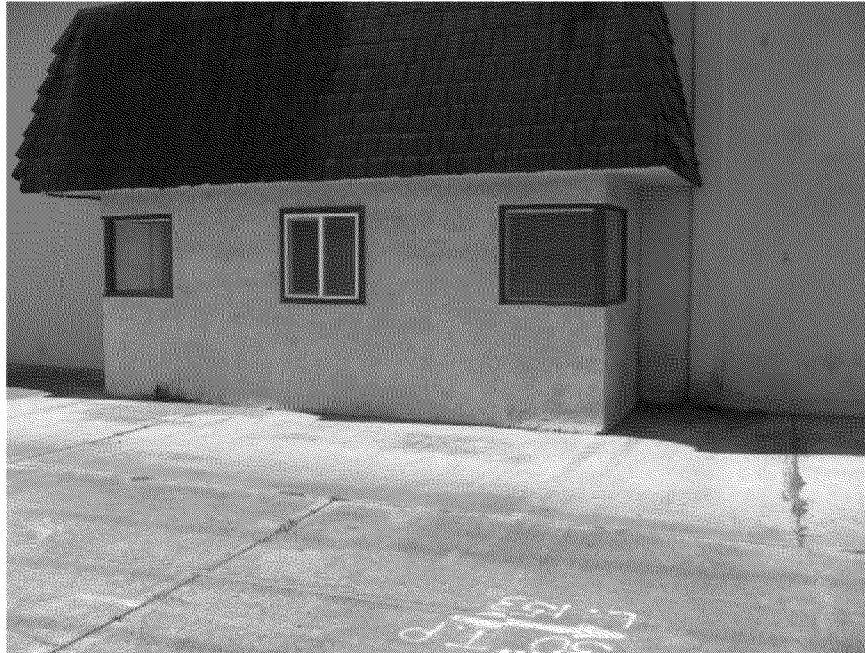
Standing behind the line looking at a permanent structure

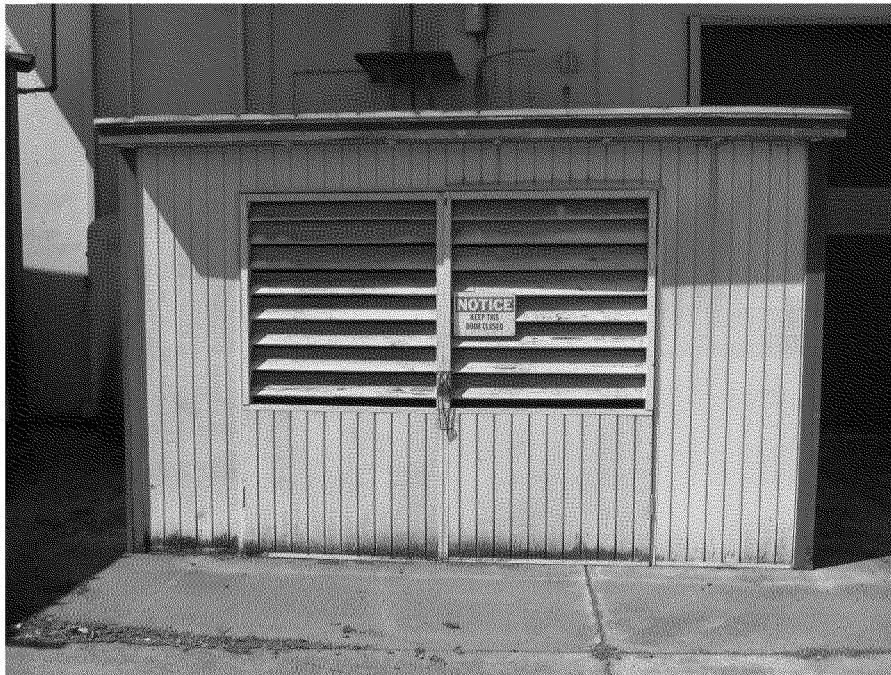
Standing on the line looking at the first shed

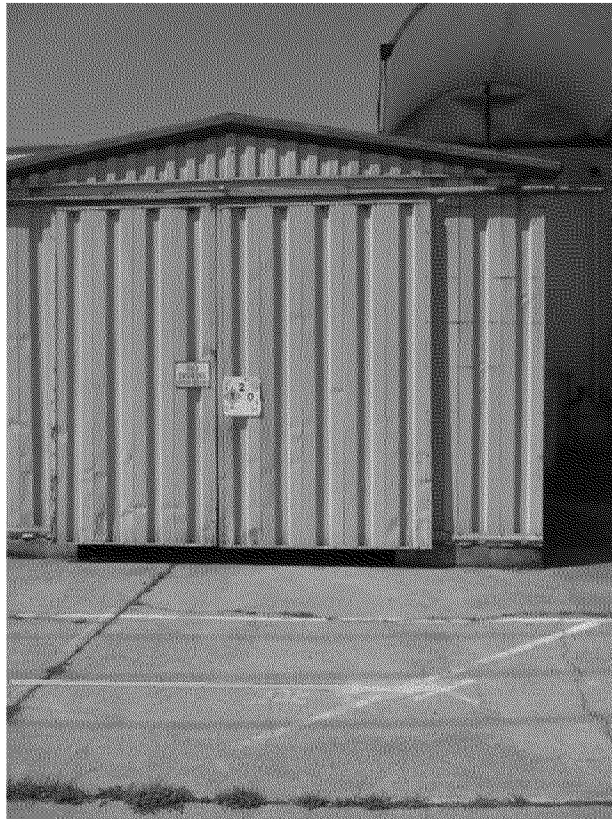
Standing behind the line looking at the shed
