Land & Environmental Management

Encroachment Pilot Report of Findings

Final Report: Redacted

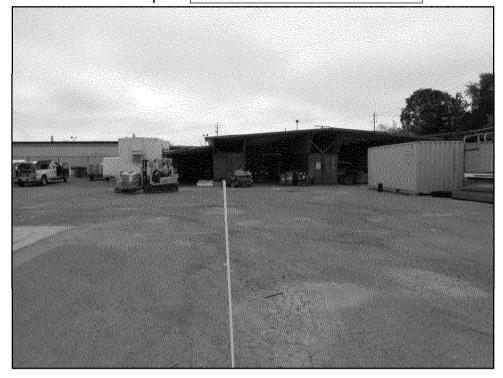
Standing on the line looking north.

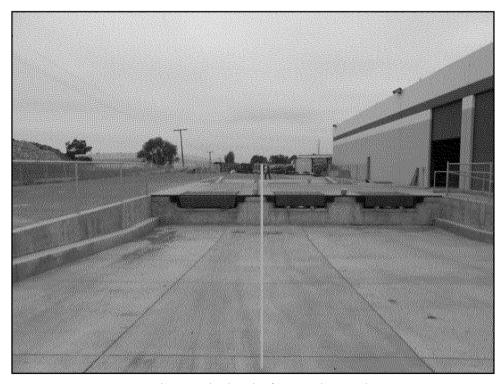
Standing on the line looking to the south.

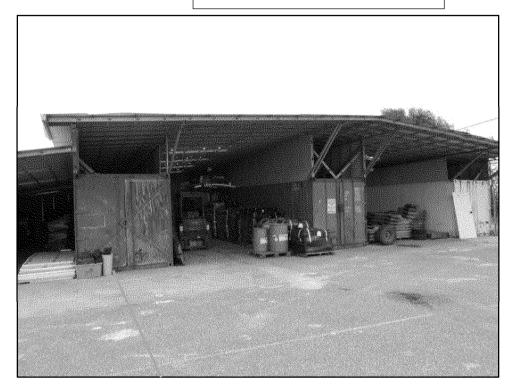
This property has two major issues:

- 1. A portion of a storage area is directly over the gas line and within the easement area.
- 2. Loading docks for heavy trucks have been constructed over the gas line and within the easement. Cover over the gas line has been reduced to approximately 15 inches.

Building is over the easement.

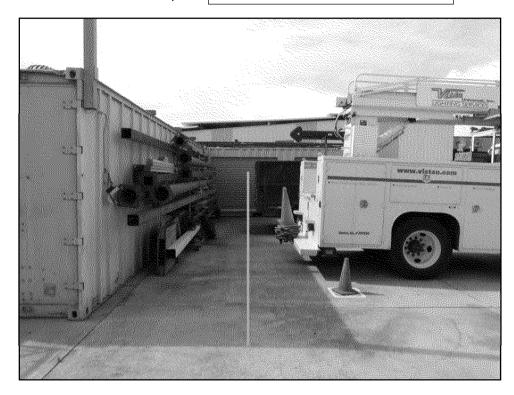
Standing on the line looking northeast.

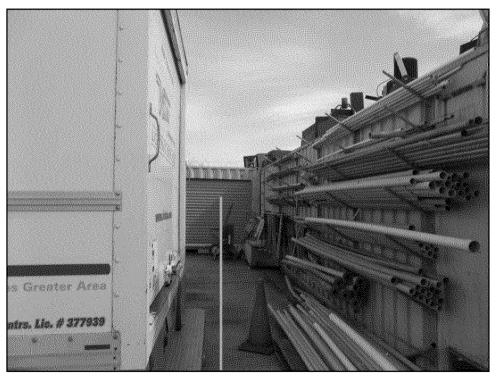
Standing on the line looking southwest.

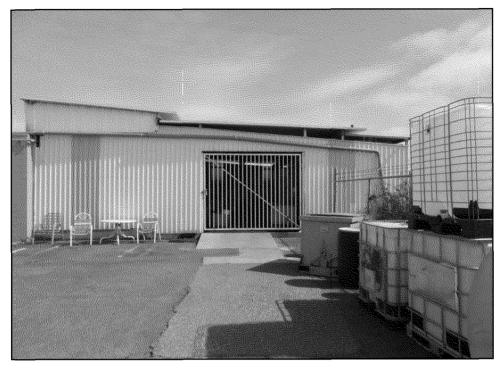
Summary:	
Redacted	building is entirely across PG&E's easement and over the pipeline across th
entire parcel.

Building is over the line.

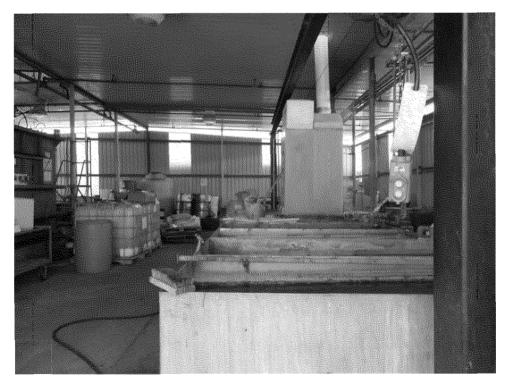
View inside the industrial shed over the line.

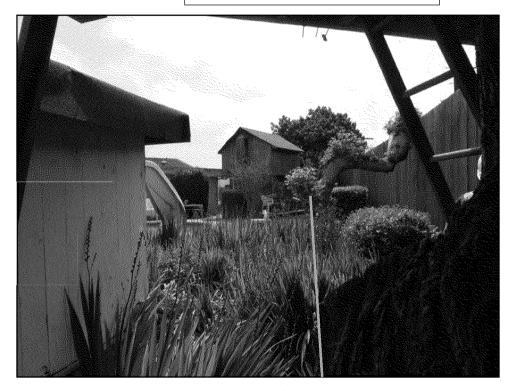
Standing on the line looking northwest.

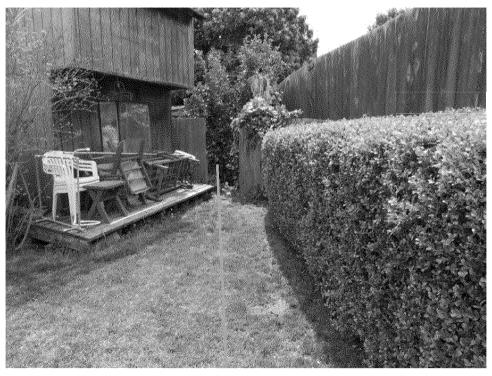
Standing on the line looking to the northwest.

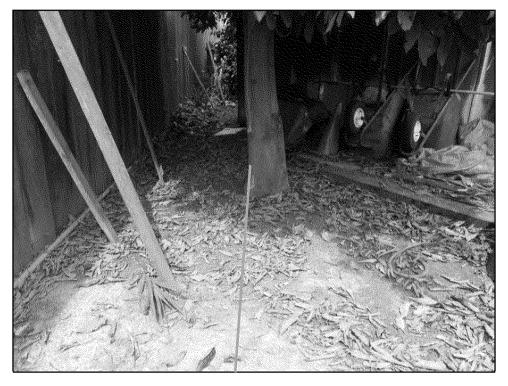
Standing on the line looking to the southeast.

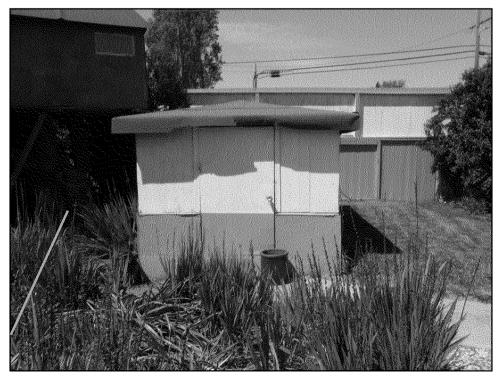
Shed within the easement area.

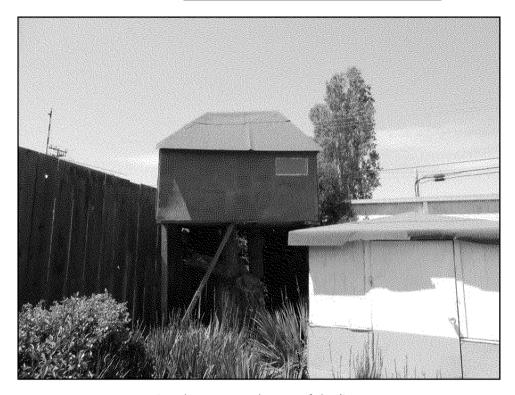
Tree house over the top of the line.

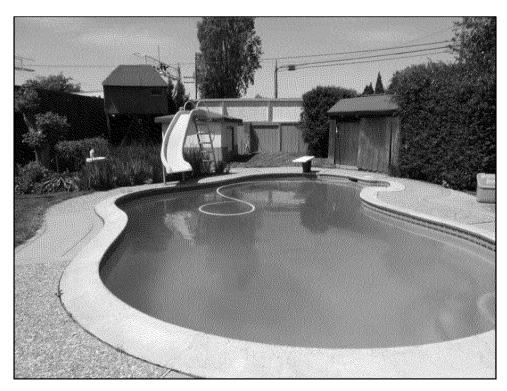
Pool deck within the easement area.

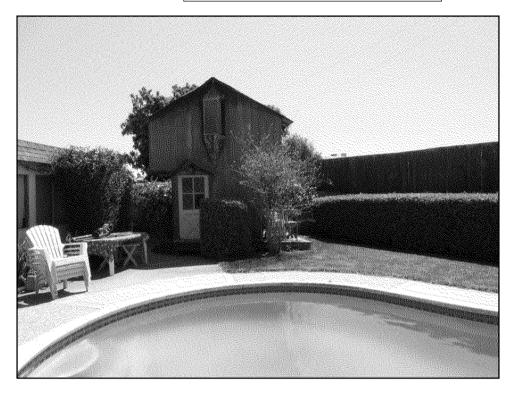
House within the easement area.

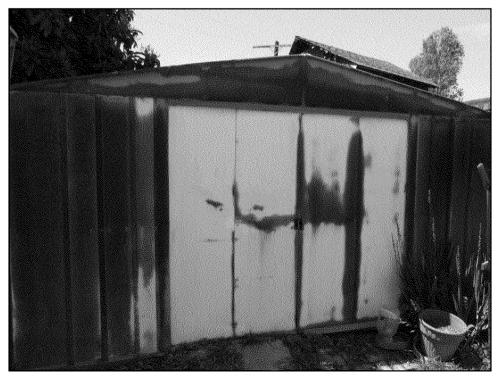
Shed within the easement area.

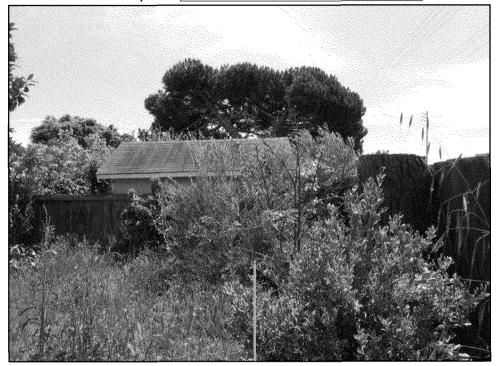
Standing on the line looking southeast.

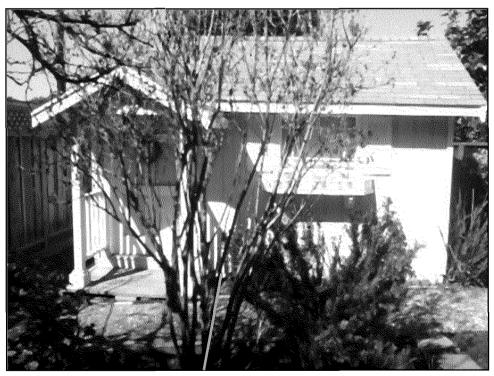
Wood Structure Playhouse is located on top of the pipe and is within the easement.

Playhouse is over the top of the line.

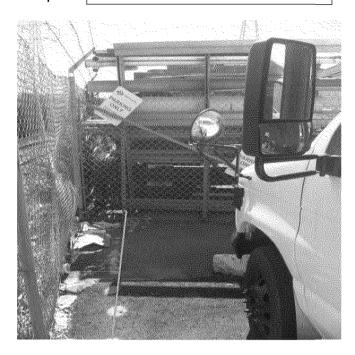
Standing on the line looking west southwest

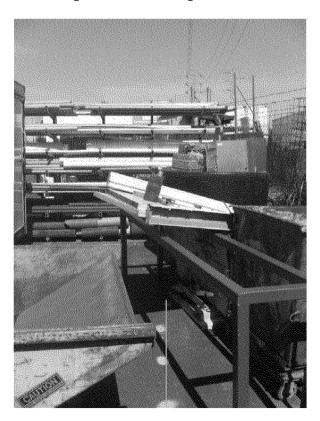
Standing on the line looking east southeast

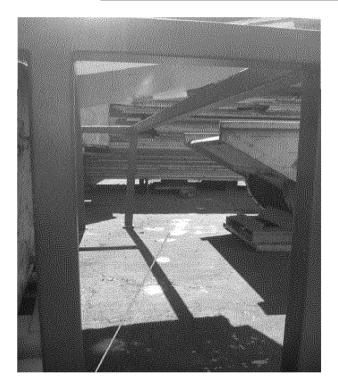
Standing on the line looking west southwest

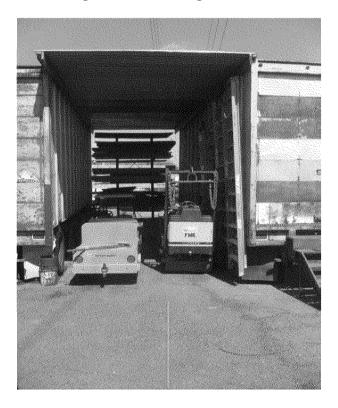
Standing on the line looking east southeast

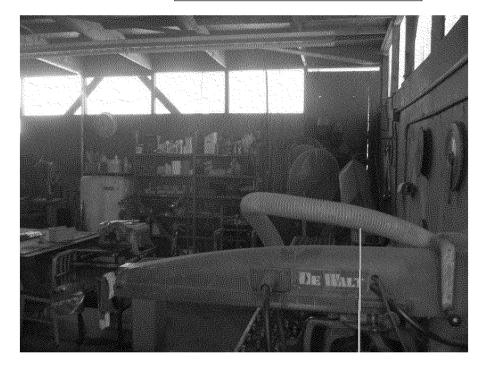
Standing on the line looking west southwest at the only non-removable structure an old shed

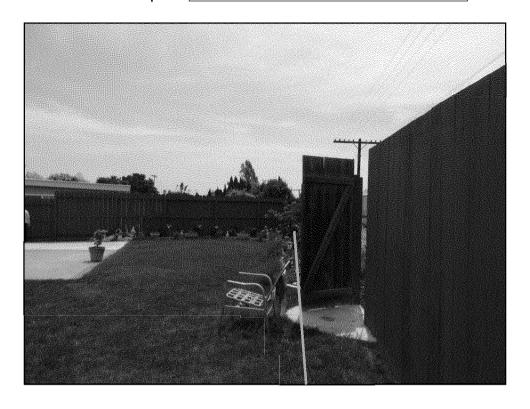
Standing on the line looking southeast.

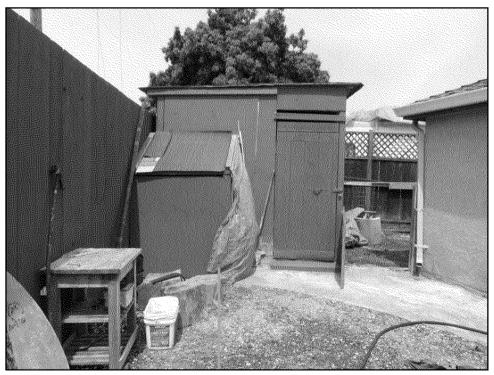
Standing on the line looking to the northwest. Shed is over the top of the line.

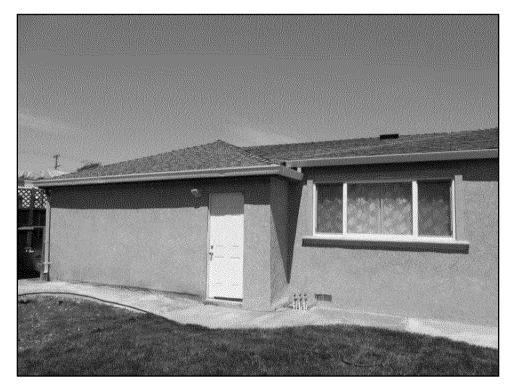
1.43' of the house is within the easement area.

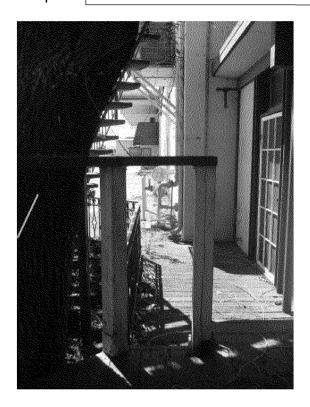
Standing to the right of the line looking southwest through the office building

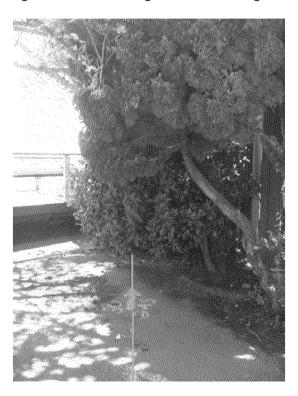
Standing on the line behind the building looking southwest there is a deck on the left

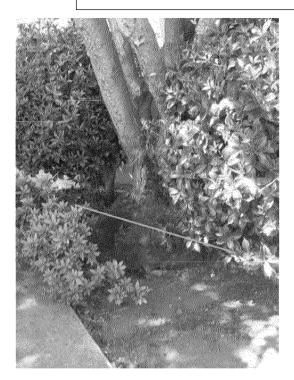
Standing behind the line looking at a cherry blossom tree that is possibly growing on top of the line

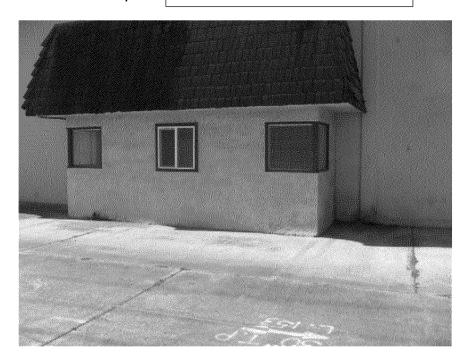
Standing behind the line looking at a permanent structure

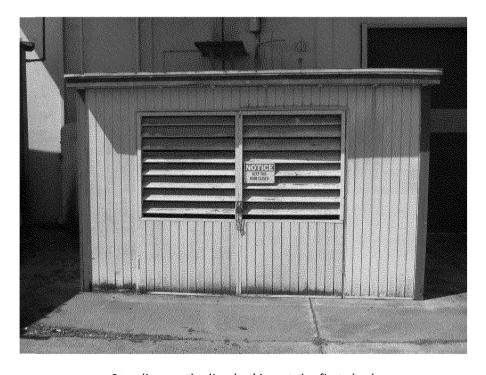
Standing on the line looking at the first shed

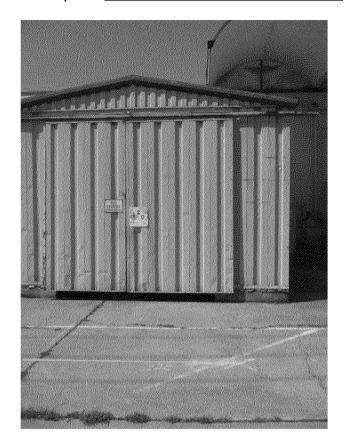
Standing behind the line looking at the shed
