**Root Cause Analysis Report:
Worker Fatality
PG&E - Kern Power Plant Demolition
Bakersfield, CA**

Location of Incident: Kern Power Plant, Bakersfield, California
Date of Incident: Tuesday, June 19, 2012, approximately 9:20 a.m.
Type of Incident: Worker fatality; struck by collapsing tank wall

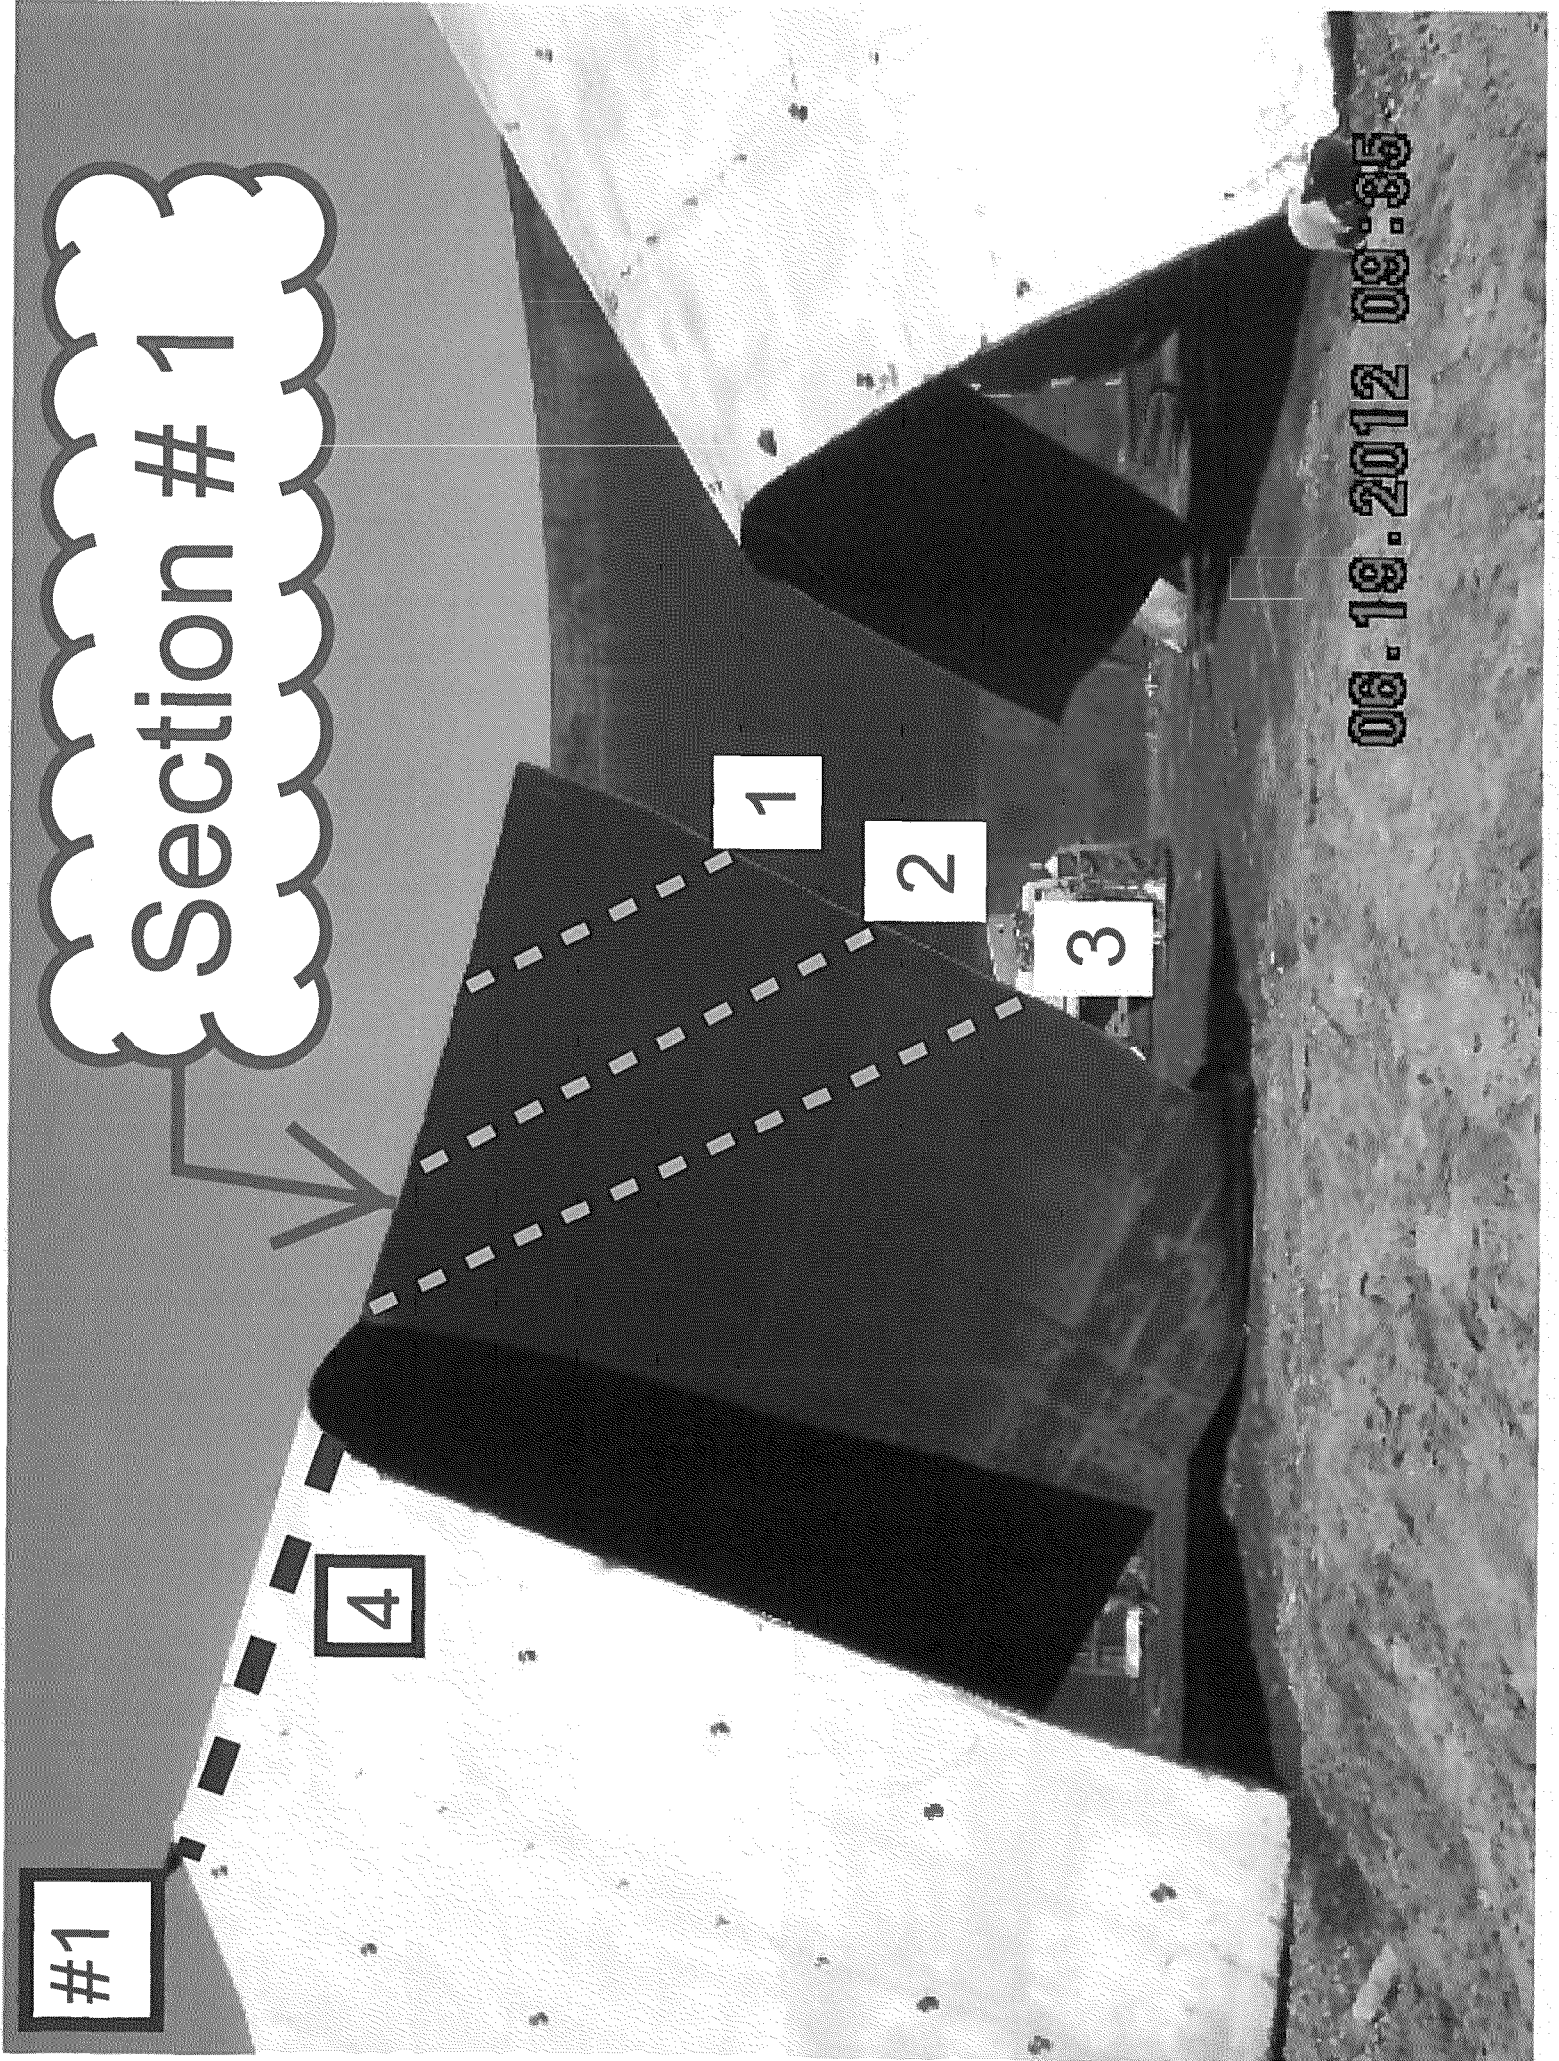
Section #1

1. Back drag and level tank perimeter areas for boom lift operations using a track loader
2. Torch man will work from a boom lift positioned outside the tank cutting 3 strips of the cantilevered portion of section #1 of the tank finishing with cut #4, felling the section within the tank(see photo #1)

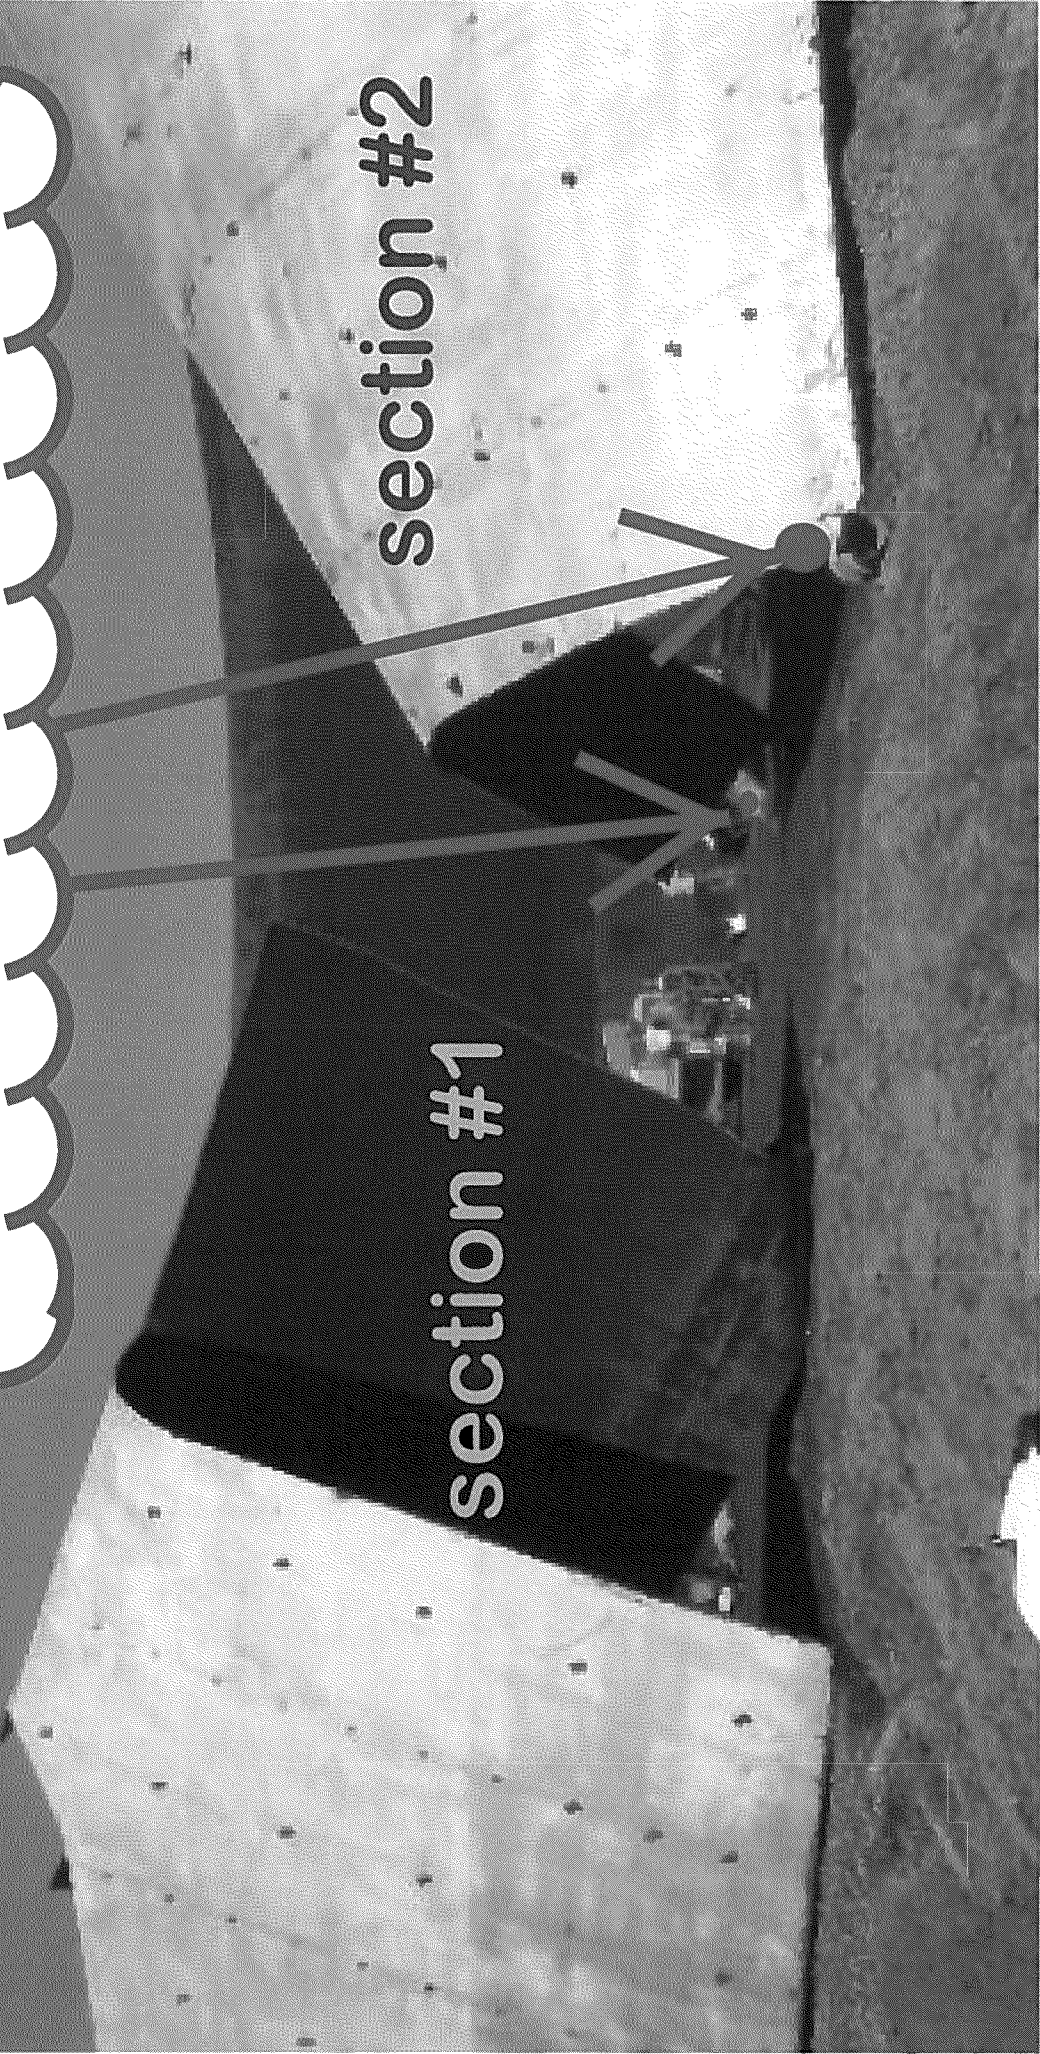
#2

Connection points for griphoist cables

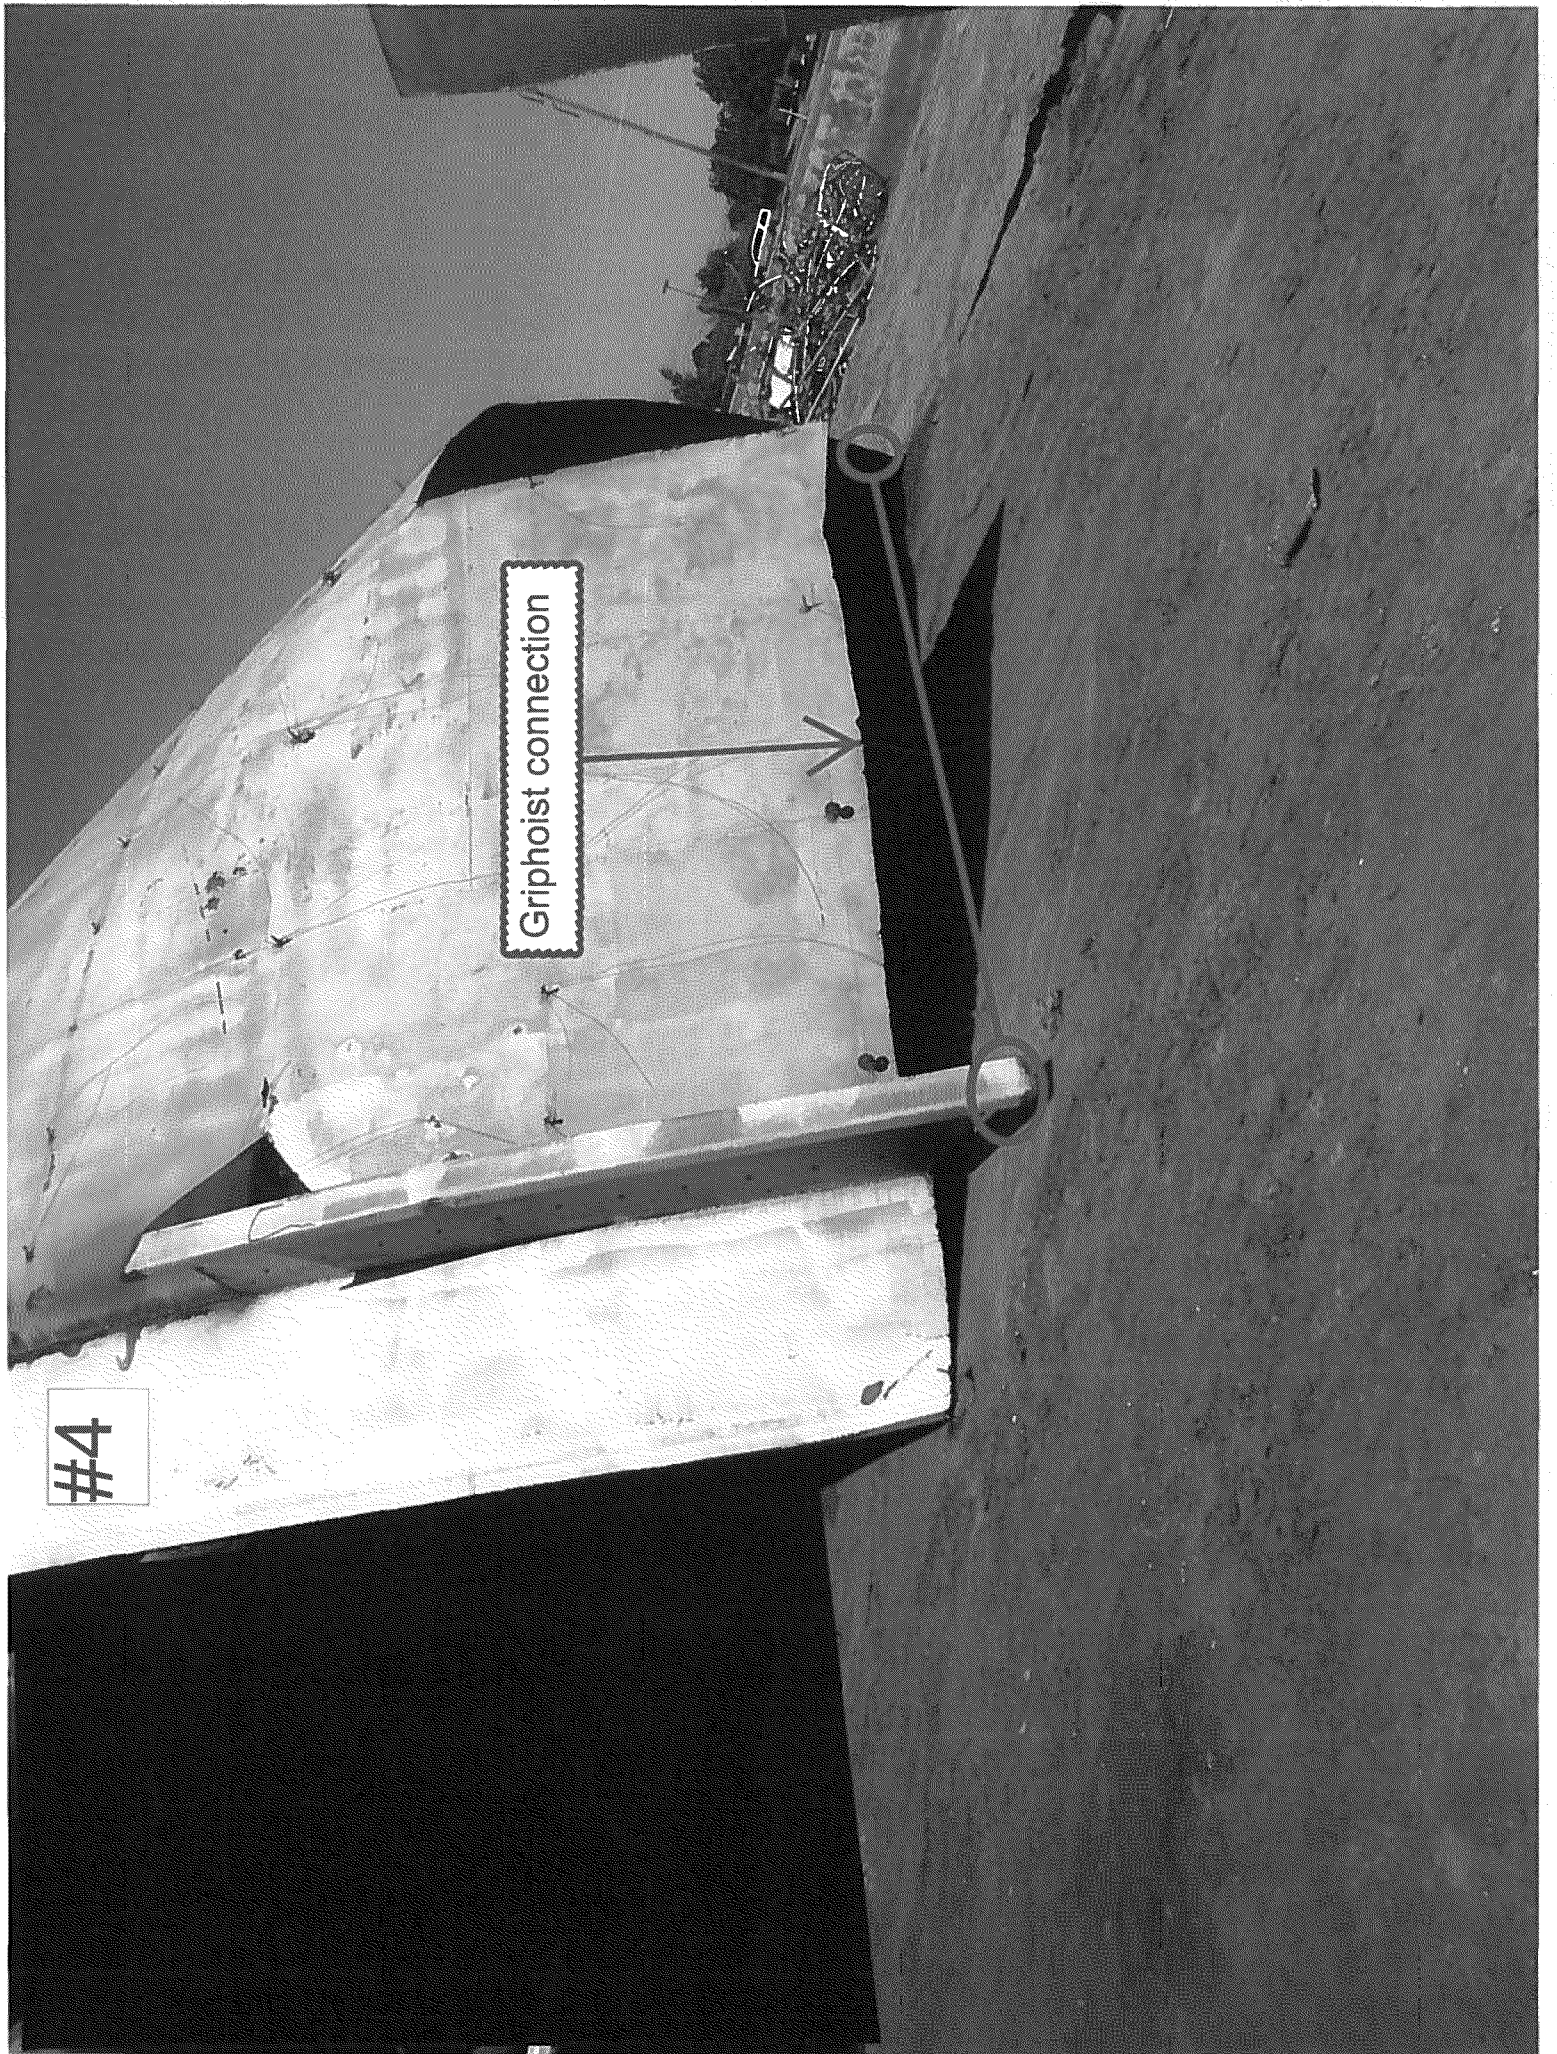
#4

griphoist cable connection point to failed section @ stiffner plate

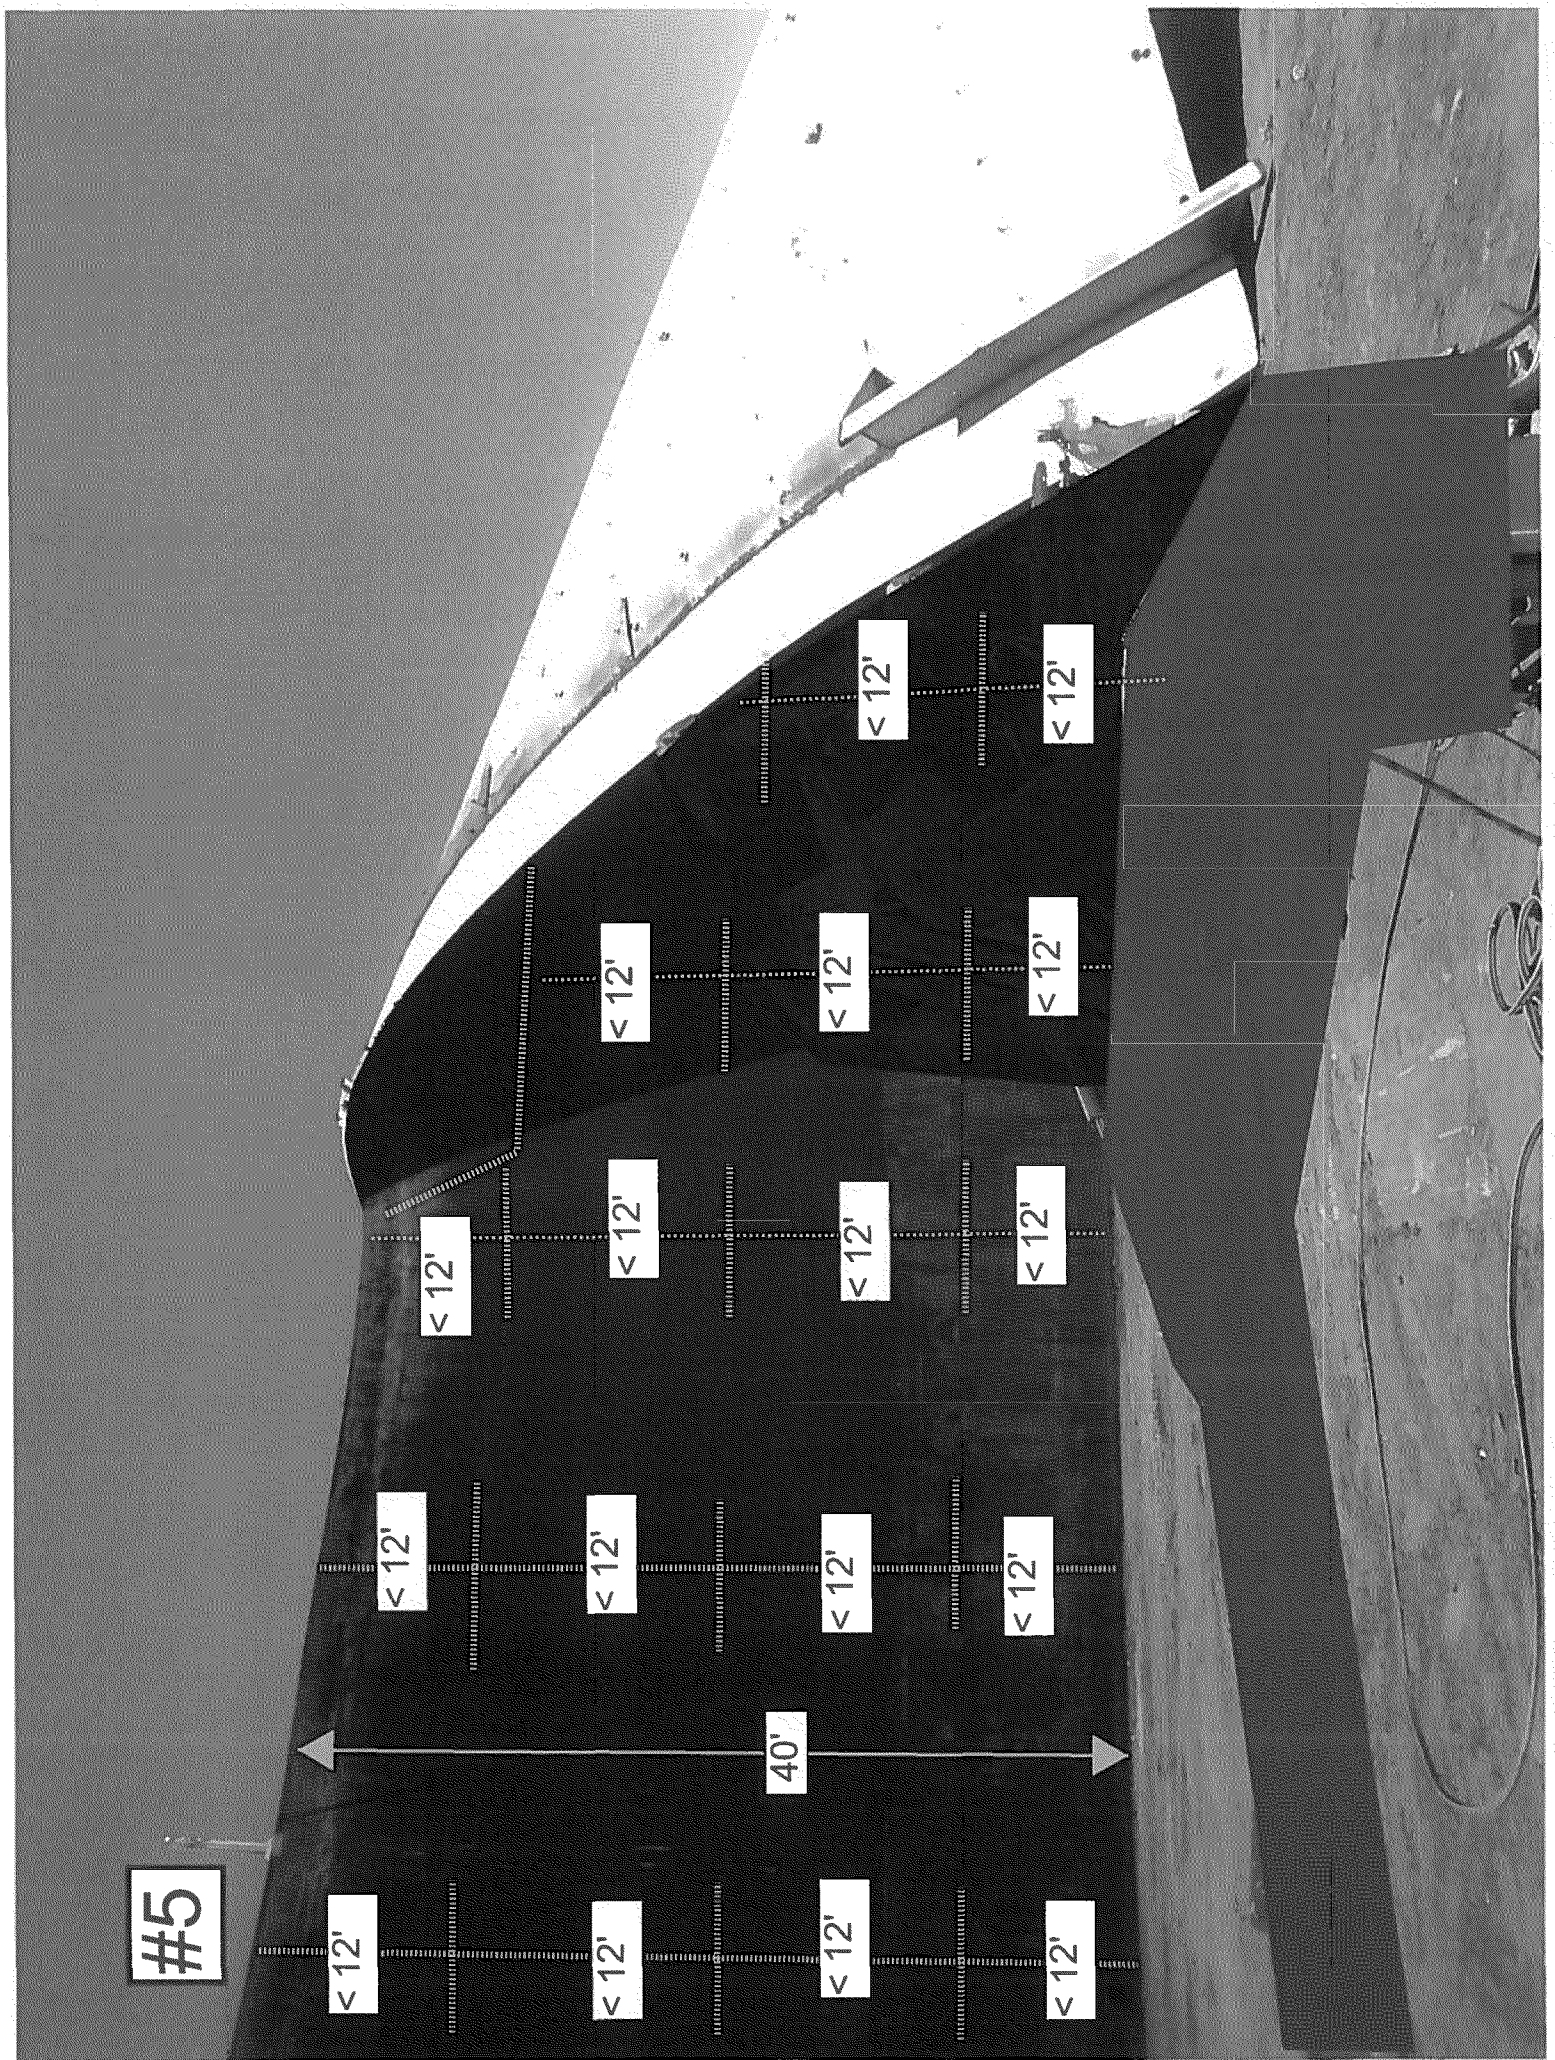
Griphoist connection

Normal tank removal activities will resume working from the outside of the tank as detailed in photo #5 and the tank removal plan enclosed

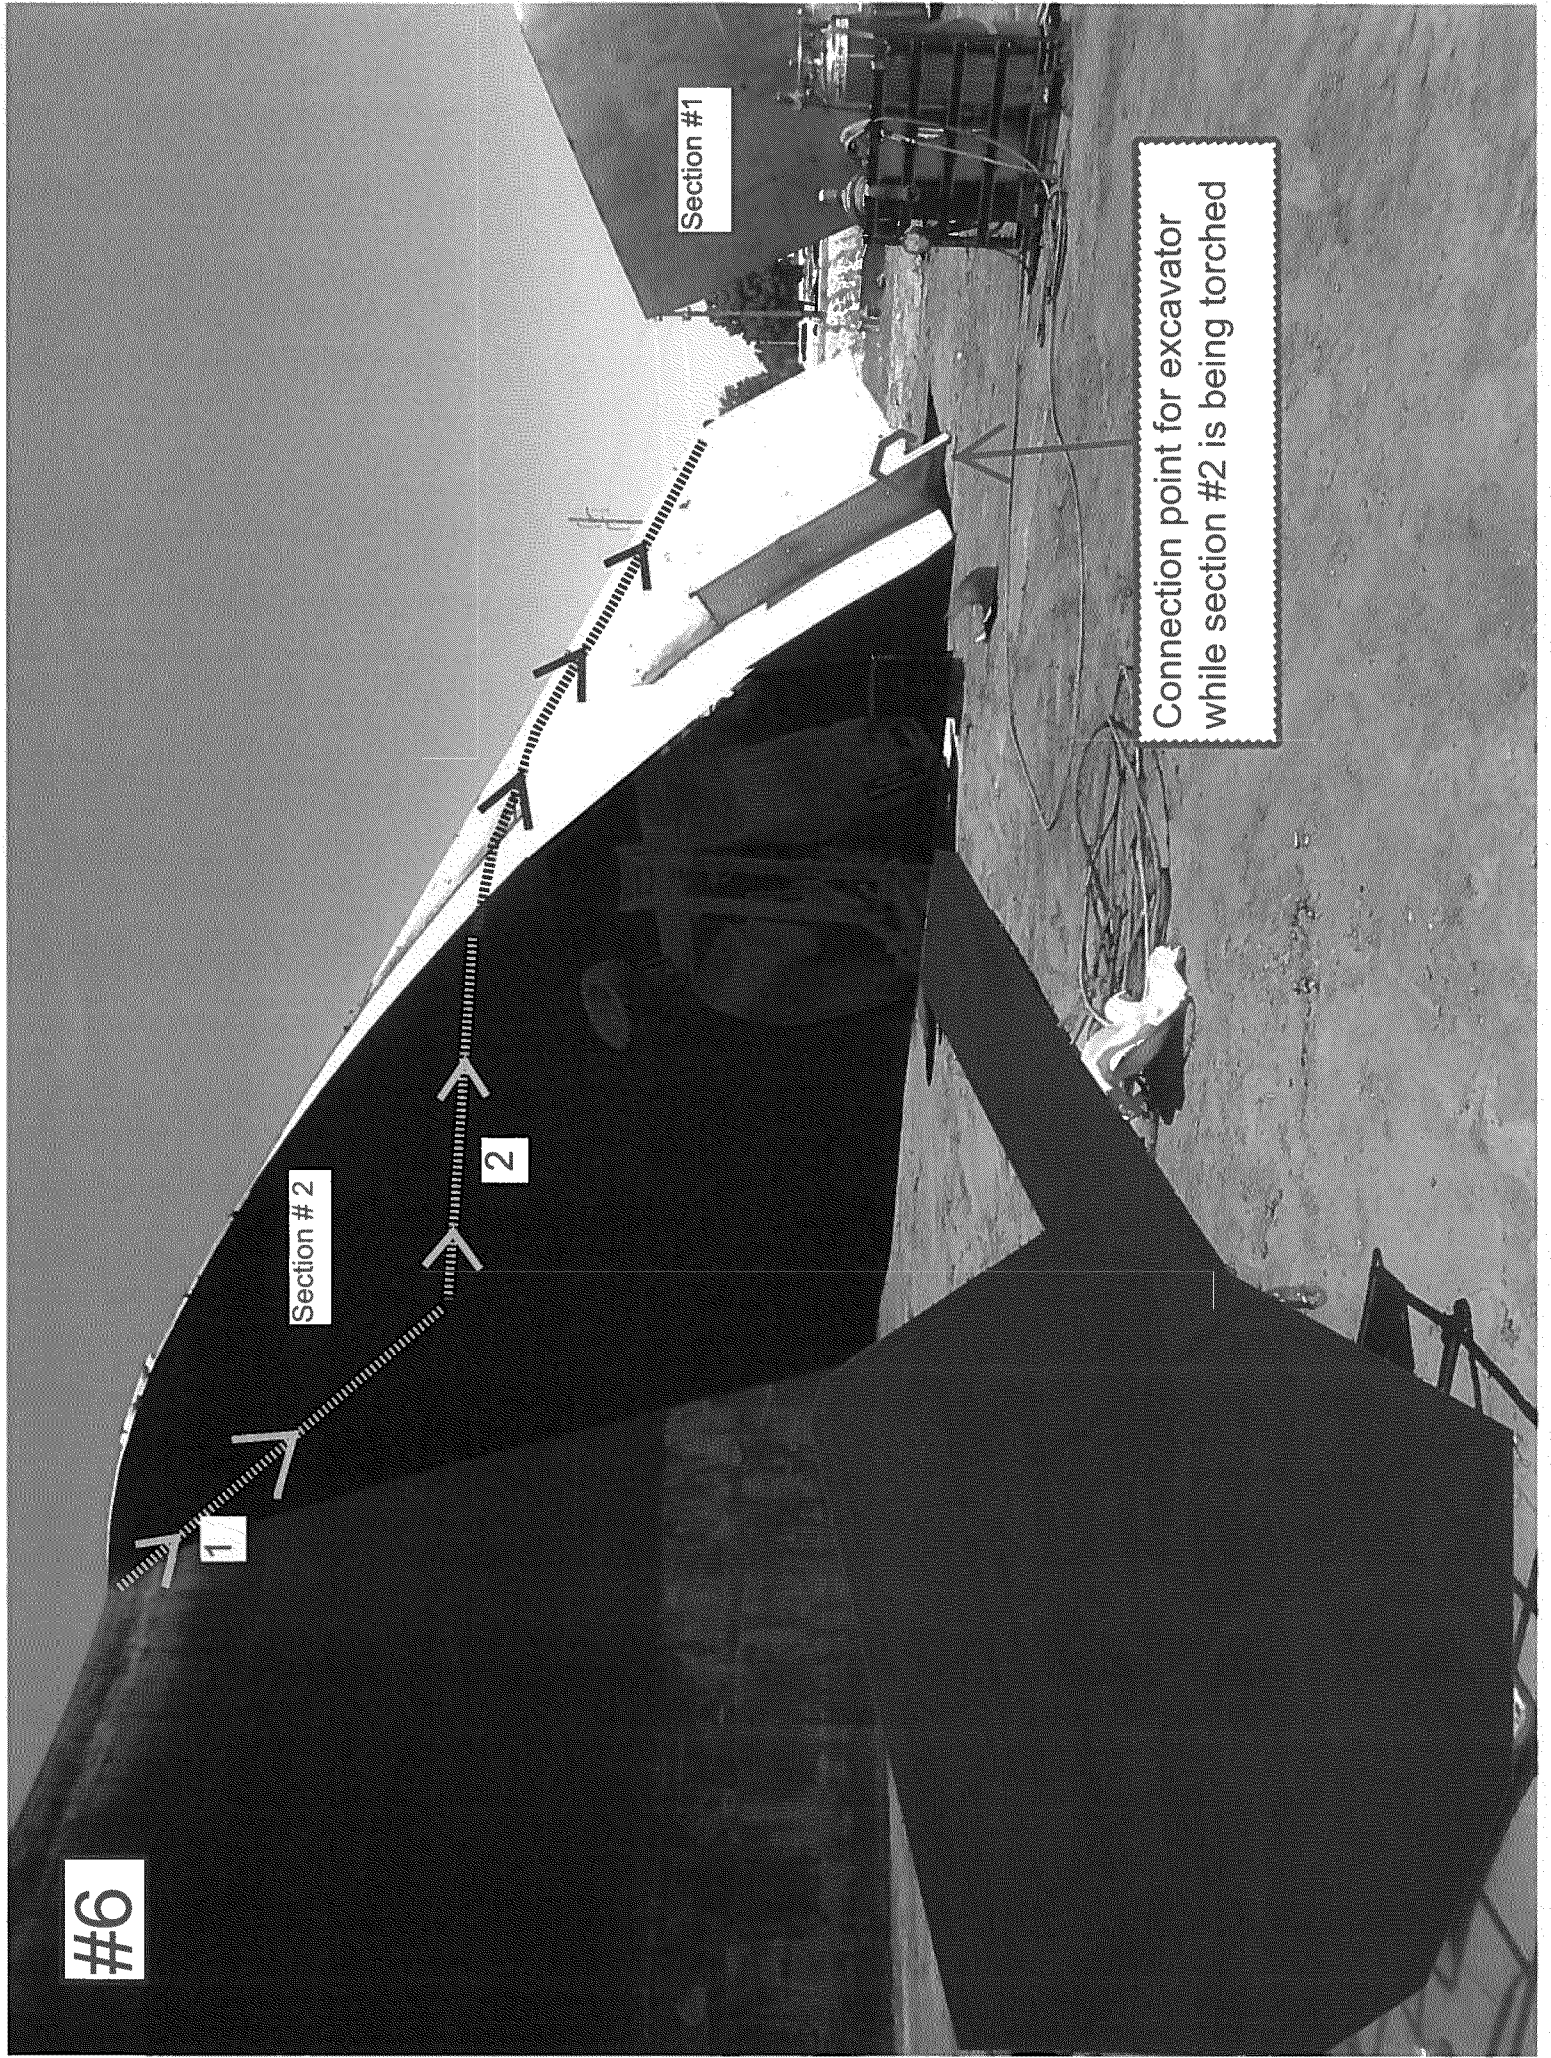
Connection point for excavator while section #2 is being torched

3. A grapple mounted excavator will remove fallen section #1 to a processing area.
4. The excavator will then re-position to the interior of the tank and secure the grapple to the stiffener plate as indicated in photo #6. This will stabilize section #2 while the curvature is removed by torching.

5. Torch man will work from boom lift positioned outside section #2 of the tank and begin torch cutting along cut line 1 down to ring #3 of the tank.
6. Torching will continue laterally along ring #3 as illustrated with line 2 of photo #6 through to the north end of the section.
