**Root Cause Analysis Report:  
Worker Fatality  
PG&E - Kern Power Plant Demolition  
Bakersfield, CA**

**Location of Incident:** Kern Power Plant, Bakersfield, California  
**Date of Incident:** Tuesday, June 19, 2012, approximately 9:20 a.m.  
**Type of Incident:** Worker fatality; struck by collapsing tank wall

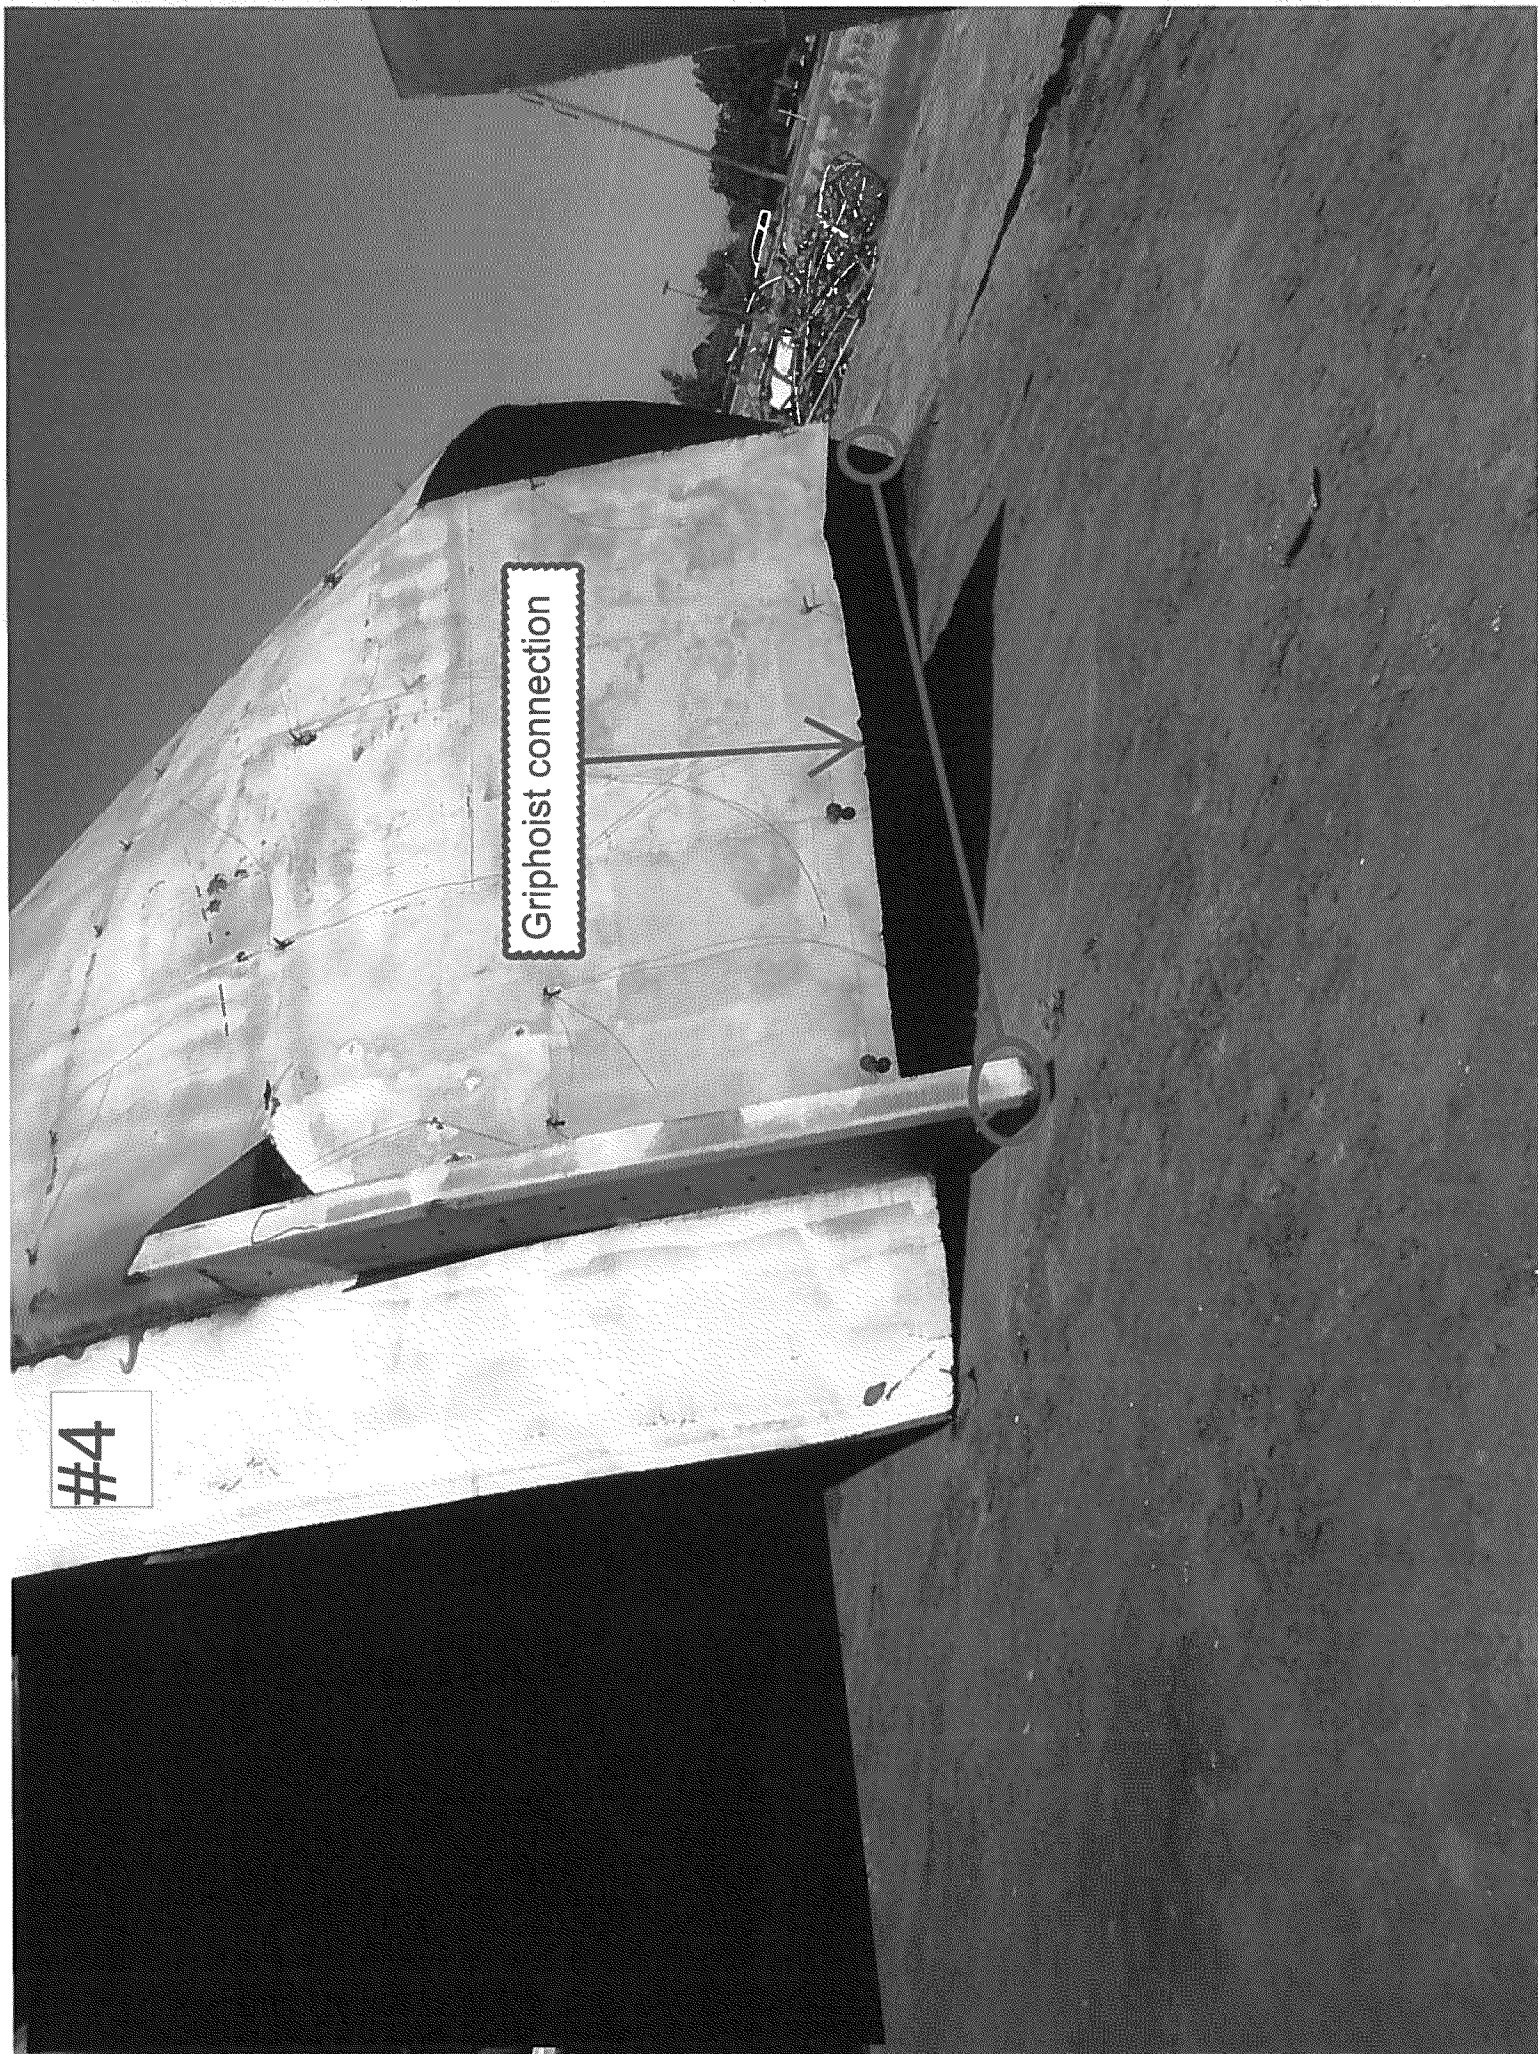
#3

grip hoist cable connection point to failed section @ stiffener plate
