**CALIFORNIA PUBLIC UTILITIES COMMISSION
Consumer Protection and Safety Division
Utilities Safety and Reliability Branch
Incident Investigation Report**

Incident E 20100317-01

Utility: Pacific Gas and Electric (PG&E)

Date and Time of the incident: 3/17/2010, 10:01:00 AM

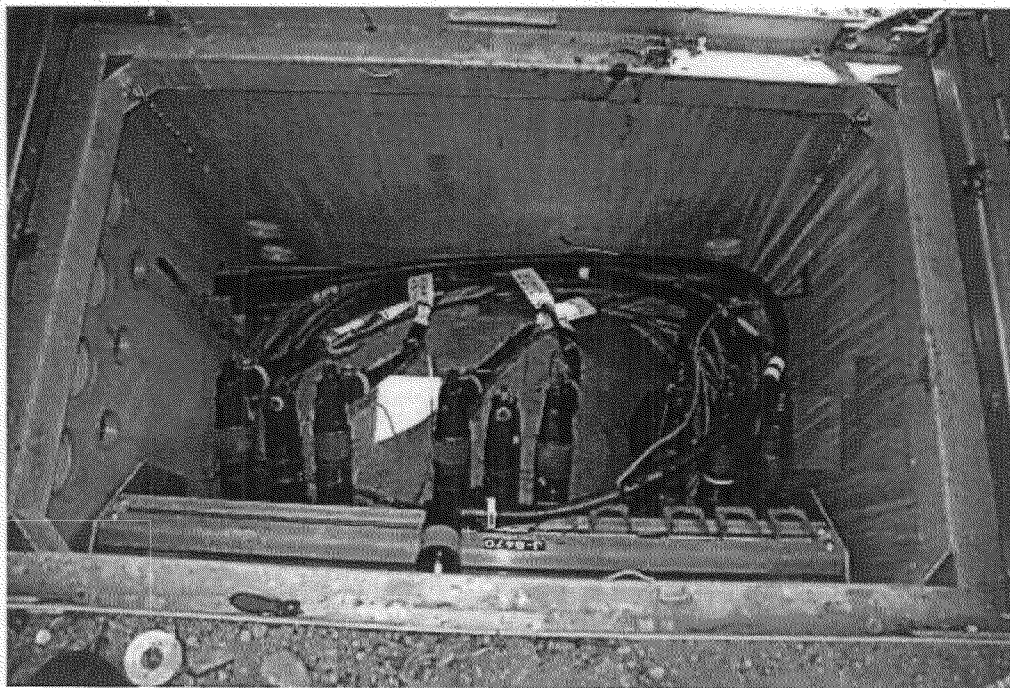
Picture 1
Junction Box

On March 17, 2010, at 1001 hours, a PG&E General Construction Lineman, Redacted, Redacted, with 5 years of experience, was fatally injured when he made contact with an energized bushing while working in a junction box. See Picture 1, titled *Junction Box* shows the junction box where the contact occurred.

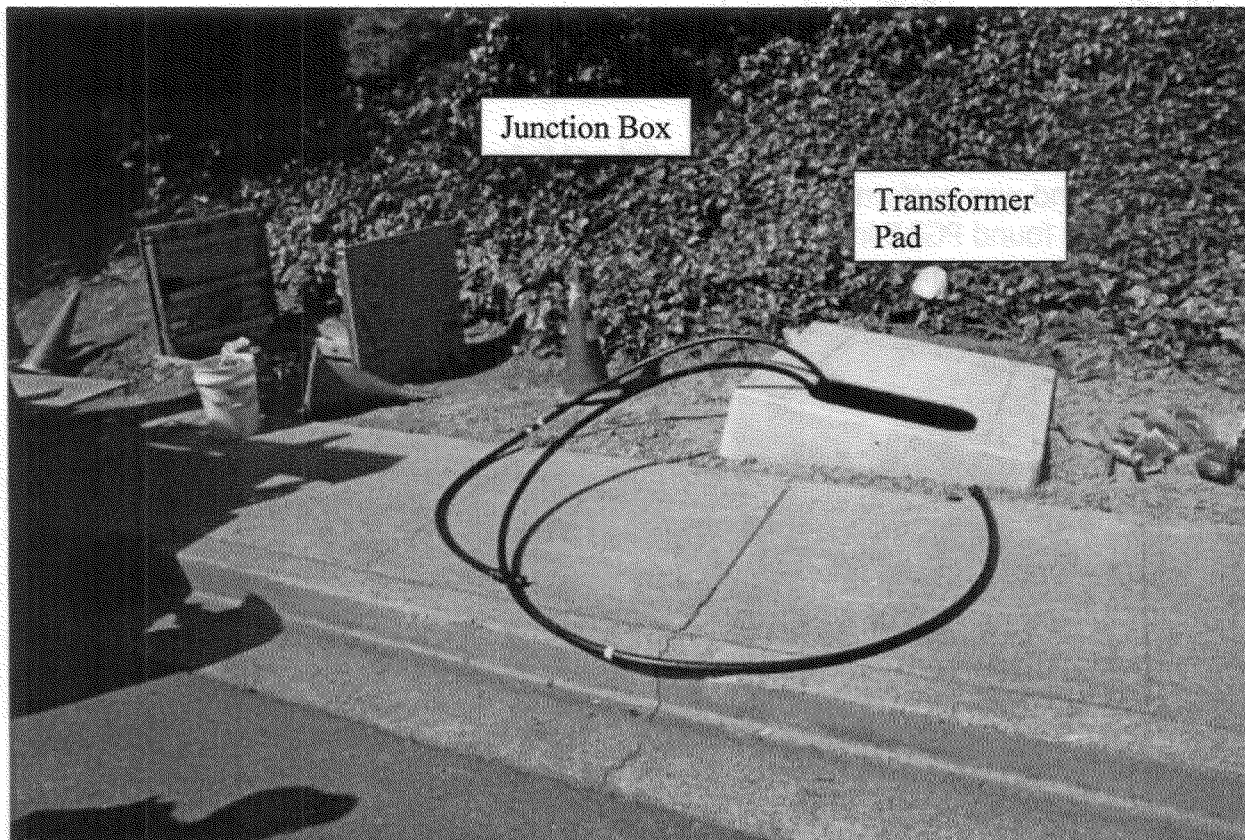
Picture 2
Energized Junction Box

[Redacted] was part of a four person crew assigned to install a new pad-mounted 23 kVA dead-front, load break transformer. Three crew members of the crew were on site and in the process of installing two primary conductors between an energized junction box and the new transformer pad. Picture 2, titled *Energized Junction Box* shows an overview of the scene. [Redacted] was inside the energized junction box pushing the cables into the transformer pad, where the transformer had yet to be placed. The other two crew members were located at the transformer pad, receiving the cables. The end of the cables in the junction box had load break elbows installed on them. While inside the energized junction box [Redacted] removed by hand an insulated cap from the junction box and the associated ground wire from an energized bushing. [Redacted] began to install one of the two new load break elbows by hand onto the exposed energized bushing. However, the ground wires of the partially seated load break elbows had not been attached to the ground scheme and were in contact with [Redacted] right leg.
