Pipeline Accident Report

Natural Gas Pipeline Rupture and Fire Near Carlsbad, New Mexico August 19, 2000

**NTSB/PAR-03/01
PB2003-916501
Notation 7310B
Adopted February 11, 2003**

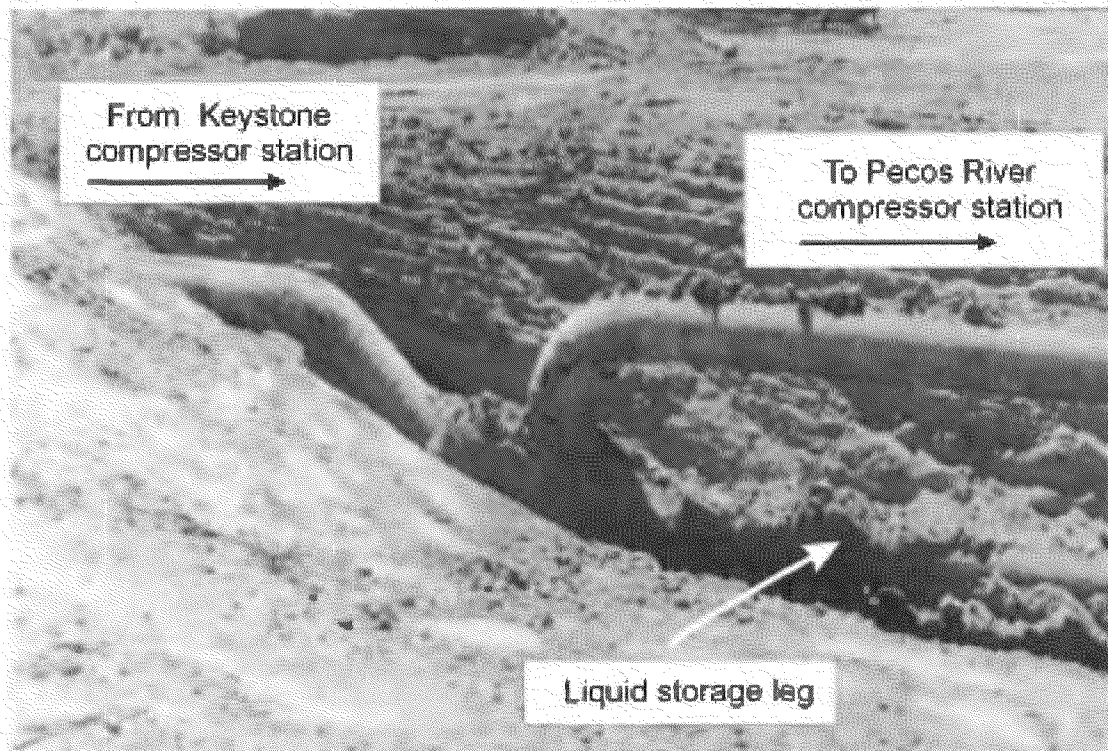
The drip¹⁷ between block valve No. 6 and the rupture site was removed from the pipeline and visually examined. The drip was found to contain a blackish oily-powdery/grainy material. At the area of its heaviest concentration, about 13 feet from the drip opening, this material filled approximately 70 percent of the cross-sectional area of the drip. No significant material was observed in the area just underneath and several inches away from the siphon drain at the closed end of the drip. No significant internal corrosion was observed in the drip.

Figure 10. Line 1103 drip after excavation.
