**NTSB, Pipeline Accident Report: Natural Gas Pipeline Rupture and Fire Near Carlsbad, New Mexico, August 19, 2000 (Feb. 11, 2003)**

# Natural Gas Pipeline Rupture and Fire Near Carlsbad, New Mexico August 19, 2000

**NTSB/PAR-03/01  
PB2003-916501  
Notation 7310B  
Adopted February 11, 2003**

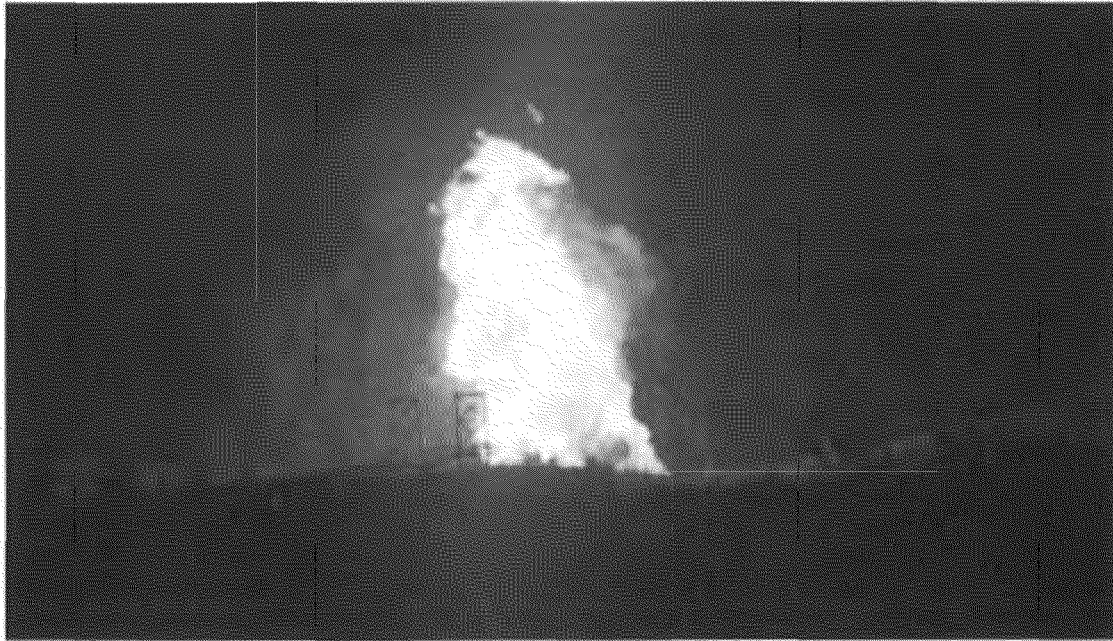
**Figure 5.** Post-rupture fire. At lower left of fireball can be seen the 85-foot-tall support structures for the pipeline suspension bridges.

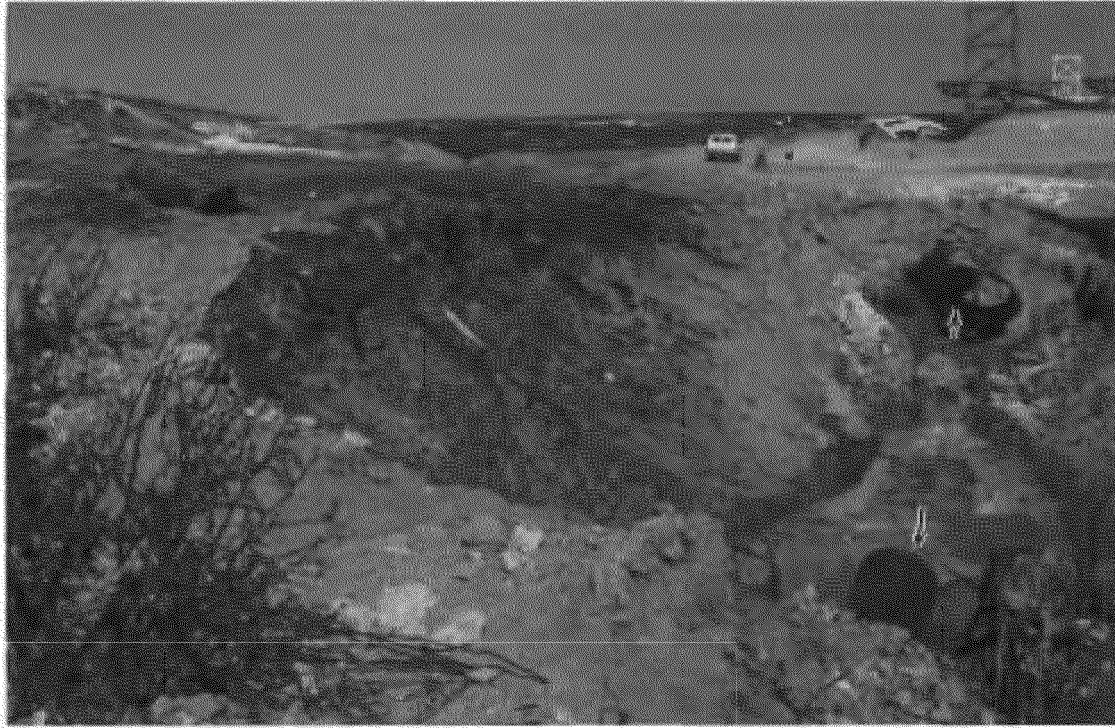
The force of the rupture and the violent ignition of the escaping gas created a 51-foot-wide crater about 113 feet along the pipe. A 49-foot section of the pipe was ejected from the crater in three pieces measuring approximately 3 feet, 20 feet, and 26 feet in length. (See figure 6.) The largest piece was found about 287 feet northwest of the crater in the direction of the suspension bridges. Investigators visually examined the pipeline that remained in the crater as well as the three ejected pieces. All three ejected pieces showed evidence of internal corrosion damage, but one of the pieces showed significantly more corrosion damage than the other two. Pits were visible on the inside surface of this piece, and at various locations, the pipe wall evidenced significant thinning. At one location, a through-wall perforation was visible. No significant corrosion damage was visible on the outside surfaces of the three pieces or on the two ends of the pipeline remaining in the crater. Pieces were cut from the ruptured pipeline segments and shipped to the Safety Board’s Materials Laboratory in Washington, D.C., for further evaluation. (That evaluation is discussed in the “Tests and Research” section of this report.)

**Figure 6.** Looking west at a portion of the crater created by the rupture. The missing section of pipe between the arrows was ejected from the crater.

Approximately 49 feet of the underground portion of line 1103 were ejected in three pieces from the crater created by the rupture. Two of the pieces of pipe were thrown 234 and 287 feet, respectively, from the northwest end of the crater toward the river. One of these pieces hit the cables that supported the pipeline suspension bridges across the river. The concrete anchor blocks for the cables, the cables themselves, and the two suspension bridge steel structures on the east side of the river were burned, as were the aboveground portions of the pipelines. The two pipelines that were being supported on the bridges (EPNG's 26-inch line 1100 and the out-of-service 16-inch line 1000) fell and came to rest on the ground on each side of the river, but neither leaked. The three vehicles and camping equipment on the east side of the river were destroyed, and vegetation along both riverbanks was burned. Based on photographs taken of the fire as it engulfed the suspension bridges, the height of the flame was calculated to be about 496 feet. EPNG, in its incident report to the Research and Special Programs Administration (RSPA), stated the cost of the accident was \$998,296.

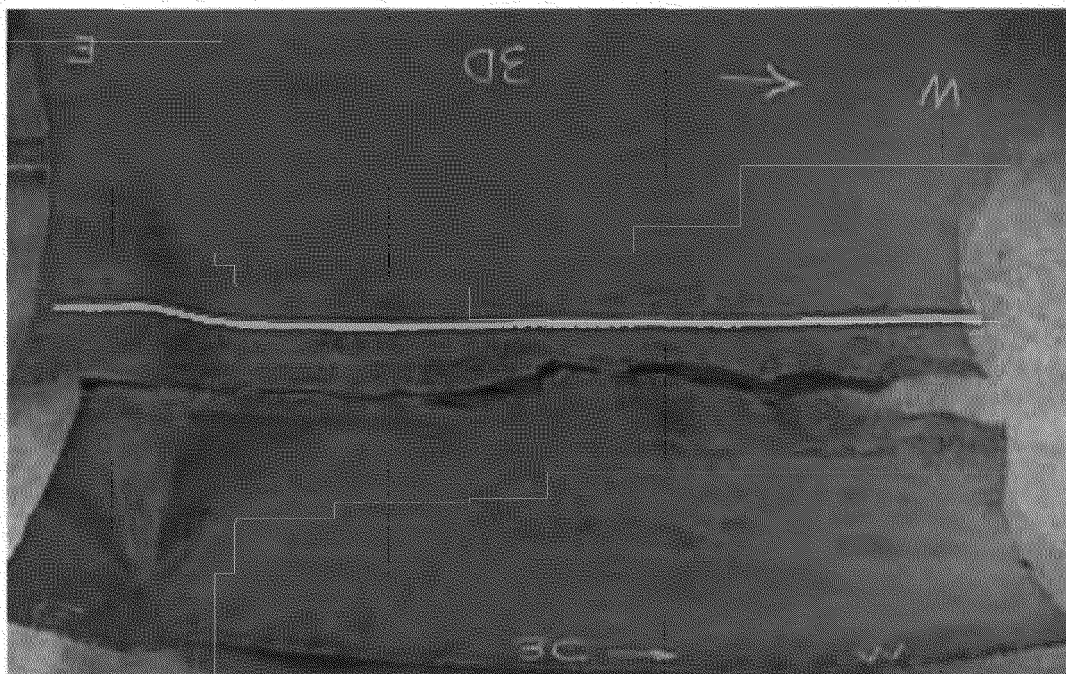
On-site examination of the three pieces of pipe that were ejected from the crater at the rupture site identified severe internal corrosion along the interior bottom of the pipe. (See figure 7.) From these three segments, eight pieces were excised and transported to the Safety Board's Materials Laboratory in Washington, D.C., for further examination. The examination of these pieces revealed no evidence of corrosion on the outside of the pipe or the internal surface across the top half of the pipe (between the 9 and 3 o'clock positions looking downstream/west). Severe wall loss due to corrosion was observed on the inside of the pipe at the bottom.

**Figure 7.** Fractured section of line 1103.

The area of corrosion damage extended 21 feet 5 inches. Sections of the girth (circumferential) and seam (longitudinal) welds that were in the bottom half of the pipe exhibited damage from internal corrosion similar to that found on the bottom pipe wall. The extent of corrosion damage (metal loss and number of pits) was most severe along the bottom of the pipe; the most severely corroded area reduced the original pipe wall thickness by 72 percent. (See figure 8.) The wall of many of the corrosion pits contained striations that extended around the pit. (See figure 9.) Within this length of corrosion damage were five circumferential wrinkles<sup>19</sup> in the pipe wall on the top of the pipe.

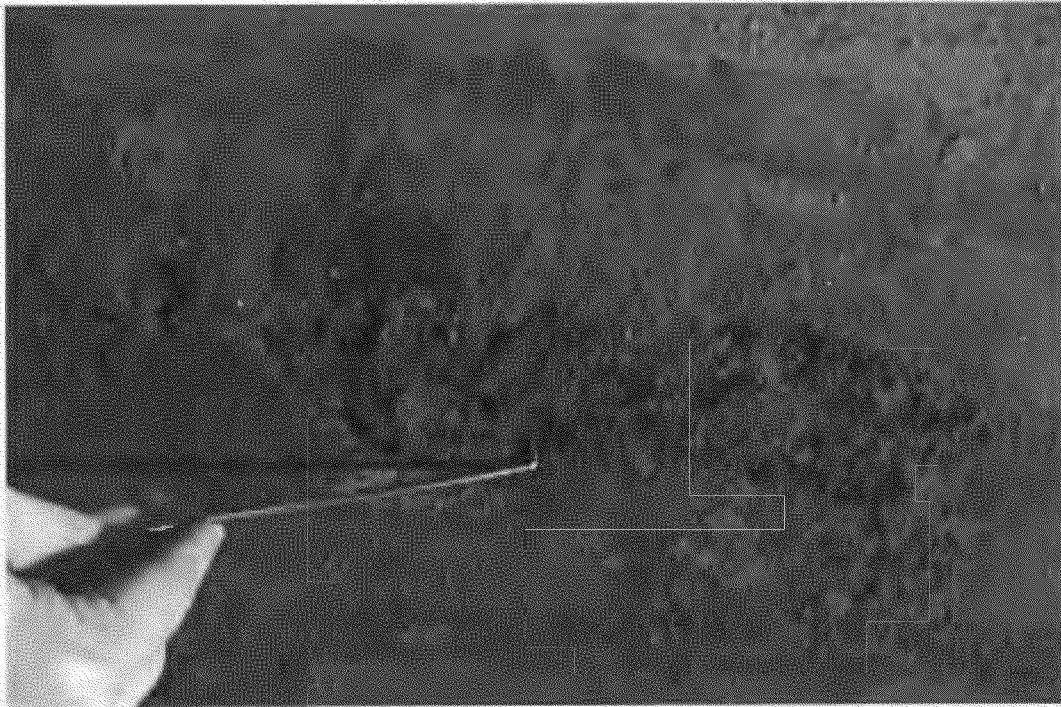
**Figure 8.** Corrosion pitting on inside of pipe near rupture site.

The Safety Board's Materials Laboratory performed x-ray dispersive spectroscopy analysis on material removed from corrosion pits and areas containing corrosion damage, both from the inside of the pipe. The analysis found high levels of chlorine and sodium in the material.

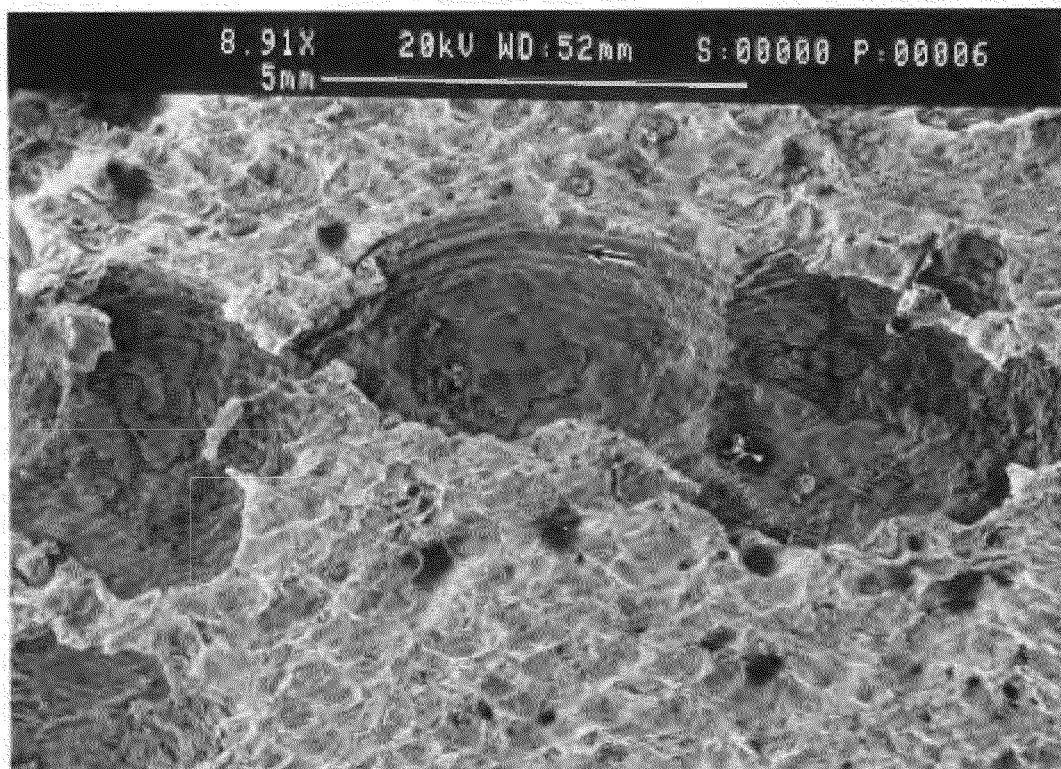
**Figure 9.** Microscopic view of corrosion pit showing striations

Examination of the fractures showed that a fracture face extended between the internal corrosion areas and the external wall of the pipe. The fracture faces resulted from overstress separation with no evidence of fatigue cracking or corrosion degradation, indicating that corrosion had not penetrated the wall of the pipe at the rupture point.

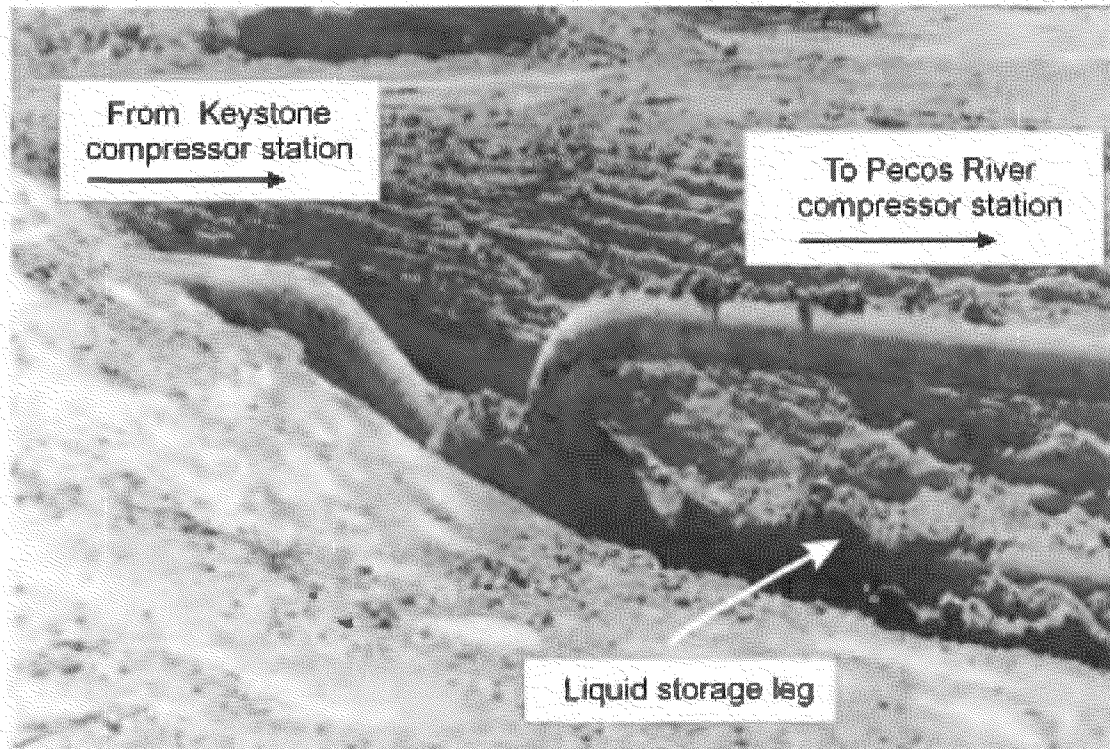
The drip<sup>17</sup> between block valve No. 6 and the rupture site was removed from the pipeline and visually examined. The drip was found to contain a blackish oily-powdery/grainy material. At the area of its heaviest concentration, about 13 feet from the drip opening, this material filled approximately 70 percent of the cross-sectional area of the drip. No significant material was observed in the area just underneath and several inches away from the siphon drain at the closed end of the drip. No significant internal corrosion was observed in the drip.

**Figure 10.** Line 1103 drip after excavation.
