NTSB, Pipeline Accident Report: Natural Gas Pipeline Rupture and Fire Near Carlsbad, New Mexico, August 19, 2000 (Feb. 11, 2003)

Natural Gas Pipeline Rupture and Fire Near Carlsbad, New Mexico August 19, 2000

**NTSB/PAR-03/01
PB2003-916501
Notation 7310B
Adopted February 11, 2003**

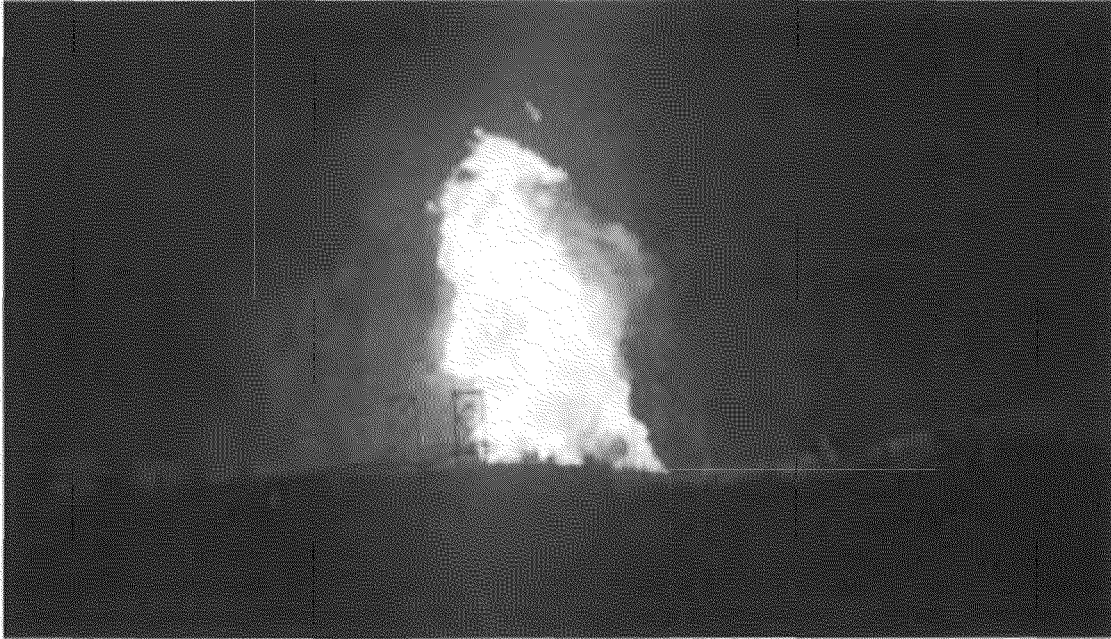
Figure 5. Post-rupture fire. At lower left of fireball can be seen the 85-foot-tall support structures for the pipeline suspension bridges.

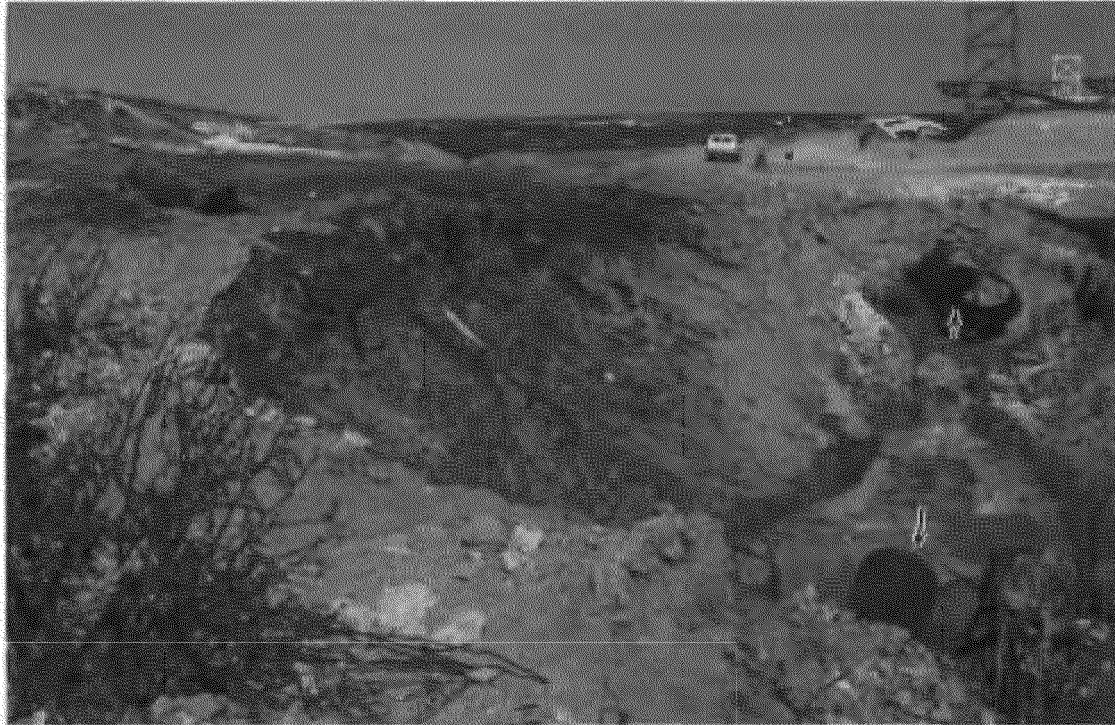
The force of the rupture and the violent ignition of the escaping gas created a 51-foot-wide crater about 113 feet along the pipe. A 49-foot section of the pipe was ejected from the crater in three pieces measuring approximately 3 feet, 20 feet, and 26 feet in length. (See figure 6.) The largest piece was found about 287 feet northwest of the crater in the direction of the suspension bridges. Investigators visually examined the pipeline that remained in the crater as well as the three ejected pieces. All three ejected pieces showed evidence of internal corrosion damage, but one of the pieces showed significantly more corrosion damage than the other two. Pits were visible on the inside surface of this piece, and at various locations, the pipe wall evidenced significant thinning. At one location, a through-wall perforation was visible. No significant corrosion damage was visible on the outside surfaces of the three pieces or on the two ends of the pipeline remaining in the crater. Pieces were cut from the ruptured pipeline segments and shipped to the Safety Board’s Materials Laboratory in Washington, D.C., for further evaluation. (That evaluation is discussed in the “Tests and Research” section of this report.)

Figure 6. Looking west at a portion of the crater created by the rupture. The missing section of pipe between the arrows was ejected from the crater.

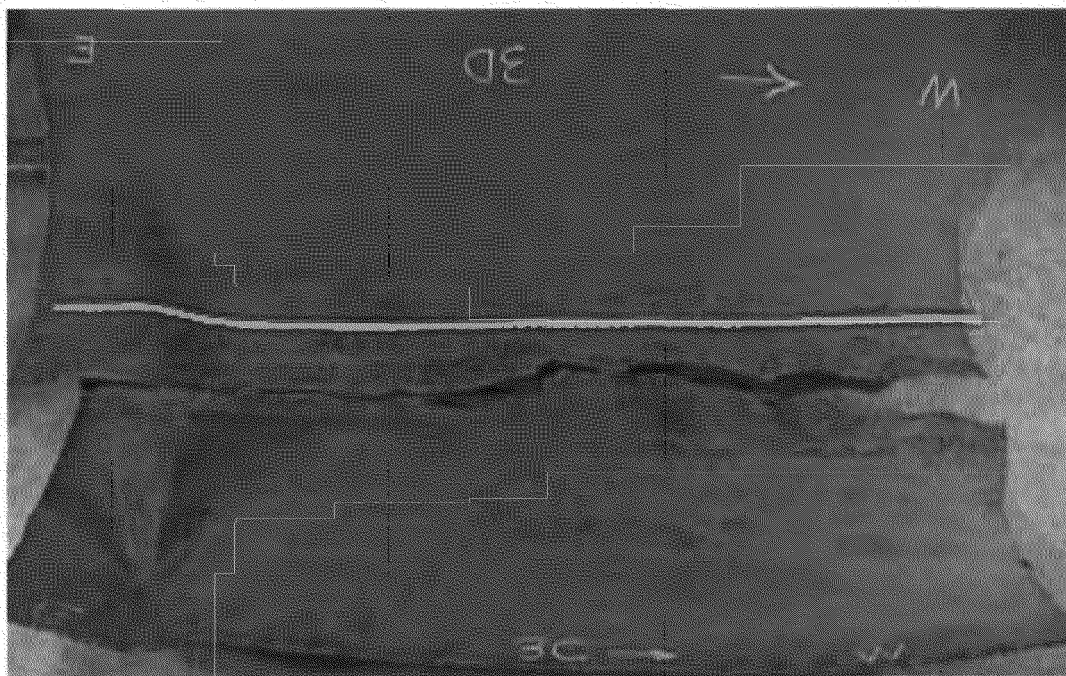
On-site examination of the three pieces of pipe that were ejected from the crater at the rupture site identified severe internal corrosion along the interior bottom of the pipe. (See figure 7.) From these three segments, eight pieces were excised and transported to the Safety Board's Materials Laboratory in Washington, D.C., for further examination. The examination of these pieces revealed no evidence of corrosion on the outside of the pipe or the internal surface across the top half of the pipe (between the 9 and 3 o'clock positions looking downstream/west). Severe wall loss due to corrosion was observed on the inside of the pipe at the bottom.

Figure 7. Fractured section of line 1103.

The area of corrosion damage extended 21 feet 5 inches. Sections of the girth (circumferential) and seam (longitudinal) welds that were in the bottom half of the pipe exhibited damage from internal corrosion similar to that found on the bottom pipe wall. The extent of corrosion damage (metal loss and number of pits) was most severe along the bottom of the pipe; the most severely corroded area reduced the original pipe wall thickness by 72 percent. (See figure 8.) The wall of many of the corrosion pits contained striations that extended around the pit. (See figure 9.) Within this length of corrosion damage were five circumferential wrinkles¹⁹ in the pipe wall on the top of the pipe.

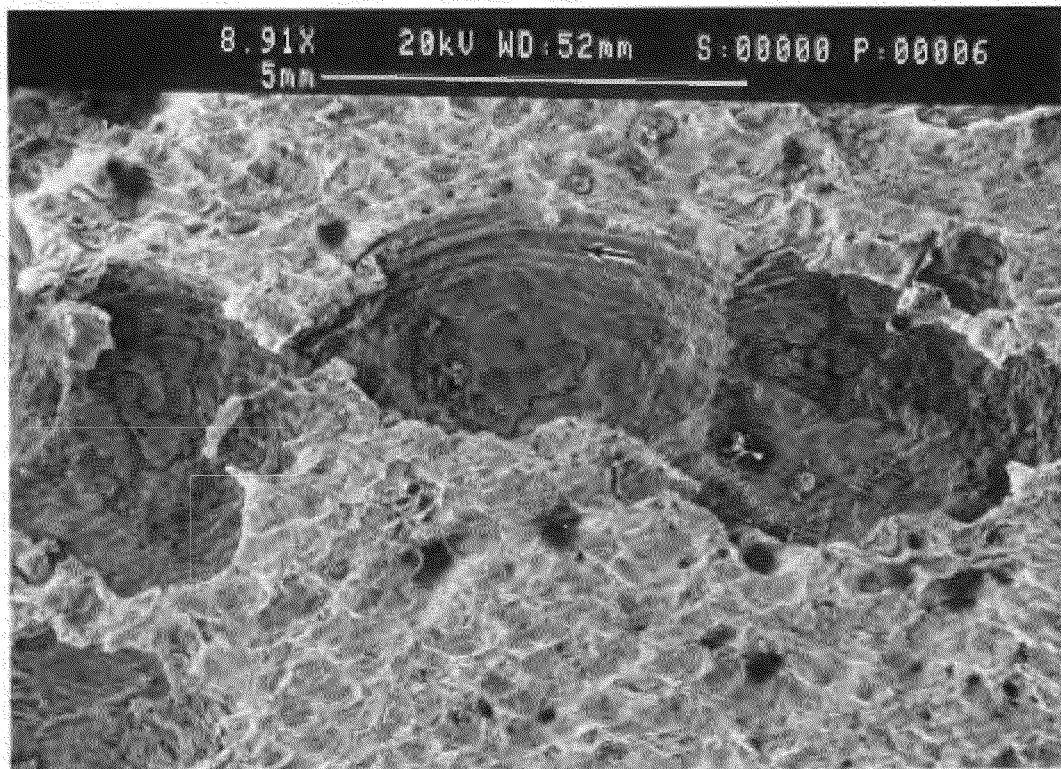
Figure 9. Microscopic view of corrosion pit showing striations

The Safety Board's Materials Laboratory performed x-ray dispersive spectroscopy analysis on material removed from corrosion pits and areas containing corrosion damage, both from the inside of the pipe. The analysis found high levels of chlorine and sodium in the material.
