SUBJECT: PG&E's Response to the June 3, 2013 ESRB Report Concerning
The April 8-11, 2013 Audit of PG&E's Pismo Beach Area Electric Transmission Facilities

Attachment A

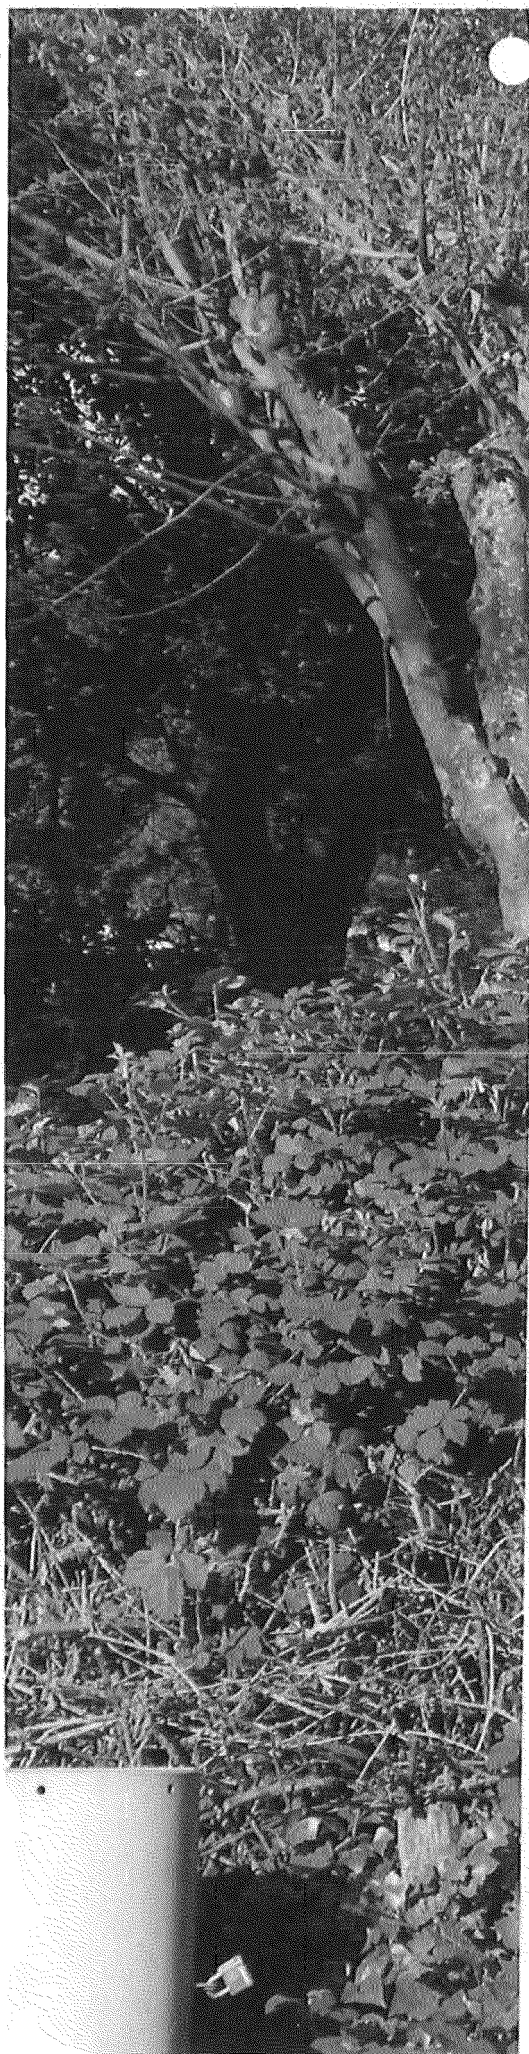
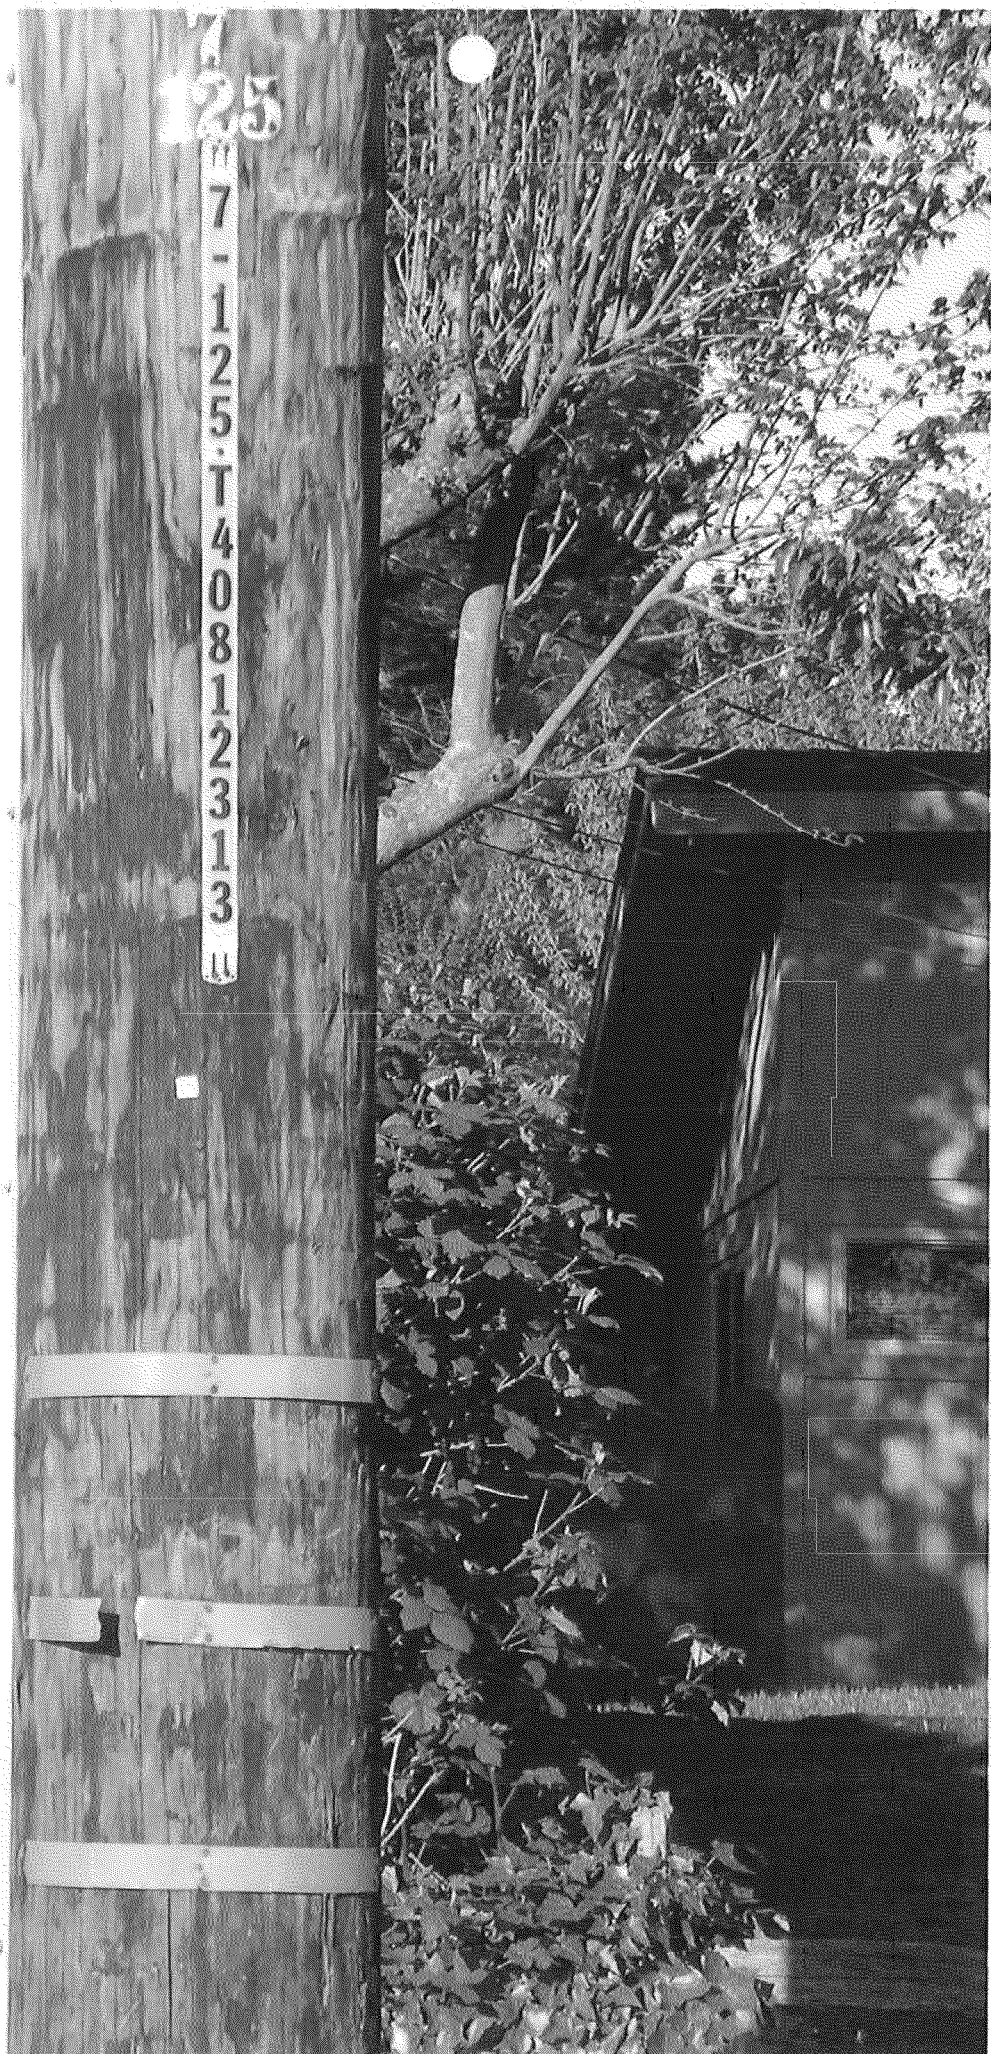
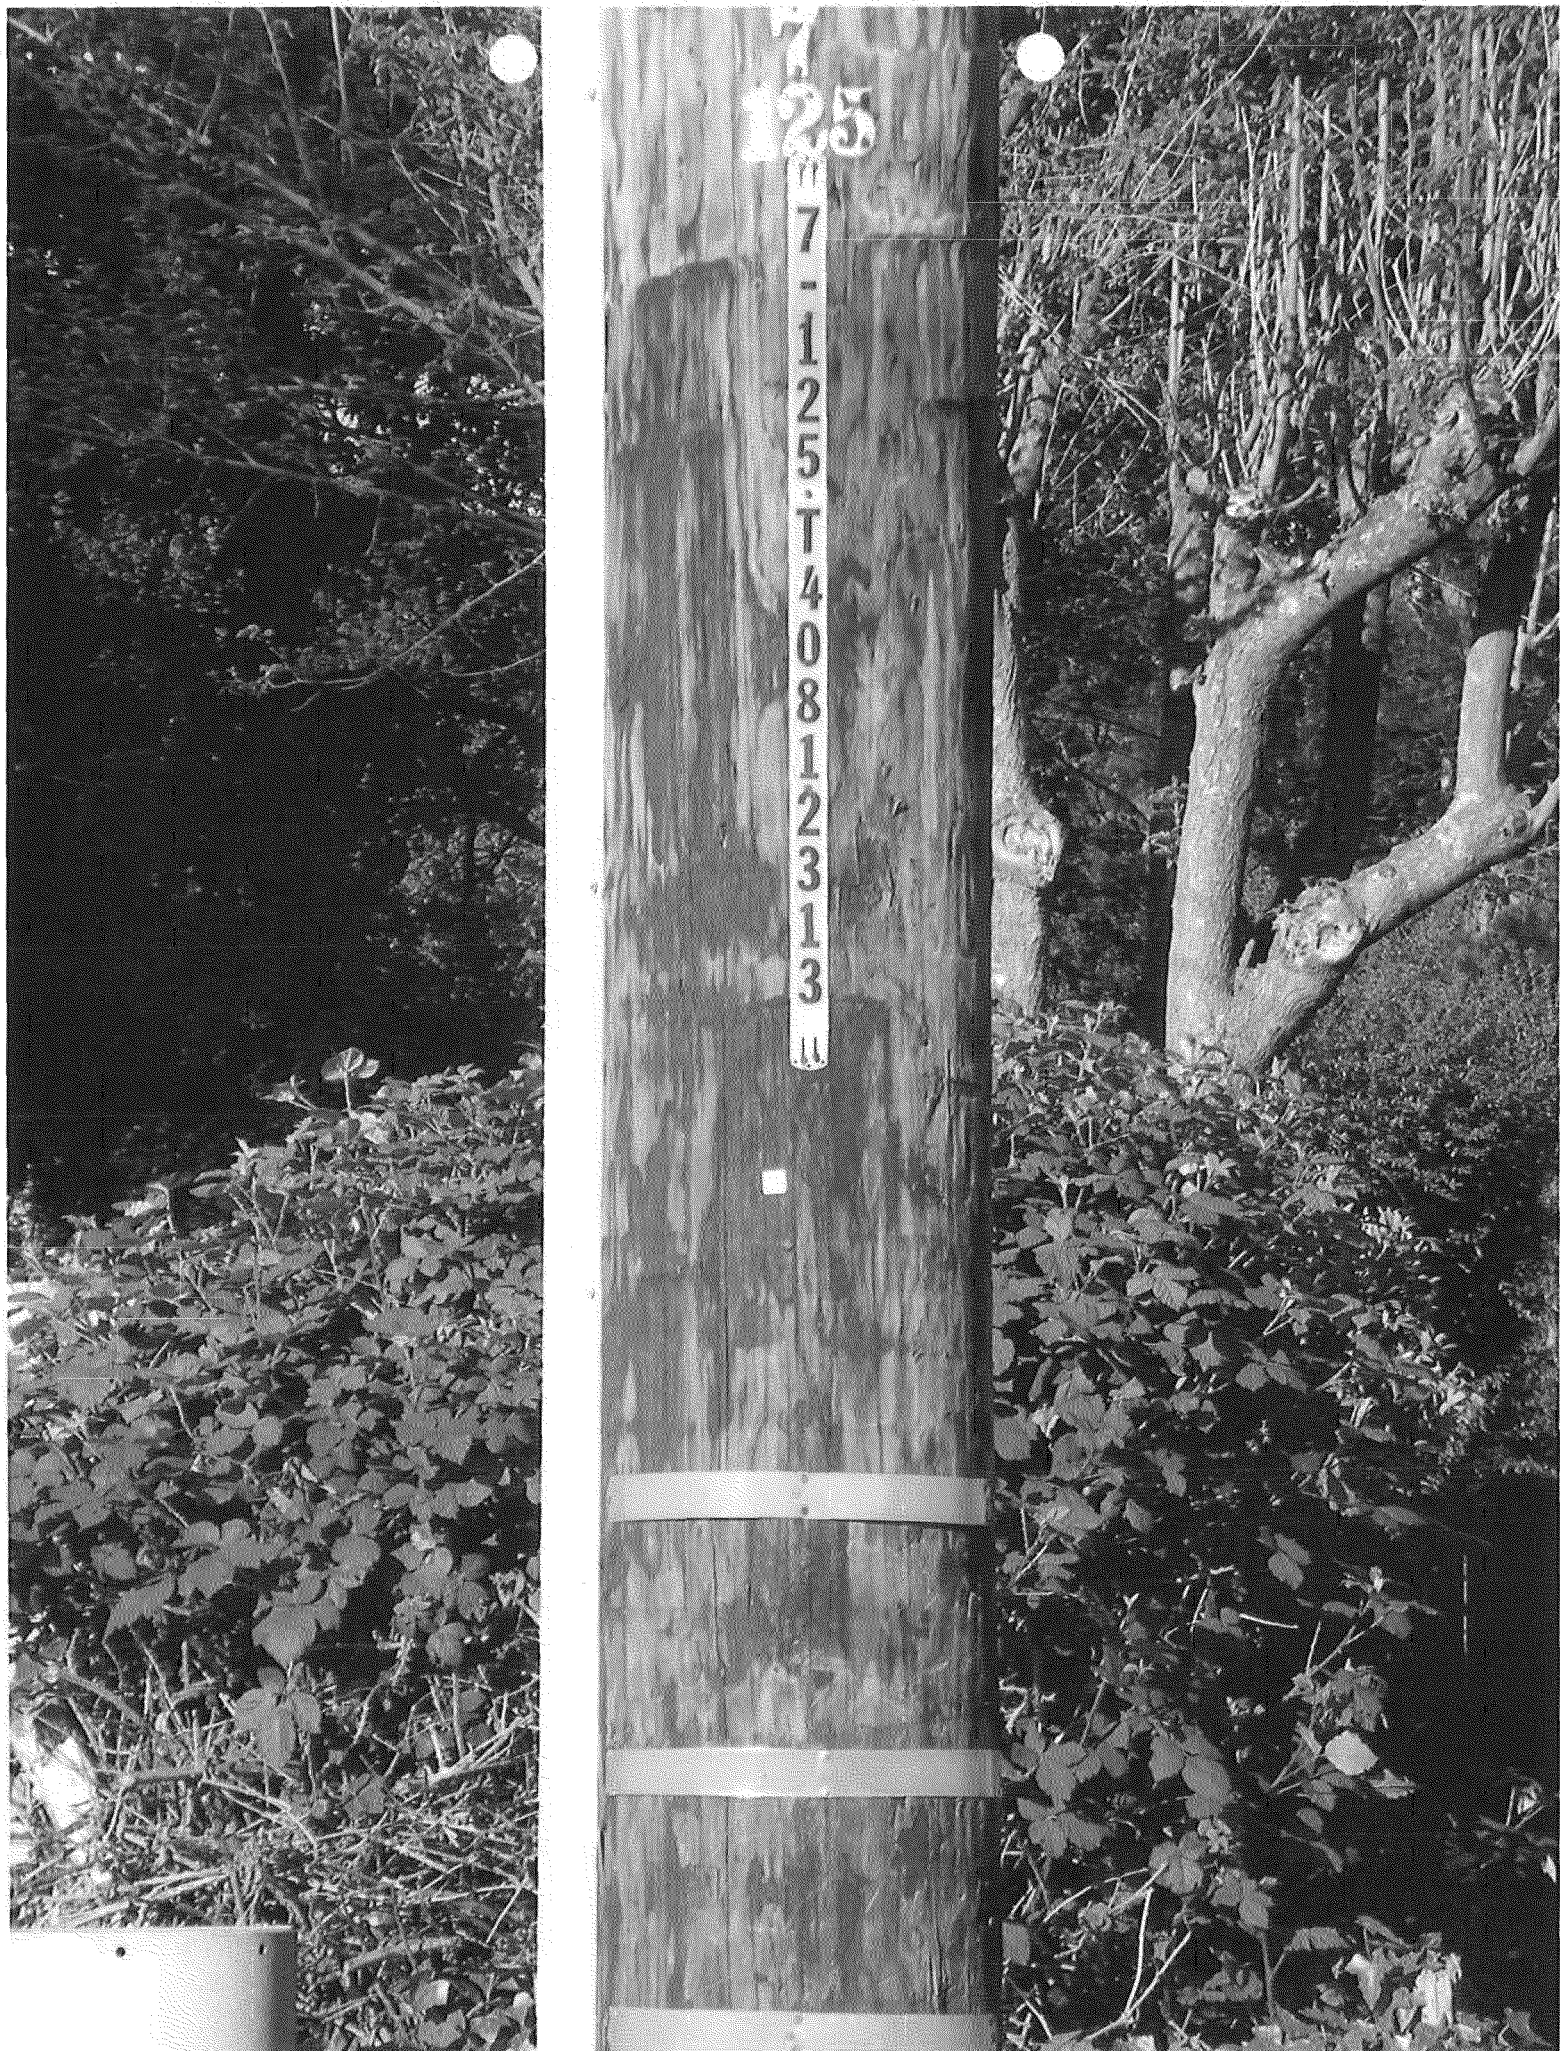
1.	Structure ID / Location:	Templeton-Atascadero, Structure 7/125
	Previous PG&E Visit (Air Patrol):	August 23, 2012
	Date of CPUC Inspection:	April 10, 2013
Explanation of Violation(s):		
<u>Damaged Visibility Strip</u>		
<p>GO 95, Rule 31.1, Design, Construction and Maintenance, states in part:</p> <p style="text-align: center;"><i>Electrical supply and communication systems shall be of suitable design and construction for their intended use, regard being given to the conditions under which they are to be supported, and shall be maintained in a condition which will enable the furnishing of safe, proper and adequate service.</i></p> <p>A damaged visibility strip was attached to Structure 7/125.</p>

REPLACE BROKEN VISIBILITY STRIPS (2)
 MIDDLE LEVEL STRIP TORN FROM POLE

The PG&E Inspector responded and replaced the damaged visibility strip at pole 7/125. Documentation of all completed work is attached as Attachment 1.
