Report No. 5004.9268

September 6, 2013

**METALLURGICAL EVALUATION OF A SECTION FROM  
L-147 MP 2.2 BRITTAN AVE. AND ROGERS AVE., SAN CARLOS**

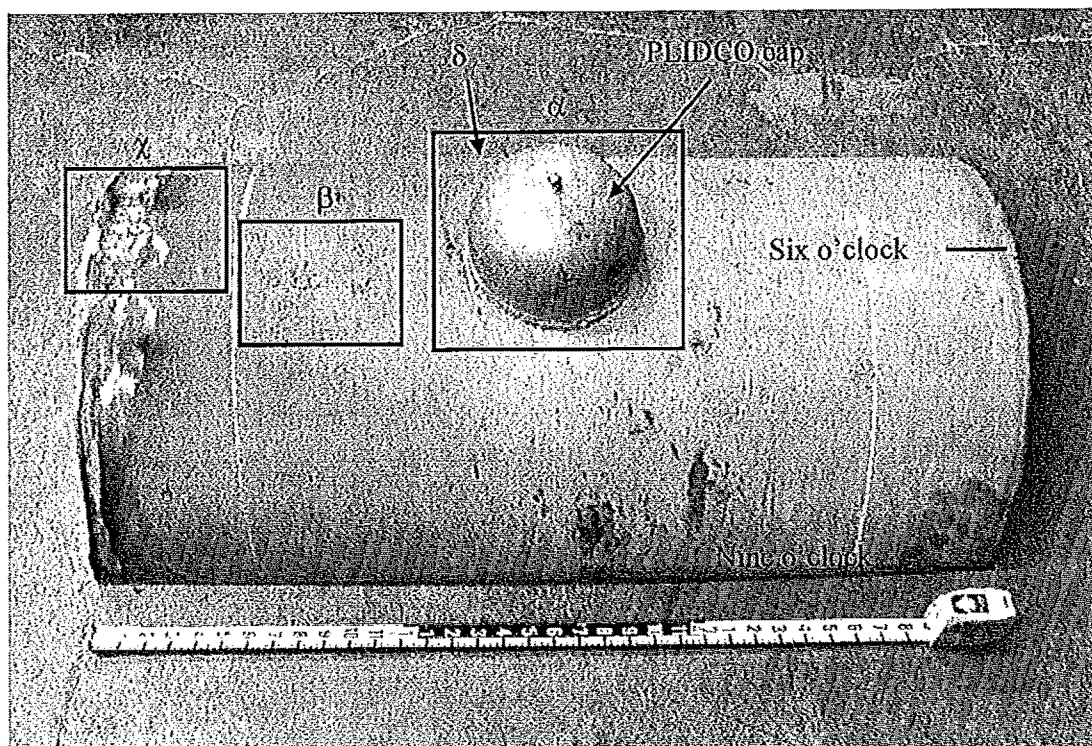
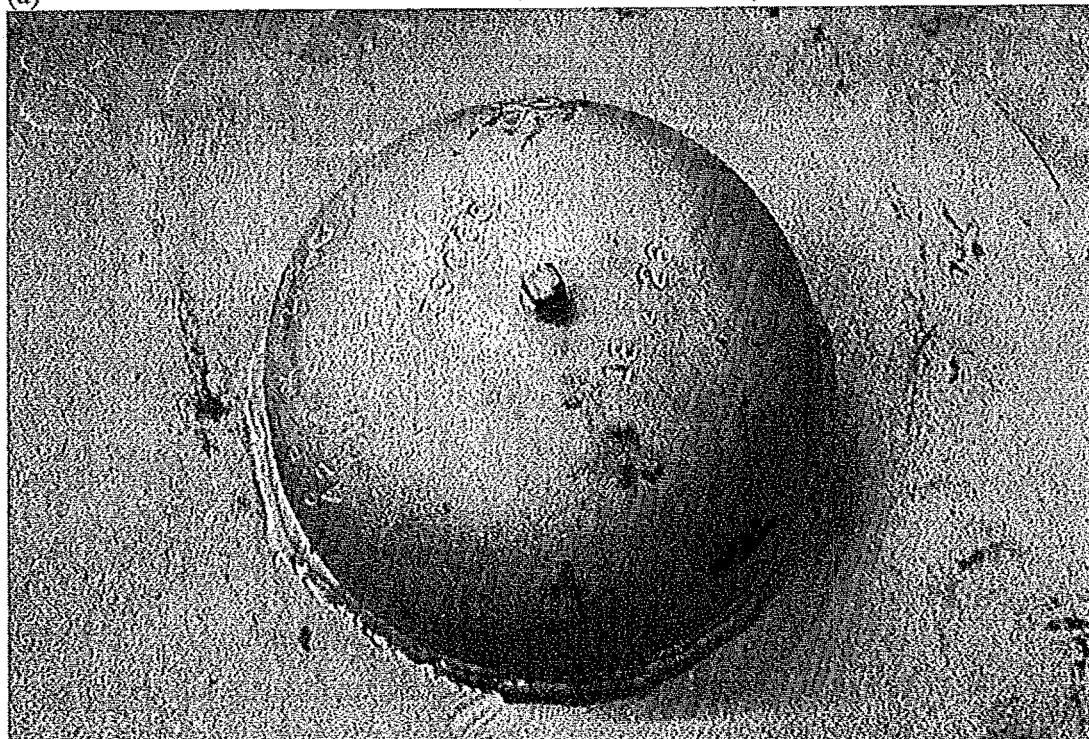
The subject sample of L-147 was received sectioned into two halves along the longitudinal axis, with the outside surface grit blasted, as shown in Figure 1 through Figure 5. The section half with the PLIDCO cap was arbitrarily labeled A and the other section was labeled B, in the laboratory. Based on the reported position of the cap, the longitudinal flame cuts were located at three o'clock and nine o'clock positions. Wall thickness measurements were made with a pointed anvil micrometer and the results are listed in Table 1. Small regions of weld metal and a few shallow hemispherical pits were present near the cap, as shown in Figure 2. Pits were also present just past the three o'clock position toward the cap, indicated in Figure 1. Pit depths were measured with a pit gage, and the results are listed in Table 2. No evidence of a leak location or repair was visible to the unaided eye on the inside surface of the pipe under the cap.

Figure 1 Photographs of the outside surface of sample half A as-received.

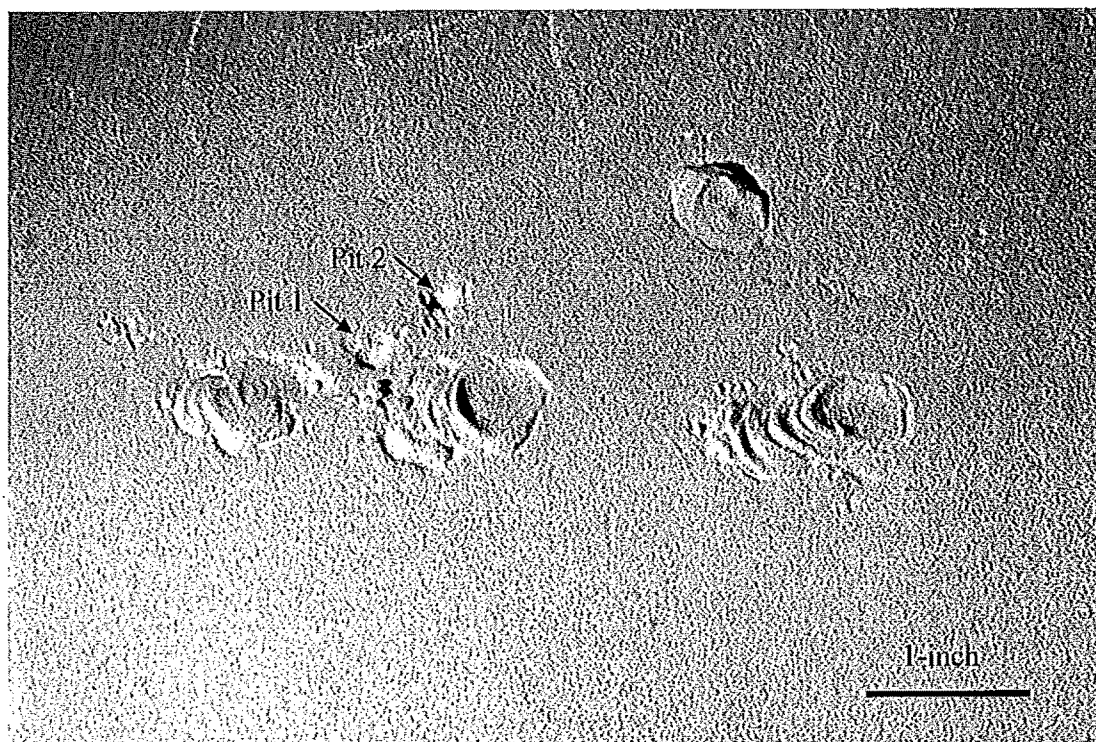
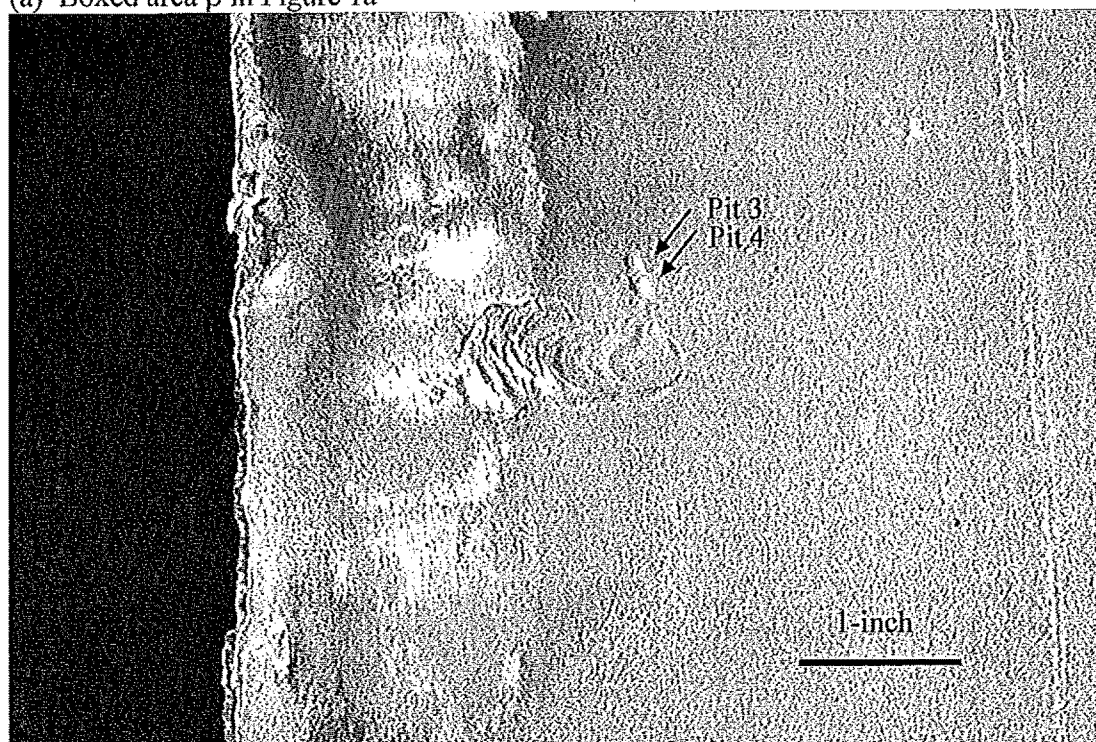
Figure 2 Photographs of the outside surface of sample half A as-received.

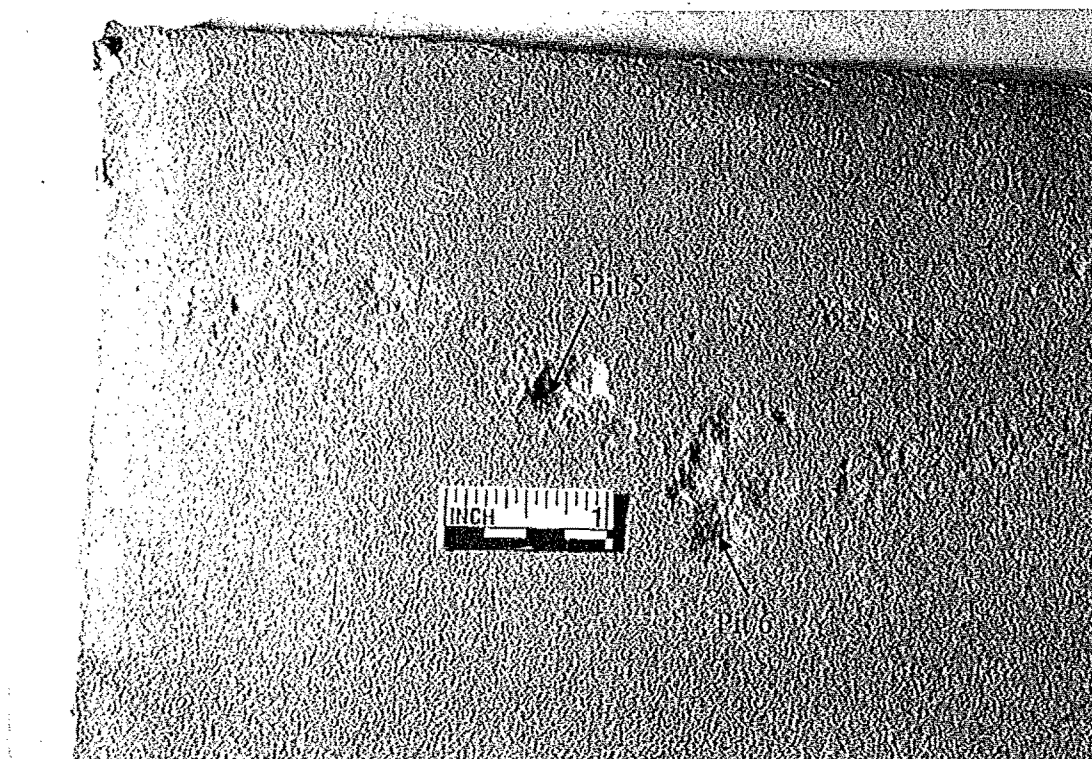
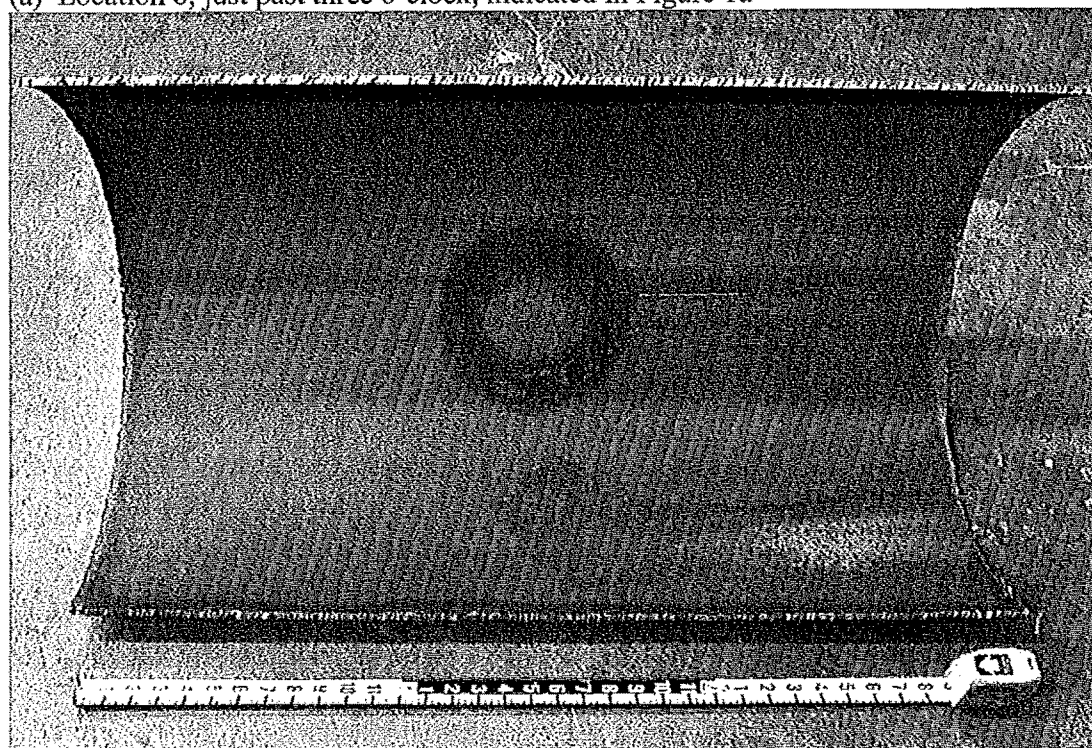
Figure 3 Photographs of pits on the outside surface and the inside surface of sample A.

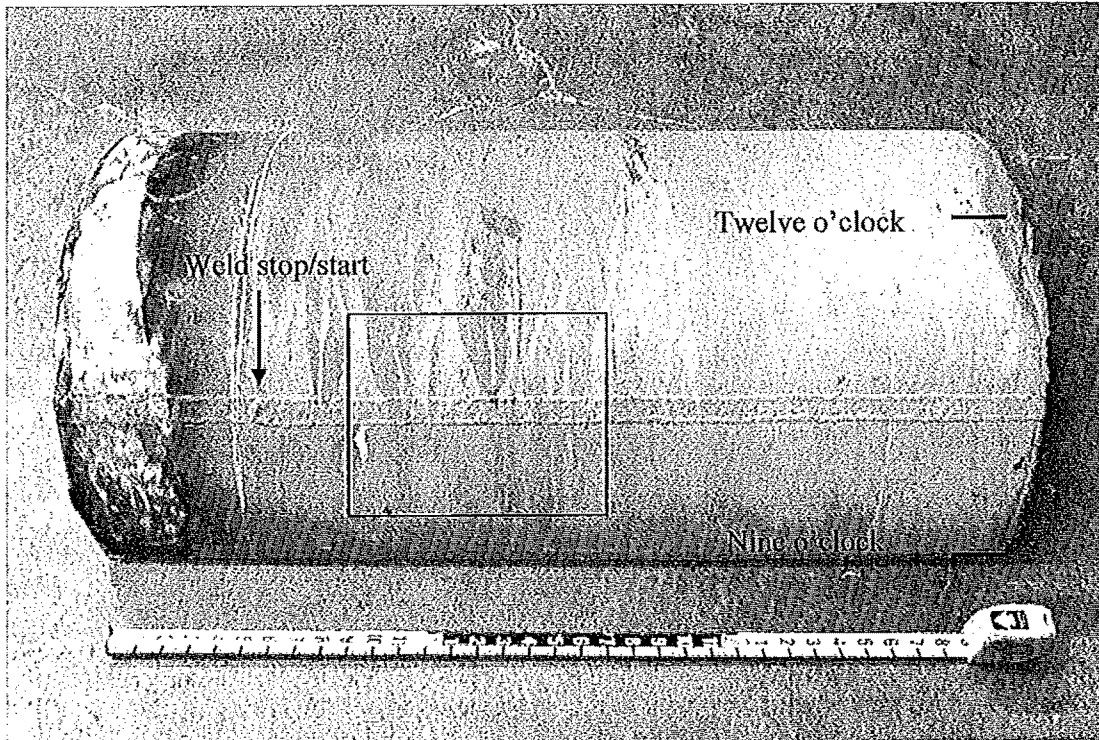
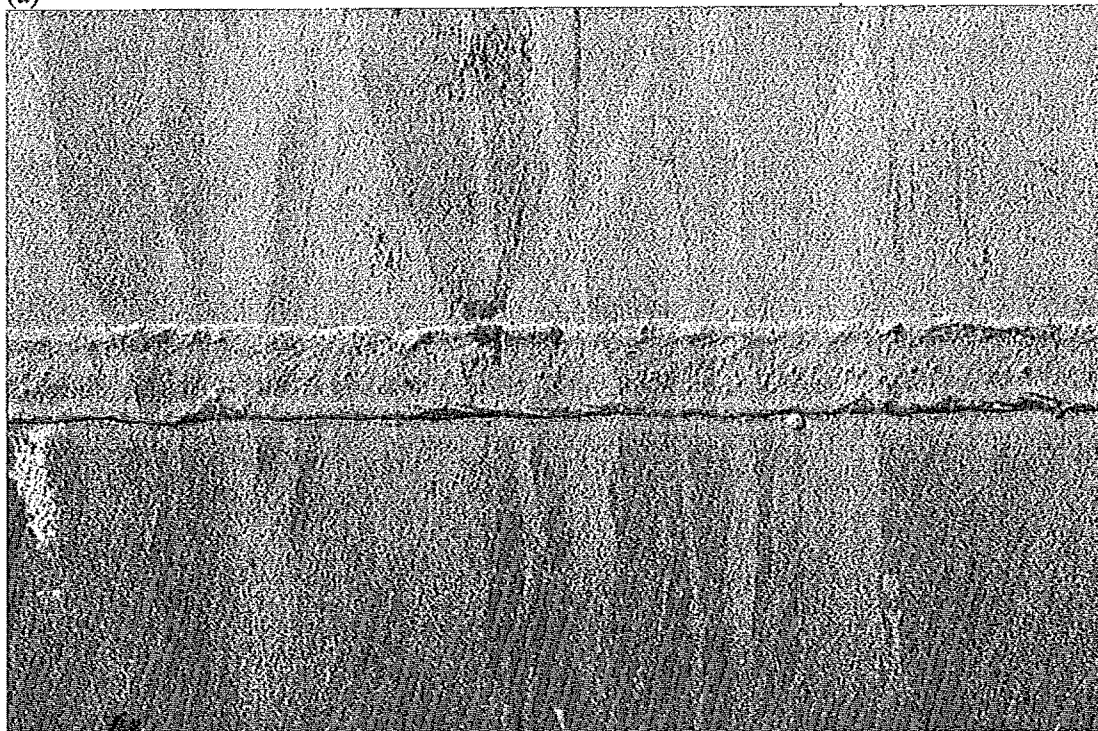
Figure 4 Photographs of the outside surface of sample half B.

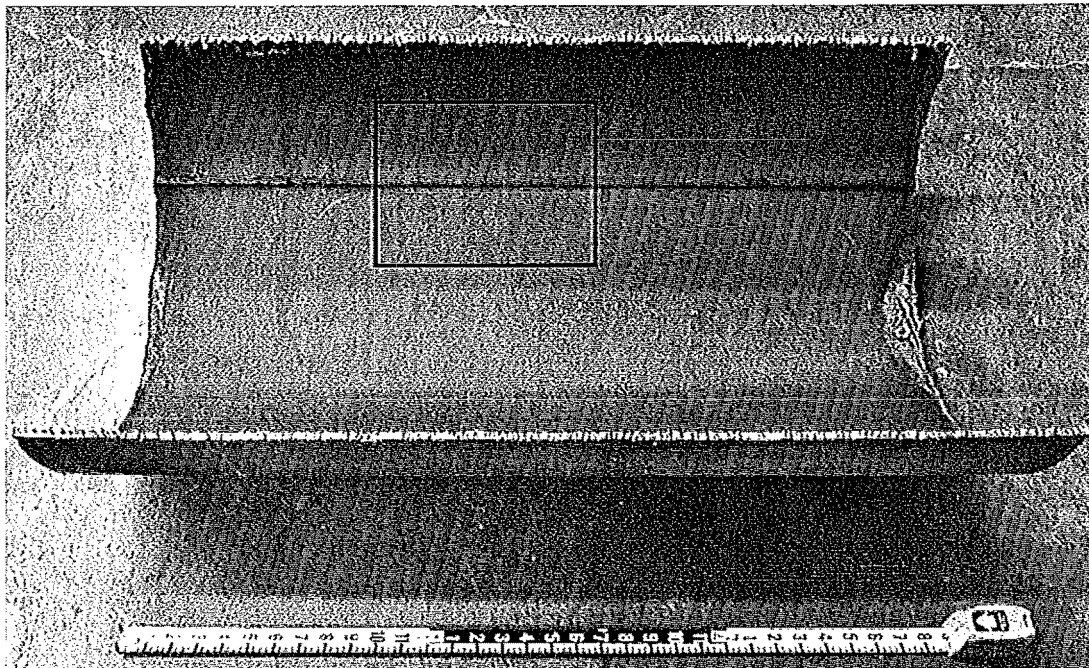
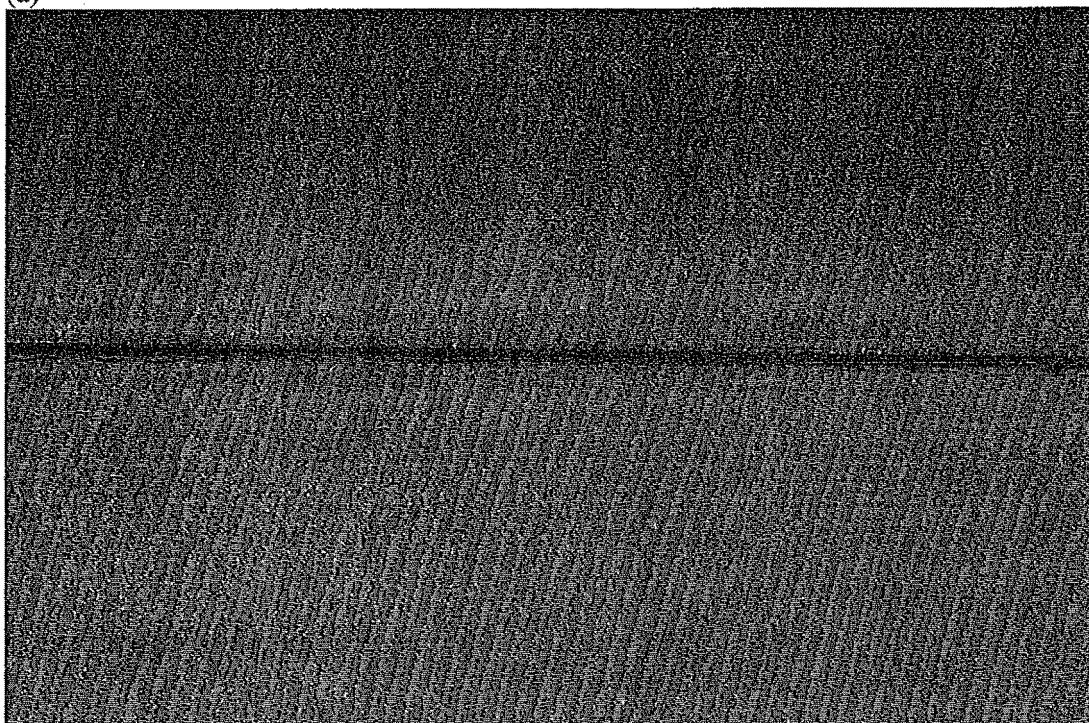
Figure 5 Photographs of the inside surface of sample half B.

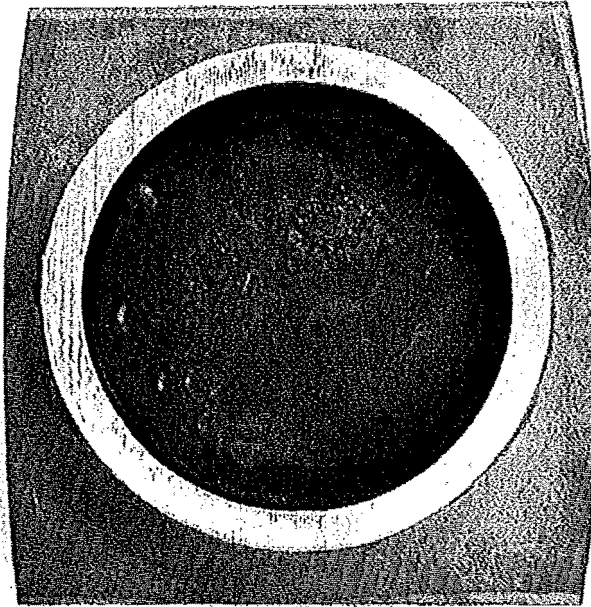
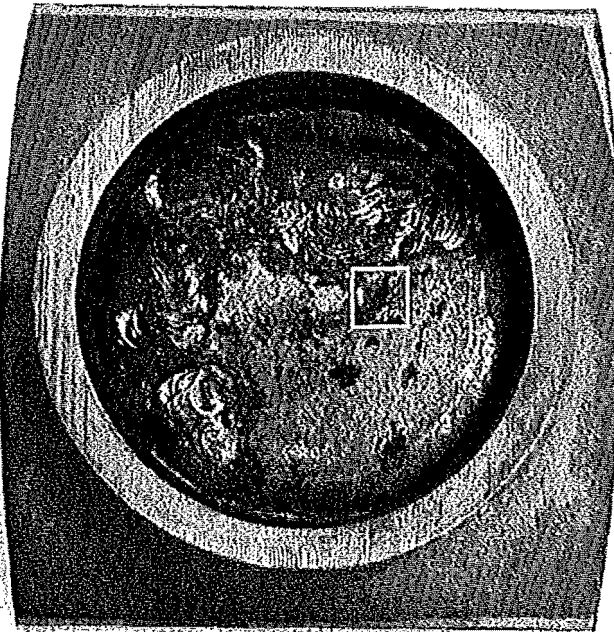
Both sides of the cap sample shown in Figure 6 were thoroughly cleaned with acetone and dried with compressed air. A liquid penetrant test was performed by applying developer to the inside surface, and penetrant was liberally applied to the outside surface in the area covered by the cap. After 1.5-hours, no indication of penetrant was visible on the inside surface.

Figure 6 Photographs of the PLIDCO cap area after sectioning.

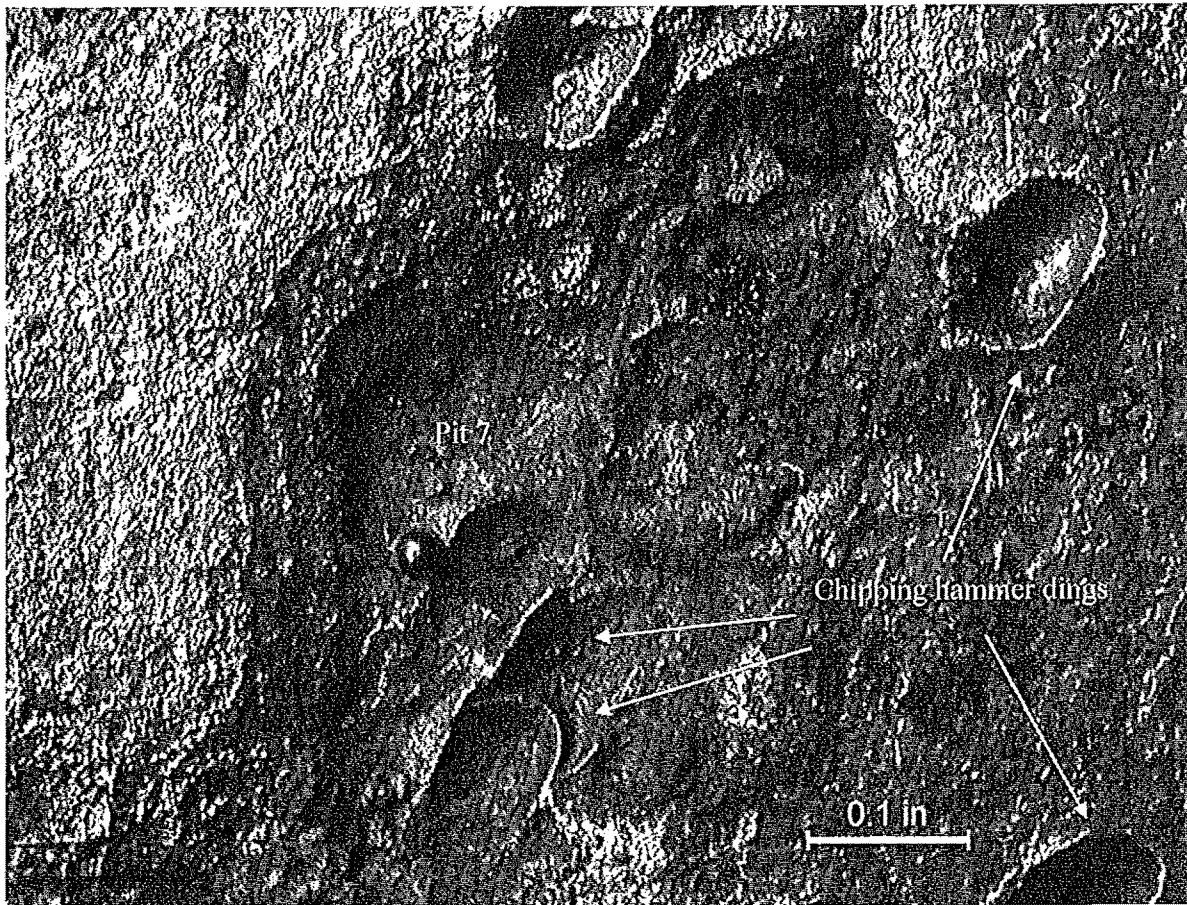
Figure 7 Macrograph of a pit under the PLIDCO cap, from the boxed area in Figure 6b.

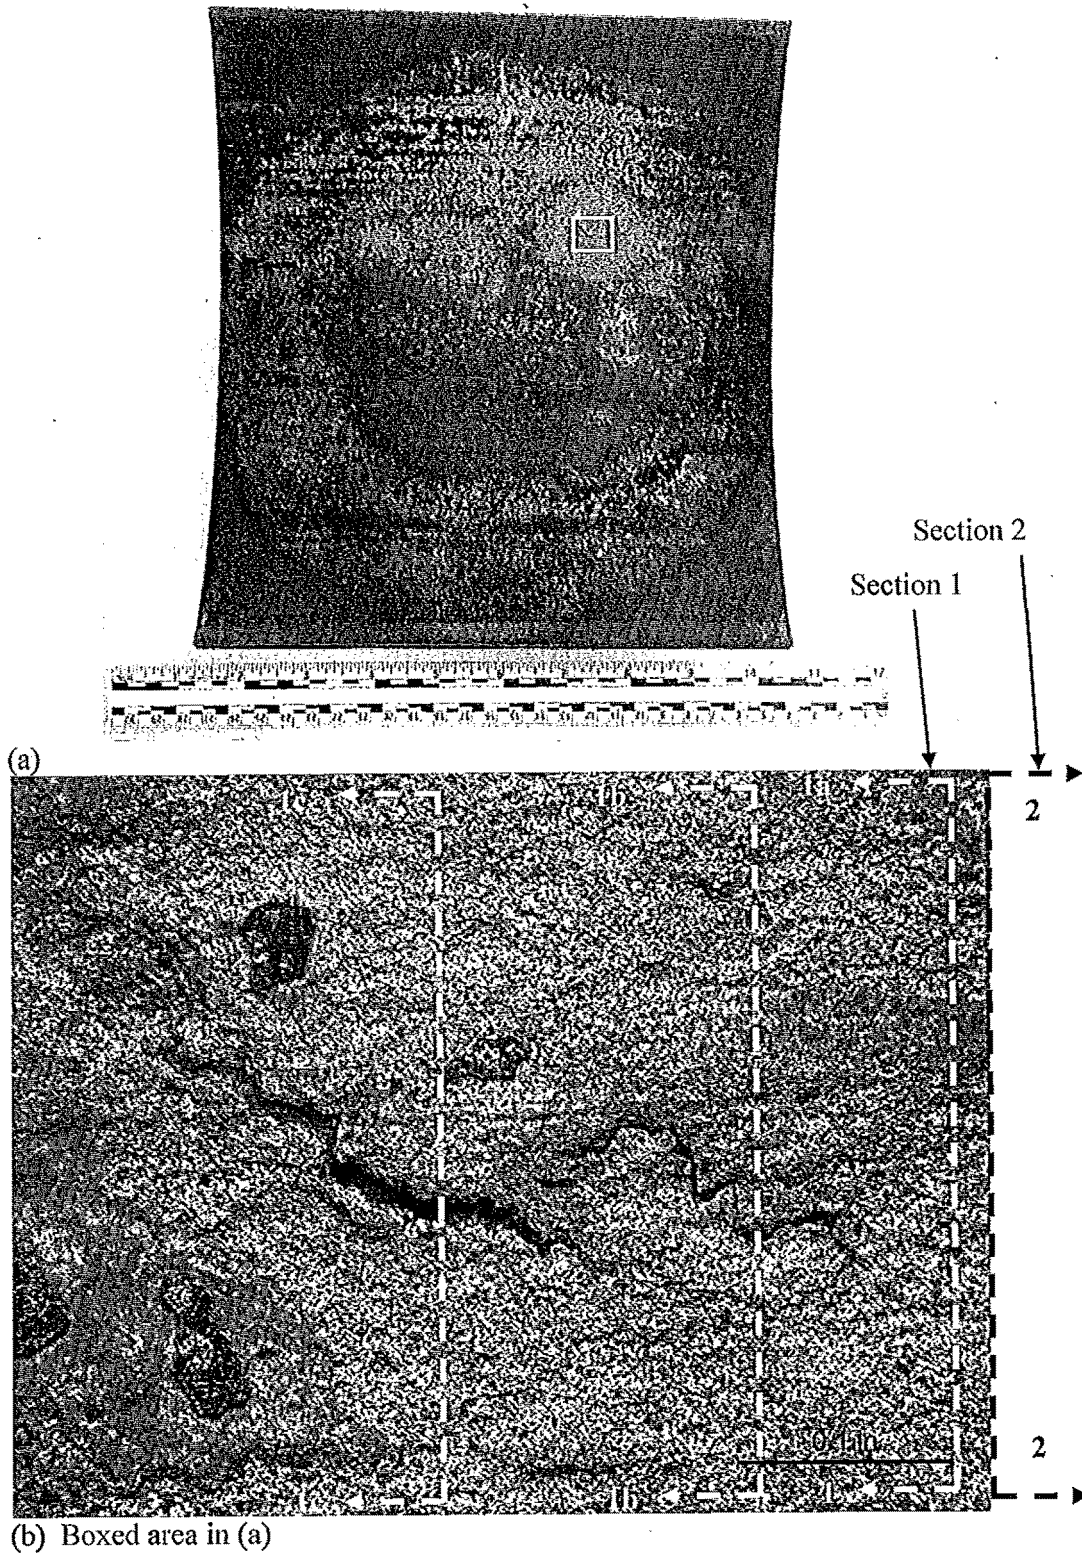
The region containing the PLIDCO cap was sectioned from sample A and the cap was cut off to expose the outside surface of the pipe wall. The outside surface was covered with rust and had a slightly oily feel. Both surfaces were cleaned with dilute Oakite® 33 and a wire brush. The outside surface is shown before and after cleaning in Figure 6. Several regions of weld metal were visible on the outside surface. Examination using low-power optical microscopy revealed a pit consistent with corrosion on the outside surface, indicated in Figure 7. The inside surface is shown after cleaning in Figure 8. Indications of heat exposure were visible on the inside surface, corresponding to the weld metal on the outside surface. No evidence of weld burn through was detected, and fine grooves typical of wrought steel surfaces were continuous across the region, which indicated that repairs did not extend to the inside surface. Examination using low-power optical microscopy revealed a crack-like feature on the inside surface within the heat affected zone of a weld deposit, as shown in Figure 8b.

The sample shown in Figure 6 was returned to PG&E for radiography. A digital radiograph of the sample is shown in Appendix A along with a photograph of the sample. A crack indication was found that corresponded to the crack-like feature detected visually on the inside surface, shown in Figure 8b.

Figure 8 Photograph (a) and macrograph (b) of the inside surface of sample half A under the PLIDCO cap, after cleaning.

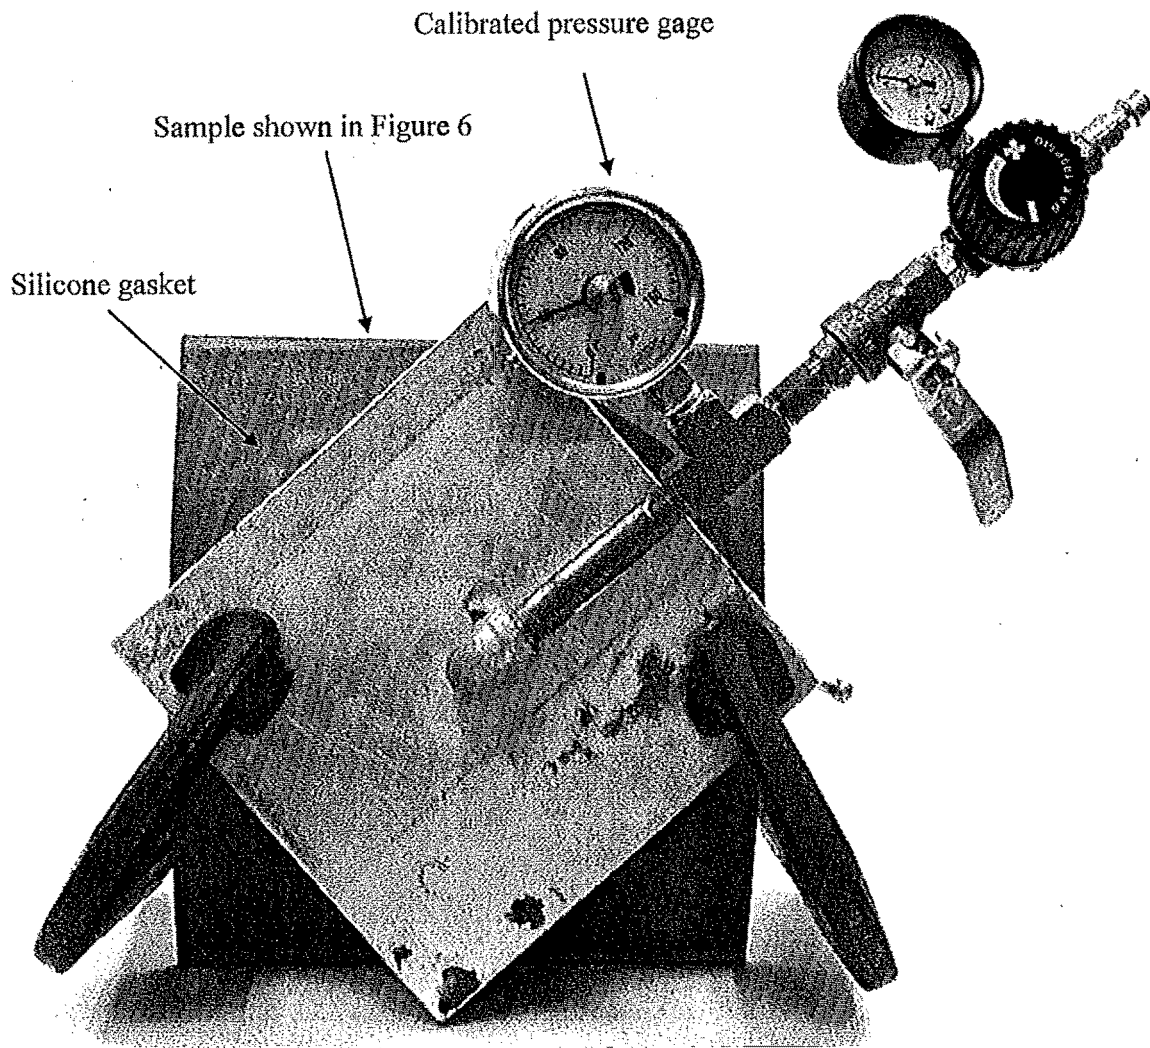
A pressure test was performed by clamping a plate over the sectioned cap, sealed with a silicone gasket, and introducing 40-psig of compressed air. Snoop® liquid leak detector was applied to the inside surface. No leaks were detected. The compressed air was valved-off, and no pressure drop from 40-psig was detected after 45-minutes.

Figure 9 Pressure test setup.

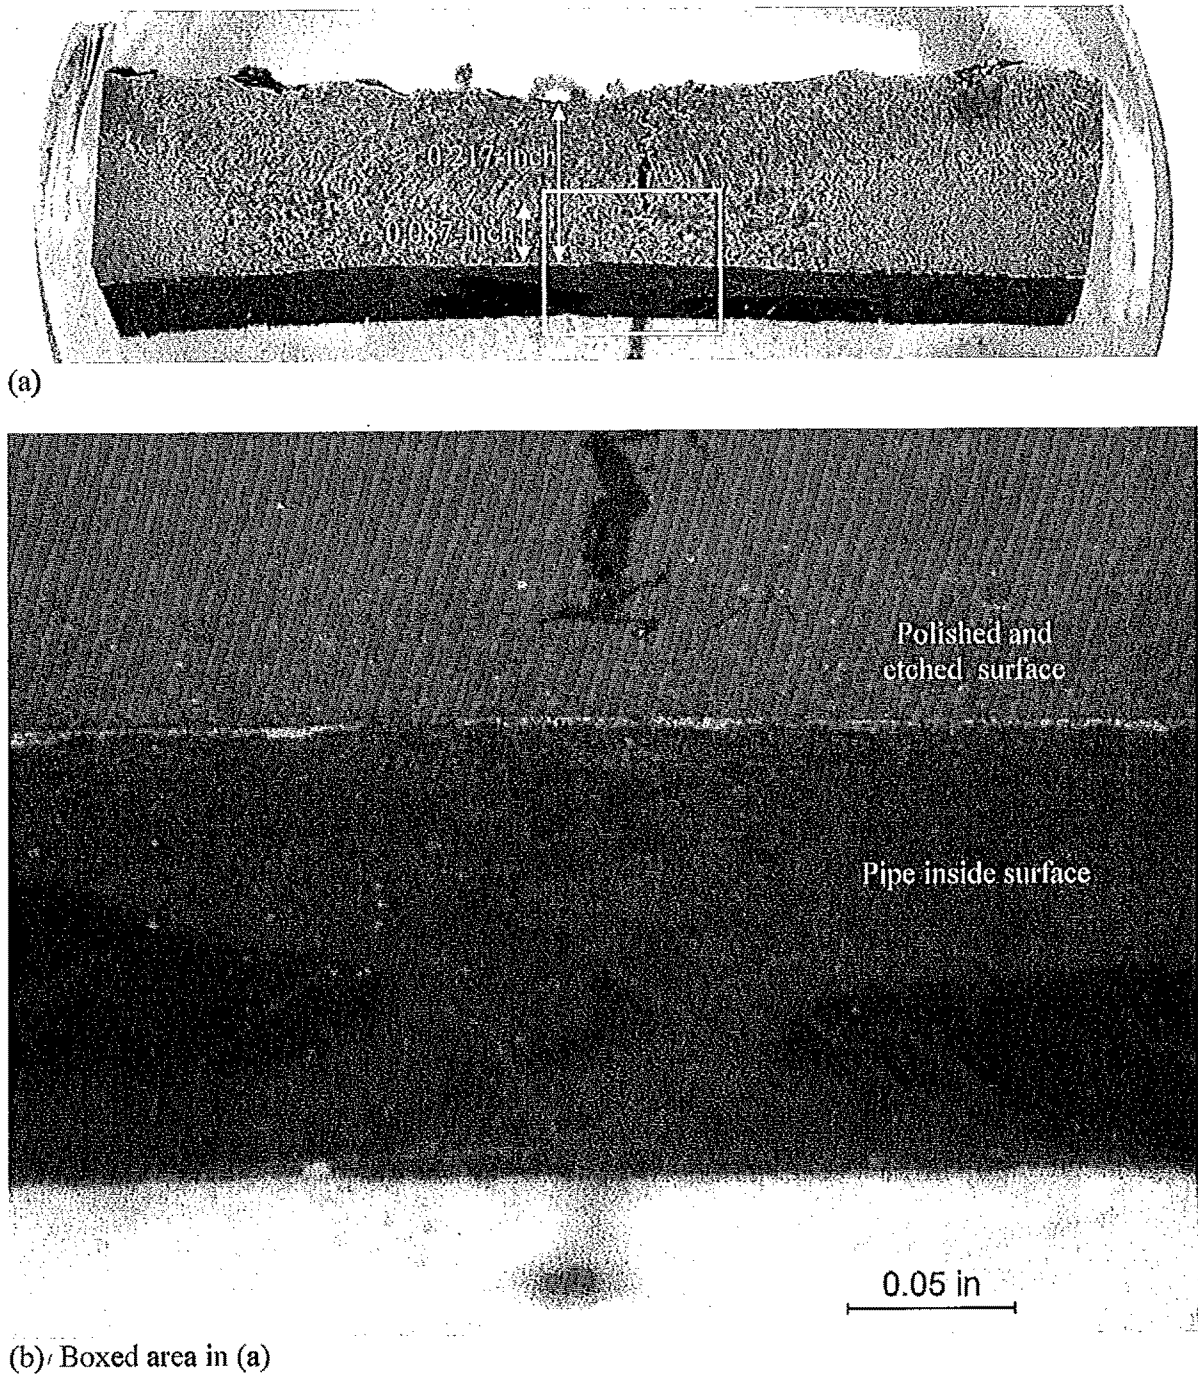
Specimens were prepared for metallography from section 1 and 2 indicated in Figure 8b. Weld crater cracks and heat affected zone liquation cracks were present in the sections. Serial grinding and polishing was performed on section 1, referred to as sections 1a, 1b, and 1c. As shown in Figure 10 through Figure 20, a weld crater crack extended from the outside surface into the weld heat affected zone in section 1a, but did not penetrate through-wall at this location. Shrinkage porosity was present near the outside surface, and intergranular cracks consistent with grain boundary liquation were present in the heat affected zone.

Figure 10 Images of the specimen prepared for metallography, section 1a. Etched with 2% nital.

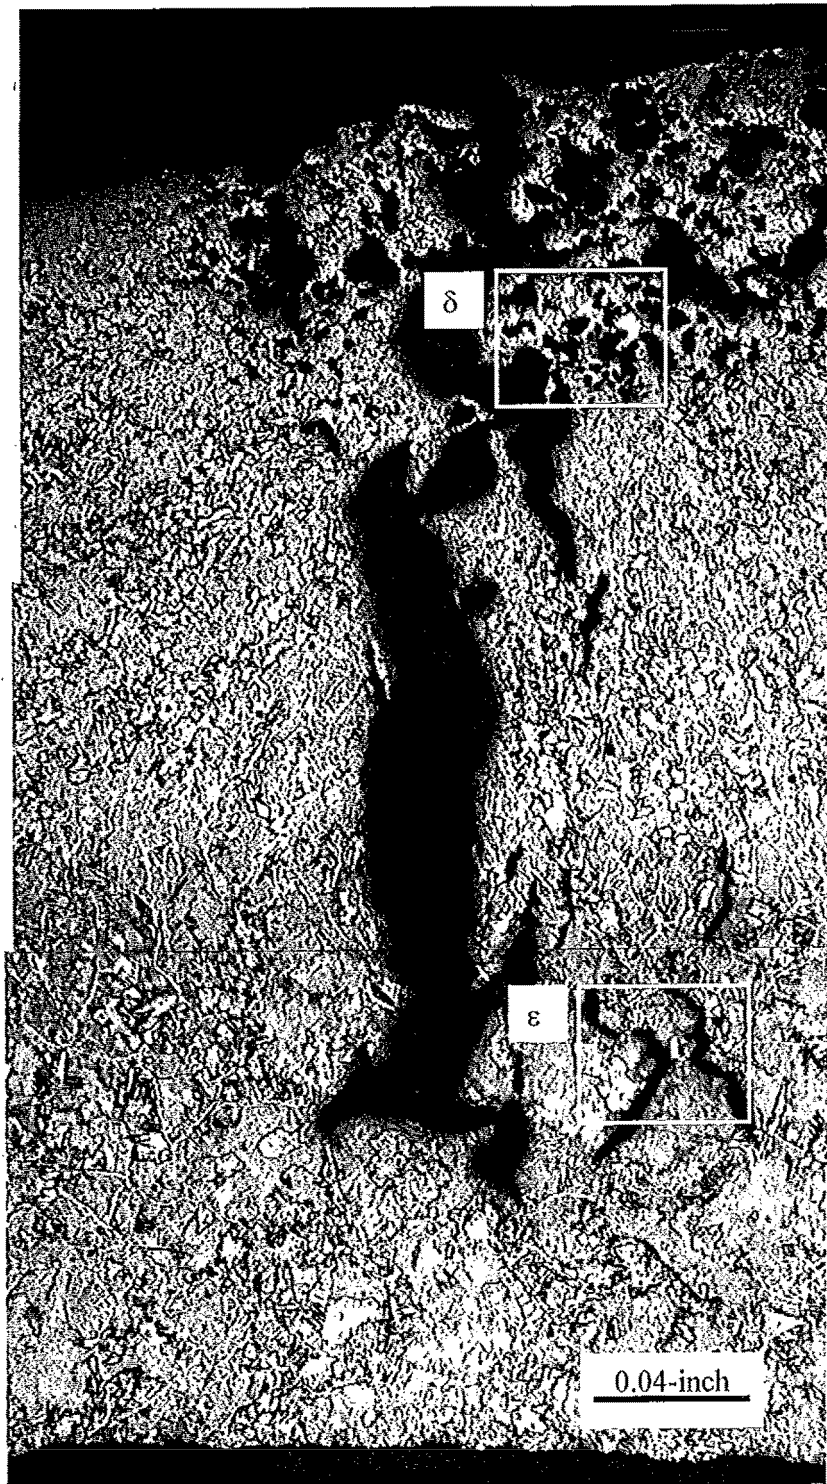
Figure 11 Composite optical micrograph of the specimen prepared for metallography, section 1a. Etched with 2% nital.

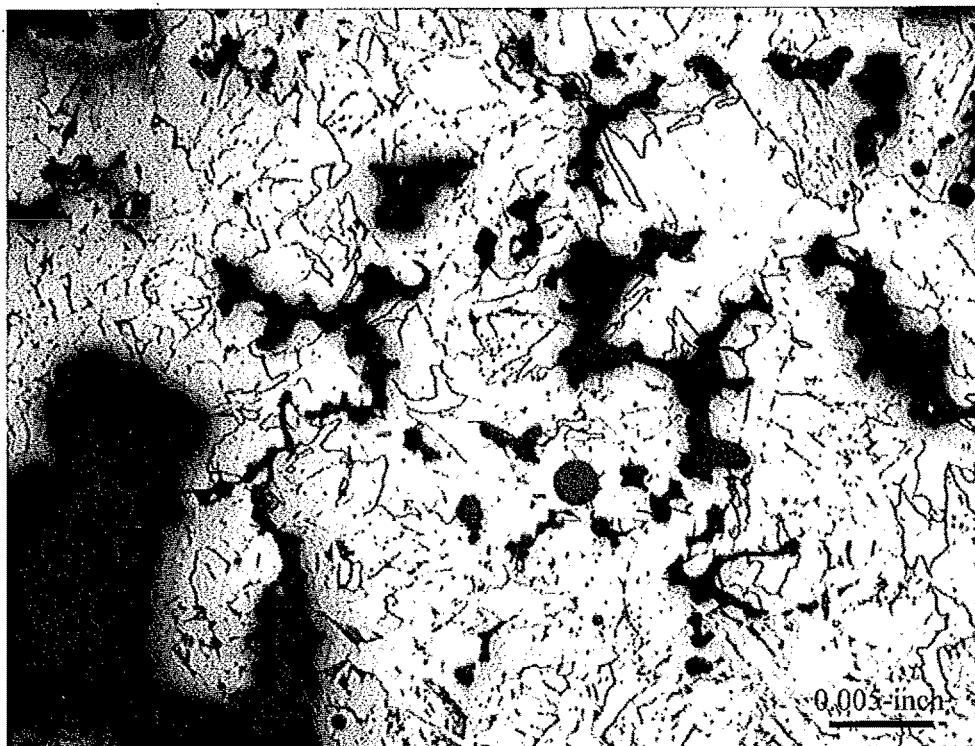
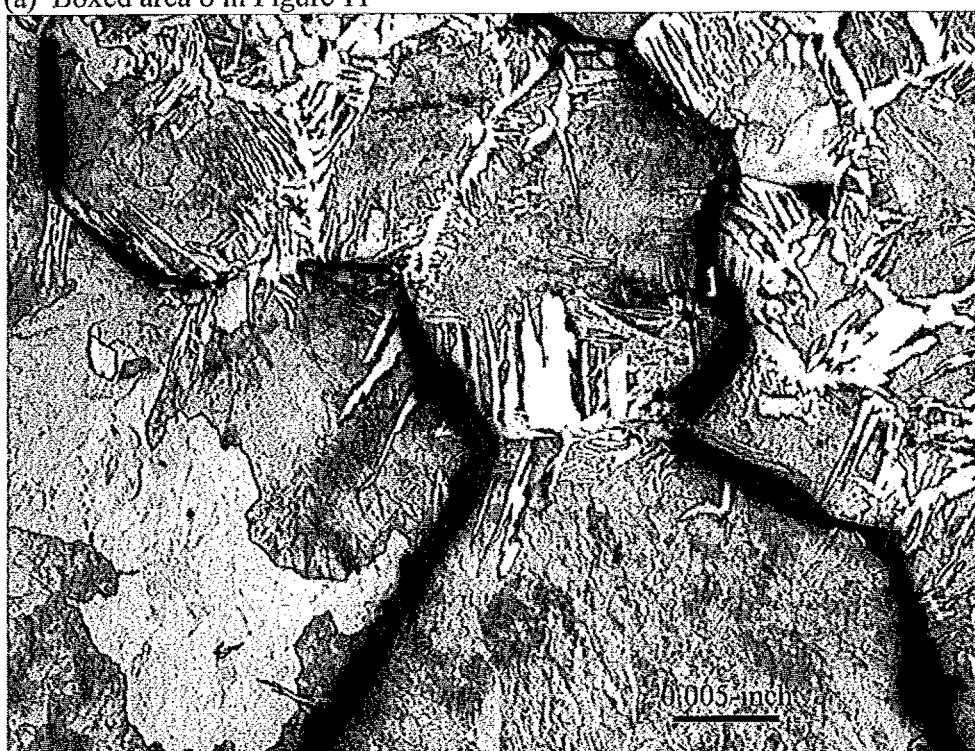
Figure 12 Optical micrographs of the specimen prepared for metallography, section 1a. Etched with 2% nital.

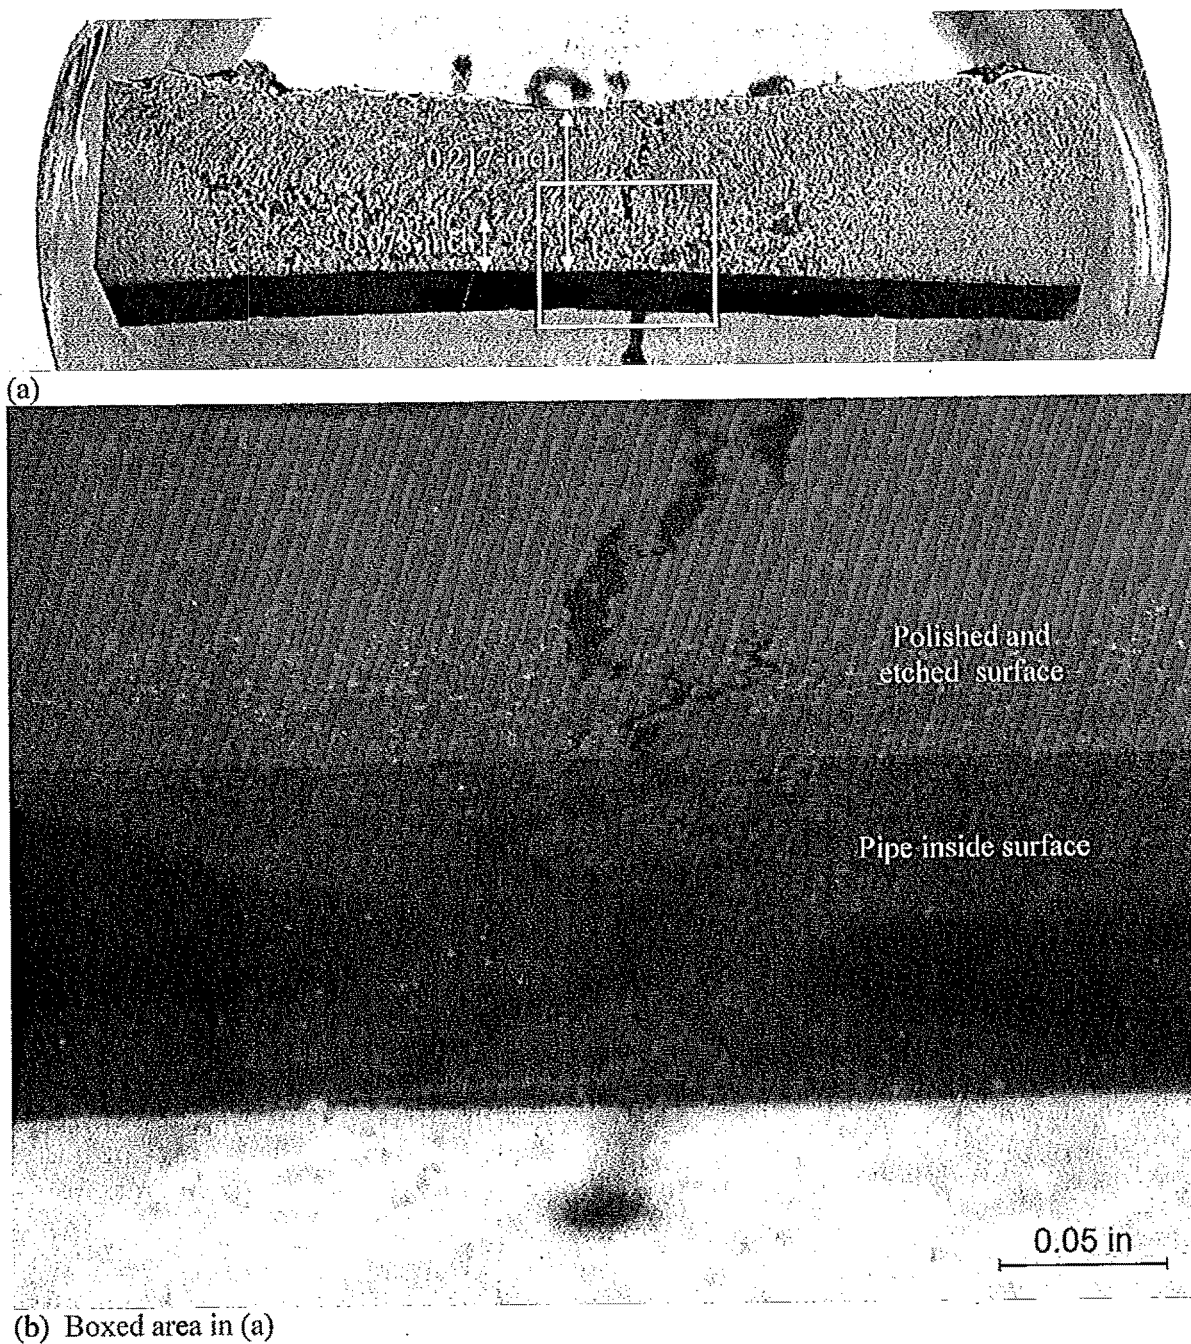
In section 1b, shown in Figure 13 through Figure 15, cracks were present from the outside surface to the inside surface. Only a few small ligaments prevented the demonstration of a through-wall leak path. However, it is likely that a leak path existed between section 1a and 1b. The weld metal crack morphology was consistent with shrinkage, and the heat affected zone crack morphology was indicative of grain boundary liquation.

Figure 13 Images of the specimen prepared for metallography, section 1b. Etched with 2% nital.

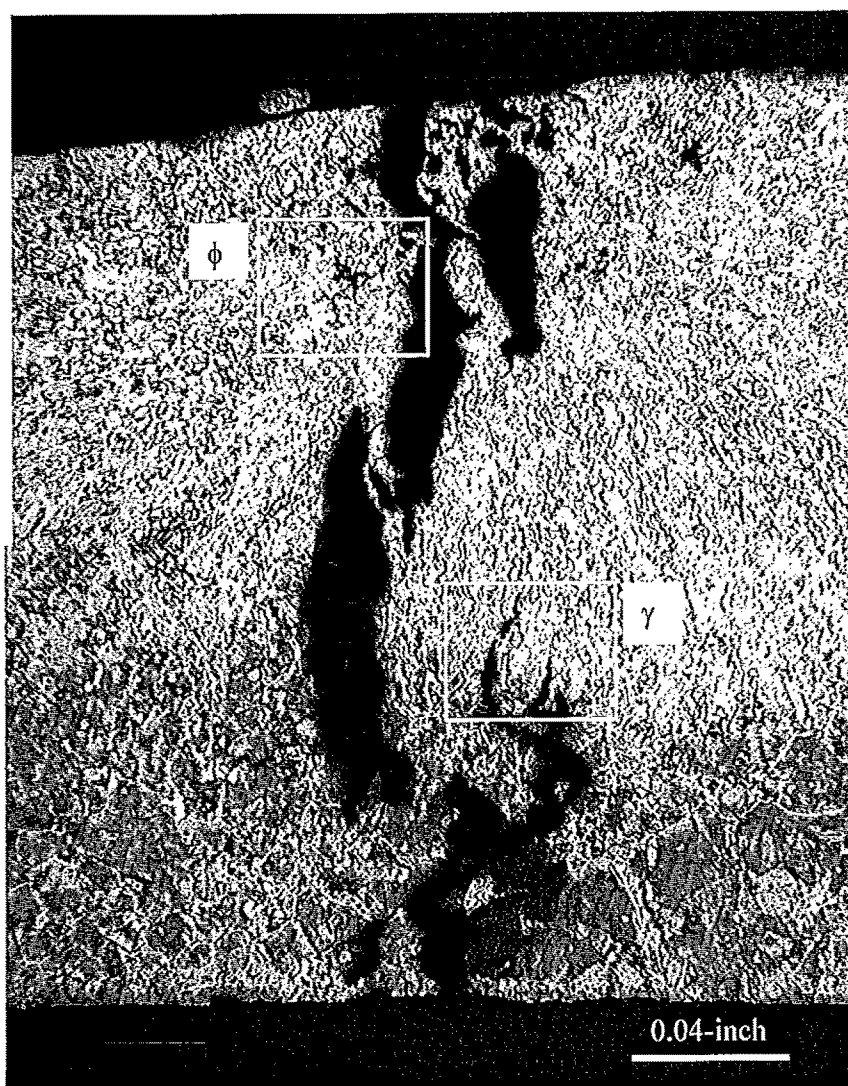
Figure 14 Composite optical micrograph of the specimen prepared for metallography, section 1b. Etched with 2% nital.

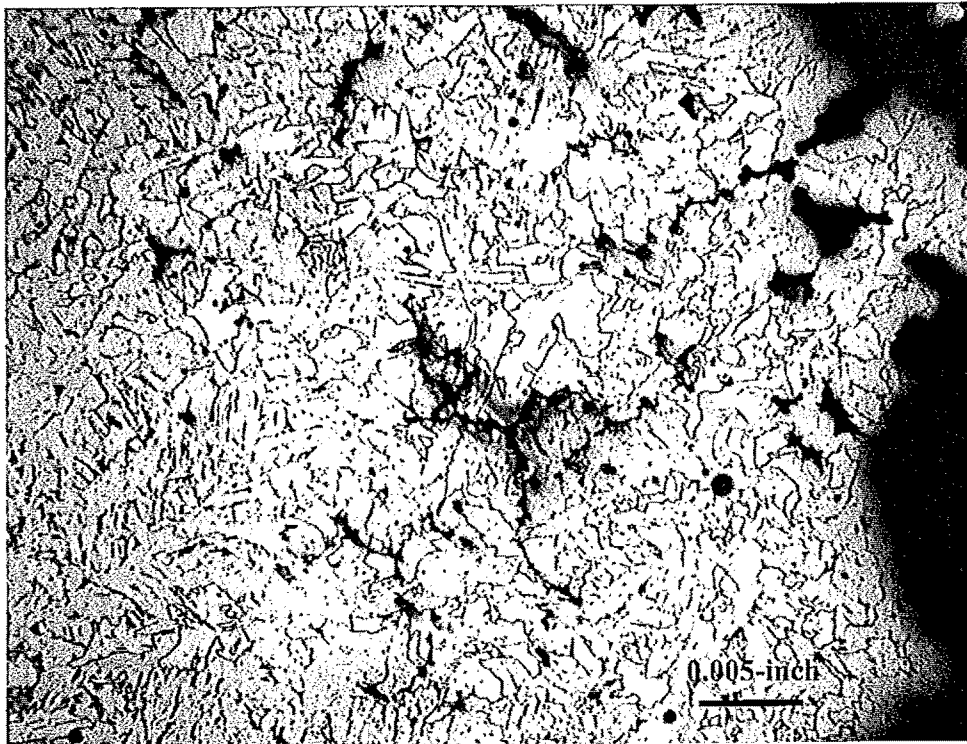
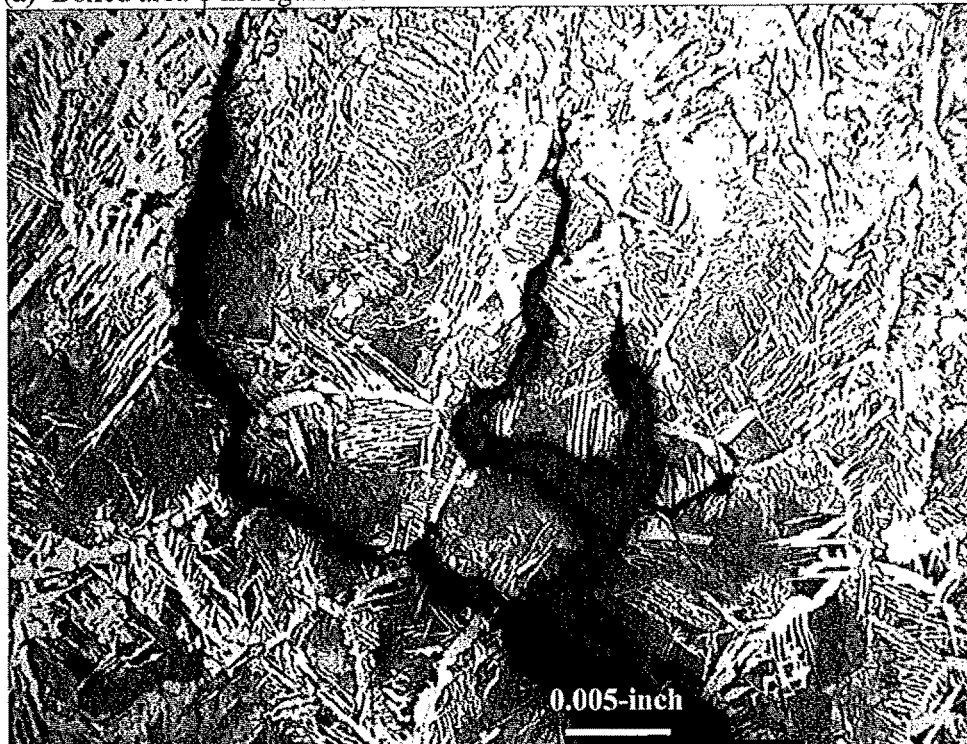
Figure 15 Optical micrographs of the specimen prepared for metallography, section 1b. Etched with 2% nital.
