Report No. 5004.9268

September 6, 2013

**METALLURGICAL EVALUATION OF A SECTION FROM  
L-147 MP 2.2 BRITTAN AVE. AND ROGERS AVE., SAN CARLOS**

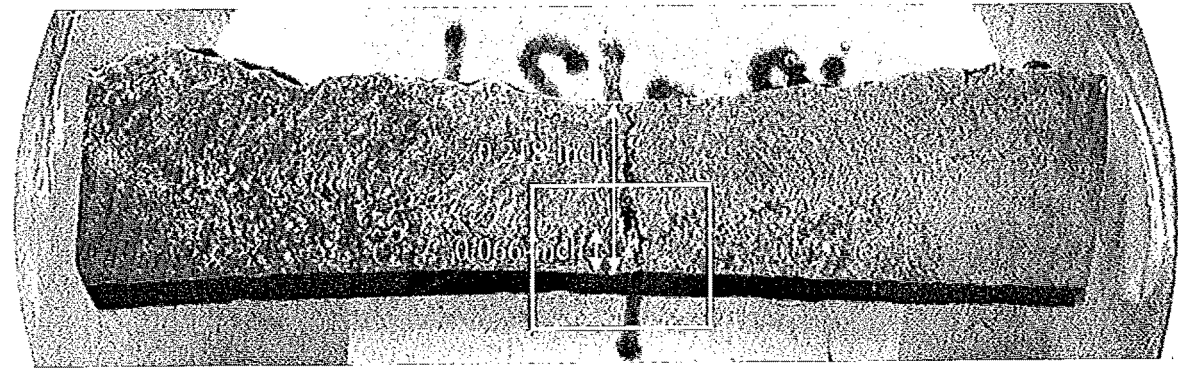
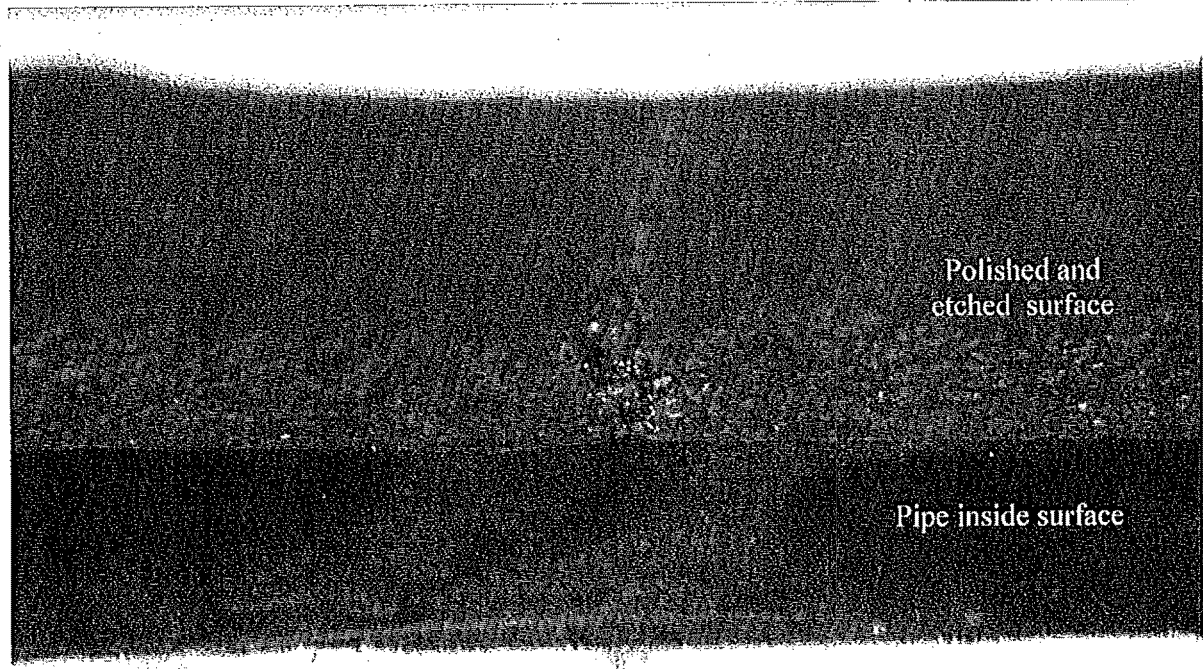
In section 1c, shown in Figure 16 through Figure 18, one small ligament at the outside surface prevented demonstration of a through-wall leak path. Once again, the weld crack morphology was consistent with shrinkage and the heat affected zone crack morphology was consistent with grain boundary liquation. In all three sections of specimen 1, the weld fusion zone followed a smooth broad contour with no indications of external corrosion prior to welding.

Figure 16 Images of the specimen prepared for metallography, section 1c. Etched with 2% nital.

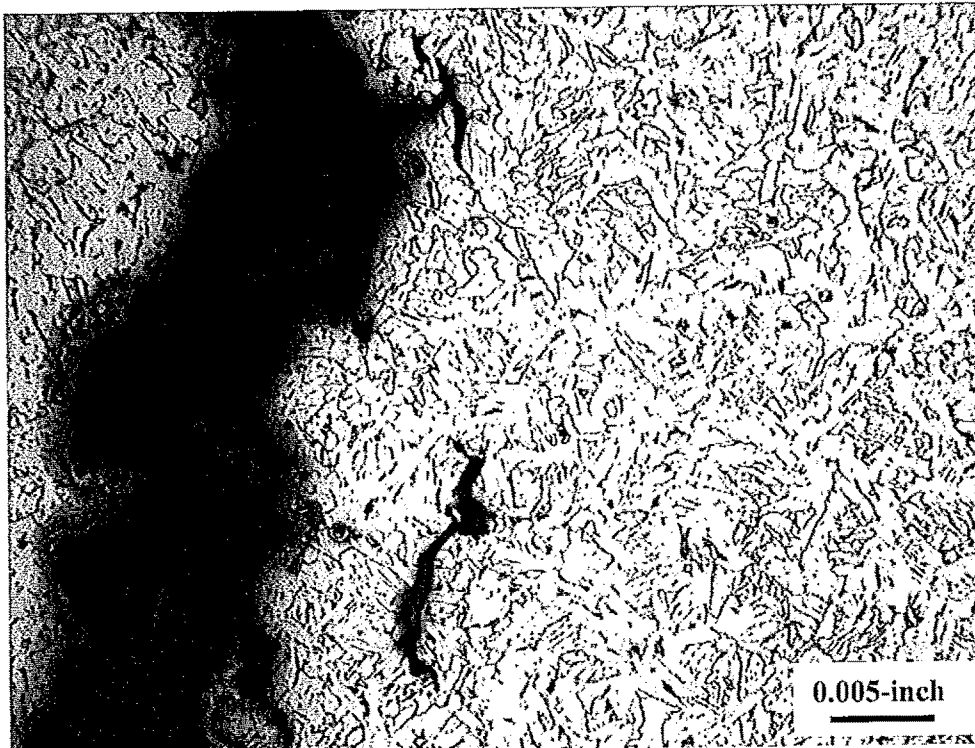
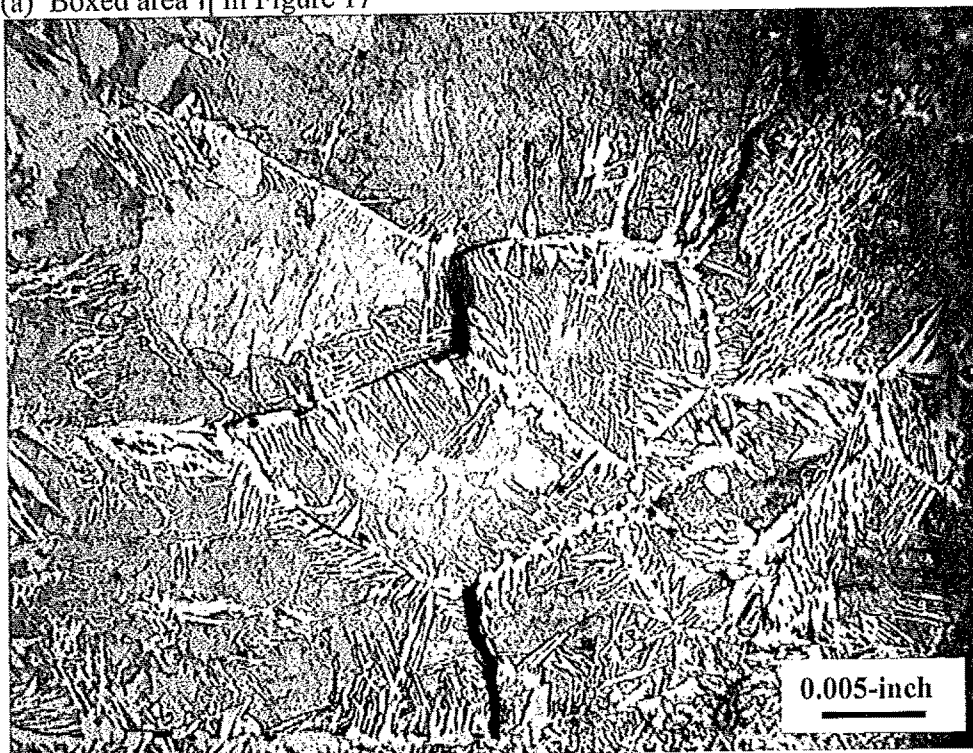
Figure 18 Optical micrographs of the specimen prepared for metallography, section 1c. Etched with 2% nital.

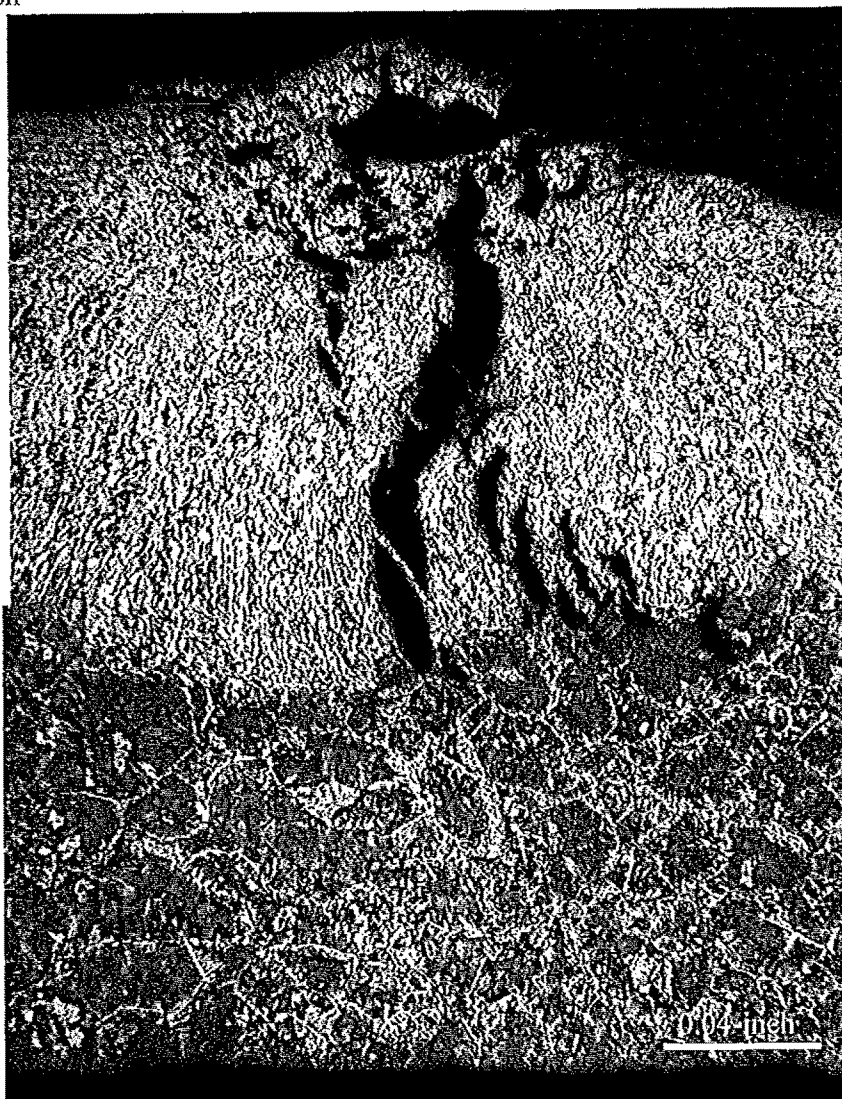
Section 2 is shown in Figure 19. The fusion zone in this section had a profile that was more varied in depth than in sections 1a through 1c, which suggested the possibility that the weld metal was deposited to build-up locations where wall thickness had been reduced by external corrosion. Measurements of the minimum thickness of base metal beneath the weld metal are shown in Figure 10, Figure 13, Figure 16, and Figure 19.

Figure 19 Photograph and composite micrograph of section 2. Etched with 2% nital.

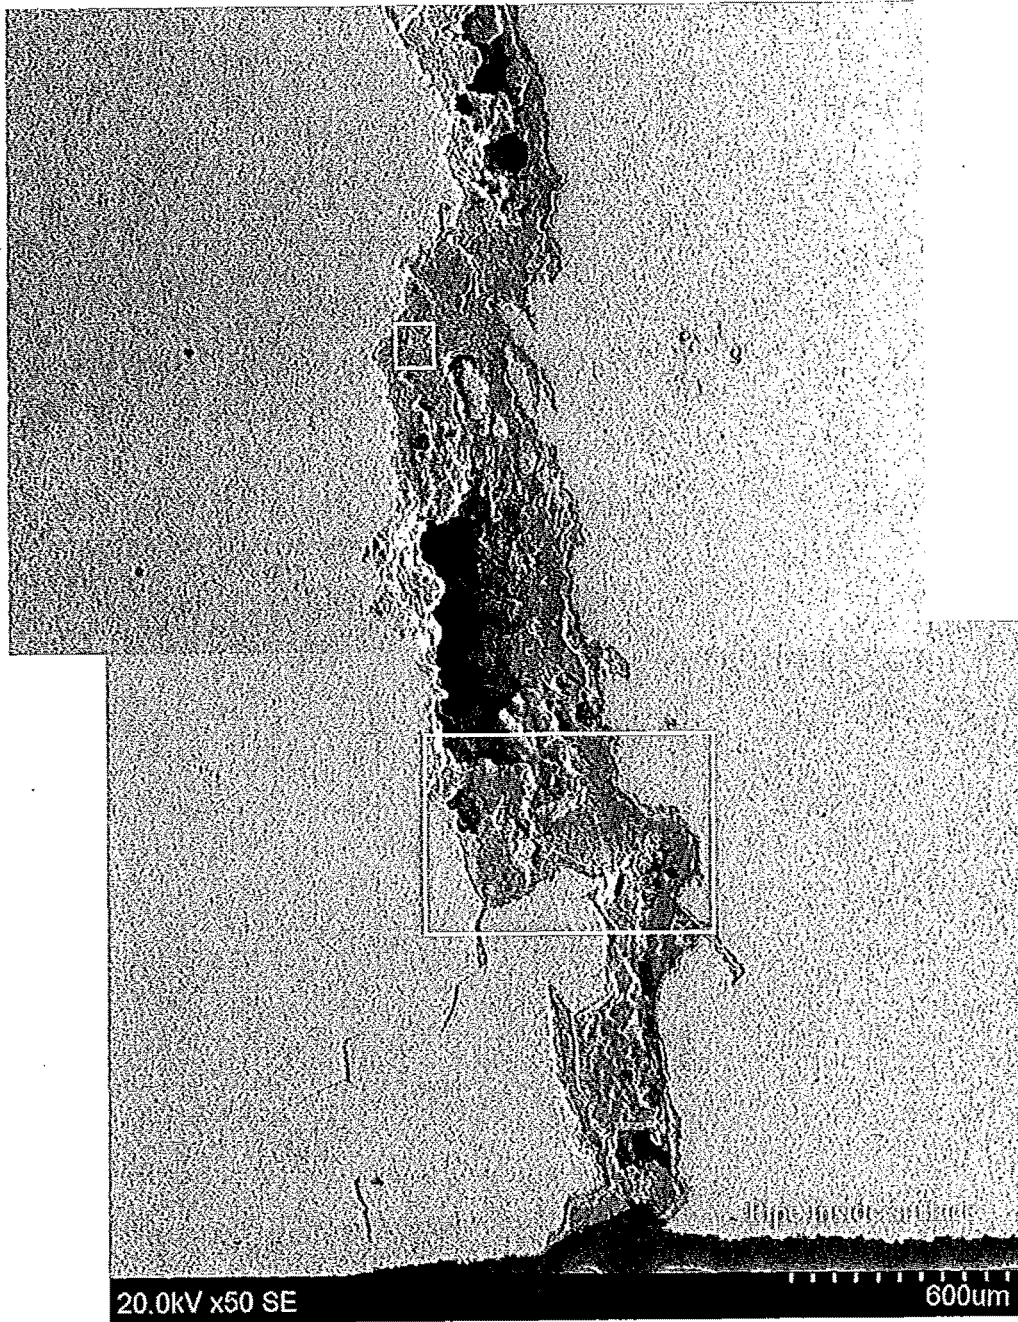
Scanning electron microscopy (SEM) and energy dispersive X-ray spectroscopy<sup>2</sup> (EDS) was performed on the section 3 polished and etched surface. A composite SEM micrograph of the crack is shown in Figure 20. Much of the crack was filled with oxide, indicated by the morphology and chemical composition of primarily iron and oxygen, with sulfur present, likely from mercaptan in the gas stream.

Figure 20 Composite SEM micrograph of the specimen prepared for metallography, section 1c.

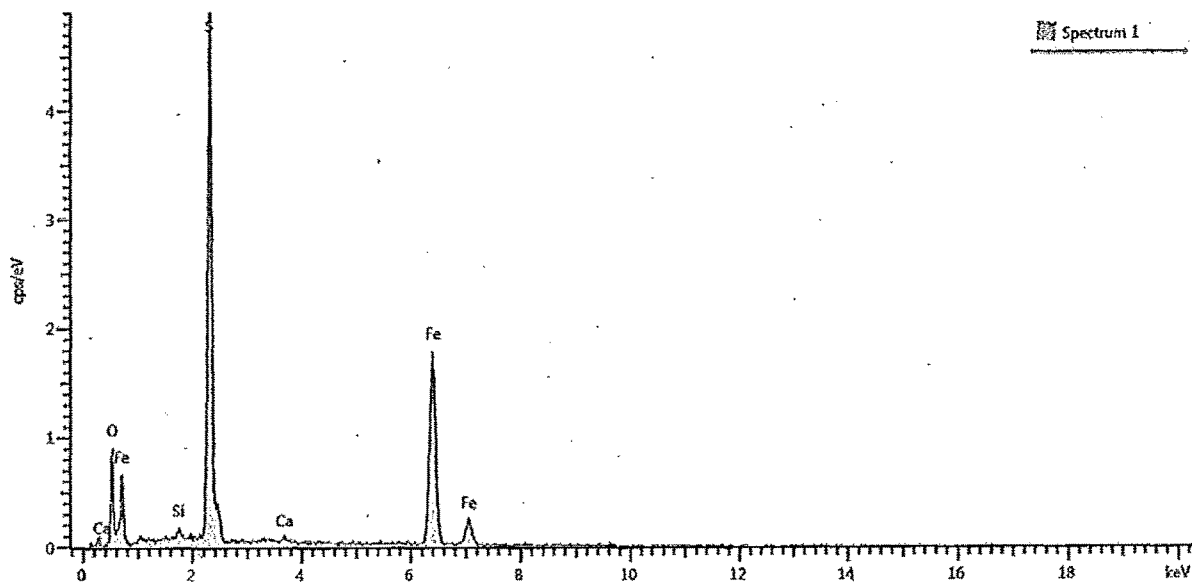
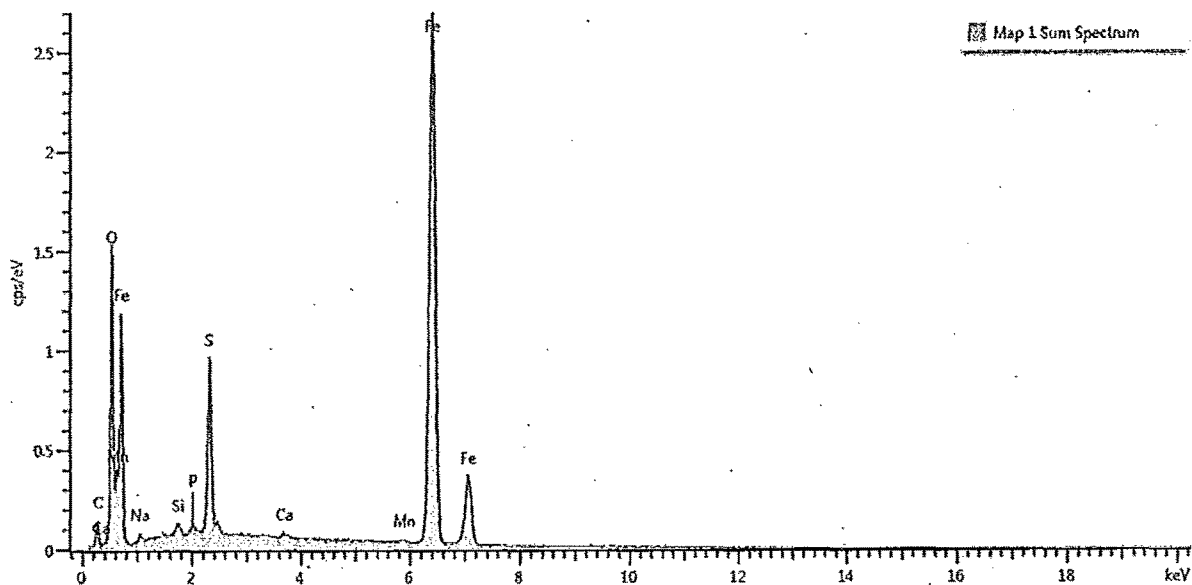
Figure 21 EDS spectra from the specimen prepared for metallography, section 1c.

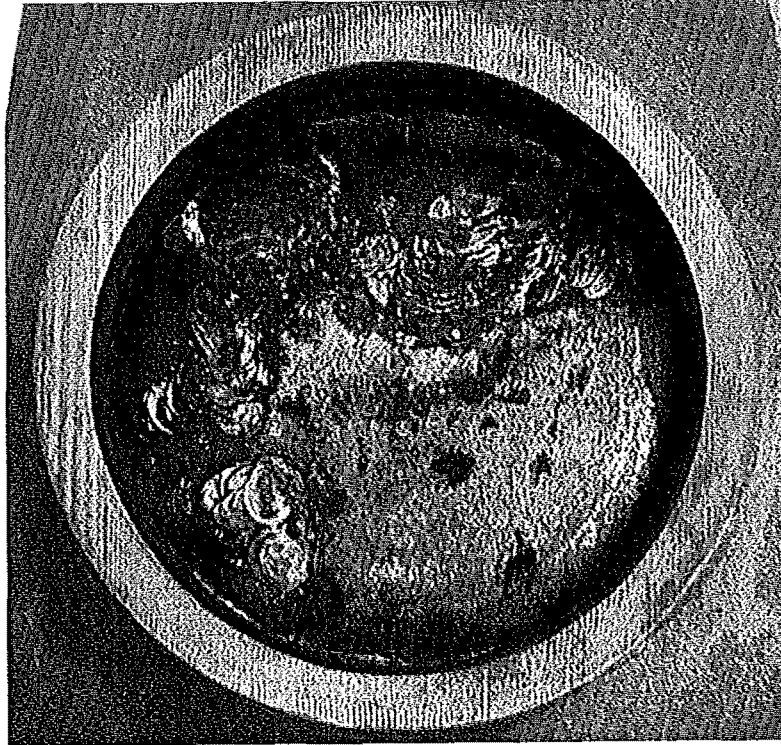
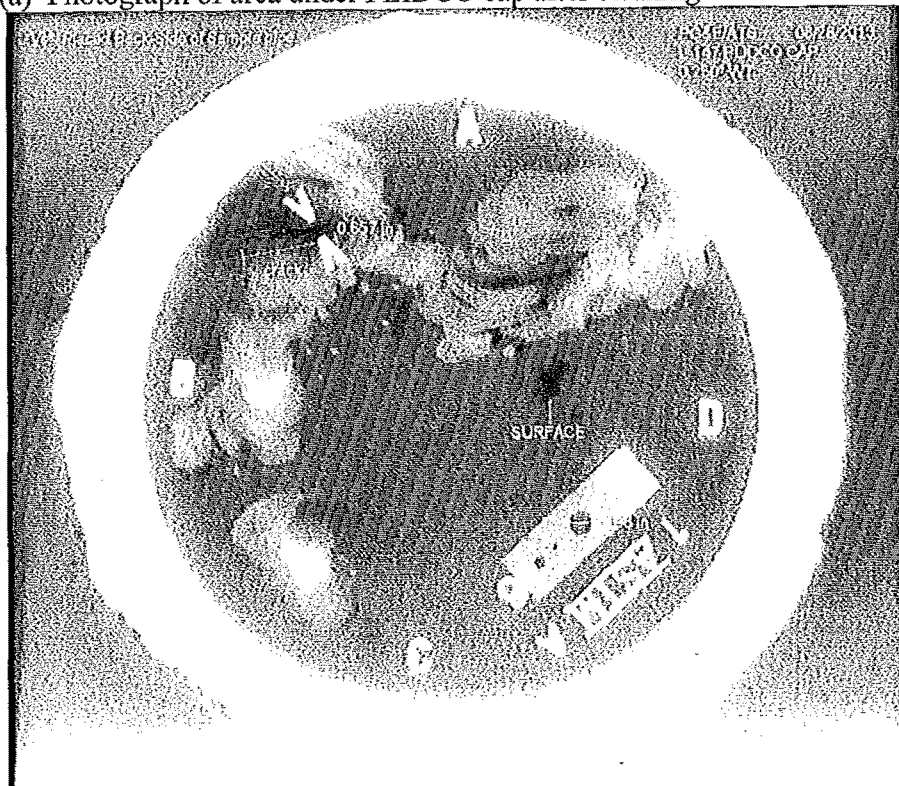
Appendix A  
(Radiograph courtesy of PG&E)

The sample shown in Figure 6 was returned to PG&E for radiography. A digital radiograph of the sample is shown in Appendix A along with a photograph of the sample. A crack indication was found that corresponded to the crack-like feature detected visually on the inside surface, shown in Figure 8b.

(a) Photograph of area under PLIDCO cap after cleaning

(b) Radiograph of area shown in (a)
