Report No. 5004,9268 Rev. 1

**METALLURGICAL EVALUATION OF A SECTION FROM
L-147 MP 2.2 BRITTAN AVE. AND ROGERS AVE., SAN CARLOS**

One section of 20-inch diameter gas transmission pipe identified as L-147 MP 2.2 Brittan Ave. and Rogers Ave., San Carlos was submitted by PG&E for metallurgical evaluation. The subject section had a PLIDCO weld cap permanent repair, and an A. O. Smith longitudinal seam weld. The section was cut out to perform a root cause investigation of a reported leak under the PLIDCO cap. It was reported the subject passed hydrotest as part of L-147 on October, 24, 2011, at a pressure of 600-psi, or 1.5 times the desired Maximum Allowable Operating Pressure (MAOP) of 400-psi, and the PLIDCO cap was located at the six o'clock position, on the bottom of the section. The purpose of this evaluation was to determine the metallurgical condition of the pipe wall under the PLIDCO cap, and perform Charpy impact testing of the A. O. Smith weld and unaffected base metal.

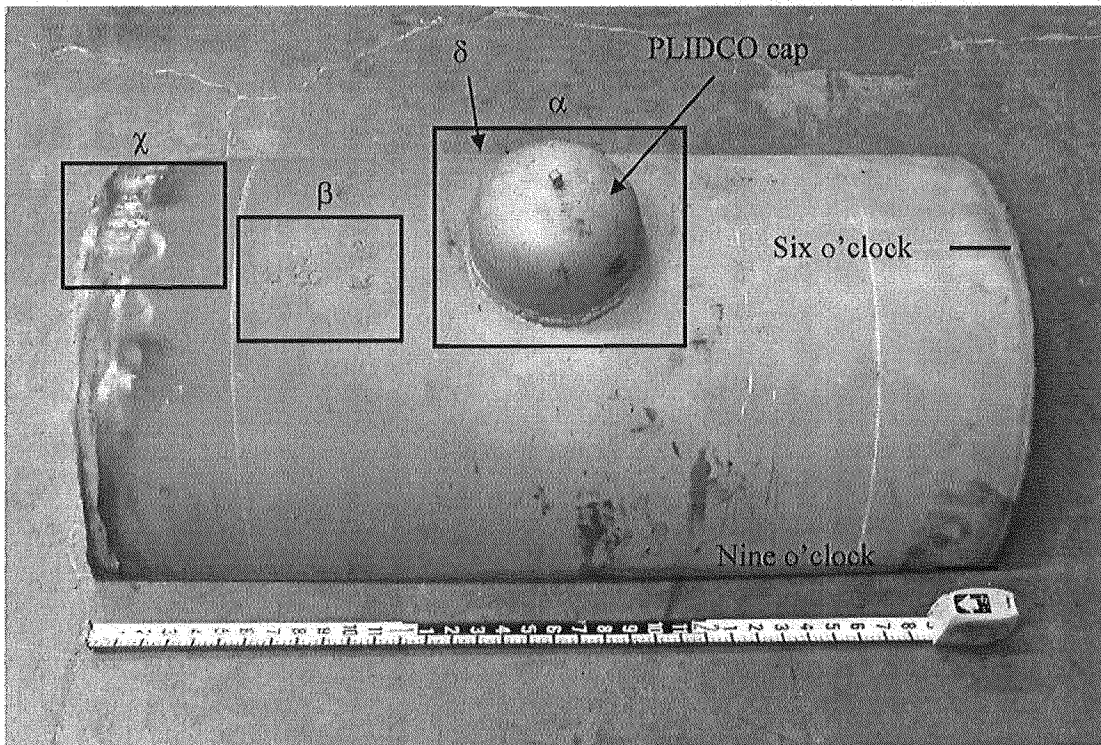
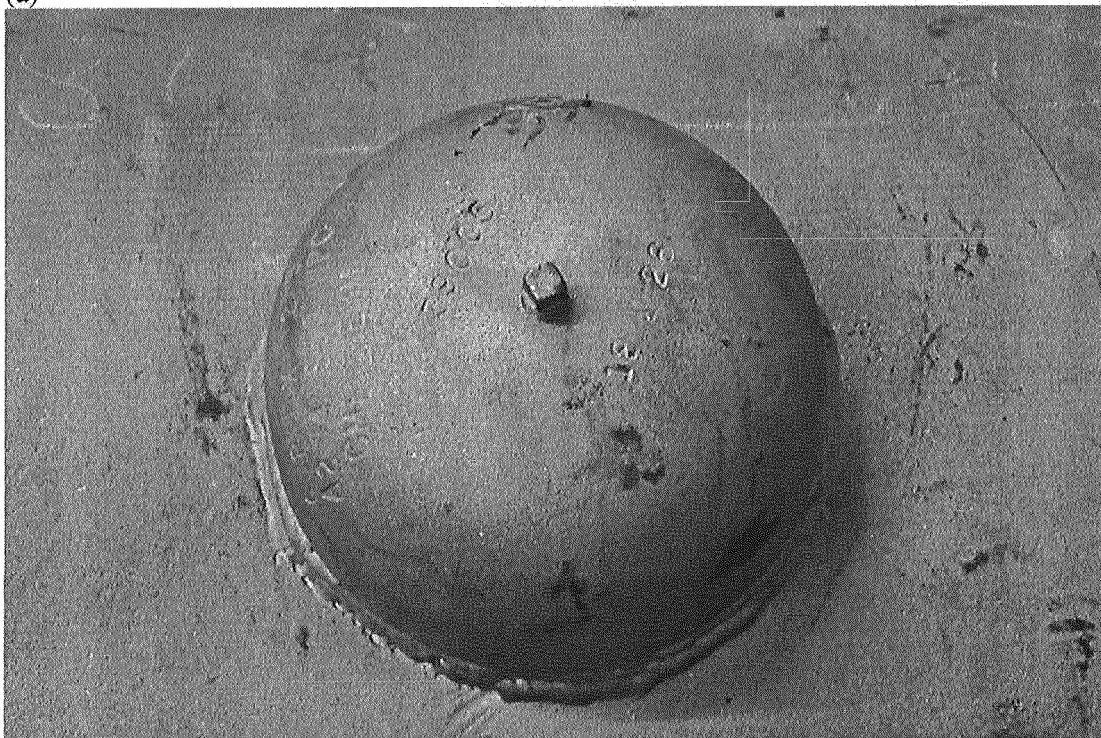
The subject sample of L-147 was received sectioned into two halves along the longitudinal axis, with the outside surface grit blasted, as shown in Figure 1 through Figure 5. The section half with the PLIDCO cap was arbitrarily labeled A and the other section was labeled B, in the laboratory. Based on the reported position of the cap, the longitudinal flame cuts were located at three o'clock and nine o'clock positions. Wall thickness measurements were made with a pointed anvil micrometer and the results are listed in Table 1. Small regions of weld metal and a few shallow hemispherical pits were present near the cap, as shown in Figure 2. Pits were also present just past the three o'clock position toward the cap, indicated in Figure 1. Pit depths were measured with a pit gage, and the results are listed in Table 2. No evidence of a leak location or repair was visible to the unaided eye on the inside surface of the pipe under the cap.

Figure 1 Photographs of the outside surface of sample half A as-received.

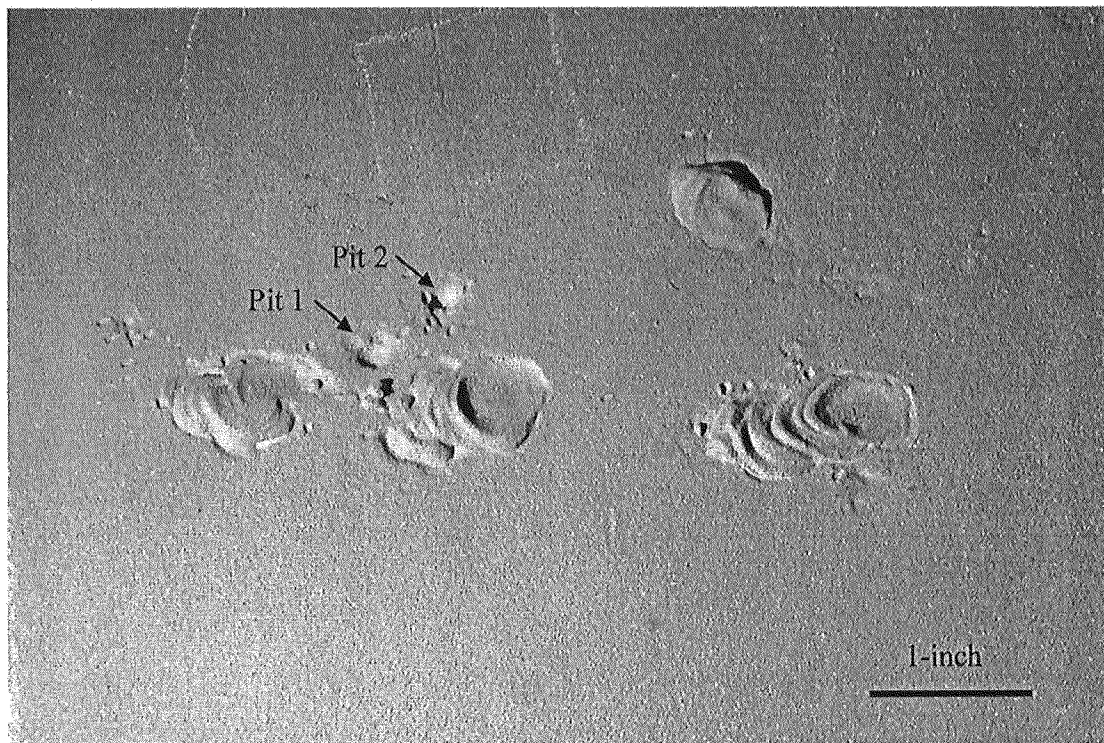
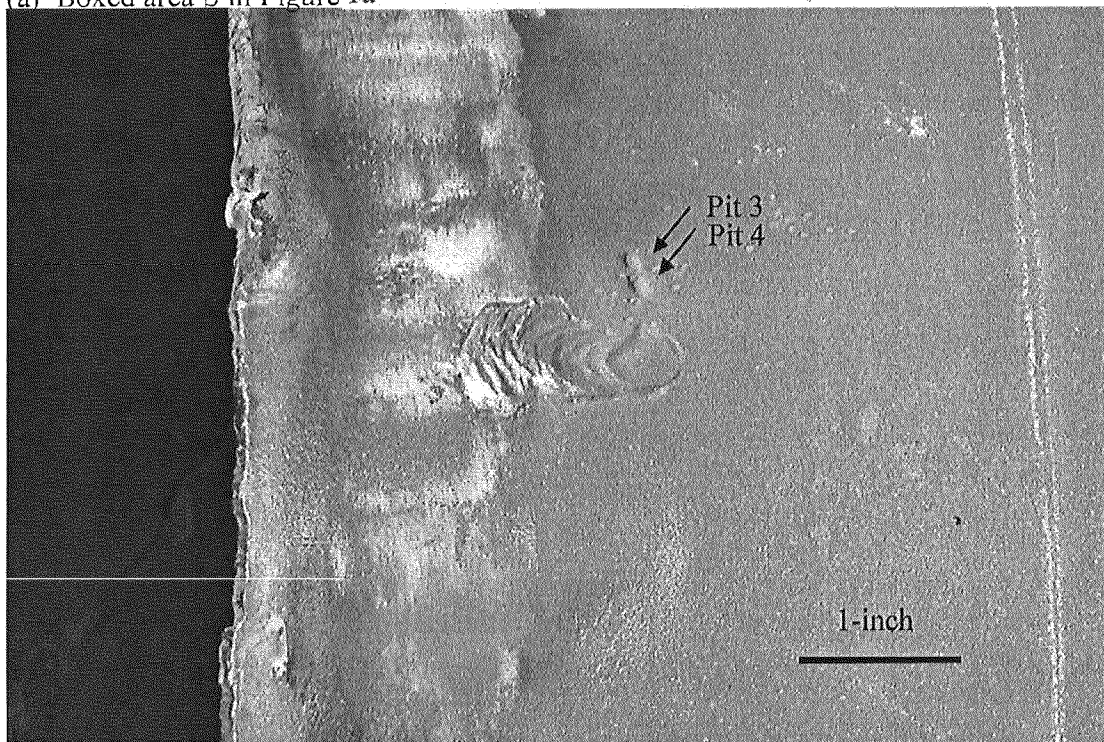
Figure 2 Photographs of the outside surface of sample half A as-received.

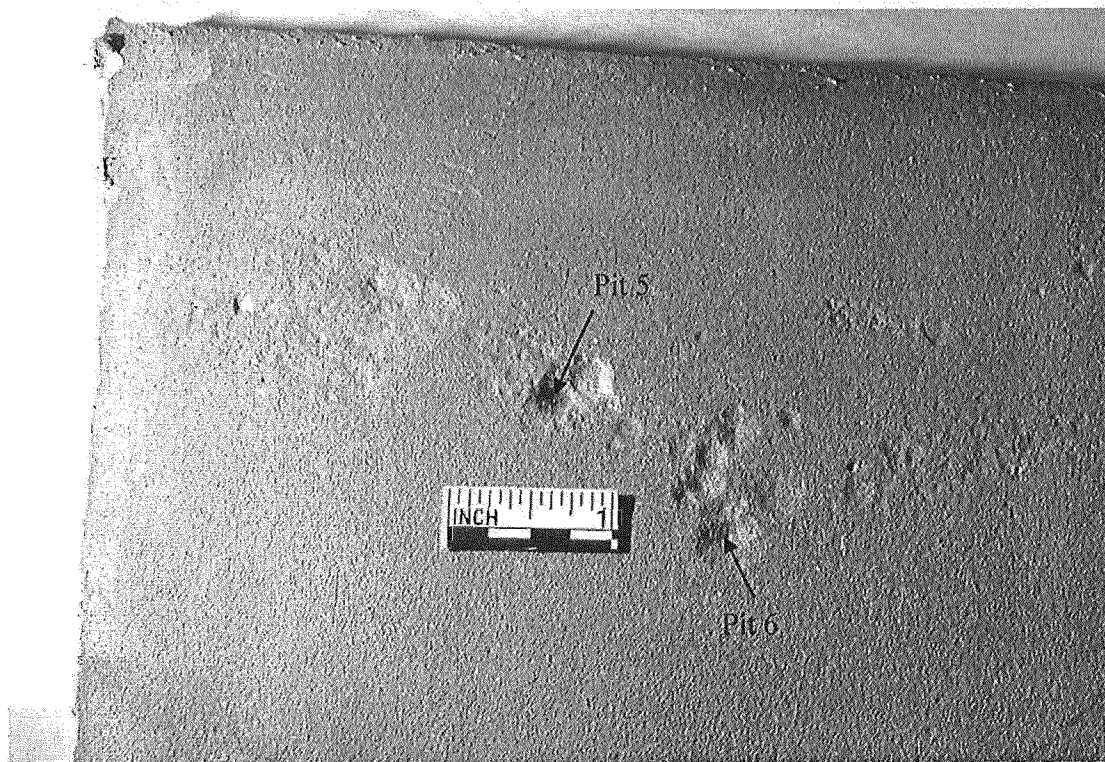
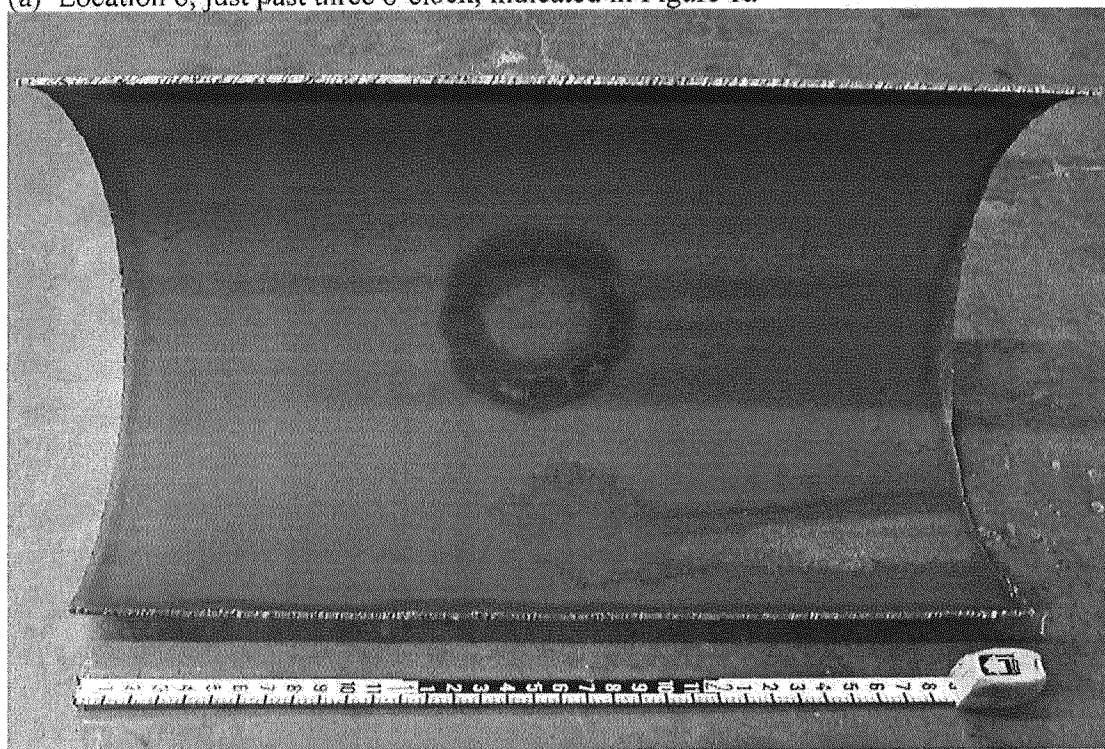
(a) Location δ , just past three o'clock, indicated in Figure 1a

Figure 3 Photographs of pits on the outside surface and the inside surface of sample A.

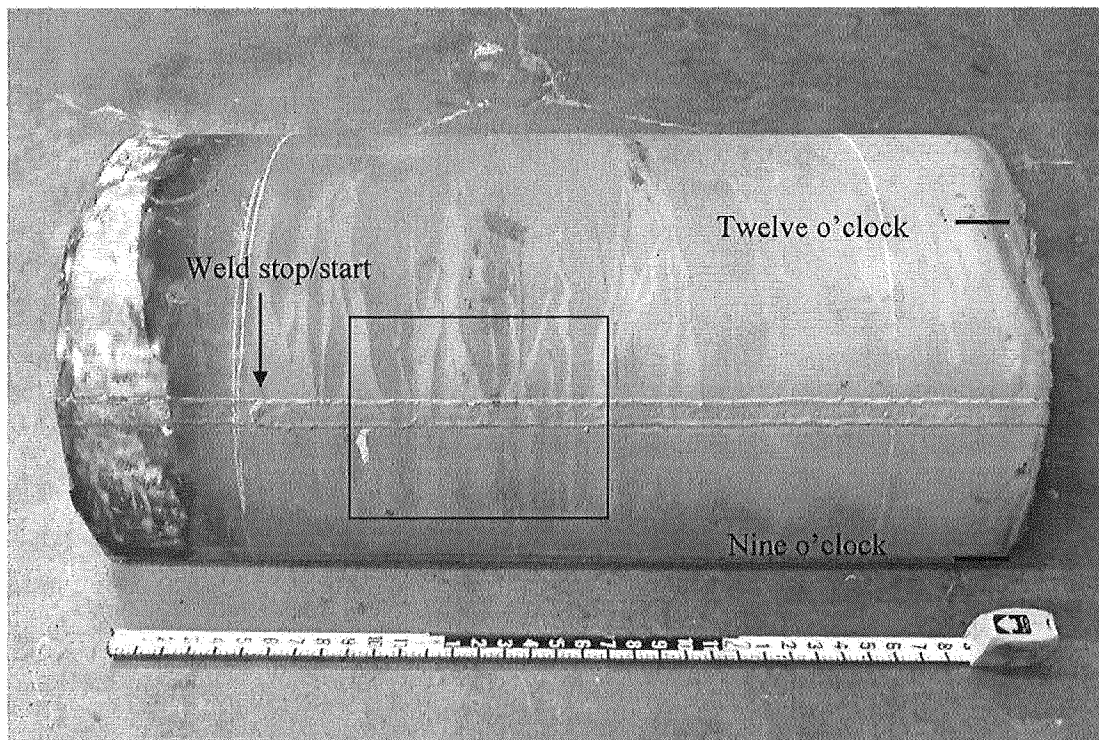
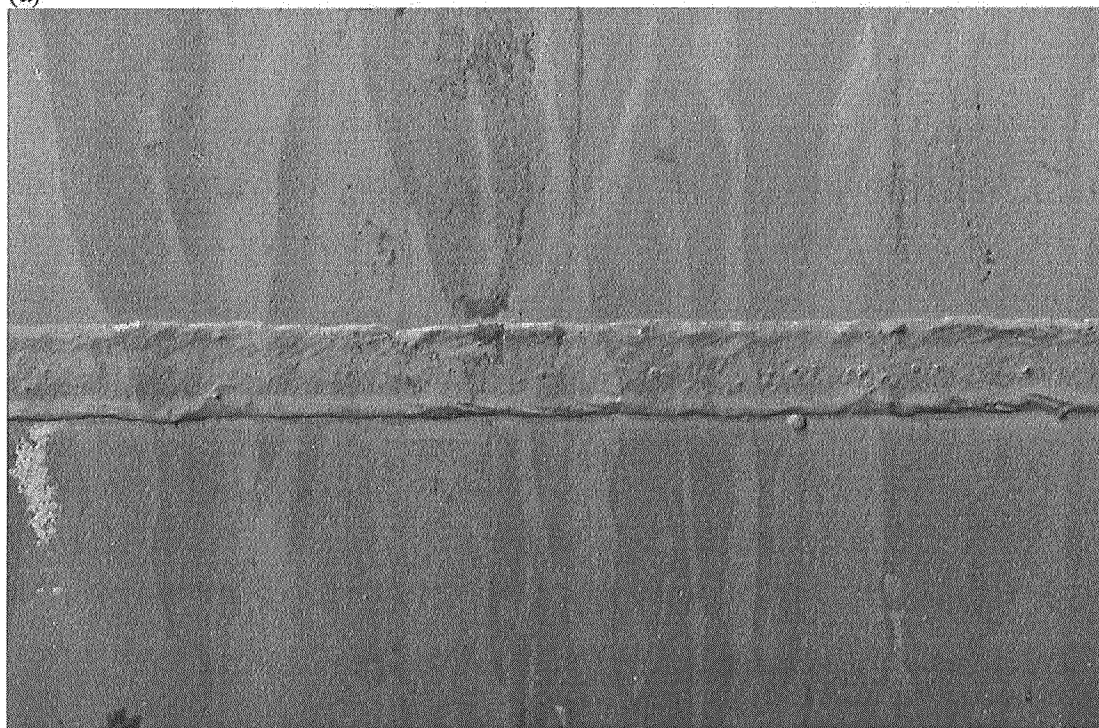
The appearance of the longitudinal seam was typical of A. O. Smith welds, a wide low-crowned cap on the outside surface and a narrow flash on the inside surface. A weld stop/start was visible on the outside surface.

Figure 4 Photographs of the outside surface of sample half B.

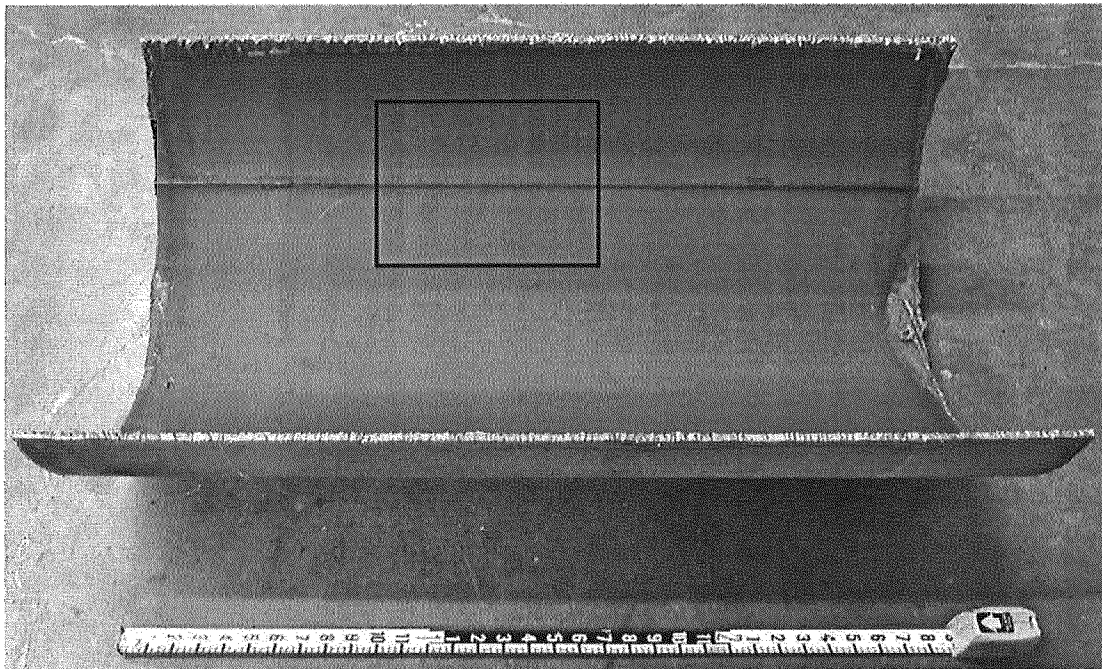
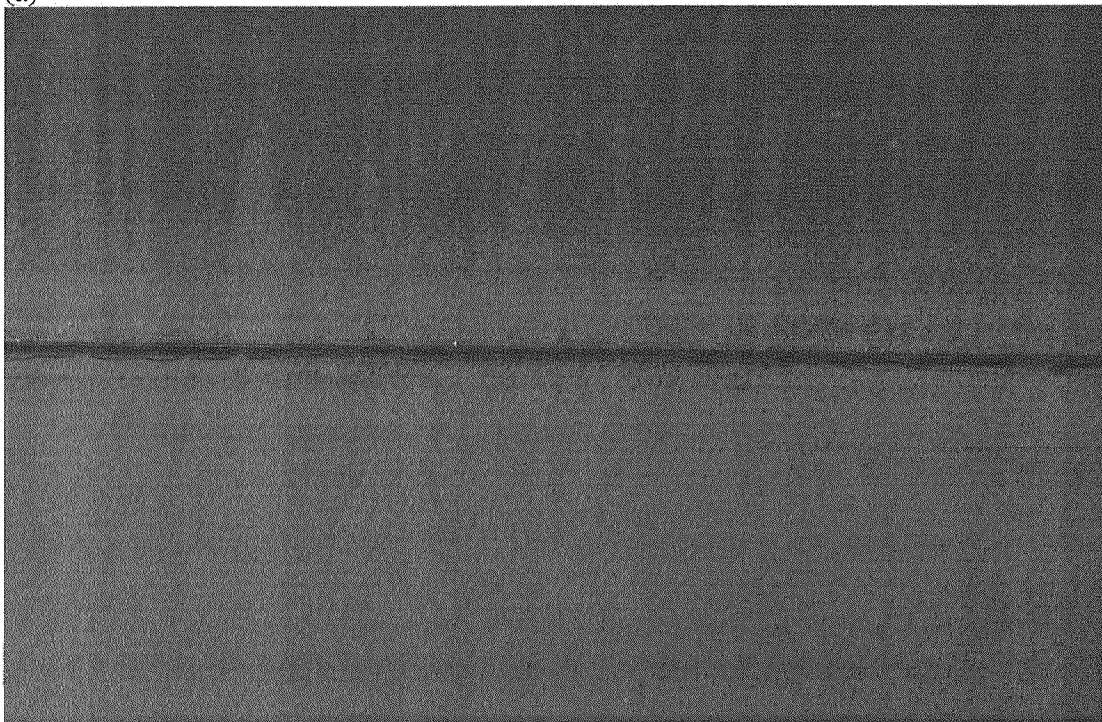
Figure 5 Photographs of the inside surface of sample half B.

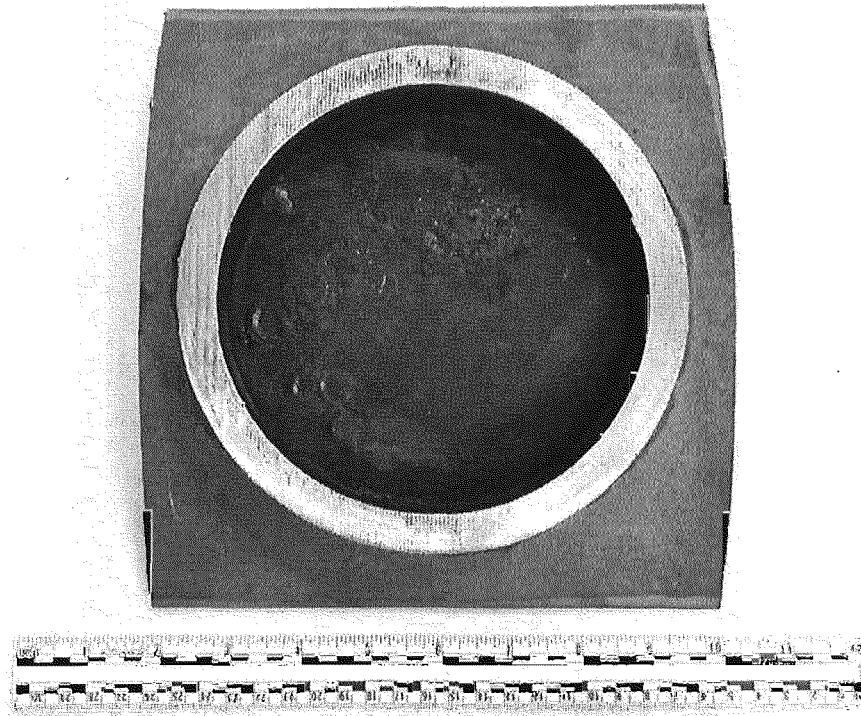
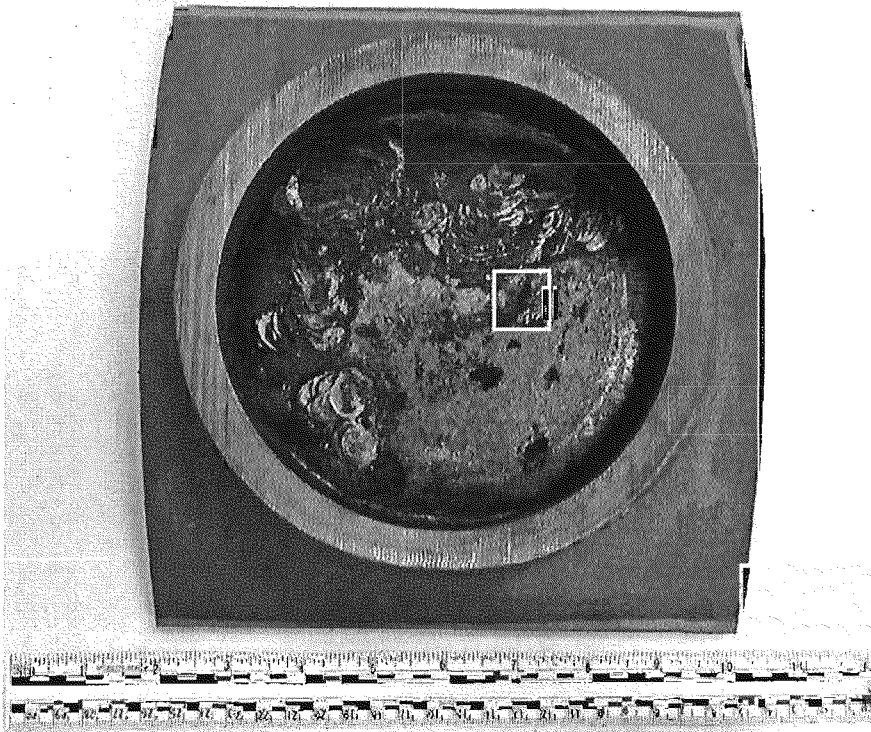
The region containing the PLIDCO cap was sectioned from sample A and the cap was cut off to expose the outside surface of the pipe wall. The outside surface was covered with rust and had a slightly oily feel. Both surfaces were cleaned with dilute Oakite® 33 and a wire brush. The outside surface is shown before and after cleaning in Figure 6. Several regions of weld metal were visible on the outside surface. Examination using low-power optical microscopy revealed a pit consistent with corrosion on the outside surface, indicated in Figure 7. The inside surface is shown after cleaning in Figure 8. Indications of heat exposure were visible on the inside surface, corresponding to the weld metal on the outside surface. No evidence of weld burn through was detected, and fine grooves typical of wrought steel surfaces were continuous across the region, which indicated that repairs did not extend to the inside surface. Examination using low-power optical microscopy revealed a crack-like feature on the inside surface within the heat affected zone of a weld deposit, as shown in Figure 8b.

Both sides of the cap sample shown in Figure 6 were thoroughly cleaned with acetone and dried with compressed air. A liquid penetrant test was performed by applying developer to the inside surface, and penetrant was liberally applied to the outside surface in the area covered by the cap. After 1.5-hours, no indication of penetrant was visible on the inside surface.

Figure 6 Photographs of the PLIDCO cap area after sectioning.

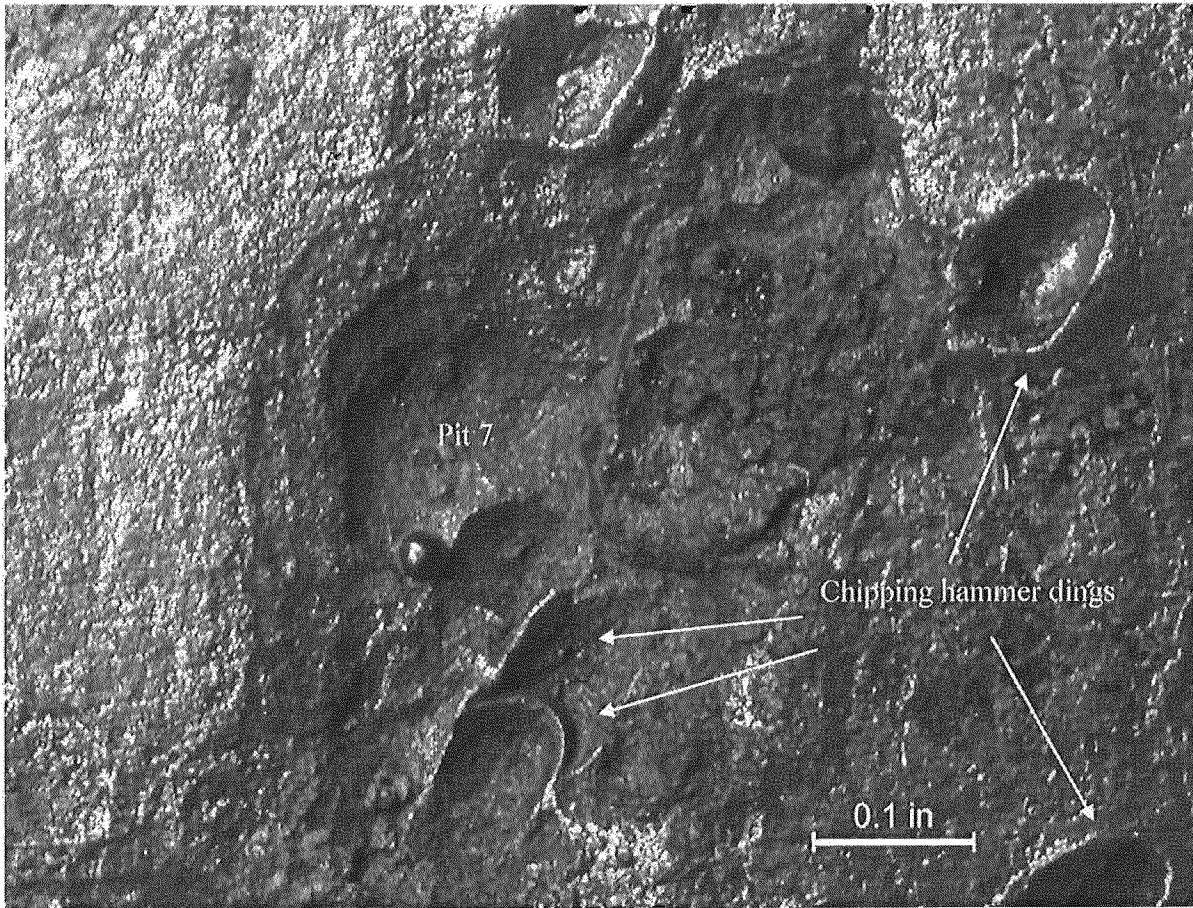
Figure 7 Macrograph of a pit under the PLIDCO cap, from the boxed area in Figure 6b.

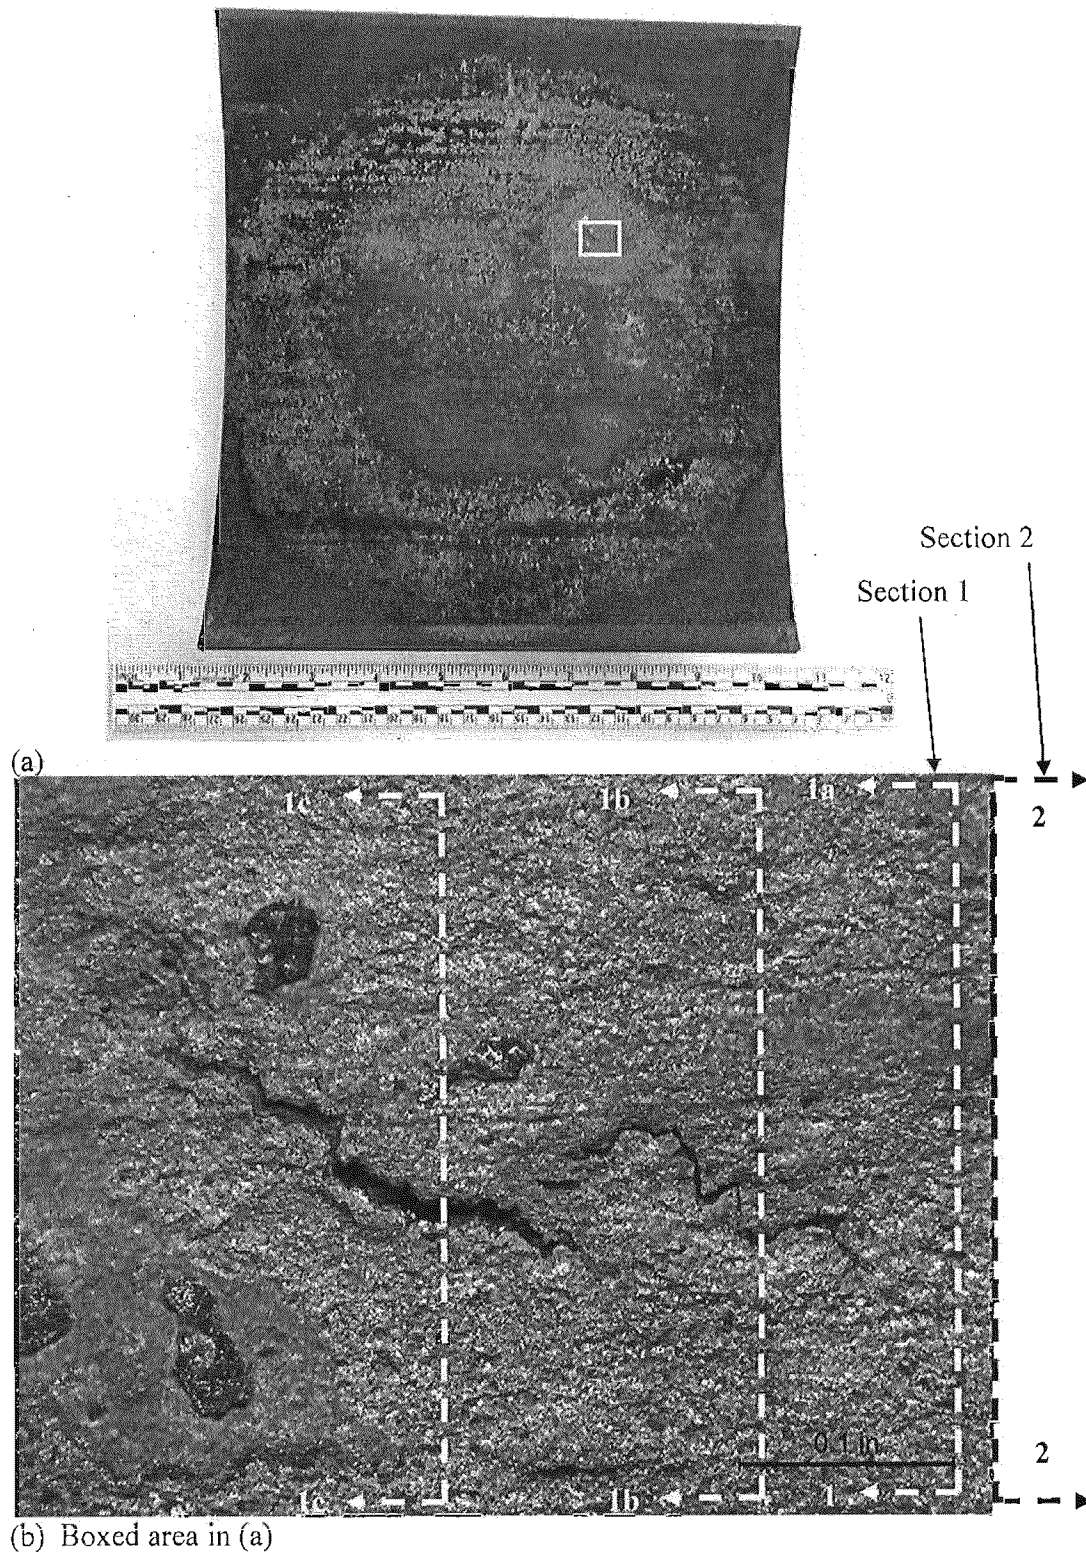
The sample shown in Figure 6 was returned to PG&E for radiography. A digital radiograph of the sample is shown in Appendix A along with a photograph of the sample. A crack indication was found that corresponded to the crack-like feature detected visually on the inside surface, shown in Figure 8b.

Figure 8 Photograph (a) and macrograph (b) of the inside surface of sample half A under the PLIDCO cap, after cleaning.

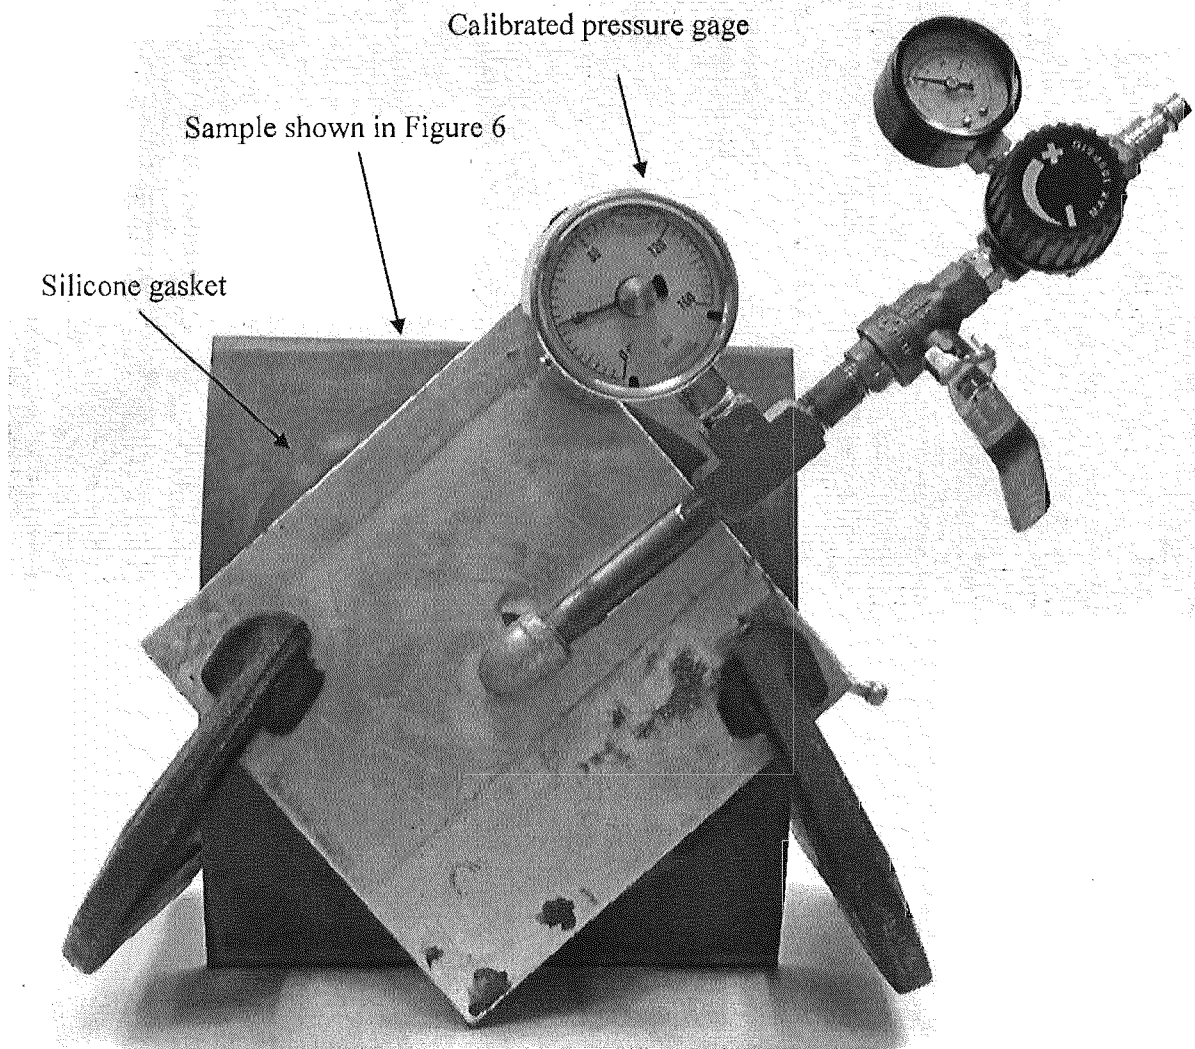
A pressure test was performed by clamping a plate over the sectioned cap, sealed with a silicone gasket, and introducing 40-psig of compressed air. Snoop® liquid leak detector was applied to the inside surface. No leaks were detected. The compressed air was valved-off, and no pressure drop from 40-psig was detected after 45-minutes.

Figure 9 Pressure test setup.

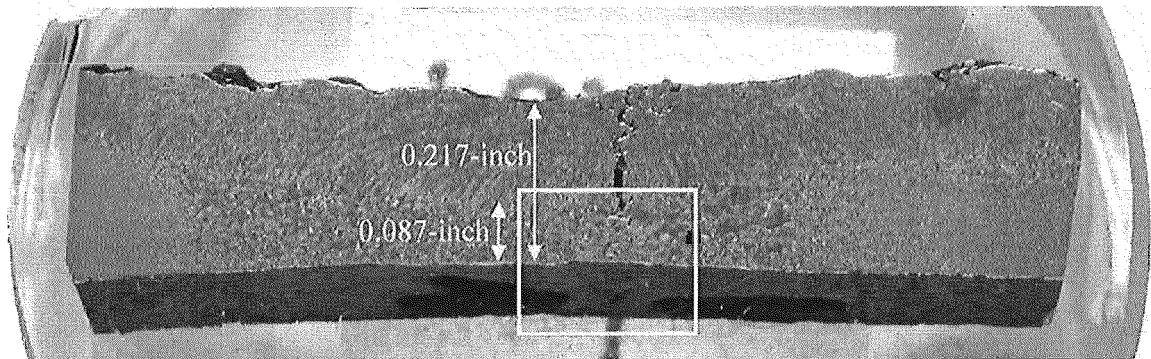
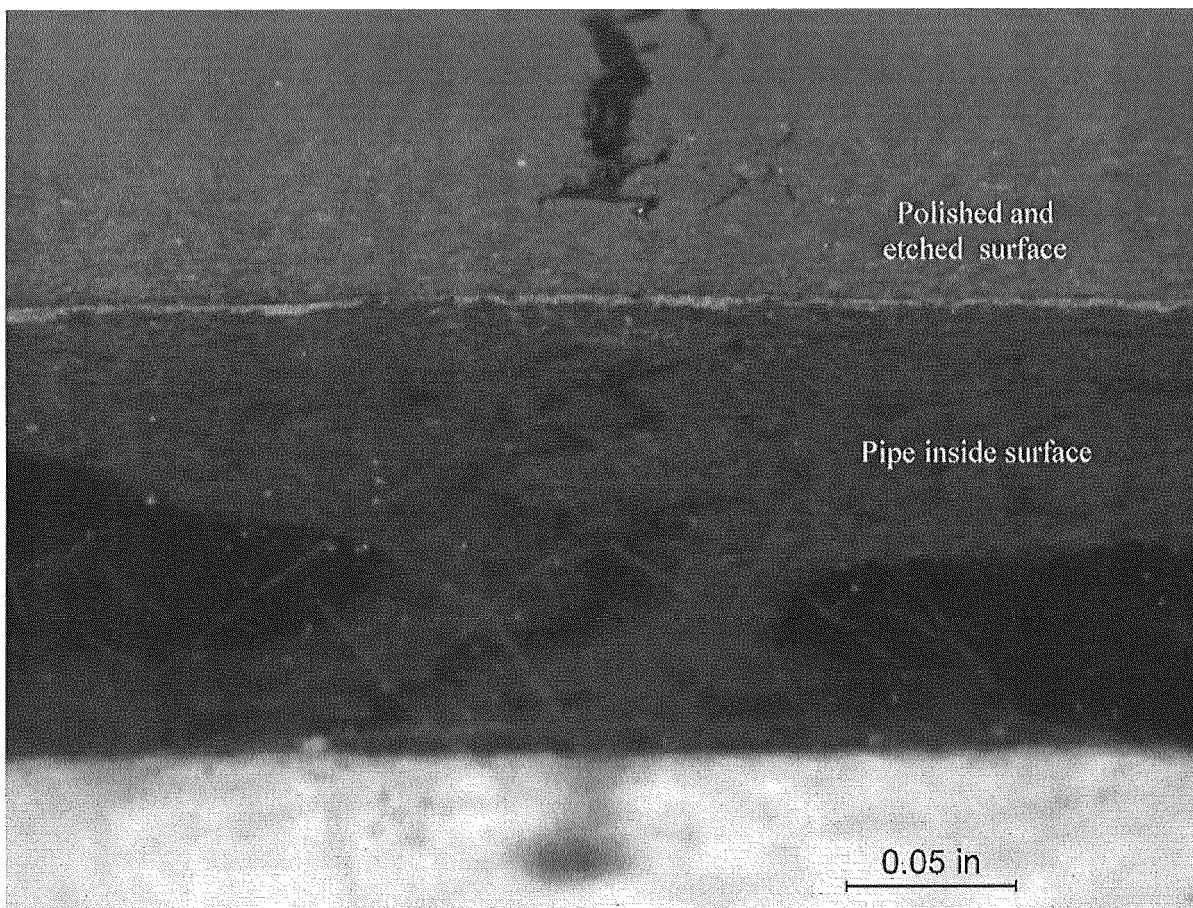
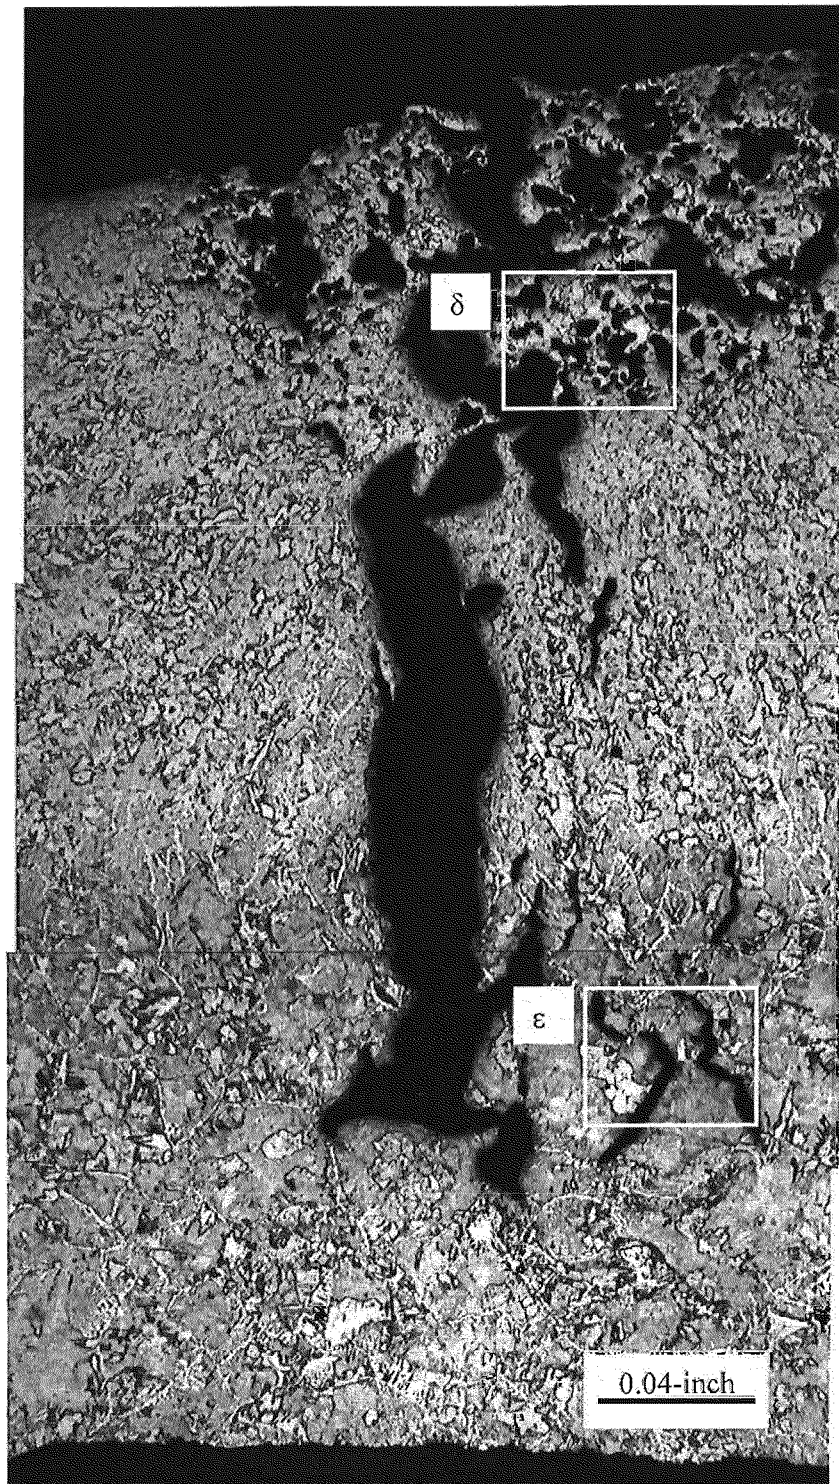
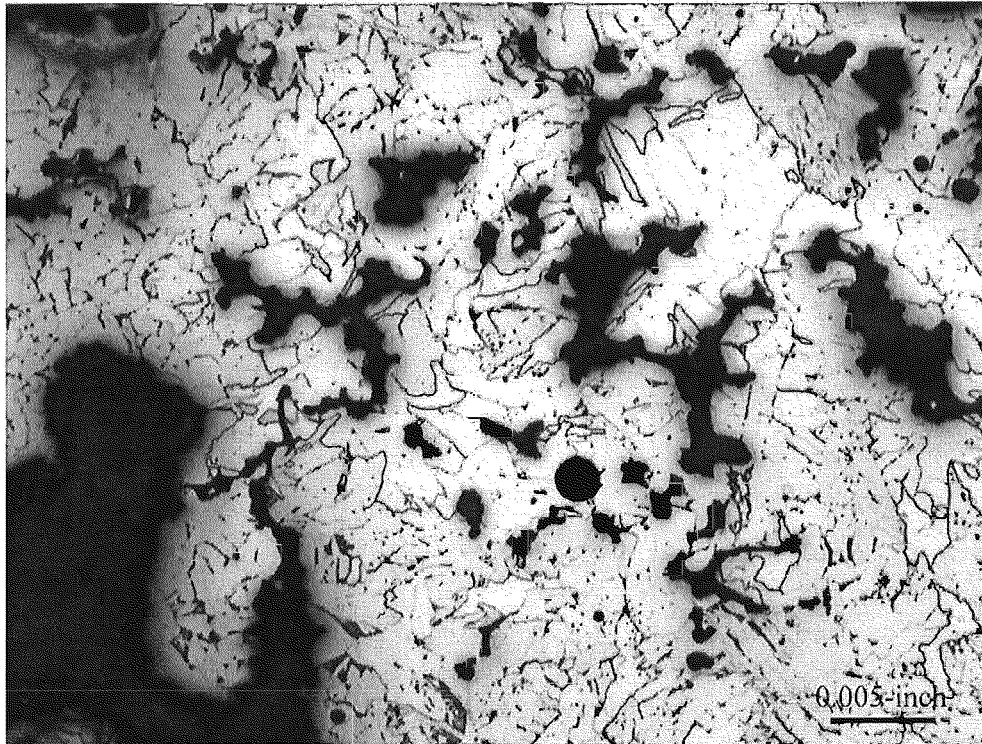
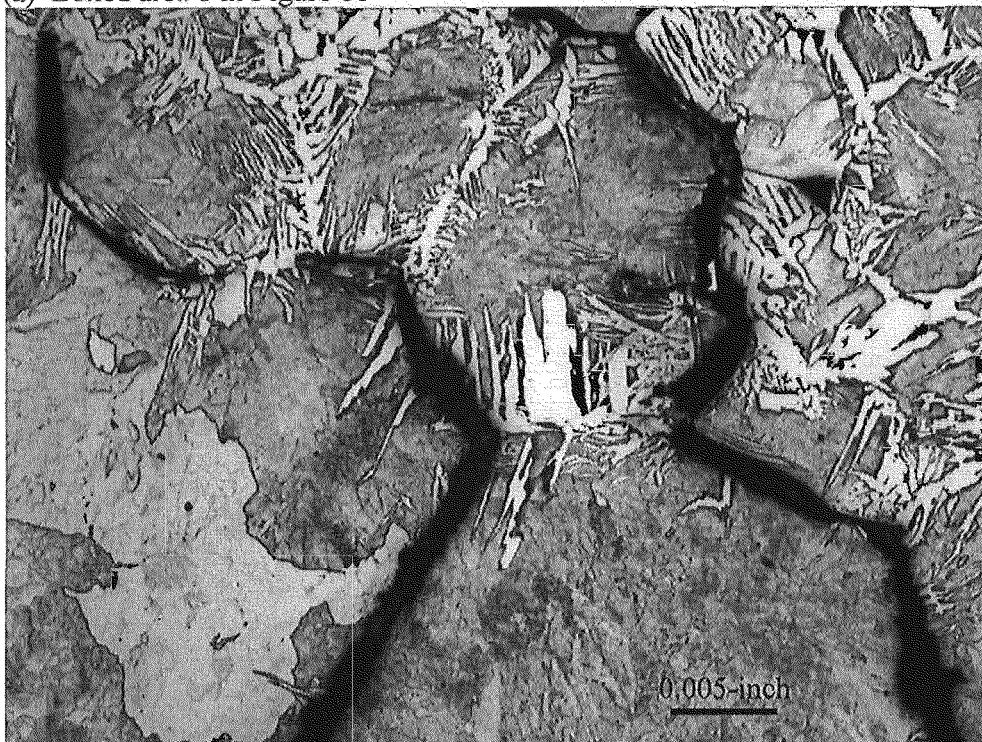
Specimens were prepared for metallography from section 1 and 2 indicated in Figure 8b. Weld crater cracks and heat affected zone liquation cracks were present in the sections. Serial grinding and polishing was performed on section 1, referred to as sections 1a, 1b, and 1c. As shown in Figure 10 through Figure 20, a weld crater crack extended from the outside surface into the weld heat affected zone in section 1a, but did not penetrate through-wall at this location. Shrinkage porosity was present near the outside surface, and intergranular cracks consistent with grain boundary liquation were present in the heat affected zone.

Figure 10 Images of the specimen prepared for metallography, section 1a. Etched with 2% nital.

Figure 11 Composite optical micrograph of the specimen prepared for metallography, section 1a. Etched with 2% nital.

Figure 12 Optical micrographs of the specimen prepared for metallography, section 1a. Etched with 2% nital.
