Report No. 5004,9268 Rev. 1

**METALLURGICAL EVALUATION OF A SECTION FROM
L-147 MP 2.2 BRITTAN AVE. AND ROGERS AVE., SAN CARLOS**

One section of 20-inch diameter gas transmission pipe identified as L-147 MP 2.2 Brittan Ave. and Rogers Ave., San Carlos was submitted by PG&E for metallurgical evaluation. The subject section had a PLIDCO weld cap permanent repair, and an A. O. Smith longitudinal seam weld. The section was cut out to perform a root cause investigation of a reported leak under the PLIDCO cap. It was reported the subject passed hydrotest as part of L-147 on October, 24, 2011, at a pressure of 600-psi, or 1.5 times the desired Maximum Allowable Operating Pressure (MAOP) of 400-psi, and the PLIDCO cap was located at the six o'clock position, on the bottom of the section. The purpose of this evaluation was to determine the metallurgical condition of the pipe wall under the PLIDCO cap, and perform Charpy impact testing of the A. O. Smith weld and unaffected base metal.

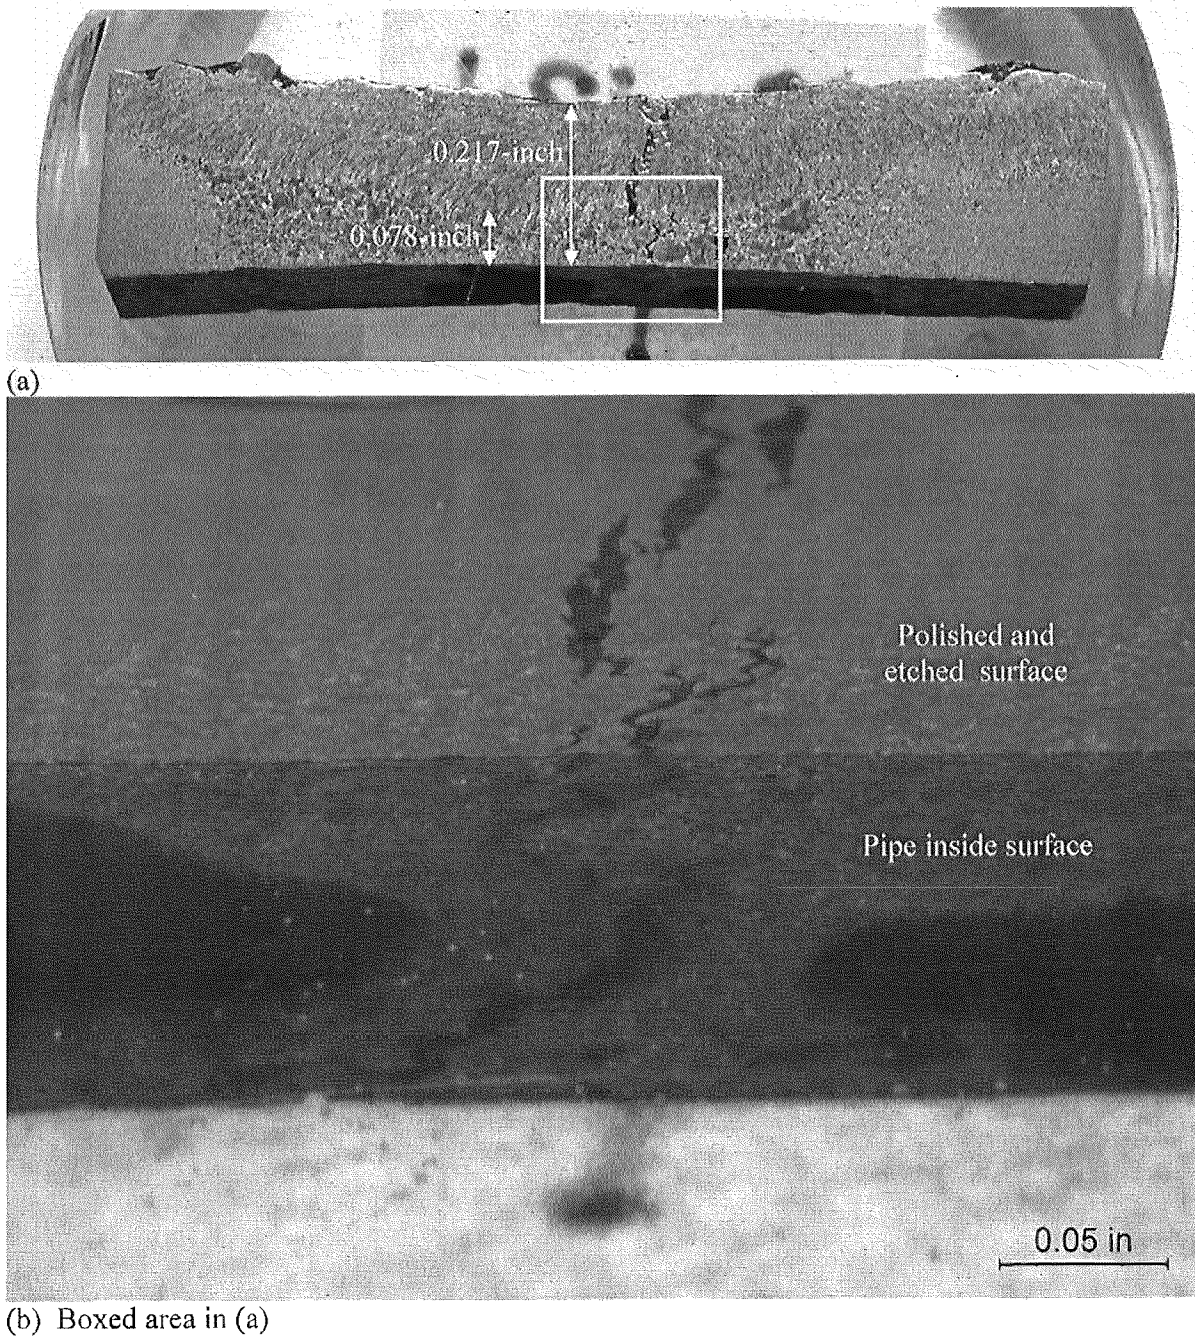
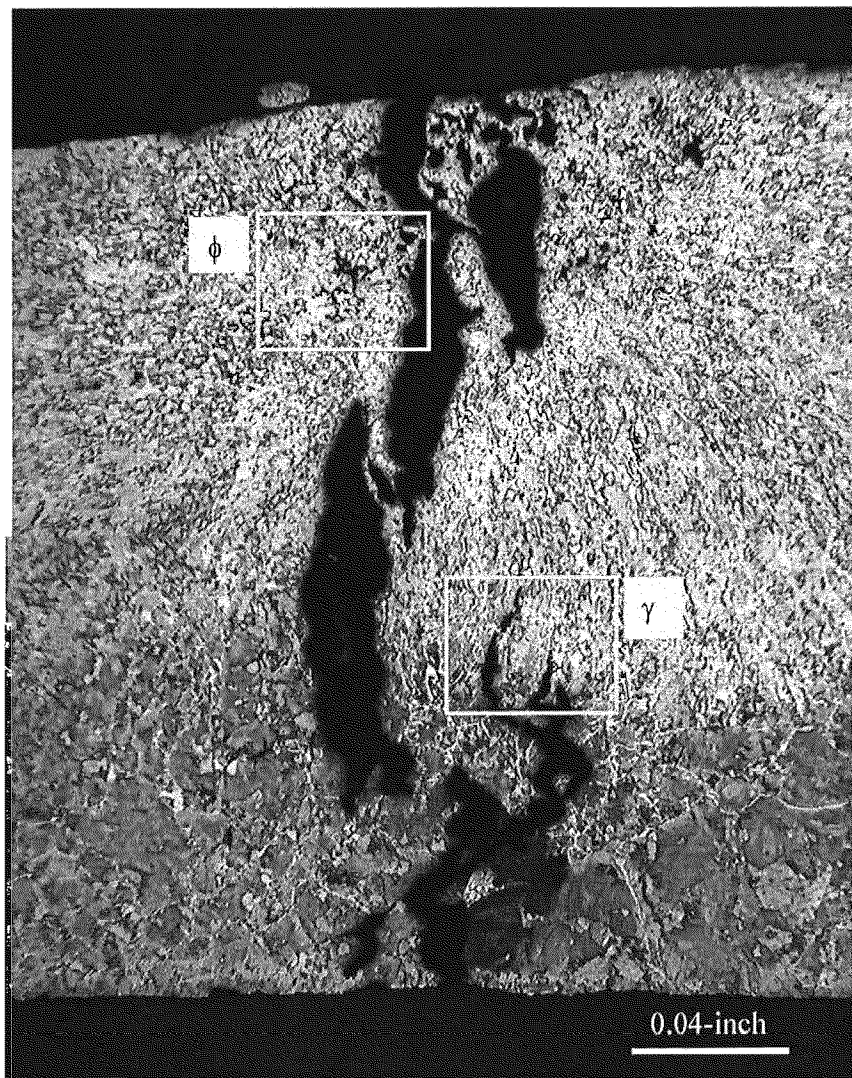
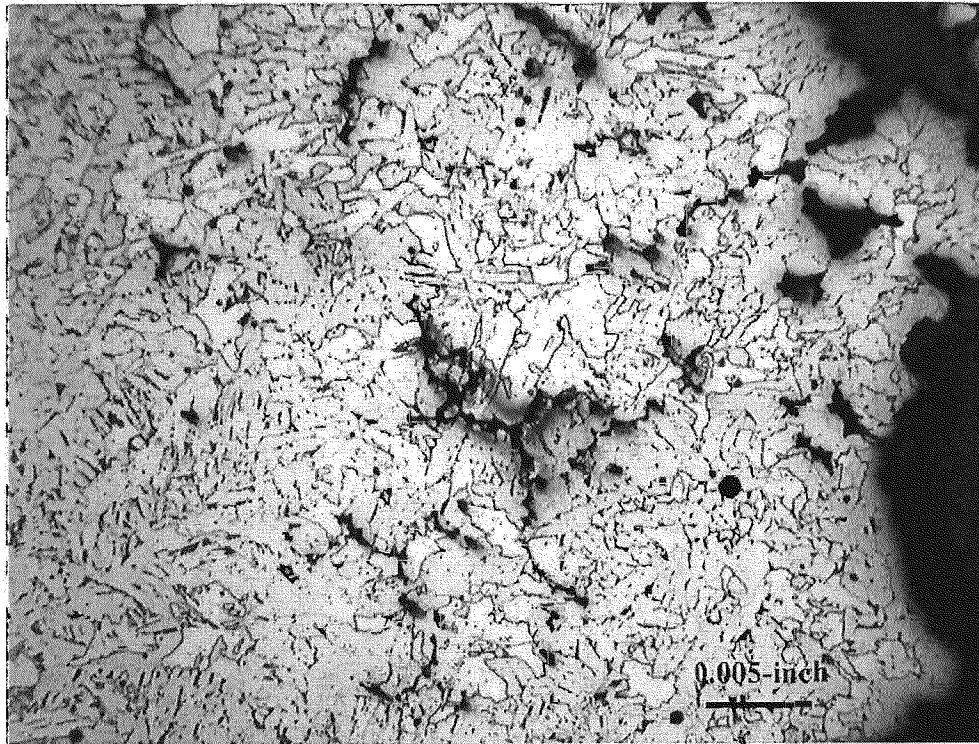
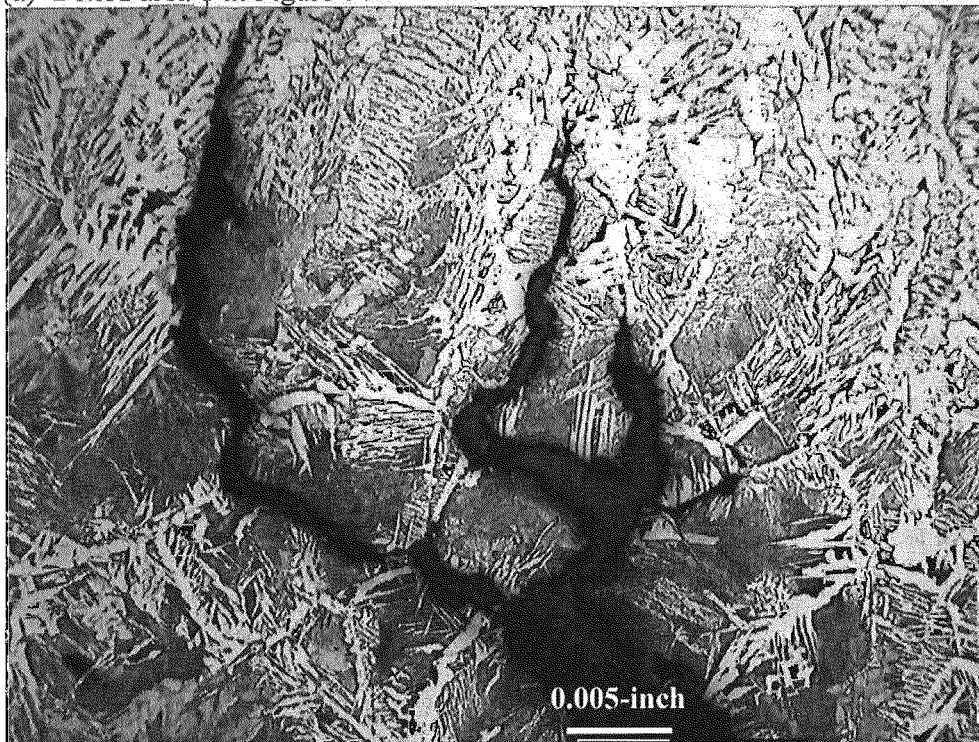
In section 1b, shown in Figure 13 through Figure 15, cracks were present from the outside surface to the inside surface. Only a few small ligaments prevented the demonstration of a through-wall leak path. However, it is likely that a leak path existed between section 1a and 1b. The weld metal crack morphology was consistent with shrinkage, and the heat affected zone crack morphology was indicative of grain boundary liquation.

Figure 13 Images of the specimen prepared for metallography, section 1b. Etched with 2% nital.

Figure 14 Composite optical micrograph of the specimen prepared for metallography, section 1b. Etched with 2% nital.

Figure 15 Optical micrographs of the specimen prepared for metallography, section 1b. Etched with 2% nital.

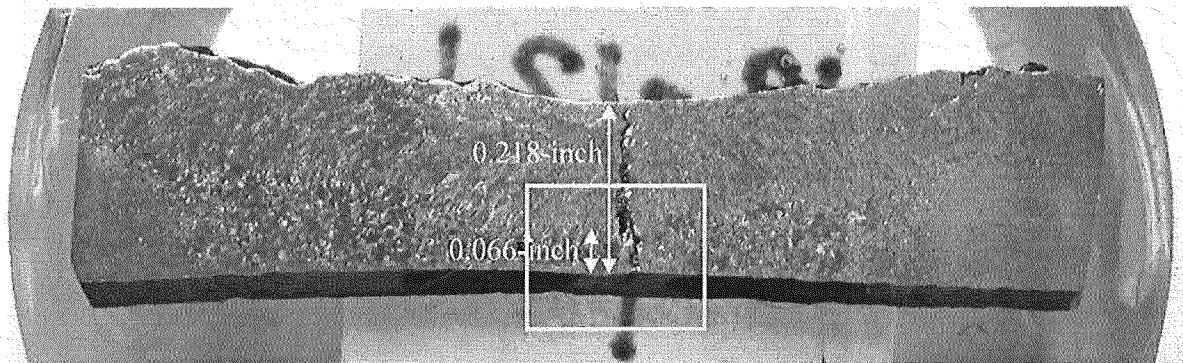
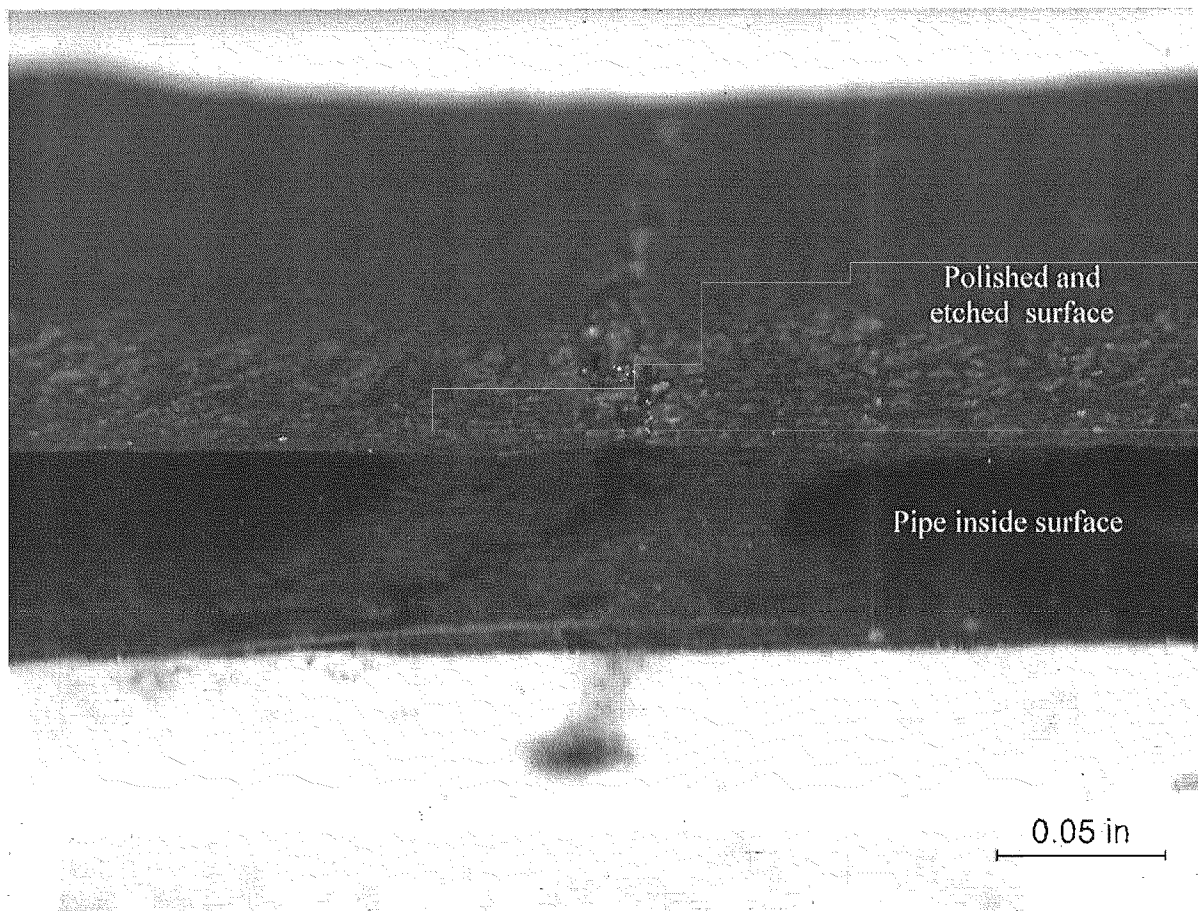
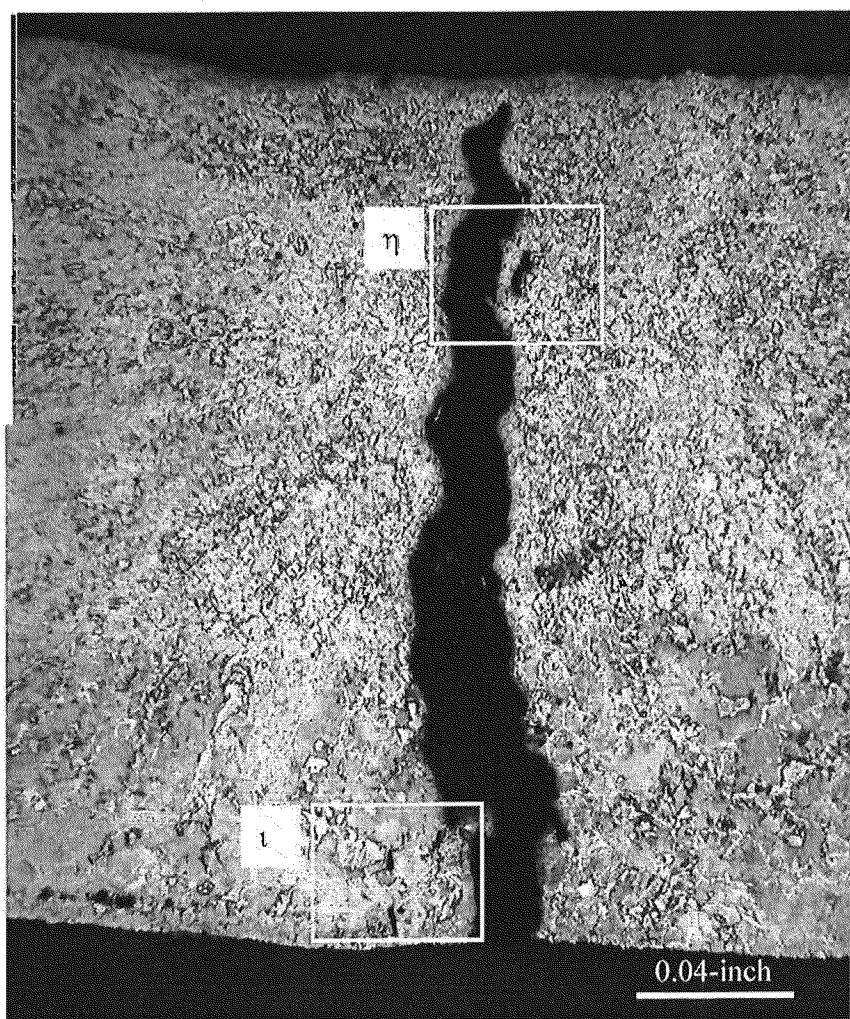
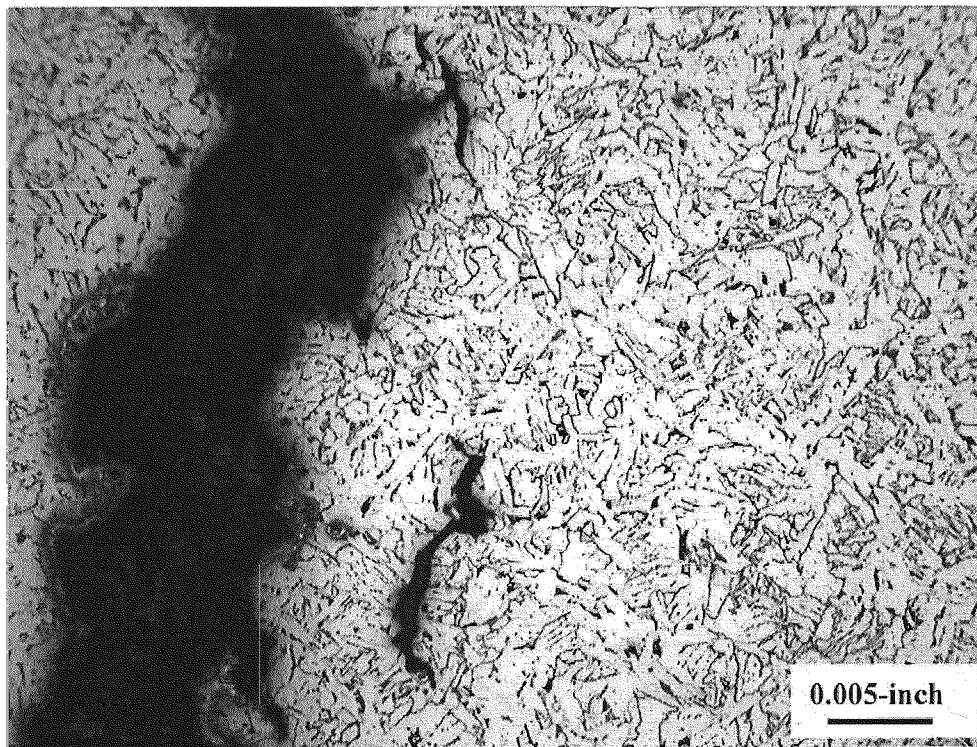
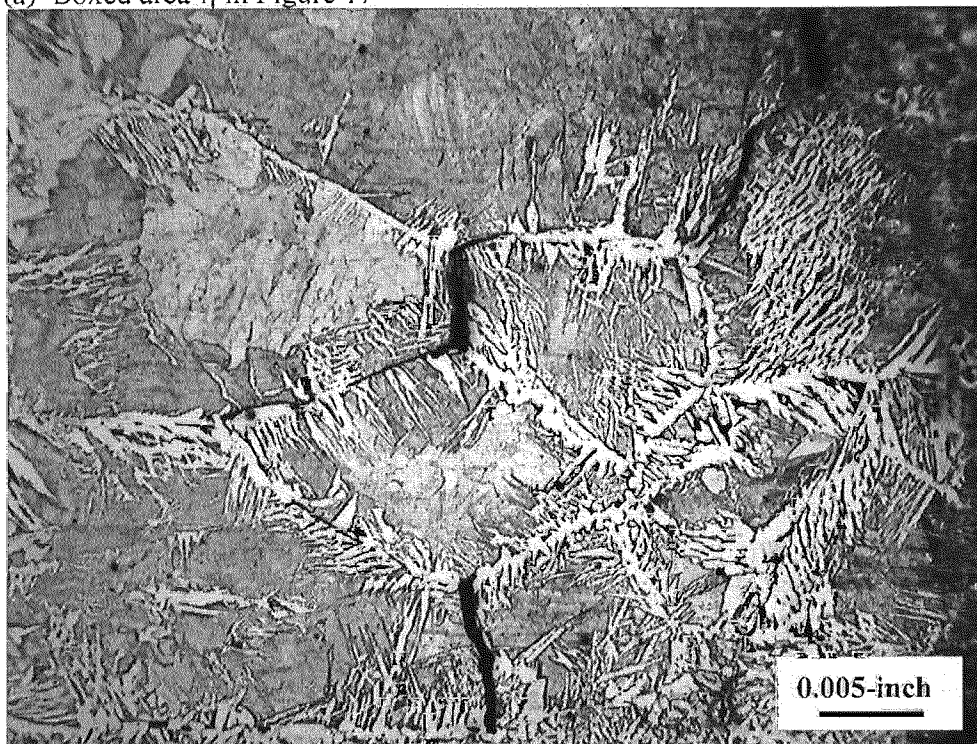
In section 1c, shown in Figure 16 through Figure 18, one small ligament at the outside surface prevented demonstration of a through-wall leak path. Once again, the weld crack morphology was consistent with shrinkage and the heat affected zone crack morphology was consistent with grain boundary liquation. In all three sections of specimen 1, the weld fusion zone followed a smooth broad contour with no indications of external corrosion prior to welding.

Figure 16 Images of the specimen prepared for metallography, section 1c. Etched with 2% nital.

Figure 17 Composite optical micrograph of the specimen prepared for metallography, section 1c. Etched with 2% nital.

Figure 18 Optical micrographs of the specimen prepared for metallography, section 1c. Etched with 2% nital.

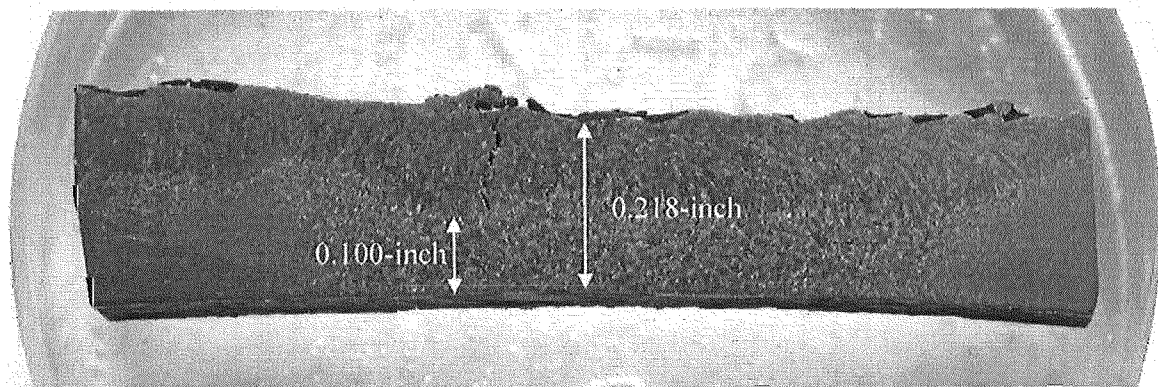
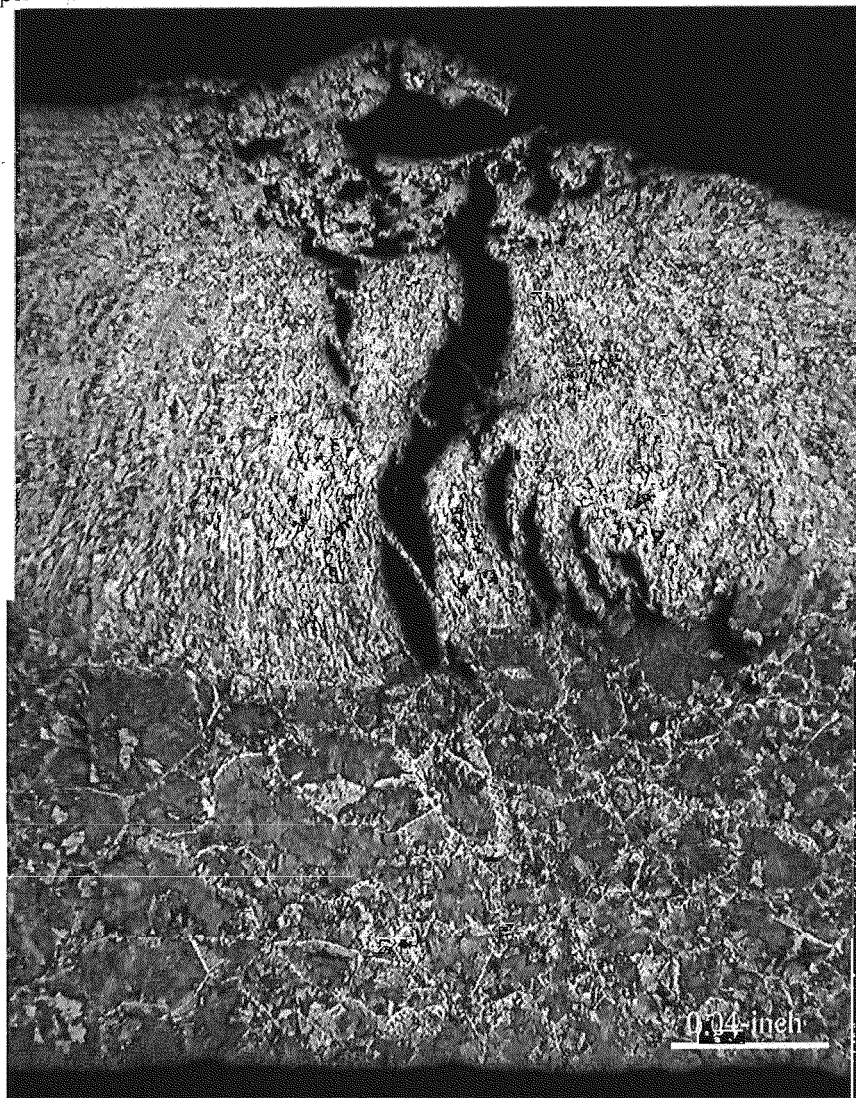
Section 2 is shown in Figure 19. The fusion zone in this section had a profile that was more varied in depth than in sections 1a through 1c, which suggested the possibility that the weld metal was deposited to build-up locations where wall thickness had been reduced by external corrosion. Measurements of the minimum thickness of base metal beneath the weld metal are shown in Figure 10, Figure 13, Figure 16, and Figure 19.

Figure 19 Photograph and composite micrograph of section 2. Etched with 2% nital.

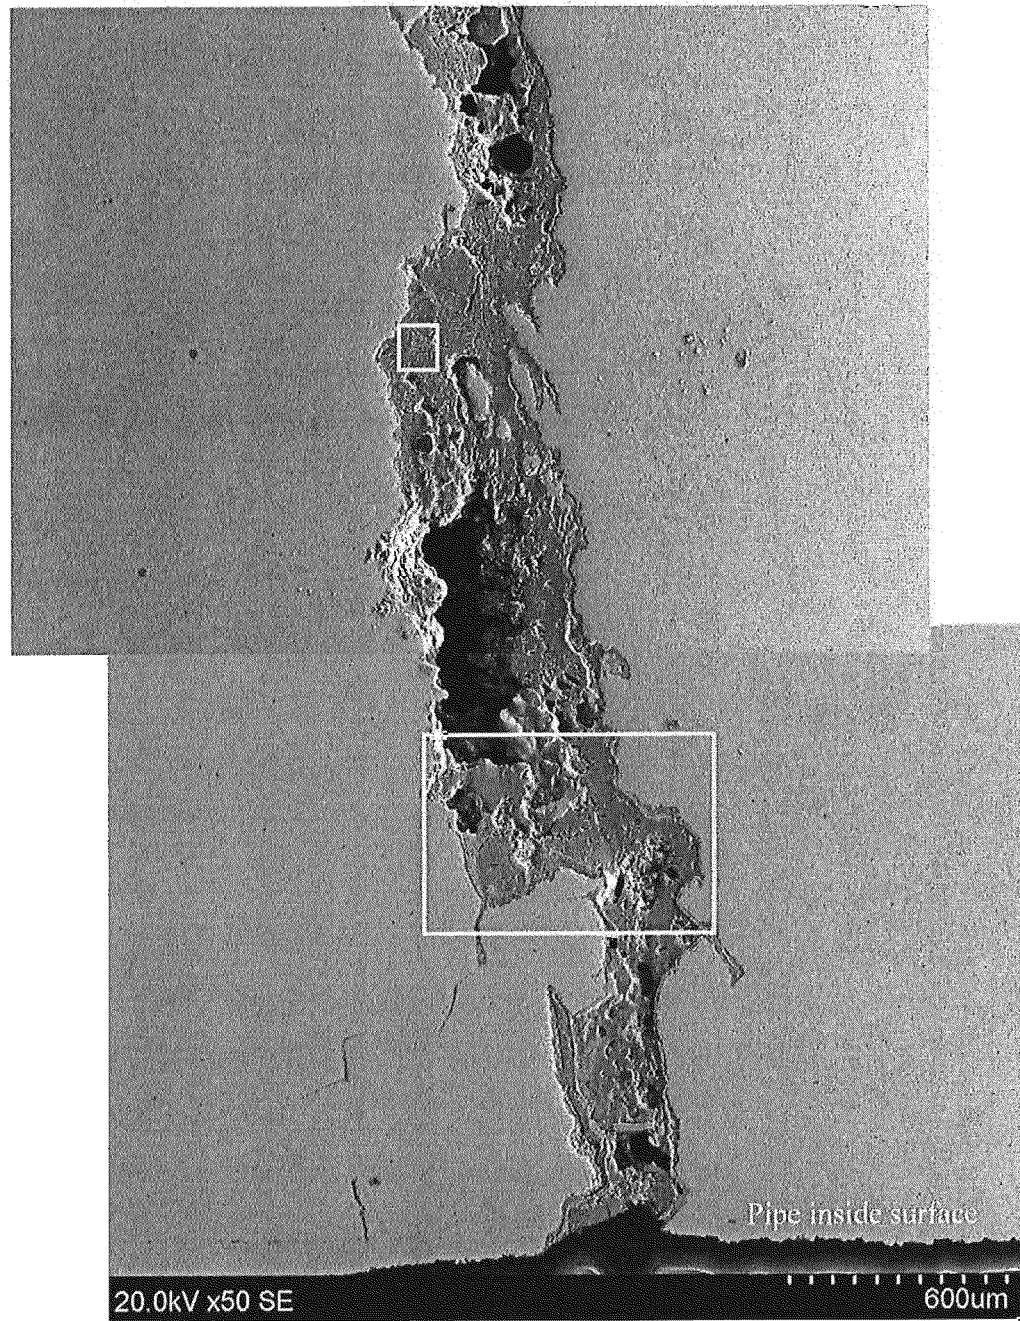
Scanning electron microscopy (SEM) and energy dispersive X-ray spectroscopy² (EDS) was performed on the section 3 polished and etched surface. A composite SEM micrograph of the crack is shown in Figure 20. Much of the crack was filled with oxide, indicated by the morphology and chemical composition of primarily iron and oxygen, with sulfur present, likely from mercaptan in the gas stream.

Figure 20 Composite SEM micrograph of the specimen prepared for metallography, section 1c.

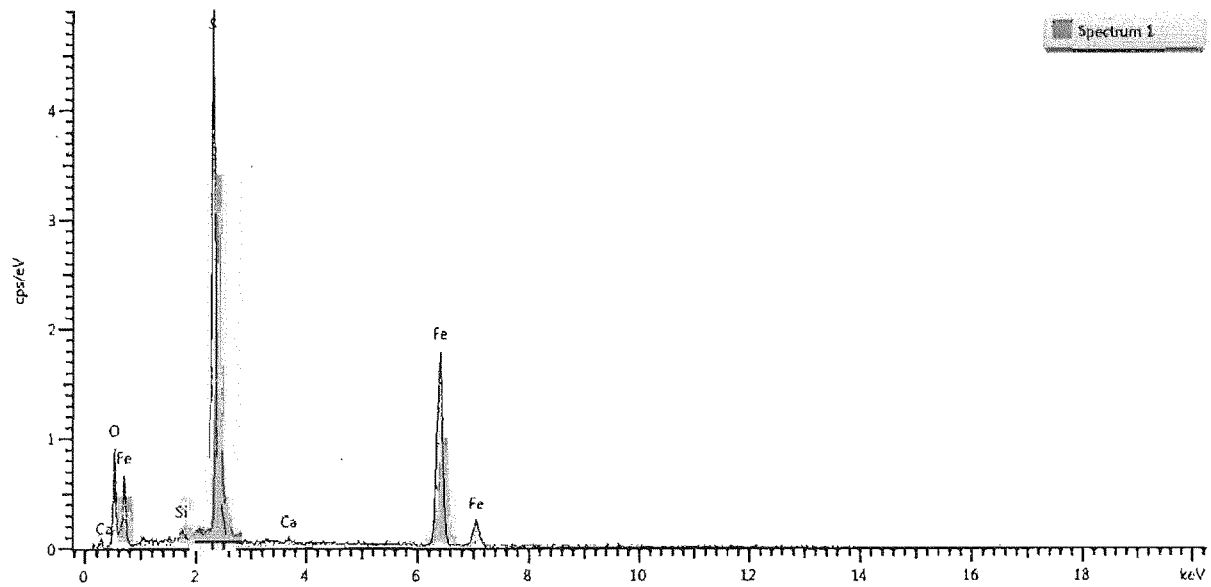
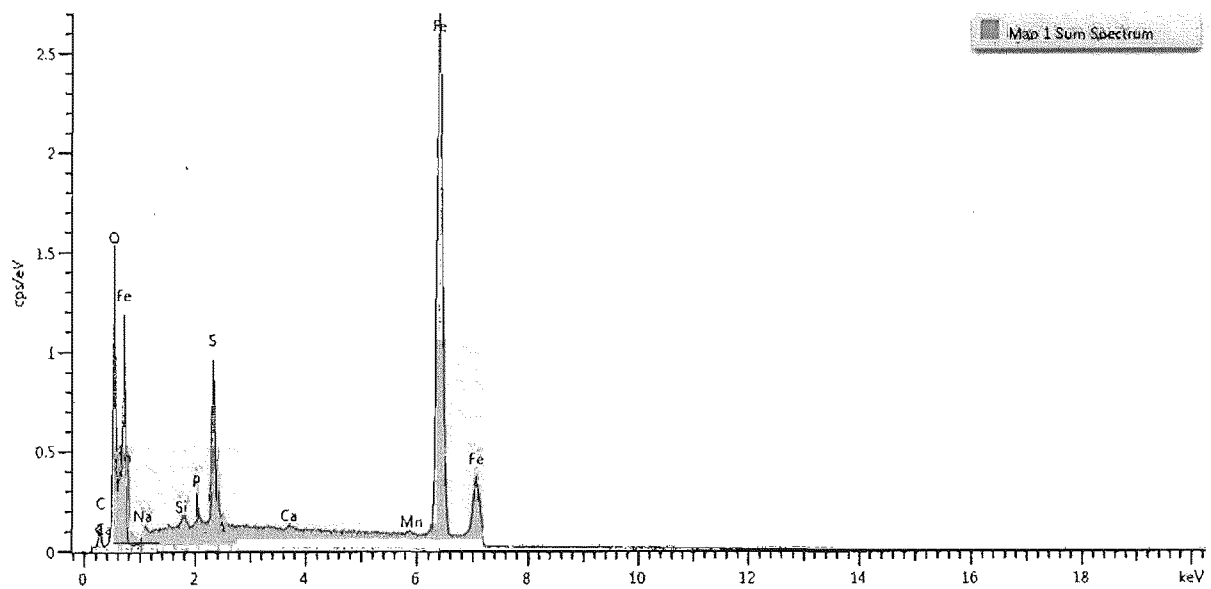
Figure 21 EDS spectra from the specimen prepared for metallography, section 1c.

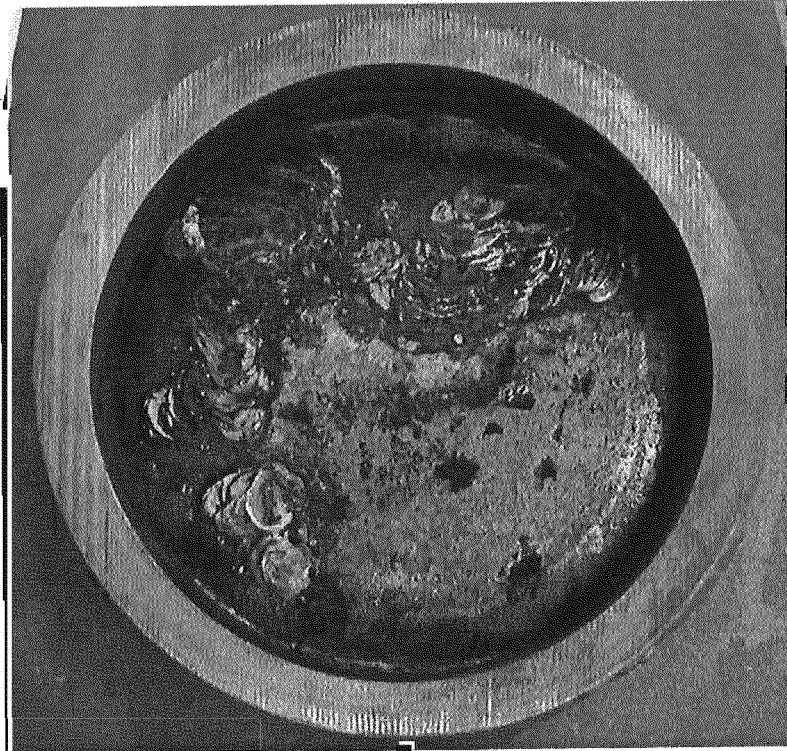
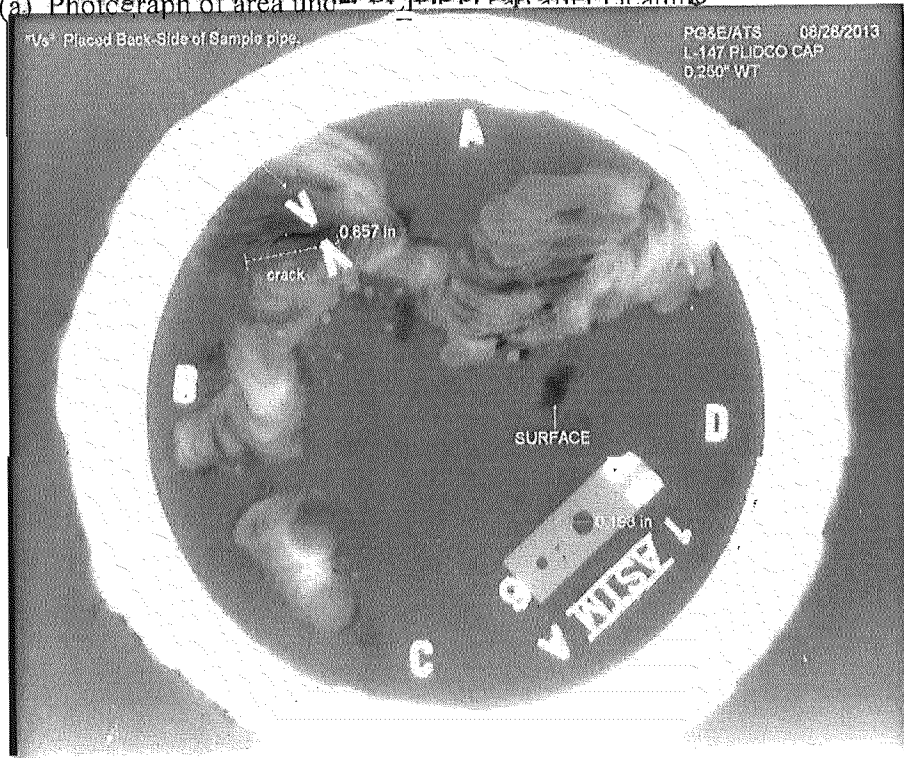
Appendix A
(Radiograph courtesy of PG&E)

The sample shown in Figure 6 was returned to PG&E for radiography. A digital radiograph of the sample is shown in Appendix A along with a photograph of the sample. A crack indication was found that corresponded to the crack-like feature detected visually on the inside surface, shown in Figure 8b.
