DECLARATION OF SUMEET SINGH

Report No. 5004.9268

**METALLURGICAL EVALUATION OF A SECTION FROM
L-147 MP 2.2 BRITTAN AVE. AND ROGERS AVE., SAN CARLOS**

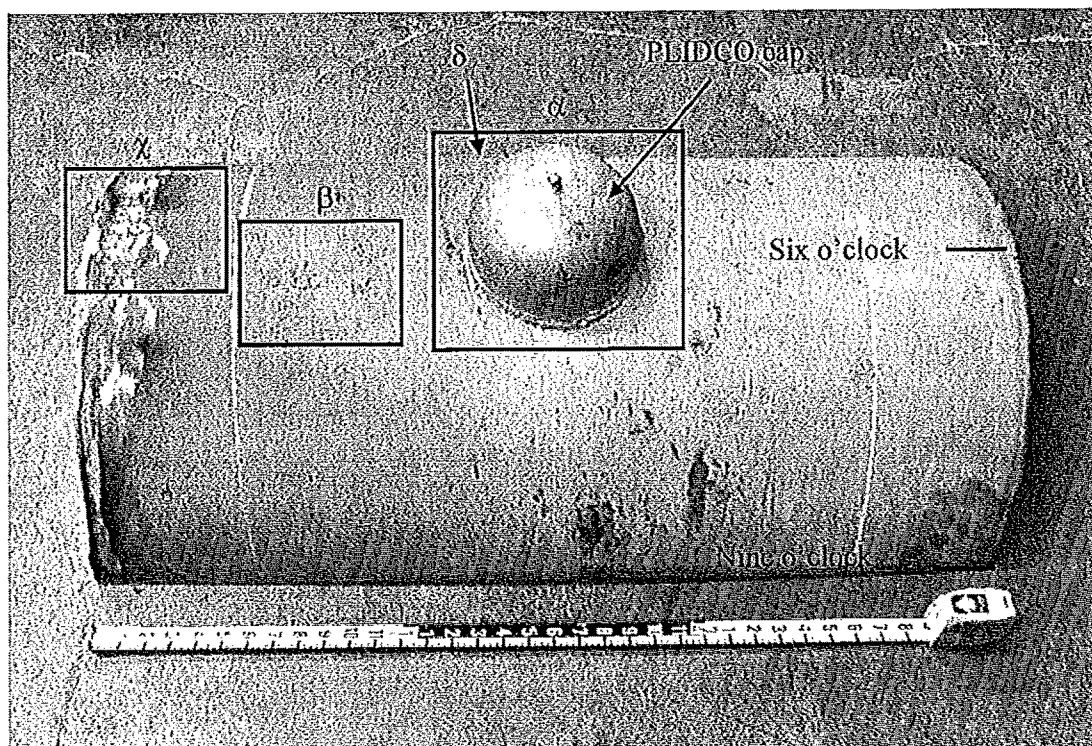
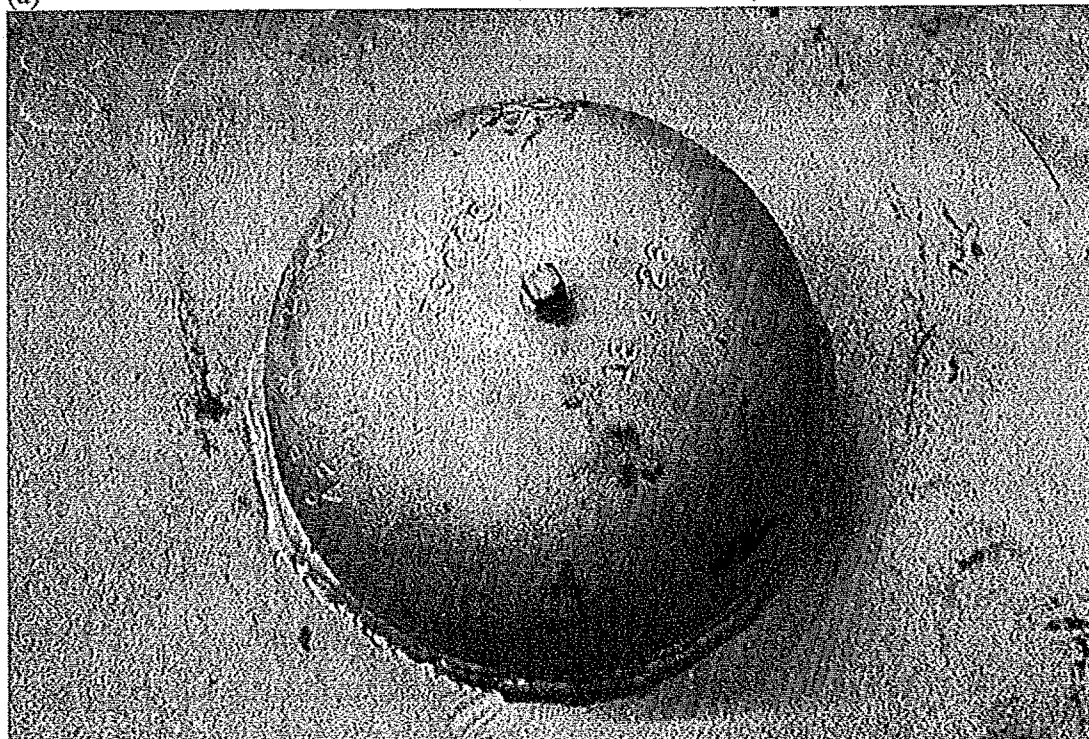
The subject sample of L-147 was received sectioned into two halves along the longitudinal axis, with the outside surface grit blasted, as shown in Figure 1 through Figure 5. The section half with the PLIDCO cap was arbitrarily labeled A and the other section was labeled B, in the laboratory. Based on the reported position of the cap, the longitudinal flame cuts were located at three o'clock and nine o'clock positions. Wall thickness measurements were made with a pointed anvil micrometer and the results are listed in Table 1. Small regions of weld metal and a few shallow hemispherical pits were present near the cap, as shown in Figure 2. Pits were also present just past the three o'clock position toward the cap, indicated in Figure 1. Pit depths were measured with a pit gage, and the results are listed in Table 2. No evidence of a leak location or repair was visible to the unaided eye on the inside surface of the pipe under the cap.

Figure 1 Photographs of the outside surface of sample half A as-received.

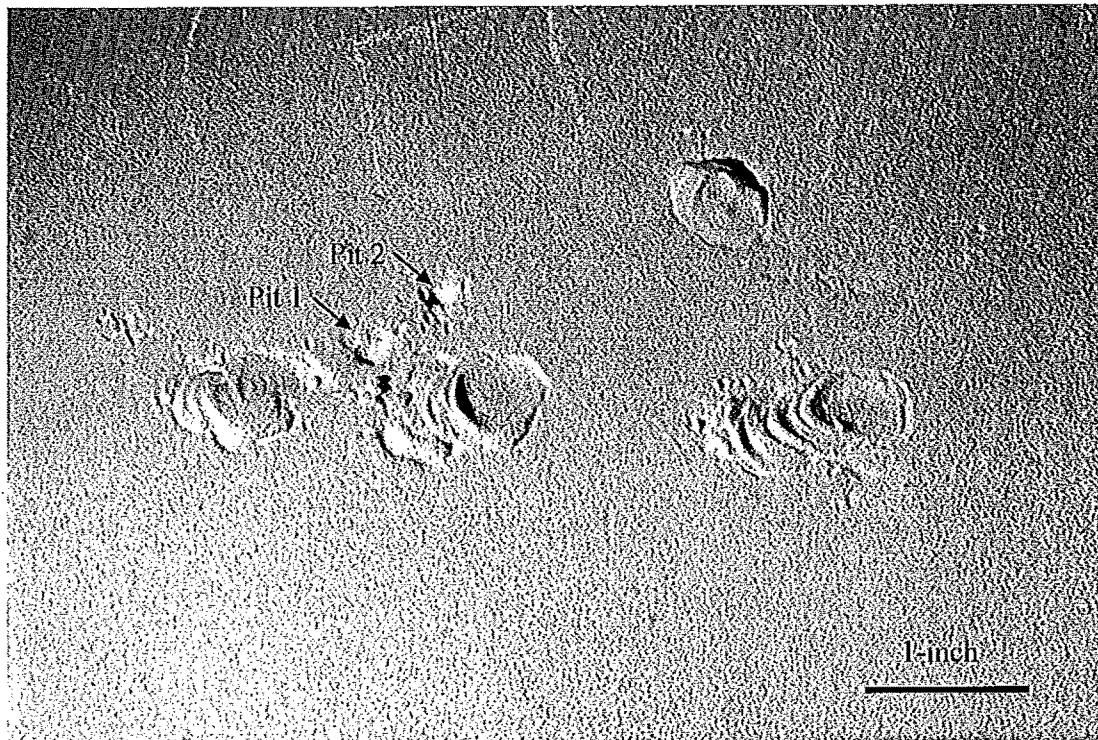
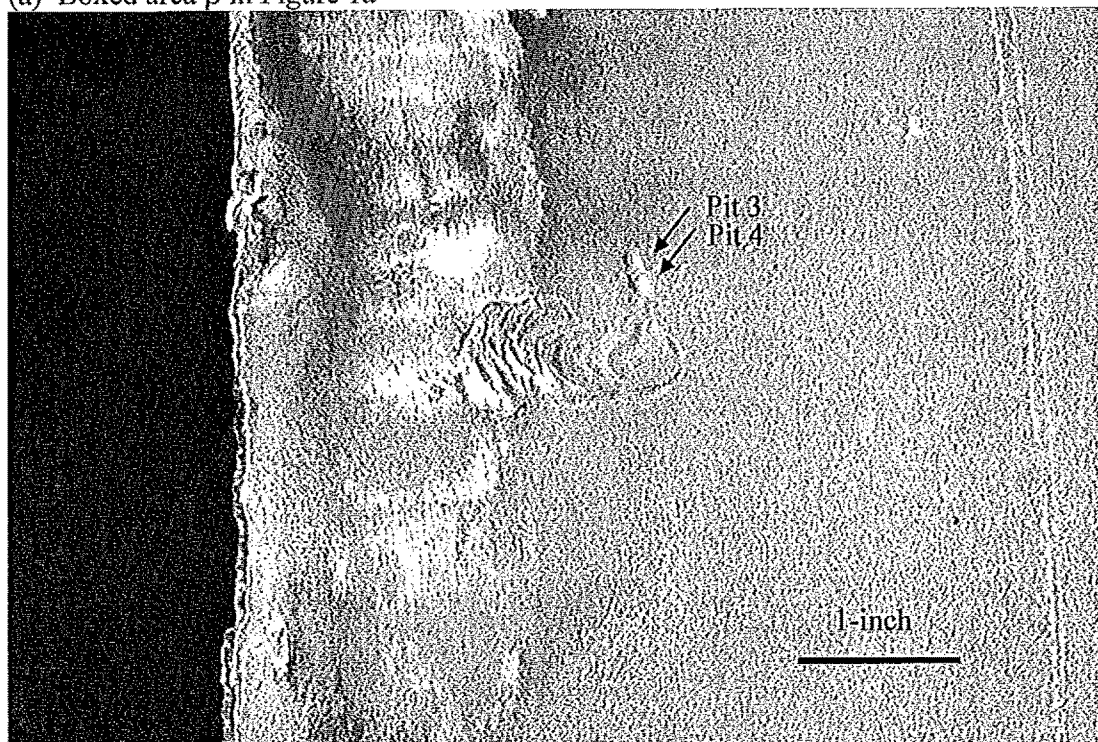
Figure 2 Photographs of the outside surface of sample half A as-received.

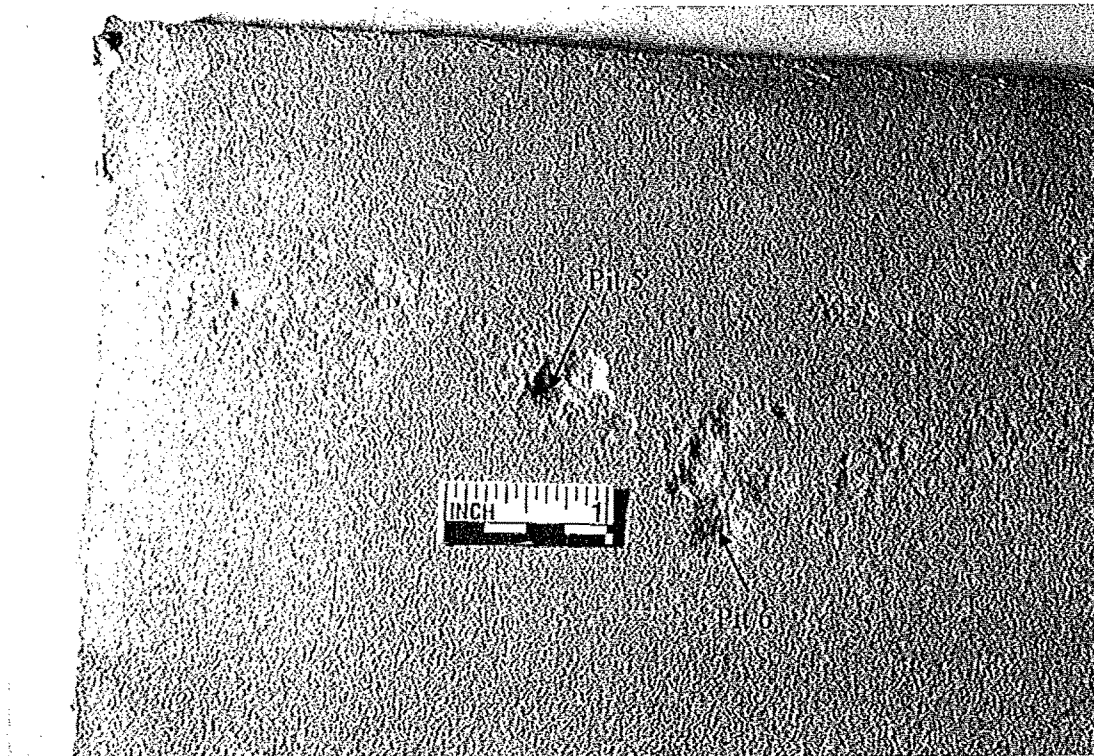
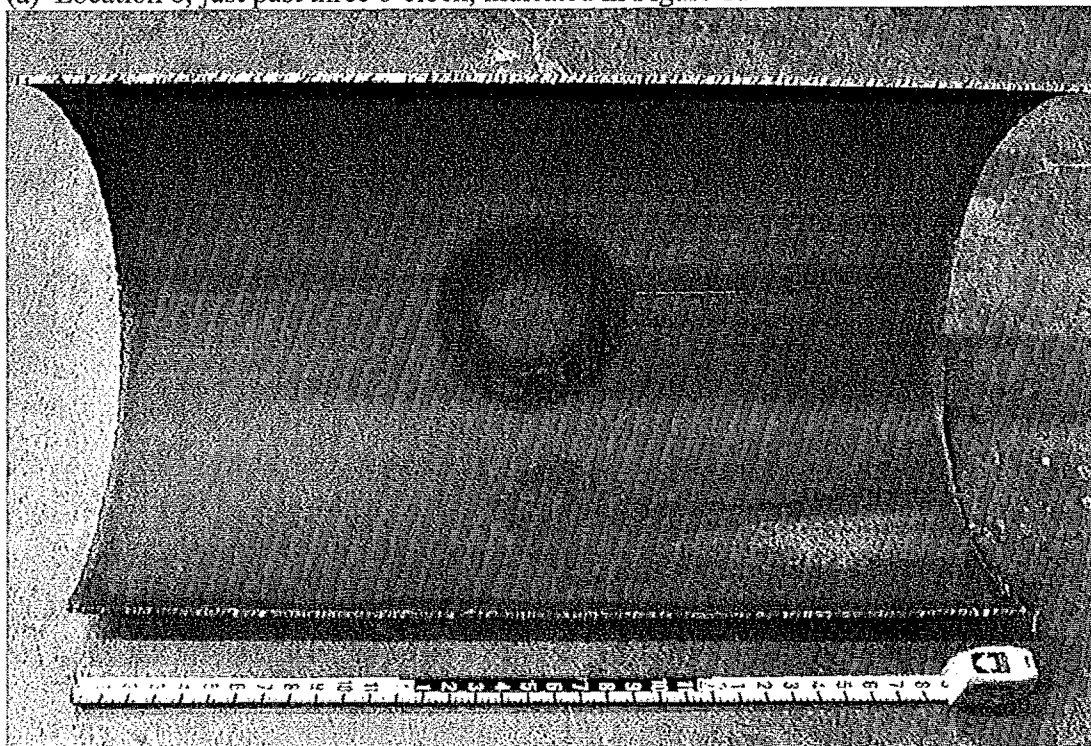
(a) Location δ , just past three o'clock, indicated in Figure 1a

Figure 3 Photographs of pits on the outside surface and the inside surface of sample A.

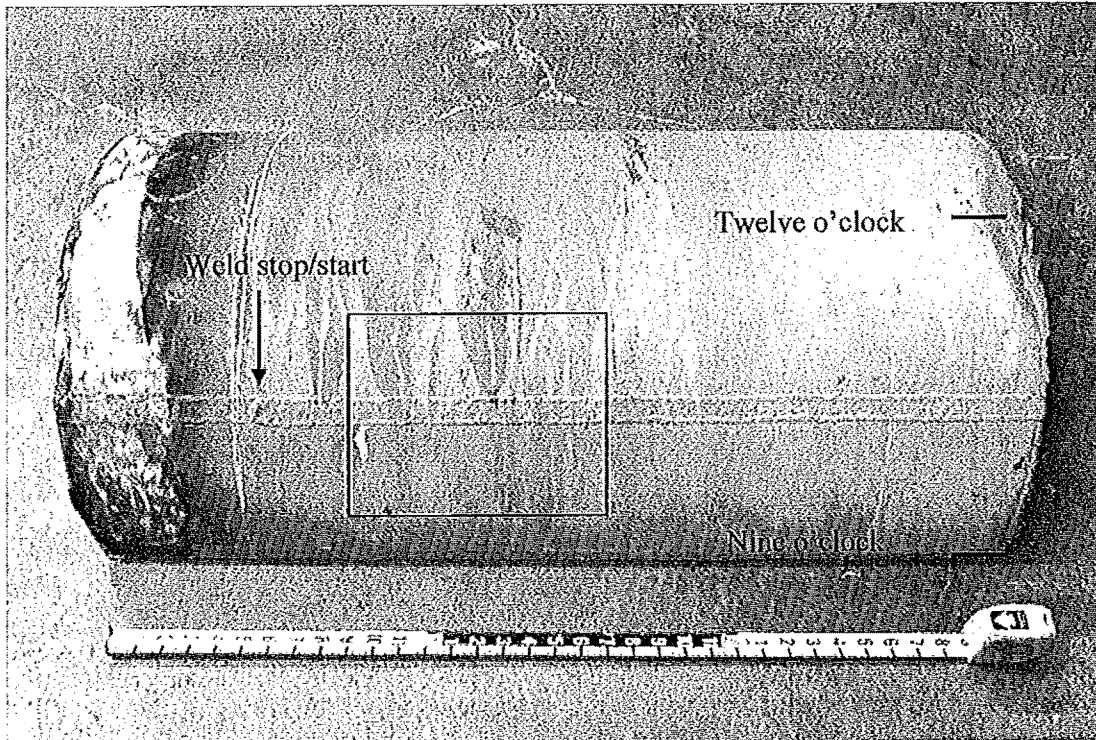
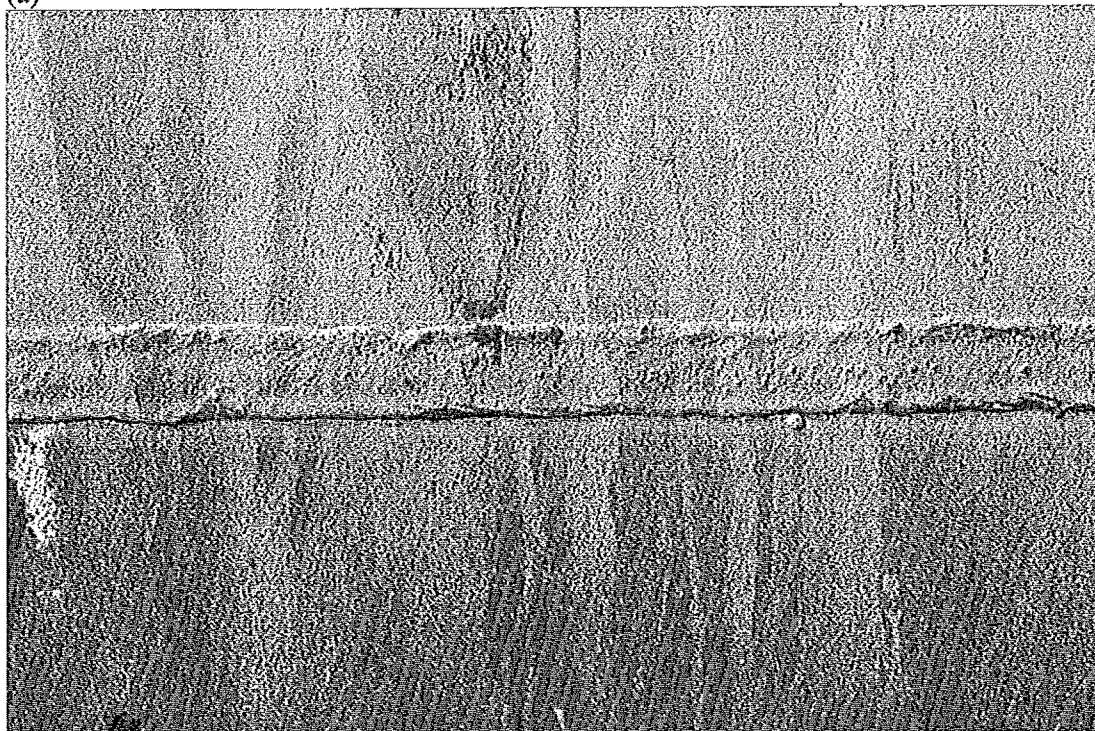
Figure 4 Photographs of the outside surface of sample half B.

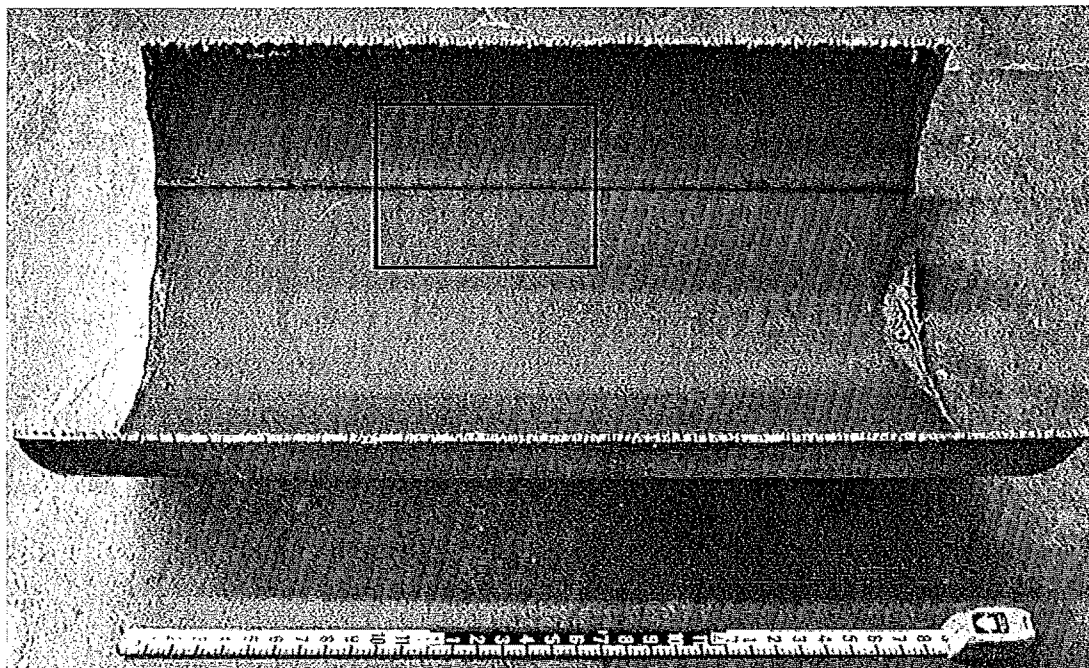
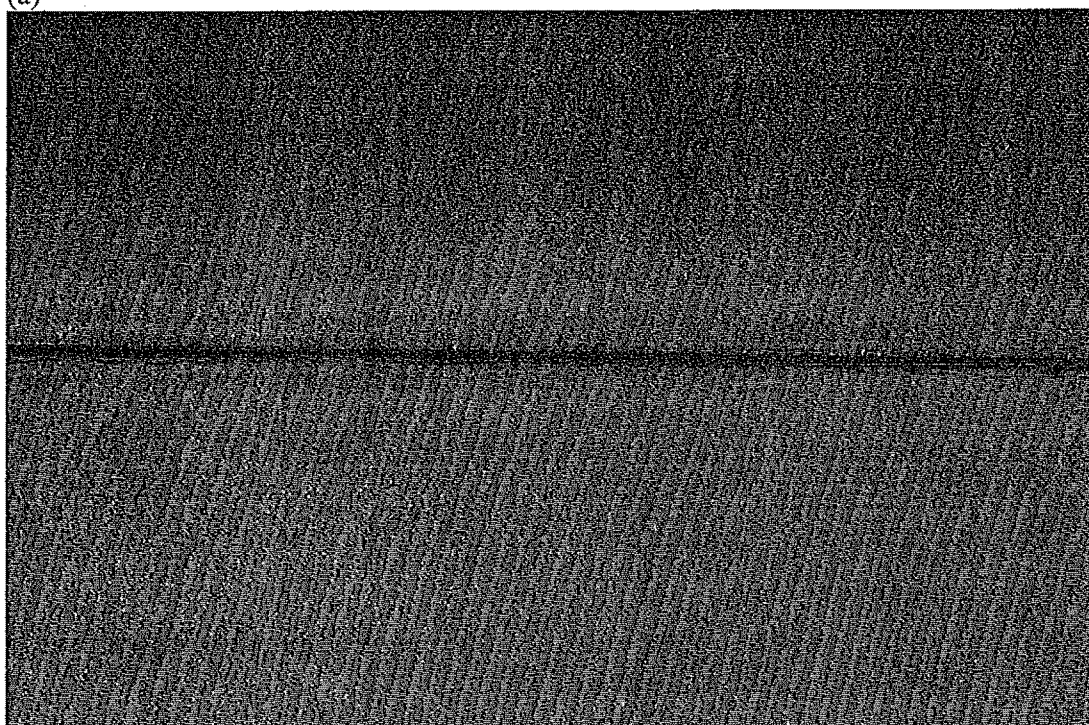
Figure 5 Photographs of the inside surface of sample half B.

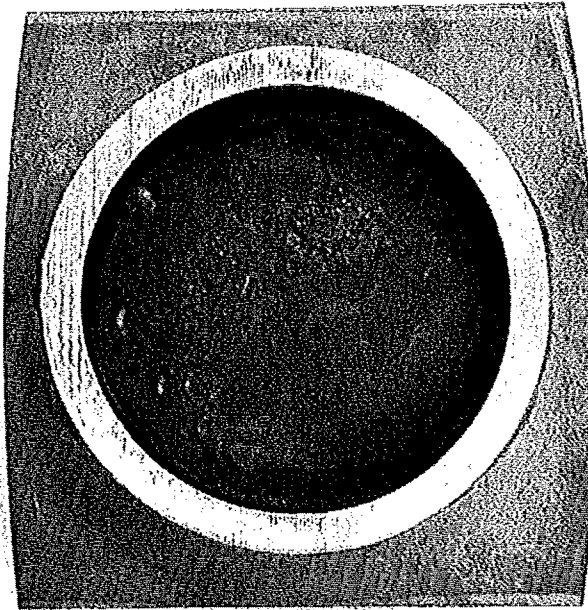
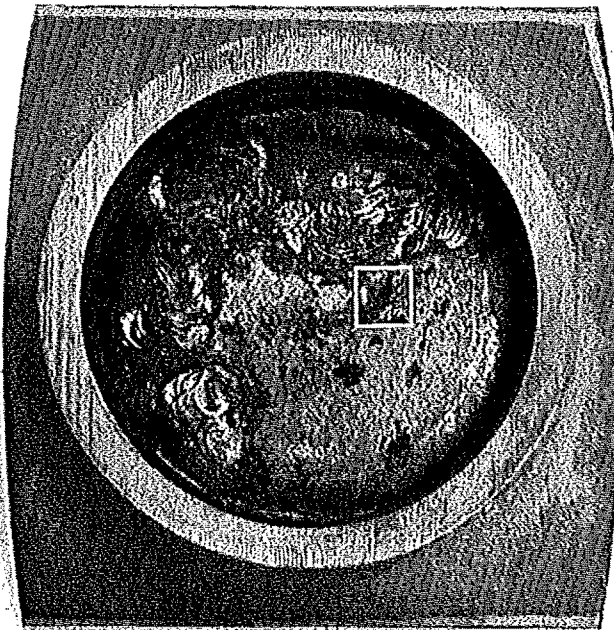
The region containing the PLIDCO cap was sectioned from sample A and the cap was cut off to expose the outside surface of the pipe wall. The outside surface was covered with rust and had a slightly oily feel. Both surfaces were cleaned with dilute Oakite® 33 and a wire brush. The outside surface is shown before and after cleaning in Figure 6. Several regions of weld metal were visible on the outside surface. Examination using low-power optical microscopy revealed a pit consistent with corrosion on the outside surface, indicated in Figure 7. The inside surface is shown after cleaning in Figure 8. Indications of heat exposure were visible on the inside surface, corresponding to the weld metal on the outside surface. No evidence of weld burn through was detected, and fine grooves typical of wrought steel surfaces were continuous across the region, which indicated that repairs did not extend to the inside surface. Examination using low-power optical microscopy revealed a crack-like feature on the inside surface within the heat affected zone of a weld deposit, as shown in Figure 8b.

Both sides of the cap sample shown in Figure 6 were thoroughly cleaned with acetone and dried with compressed air. A liquid penetrant test was performed by applying developer to the inside surface, and penetrant was liberally applied to the outside surface in the area covered by the cap. After 1.5-hours, no indication of penetrant was visible on the inside surface.

Figure 6 Photographs of the PLIDCO cap area after sectioning.

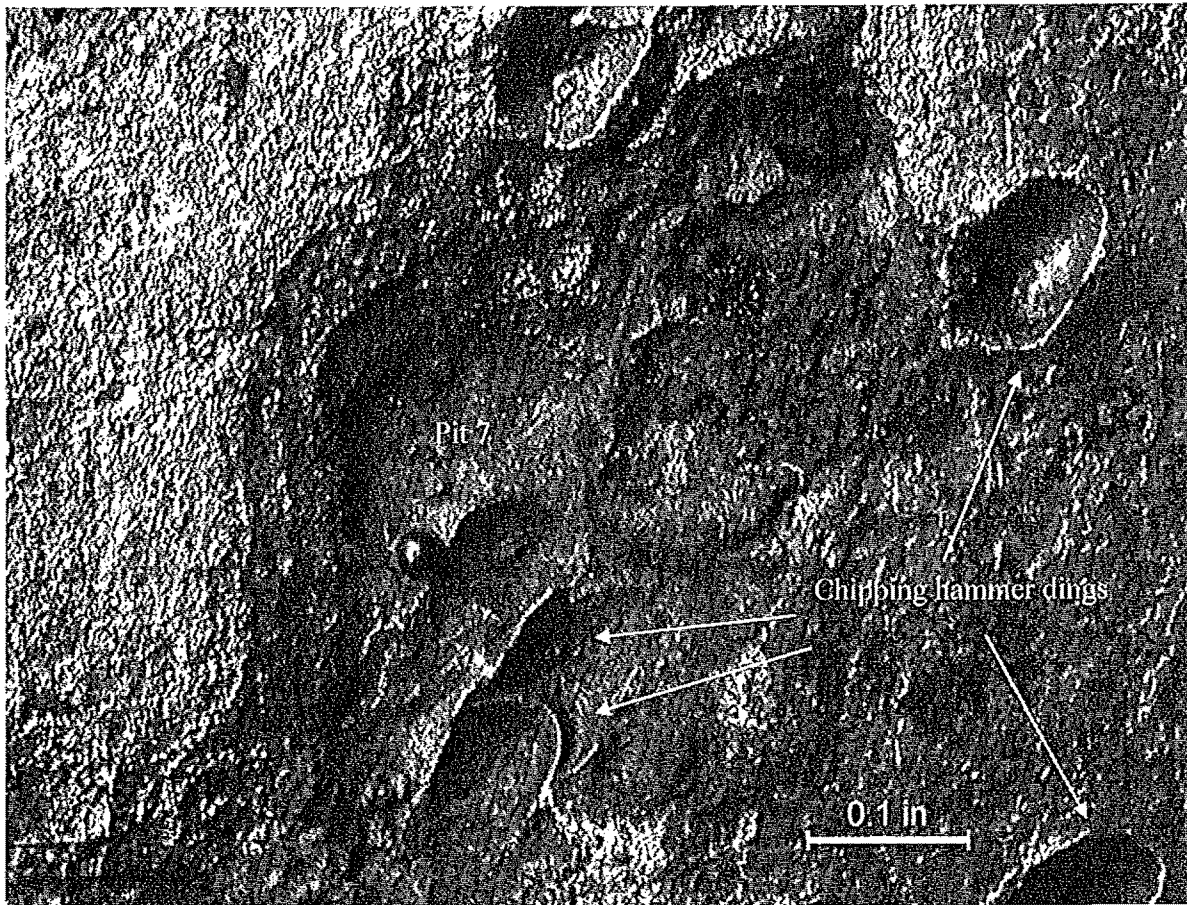
Figure 7 Macrograph of a pit under the PLIDCO cap, from the boxed area in Figure 6b.

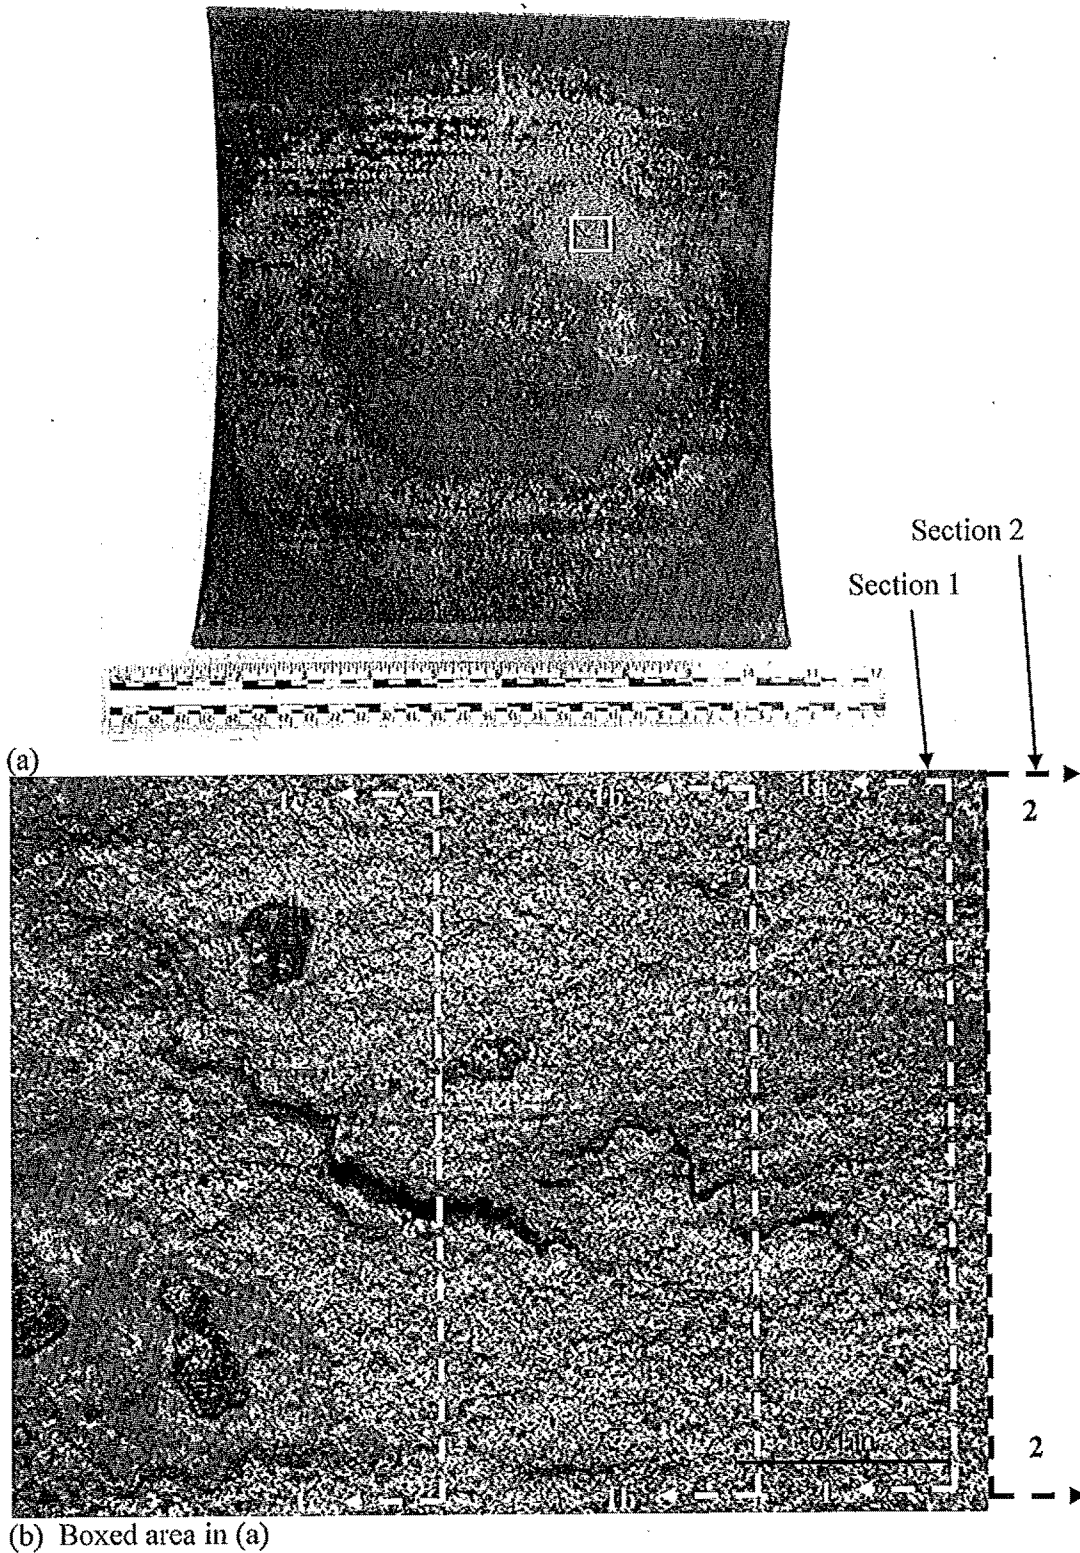
The sample shown in Figure 6 was returned to PG&E for radiography. A digital radiograph of the sample is shown in Appendix A along with a photograph of the sample. A crack indication was found that corresponded to the crack-like feature detected visually on the inside surface, shown in Figure 8b.

Figure 8 Photograph (a) and macrograph (b) of the inside surface of sample half A under the PLIDCO cap, after cleaning.

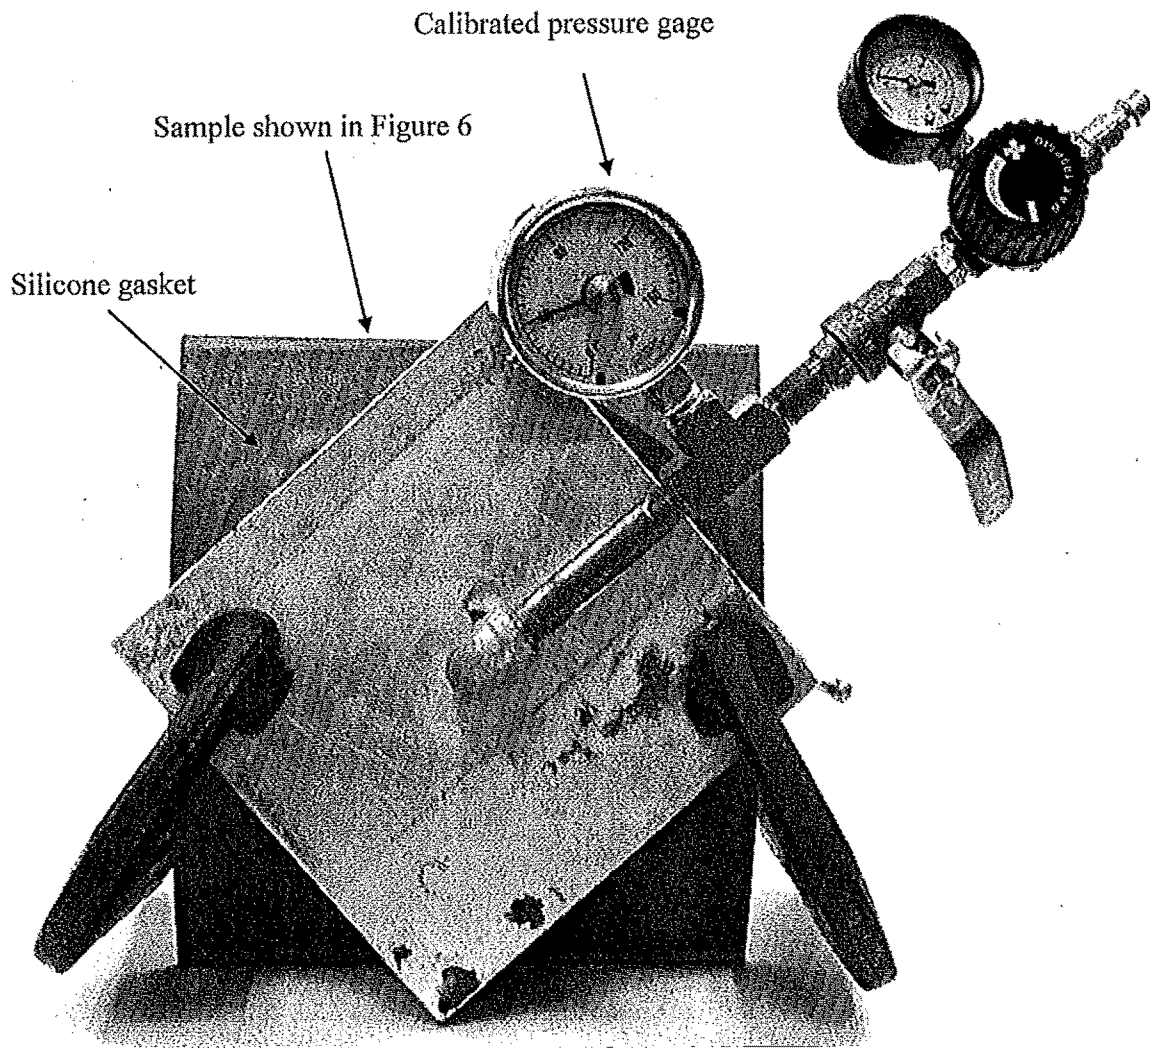
A pressure test was performed by clamping a plate over the sectioned cap, sealed with a silicone gasket, and introducing 40-psig of compressed air. Snoop® liquid leak detector was applied to the inside surface. No leaks were detected. The compressed air was valved-off, and no pressure drop from 40-psig was detected after 45-minutes.

Figure 9 Pressure test setup.

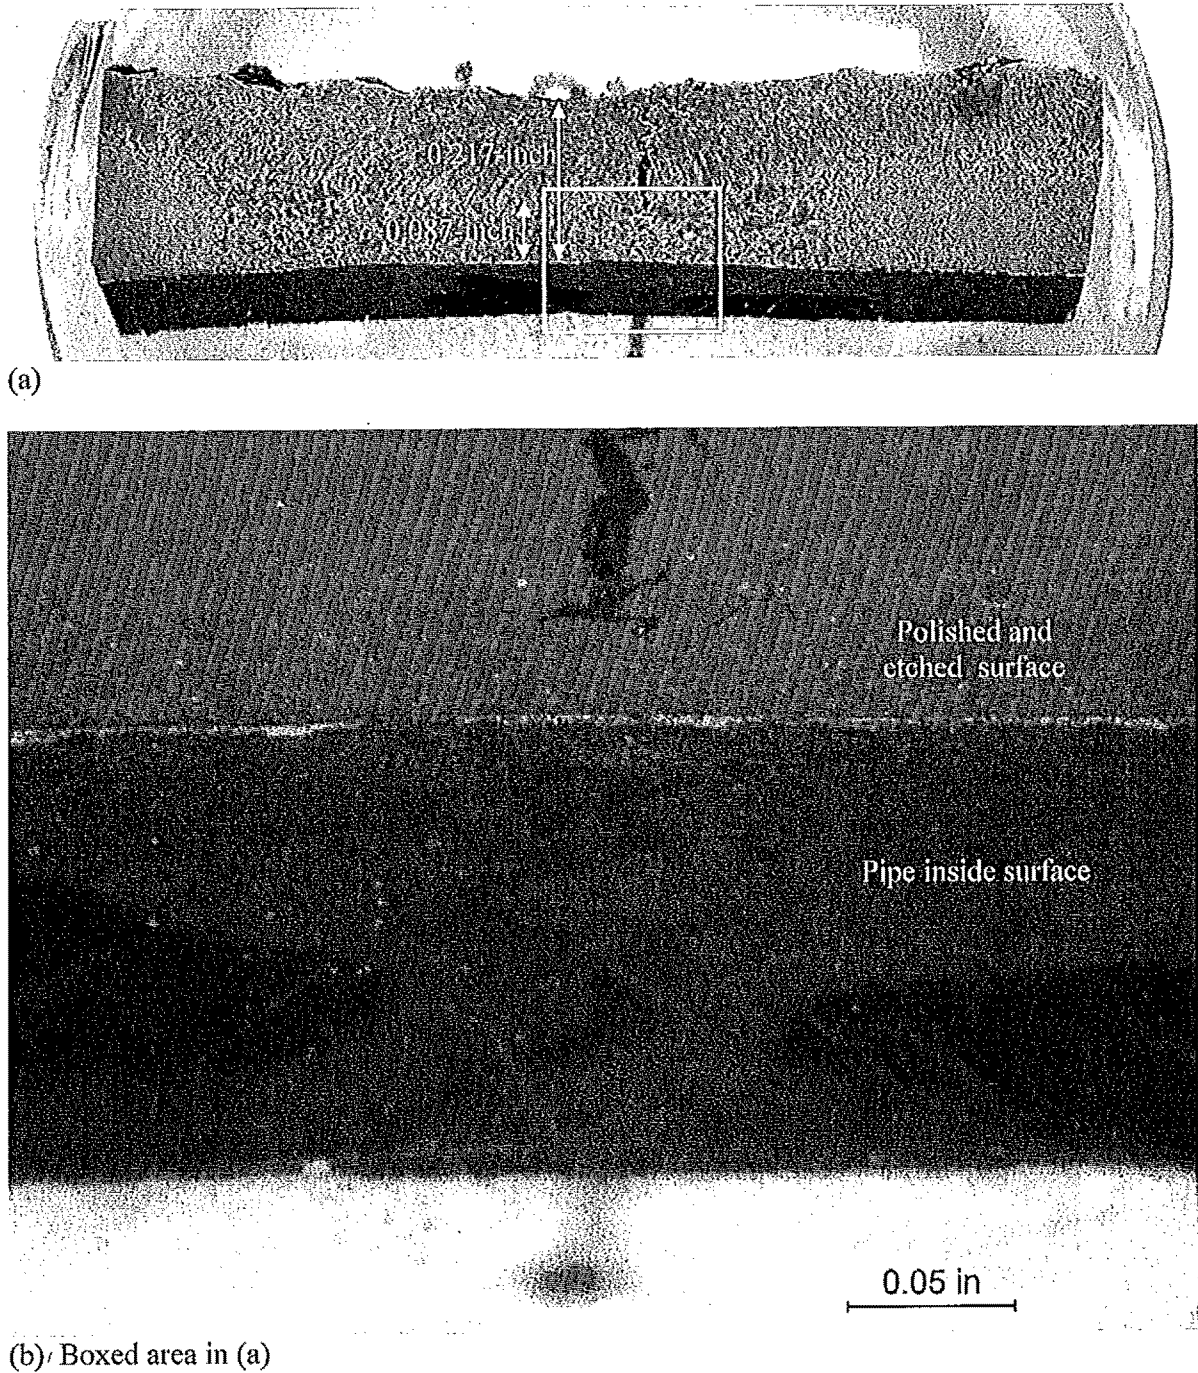
Specimens were prepared for metallography from section 1 and 2 indicated in Figure 8b. Weld crater cracks and heat affected zone liquation cracks were present in the sections. Serial grinding and polishing was performed on section 1, referred to as sections 1a, 1b, and 1c. As shown in Figure 10 through Figure 20, a weld crater crack extended from the outside surface into the weld heat affected zone in section 1a, but did not penetrate through-wall at this location. Shrinkage porosity was present near the outside surface, and intergranular cracks consistent with grain boundary liquation were present in the heat affected zone.

Section 2 is shown in Figure 19. The fusion zone in this section had a profile that was more varied in depth than in sections 1a through 1c, which suggested the possibility that the weld metal was deposited to build-up locations where wall thickness had been reduced by external corrosion. Measurements of the minimum thickness of base metal beneath the weld metal are shown in Figure 10, Figure 13, Figure 16, and Figure 19.

Figure 10 Images of the specimen prepared for metallography, section 1a. Etched with 2% nital.

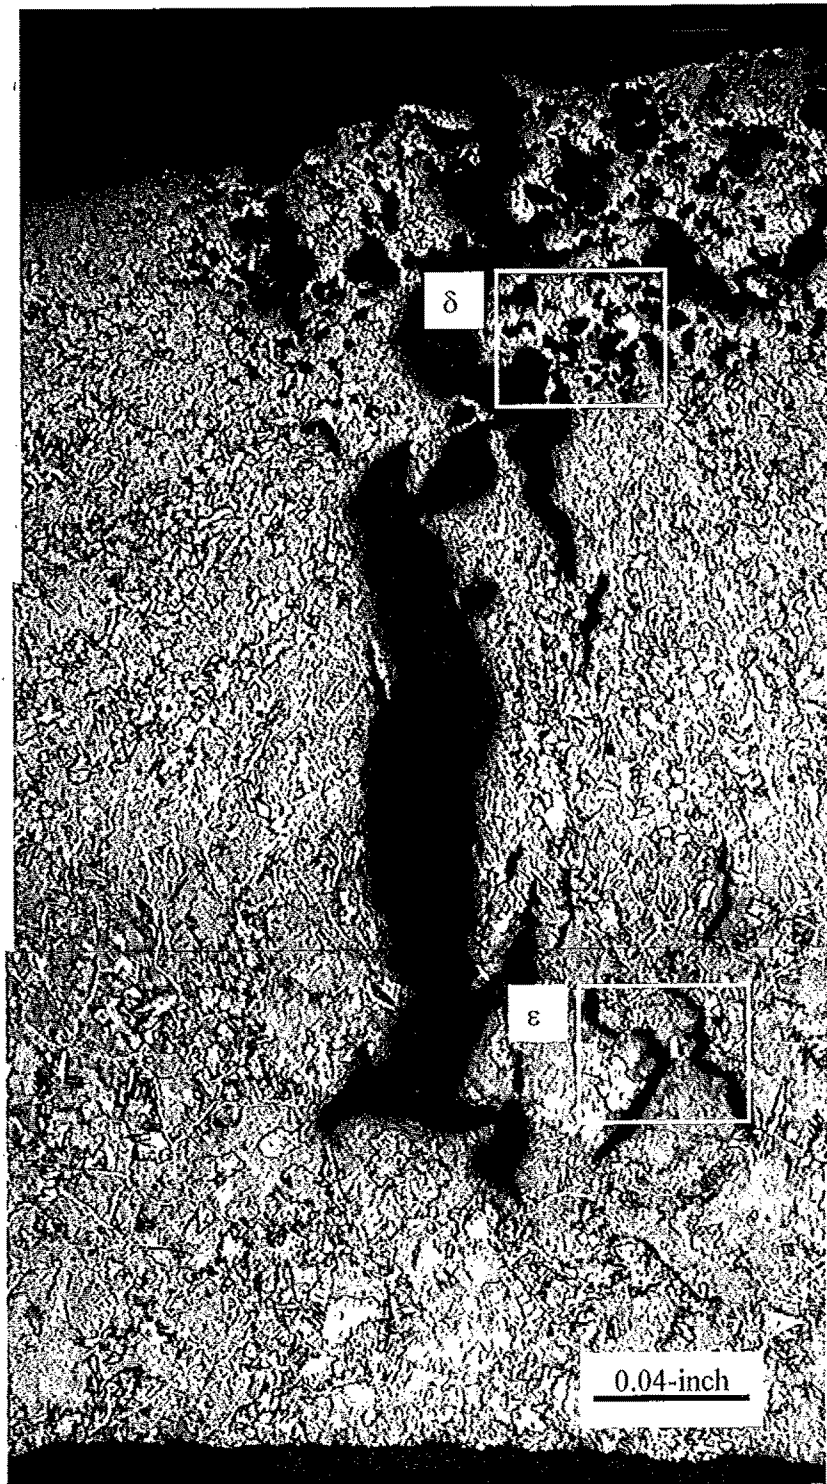
Figure 11 Composite optical micrograph of the specimen prepared for metallography, section 1a. Etched with 2% nital.

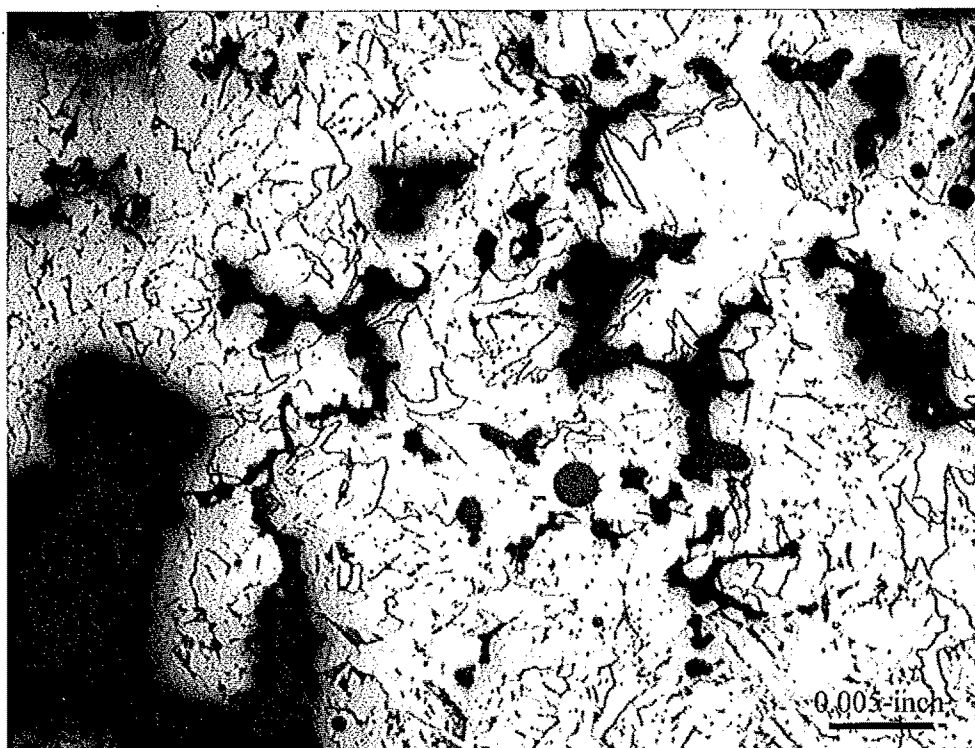
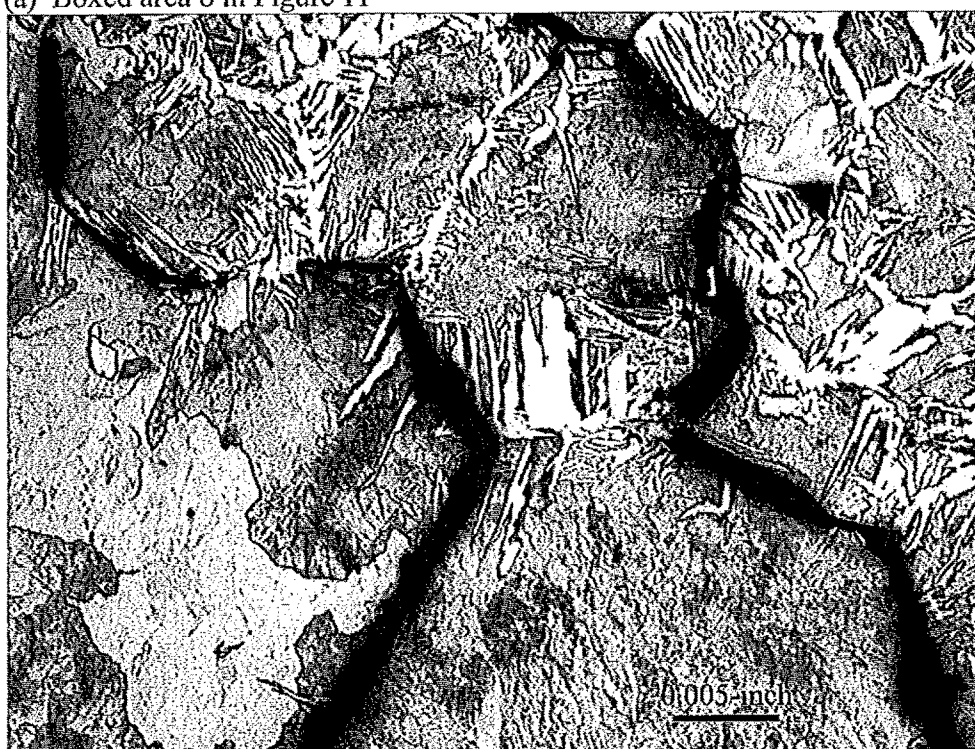
Figure 12 Optical micrographs of the specimen prepared for metallography, section 1a. Etched with 2% nital.

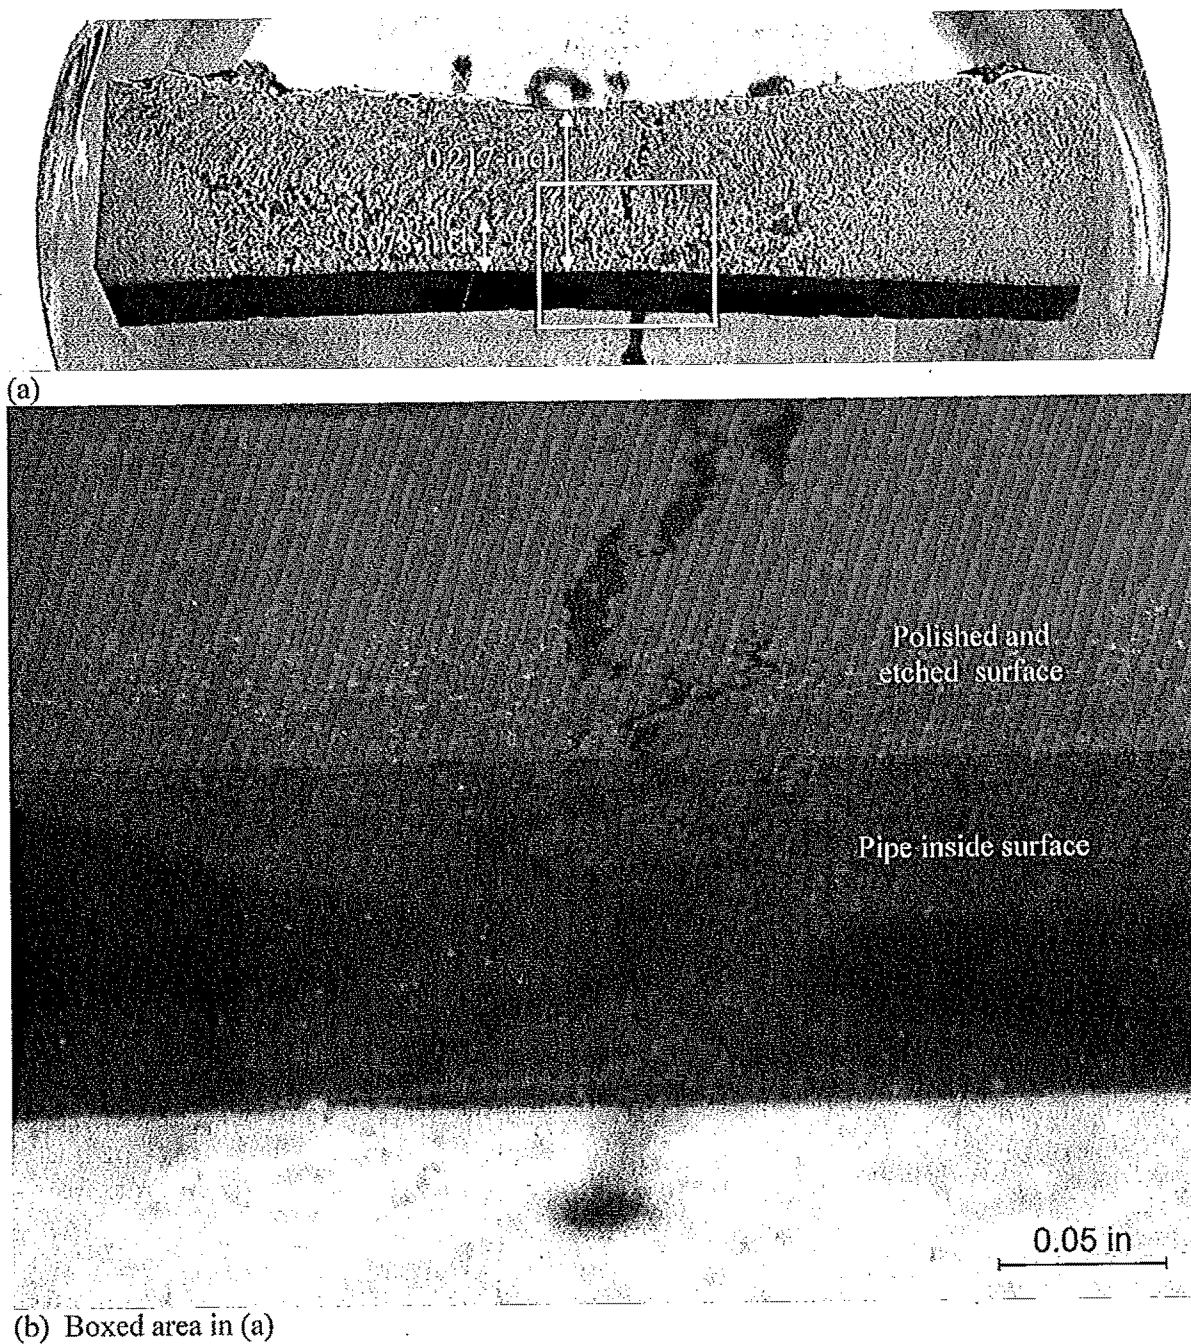
In section 1b, shown in Figure 13 through Figure 15, cracks were present from the outside surface to the inside surface. Only a few small ligaments prevented the demonstration of a through-wall leak path. However, it is likely that a leak path existed between section 1a and 1b. The weld metal crack morphology was consistent with shrinkage, and the heat affected zone crack morphology was indicative of grain boundary liquation.

Figure 13 Images of the specimen prepared for metallography, section 1b. Etched with 2% nital.

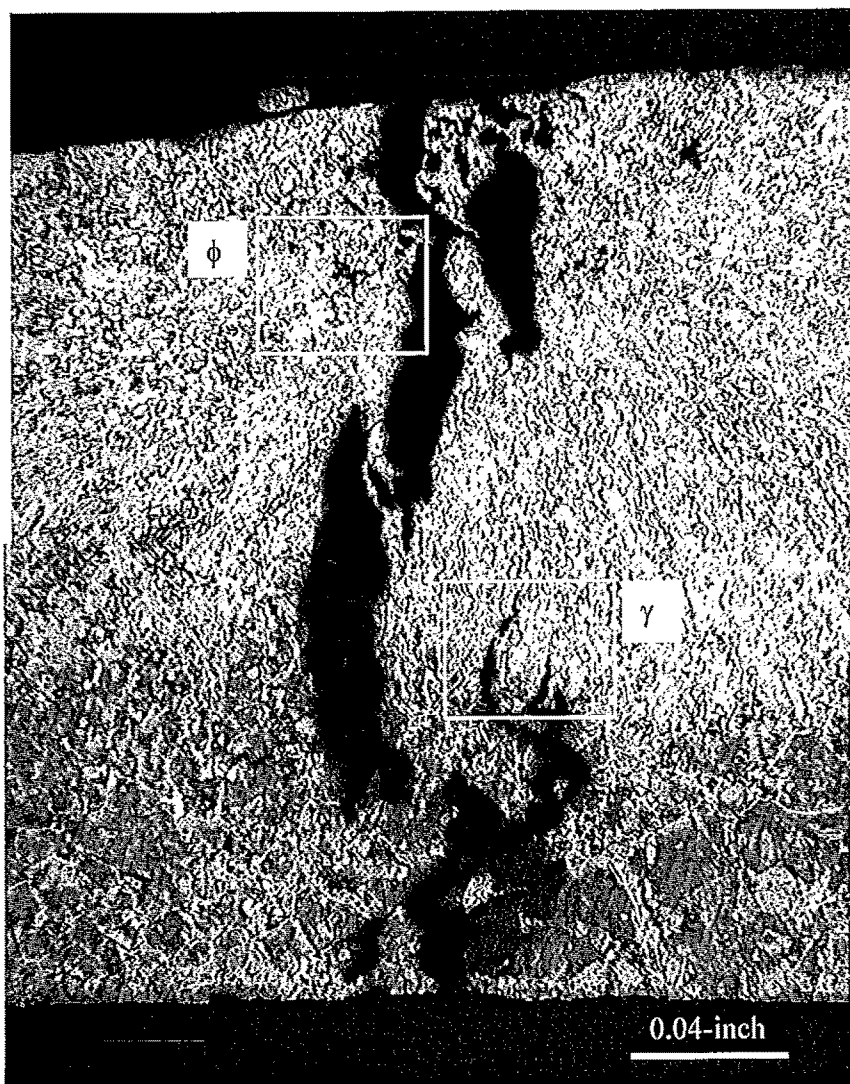
Figure 14 Composite optical micrograph of the specimen prepared for metallography, section 1b. Etched with 2% nital.

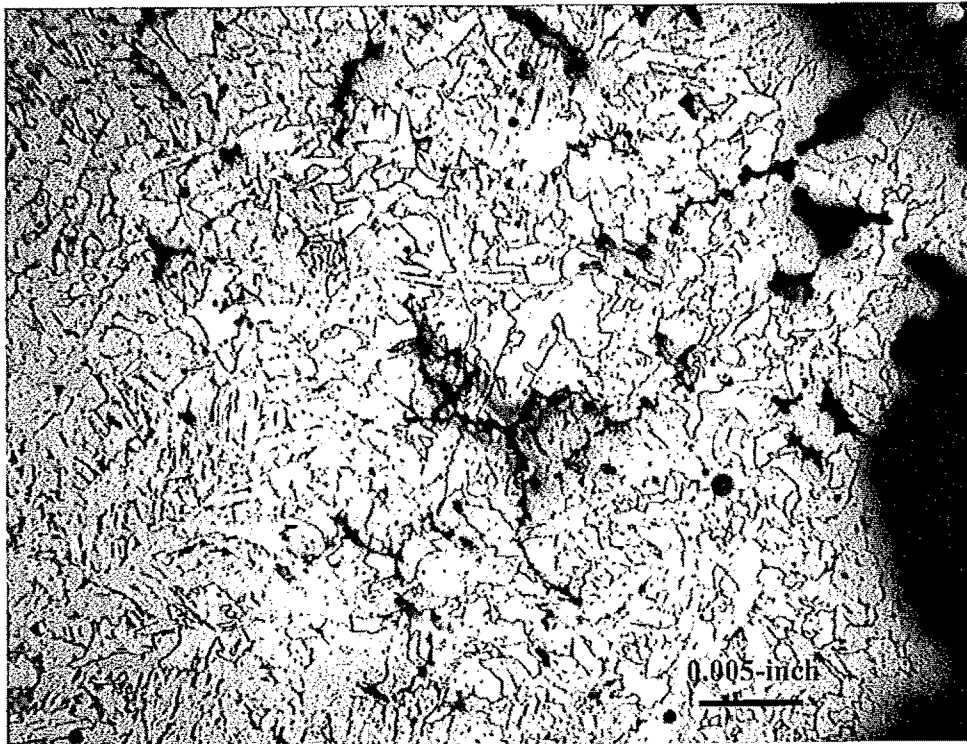
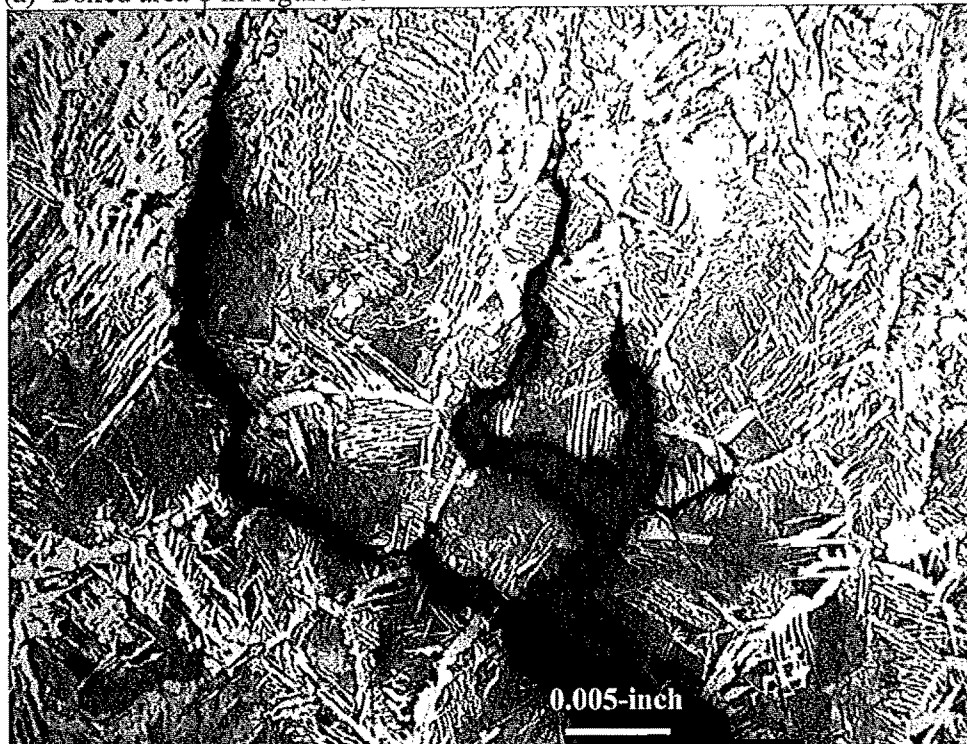
Figure 15 Optical micrographs of the specimen prepared for metallography, section 1b. Etched with 2% nital.
