DECLARATION OF SUMEET SINGH

Report No. 5004.9268

**METALLURGICAL EVALUATION OF A SECTION FROM
L-147 MP 2.2 BRITTAN AVE. AND ROGERS AVE., SAN CARLOS**

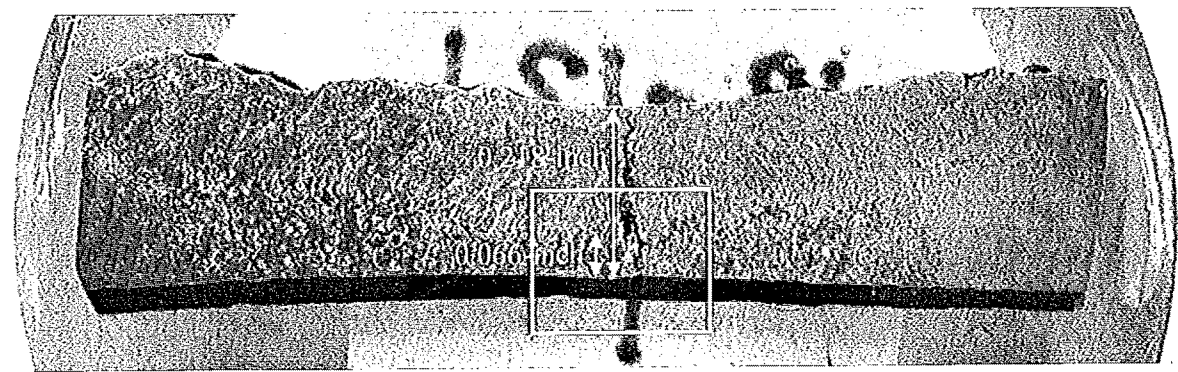
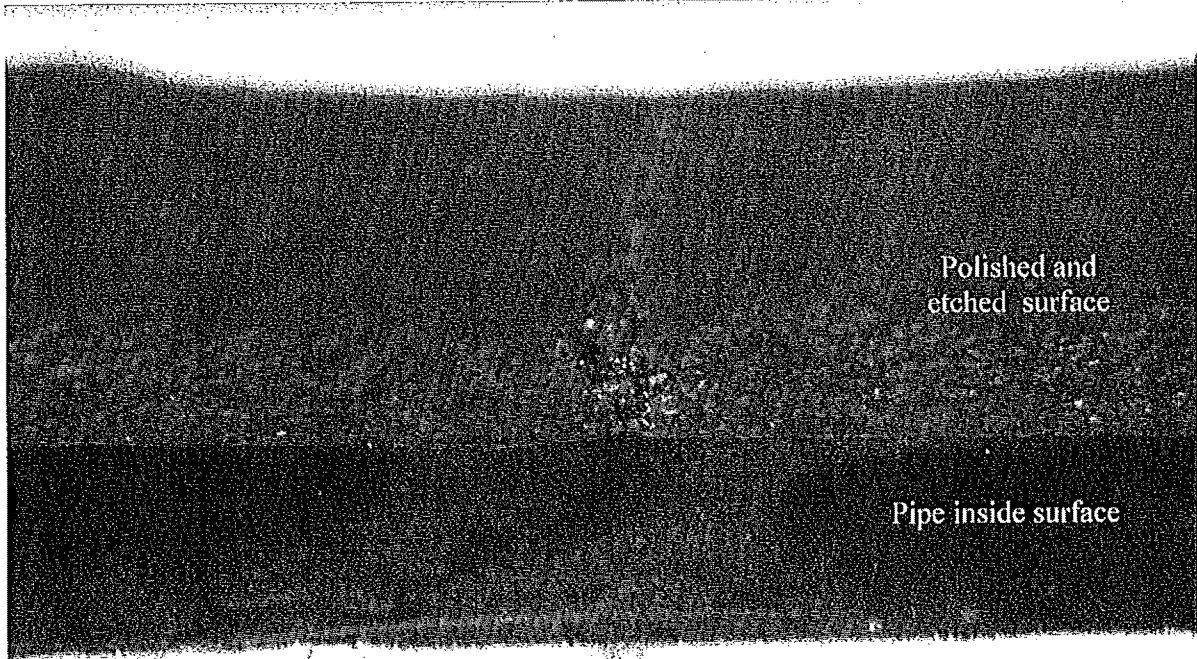
In section 1c, shown in Figure 16 through Figure 18, one small ligament at the outside surface prevented demonstration of a through-wall leak path. Once again, the weld crack morphology was consistent with shrinkage and the heat affected zone crack morphology was consistent with grain boundary liquation. In all three sections of specimen 1, the weld fusion zone followed a smooth broad contour with no indications of external corrosion prior to welding.

Figure 16 Images of the specimen prepared for metallography, section 1c. Etched with 2% nital.

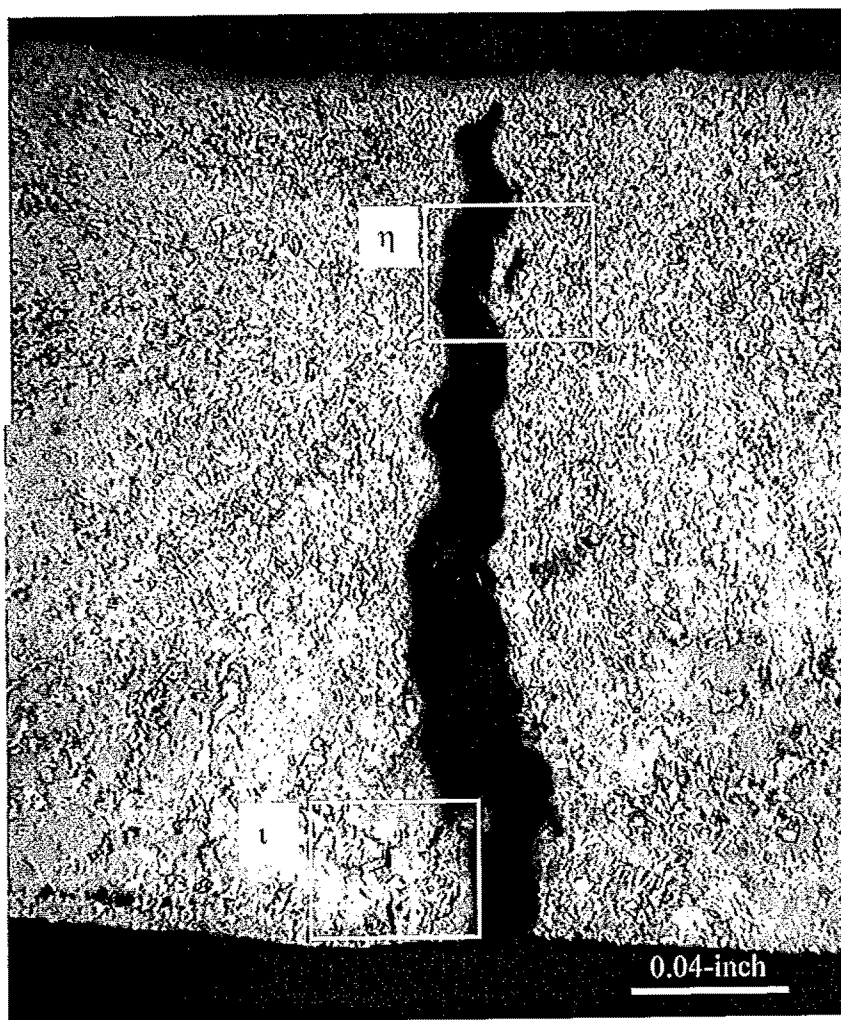
Figure 17 Composite optical micrograph of the specimen prepared for metallography, section 1c. Etched with 2% nital.

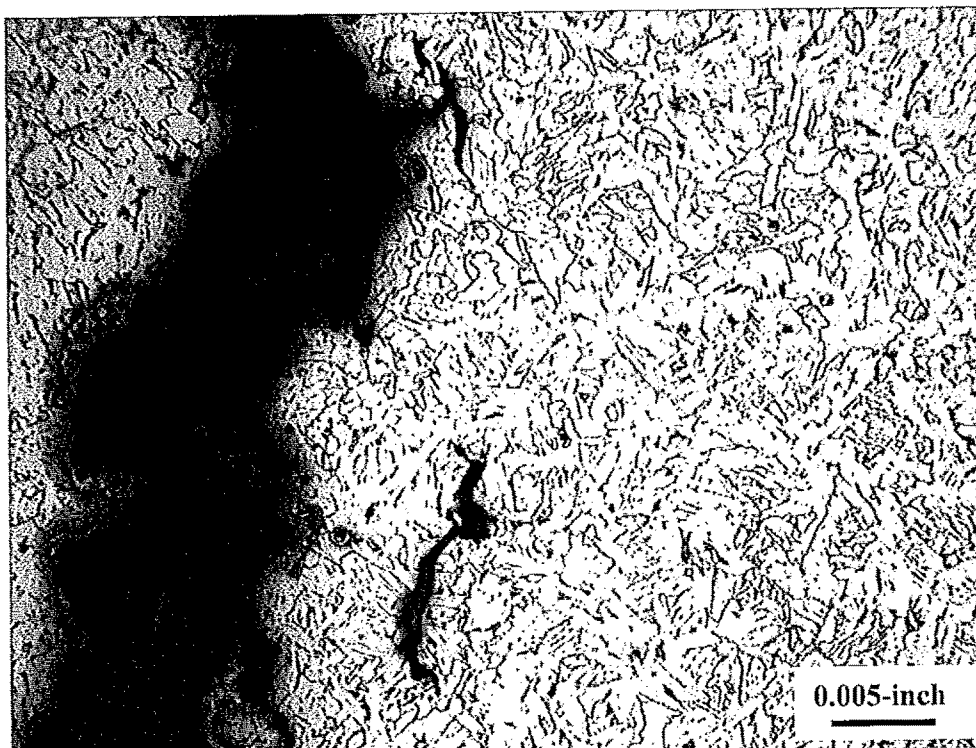
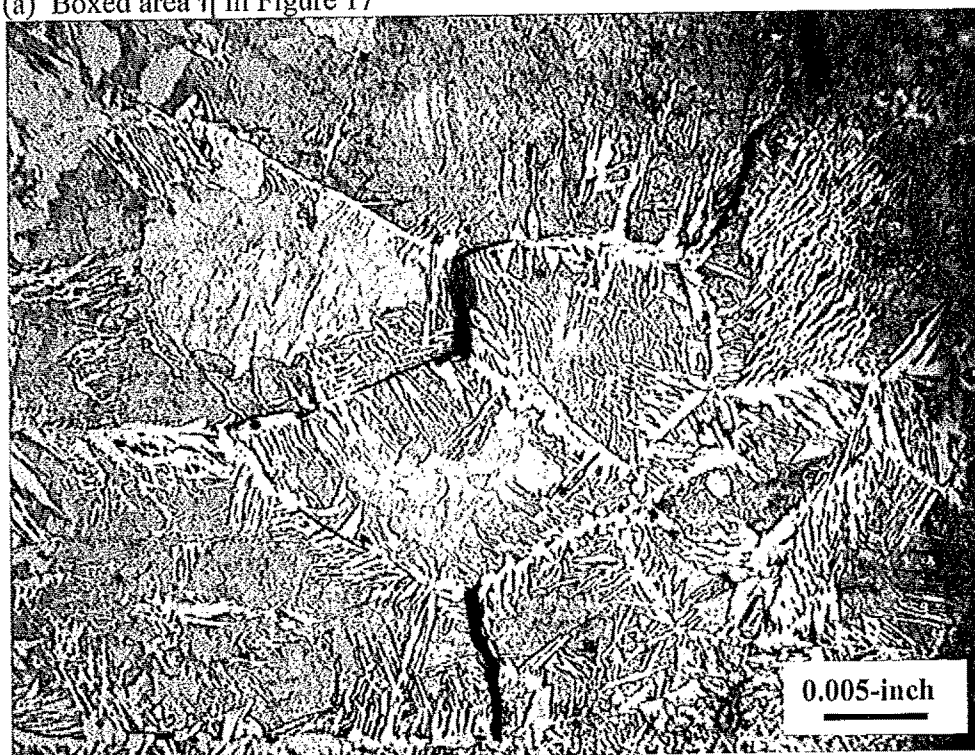
Figure 18 Optical micrographs of the specimen prepared for metallography, section 1c. Etched with 2% nital.

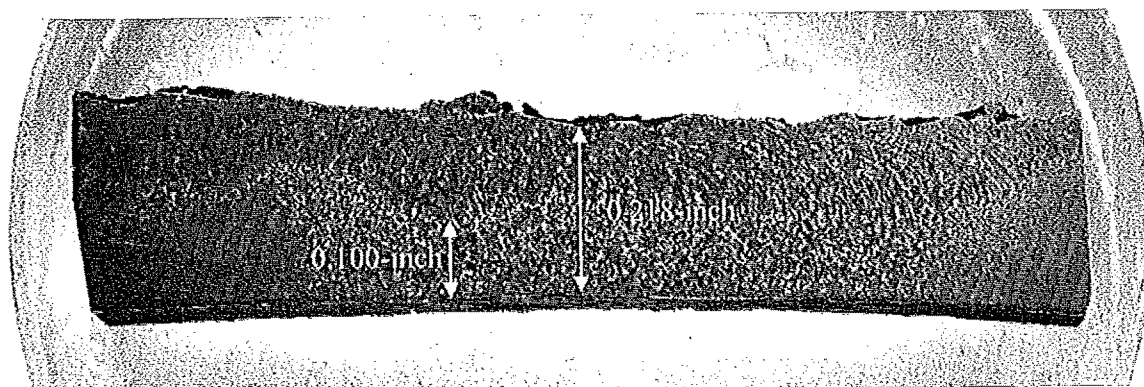
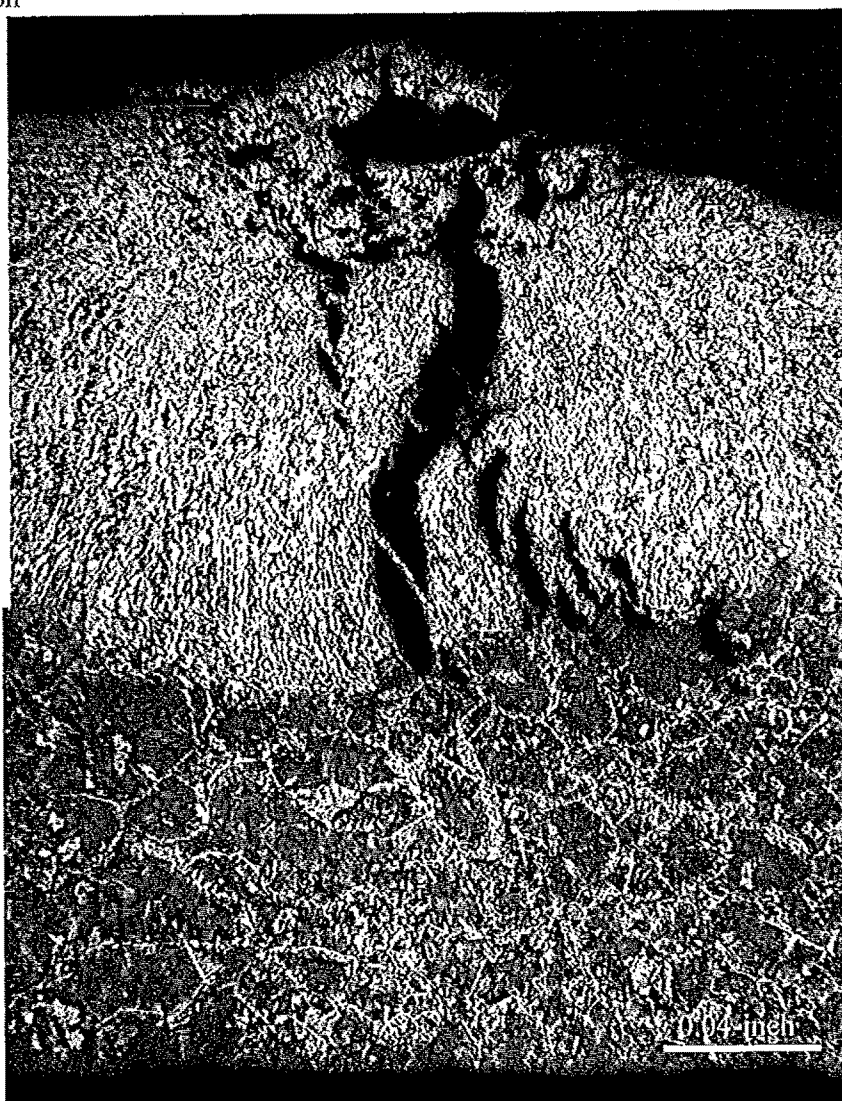
Section 2 is shown in Figure 19. The fusion zone in this section had a profile that was more varied in depth than in sections 1a through 1c, which suggested the possibility that the weld metal was deposited to build-up locations where wall thickness had been reduced by external corrosion. Measurements of the minimum thickness of base metal beneath the weld metal are shown in Figure 10, Figure 13, Figure 16, and Figure 19.

Figure 19 Photograph and composite micrograph of section 2. Etched with 2% nital.

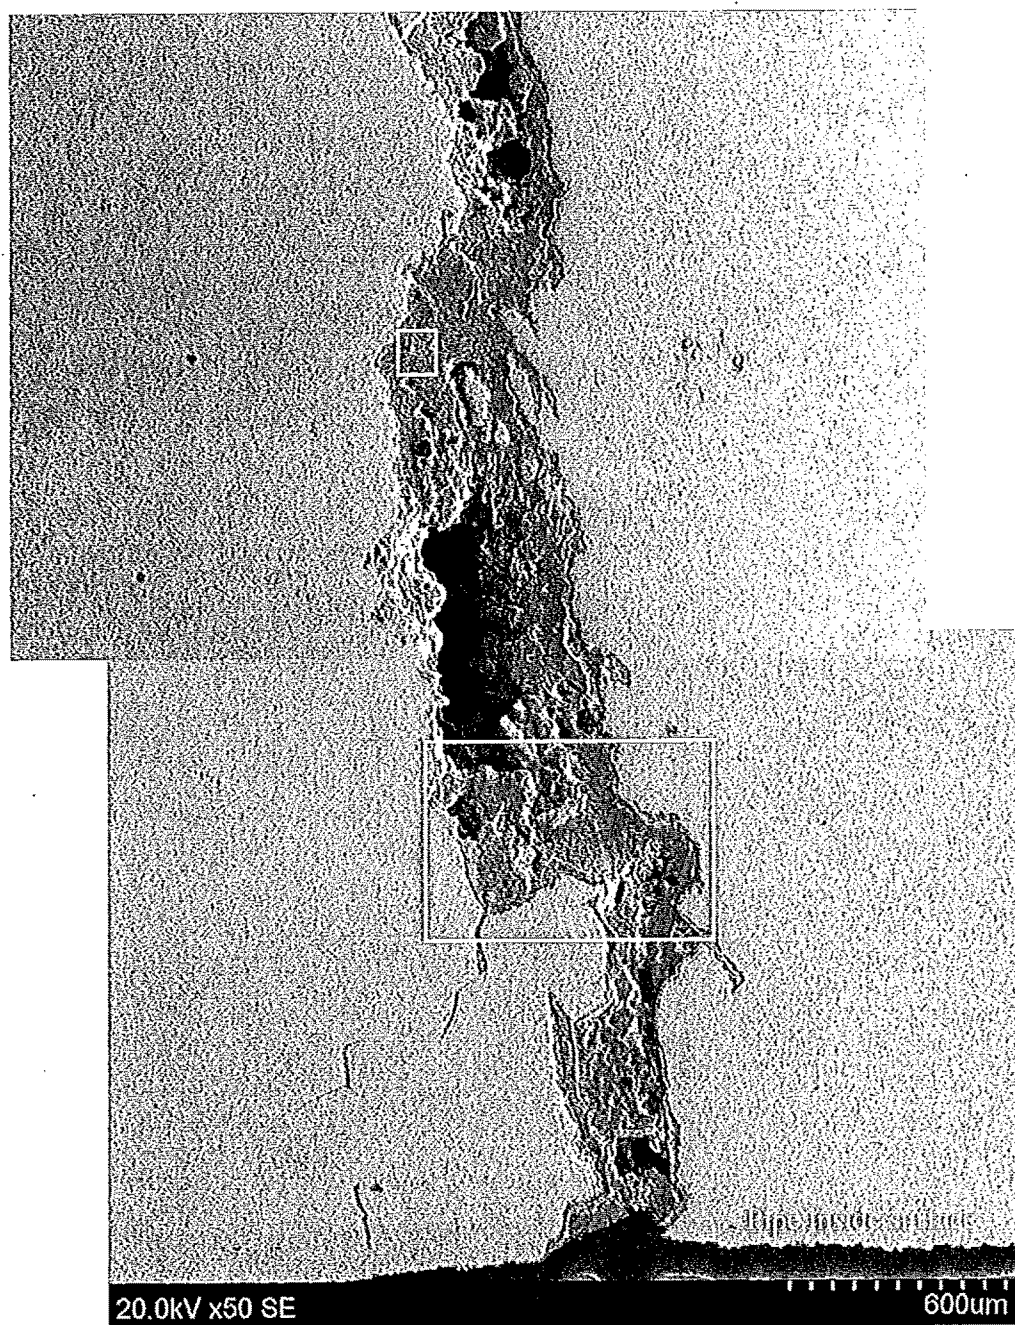
Scanning electron microscopy (SEM) and energy dispersive X-ray spectroscopy² (EDS) was performed on the section 3 polished and etched surface. A composite SEM micrograph of the crack is shown in Figure 20. Much of the crack was filled with oxide, indicated by the morphology and chemical composition of primarily iron and oxygen, with sulfur present, likely from mercaptan in the gas stream.

Figure 20 Composite SEM micrograph of the specimen prepared for metallography, section 1c.

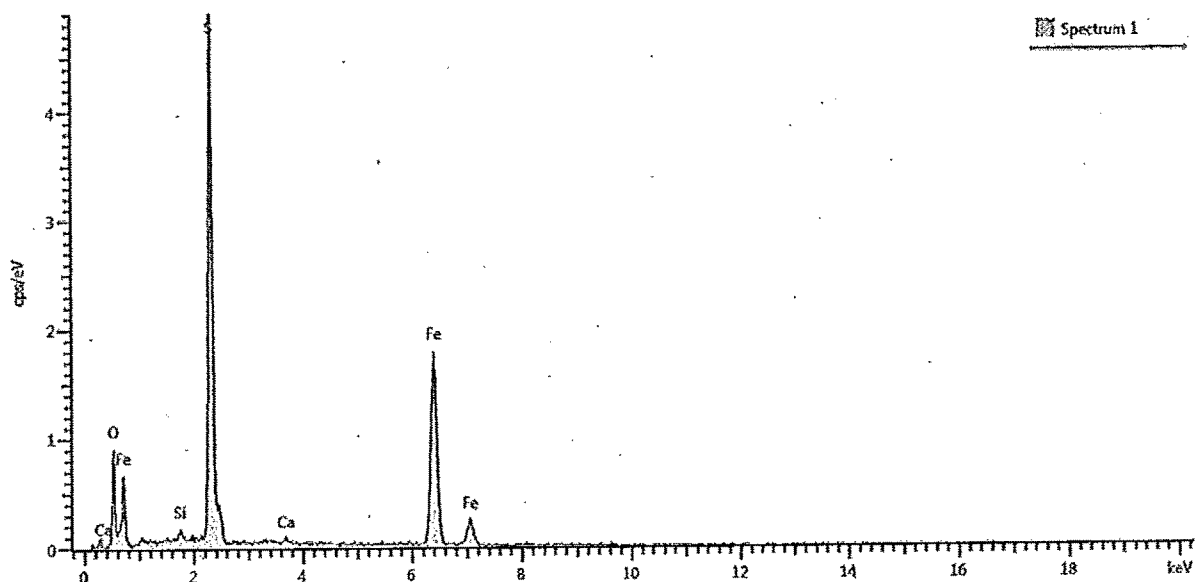
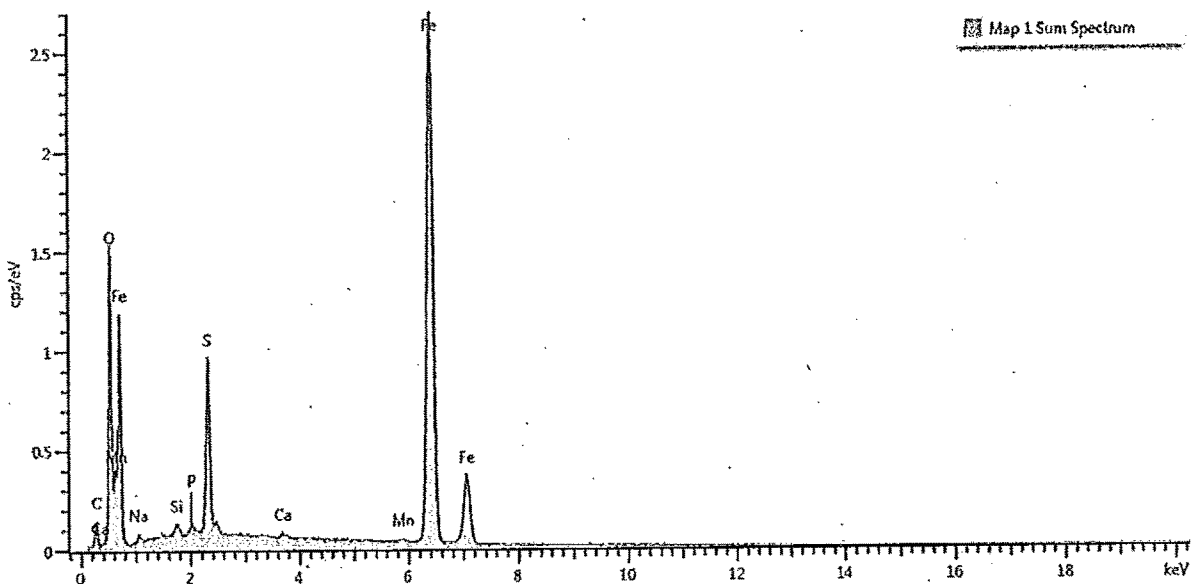
Figure 21 EDS spectra from the specimen prepared for metallography, section 1c.

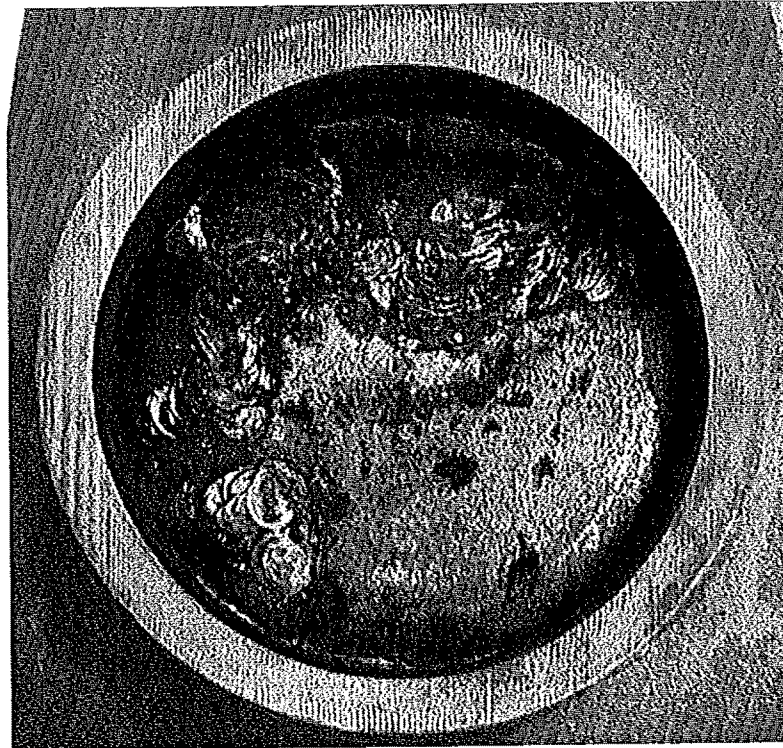
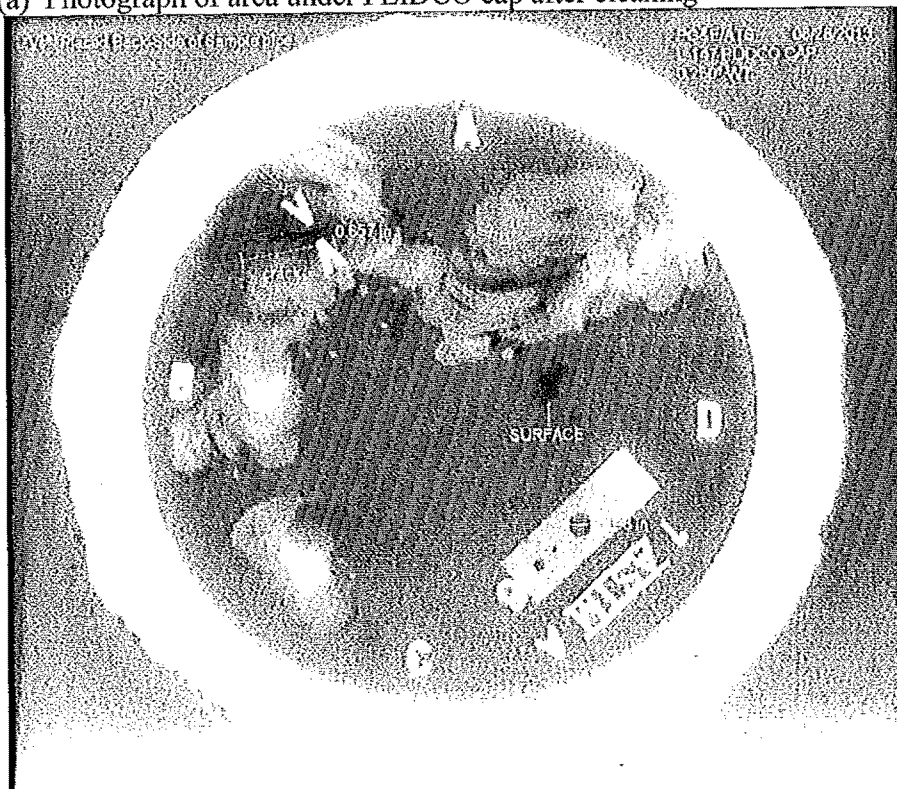
Appendix A
(Radiograph courtesy of PG&E)

The sample shown in Figure 6 was returned to PG&E for radiography. A digital radiograph of the sample is shown in Appendix A along with a photograph of the sample. A crack indication was found that corresponded to the crack-like feature detected visually on the inside surface, shown in Figure 8b.
