Report No. 5004.9268 Rev. 1

**METALLURGICAL EVALUATION OF A SECTION FROM
L-147 MP 2.2 BRITTAN AVE. AND ROGERS AVE., SAN CARLOS**

One section of 20-inch diameter gas transmission pipe identified as L-147 MP 2.2 Brittan Ave. and Rogers Ave., San Carlos was submitted by PG&E for metallurgical evaluation. The subject section had a PLIDCO weld cap permanent repair, and an A. O. Smith longitudinal seam weld. The section was cut out to perform a root cause investigation of a reported leak under the PLIDCO cap. It was reported the subject passed hydrotest as part of L-147 on October, 24, 2011, at a pressure of 600-psi, or 1.5 times the desired Maximum Allowable Operating Pressure (MAOP) of 400-psi, and the PLIDCO cap was located at the six o'clock position, on the bottom of the section. The purpose of this evaluation was to determine the metallurgical condition of the pipe wall under the PLIDCO cap, and perform Charpy impact testing of the A. O. Smith weld and unaffected base metal.

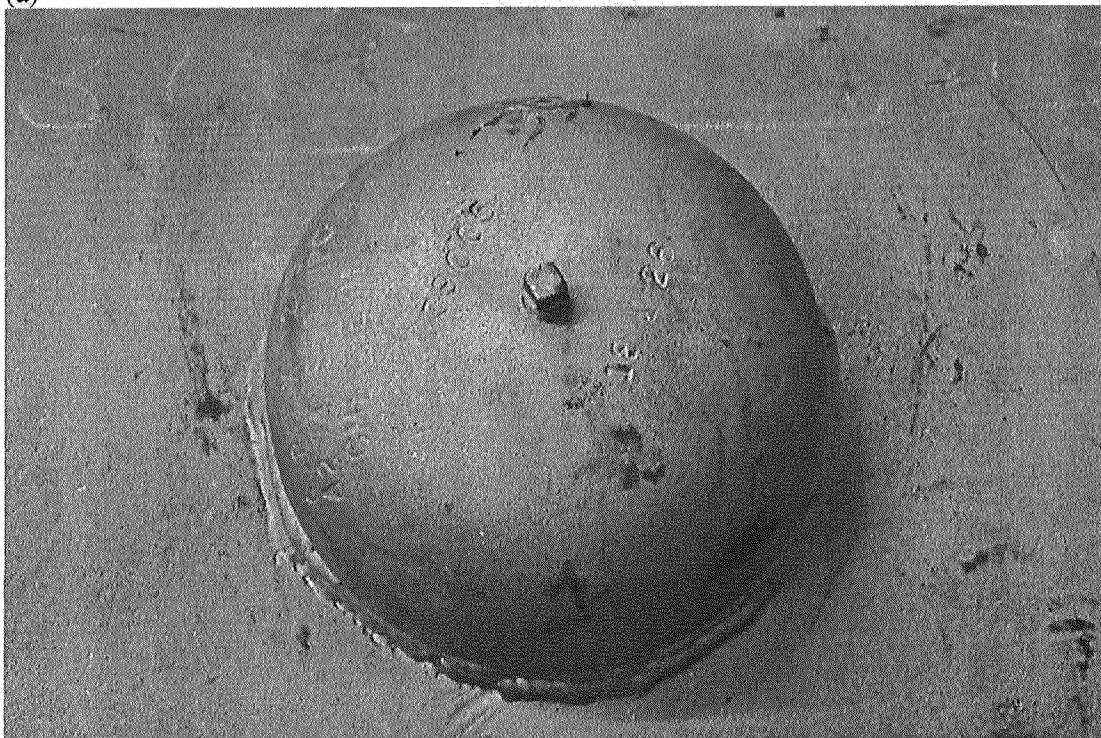
The subject sample of L-147 was received sectioned into two halves along the longitudinal axis, with the outside surface grit blasted, as shown in Figure 1 through Figure 5. The section half with the PLIDCO cap was arbitrarily labeled A and the other section was labeled B, in the laboratory. Based on the reported position of the cap, the longitudinal flame cuts were located at three o'clock and nine o'clock positions. Wall thickness measurements were made with a pointed anvil micrometer and the results are listed in Table 1. Small regions of weld metal and a few shallow hemispherical pits were present near the cap, as shown in Figure 2. Pits were also present just past the three o'clock position toward the cap, indicated in Figure 1. Pit depths were measured with a pit gage, and the results are listed in Table 2. No evidence of a leak location or repair was visible to the unaided eye on the inside surface of the pipe under the cap.

Figure 1 Photographs of the outside surface of sample half A as-received.

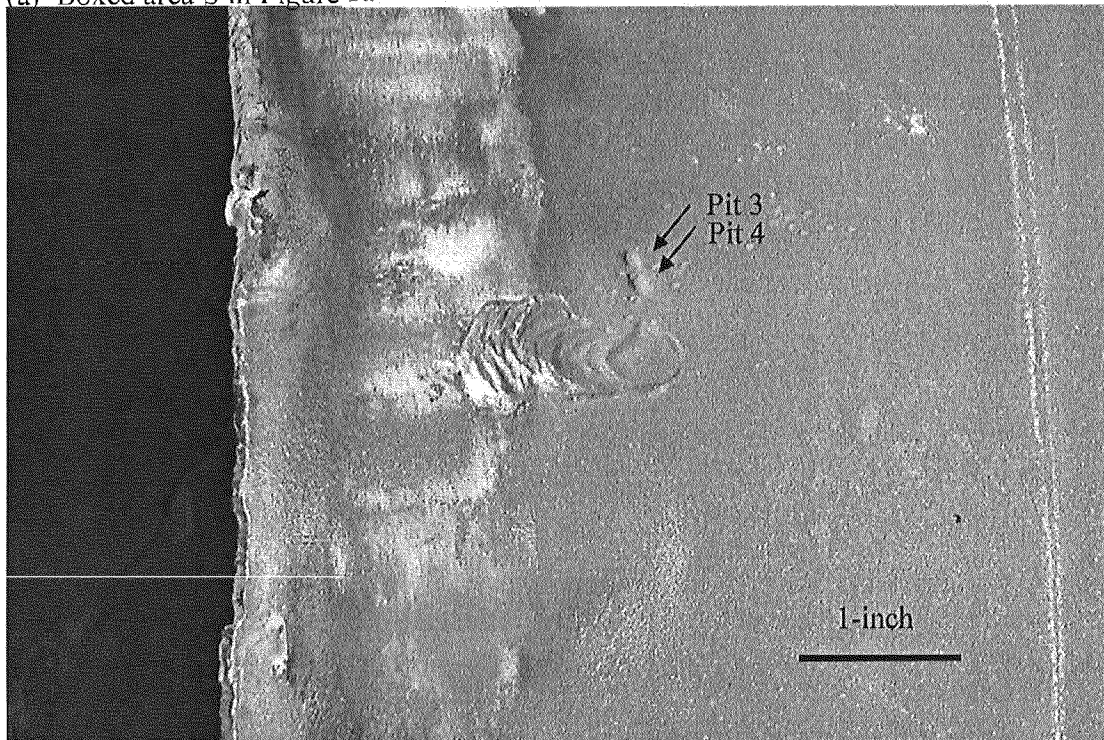
Figure 2 Photographs of the outside surface of sample half A as-received.

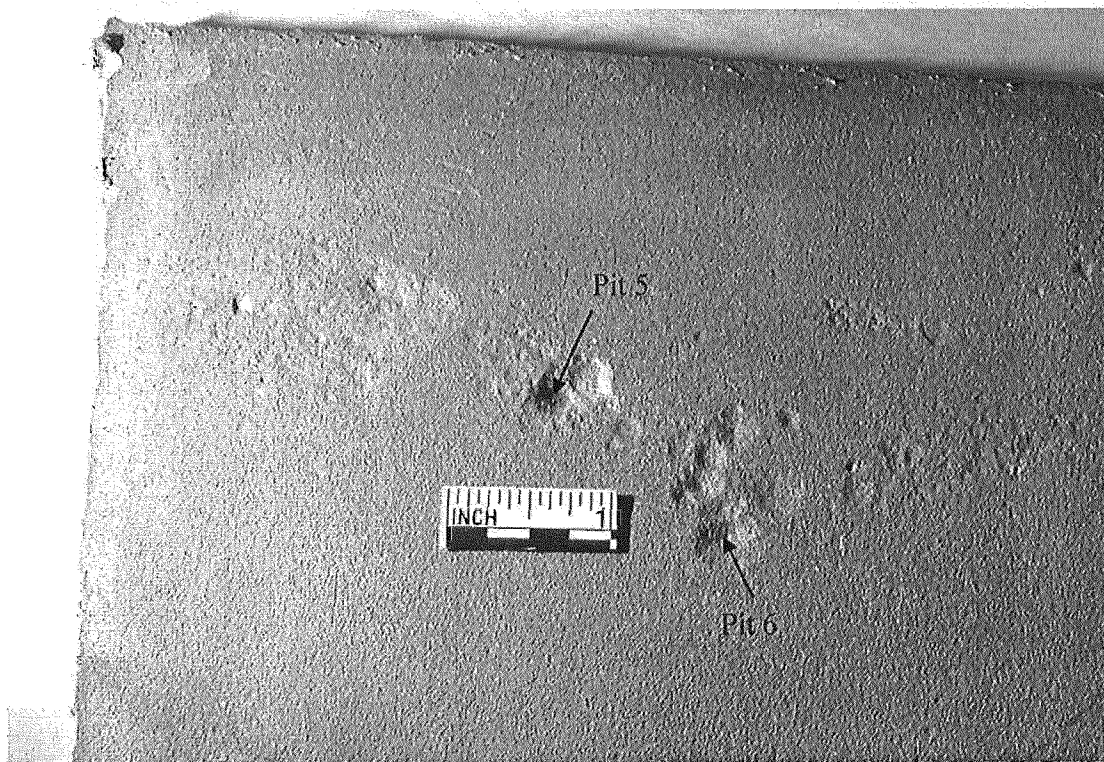
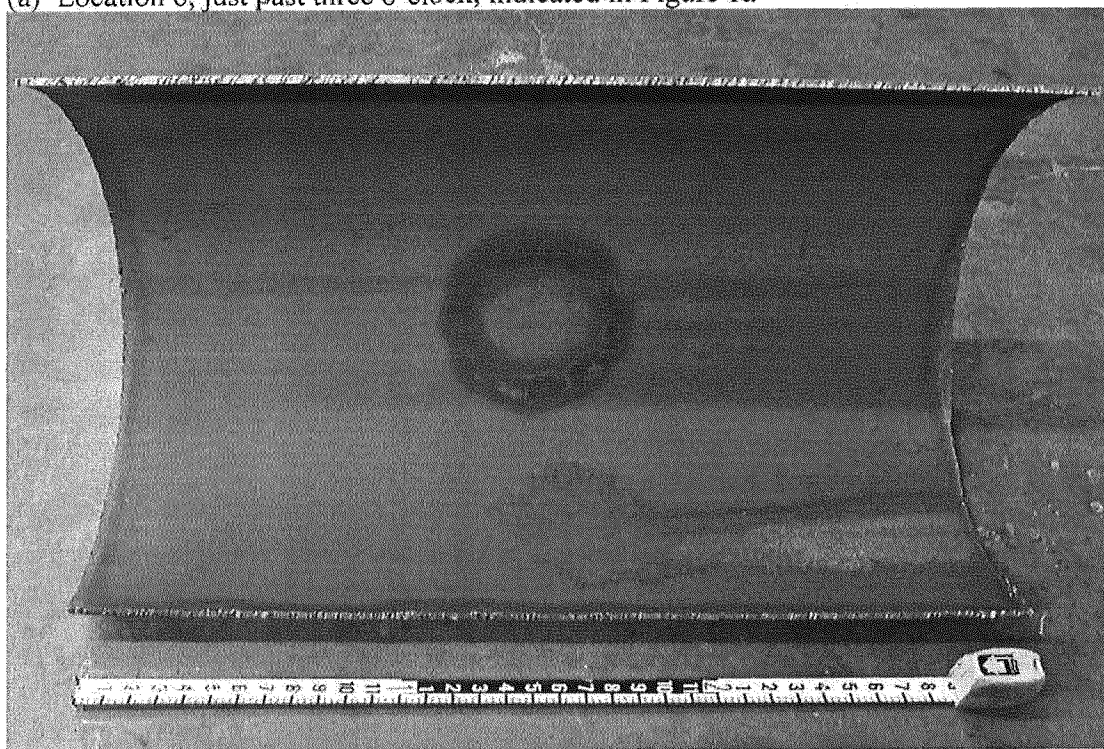
Figure 3 Photographs of pits on the outside surface and the inside surface of sample A.

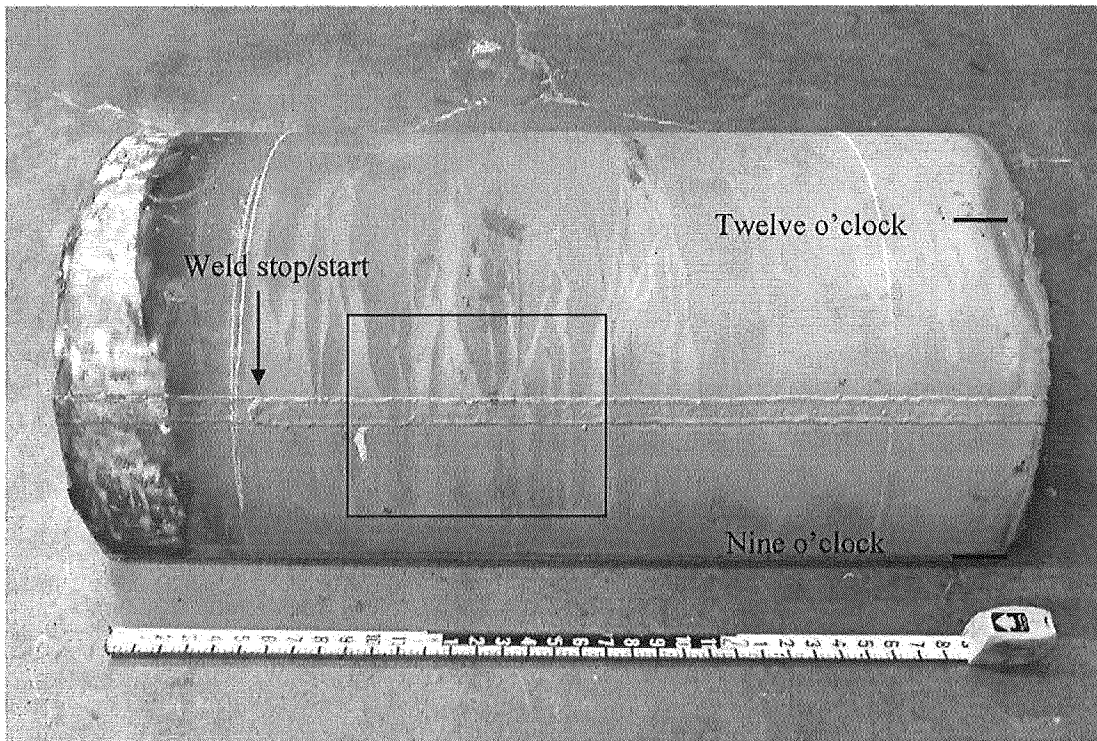
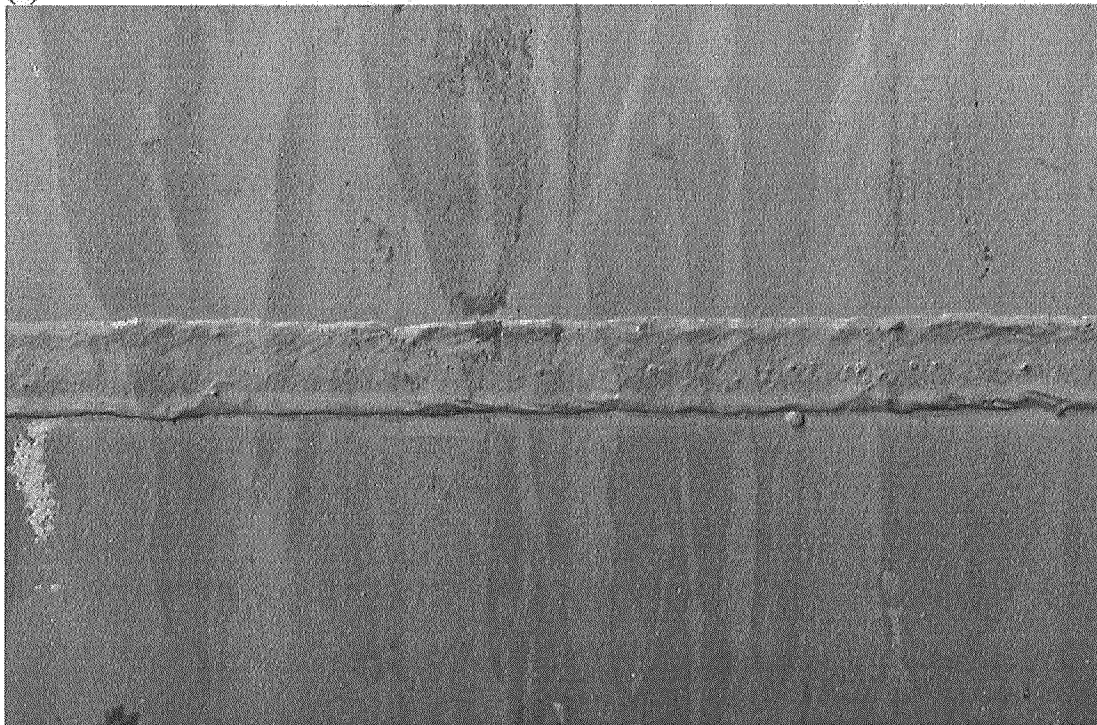
The appearance of the longitudinal seam was typical of A. O. Smith welds, a wide low-crowned cap on the outside surface and a narrow flash on the inside surface. A weld stop/start was visible on the outside surface.

Figure 4 Photographs of the outside surface of sample half B.

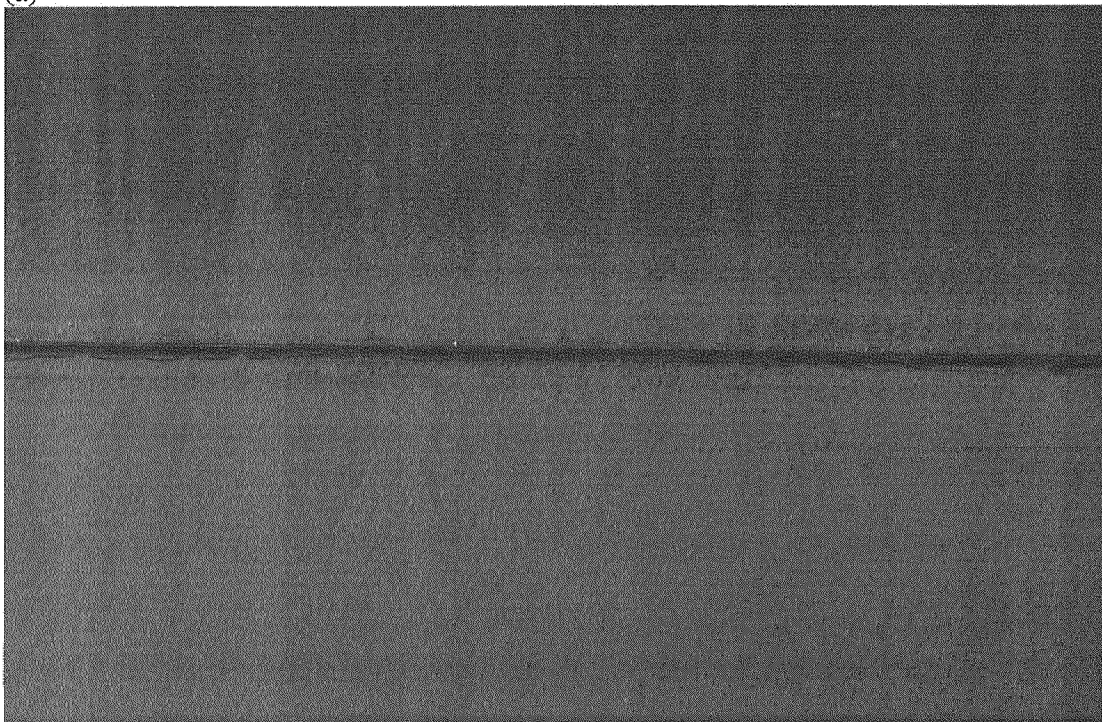
Figure 5 Photographs of the inside surface of sample half B.

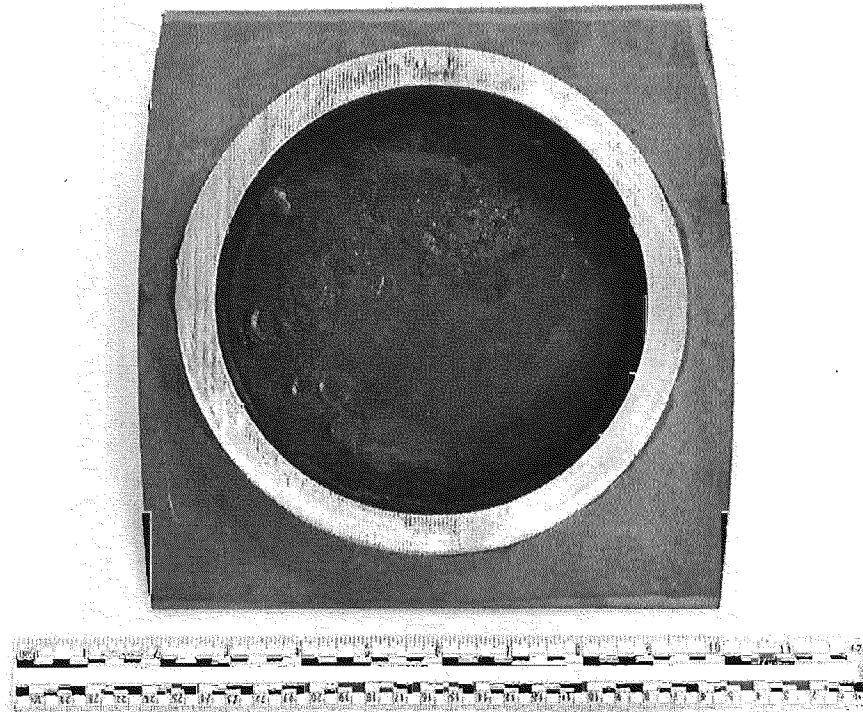
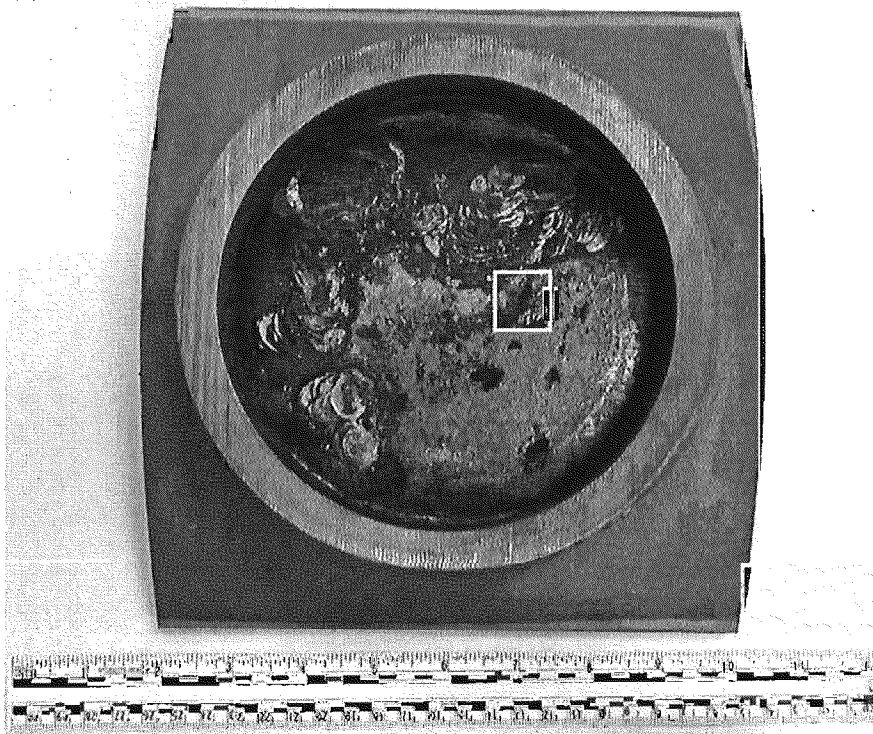
The region containing the PLIDCO cap was sectioned from sample A and the cap was cut off to expose the outside surface of the pipe wall. The outside surface was covered with rust and had a slightly oily feel. Both surfaces were cleaned with dilute Oakite® 33 and a wire brush. The outside surface is shown before and after cleaning in Figure 6. Several regions of weld metal were visible on the outside surface. Examination using low-power optical microscopy revealed a pit consistent with corrosion on the outside surface, indicated in Figure 7. The inside surface is shown after cleaning in Figure 8. Indications of heat exposure were visible on the inside surface, corresponding to the weld metal on the outside surface. No evidence of weld burn through was detected, and fine grooves typical of wrought steel surfaces were continuous across the region, which indicated that repairs did not extend to the inside surface. Examination using low-power optical microscopy revealed a crack-like feature on the inside surface within the heat affected zone of a weld deposit, as shown in Figure 8b.

Both sides of the cap sample shown in Figure 6 were thoroughly cleaned with acetone and dried with compressed air. A liquid penetrant test was performed by applying developer to the inside surface, and penetrant was liberally applied to the outside surface in the area covered by the cap. After 1.5-hours, no indication of penetrant was visible on the inside surface.

Figure 6 Photographs of the PLIDCO cap area after sectioning.

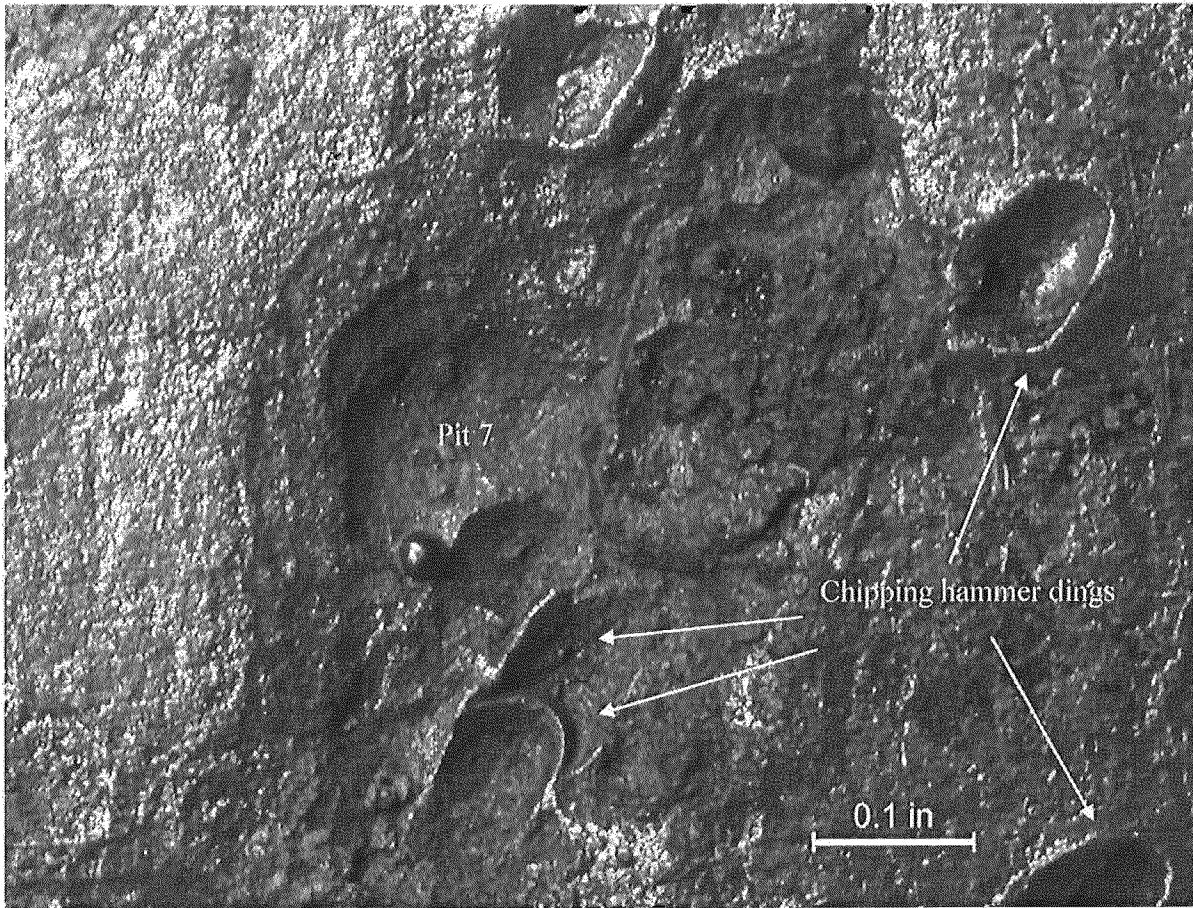
Figure 7 Macrograph of a pit under the PLIDCO cap, from the boxed area in Figure 6b.

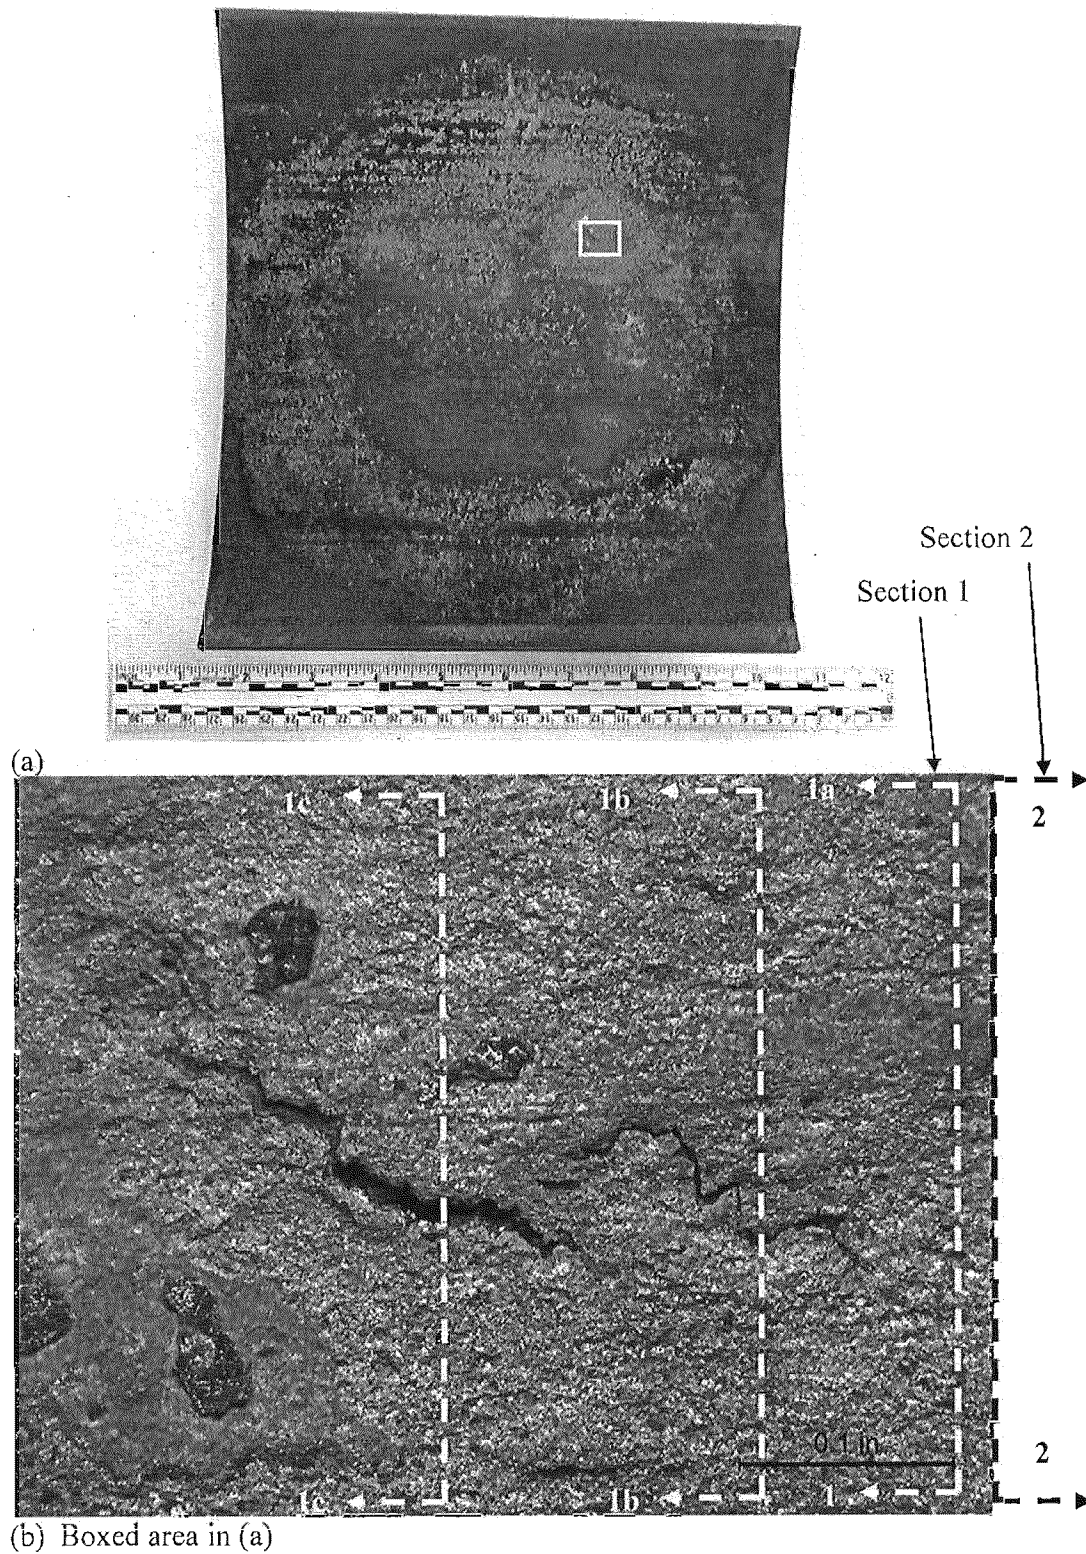
The sample shown in Figure 6 was returned to PG&E for radiography. A digital radiograph of the sample is shown in Appendix A along with a photograph of the sample. A crack indication was found that corresponded to the crack-like feature detected visually on the inside surface, shown in Figure 8b.

Figure 8 Photograph (a) and macrograph (b) of the inside surface of sample half A under the PLIDCO cap, after cleaning.

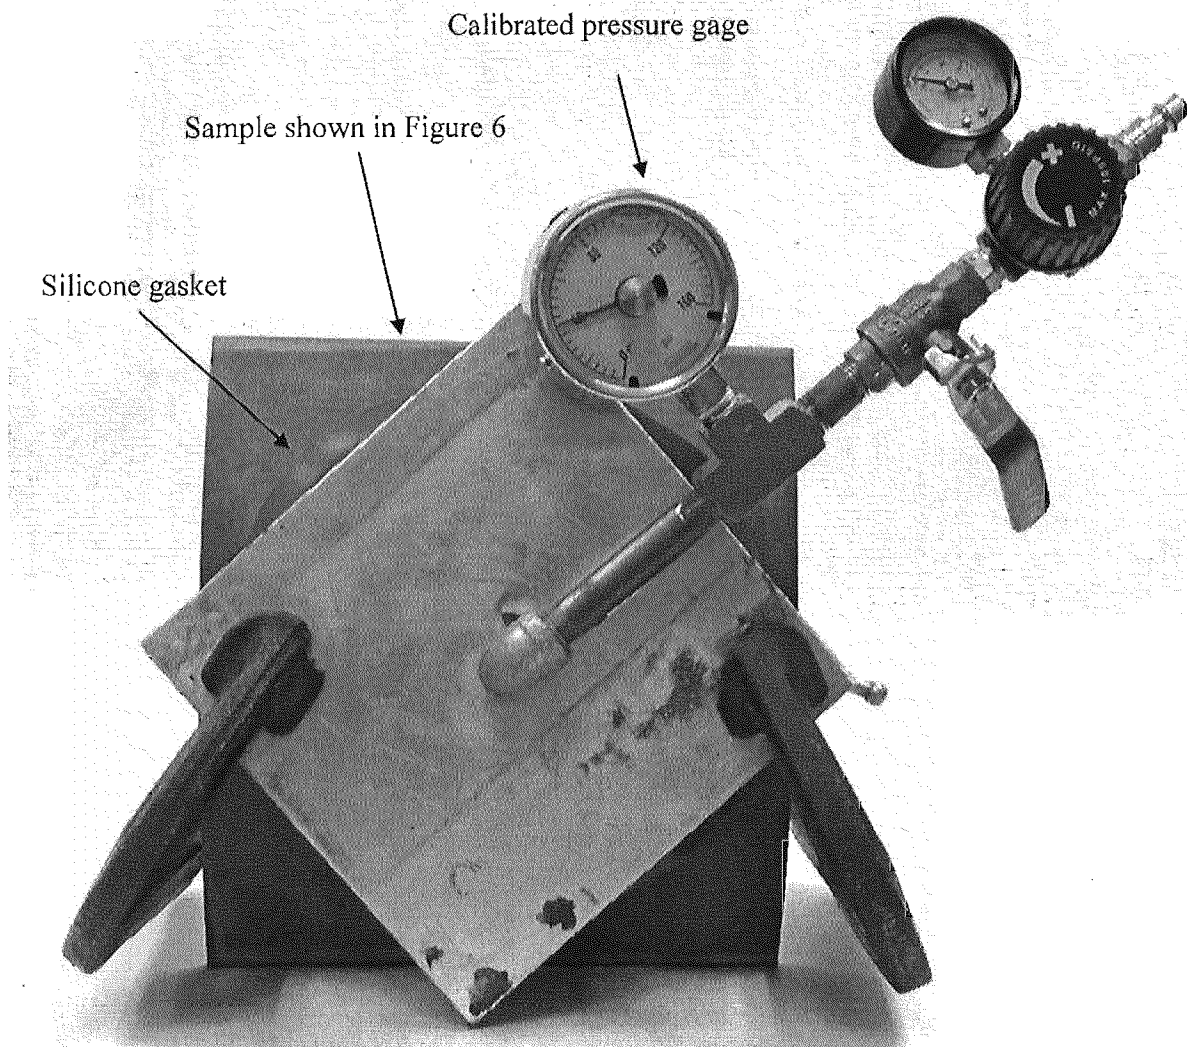
Figure 9 Pressure test setup.

A pressure test was performed by clamping a plate over the sectioned cap, sealed with a silicone gasket, and introducing 40-psig of compressed air. Snoop® liquid leak detector was applied to the inside surface. No leaks were detected. The compressed air was valved-off, and no pressure drop from 40-psig was detected after 45-minutes.

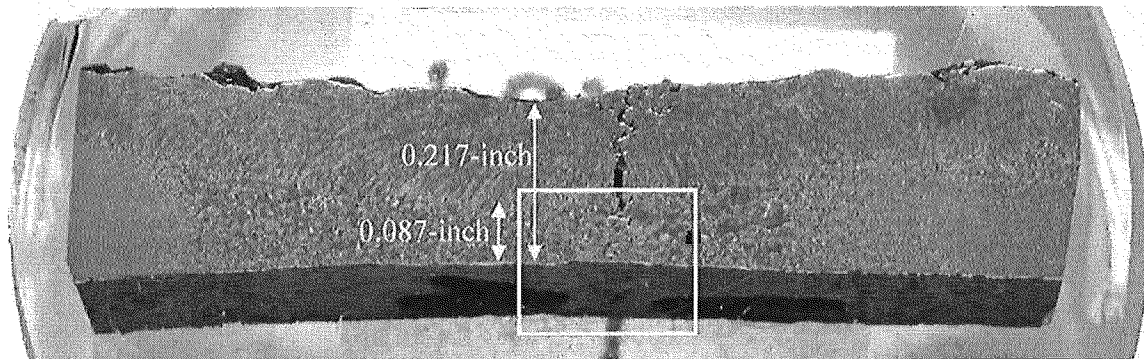
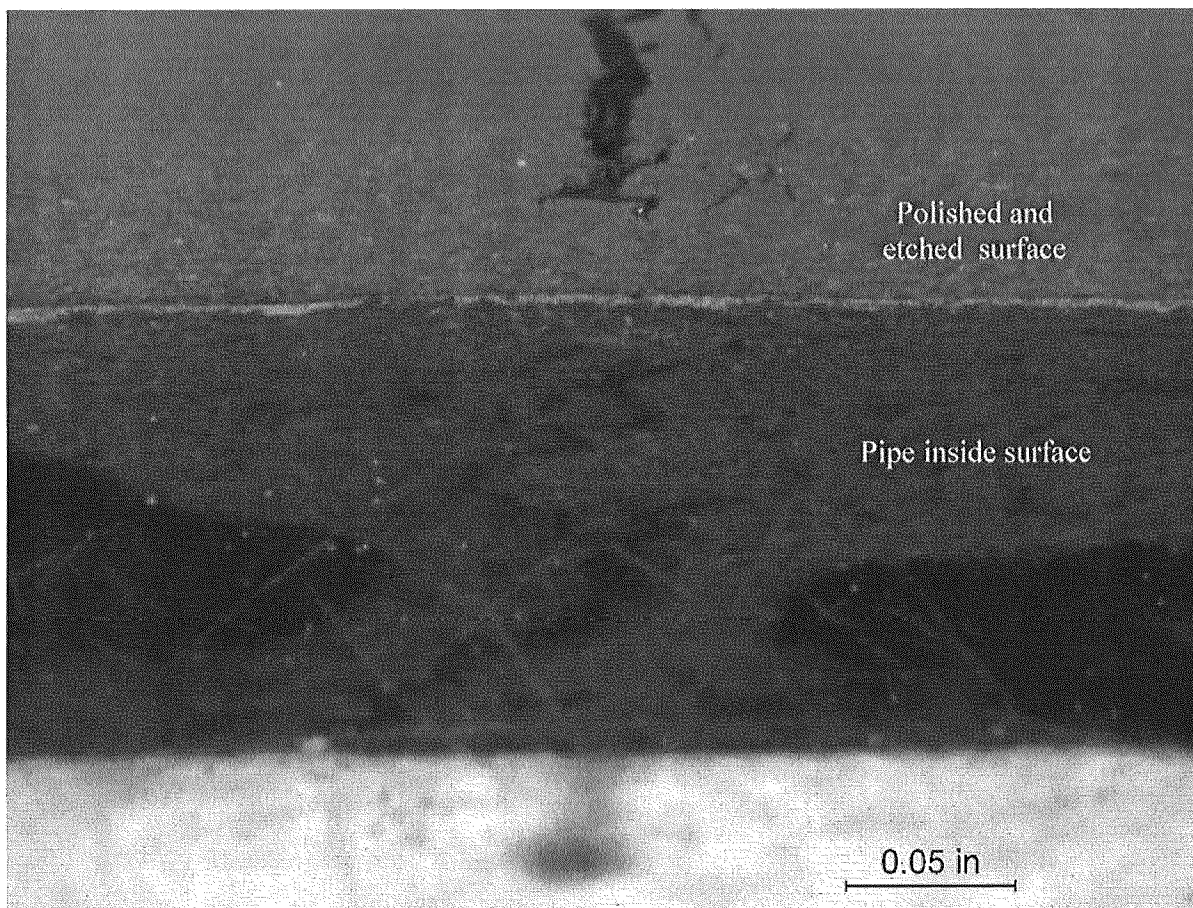
Specimens were prepared for metallography from section 1 and 2 indicated in Figure 8b. Weld crater cracks and heat affected zone liquation cracks were present in the sections. Serial grinding and polishing was performed on section 1, referred to as sections 1a, 1b, and 1c. As shown in Figure 10 through Figure 20, a weld crater crack extended from the outside surface into the weld heat affected zone in section 1a, but did not penetrate through-wall at this location. Shrinkage porosity was present near the outside surface, and intergranular cracks consistent with grain boundary liquation were present in the heat affected zone.

Figure 10 Images of the specimen prepared for metallography, section 1a. Etched with 2% nital.

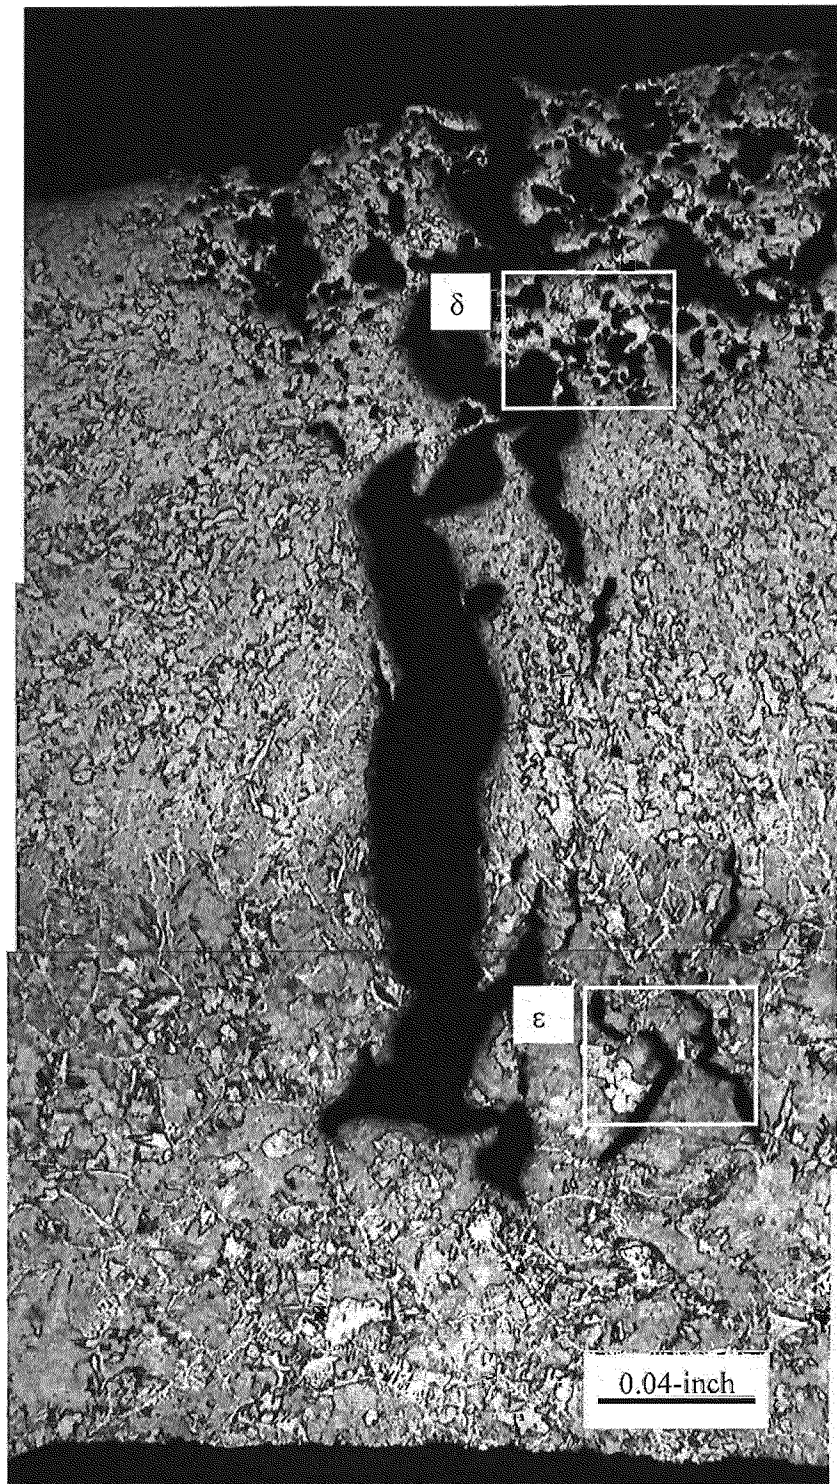
Figure 11 Composite optical micrograph of the specimen prepared for metallography, section 1a. Etched with 2% nital.

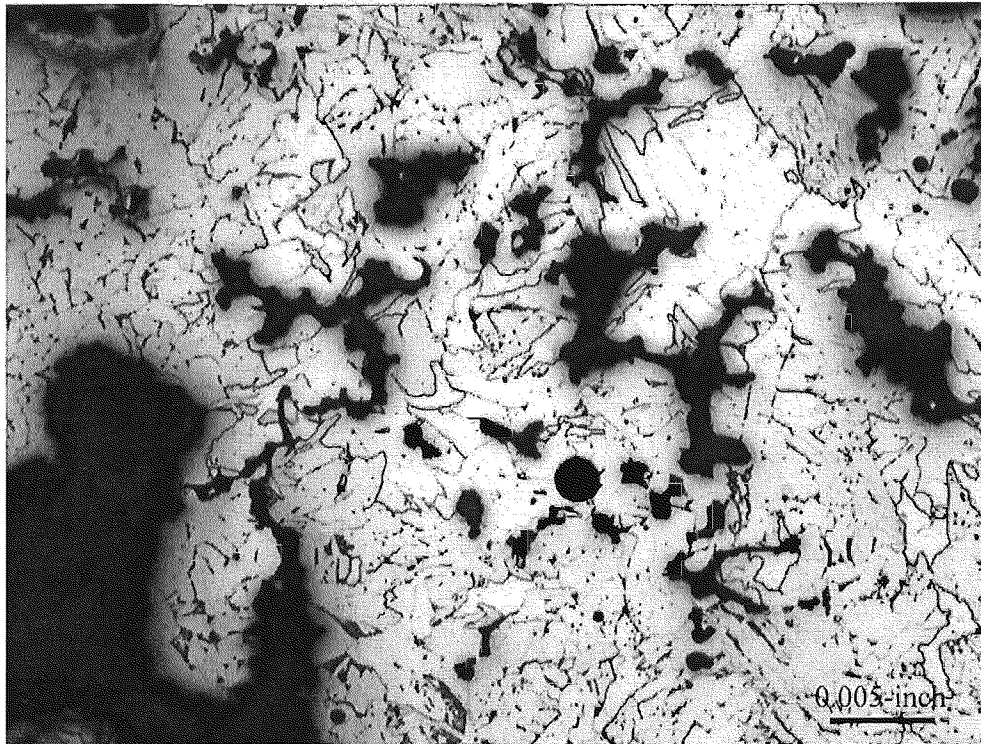
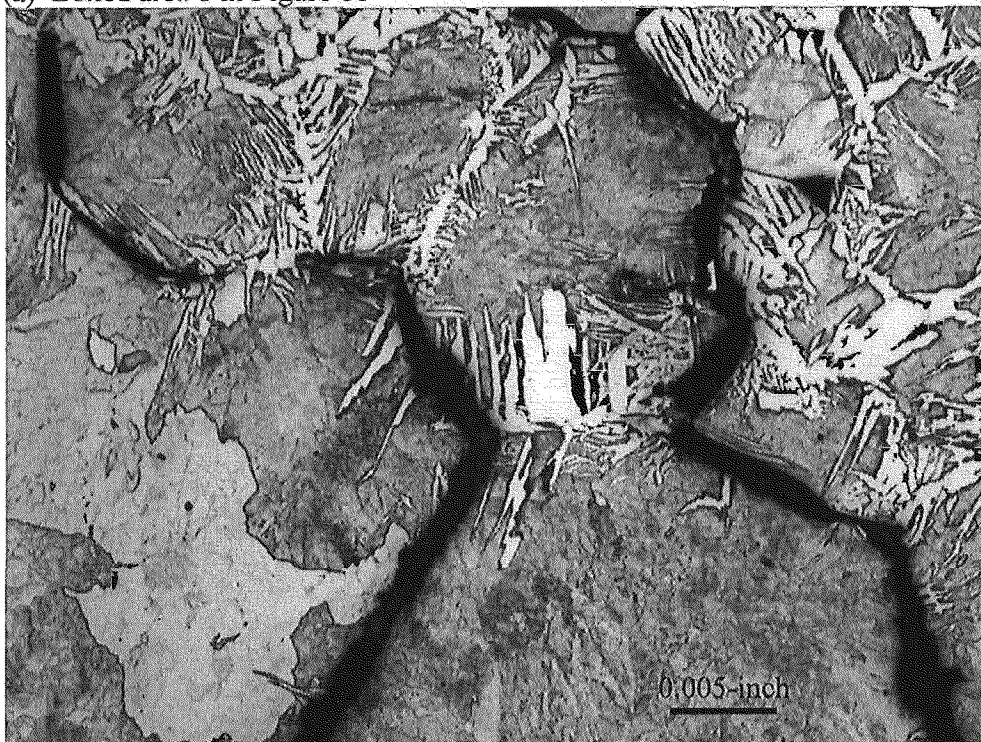
Figure 12 Optical micrographs of the specimen prepared for metallography, section 1a. Etched with 2% nital.

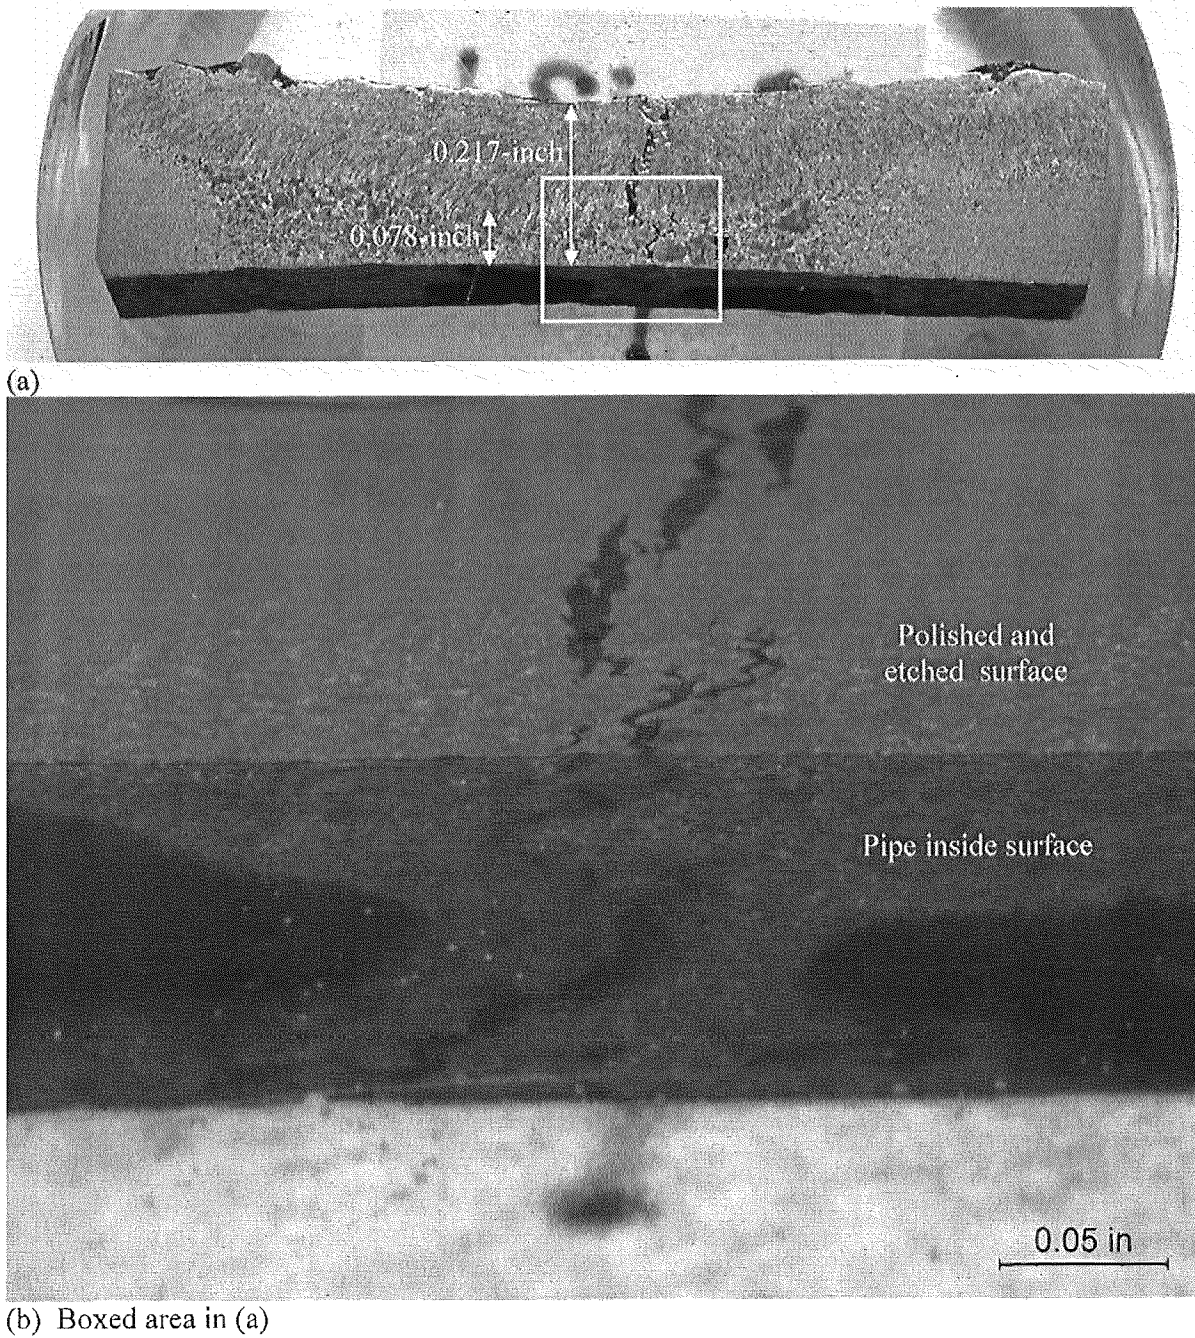
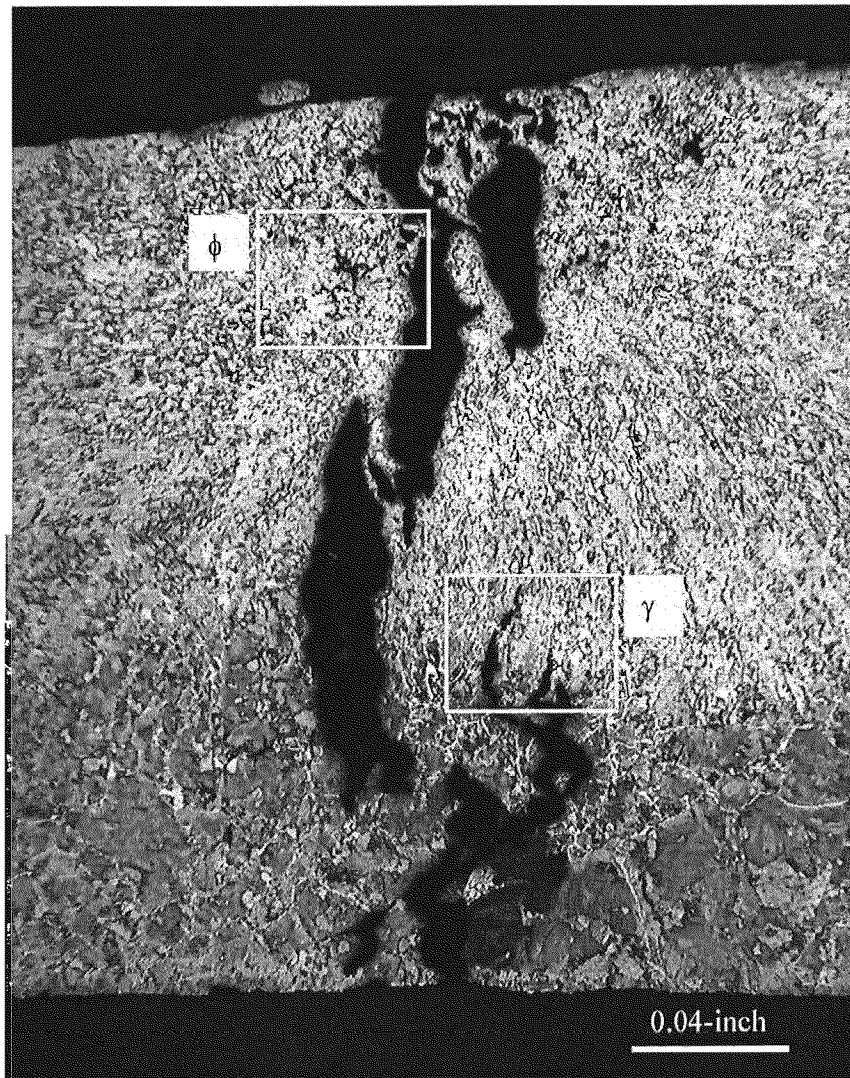
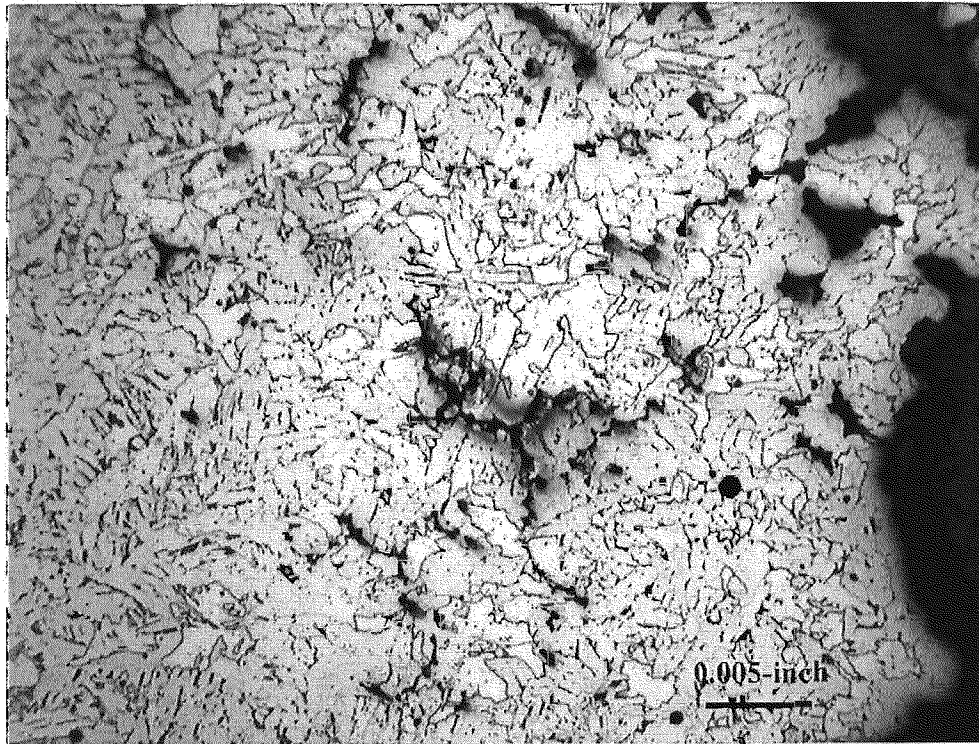
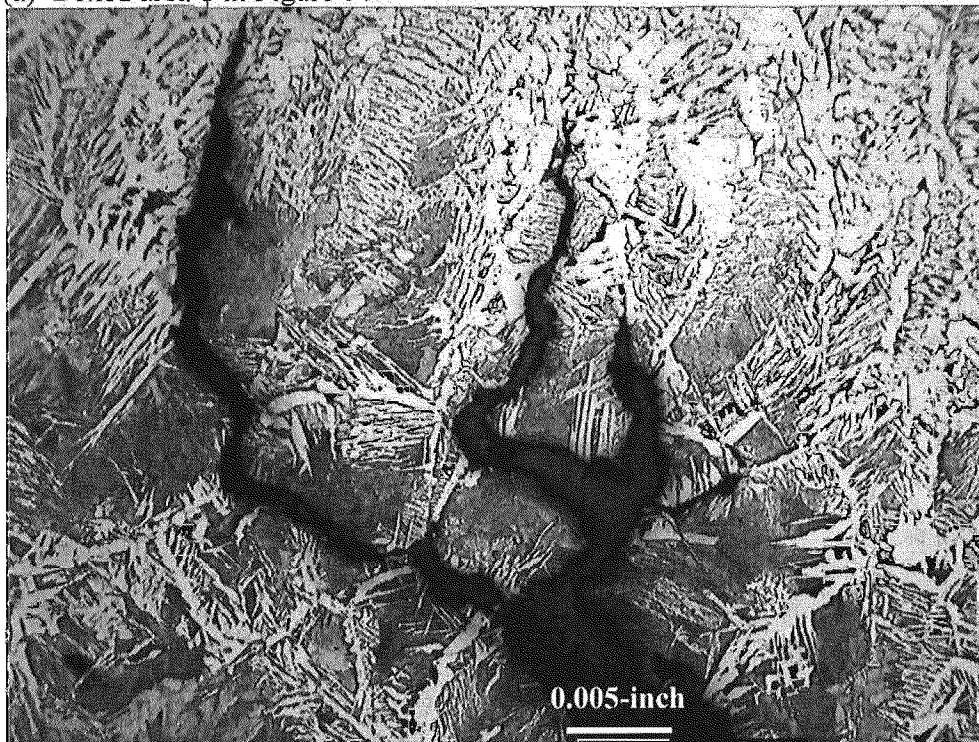
In section 1b, shown in Figure 13 through Figure 15, cracks were present from the outside surface to the inside surface. Only a few small ligaments prevented the demonstration of a through-wall leak path. However, it is likely that a leak path existed between section 1a and 1b. The weld metal crack morphology was consistent with shrinkage, and the heat affected zone crack morphology was indicative of grain boundary liquation.

Figure 13 Images of the specimen prepared for metallography, section 1b. Etched with 2% nital.
