Report No. 5004.9268 Rev. 1

**METALLURGICAL EVALUATION OF A SECTION FROM
L-147 MP 2.2 BRITTAN AVE. AND ROGERS AVE., SAN CARLOS**

One section of 20-inch diameter gas transmission pipe identified as L-147 MP 2.2 Brittan Ave. and Rogers Ave., San Carlos was submitted by PG&E for metallurgical evaluation. The subject section had a PLIDCO weld cap permanent repair, and an A. O. Smith longitudinal seam weld. The section was cut out to perform a root cause investigation of a reported leak under the PLIDCO cap. It was reported the subject passed hydrotest as part of L-147 on October, 24, 2011, at a pressure of 600-psi, or 1.5 times the desired Maximum Allowable Operating Pressure (MAOP) of 400-psi, and the PLIDCO cap was located at the six o'clock position, on the bottom of the section. The purpose of this evaluation was to determine the metallurgical condition of the pipe wall under the PLIDCO cap, and perform Charpy impact testing of the A. O. Smith weld and unaffected base metal.

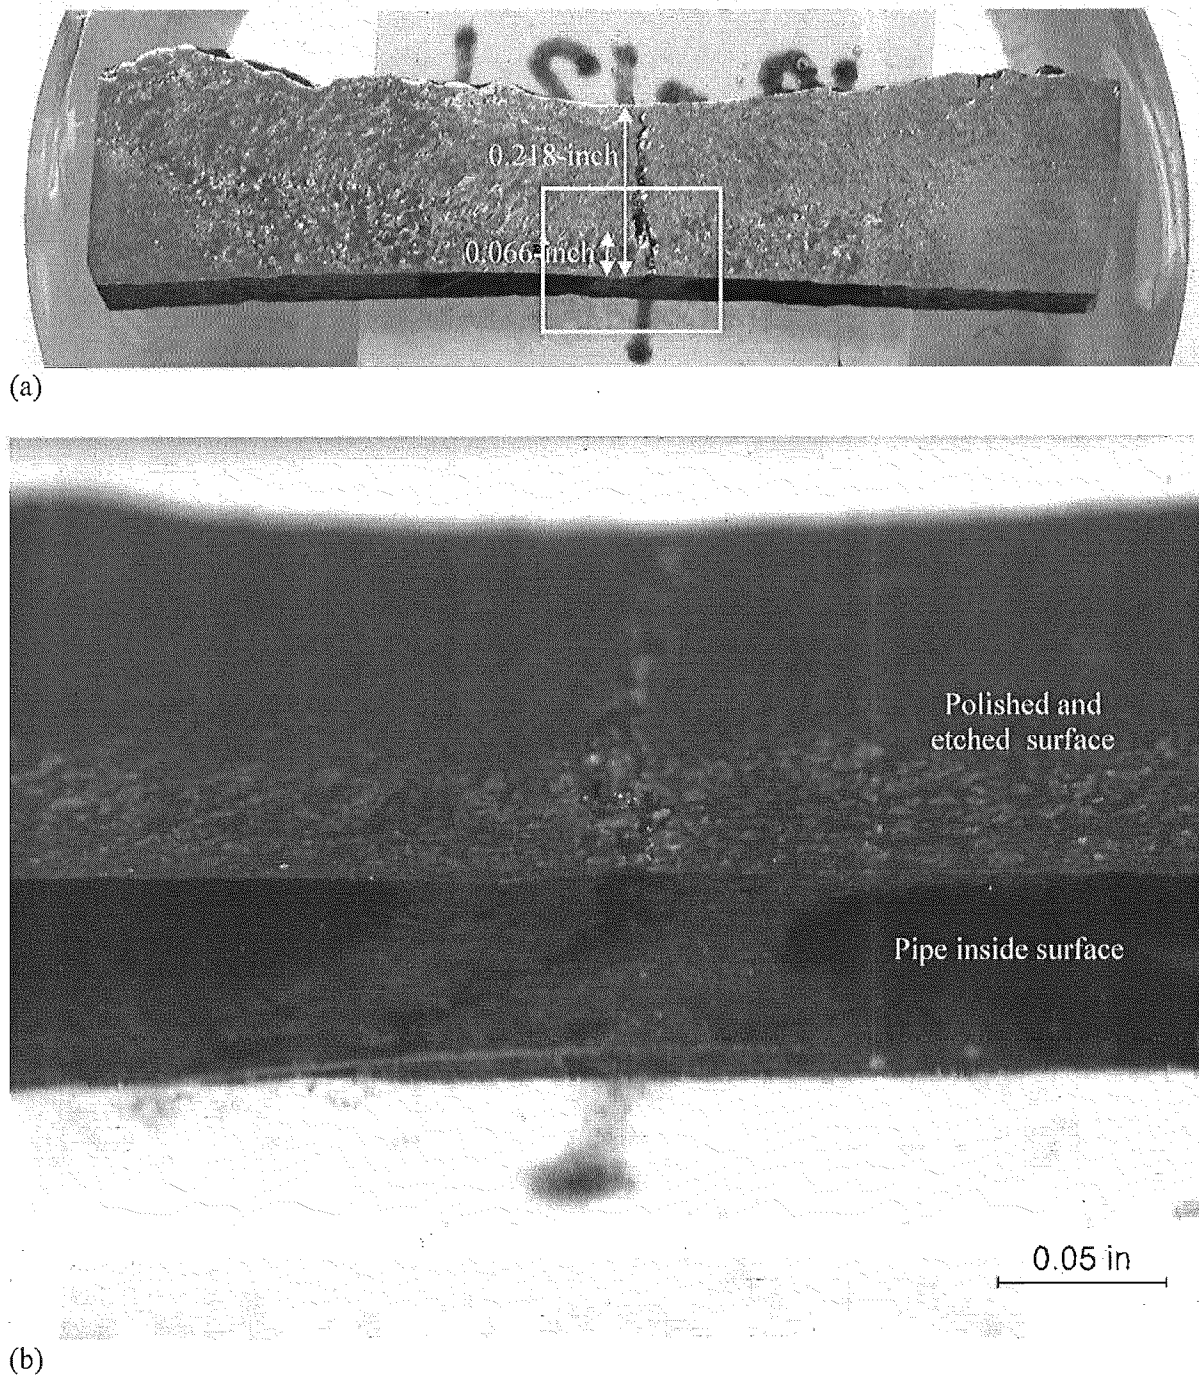
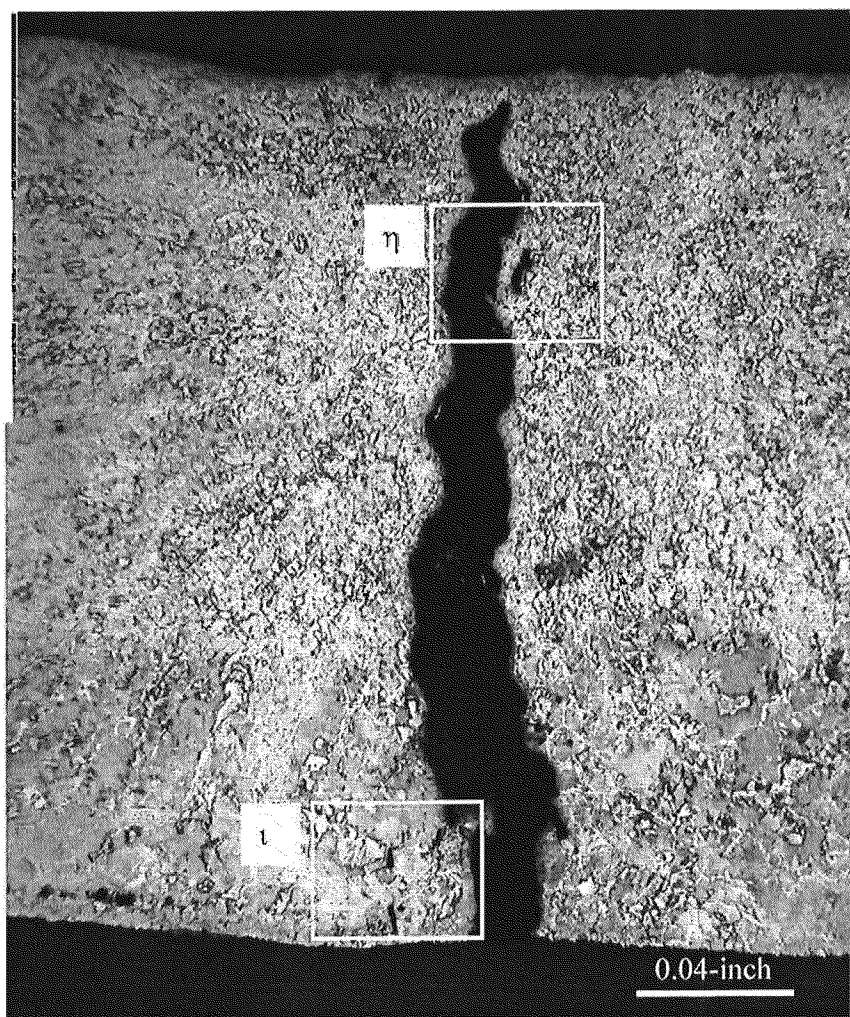
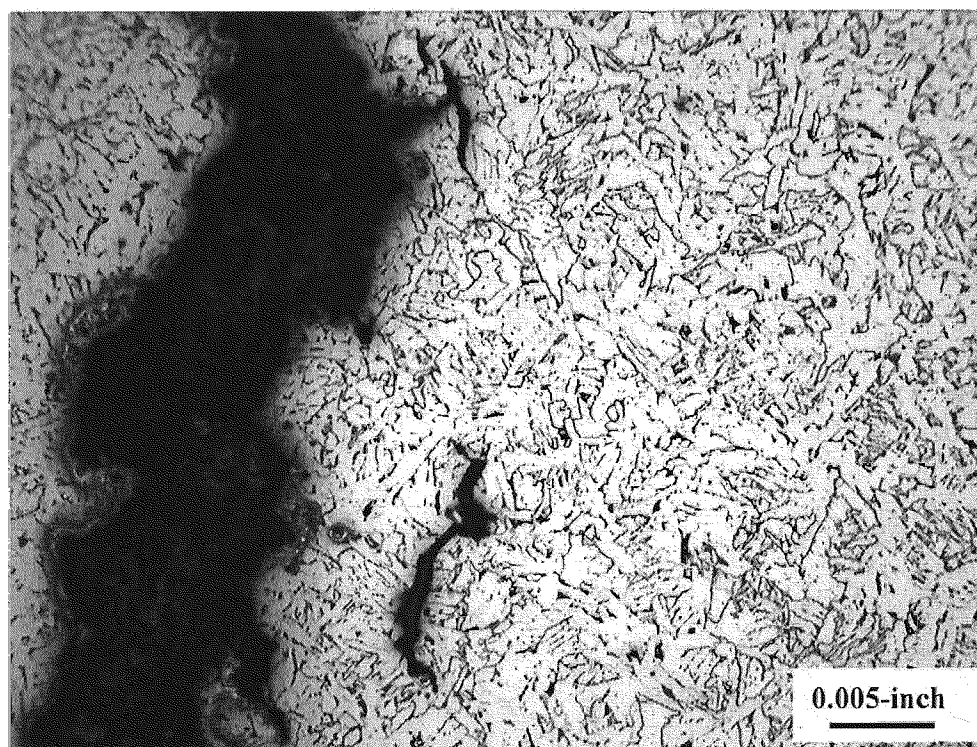
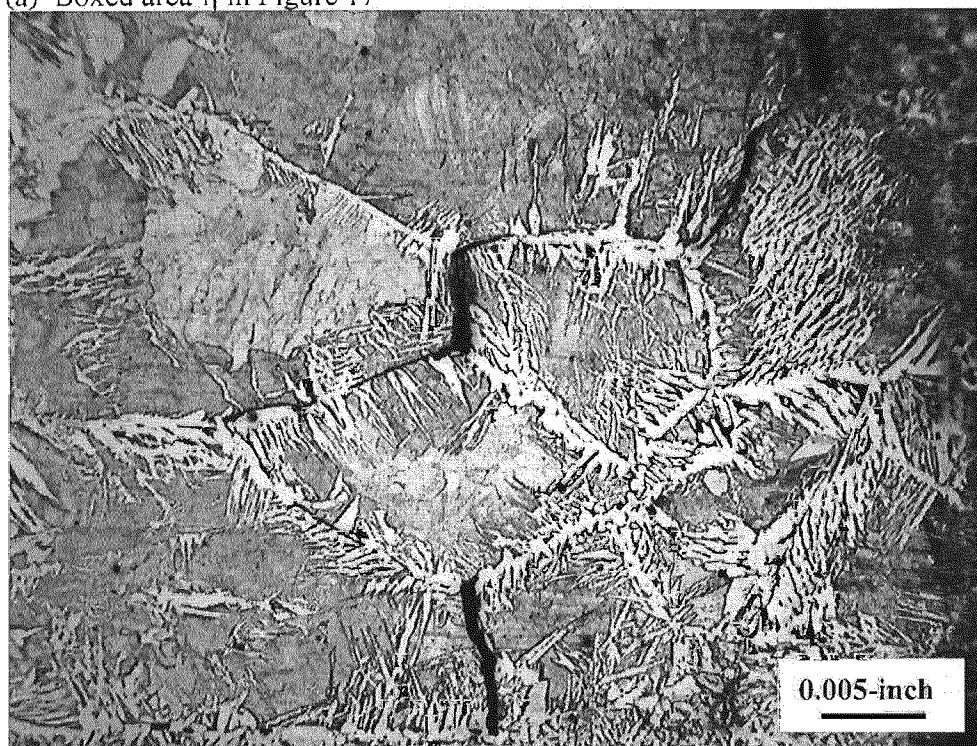
In section 1c, shown in Figure 16 through Figure 18, one small ligament at the outside surface prevented demonstration of a through-wall leak path. Once again, the weld crack morphology was consistent with shrinkage and the heat affected zone crack morphology was consistent with grain boundary liquation. In all three sections of specimen 1, the weld fusion zone followed a smooth broad contour with no indications of external corrosion prior to welding.

Figure 16 Images of the specimen prepared for metallography, section 1c. Etched with 2% nital.

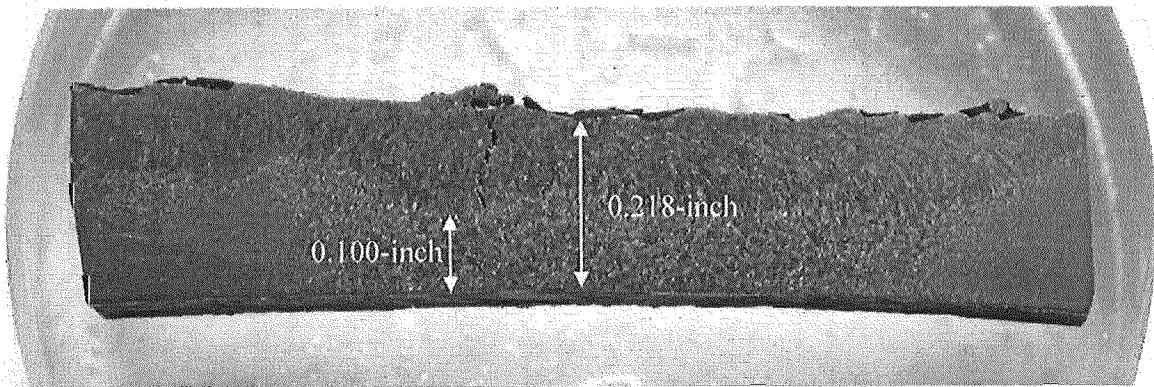
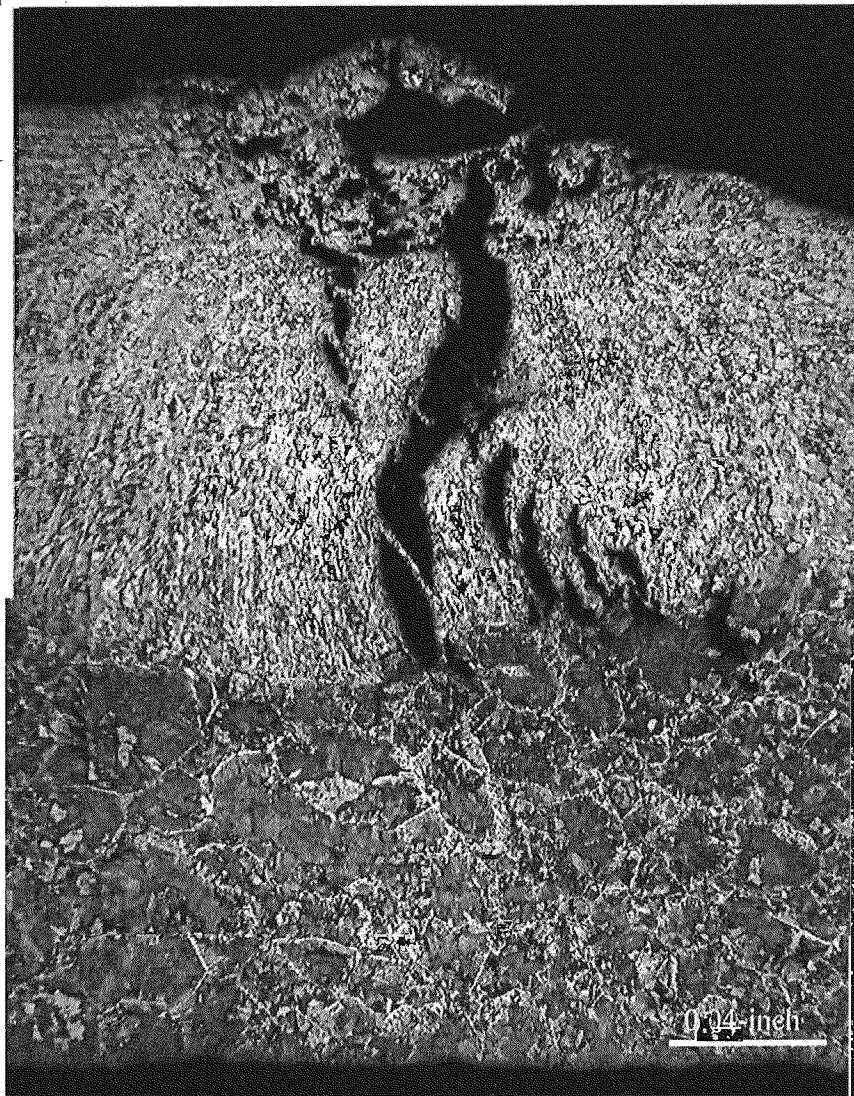
Section 2 is shown in Figure 19. The fusion zone in this section had a profile that was more varied in depth than in sections 1a through 1c, which suggested the possibility that the weld metal was deposited to build-up locations where wall thickness had been reduced by external corrosion. Measurements of the minimum thickness of base metal beneath the weld metal are shown in Figure 10, Figure 13, Figure 16, and Figure 19.

Figure 19 Photograph and composite micrograph of section 2. Etched with 2% nital.

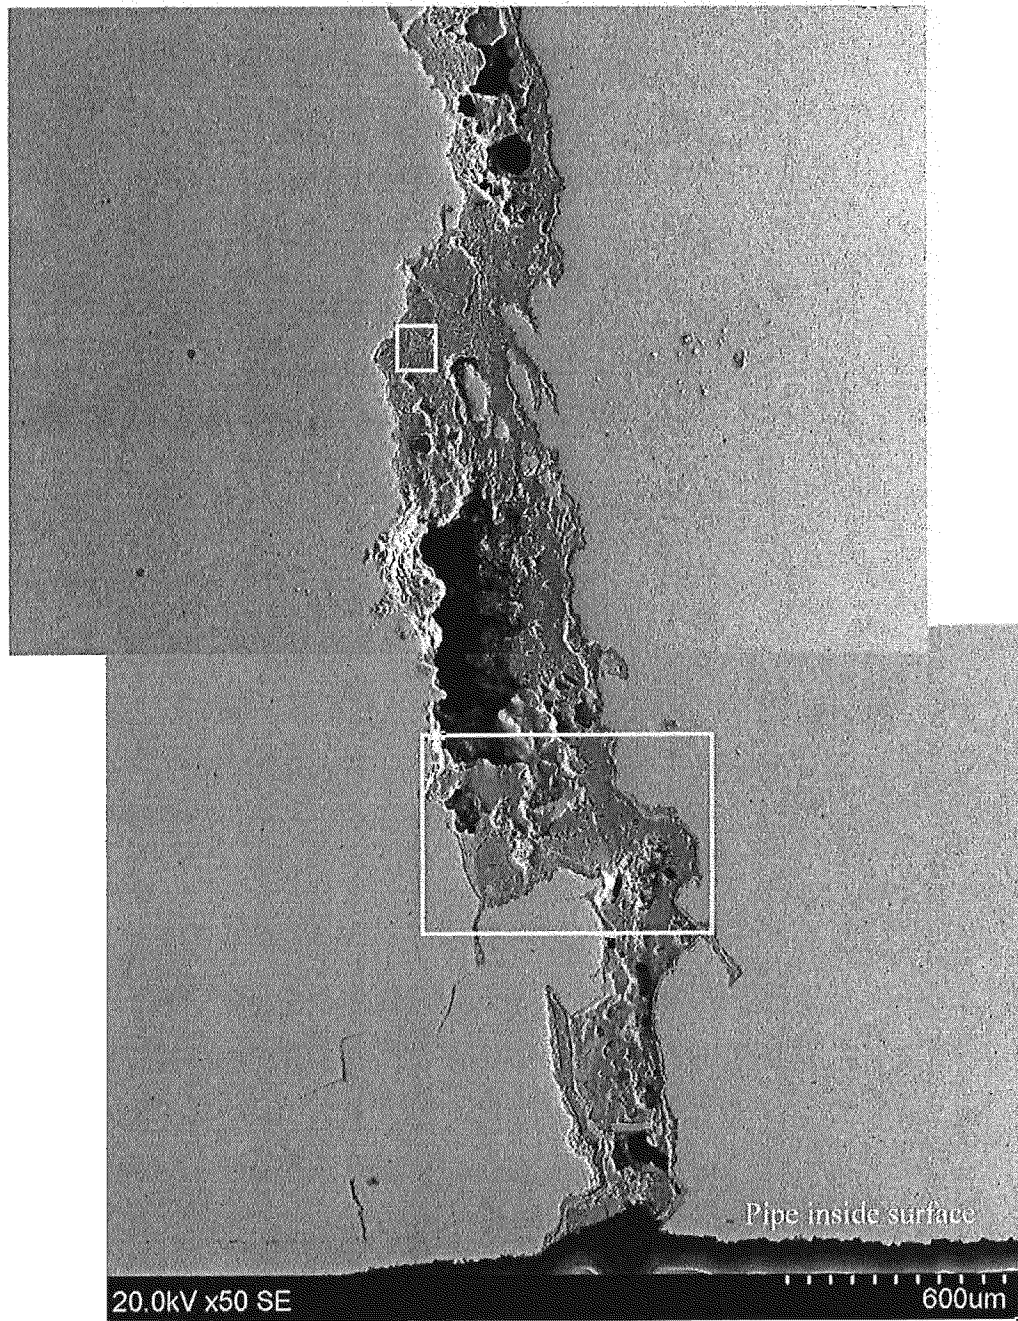
Scanning electron microscopy (SEM) and energy dispersive X-ray spectroscopy² (EDS) was performed on the section 3 polished and etched surface. A composite SEM micrograph of the crack is shown in Figure 20. Much of the crack was filled with oxide, indicated by the morphology and chemical composition of primarily iron and oxygen, with sulfur present, likely from mercaptan in the gas stream.

Figure 20 Composite SEM micrograph of the specimen prepared for metallography, section 1c.

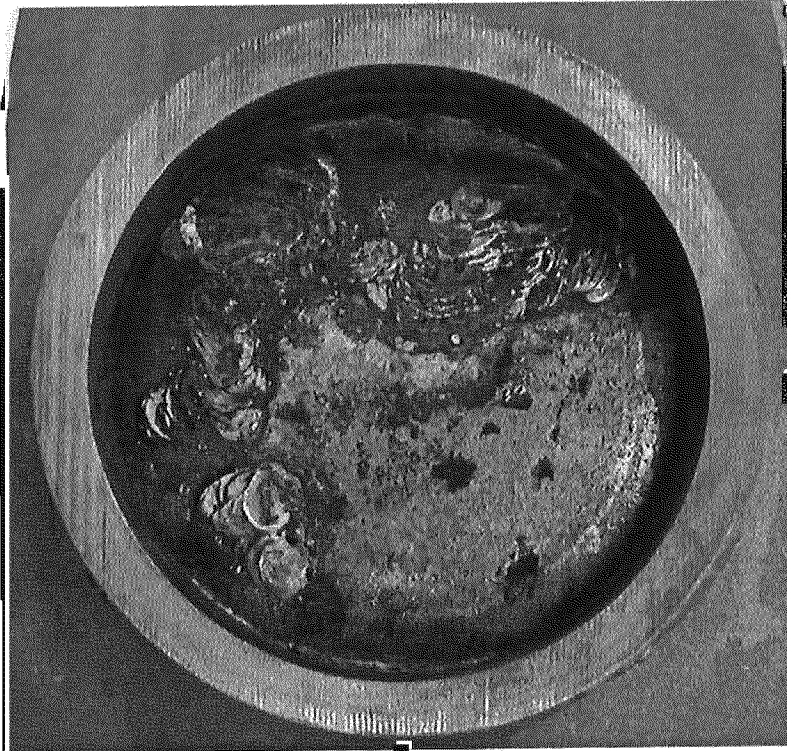
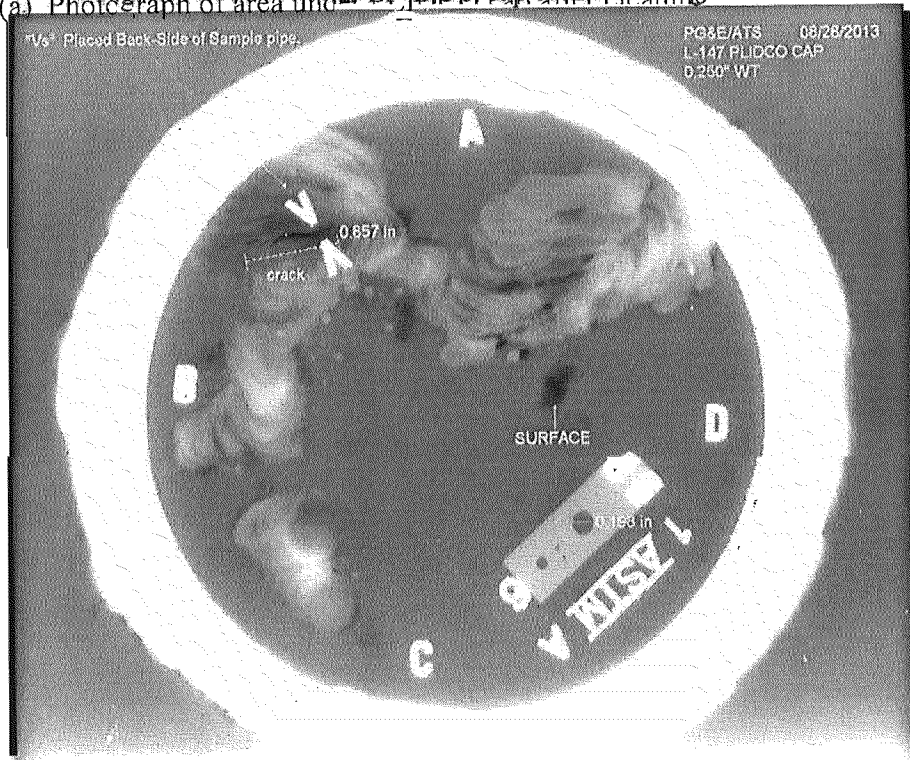
Appendix A
(Radiograph courtesy of PG&E)

The sample shown in Figure 6 was returned to PG&E for radiography. A digital radiograph of the sample is shown in Appendix A along with a photograph of the sample. A crack indication was found that corresponded to the crack-like feature detected visually on the inside surface, shown in Figure 8b.
