Order Instituting Rulemaking on the
Commission's Own Motion to Adopt New
Safety and Reliability Regulations for Natural
Gas Transmission and Distribution Pipelines
and Related Ratemaking Mechanisms

**DECLARATION OF SUMEET SINGH
SUPPLEMENTING THE VERIFIED STATEMENT OF
PACIFIC GAS AND ELECTRIC COMPANY'S VICE
PRESIDENT OF GAS TRANSMISSION MAINTENANCE
AND CONSTRUCTION IN RESPONSE TO RULING OF
ASSIGNED COMMISSIONER AND ASSIGNED
ADMINISTRATIVE LAW JUDGE.**

Report No. 5004.9268

**METALLURGICAL EVALUATION OF A SECTION FROM
L-147 MP 2.2 BRITTAN AVE. AND ROGERS AVE., SAN CARLOS**

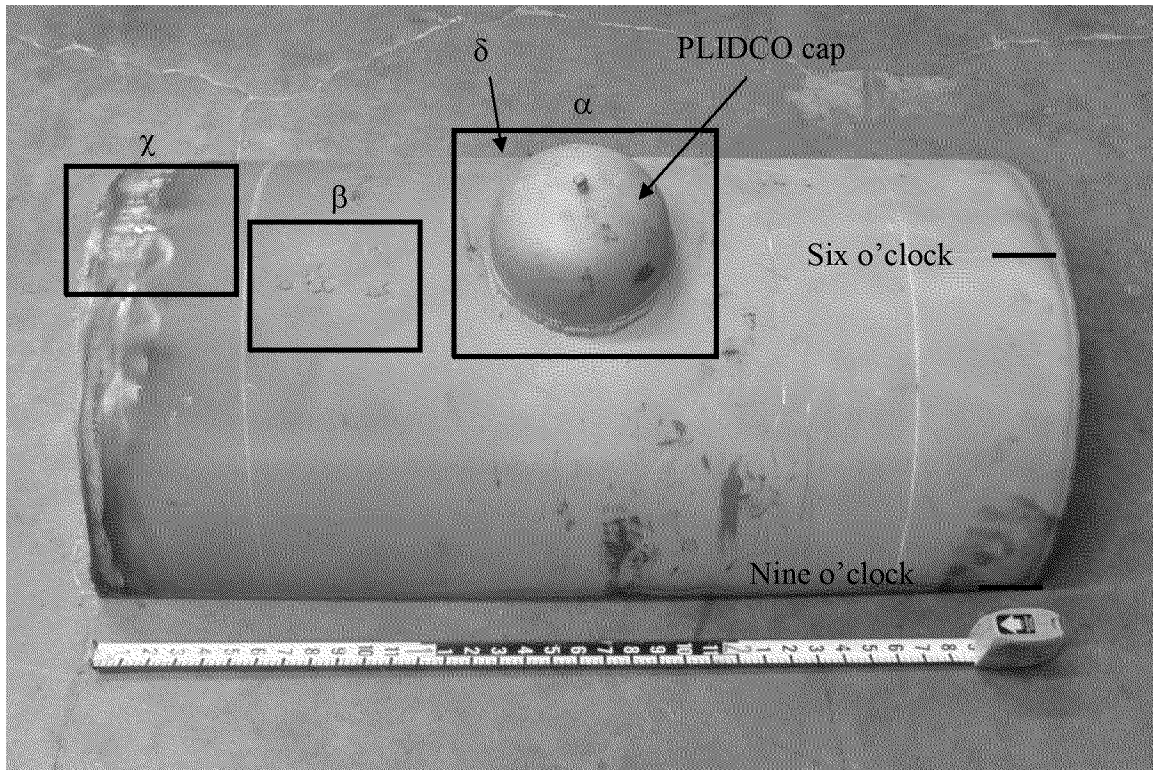
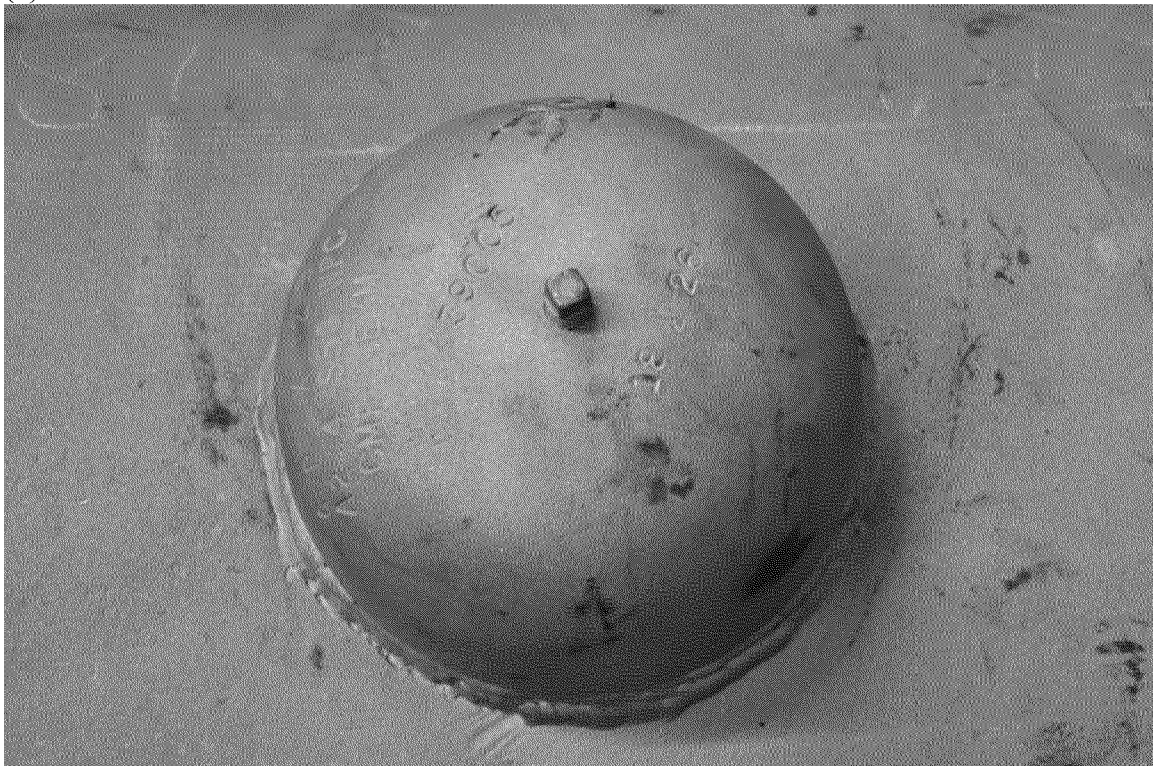
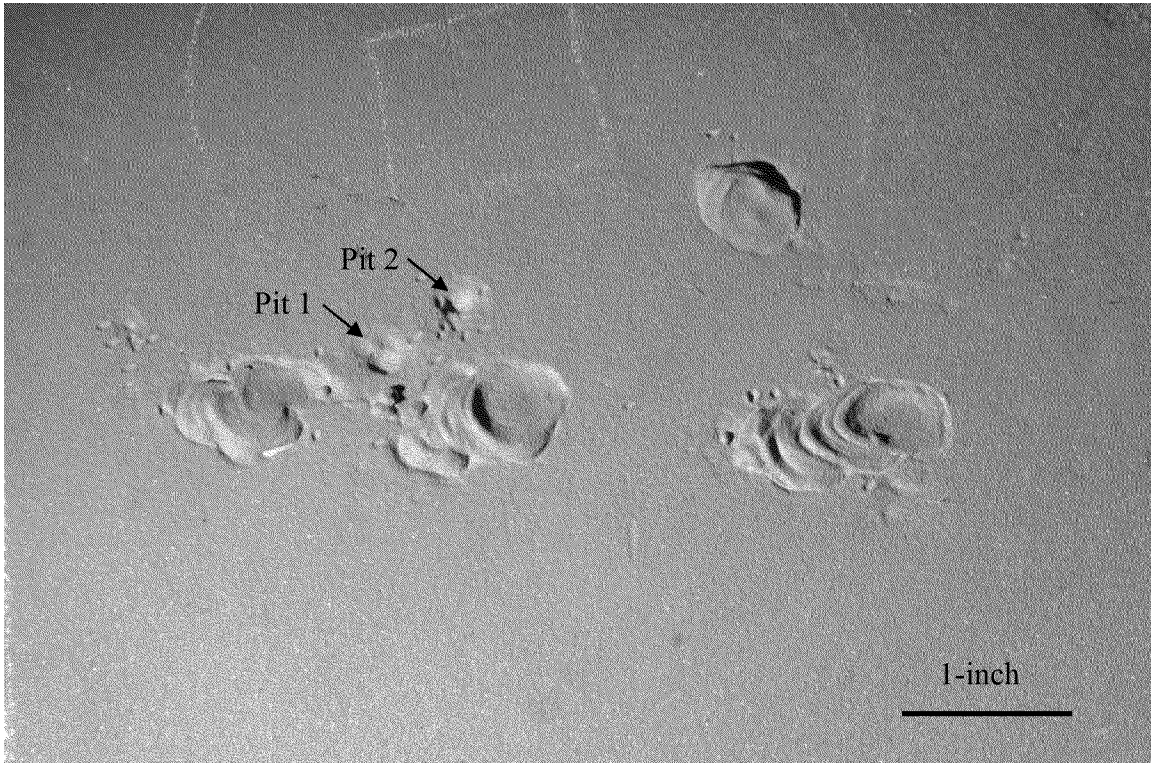
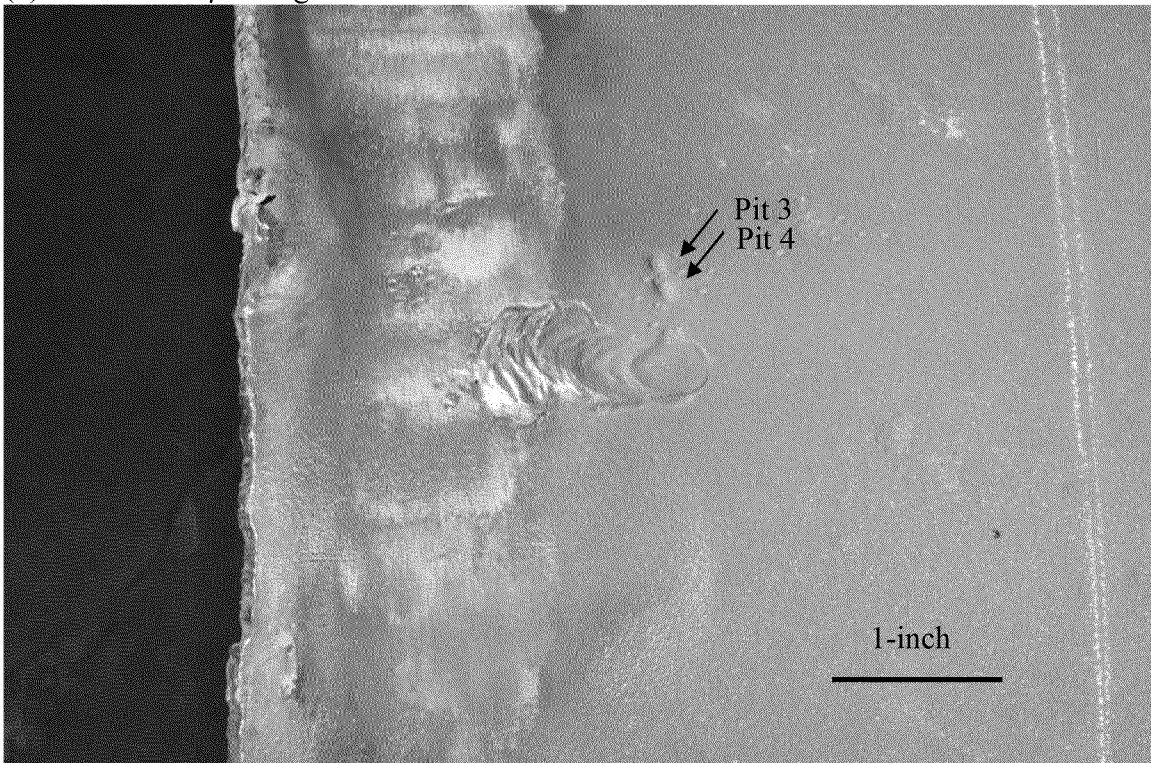
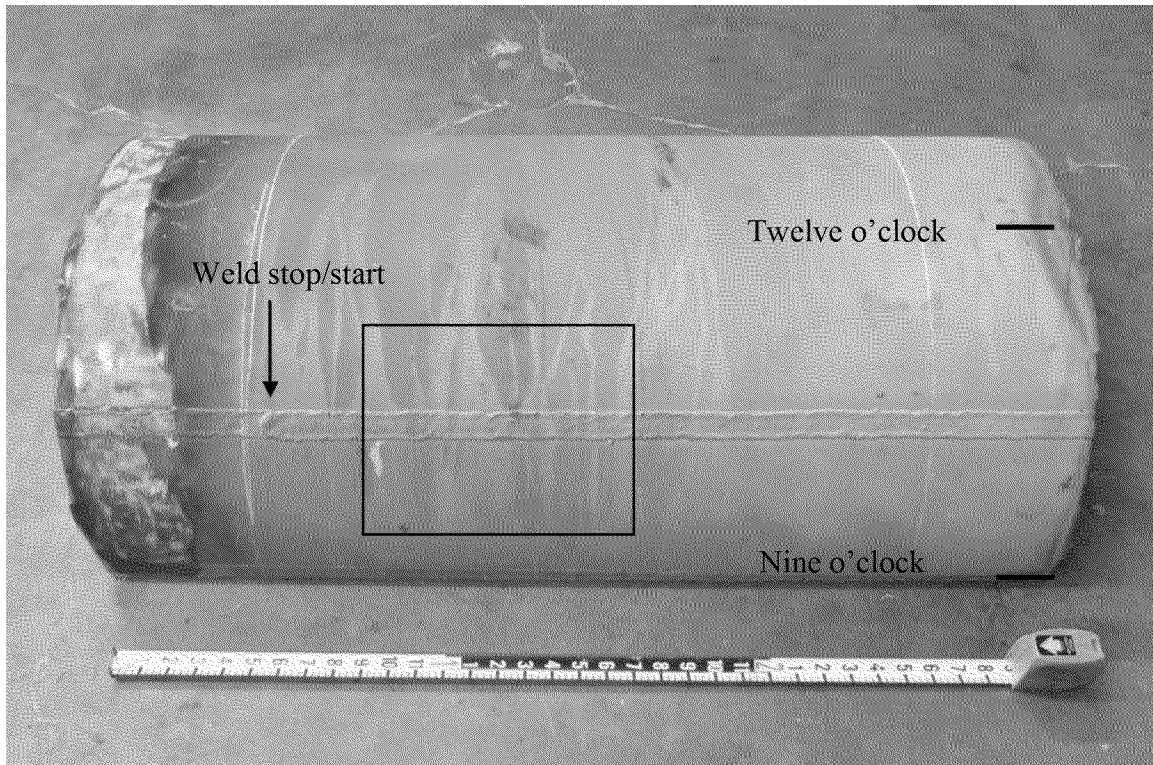
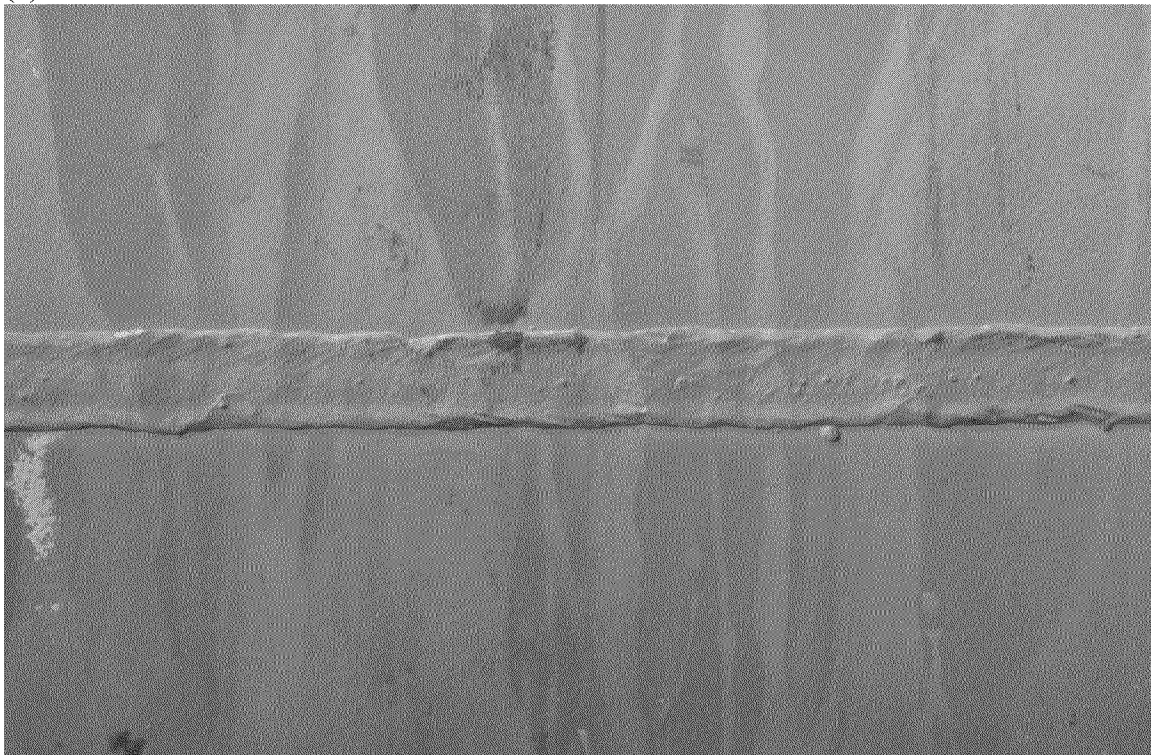
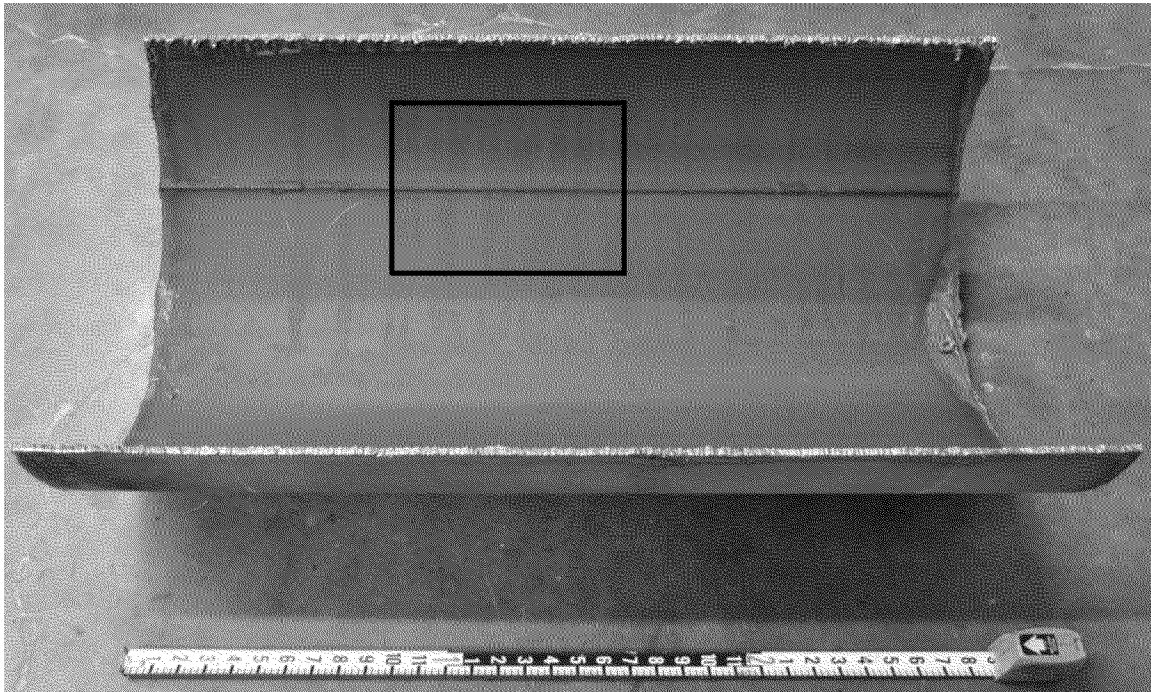
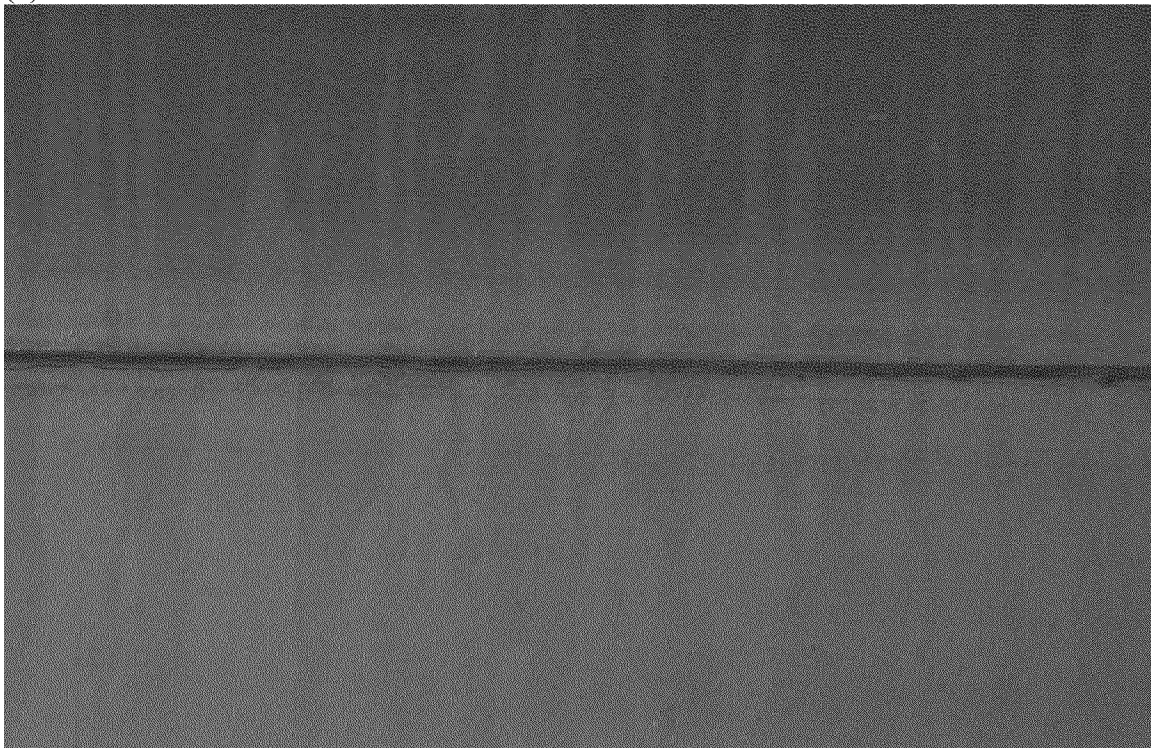
The subject sample of L-147 was received sectioned into two halves along the longitudinal axis, with the outside surface grit blasted, as shown in Figure 1 through Figure 5. The section half with the PLIDCO cap was arbitrarily labeled A and the other section was labeled B, in the laboratory. Based on the reported position of the cap, the longitudinal flame cuts were located at three o'clock and nine o'clock positions. Wall thickness measurements were made with a pointed anvil micrometer and the results are listed in Table 1. Small regions of weld metal and a few shallow hemispherical pits were present near the cap, as shown in Figure 2. Pits were also present just past the three o'clock position toward the cap, indicated in Figure 1. Pit depths were measured with a pit gage, and the results are listed in Table 2. No evidence of a leak location or repair was visible to the unaided eye on the inside surface of the pipe under the cap.

The appearance of the longitudinal seam was typical of A. O. Smith welds, a wide low-crowned cap on the outside surface and a narrow flash on the inside surface. A weld stop/start was visible on the outside surface.

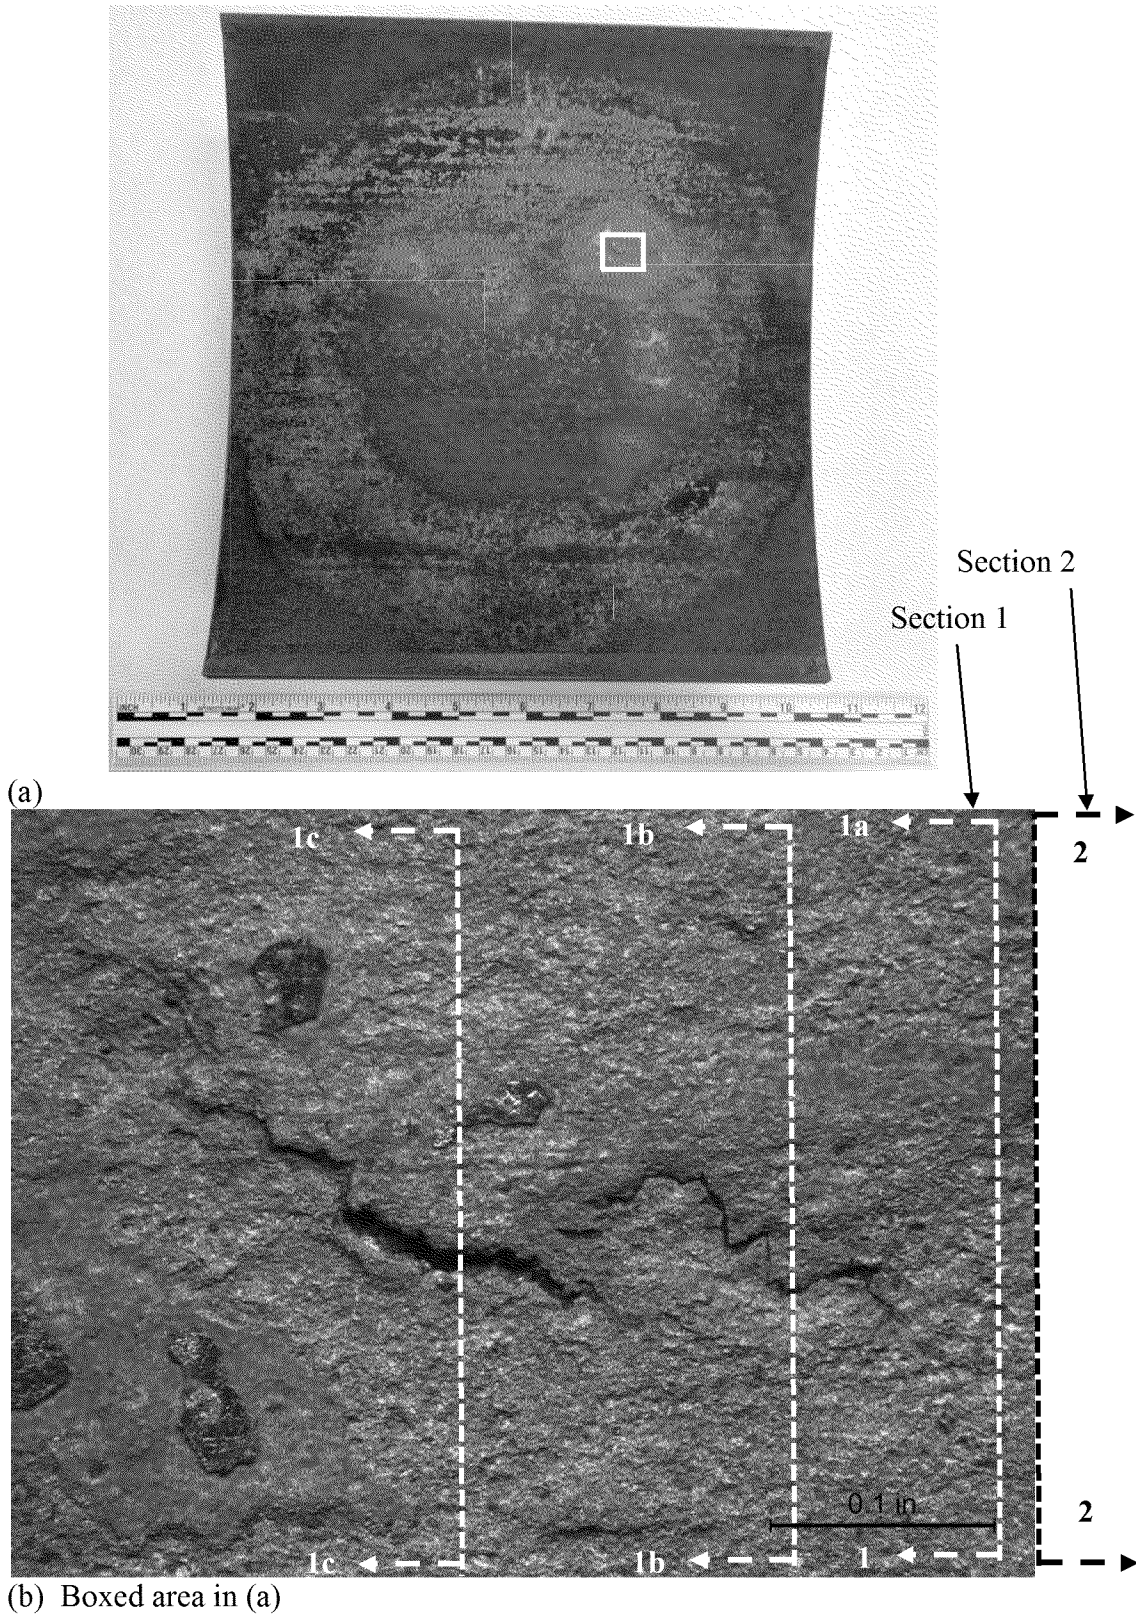
Figure 8 Photograph (a) and macrograph (b) of the inside surface of sample half A under the PLIDCO cap, after cleaning.

The region containing the PLIDCO cap was sectioned from sample A and the cap was cut off to expose the outside surface of the pipe wall. The outside surface was covered with rust and had a slightly oily feel. Both surfaces were cleaned with dilute Oakite® 33 and a wire brush. The outside surface is shown before and after cleaning in Figure 6. Several regions of weld metal were visible on the outside surface. Examination using low-power optical microscopy revealed a pit consistent with corrosion on the outside surface, indicated in Figure 7. The inside surface is shown after cleaning in Figure 8. Indications of heat exposure were visible on the inside surface, corresponding to the weld metal on the outside surface. No evidence of weld burn through was detected, and fine grooves typical of wrought steel surfaces were continuous across the region, which indicated that repairs did not extend to the inside surface. Examination using low-power optical microscopy revealed a crack-like feature on the inside surface within the heat affected zone of a weld deposit, as shown in Figure 8b.

The sample shown in Figure 6 was returned to PG&E for radiography. A digital radiograph of the sample is shown in Appendix A along with a photograph of the sample. A crack indication was found that corresponded to the crack-like feature detected visually on the inside surface, shown in Figure 8b.

Specimens were prepared for metallography from section 1 and 2 indicated in Figure 8b. Weld crater cracks and heat affected zone liquation cracks were present in the sections. Serial grinding and polishing was performed on section 1, referred to as sections 1a, 1b, and 1c. As shown in Figure 10 through Figure 20, a weld crater crack extended from the outside surface into the weld heat affected zone in section 1a, but did not penetrate through the wall at this location. Shrinkage porosity was present near the outside surface, and intergranular cracks consistent with grain boundary liquation were present in the heat affected zone.

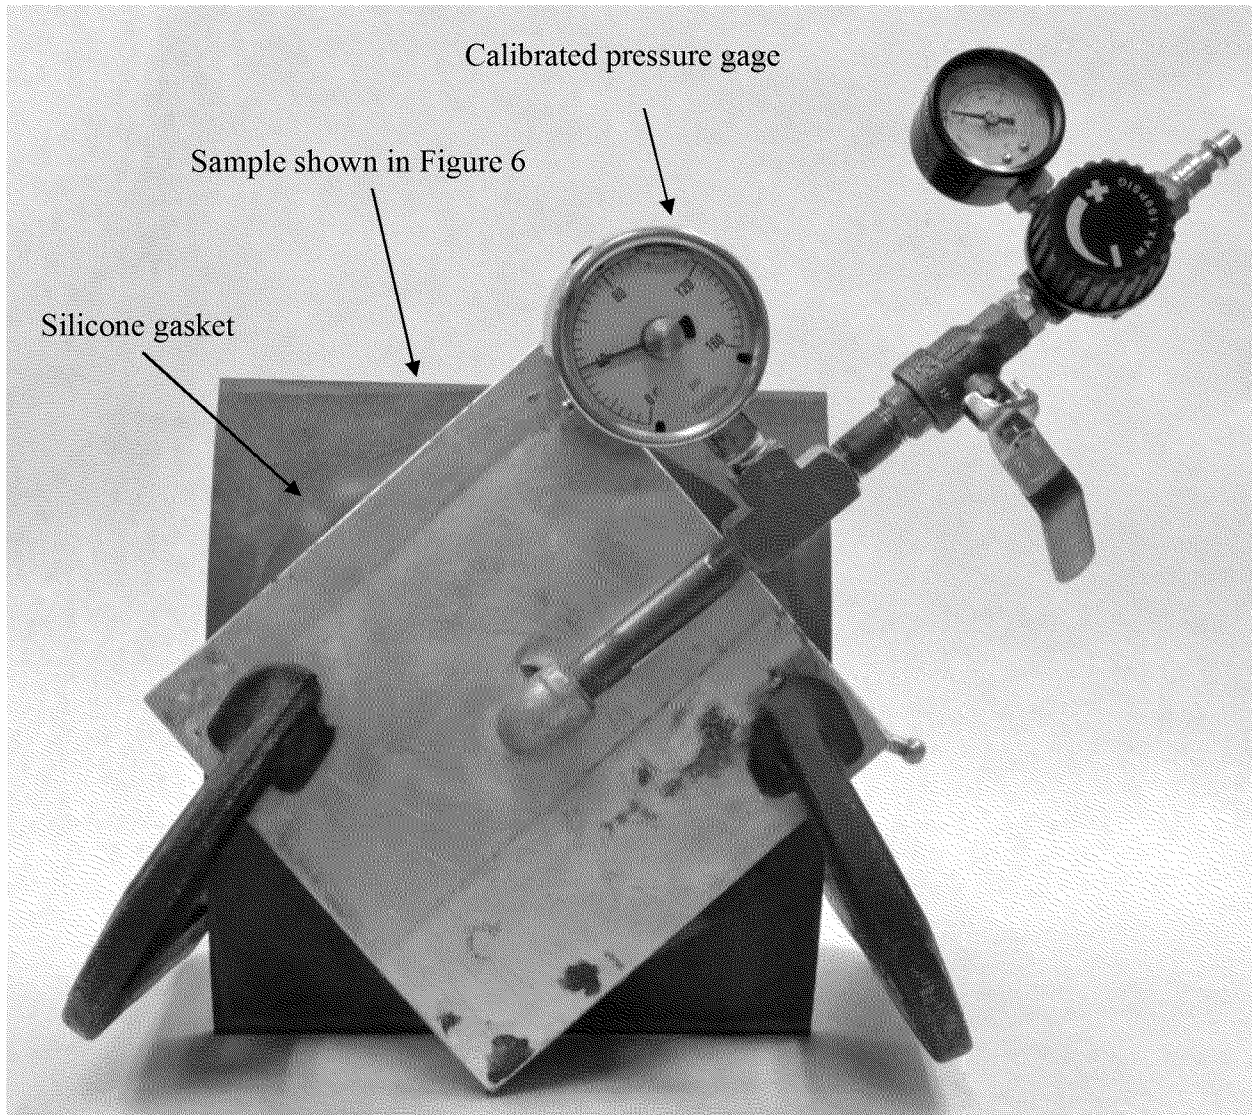
Figure 9 Pressure test setup.

A pressure test was performed by clamping a plate over the sectioned cap, sealed with a silicone gasket, and introducing 40-psig of compressed air. Snoop® liquid leak detector was applied to the inside surface. No leaks were detected. The compressed air was valved-off, and no pressure drop from 40-psig was detected after 45-minutes.

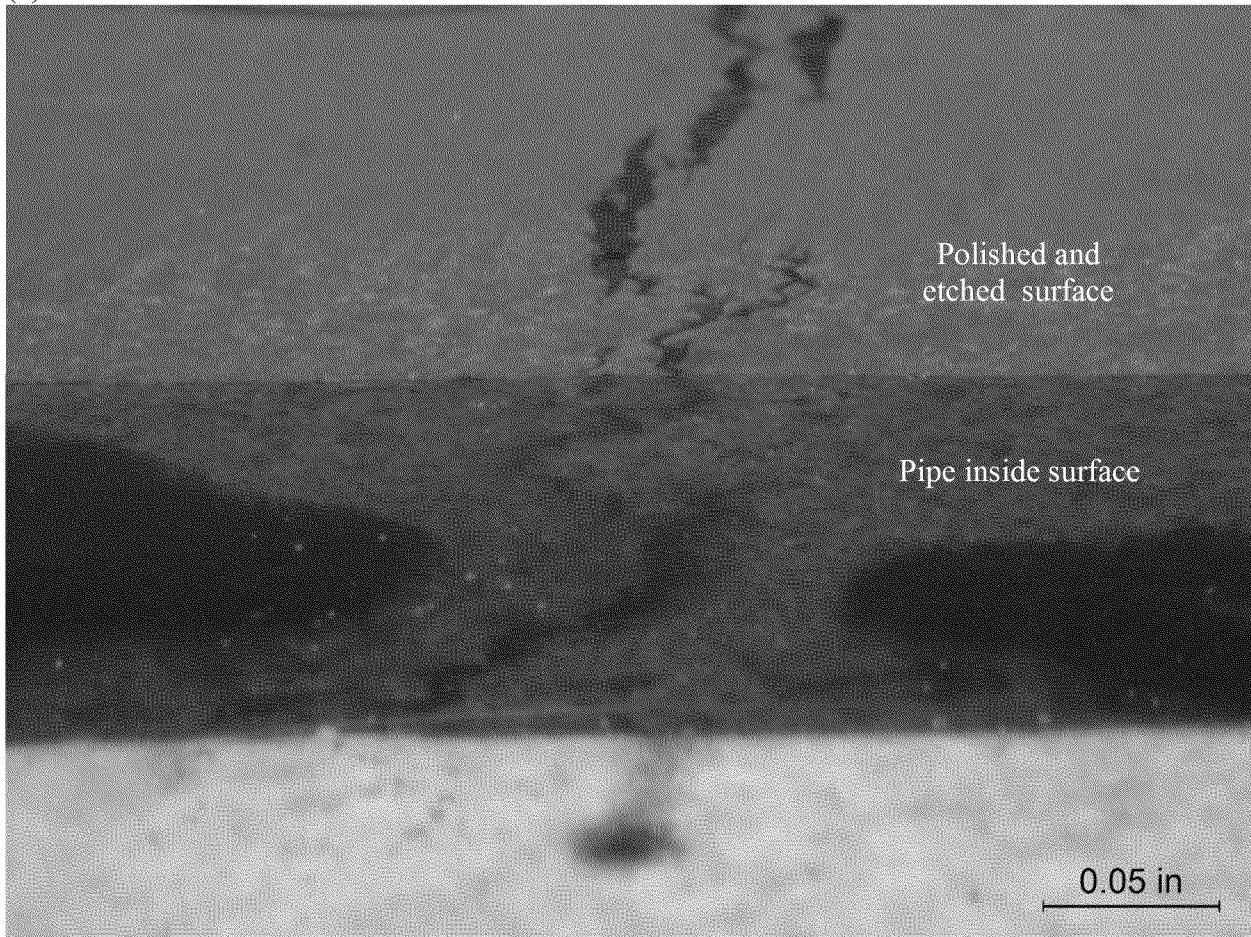
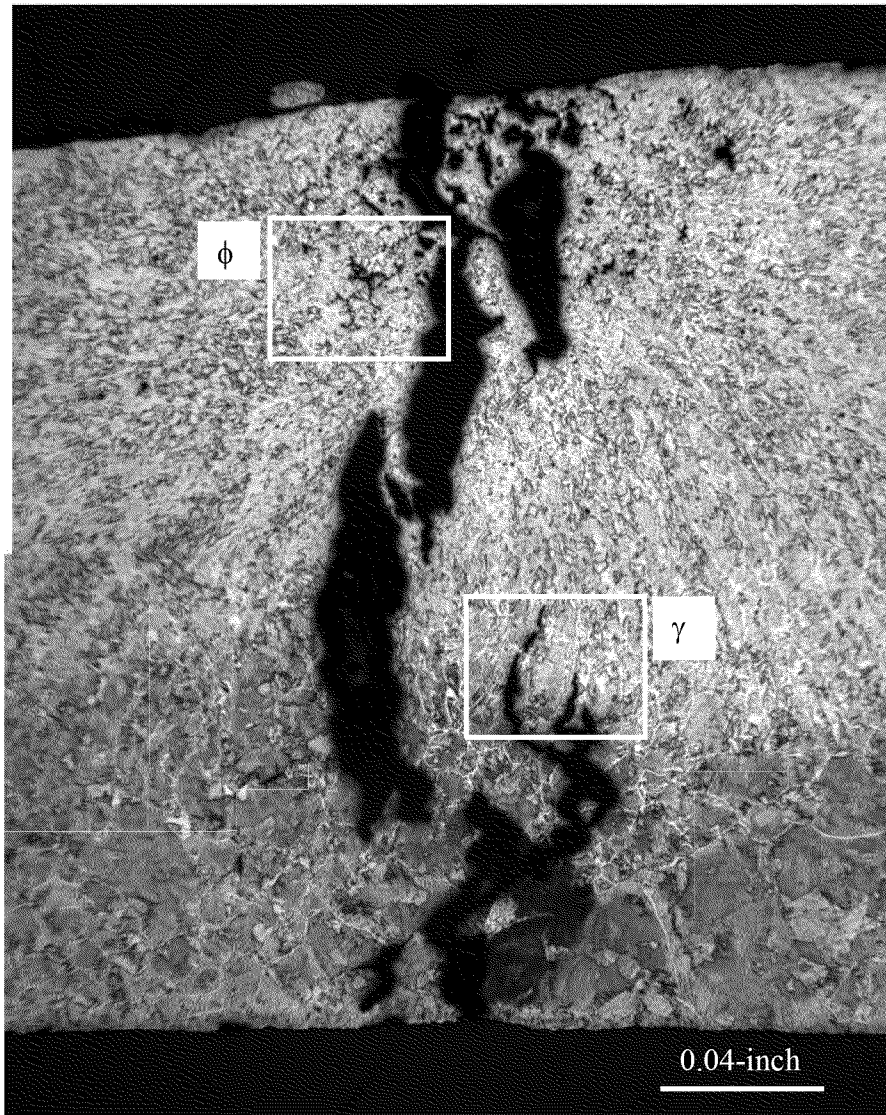
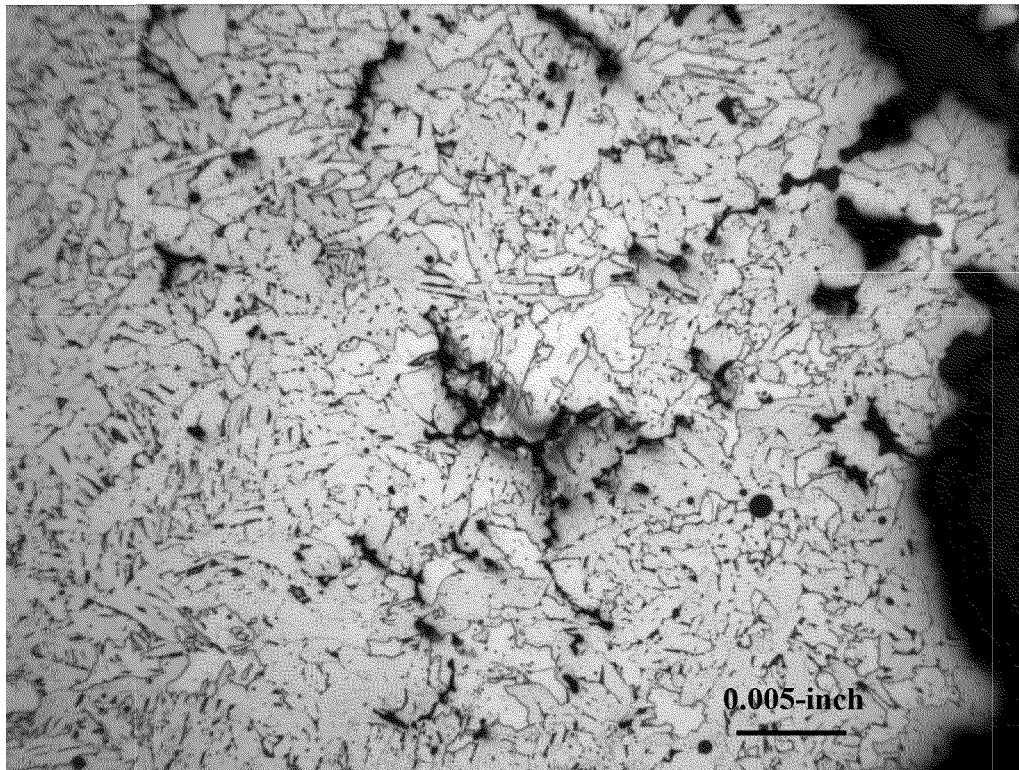
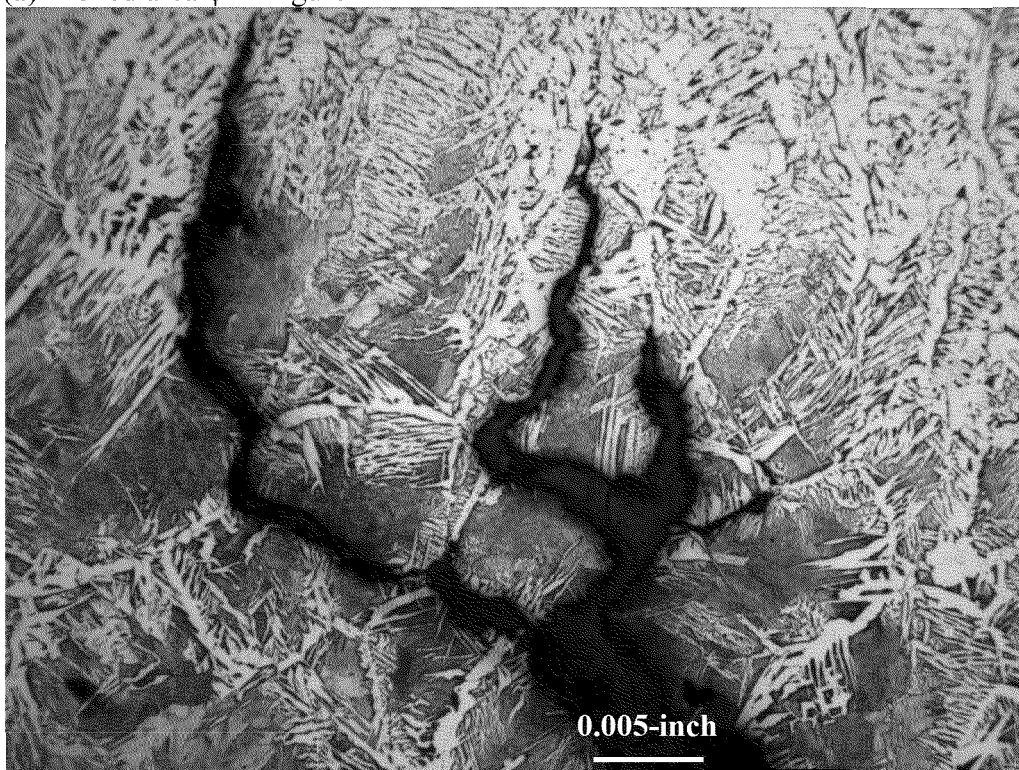
In section 1b, shown in Figure 13 through Figure 15, cracks were present from the outside surface to the inside surface. Only a few small ligaments prevented the demonstration of a through-wall leak path. However, it is likely that a leak path existed between section 1a and 1b. The weld metal crack morphology was consistent with shrinkage, and the heat affected zone crack morphology was indicative of grain boundary liquation.

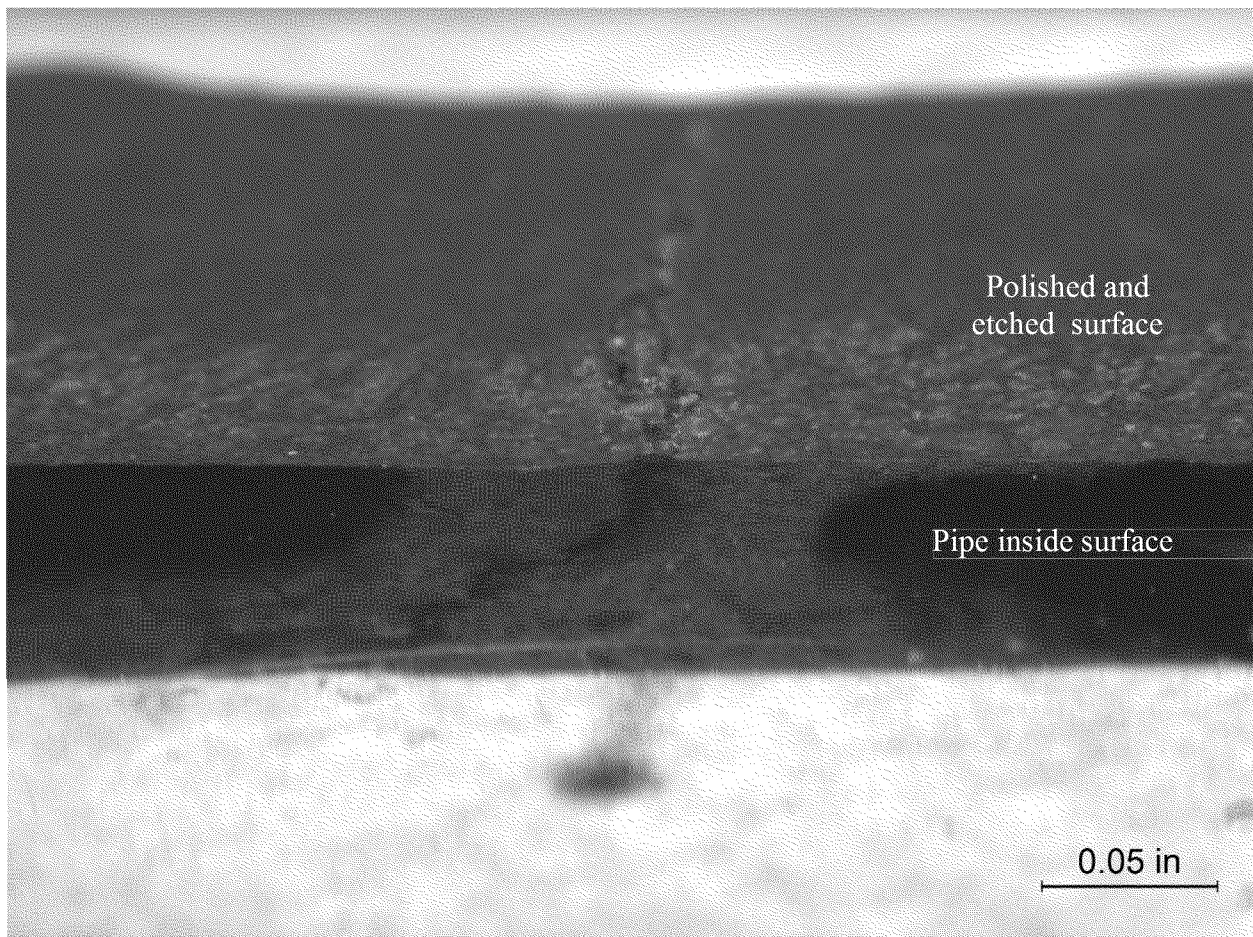
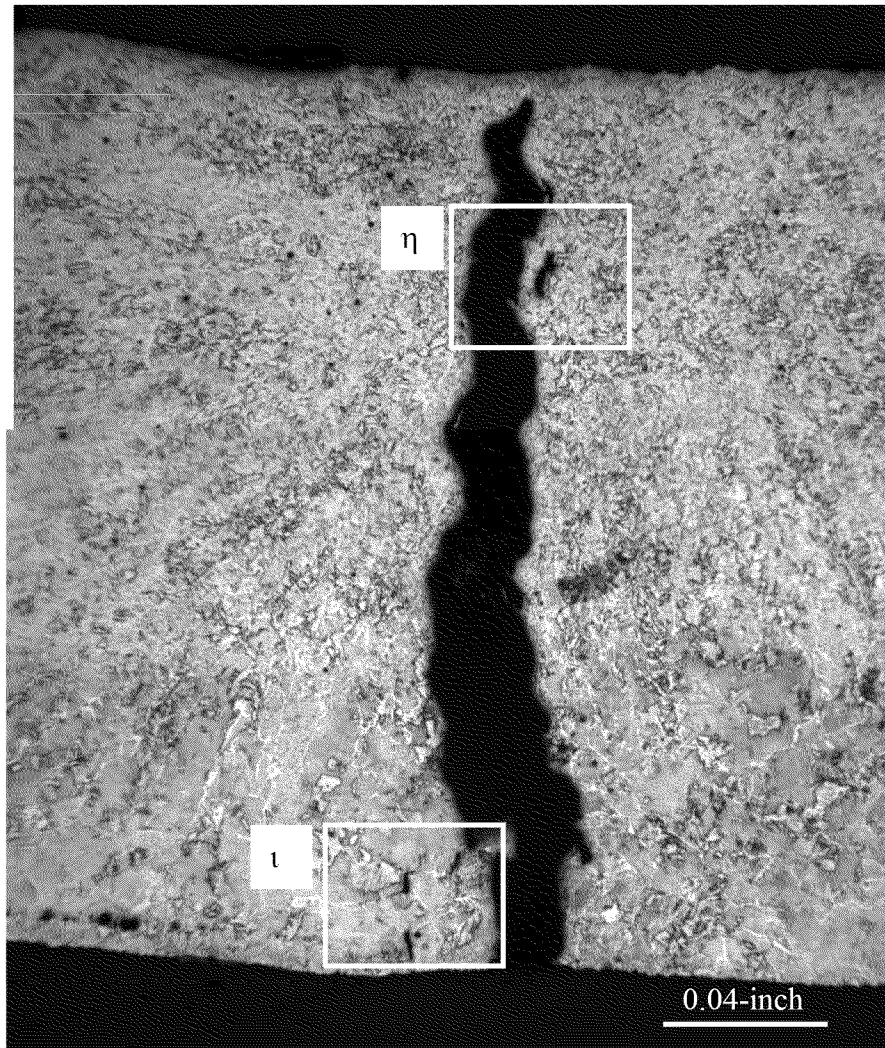
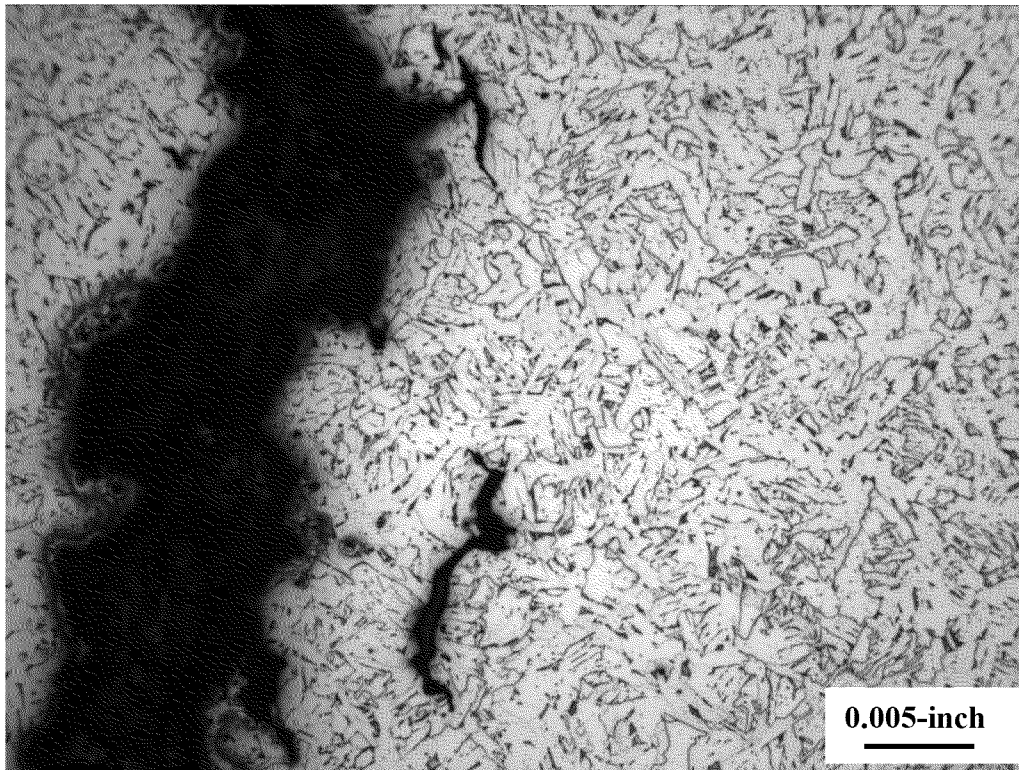
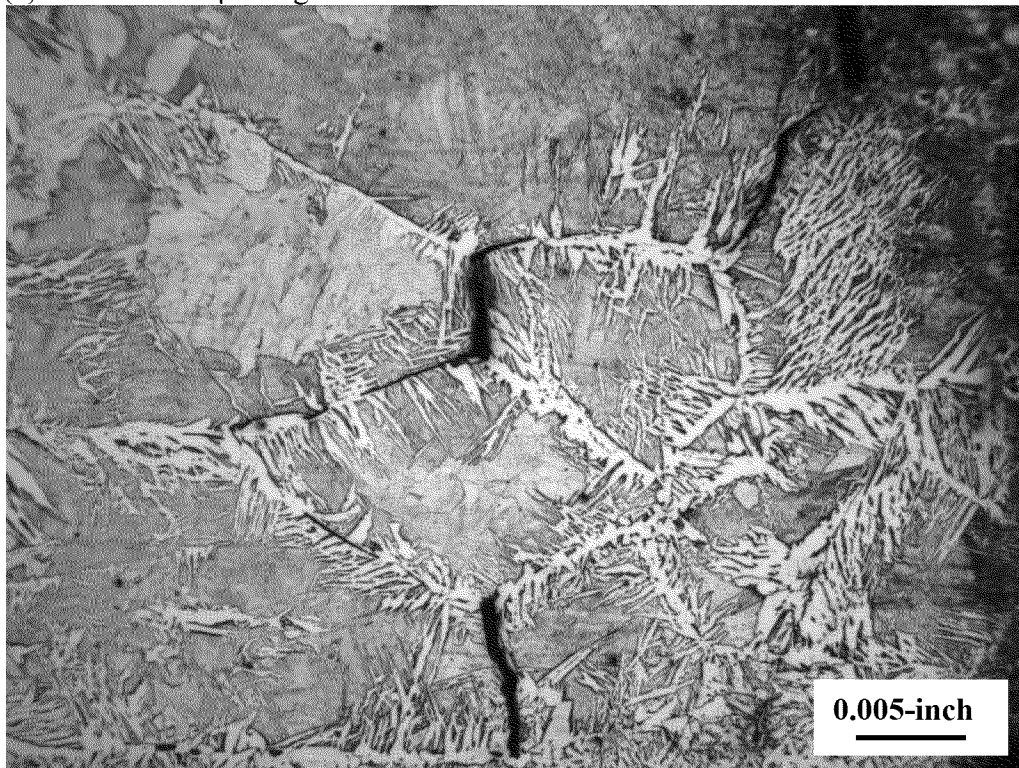
In section 1c, shown in Figure 16 through Figure 18, one small ligament at the outside surface prevented demonstration of a through-wall leak path. Once again, the weld crack morphology was consistent with shrinkage and the heat affected zone crack morphology was consistent with grain boundary liquation. In all three sections of specimen 1, the weld fusion zone followed a smooth broad contour with no indications of external corrosion prior to welding.

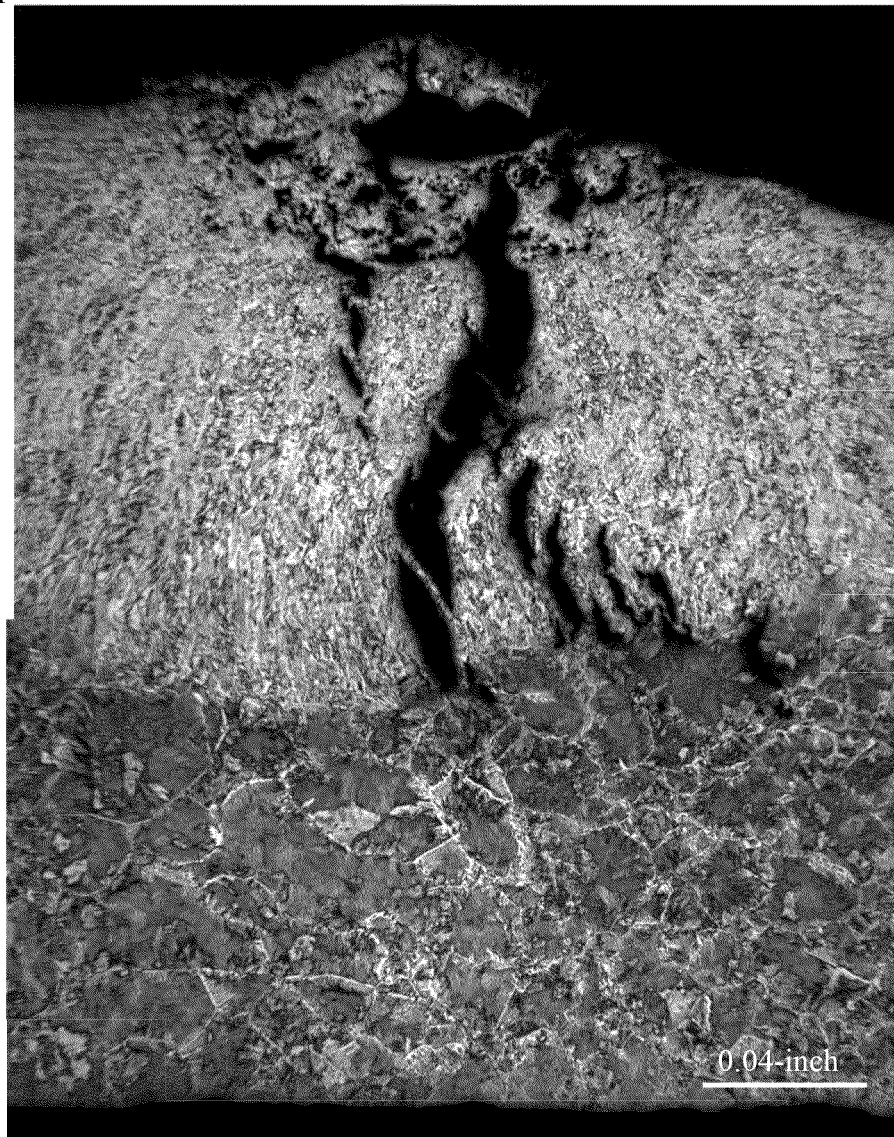
Figure 19 Photograph and composite micrograph of section 2. Etched with 2% nital.

Section 2 is shown in Figure 19. The fusion zone in this section had a profile that was more varied in depth than in sections 1a through 1c, which suggested the possibility that the weld metal was deposited to build-up locations where wall thickness had been reduced by external corrosion. Measurements of the minimum thickness of base metal beneath the weld metal are shown in Figure 10, Figure 13, Figure 16, and Figure 19.

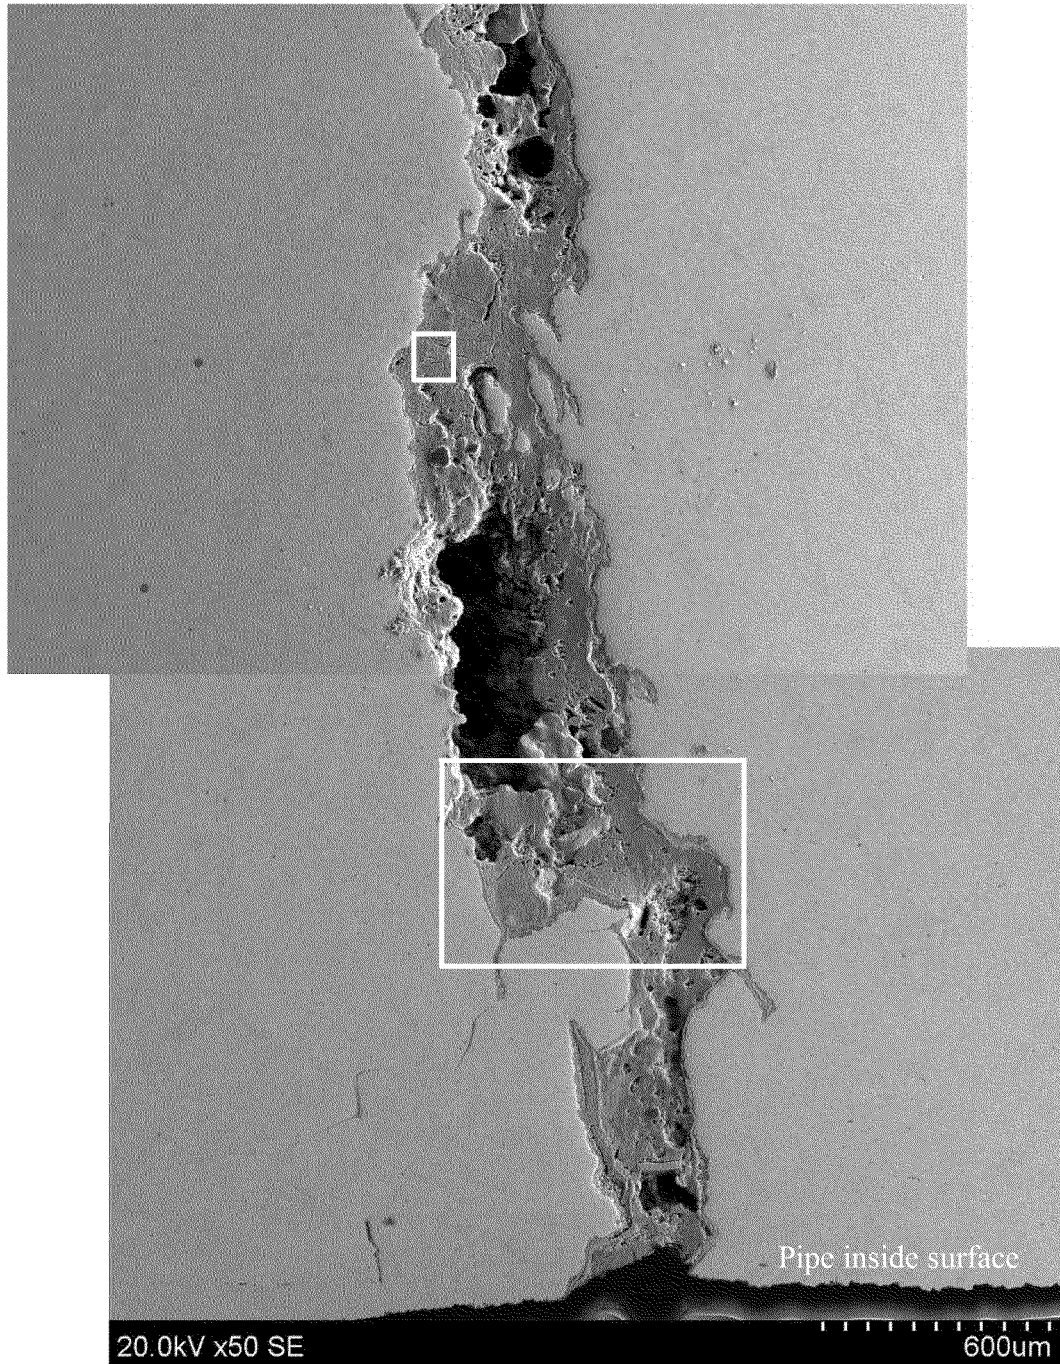
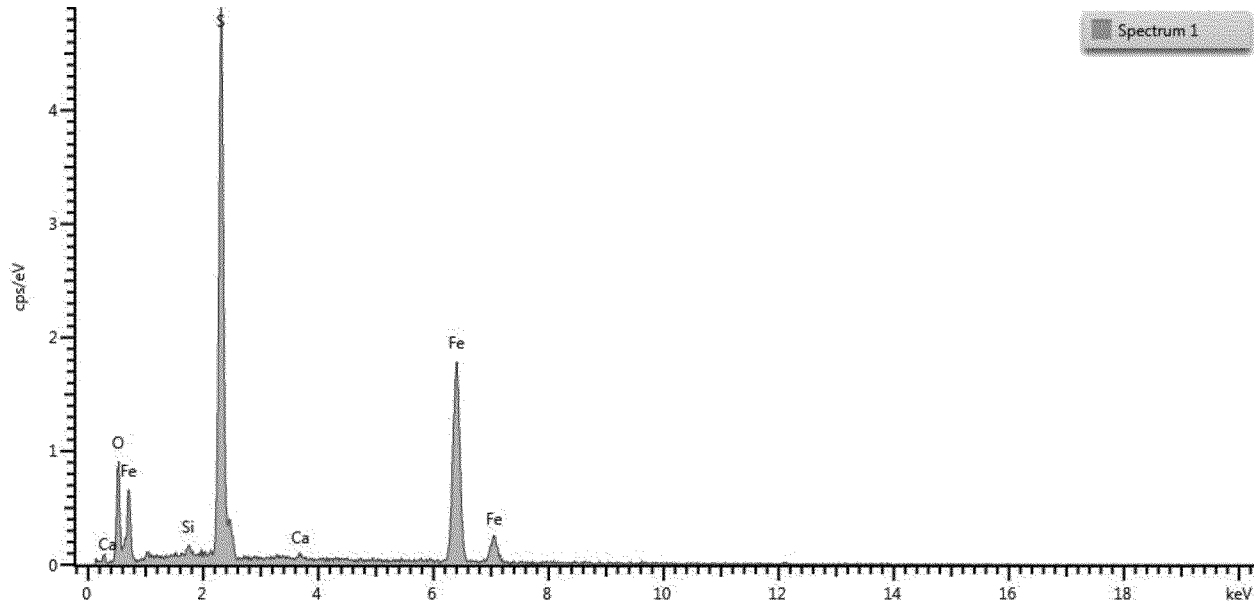
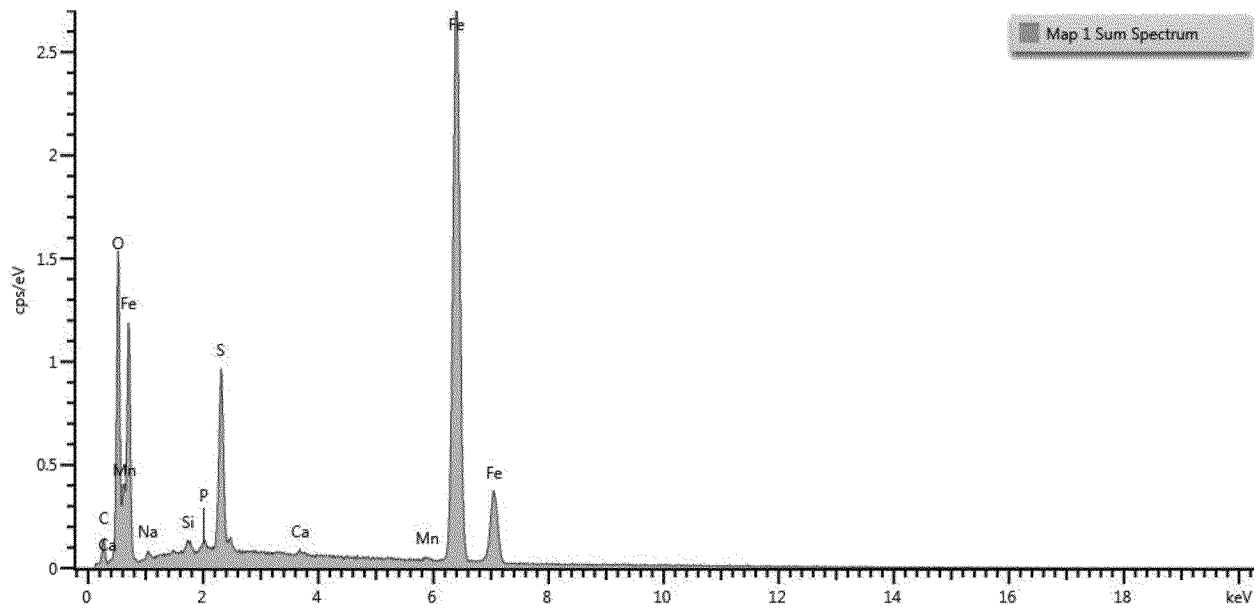
Scanning electron microscopy (SEM) and energy dispersive X-ray spectroscopy² (EDS) was performed on the section 3 polished and etched surface. A composite SEM micrograph of the crack is shown in Figure 20. Much of the crack was filled with oxide, indicated by the morphology and chemical composition of primarily iron and oxygen, with sulfur present, likely from mercaptan in the gas stream.
