Order Instituting Rulemaking on the
Commission's Own Motion to Adopt New
Safety and Reliability Regulations for Natural
Gas Transmission and Distribution Pipelines
and Related Ratemaking Mechanisms

**DECLARATION OF SUMEET SINGH
SUPPLEMENTING THE VERIFIED STATEMENT OF
PACIFIC GAS AND ELECTRIC COMPANY'S VICE
PRESIDENT OF GAS TRANSMISSION MAINTENANCE
AND CONSTRUCTION IN RESPONSE TO RULING OF
ASSIGNED COMMISSIONER AND ASSIGNED
ADMINISTRATIVE LAW JUDGE.**

Report No. 5004.9268

**METALLURGICAL EVALUATION OF A SECTION FROM
L-147 MP 2.2 BRITTAN AVE. AND ROGERS AVE., SAN CARLOS**

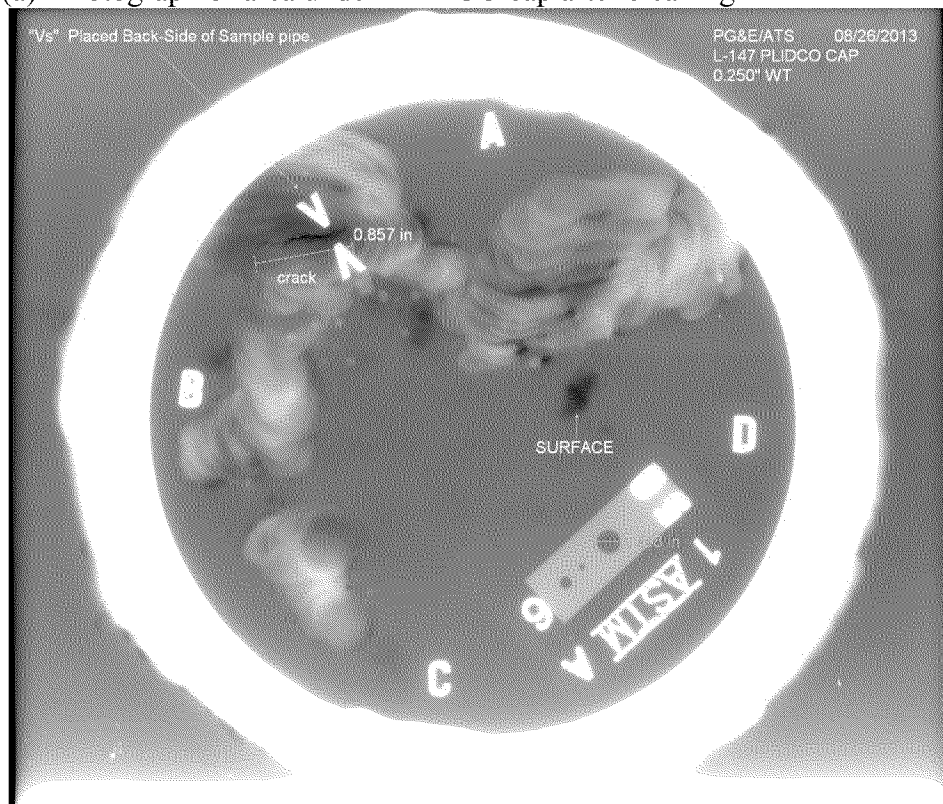
(b) Radiograph of area shown in (a)

The sample shown in Figure 6 was returned to PG&E for radiography. A digital radiograph of the sample is shown in Appendix A along with a photograph of the sample. A crack indication was found that corresponded to the crack-like feature detected visually on the inside surface, shown in Figure 8b.
