Arizona-Southern California Outages on September 8, 2011

Causes and Recommendations

Prepared by the Staffs of the
Federal Energy Regulatory Commission
and the
North American Electric Reliability Corporation

April 2012

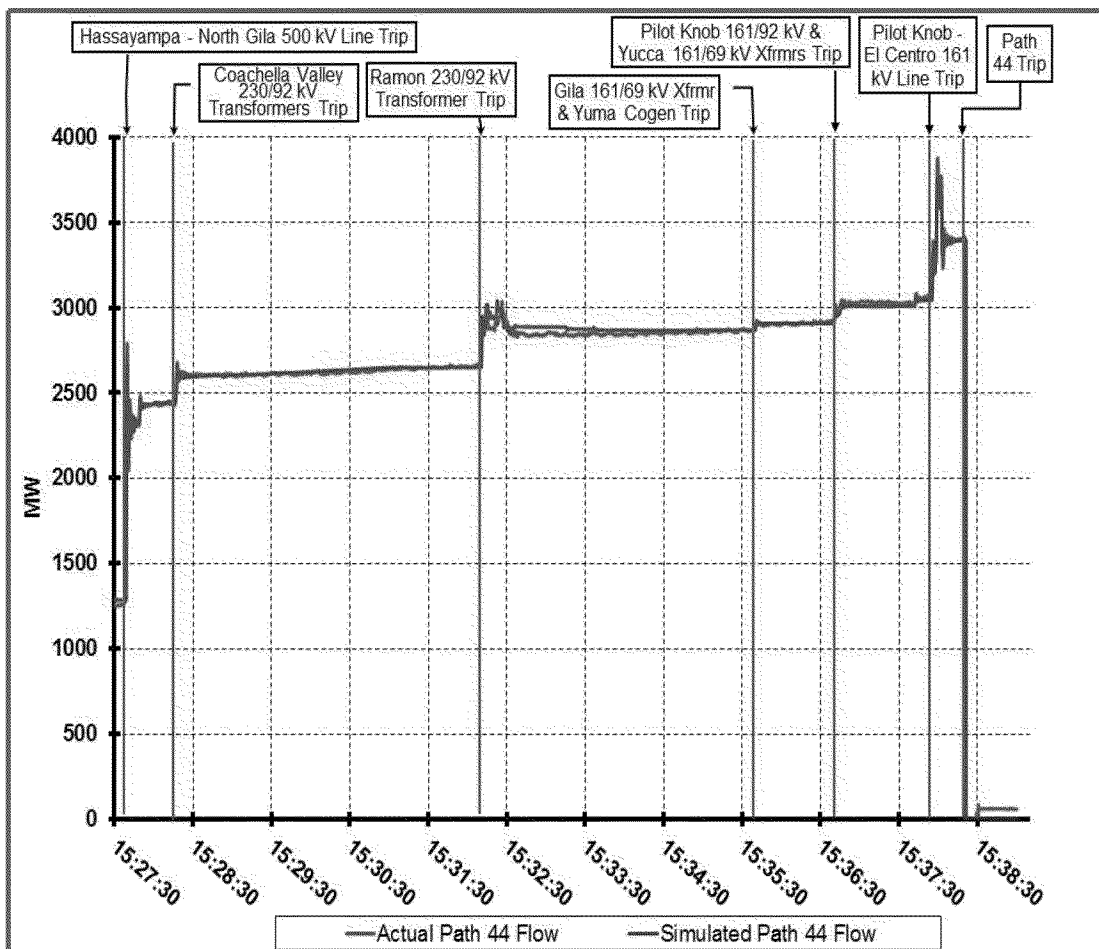
Figure 1: Comparison of Actual and Simulated Path 44 Flows

As the first step in performing power flow and dynamic stability analyses, the Modeling and Simulation team developed and benchmarked a modeling case of system conditions prior to the event. The team started with the WECC heavy summer base case and made adjustments based on State Estimator snapshots, EMS data, actual generation and schedules, PMU data, and a base case prepared by a separate team (led by CAISO) that studied the event. The team further adjusted and benchmarked the base case using SCADA and PMU data to match the system conditions for the entire event. The team devoted considerable time and effort to resolving discrepancies between the various sources of data to best calibrate the modeling case to actual measured data. As illustrated by **Figure 1**, on the next page, and described in more detail in Appendix D, the Modeling and Simulation team achieved a significant degree of accuracy. This figure compares Path 44 flows simulated by the Modeling and Simulation team to actual Path 44 PMU data.

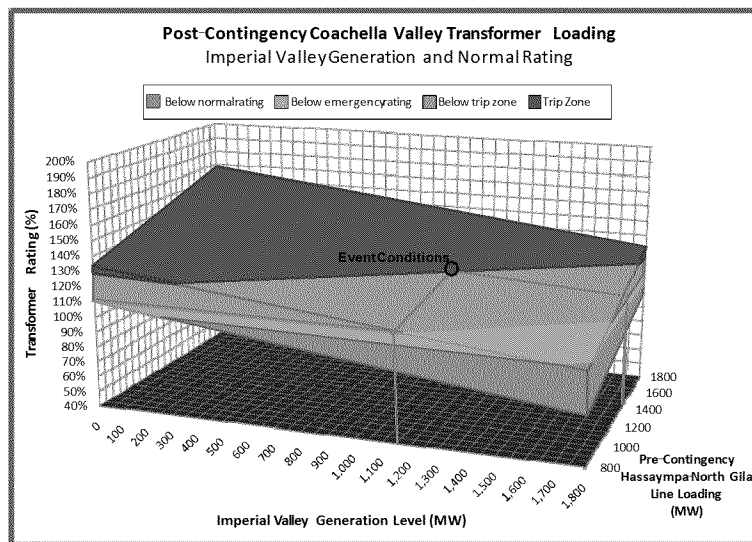
Figure 7 : Post-Contingency CV Transformer Loading Based on Imperial Valley Generation

In general, adding generation in San Diego, CFE, or Imperial Valley and backing down generation in APS’s system (east of Path 49) would reduce the loading on IID’s 92 kV system for the loss of H-NG. For example, an additional 600 MW of generation at Imperial Valley and a reduction of generation in APS’s system by the same amount would have reduced the pre-contingency loading on H-NG by 20% and improved the post-contingency voltage in WALC’s Blythe area by approximately 4%. Under this condition, the loading on the CV transformers for the loss of H-NG would be approximately 111% of their normal rating (166 MVA), well below their trip setting of 127%. This is a further demonstration of the importance of including all facilities when deriving SOLs.

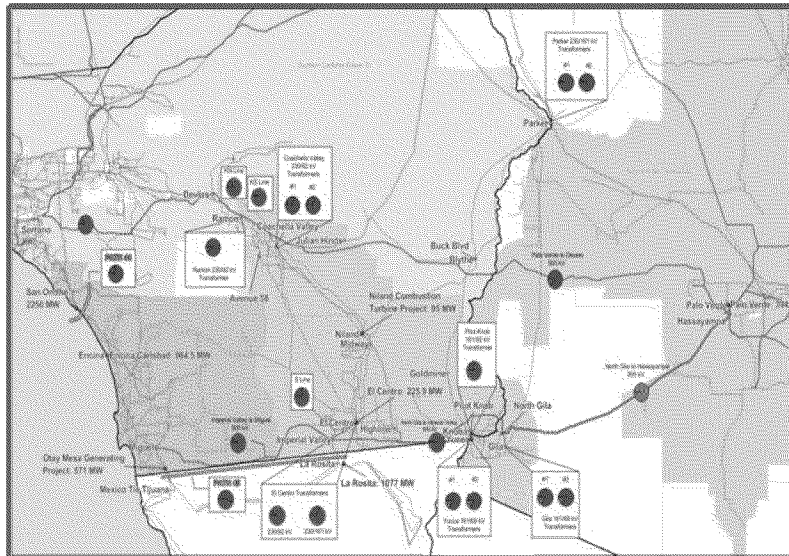
15:27:39 – The Hassayampa- North Gila 500 kV line tripped.

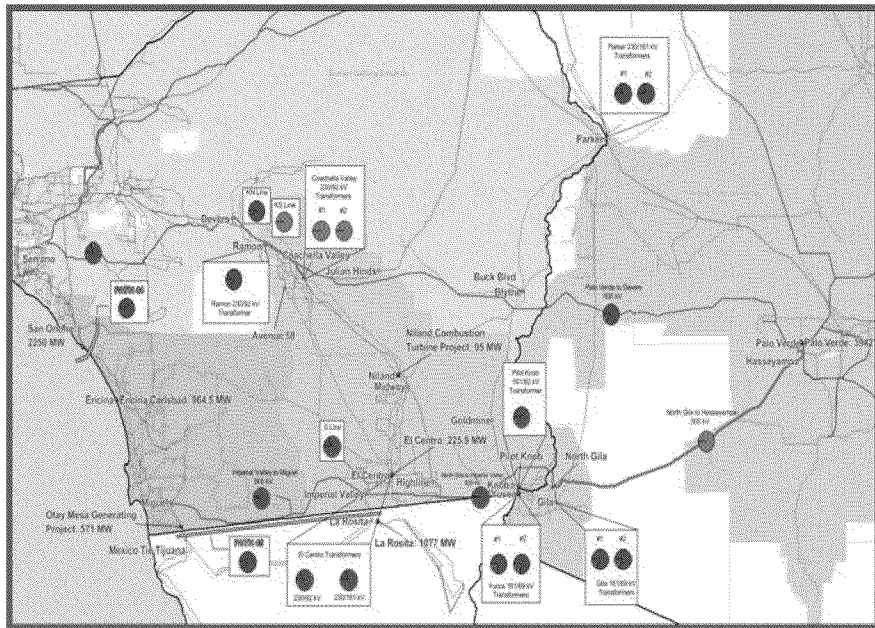
15:28:17 – Two Coachella Valley 230/92 kV transformers and the Coachella Valley Ramon 230 kV “KS” line tripped. (030)

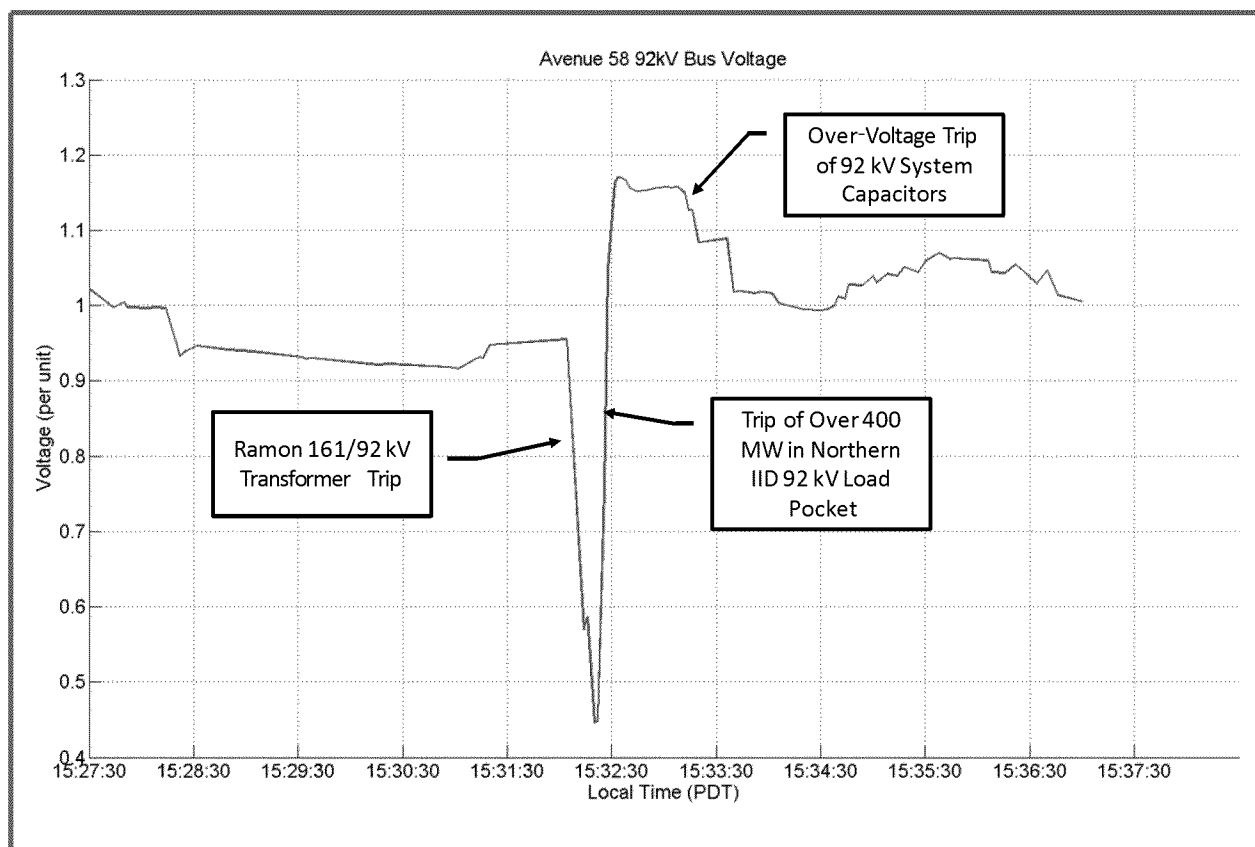
Figure 9: 92kV Voltage (per unit) at Avenue 58

The loss of IID's northern resources and subsequent system response caused IID to lose multiple generators connected to its 92 kV system, including IID's Niland Gas Turbine 2 (generating 45 MW), IID's CV Gas Turbine 4 (generating 20 MW), independent power producer Colmac's unit (generating 46 MW), and IID's Drop 4 Unit 2 Hydro Generator (generating 10.3 MW).

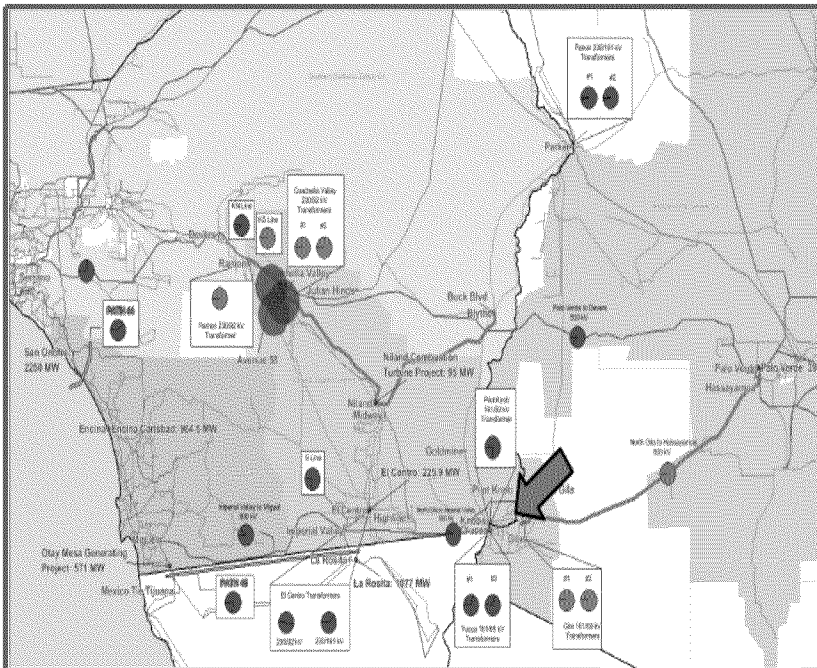
Time: 15:35:31 – Yuma Cogen (YCA) tripped. (180)

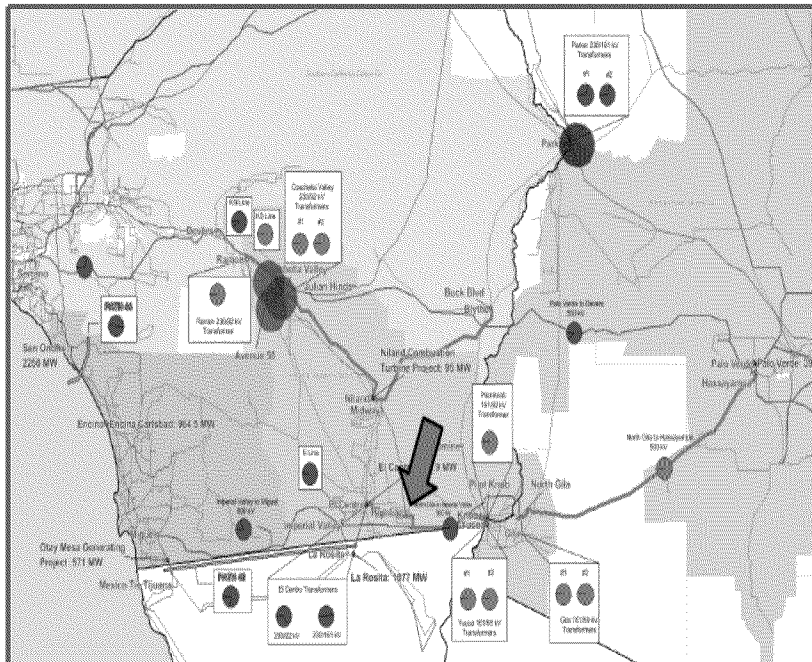
Time: 15:37:55 – The El Centro-Pilot Knob 161 kV line tripped. (230)

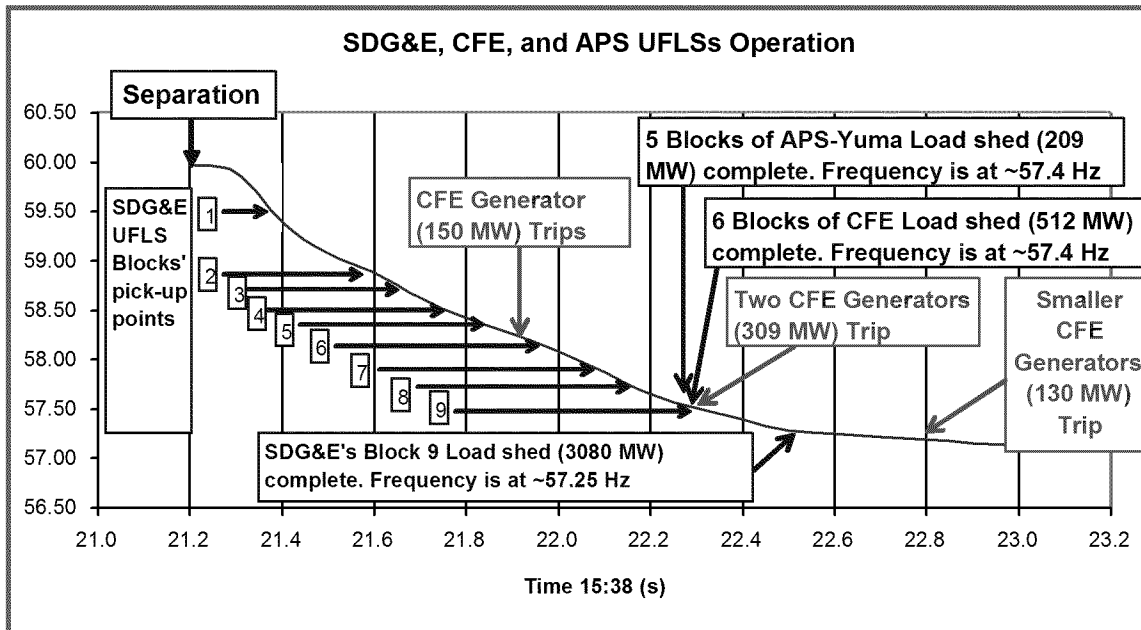
Figure 11: Frequency Performance in the SDG&E/Yuma/CFE Island

The CFE island separated from SDG&E after their only two remaining ties tripped in rapid succession. At 15:38:22.2, the Otay Mesa-Tijuana 230 kV transmission line open-ended at Tijuana in CFE's territory due to underfrequency protection.⁵⁵ Less than a second later, at 15:38:23.13, the Imperial Valley-La Rosita 230 kV transmission line open-ended at Imperial Valley in SDG&E's territory by underfrequency protection.⁵⁶ According to CFE, its UFLS program was not designed for the operation of a SDG&E/CFE/Yuma island, but for the operation of a "southern WECC island."

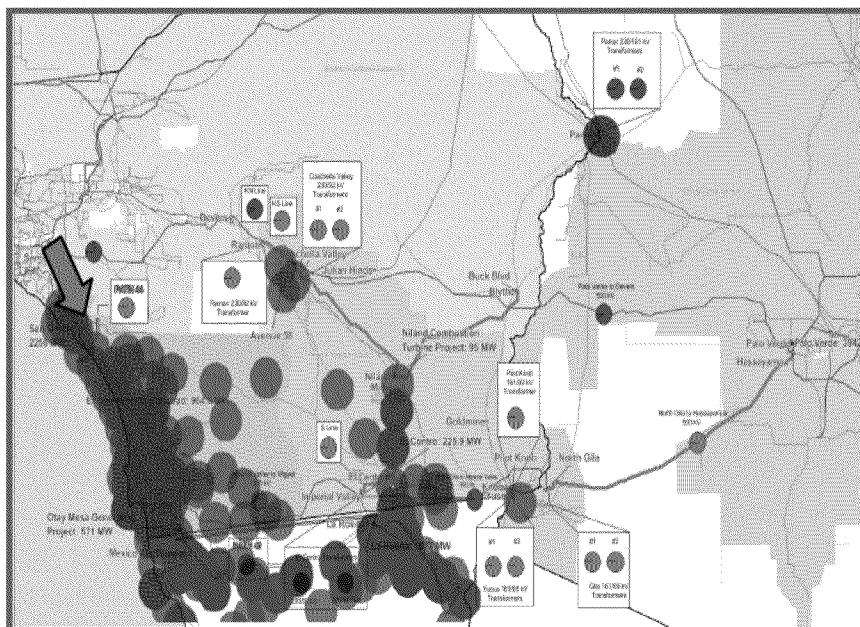
Time: 15:38:30 – The South of SONGS Separation Scheme operates and both SONGS units tripped. (300)

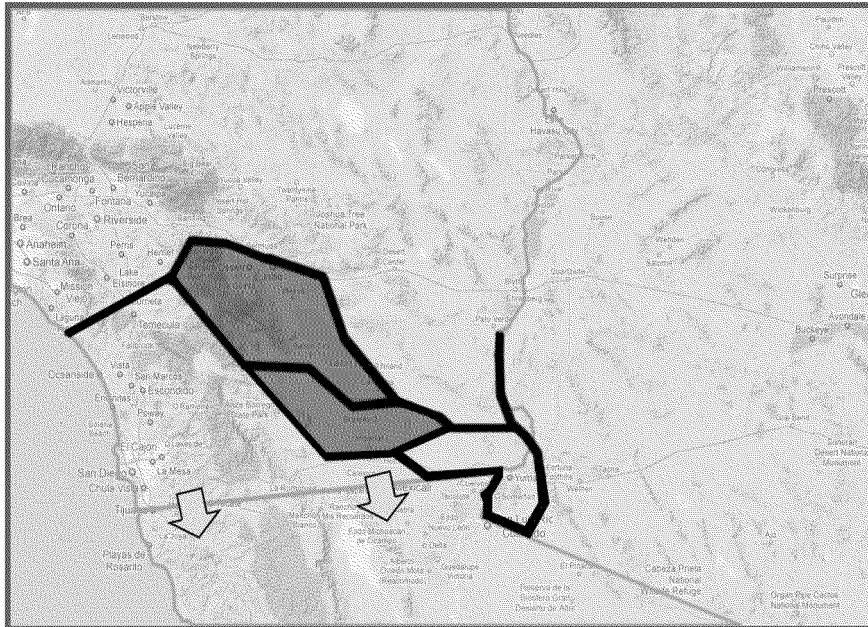
The Yuma island separated from SDG&E at 15:38:23.12, when the Imperial Valley-North Gila 500 kV transmission line tripped by underfrequency protection. APS's UFLS operated on 26 out of the 28 feeders in the Yuma area prior to the loss of the local Yucca steam generators that were on line. However, there was insufficient local generation to stabilize the load pocket in Yuma. At 15:38:38, the Yuma island internal units tripped on underfrequency protection.

Yuma Separates (Time: 15.38.23.12)

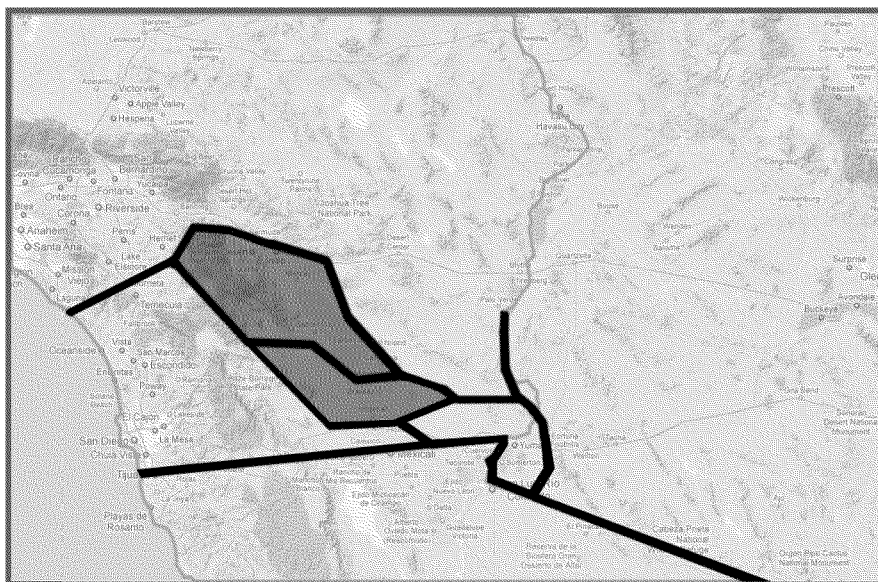
CFE Separates (Time: 15.38.23.13)

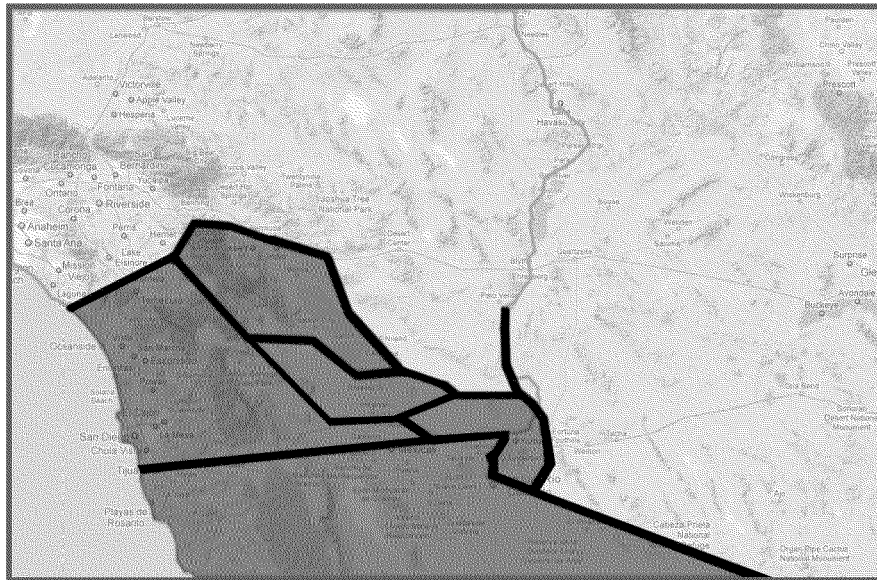
By 15:38:38, the SDG&E, CFE and Yuma islands had all collapsed, leaving approximately 2.7 million customers without power.

SDG&E, CFE, and Yuma Blackout (by 15.38.30)

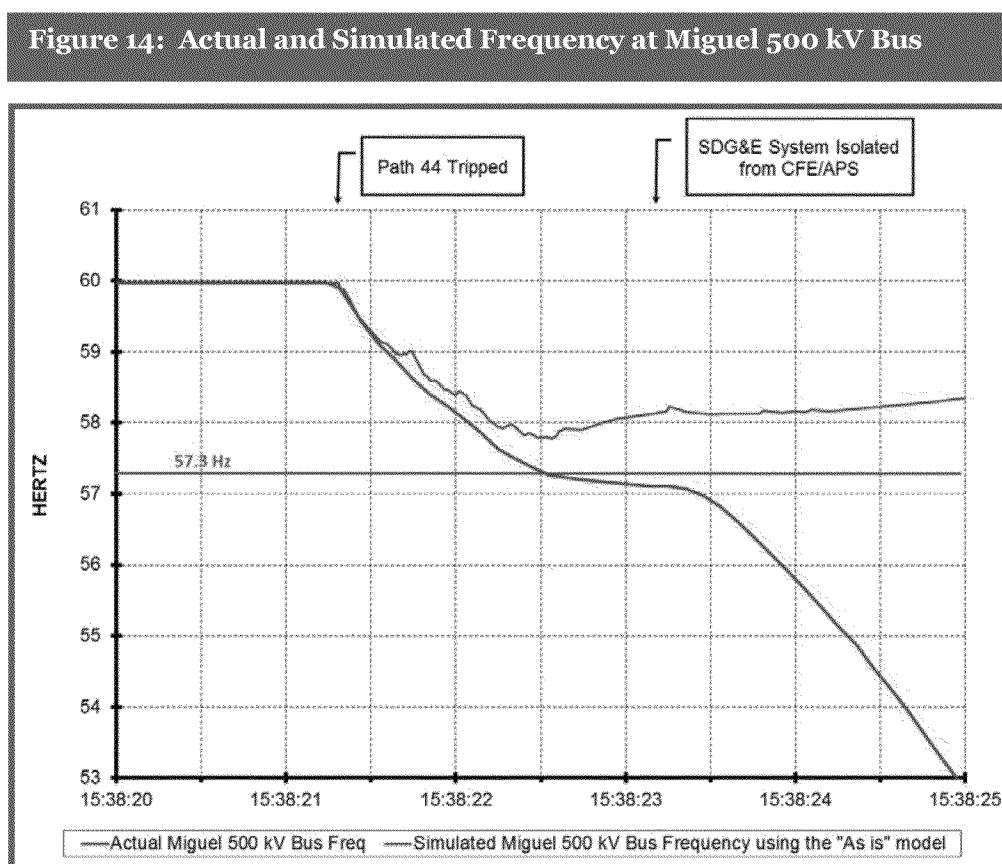
This inability to use the existing system models to reproduce the actual event is also evident in the post-event analysis that was prepared by SDG&E on the effectiveness of UFLS programs following the September 8th event.⁷⁵ The SDG&E post-event analysis shows that the UFLS performance should have prevented the SDG&E system from frequency collapse, similar to the “as is” results shown in **Figure 14**, below. However, the SDG&E analysis does not explain why the simulation results are so different than the actual system responses—i.e., successful islanding operation versus system collapse.

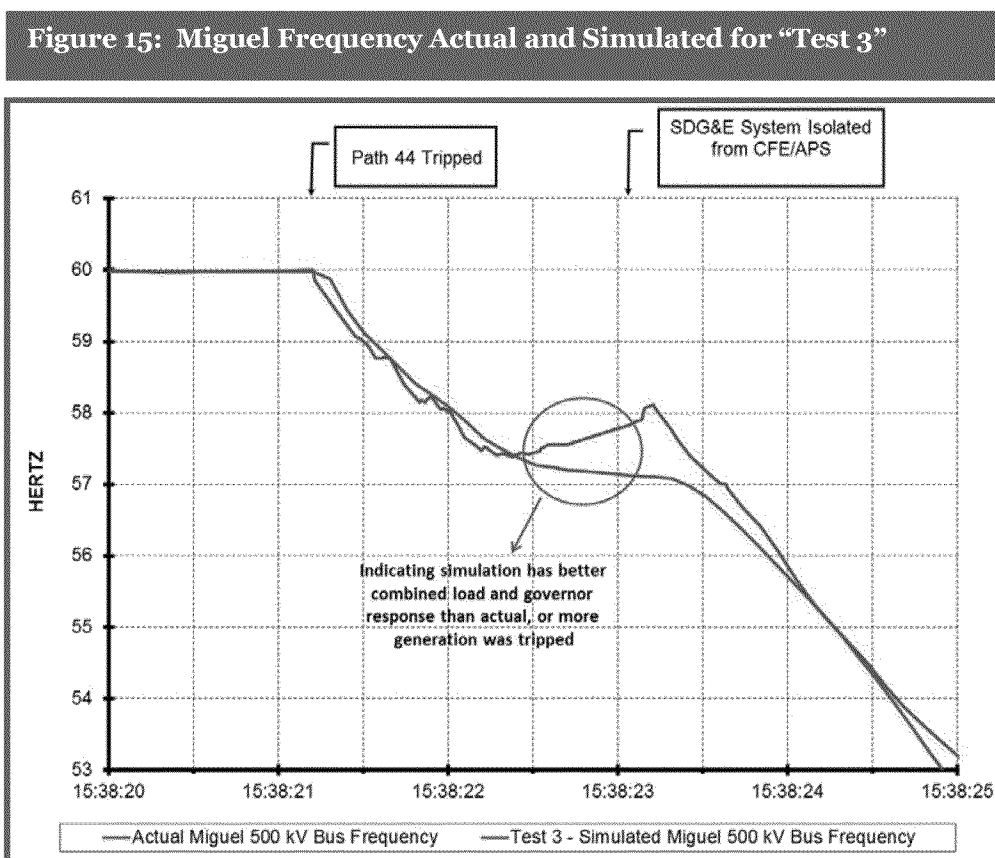
Figure 15, below, shows results of “Test 3.” As can be seen, this simulation more closely follows the actual event than the “as-is” model used in Figure 14.

The simulation studies explain the ineffectiveness of the UFLS program, despite up to 75% of SDG&E load that was shed within 1.3 seconds of the SONGS separation scheme operating. The simulation analysis confirmed findings in the inquiry’s SOE that the frequency collapse was caused by generation trips and UFLS misoperations within CFE shortly after Path 44’s separation, followed by additional generation trips within SDG&E around the time it separated from CFE/APS.

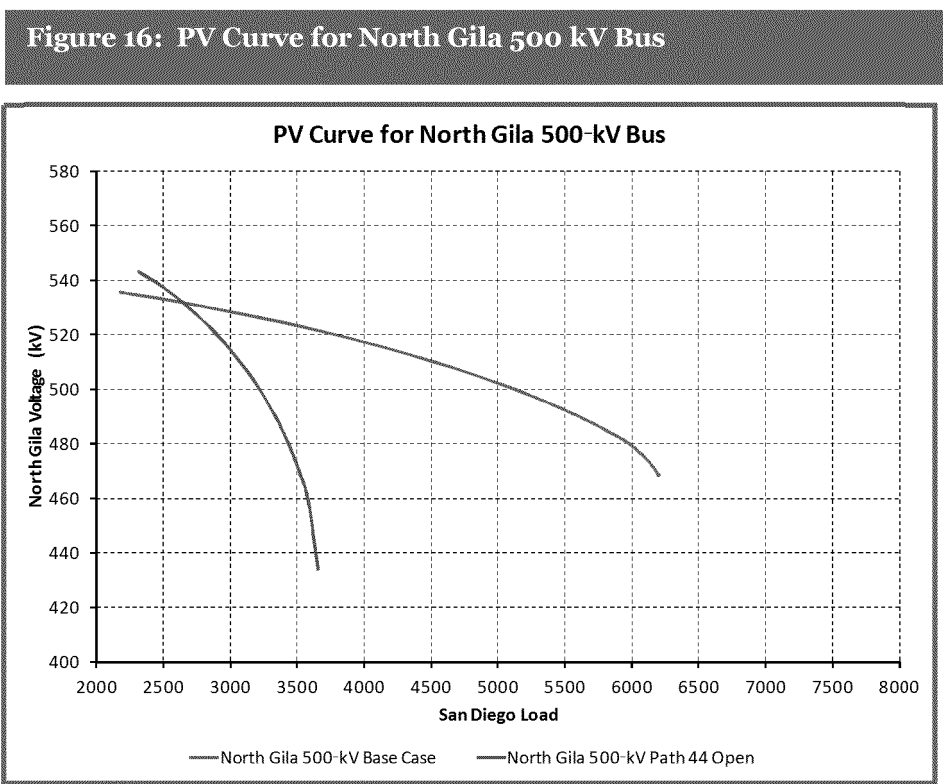
The inquiry conducted a simulation to evaluate what would happen if the SONGS separation scheme inadvertently operated during normal system operations (e.g., in the absence of any outages, overloads, or SOL violations). Based on this simulation, the inquiry determined that under certain high load conditions, the operation of the scheme could result in voltage collapse and a blackout in SDG&E's and CFE's territories. The inquiry conducted a voltage stability study using a Power-Voltage (P-V) curve to estimate the amount of SDG&E load that could reliably be supplied after an inadvertent operation of the SONGS separation scheme. The P-V curve below in **Figure 16** demonstrates that such operation would lead to a voltage collapse and a blackout in the SDG&E and CFE territories under certain high load conditions.

Specifically, the system is most likely to collapse when the SDG&E load exceeds 3,500 MW. In 2010, SDG&E's load exceeded this amount for 851 hours,⁹⁷ meaning that

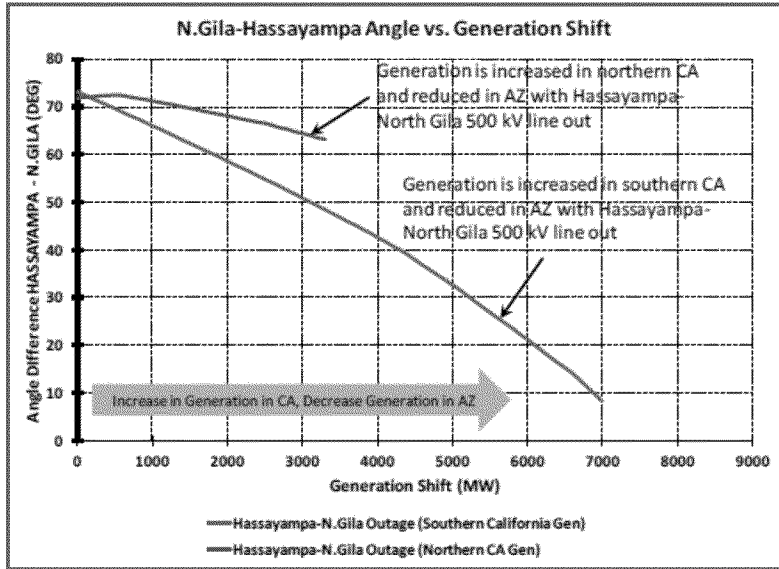
Figure 17: Phase Angle of H-NG vs. Generation Shift

The blue line in Figure 17 illustrates that with the particular conditions of the September 8th event, approximately 1,800 MW needed to be redispatched on both ends of H-NG (and close to the terminals, in Southern California and Arizona) in order to close the voltage phase angle from 72 degrees to 60 degrees (i.e., to within the permissive 60 degree setting of the synchro-check relay). The green line shows that more generation—more than twice as much—must be redispatched if units are chosen in Northern California to close the angle between Hassayampa and North Gila.

While system operators could redispatch generation from available spinning reserves or commit units in the Southern and/or Northern California area, it is questionable how quickly 1,800 MW could be dispatched.
