# Arizona-Southern California Outages on September 8, 2011

## Causes and Recommendations

Prepared by the Staffs of the  
Federal Energy Regulatory Commission  
*and the*  
North American Electric Reliability Corporation

April 2012

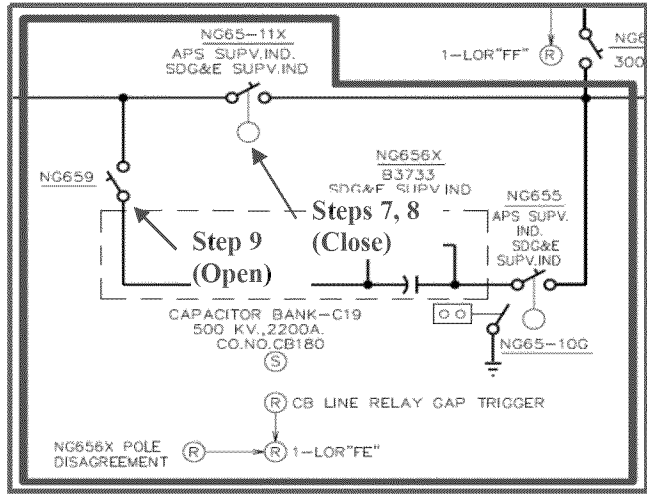
**Figure 6: APS Series Capacitor Bank**

At 15:27:39, the arc that had developed on each phase of the disconnect switch lengthened as the switch continued to open, to the point where two phases came into contact. This caused H-NG to trip to clear this phase-to-phase (A to C) fault. The high-speed protection system correctly detected the fault and tripped the line in 2.6 cycles (43 milliseconds). After discussion with the technician, APS operators erroneously believed that they could return the line to service in approximately minutes, even though they had no situational awareness of a large phase angle difference caused by the outage. More time would have been needed to redispatch generation to reduce the phase angle difference to the allowed value. APS system operators informed CAISO, Salt River Project (SRP), and WECC RC that the line would be reclosed quickly, even though they were unaware that this was not possible because of the large phase angle difference that

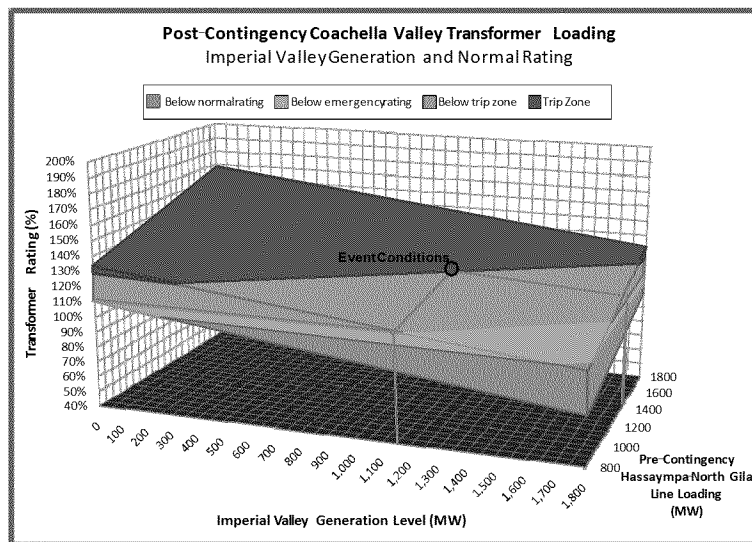
**Figure 7 : Post-Contingency CV Transformer Loading Based on Imperial Valley Generation**

In general, adding generation in San Diego, CFE, or Imperial Valley and backing down generation in APS’s system (east of Path 49) would reduce the loading on IID’s 92 kV system for the loss of H-NG. For example, an additional 600 MW of generation at Imperial Valley and a reduction of generation in APS’s system by the same amount would have reduced the pre-contingency loading on H-NG by 20% and improved the post-contingency voltage in WALC’s Blythe area by approximately 4%. Under this condition, the loading on the CV transformers for the loss of H-NG would be approximately 111% of their normal rating (166 MVA), well below their trip setting of 127%. This is a further demonstration of the importance of including all facilities when deriving SOLs.

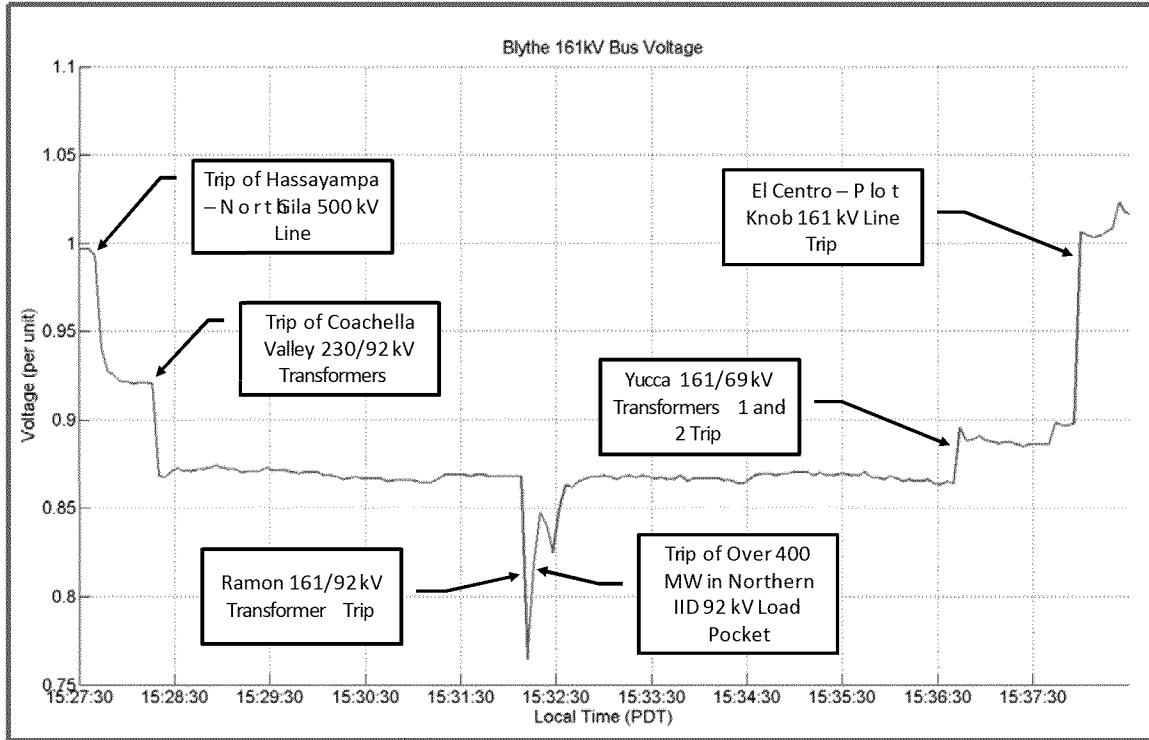
Figure 8: Blythe 161kV Voltage

On September 8, 2011, CAISO had partial visibility of IID’s system, but could not see that the CV banks had tripped. Prior to the event CAISO and IID had been working together to increase their mutual visibility and those efforts are continuing. Currently, CAISO receives loading data from the 230 kV side of the CV transformers.

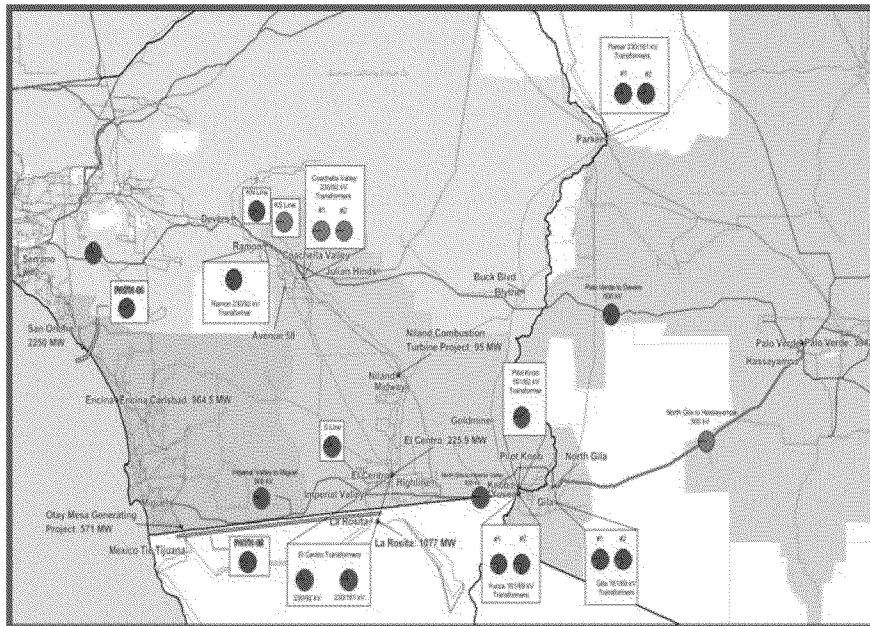
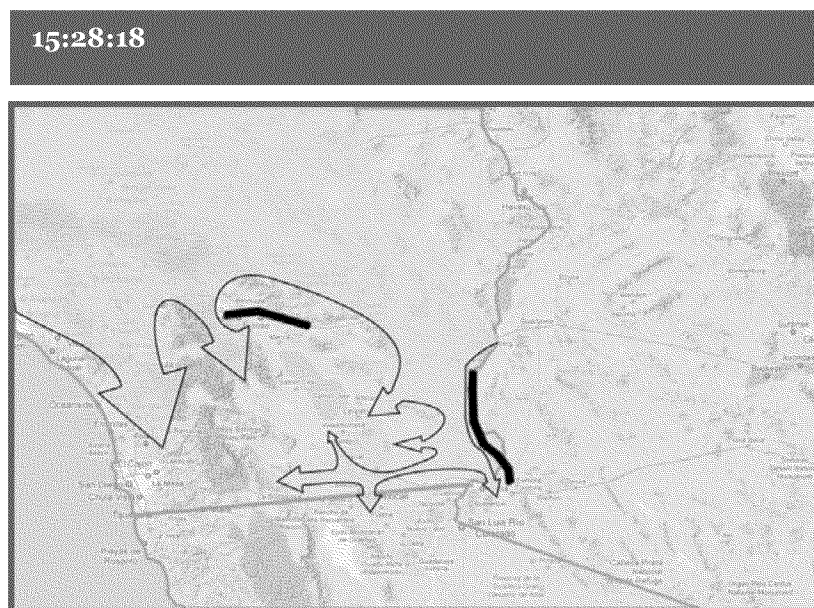
**15:28:17 – Two Coachella Valley 230/92 kV transformers and the Coachella Valley Ramon 230 kV “KS” line tripped. (030)**

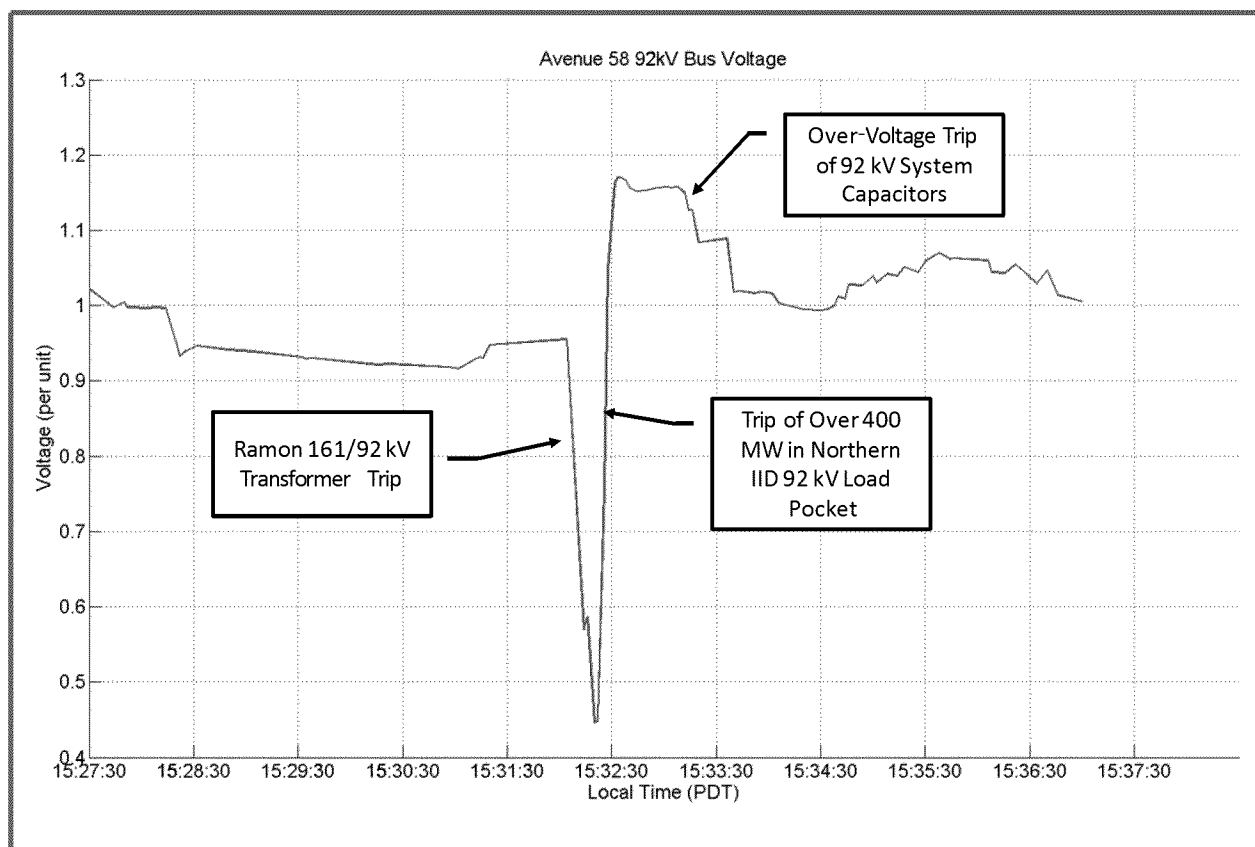
**Figure 9: 92kV Voltage (per unit) at Avenue 58**

The loss of IID's northern resources and subsequent system response caused IID to lose multiple generators connected to its 92 kV system, including IID's Niland Gas Turbine 2 (generating 45 MW), IID's CV Gas Turbine 4 (generating 20 MW), independent power producer Colmac's unit (generating 46 MW), and IID's Drop 4 Unit 2 Hydro Generator (generating 10.3 MW).

IID also began losing transmission lines. The Blythe-Niland 161 kV "F" Line, which saw increased loading during Phase 2, tripped at 15:32:13 (approximately 3 seconds after loss of the Ramon banks). Its normal rating was 165 MVA, and it was set to trip at 129% of the normal rating (212 MVA at nominal voltage) with a 3-second time delay.<sup>46</sup> The Niland-CV 161 kV "N" Line, carrying 83 MVA, tripped approximately 2 seconds later at 15:32:15.29 due to Zone 3 distance protection.<sup>47</sup>

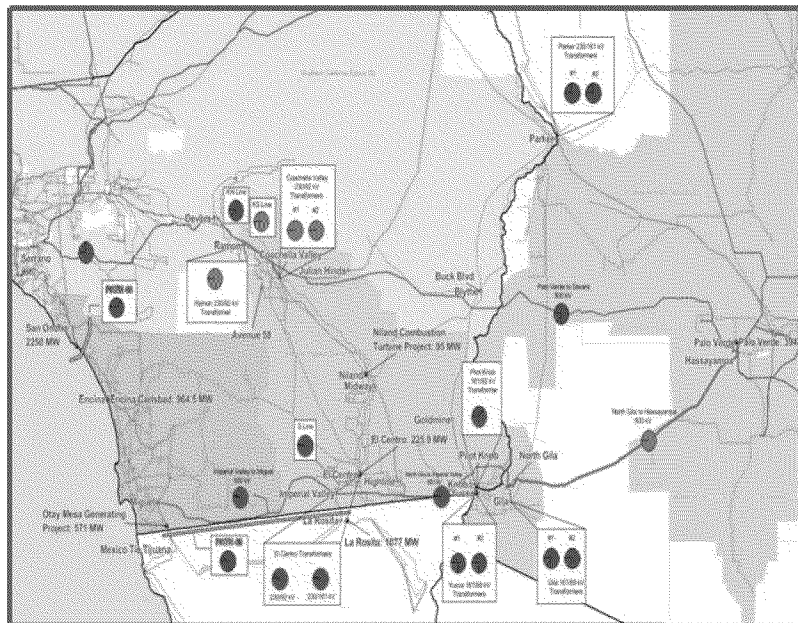
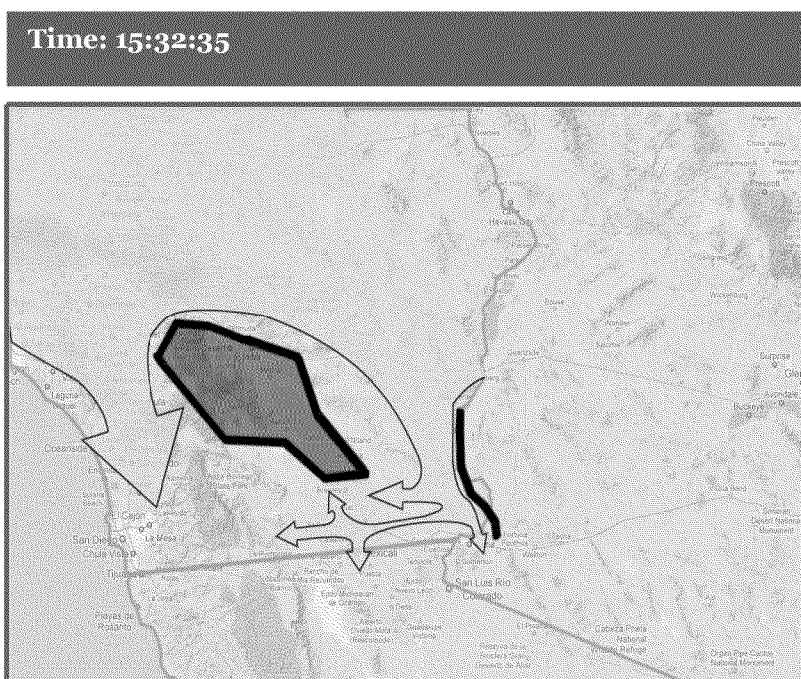
**Time: 15:32:10 – The Ramon 230/92 kV transformer tripped and IID shed 444 MW of load. (110)**

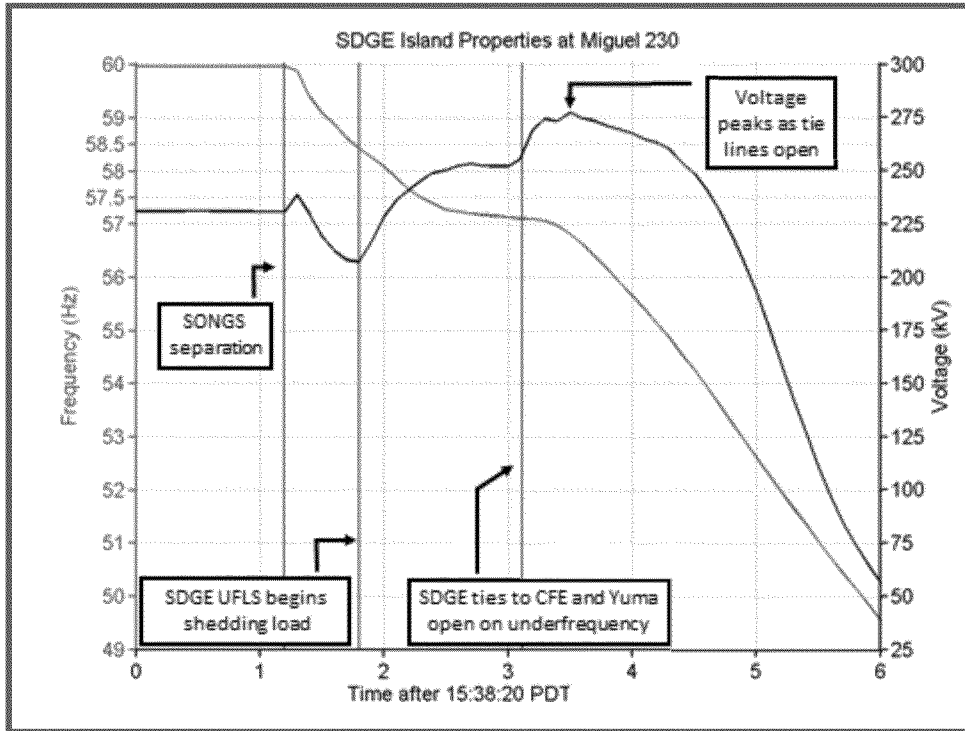
**Figure 10: Frequency, Voltage in the SDG&E/Yuma/CFE Island**

The CFE island separated from SDG&E after their only two remaining ties tripped in rapid succession. At 15:38:22.2, the Otay Mesa-Tijuana 230 kV transmission line open-ended at Tijuana in CFE's territory due to underfrequency protection.<sup>55</sup> Less than a second later, at 15:38:23.13, the Imperial Valley-La Rosita 230 kV transmission line open-ended at Imperial Valley in SDG&E's territory by underfrequency protection.<sup>56</sup> According to CFE, its UFLS program was not designed for the operation of a SDG&E/CFE/Yuma island, but for the operation of a "southern WECC island."

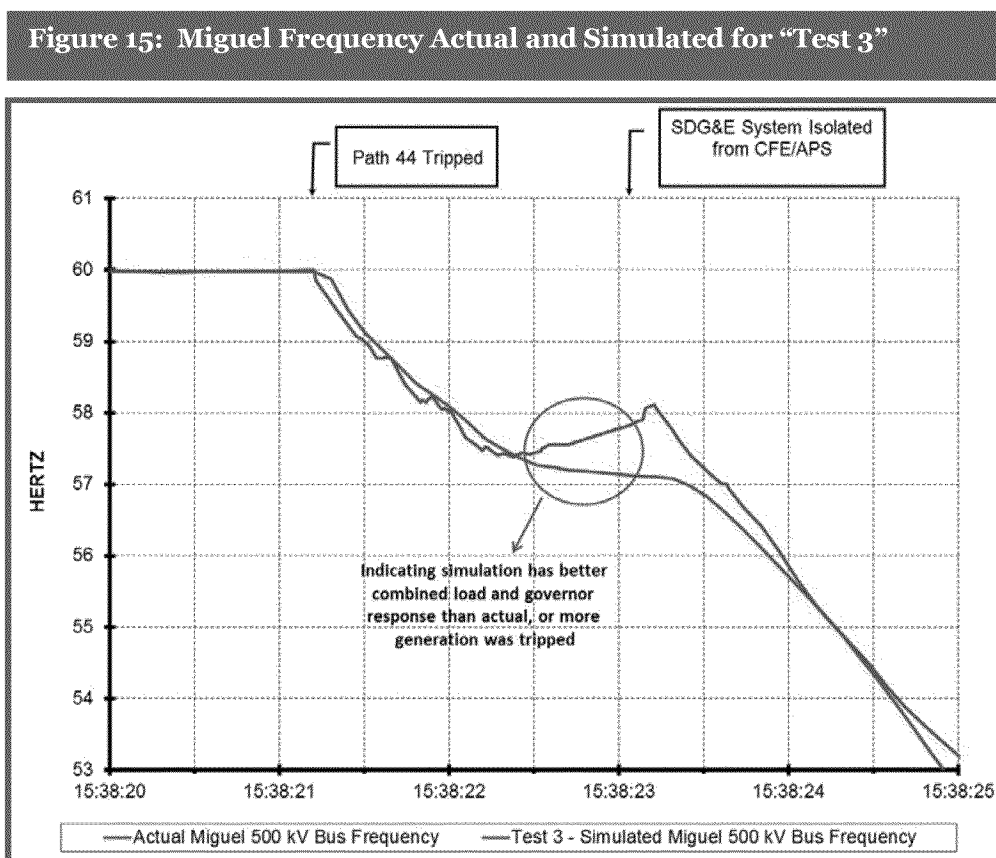
**Figure 15**, below, shows results of “Test 3.” As can be seen, this simulation more closely follows the actual event than the “as-is” model used in Figure 14.

The simulation studies explain the ineffectiveness of the UFLS program, despite up to 75% of SDG&E load that was shed within 1.3 seconds of the SONGS separation scheme operating. The simulation analysis confirmed findings in the inquiry’s SOE that the frequency collapse was caused by generation trips and UFLS misoperations within CFE shortly after Path 44’s separation, followed by additional generation trips within SDG&E around the time it separated from CFE/APS.

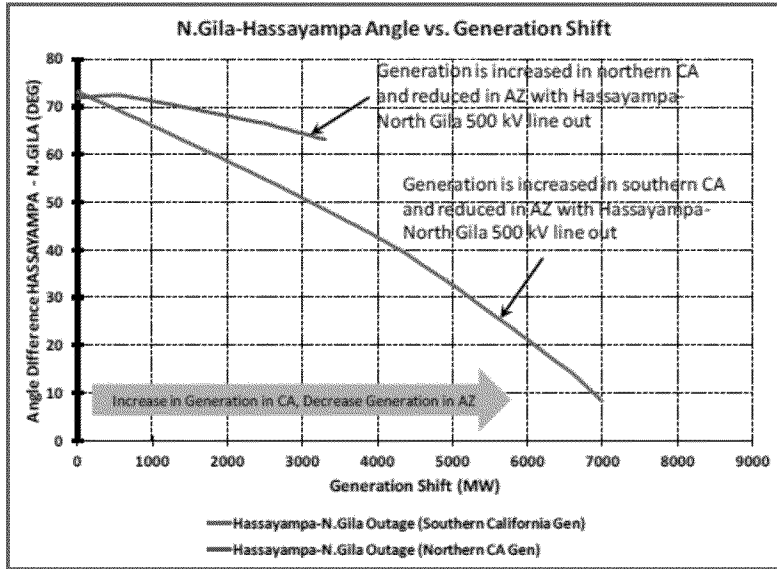
**Figure 17: Phase Angle of H-NG vs. Generation Shift**

The blue line in Figure 17 illustrates that with the particular conditions of the September 8th event, approximately 1,800 MW needed to be redispatched on both ends of H-NG (and close to the terminals, in Southern California and Arizona) in order to close the voltage phase angle from 72 degrees to 60 degrees (i.e., to within the permissive 60 degree setting of the synchro-check relay). The green line shows that more generation—more than twice as much—must be redispatched if units are chosen in Northern California to close the angle between Hassayampa and North Gila.

While system operators could redispatch generation from available spinning reserves or commit units in the Southern and/or Northern California area, it is questionable how quickly 1,800 MW could be dispatched.
