**DECLARATION OF SUMEET SINGH  
SUPPLEMENTING THE VERIFIED STATEMENT OF  
PACIFIC GAS AND ELECTRIC COMPANY'S VICE  
PRESIDENT OF GAS TRANSMISSION MAINTENANCE  
AND CONSTRUCTION IN RESPONSE TO RULING OF  
ASSIGNED COMMISSIONER AND ASSIGNED  
ADMINISTRATIVE LAW JUDGE.**

5. Attached as Exhibit 1 is a copy of Anamet's September 6, 2013 Report No. 5005.9268, Metallurgical Evaluation of a Section From L-147 MP 2.2 Brittan Ave. and Rogers Ave., San Carlos.

Report No. 5004.9268

**METALLURGICAL EVALUATION OF A SECTION FROM  
L-147 MP 2.2 BRITTAN AVE. AND ROGERS AVE., SAN CARLOS**

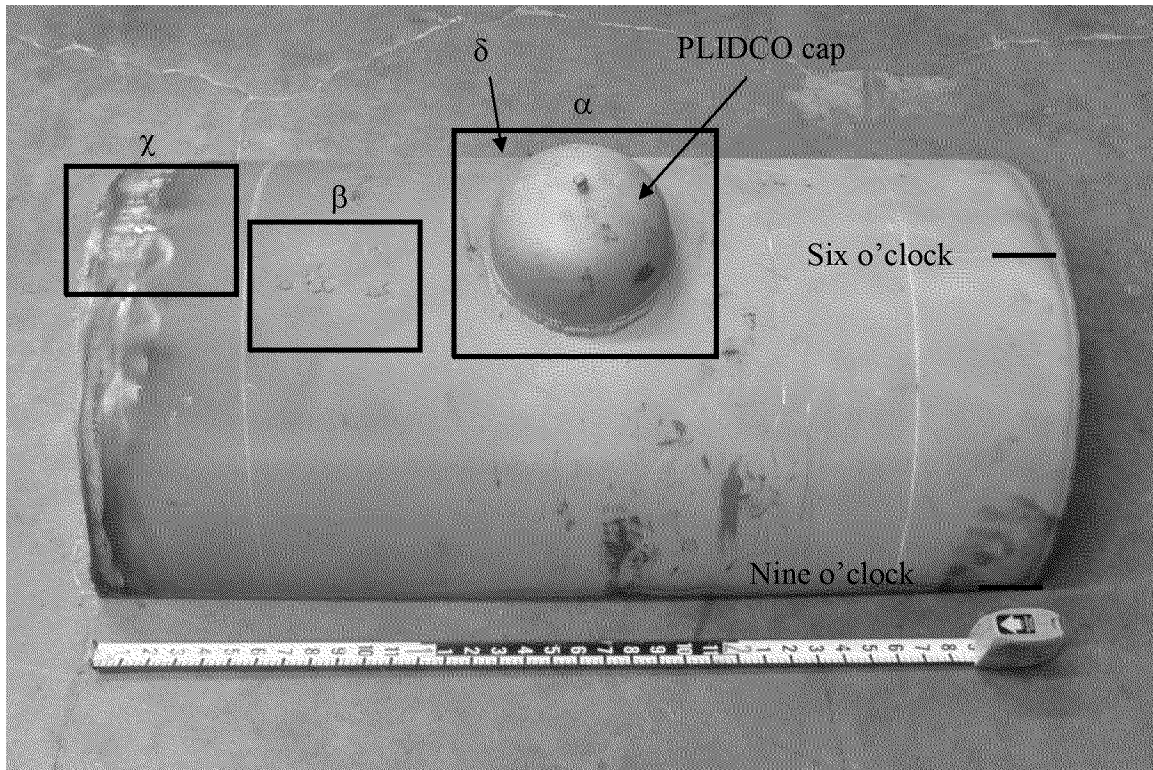
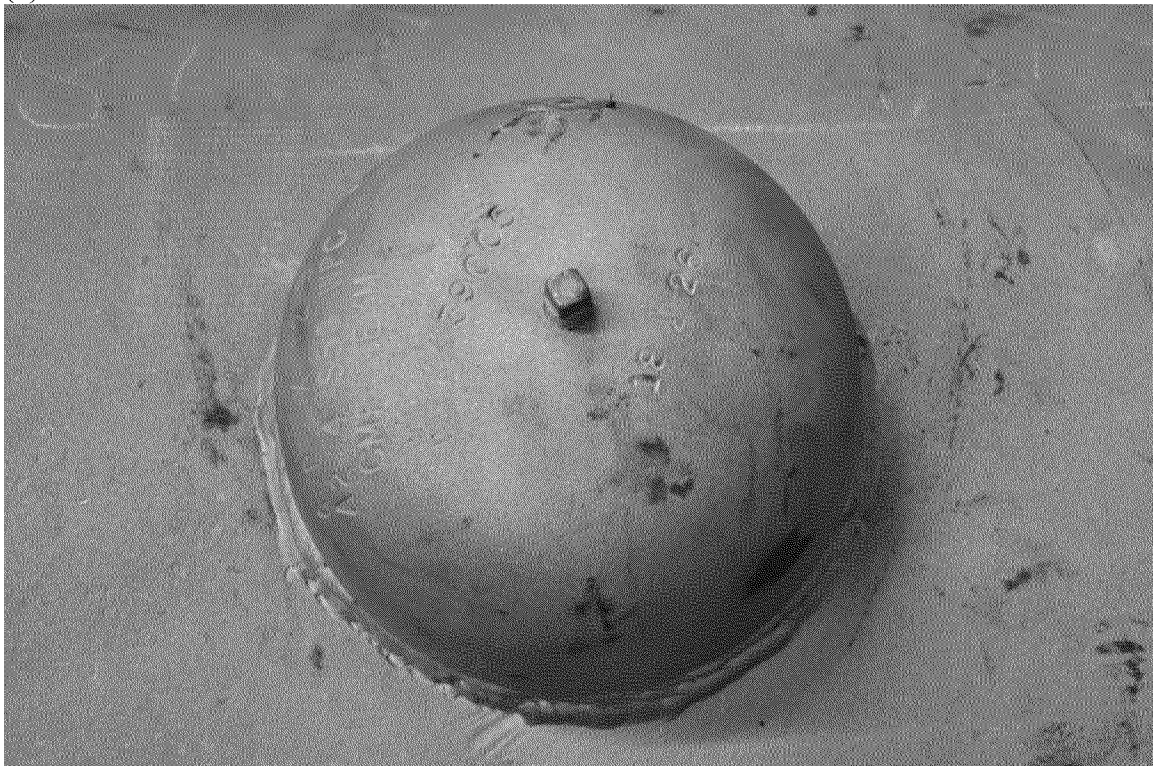
Figure 1 Photographs of the outside surface of sample half A as-received.

The subject sample of L-147 was received sectioned into two halves along the longitudinal axis, with the outside surface grit blasted, as shown in Figure 1 through Figure 5. The section half with the PLIDCO cap was arbitrarily labeled A and the other section was labeled B, in the laboratory. Based on the reported position of the cap, the longitudinal flame cuts were located at three o'clock and nine o'clock positions. Wall thickness measurements were made with a pointed anvil micrometer and the results are listed in Table 1. Small regions of weld metal and a few shallow hemispherical pits were present near the cap, as shown in Figure 2. Pits were also present just past the three o'clock position toward the cap, indicated in Figure 1. Pit depths were measured with a pit gage, and the results are listed in Table 2. No evidence of a leak location or repair was visible to the unaided eye on the inside surface of the pipe under the cap.

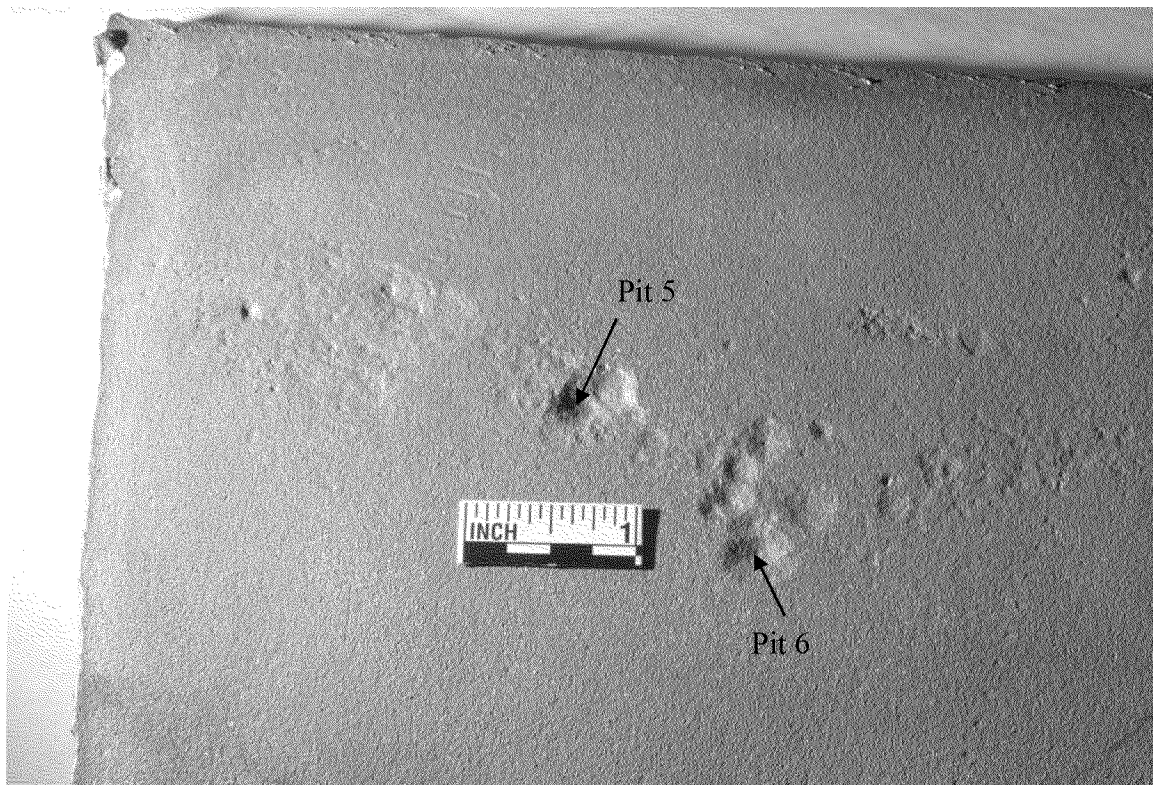
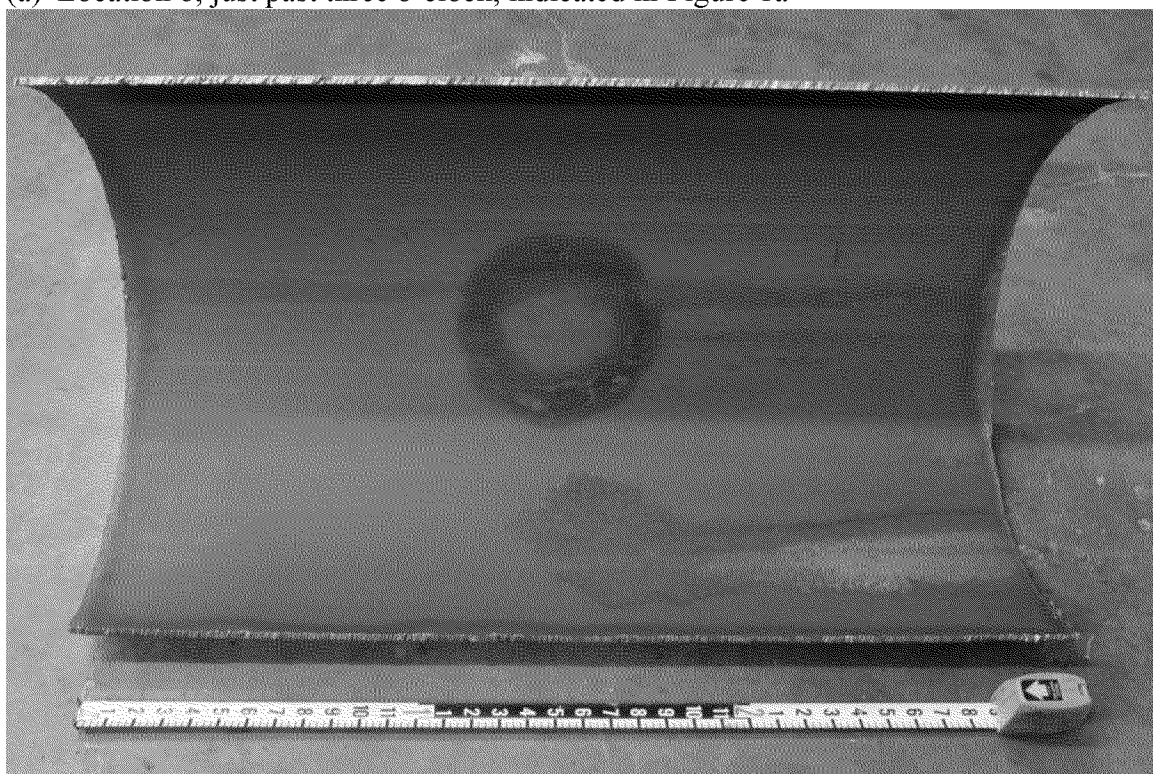
Figure 3 Photographs of pits on the outside surface and the inside surface of sample A.

(a) Location  $\delta$ , just past three o'clock, indicated in Figure 1a

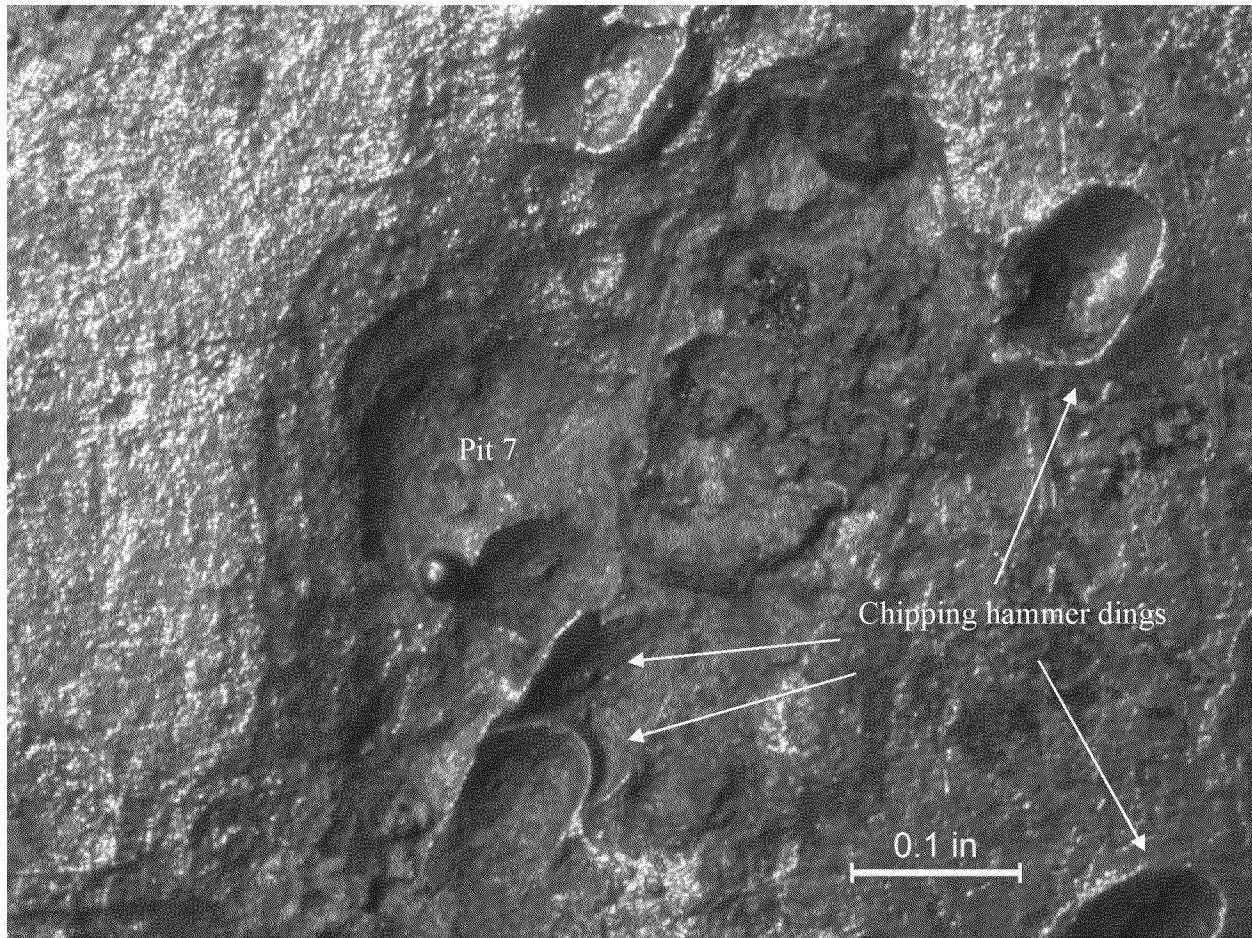
Figure 7 Macrograph of a pit under the PLIDCO cap, from the boxed area in Figure 6b.

The region containing the PLIDCO cap was sectioned from sample A and the cap was cut off to expose the outside surface of the pipe wall. The outside surface was covered with rust and had a slightly oily feel. Both surfaces were cleaned with dilute Oakite® 33 and a wire brush. The outside surface is shown before and after cleaning in Figure 6. Several regions of weld metal were visible on the outside surface. Examination using low-power optical microscopy revealed a pit consistent with corrosion on the outside surface, indicated in Figure 7. The inside surface is shown after cleaning in Figure 8. Indications of heat exposure were visible on the inside surface, corresponding to the weld metal on the outside surface. No evidence of weld burn through was detected, and fine grooves typical of wrought steel surfaces were continuous across the region, which indicated that repairs did not extend to the inside surface. Examination using low-power optical microscopy revealed a crack-like feature on the inside surface within the heat affected zone of a weld deposit, as shown in Figure 8b.

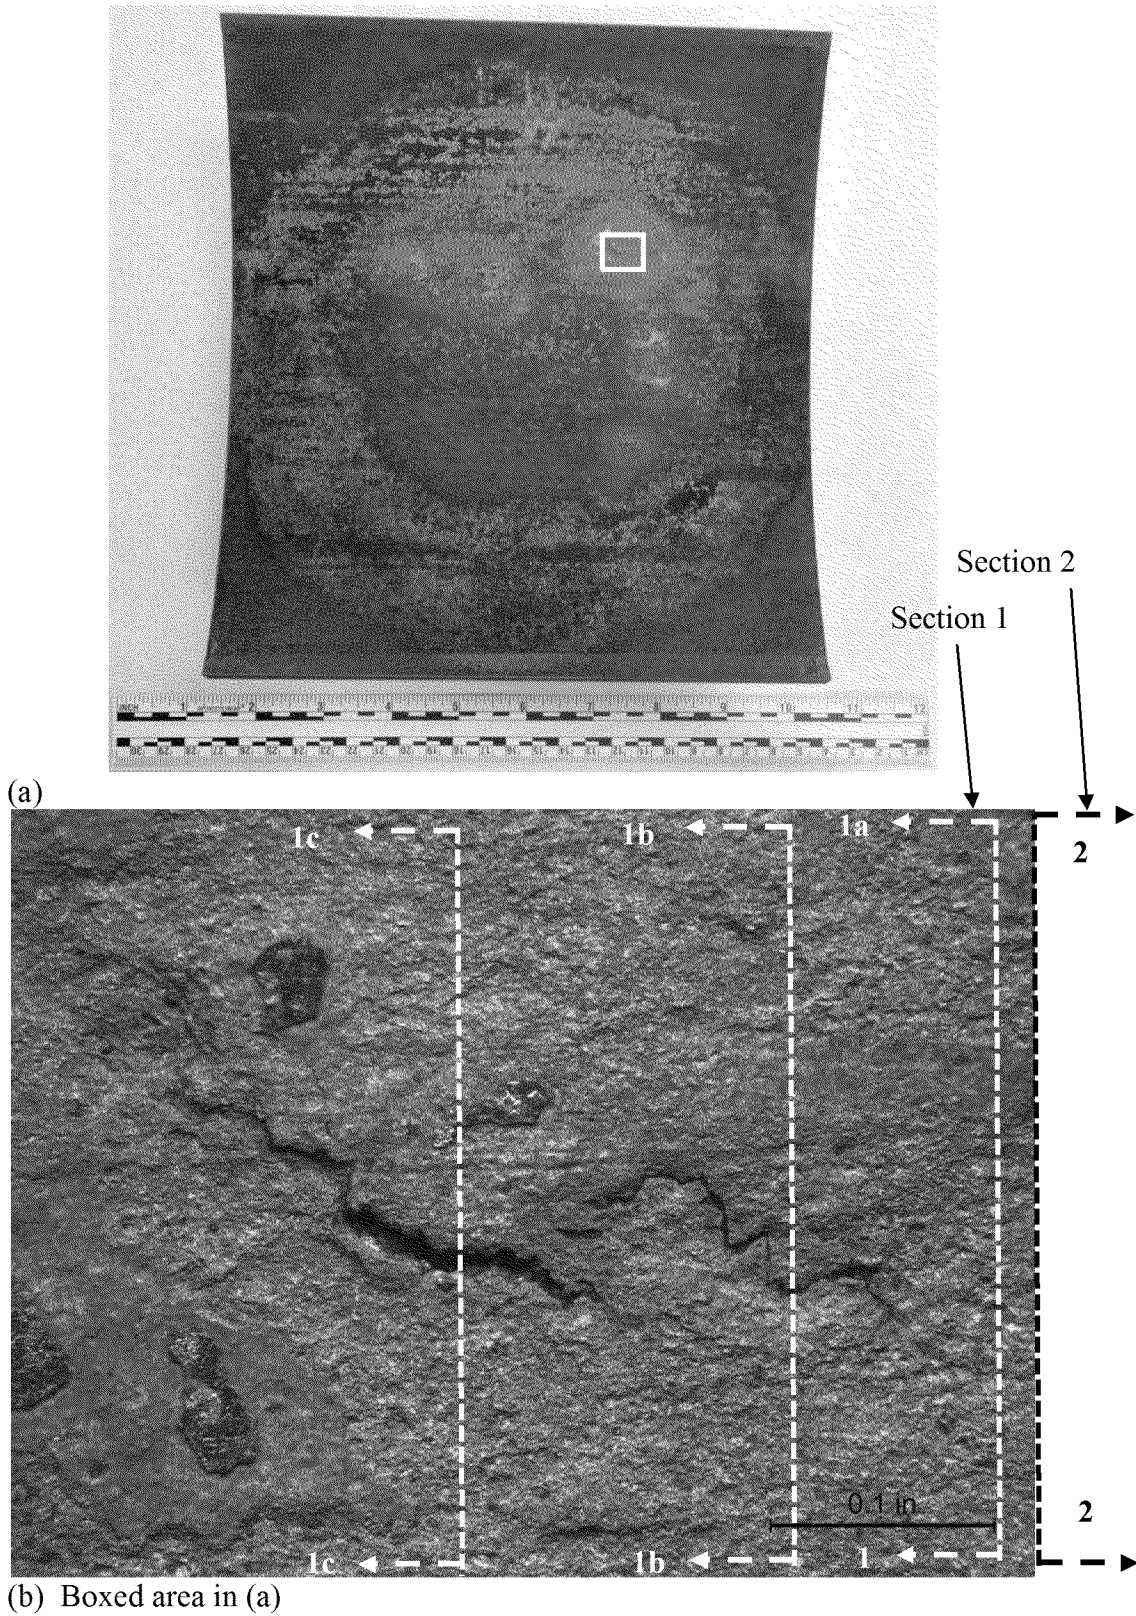
Figure 8 Photograph (a) and macrograph (b) of the inside surface of sample half A under the PLIDCO cap, after cleaning.

The sample shown in Figure 6 was returned to PG&E for radiography. A digital radiograph of the sample is shown in Appendix A along with a photograph of the sample. A crack indication was found that corresponded to the crack-like feature detected visually on the inside surface, shown in Figure 8b.

Specimens were prepared for metallography from section 1 and 2 indicated in Figure 8b. Weld crater cracks and heat affected zone liquation cracks were present in the sections. Serial grinding and polishing was performed on section 1, referred to as sections 1a, 1b, and 1c. As shown in Figure 10 through Figure 20, a weld crater crack extended from the outside surface into the weld heat affected zone in section 1a, but did not penetrate through the wall at this location. Shrinkage porosity was present near the outside surface, and intergranular cracks consistent with grain boundary liquation were present in the heat affected zone.

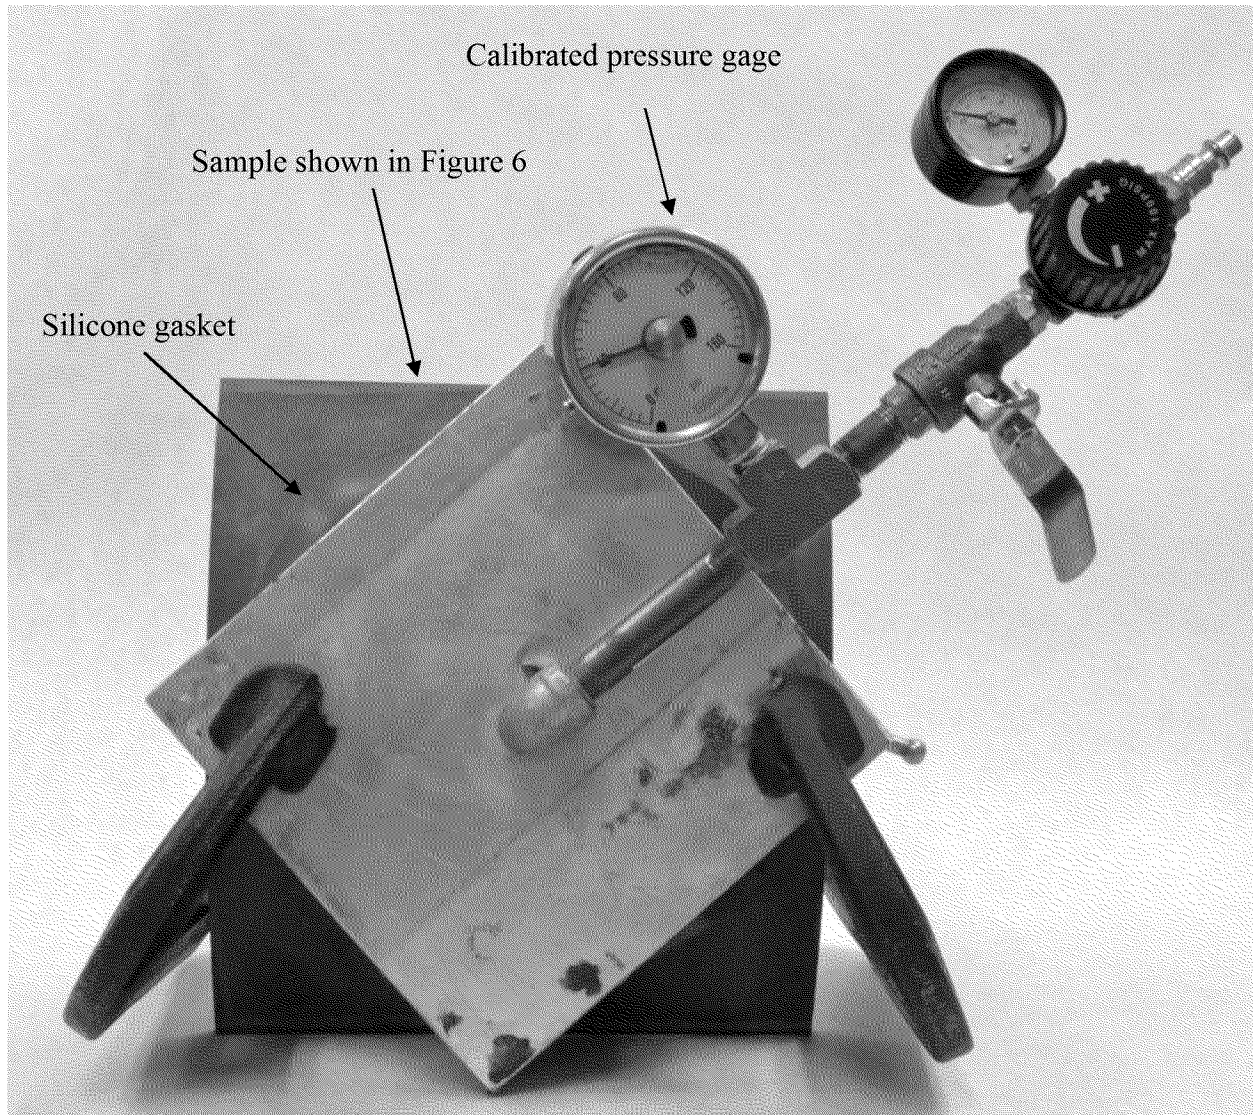
Figure 9 Pressure test setup.

A pressure test was performed by clamping a plate over the sectioned cap, sealed with a silicone gasket, and introducing 40-psig of compressed air. Snoop® liquid leak detector was applied to the inside surface. No leaks were detected. The compressed air was valved-off, and no pressure drop from 40-psig was detected after 45-minutes.

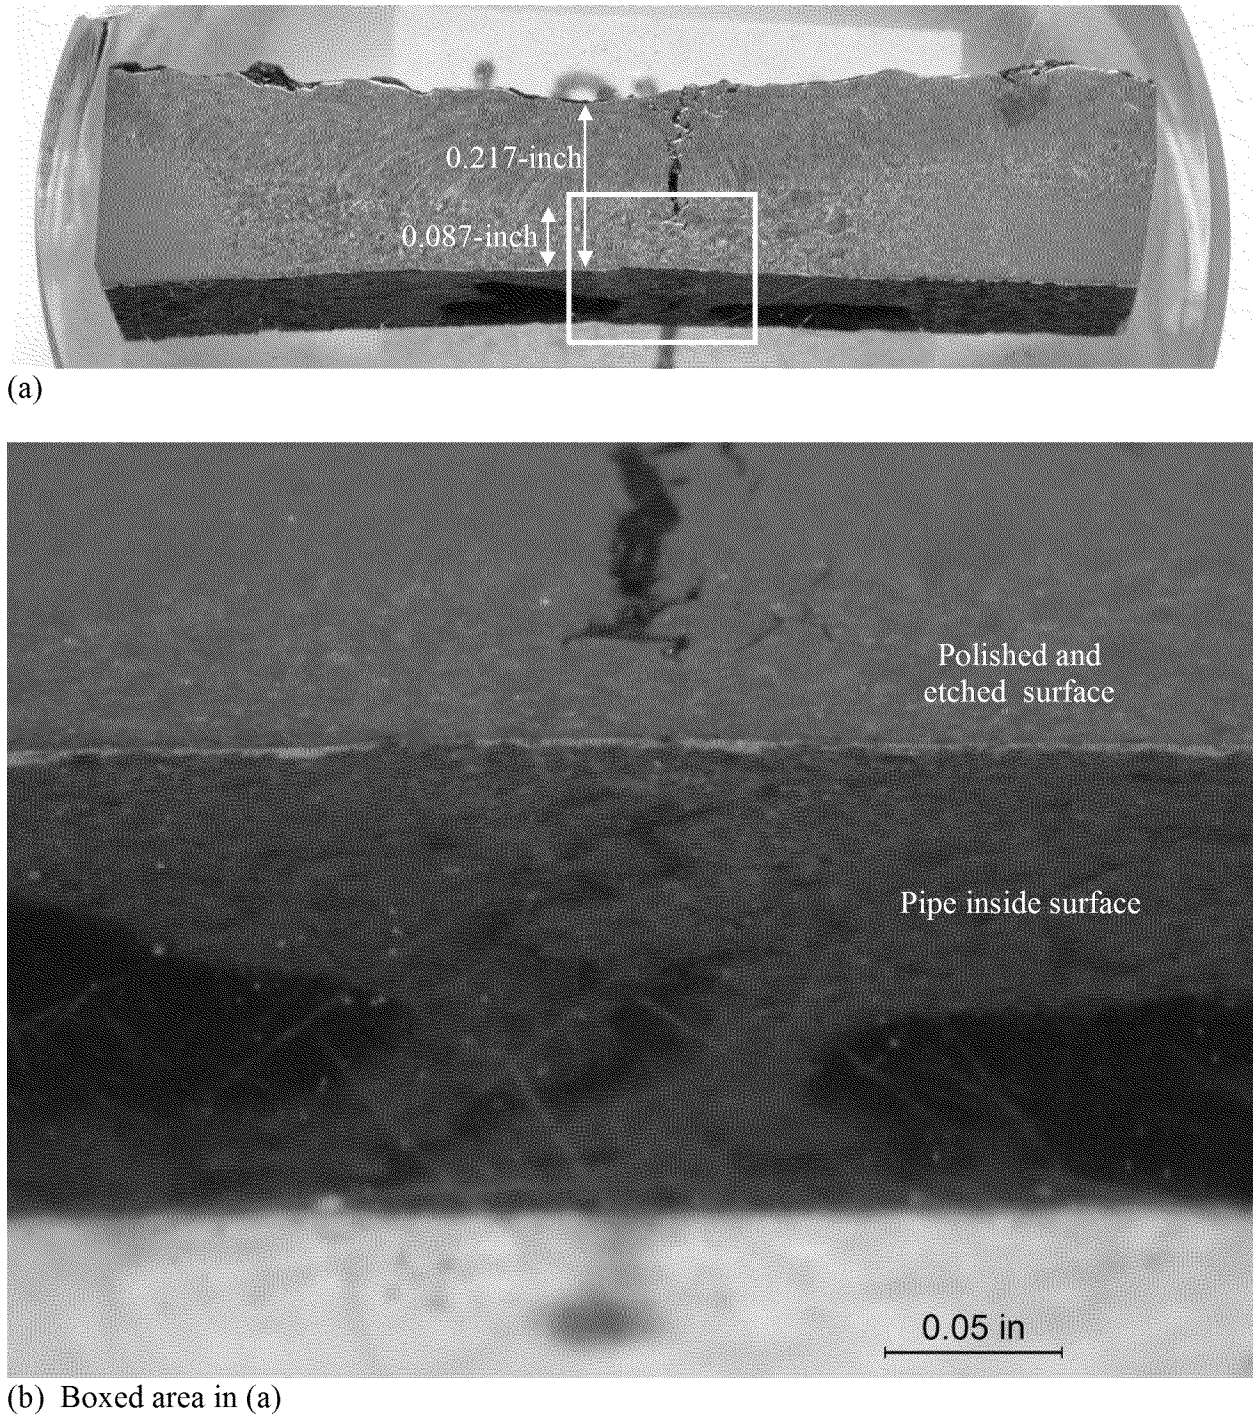
Figure 10 Images of the specimen prepared for metallography, section 1a. Etched with 2% nital.

Section 2 is shown in Figure 19. The fusion zone in this section had a profile that was more varied in depth than in sections 1a through 1c, which suggested the possibility that the weld metal was deposited to build-up locations where wall thickness had been reduced by external corrosion. Measurements of the minimum thickness of base metal beneath the weld metal are shown in Figure 10, Figure 13, Figure 16, and Figure 19.

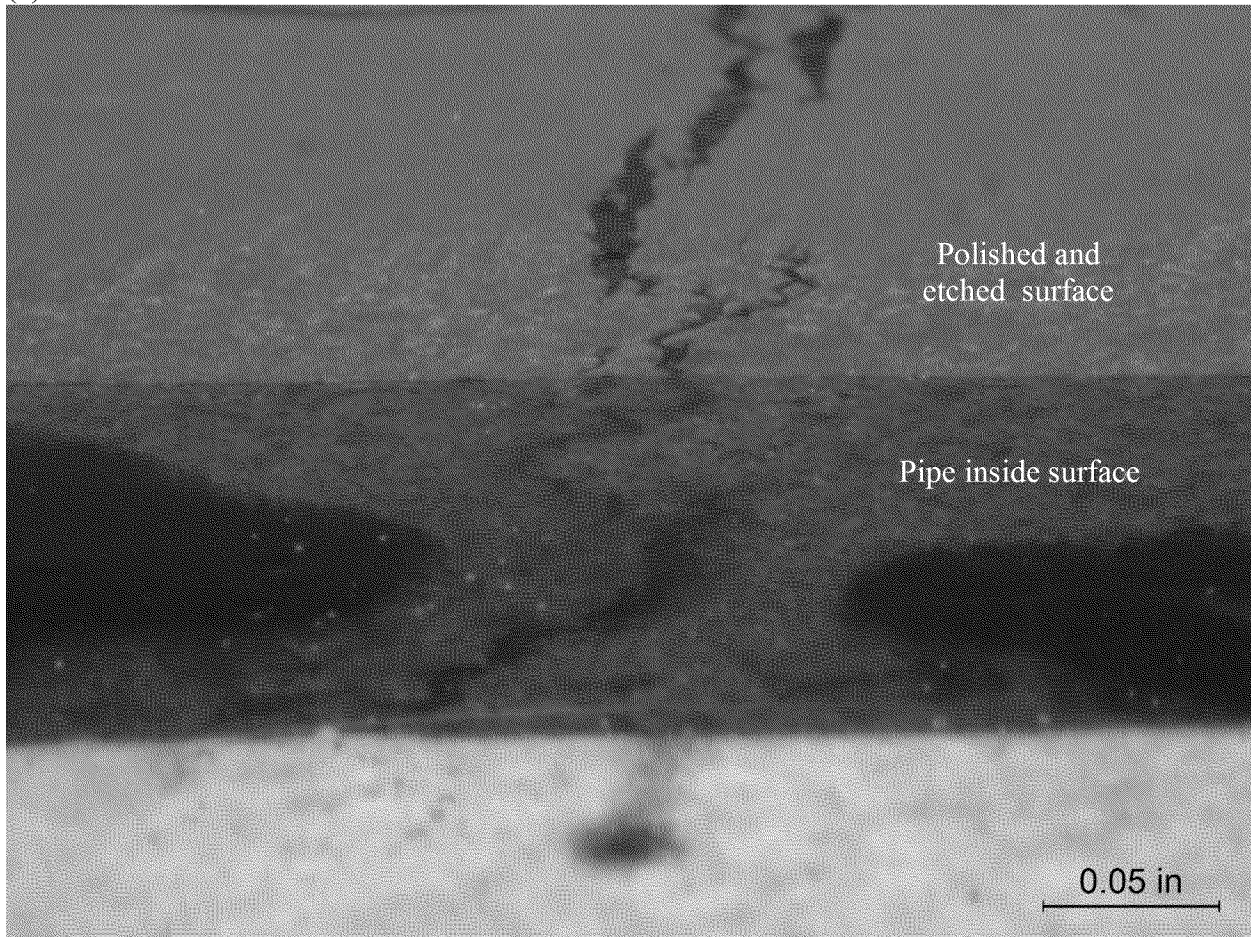
Figure 13 Images of the specimen prepared for metallography, section 1b. Etched with 2% nital.

In section 1b, shown in Figure 13 through Figure 15, cracks were present from the outside surface to the inside surface. Only a few small ligaments prevented the demonstration of a through-wall leak path. However, it is likely that a leak path existed between section 1a and 1b. The weld metal crack morphology was consistent with shrinkage, and the heat affected zone crack morphology was indicative of grain boundary liquation.

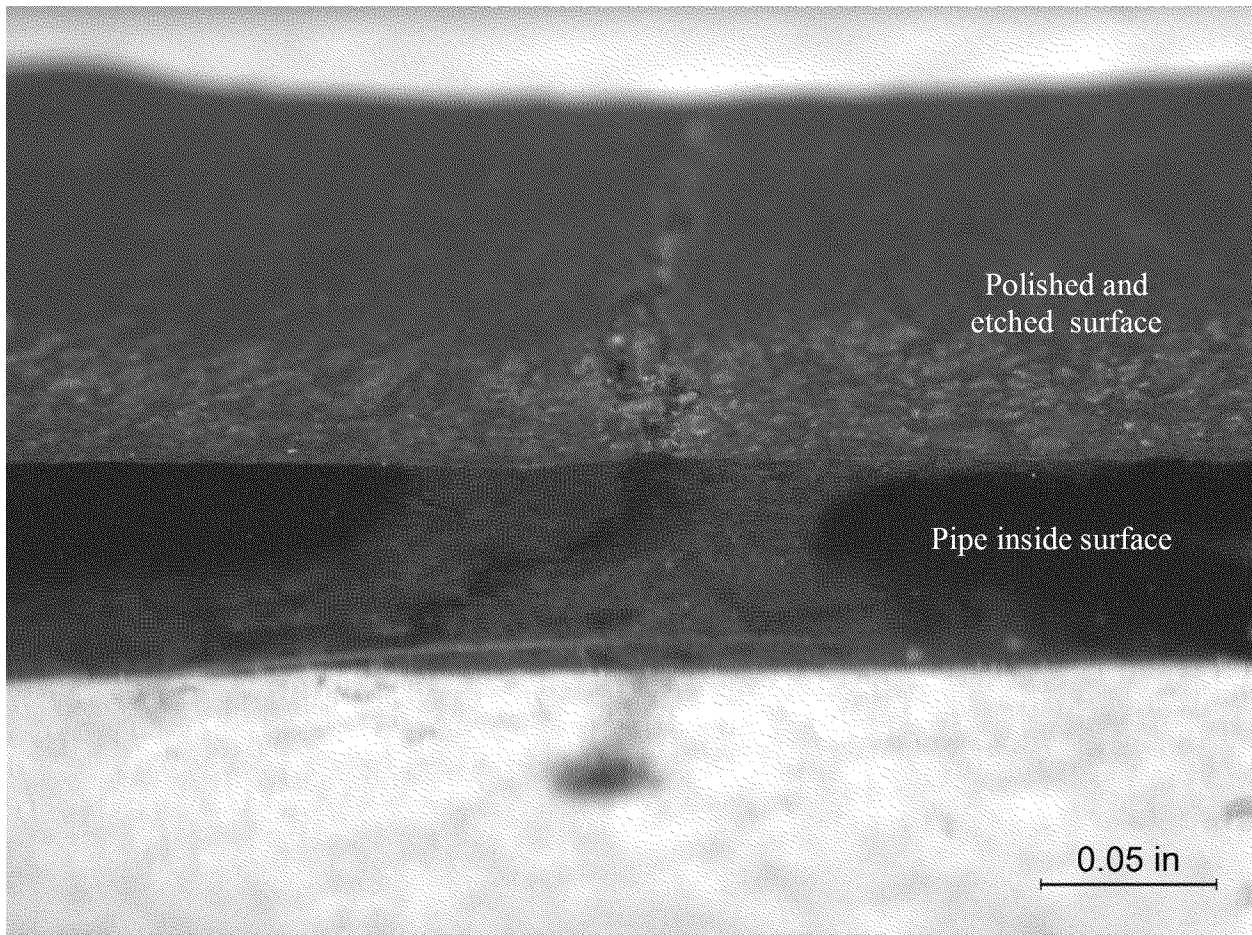
Figure 16 Images of the specimen prepared for metallography, section 1c. Etched with 2% nital.

In section 1c, shown in Figure 16 through Figure 18, one small ligament at the outside surface prevented demonstration of a through-wall leak path. Once again, the weld crack morphology was consistent with shrinkage and the heat affected zone crack morphology was consistent with grain boundary liquation. In all three sections of specimen 1, the weld fusion zone followed a smooth broad contour with no indications of external corrosion prior to welding.

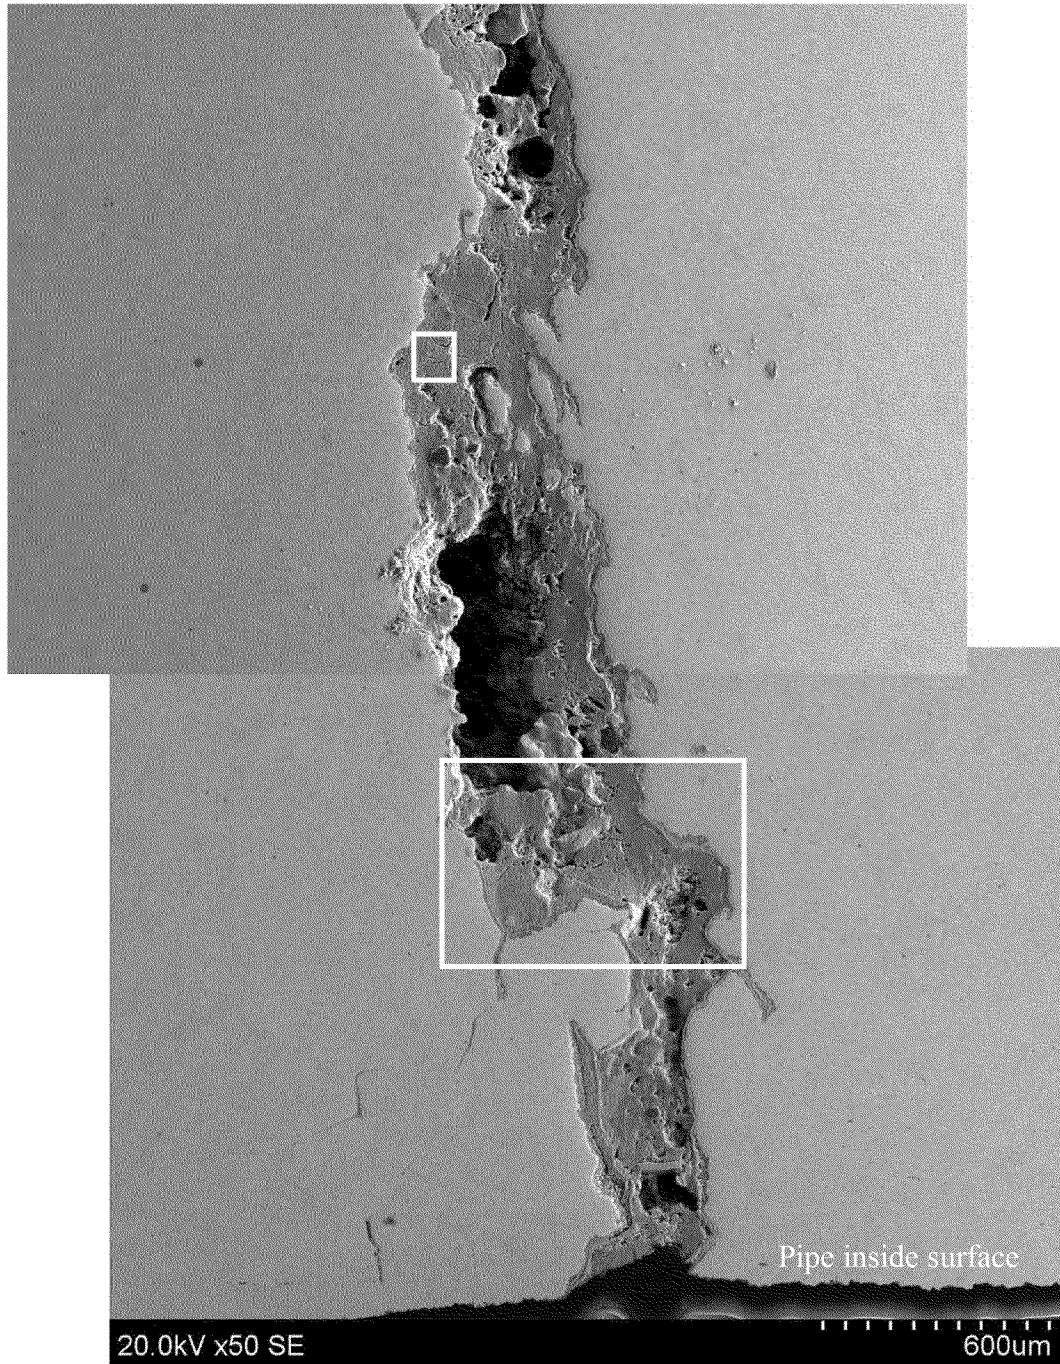
Figure 20 Composite SEM micrograph of the specimen prepared for metallography, section 1c.

Scanning electron microscopy (SEM) and energy dispersive X-ray spectroscopy<sup>2</sup> (EDS) was performed on the section 3 polished and etched surface. A composite SEM micrograph of the crack is shown in Figure 20. Much of the crack was filled with oxide, indicated by the morphology and chemical composition of primarily iron and oxygen, with sulfur present, likely from mercaptan in the gas stream.
