**BEFORE THE PUBLIC UTILITIES COMMISSION
OF THE STATE OF CALIFORNIA**

Order Instituting Rulemaking on the
Commission's Own Motion to Adopt New
Safety and Reliability Regulations for Natural
Gas Transmission and Distribution Pipelines
and Related Ratemaking Mechanisms

**DECLARATION OF SUMEET SINGH SUPPLEMENTING THE VERIFIED
STATEMENT OF PACIFIC GAS AND ELECTRIC COMPANY'S VICE
PRESIDENT OF GAS TRANSMISSION MAINTENANCE AND CONSTRUCTION
IN RESPONSE TO RULING OF ASSIGNED COMMISSIONER AND ASSIGNED
ADMINISTRATIVE LAW JUDGE**

**PG&E Line 147 Britton
and Rogers Avenue Leak:
Metallurgical Analysis**

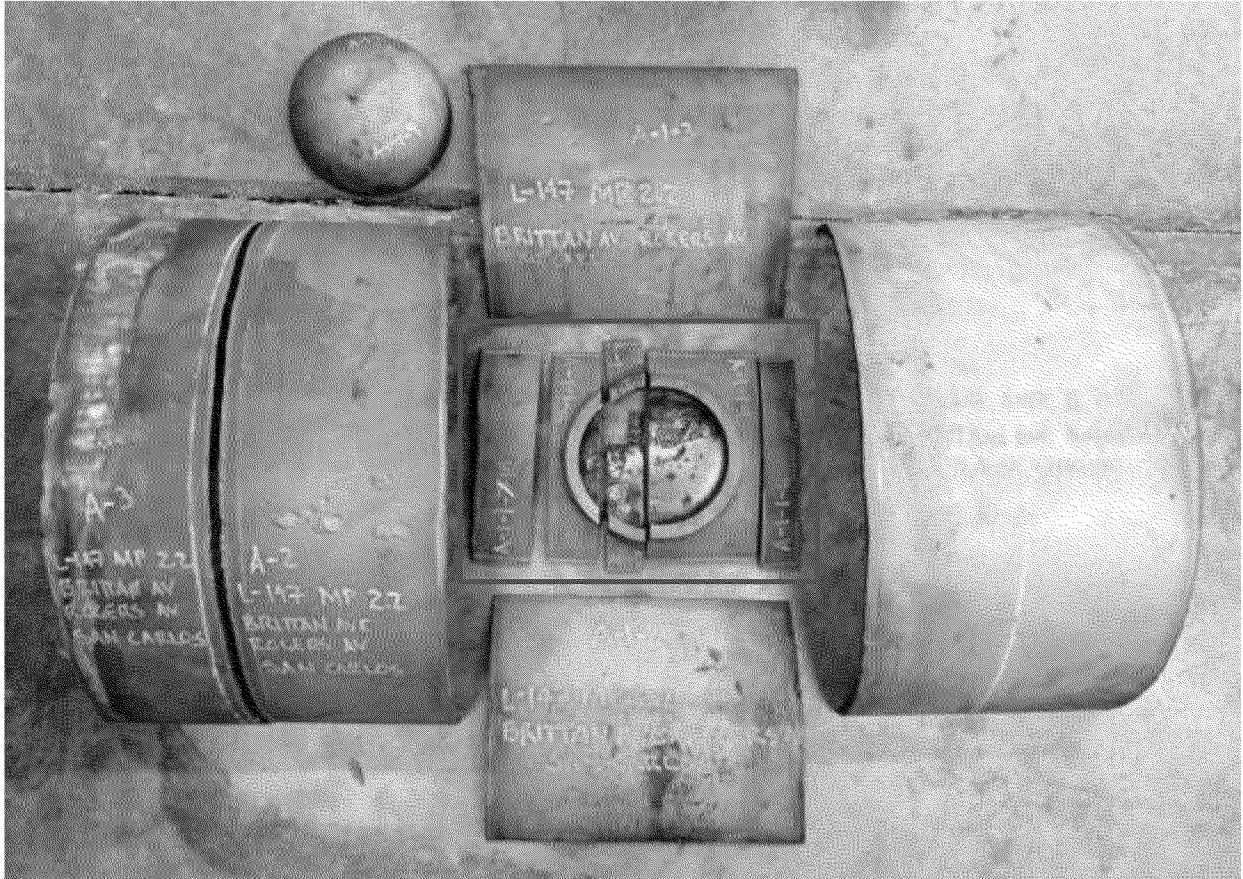
Figure 1. Photograph of the section of L-147 containing the crack and the PLIDCO cap welded over it to stop the gas leak. The red box shows the area magnified in Figure 3. Note the sectioning of the pipe and the yellow markings were made by Anamet.

The leak site was located in the area in the red box in Figure 1; enlarged in Figure 3. A PLIDCO cap had been welded onto the pipe to stop the leak until the subject pipe section could be removed. Beneath the cap, several weld repairs had been conducted. Anamet had sectioned the approximately 0.4-inch long crack into two pieces, then mounted, polished and etched the parts for analysis. The two metallurgical mounts are shown in Figure 4 as received from Anamet. Exponent retained Anamet's sample ID numbers, which for the metallurgical mounts are A-1-1-8 and A-1-1-7, left and right, respectively in Figure 4. As indicated in Anamet's report, these samples were subjected to serial grinding to evaluate different leak cross-sections. As such, portions of the leak that have been ground-away are no longer available for examination.

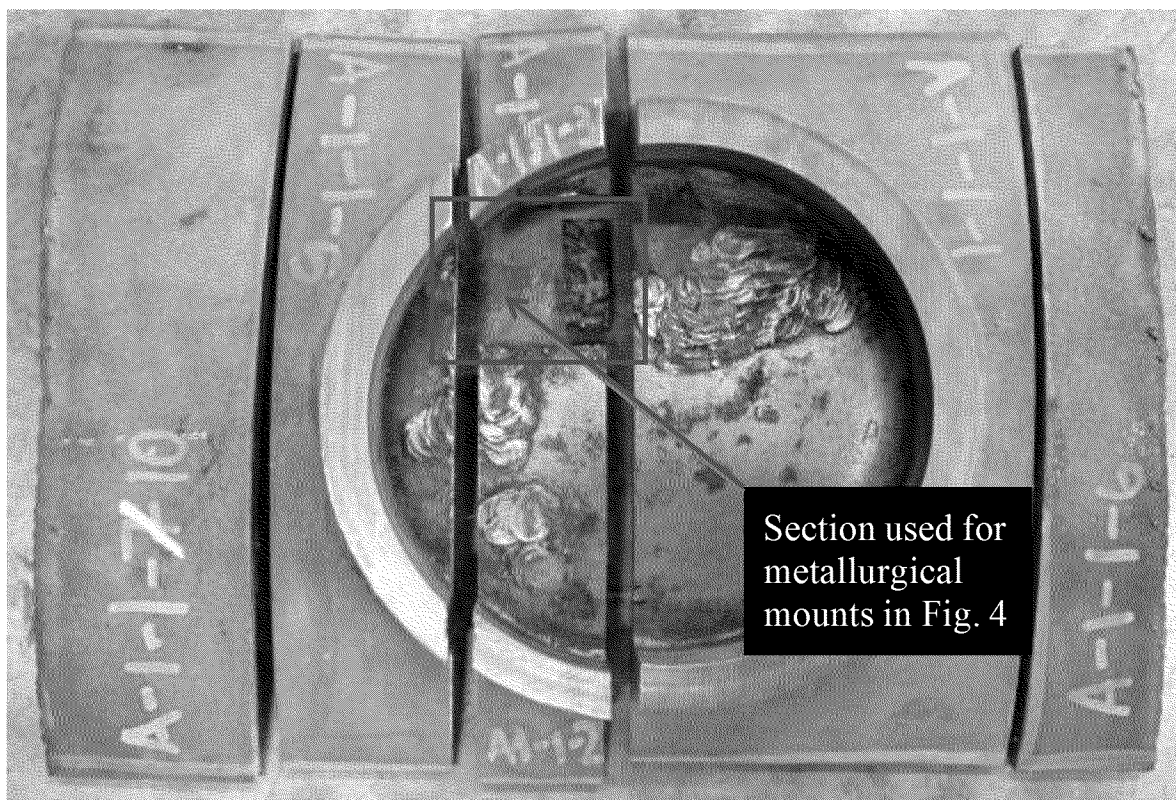
Figure 3. Photograph of the section of L-147 (boxed in red in Figure 1) containing the crack and the PLIDCO cap. Note the sectioning of the pipe and the yellow markings were made by Anamet.

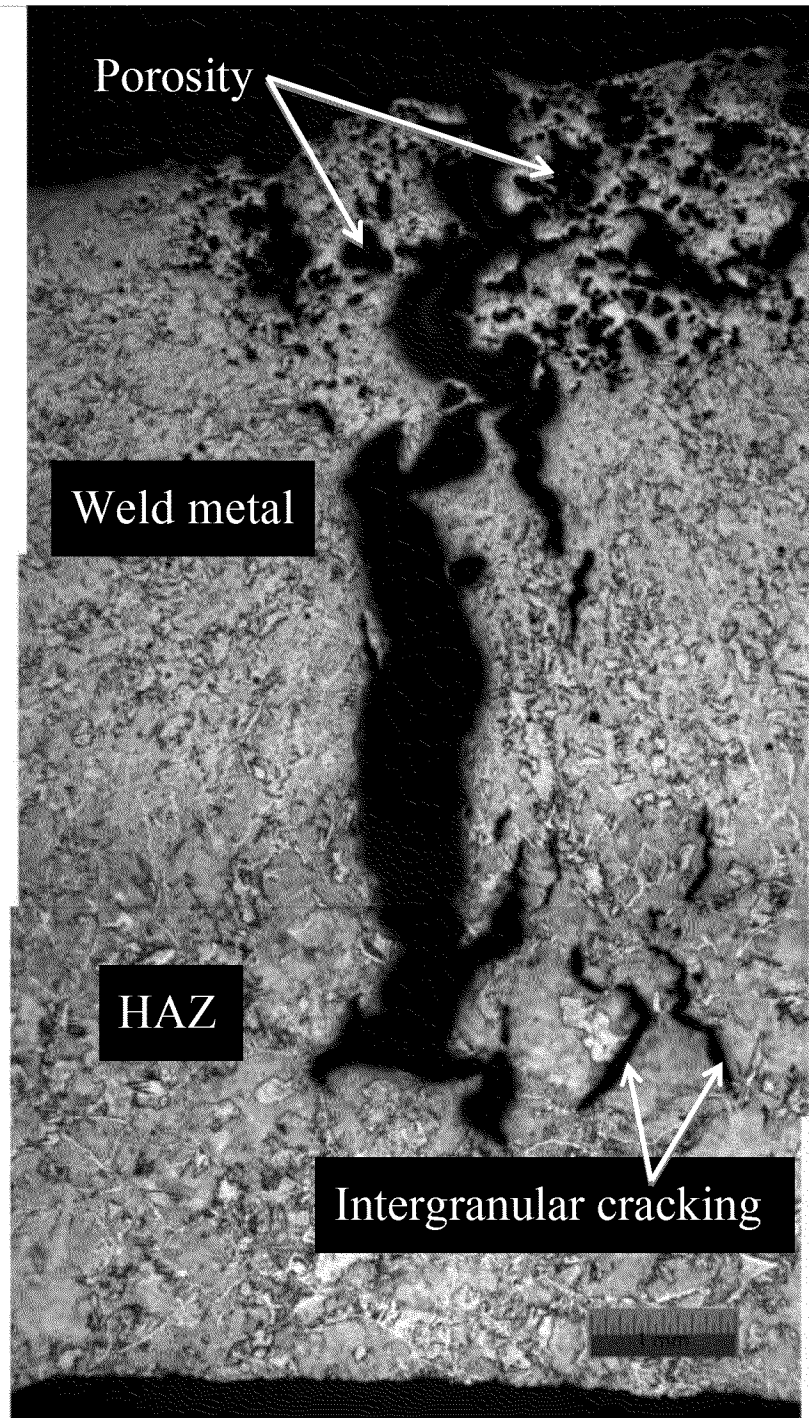
Anamet sectioned the subject leak perpendicular to the longitudinal axis of the pipe, and conducted metallographic analyses as described in their September 6, 2013 report. A composite optical image from Anamet's report, shown here as Figure 11, shows that the weld repair contained significant weld porosity and cracks near the center of the weld bead that run parallel to the dendritic structure. There is also evidence of intergranular fracture in the heat-affected zone (HAZ) next to the weld.

Figure 11. Composite optical micrograph of a metallurgical mount prepared by Anamet. Image reproduced from the September 6, 2013 Anamet report with permission from Anamet.

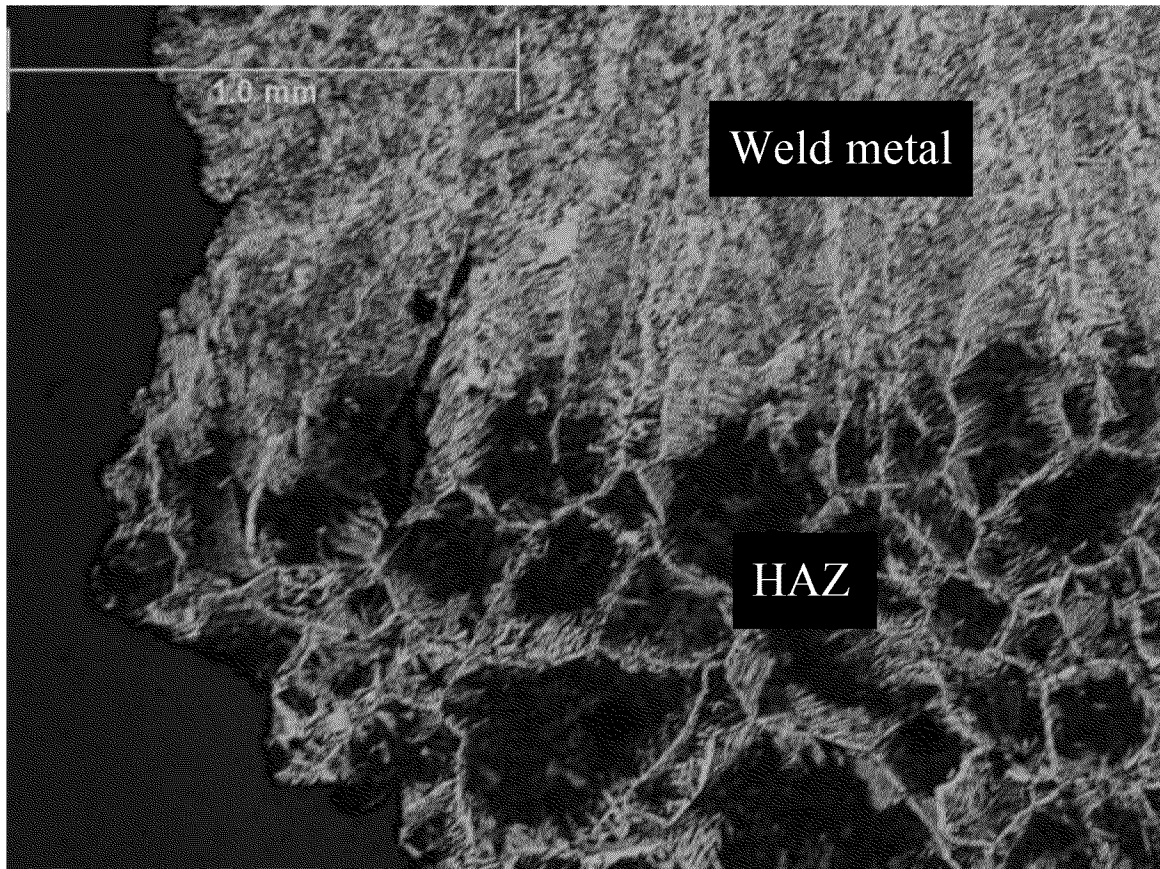
Following our fractographic examination, Exponent put the broken halves of the crack back together for further metallographic analysis and microhardness testing, shown in Figure 12 and Figure 13. The samples were re-polished and etched with two-percent nital solution. Like Anamet's analysis, significant porosity and interdendritic cracking were observed within the repair weld. The HAZ below the weld was characterized by grain coarsening with Widmanstatten-morphology pro-eutectoid ferrite, shown in Figure 14. The very large grains within the HAZ and the solidification cracking of the weld pool are both consistent of slow weld speeds with high heat input.

Figure 14. Metallographic image that shows significant grain coarsening beneath the weld in Sample A-1-1-8, with Widmanstatten ferrite at the prior-austenite grain boundaries in the heat-affected zone (HAZ).

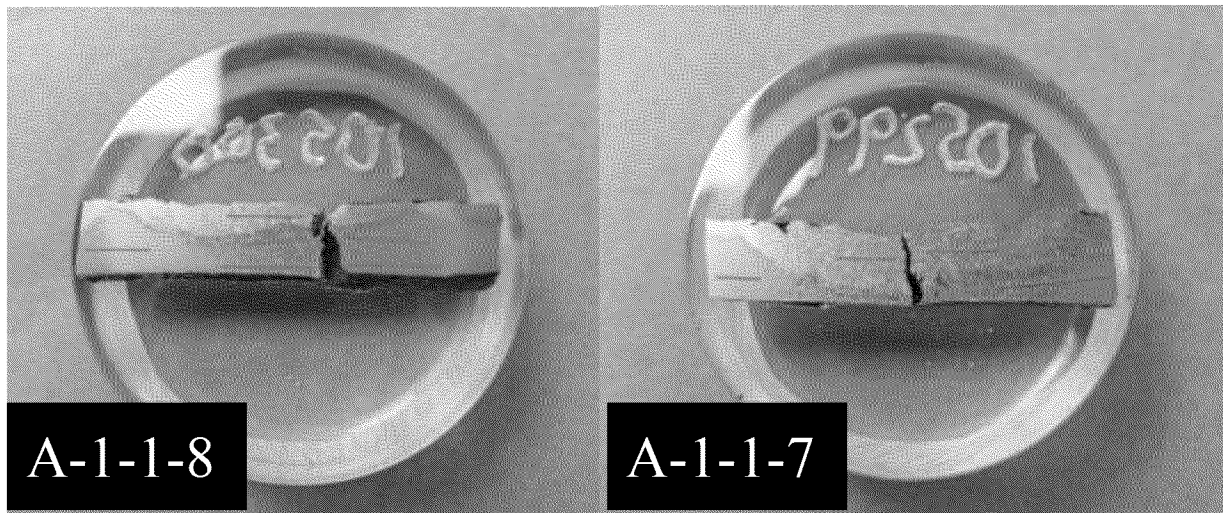
Vickers microhardness (HV) traverses were conducted over both metallographic mounts to assess hardness in the weld, HAZ, and base metal, shown by red lines in Figure 16. Each microhardness traverse and associated values are shown in Appendix B. Accounting for all testing samples, the base and weld metal exhibited average hardness values between 130-155 HV. The HAZ exhibited slightly higher hardness levels, between 155-190HV. However, it should be noted that the HAZ hardness levels are relatively low, consistent with the significant

grain coarsening observed. For carbon steels, a hardness of over 350HV would be considered excessive, and indicate a possible susceptibility to hydrogen cracking in the HAZ.^{4,5}

Figure 16. Metallurgical mounts of samples A-1-1-8 and A-1-1-7 made subsequent to opening the crack and examining it via optical microscopy and SEM/EDS. The red lines show where strings of microhardness testing points.
