R.11-02-019
(Filed February 24, 2011)

**DECLARATION OF SUMEET SINGH SUPPLEMENTING THE VERIFIED
STATEMENT OF PACIFIC GAS AND ELECTRIC COMPANY'S VICE
PRESIDENT OF GAS TRANSMISSION MAINTENANCE AND CONSTRUCTION
IN RESPONSE TO RULING OF ASSIGNED COMMISSIONER AND ASSIGNED
ADMINISTRATIVE LAW JUDGE**

**PG&E Line 147 Britton
and Rogers Avenue Leak:
Metallurgical Analysis**

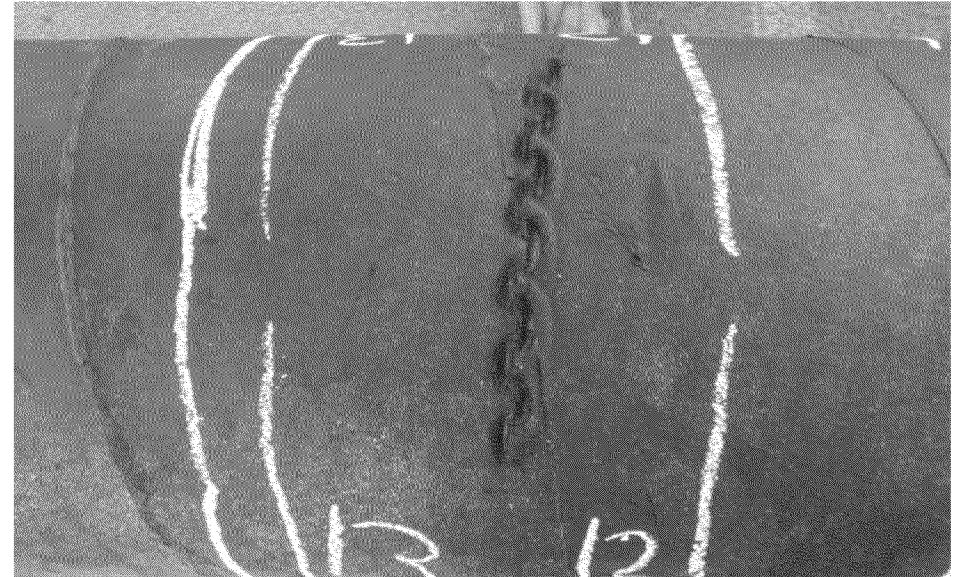
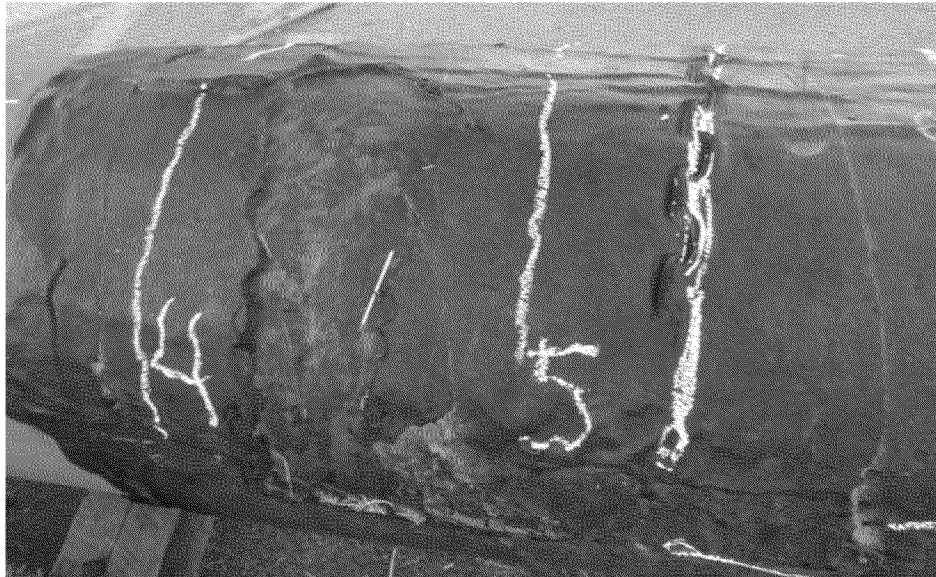
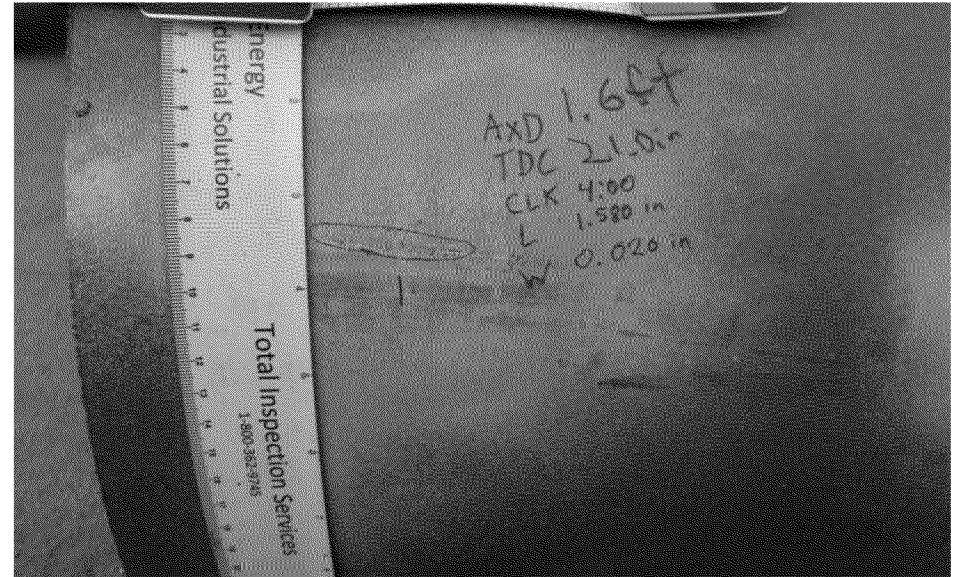
Coating damaged from removal process.

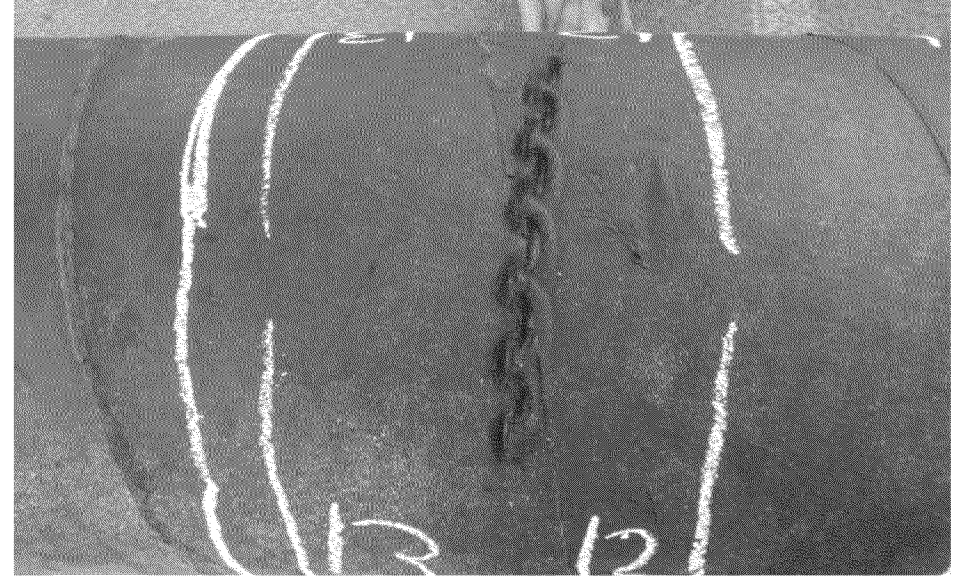
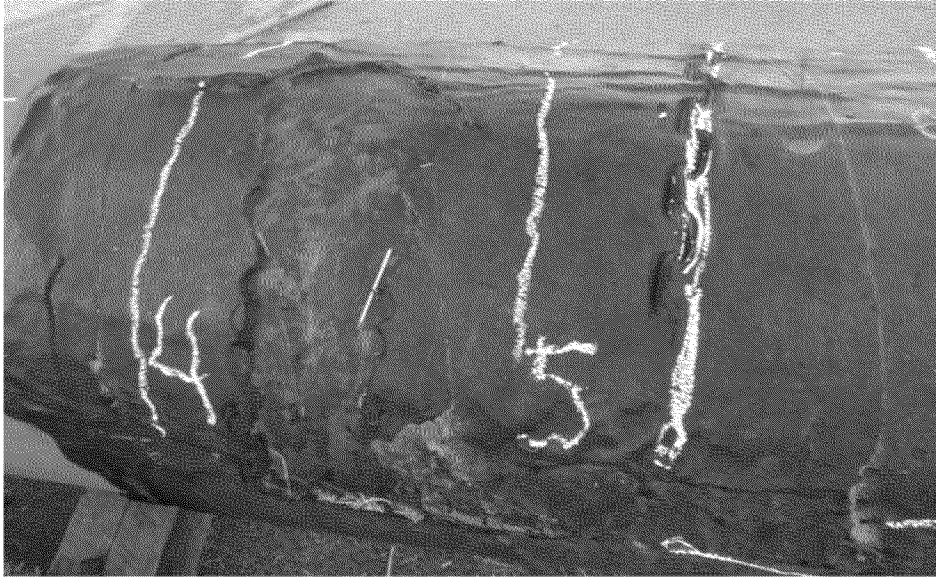
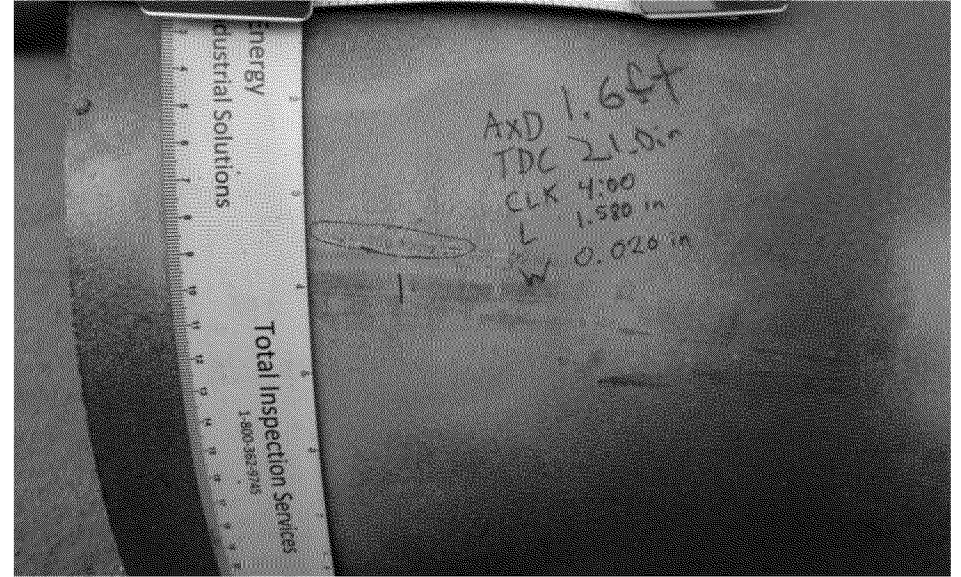
Coating damaged from removal process.

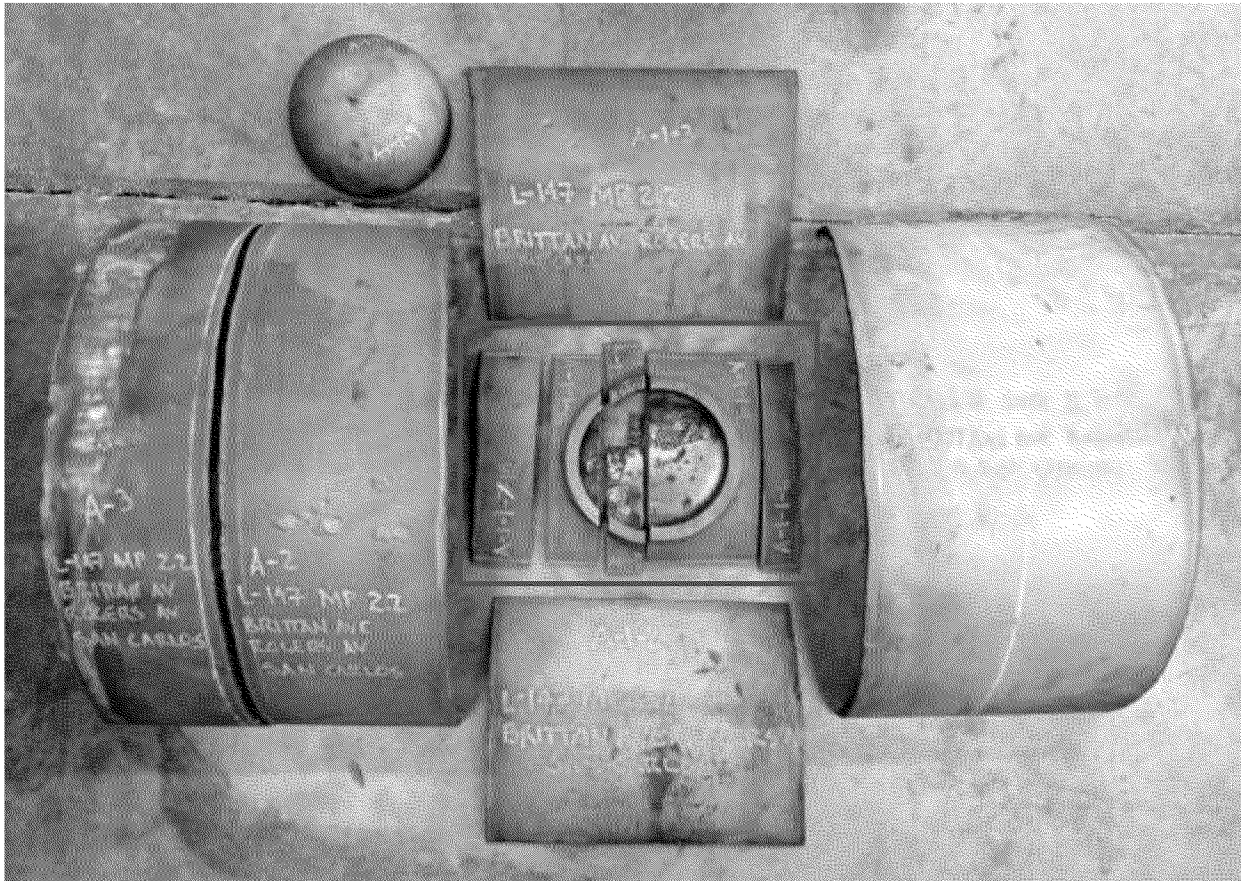
Figure 1. Photograph of the section of L-147 containing the crack and the PLIDCO cap welded over it to stop the gas leak. The red box shows the area magnified in Figure 3. Note the sectioning of the pipe and the yellow markings were made by Anamet.

The leak site was located in the area in the red box in Figure 1; enlarged in Figure 3. A PLIDCO cap had been welded onto the pipe to stop the leak until the subject pipe section could be removed. Beneath the cap, several weld repairs had been conducted. Anamet had sectioned the approximately 0.4-inch long crack into two pieces, then mounted, polished and etched the parts for analysis. The two metallurgical mounts are shown in Figure 4 as received from Anamet. Exponent retained Anamet's sample ID numbers, which for the metallurgical mounts are A-1-1-8 and A-1-1-7, left and right, respectively in Figure 4. As indicated in Anamet's report, these samples were subjected to serial grinding to evaluate different leak cross-sections. As such, portions of the leak that have been ground-away are no longer available for examination.

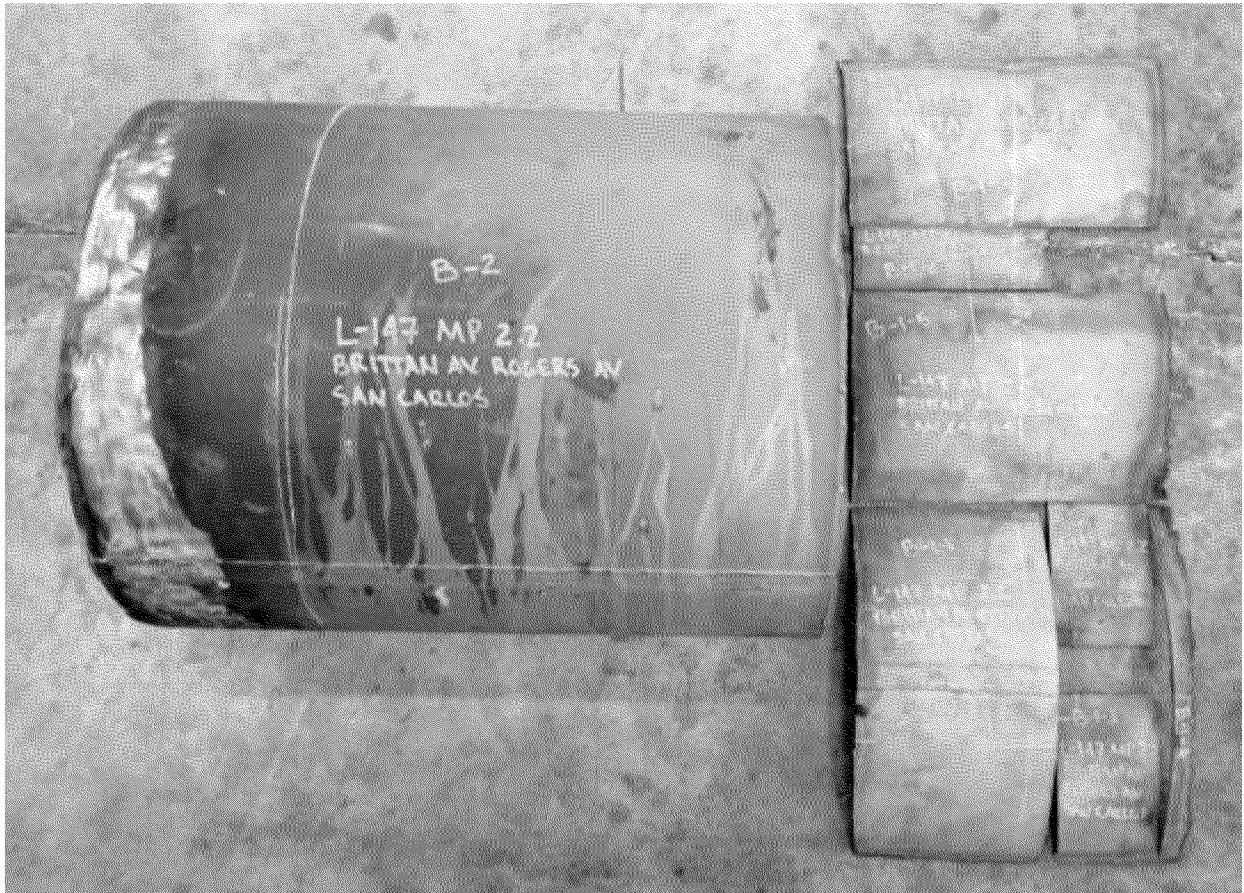
Figure 2. Photograph of a section of L-147 removed from the section of pipe containing the crack. Note the sectioning of the pipe and the yellow markings were made by Anamet.

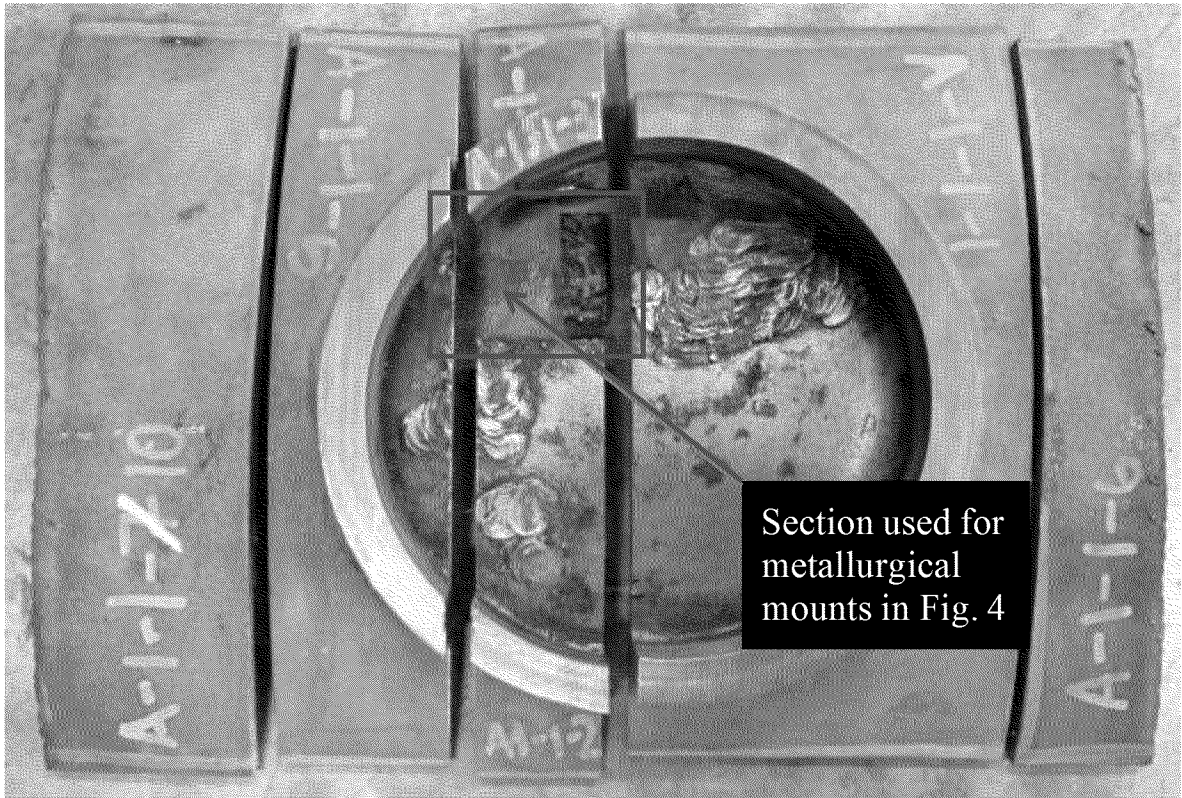
Figure 3. Photograph of the section of L-147 (boxed in red in Figure 1) containing the crack and the PLIDCO cap. Note the sectioning of the pipe and the yellow markings were made by Anamet.

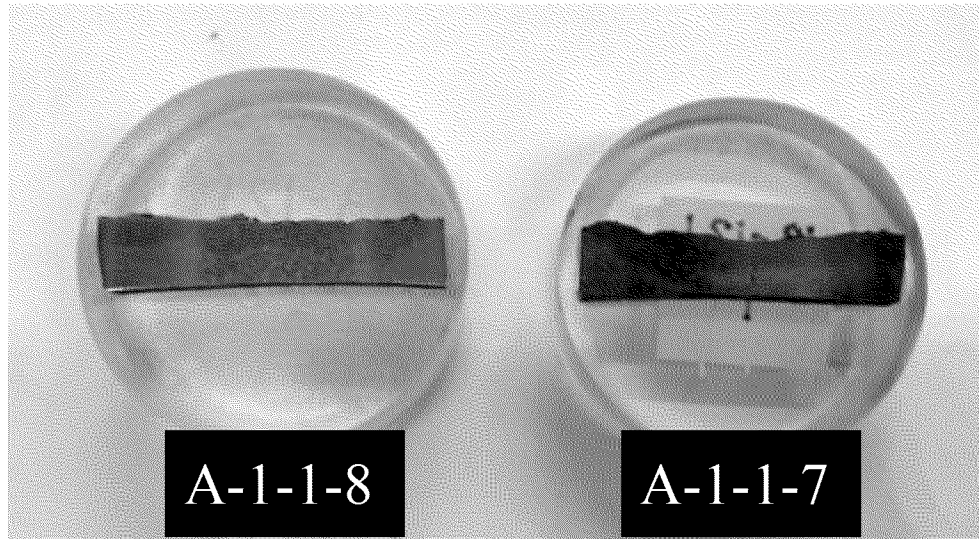
Figure 4. Photograph of the metallurgical mounts of the area containing the crack in L-147 under the PLIDCO cap. Note the metallurgical mounts were made by Anamet: Exponent retained Anamet's sample ID numbers A-1-1-8 (left); A-1-1-7 (right).

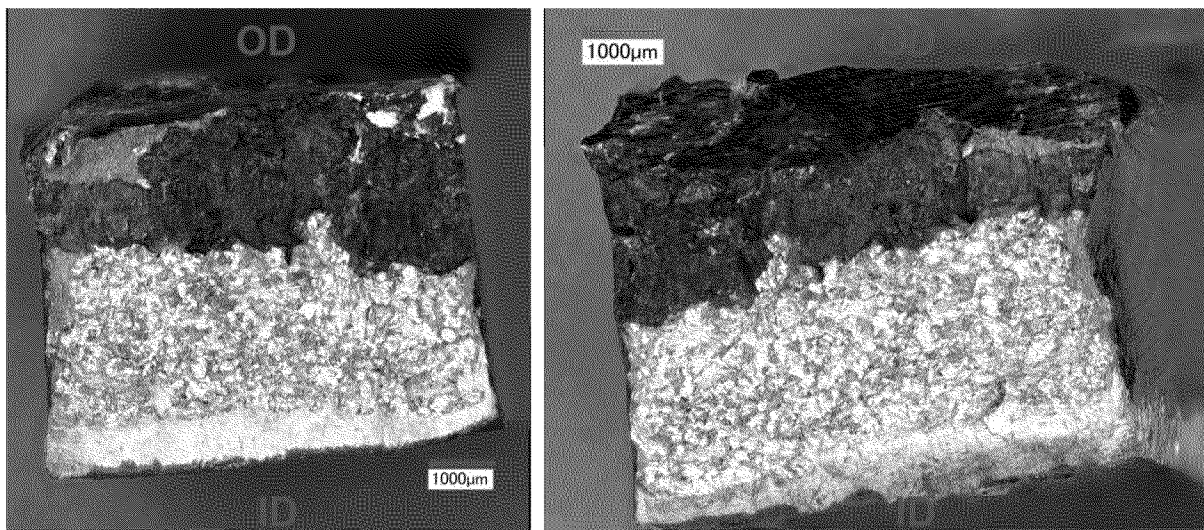
Figure 5. Optical micrographs of the leak surface after opening Anamet's A-1-1-8 metallurgical mount.

As shown in Figure 5, the pre-existing crack in Sample A-1-1-8 only extended from the OD approximately halfway through the pipe wall. The pre-existing crack A-1-1-7 extended from the ID nearly to the OD surface. While neither of these two samples display a clear ID-to-OD leak path, the pre-existing crack in Sample A-1-1-7 extends nearly through the pipe wall thickness. Based on the metallographic images in Anamet's report, as well as fractographic analysis of the remaining broken-open metallographic specimens, it is apparent that the through-wall (ID-to-OD) path for the subject leak was less than the 0.4 inch total length of the cracks.

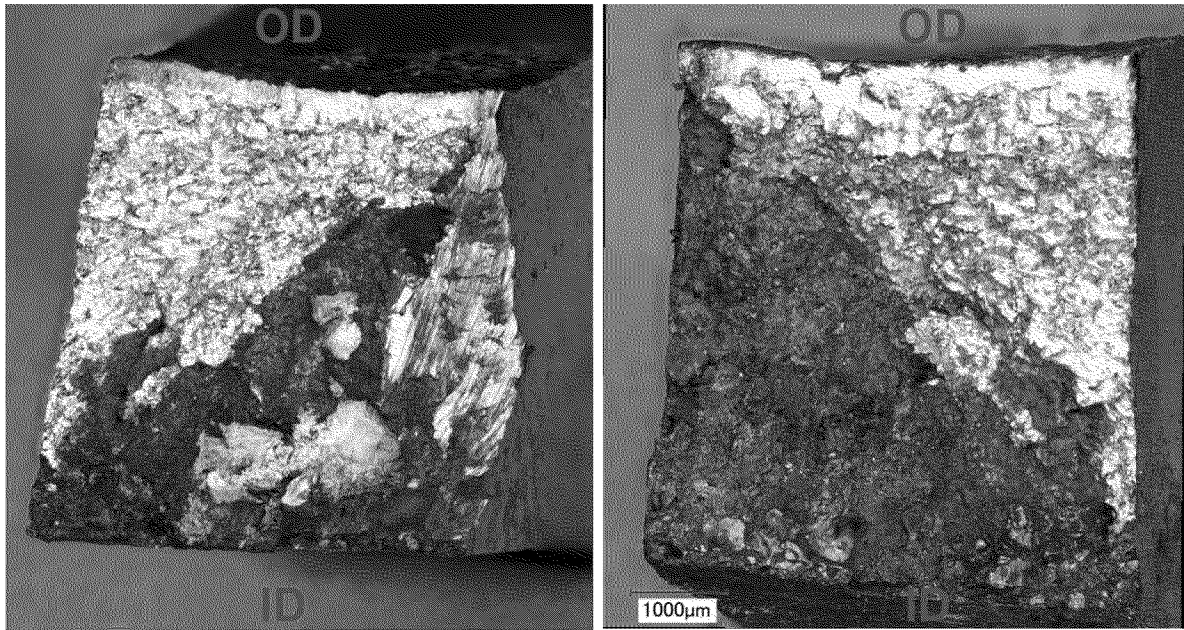
Figure 6. Optical micrographs of the leak surface after opening Anamet's A-1-1-7 metallurgical mount.

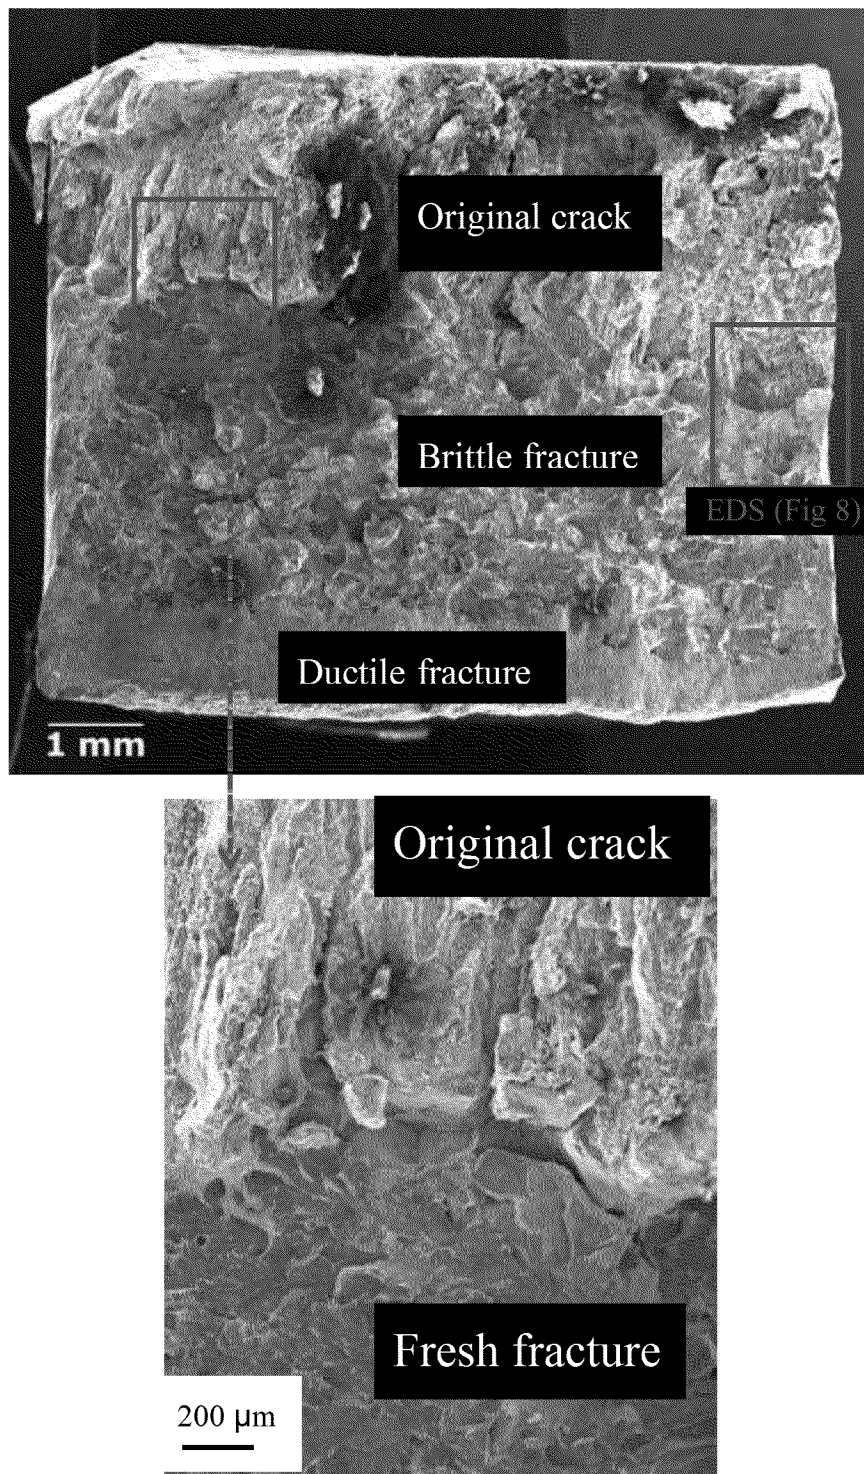
Figure 7. SEM images of Sample A-1-1-8 fracture surface (left side of Figure 5). Top image shows the entire surface with one red box magnified (bottom image) and another red box for the area analyzed with EDS in Figure 8.

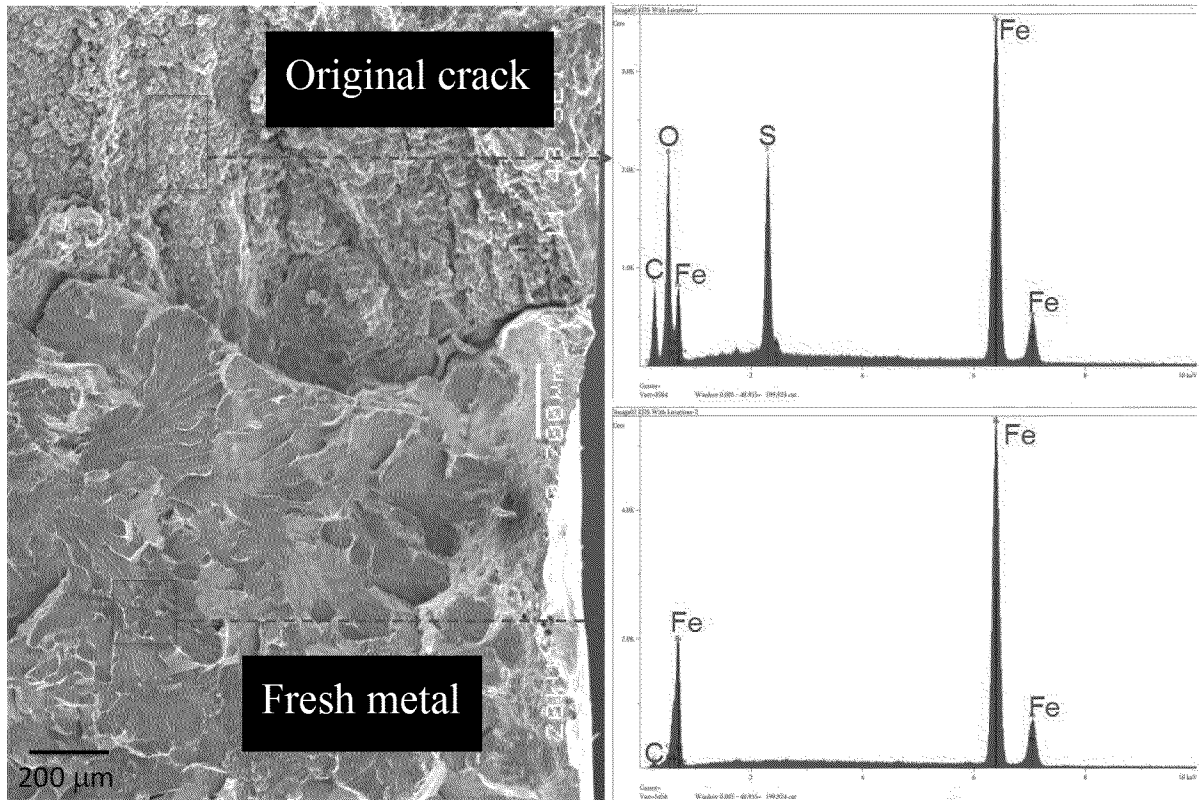
The Sample A-1-1-8 fracture surface was examined using EDS, which is highlighted in the red box in top image of Figure 7 and presented in Figure 8. The freshly-induced cleavage fracture surface below shows only the presence of iron and a small amount of carbon. The original crack surface, however, exhibited significantly increased levels of carbon, oxygen and sulfur, consistent with iron oxide (rust) as well as sulfur deposits. The sulfur is most likely from mercaptan-based odorizer added to natural gas to give the characteristic “rotten-egg” smell.

Figure 8. EDS analysis of the area in the red box in the right side of the top image in Figure 7. The lower portion is the freshly cracked surface; the top is the surface of the original crack composed of iron oxide with a large amount of sulfur, likely from the mercaptans added to give scent to the gas.

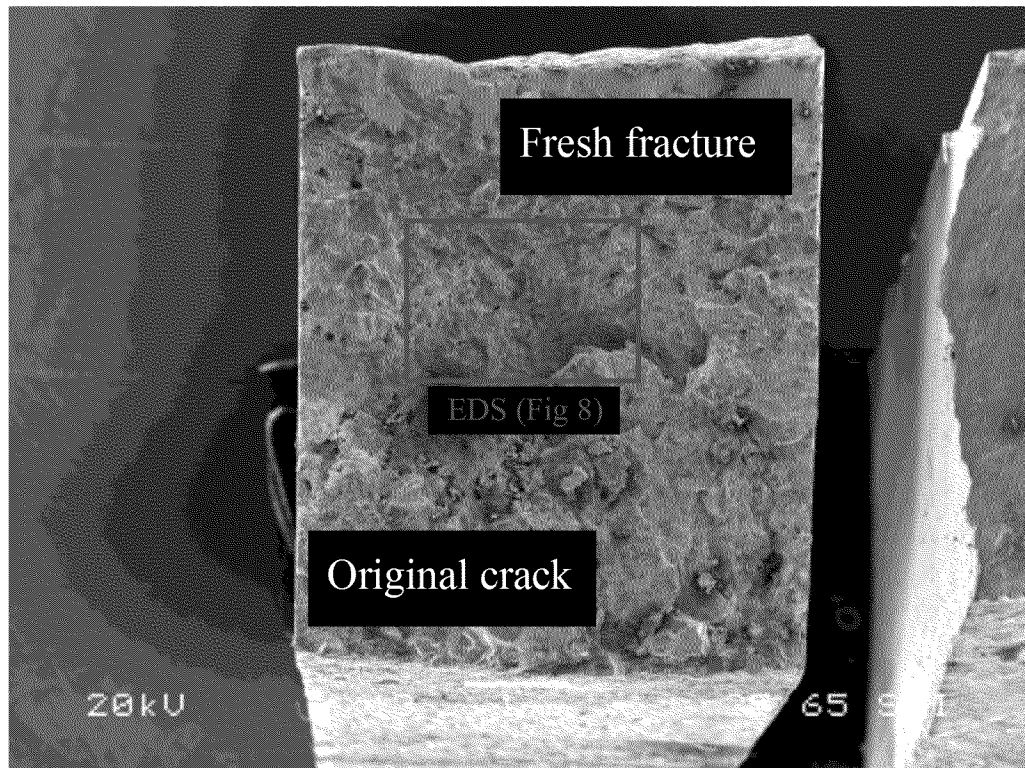
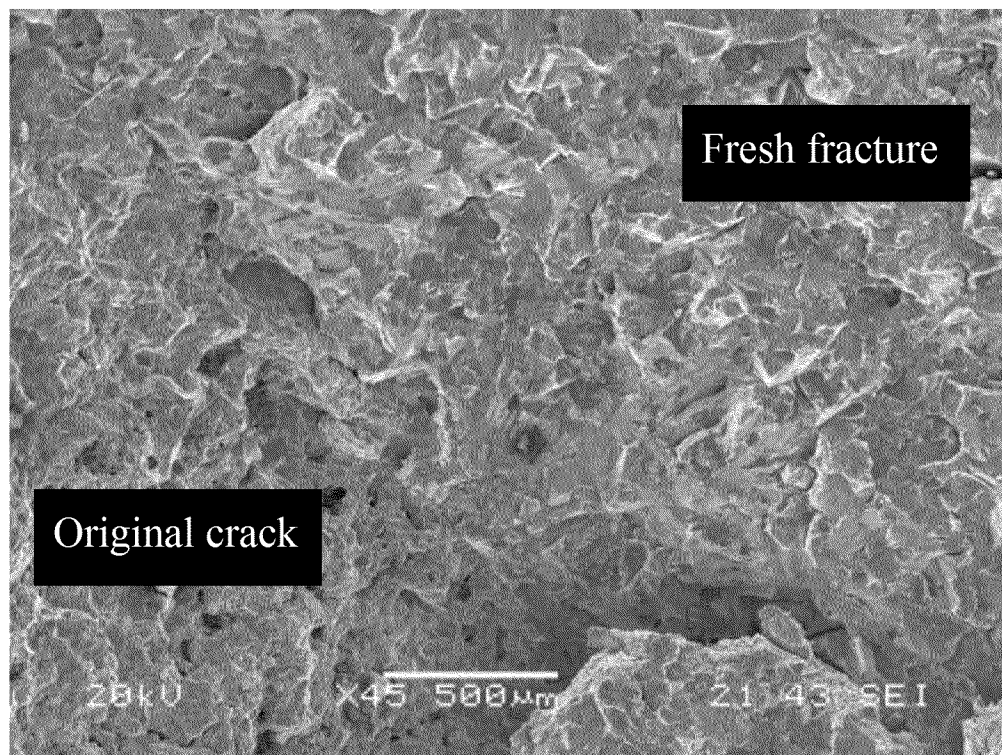
Similar SEM and EDS examination was performed on the Sample A-1-1-7 fracture surface faces, example images are shown in Figure 9 and Figure 10. The substantial oxide deposits on the original leak surface obscured much of fracture morphology in the original-cracked portion of Sample A-1-1-7, as shown in Figure 9. However, the transition between the original crack surface and the intentional brittle (cleavage) fracture area showed no evidence of progressive growth, also shown in Figure 9.

Figure 9. One side of the crack surface in Sample A-1-1-7 (right side of Figure 6). The red box shows the area analyzed with EDS in Figure 10.

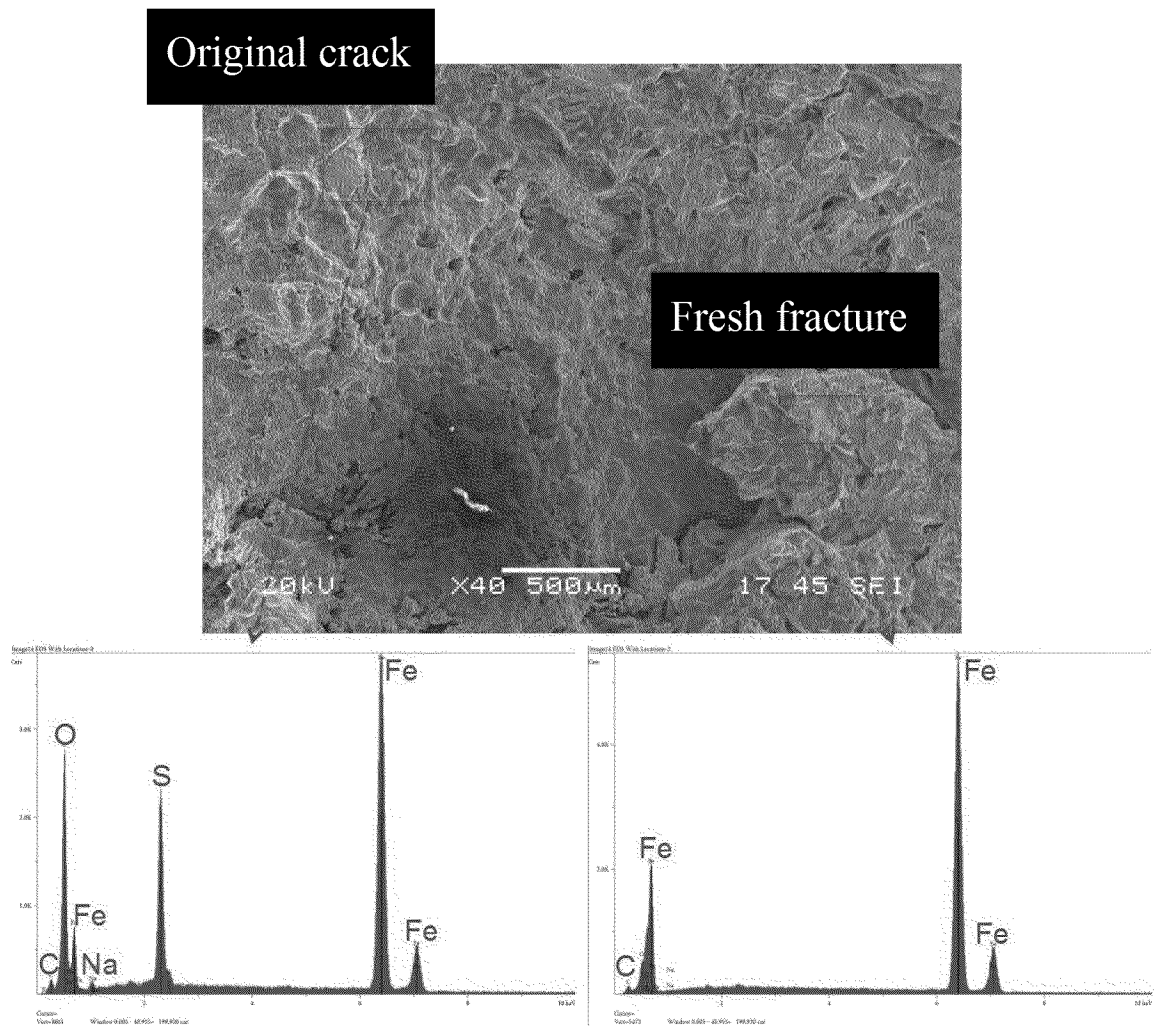
EDS analysis of the Sample A-1-1-7 fracture surface showed similar findings as exhibited in Sample A-1-1-8. The freshly-exposed brittle fracture surface showed primarily iron with a small amount of carbon, while the original leak surface exhibited significant amounts of carbon, oxygen, and sulfur, as shown in Figure 10.

Figure 10. EDS analysis of the area in the red box in the top image in Figure 9. The right side is the freshly cracked surface; the left side is the surface of the original crack composed of iron oxide with significant sulfur.

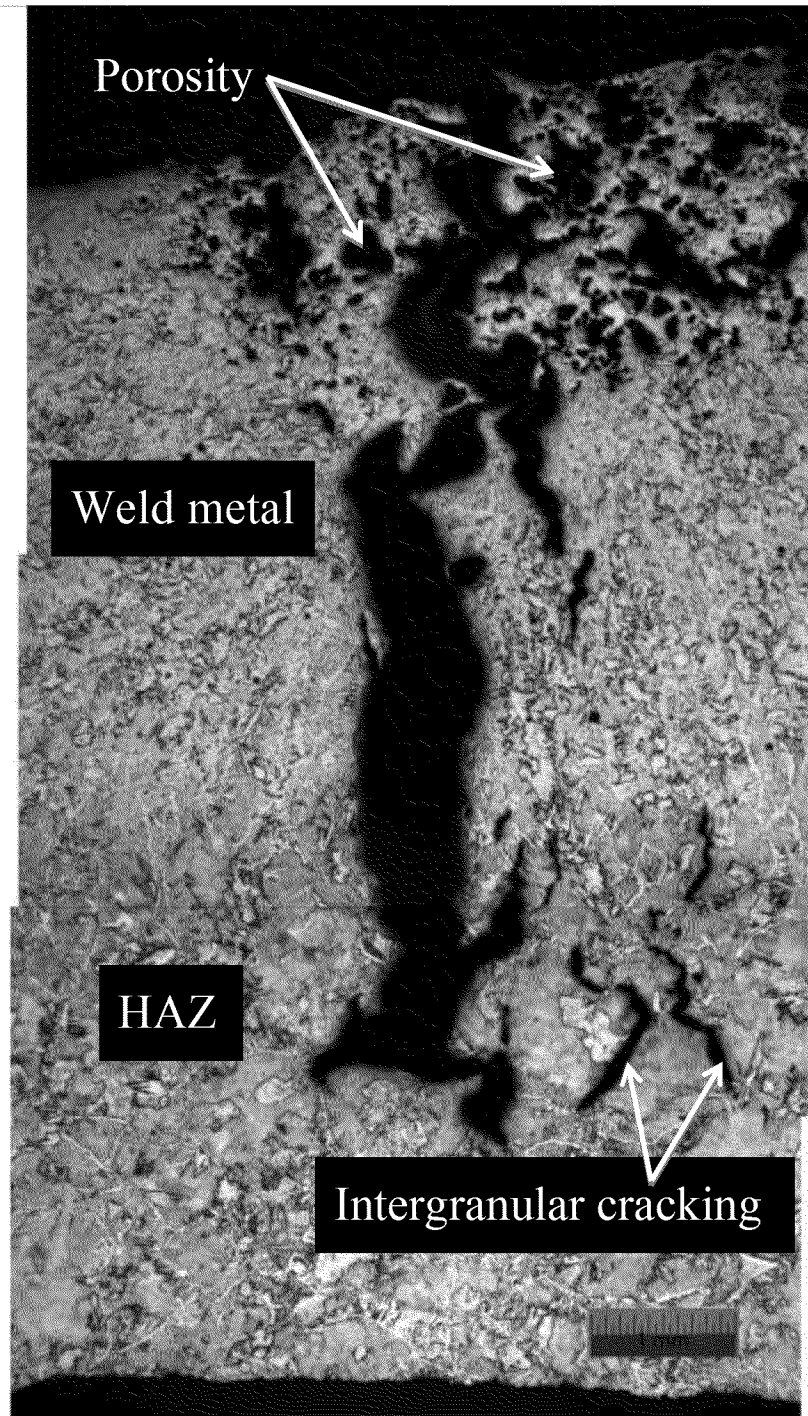
Anamet sectioned the subject leak perpendicular to the longitudinal axis of the pipe, and conducted metallographic analyses as described in their September 6, 2013 report. A composite optical image from Anamet's report, shown here as Figure 11, shows that the weld repair contained significant weld porosity and cracks near the center of the weld bead that run parallel to the dendritic structure. There is also evidence of intergranular fracture in the heat-affected zone (HAZ) next to the weld.

Figure 11. Composite optical micrograph of a metallurgical mount prepared by Anamet. Image reproduced from the September 6, 2013 Anamet report with permission from Anamet.

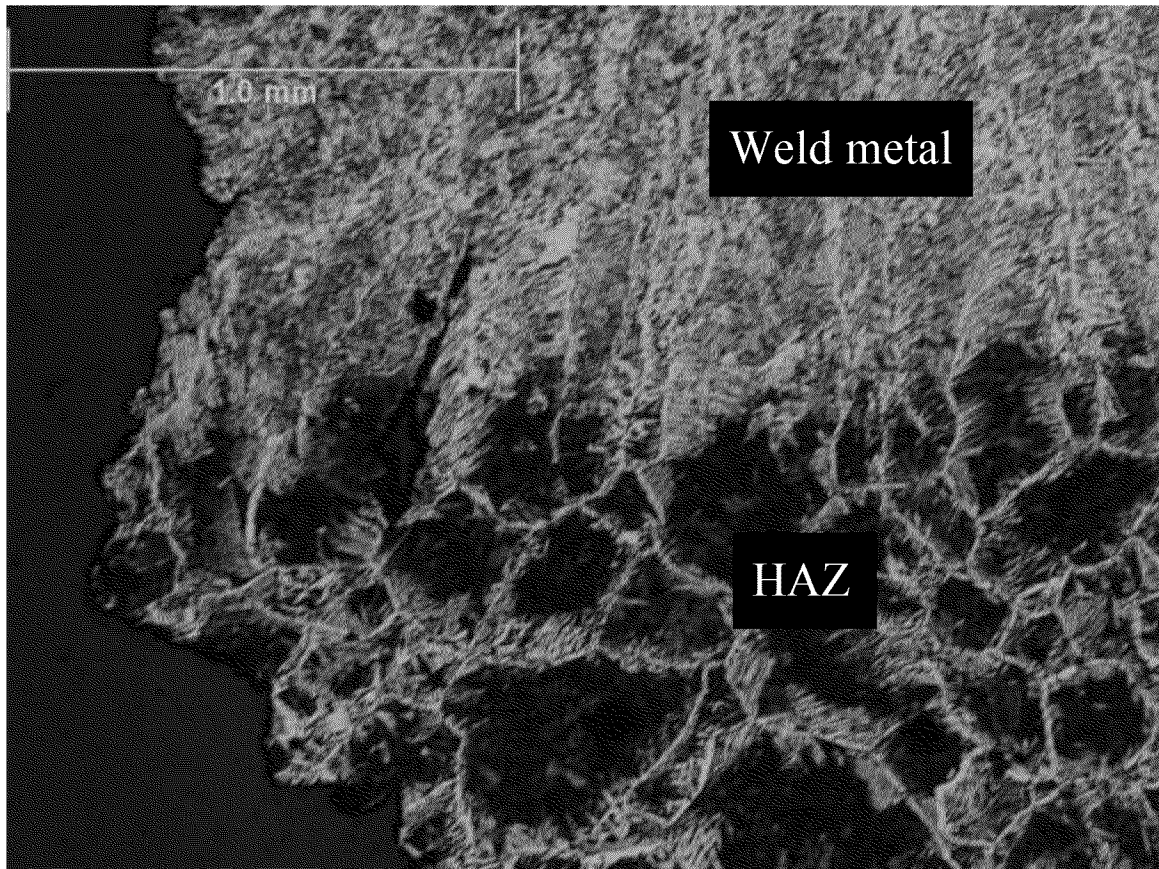
Figure 14. Metallographic image that shows significant grain coarsening beneath the weld in Sample A-1-1-8, with Widmanstatten ferrite at the prior-austenite grain boundaries in the heat-affected zone (HAZ).

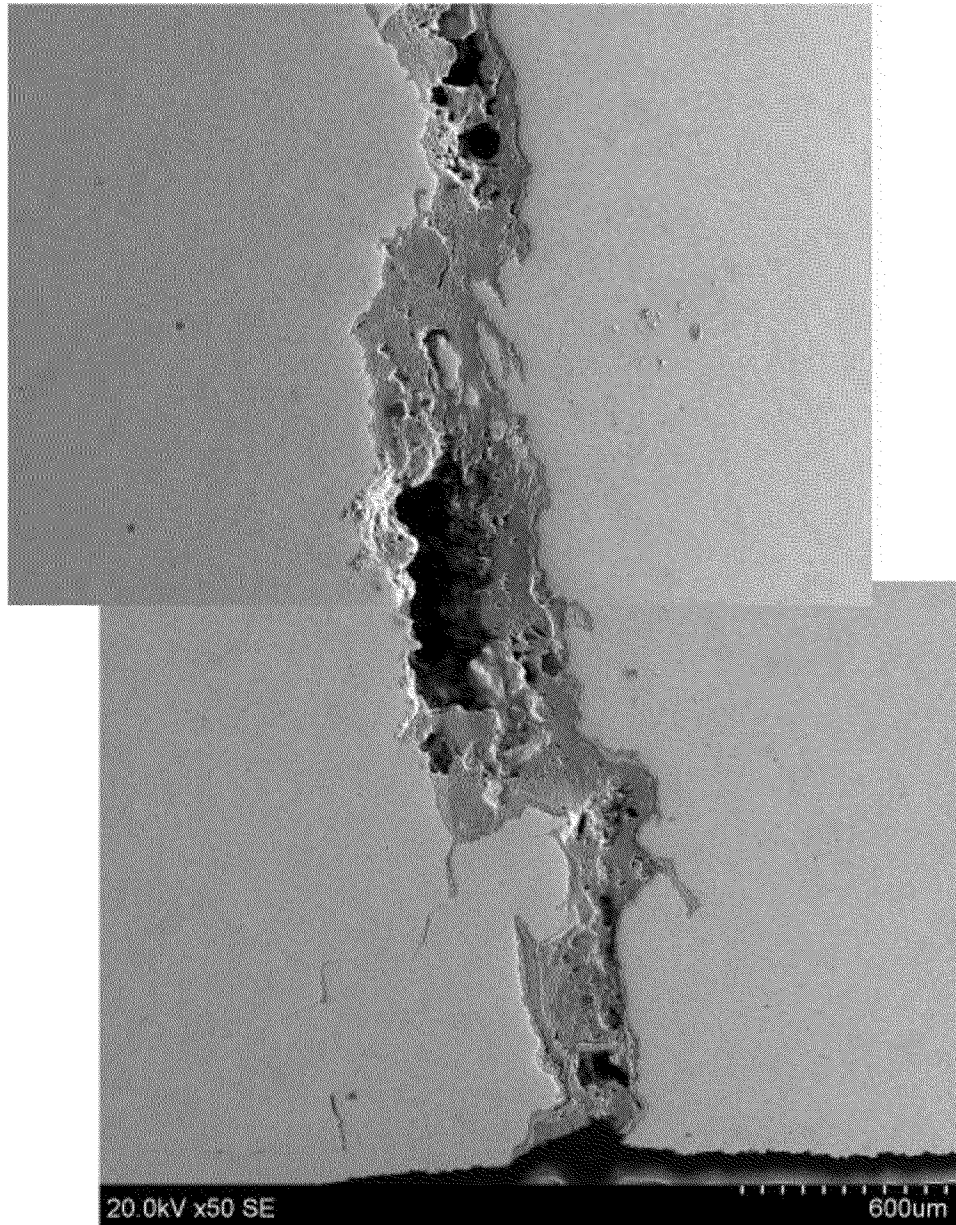
Anamet conducted SEM/EDS analysis of the unopened crack in a metallographic mount: originally Figure 20 in their September 6, 2013 report, shown here as Figure 15. Consistent with Exponent's analysis, Anamet determined that the crack was filled with iron oxide and contained appreciable amounts of sulfur.

Figure 15. Composite SEM micrograph of the metallographic mount prepared by Anamet. Image reproduced from the September 6, 2013 Anamet report with permission from Anamet.

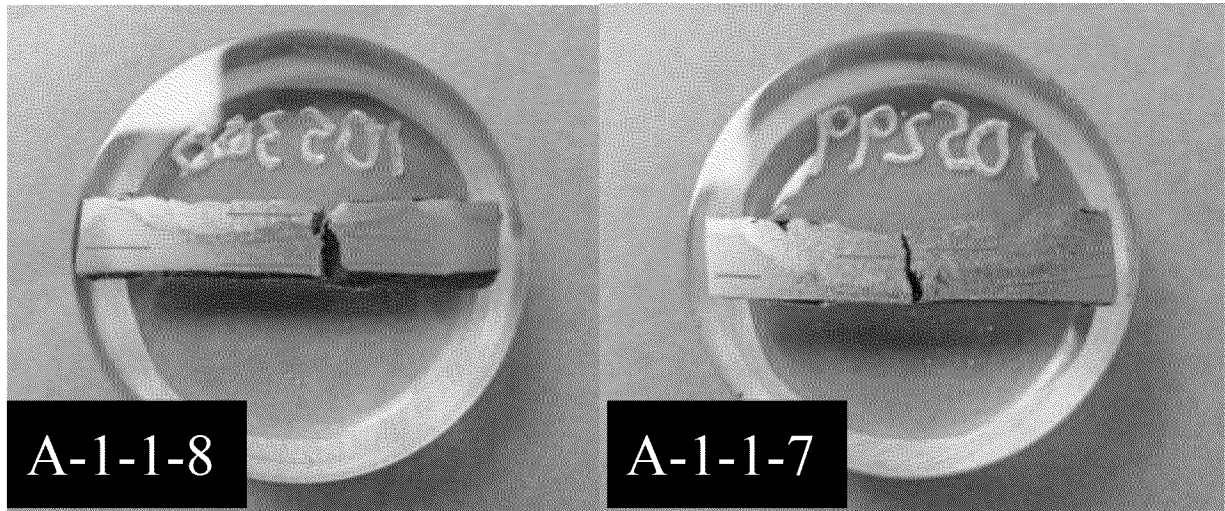
Vickers microhardness (HV) traverses were conducted over both metallographic mounts to assess hardness in the weld, HAZ, and base metal, shown by red lines in Figure 16. Each microhardness traverse and associated values are shown in Appendix B. Accounting for all testing samples, the base and weld metal exhibited average hardness values between 130-155 HV. The HAZ exhibited slightly higher hardness levels, between 155-190HV. However, it should be noted that the HAZ hardness levels are relatively low, consistent with the significant

grain coarsening observed. For carbon steels, a hardness of over 350HV would be considered excessive, and indicate a possible susceptibility to hydrogen cracking in the HAZ.^{4, 5}

Figure 16. Metallurgical mounts of samples A-1-1-8 and A-1-1-7 made subsequent to opening the crack and examining it via optical microscopy and SEM/EDS. The red lines show where strings of microhardness testing points.
