**BEFORE THE PUBLIC UTILITIES COMMISSION
OF THE STATE OF CALIFORNIA**

R.11-02-019
(Filed February 24, 2011)

**DECLARATION OF SUMEET SINGH SUPPLEMENTING THE VERIFIED
STATEMENT OF PACIFIC GAS AND ELECTRIC COMPANY'S VICE
PRESIDENT OF GAS TRANSMISSION MAINTENANCE AND CONSTRUCTION
IN RESPONSE TO RULING OF ASSIGNED COMMISSIONER AND ASSIGNED
ADMINISTRATIVE LAW JUDGE**

**PG&E Line 147 Britton
and Rogers Avenue Leak:
Metallurgical Analysis**

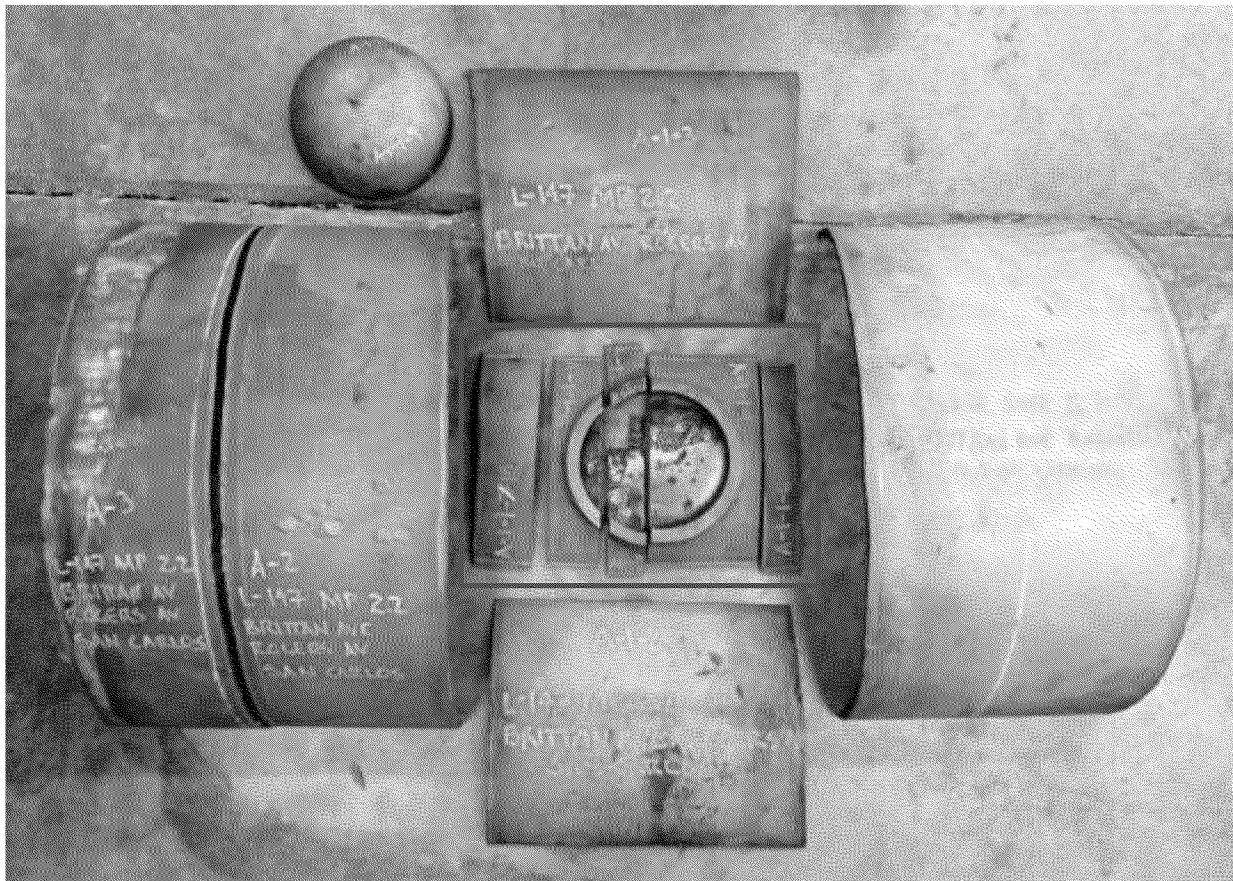
Figure 1. Photograph of the section of L-147 containing the crack and the PLIDCO cap welded over it to stop the gas leak. The red box shows the area magnified in Figure 3. Note the sectioning of the pipe and the yellow markings were made by Anamet.

The leak site was located in the area in the red box in Figure 1; enlarged in Figure 3. A PLIDCO cap had been welded onto the pipe to stop the leak until the subject pipe section could be removed. Beneath the cap, several weld repairs had been conducted. Anamet had sectioned the approximately 0.4-inch long crack into two pieces, then mounted, polished and etched the parts for analysis. The two metallurgical mounts are shown in Figure 4 as received from Anamet. Exponent retained Anamet's sample ID numbers, which for the metallurgical mounts are A-1-1-8 and A-1-1-7, left and right, respectively in Figure 4. As indicated in Anamet's report, these samples were subjected to serial grinding to evaluate different leak cross-sections. As such, portions of the leak that have been ground-away are no longer available for examination.

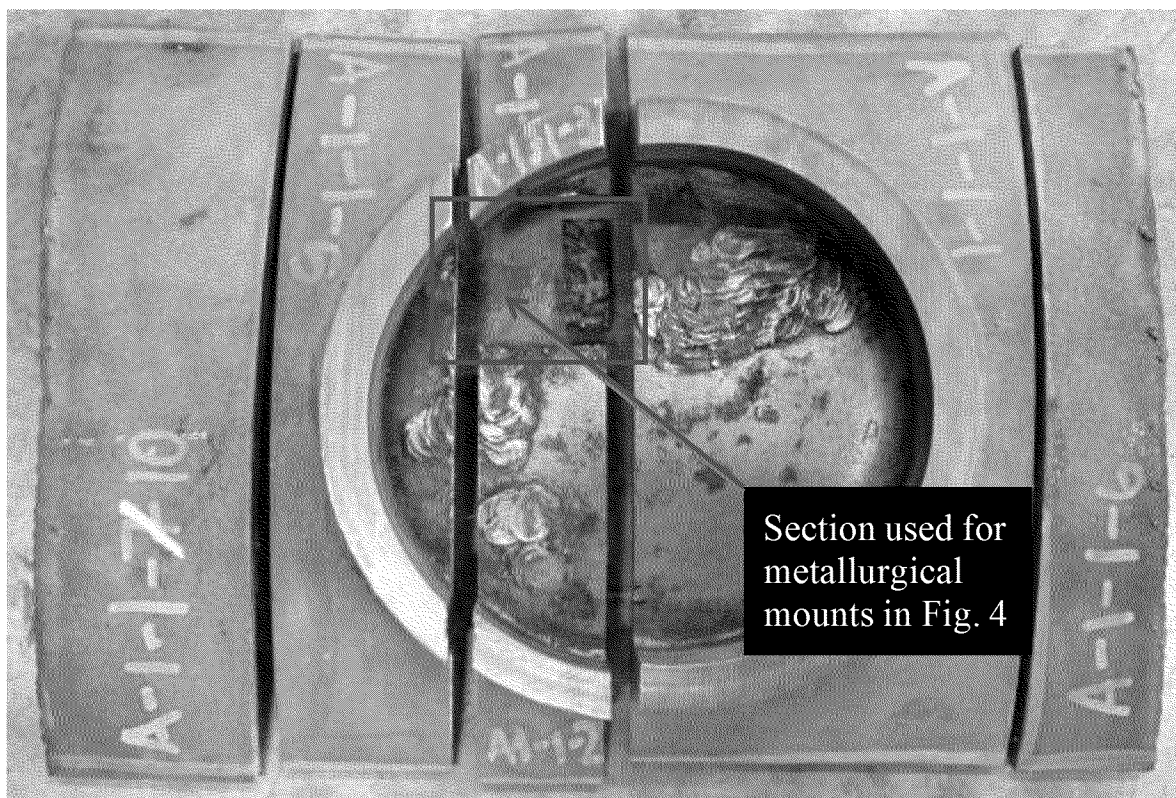
Figure 3. Photograph of the section of L-147 (boxed in red in Figure 1) containing the crack and the PLIDCO cap. Note the sectioning of the pipe and the yellow markings were made by Anamet.

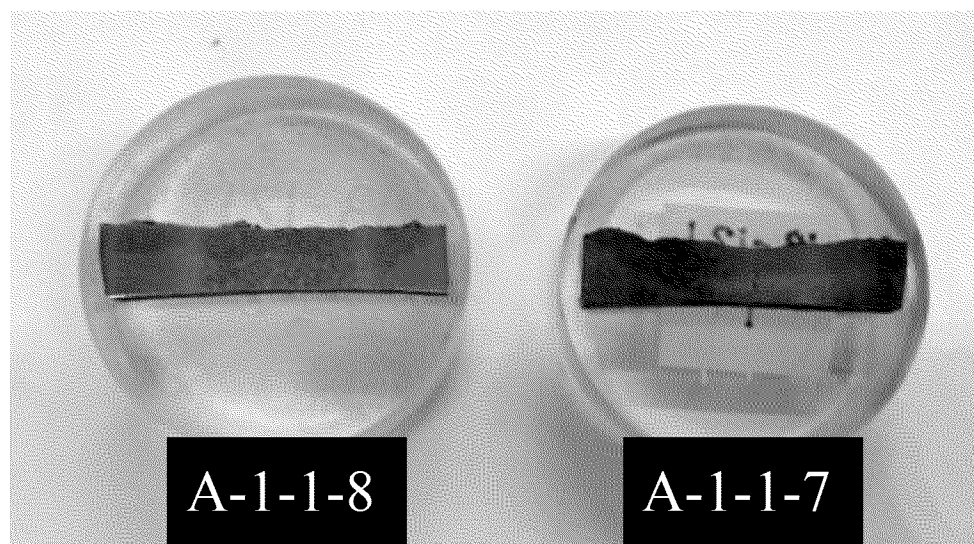
Figure 4. Photograph of the metallurgical mounts of the area containing the crack in L-147 under the PLIDCO cap. Note the metallurgical mounts were made by Anamet: Exponent retained Anamet's sample ID numbers A-1-1-8 (left); A-1-1-7 (right).

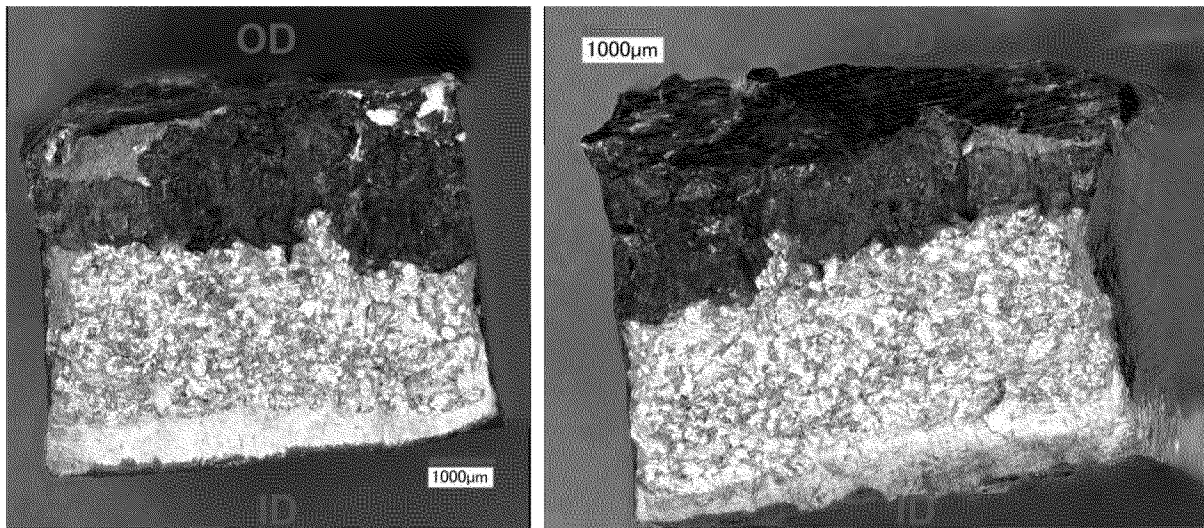
Figure 5. Optical micrographs of the leak surface after opening Anamet's A-1-1-8 metallurgical mount.

As shown in Figure 5, the pre-existing crack in Sample A-1-1-8 only extended from the OD approximately halfway through the pipe wall. The pre-existing crack A-1-1-7 extended from the ID nearly to the OD surface. While neither of these two samples display a clear ID-to-OD leak path, the pre-existing crack in Sample A-1-1-7 extends nearly through the pipe wall thickness. Based on the metallographic images in Anamet's report, as well as fractographic analysis of the remaining broken-open metallographic specimens, it is apparent that the through-wall (ID-to-OD) path for the subject leak was less than the 0.4 inch total length of the cracks.

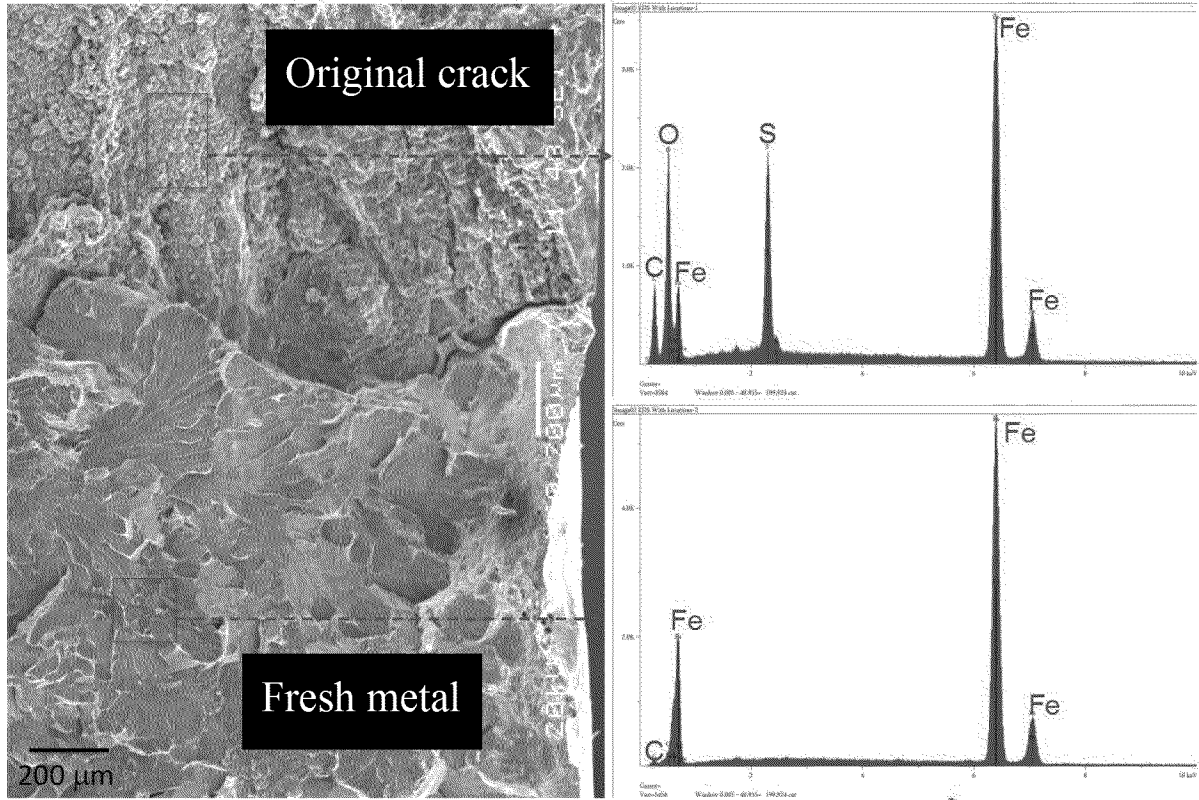
The Sample A-1-1-8 fracture surface was examined using EDS, which is highlighted in the red box in top image of Figure 7 and presented in Figure 8. The freshly-induced cleavage fracture surface below shows only the presence of iron and a small amount of carbon. The original crack surface, however, exhibited significantly increased levels of carbon, oxygen and sulfur, consistent with iron oxide (rust) as well as sulfur deposits. The sulfur is most likely from mercaptan-based odorizer added to natural gas to give the characteristic “rotten-egg” smell.

Figure 8. EDS analysis of the area in the red box in the right side of the top image in Figure 7. The lower portion is the freshly cracked surface; the top is the surface of the original crack composed of iron oxide with a large amount of sulfur, likely from the mercaptans added to give scent to the gas.

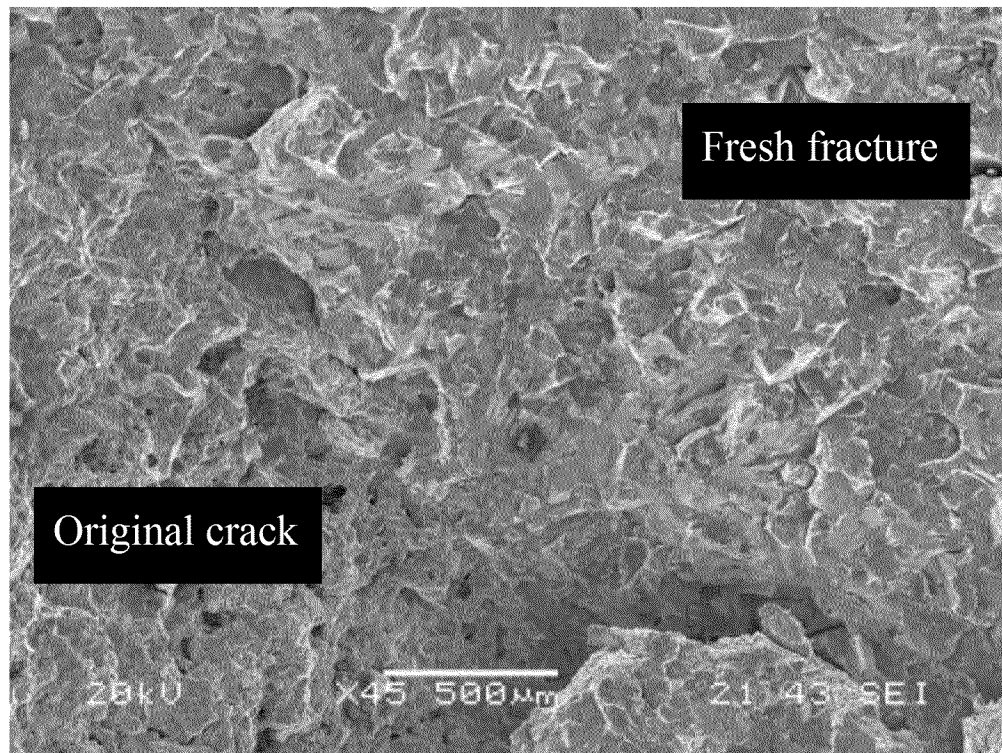
Similar SEM and EDS examination was performed on the Sample A-1-1-7 fracture surface faces, example images are shown in Figure 9 and Figure 10. The substantial oxide deposits on the original leak surface obscured much of fracture morphology in the original-cracked portion of Sample A-1-1-7, as shown in Figure 9. However, the transition between the original crack surface and the intentional brittle (cleavage) fracture area showed no evidence of progressive growth, also shown in Figure 9.

Figure 9. One side of the crack surface in Sample A-1-1-7 (right side of Figure 6). The red box shows the area analyzed with EDS in Figure 10.

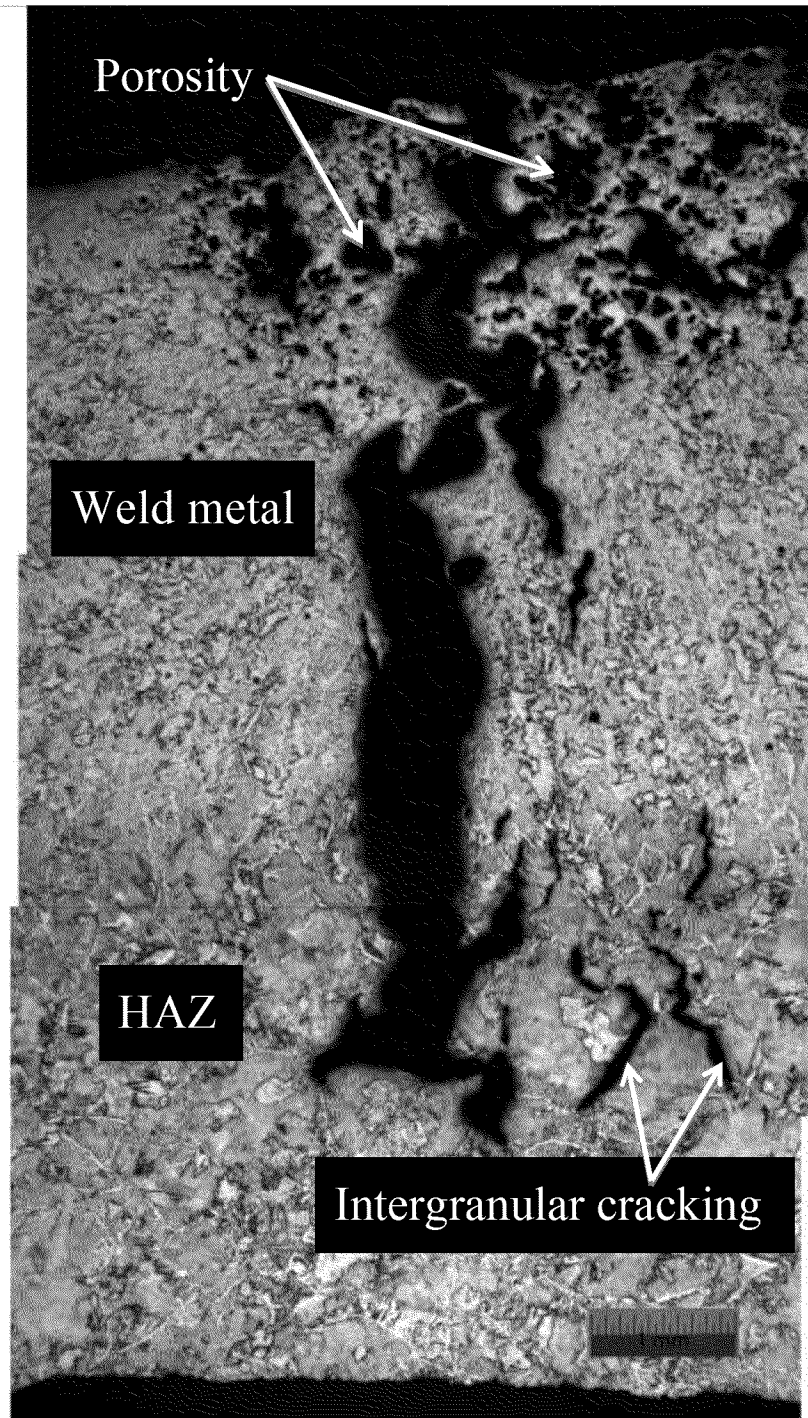
Anamet sectioned the subject leak perpendicular to the longitudinal axis of the pipe, and conducted metallographic analyses as described in their September 6, 2013 report. A composite optical image from Anamet's report, shown here as Figure 11, shows that the weld repair contained significant weld porosity and cracks near the center of the weld bead that run parallel to the dendritic structure. There is also evidence of intergranular fracture in the heat-affected zone (HAZ) next to the weld.

Figure 11. Composite optical micrograph of a metallurgical mount prepared by Anamet. Image reproduced from the September 6, 2013 Anamet report with permission from Anamet.

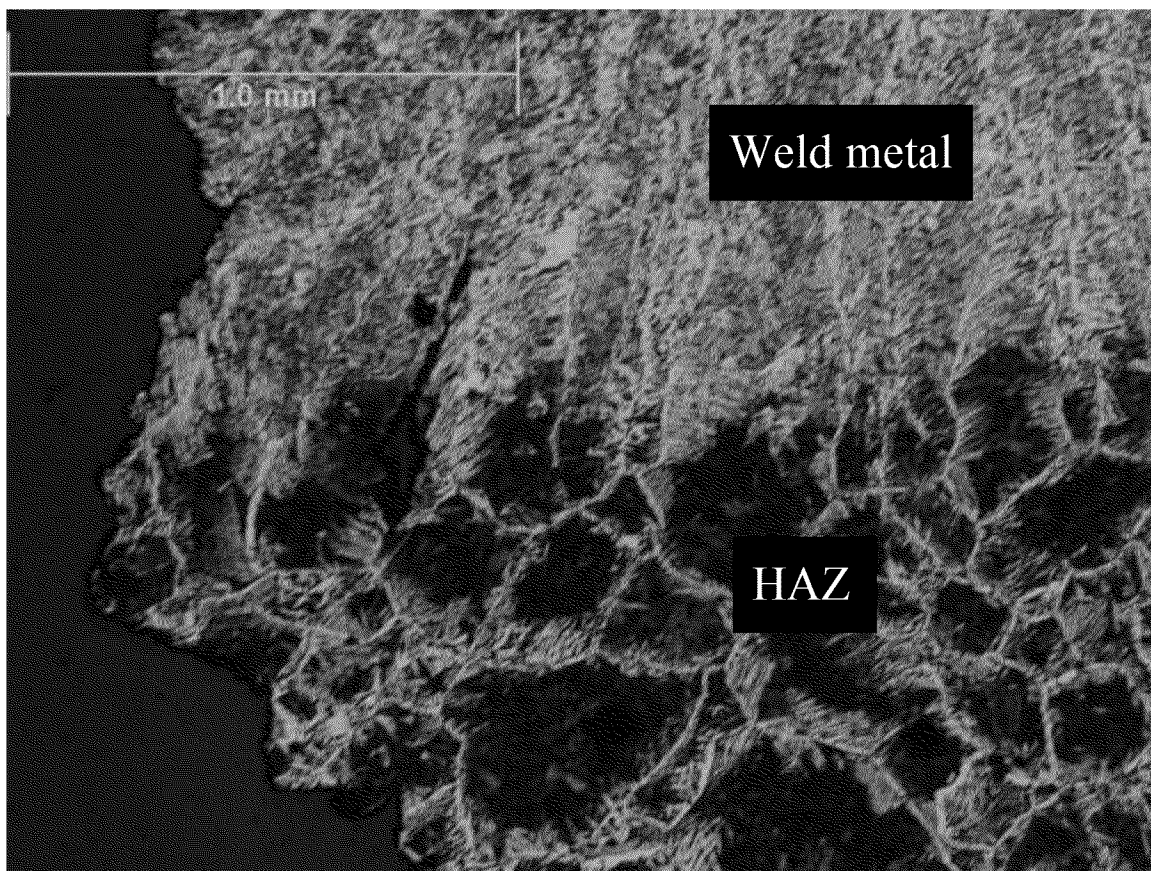
Figure 14. Metallographic image that shows significant grain coarsening beneath the weld in Sample A-1-1-8, with Widmanstatten ferrite at the prior-austenite grain boundaries in the heat-affected zone (HAZ).

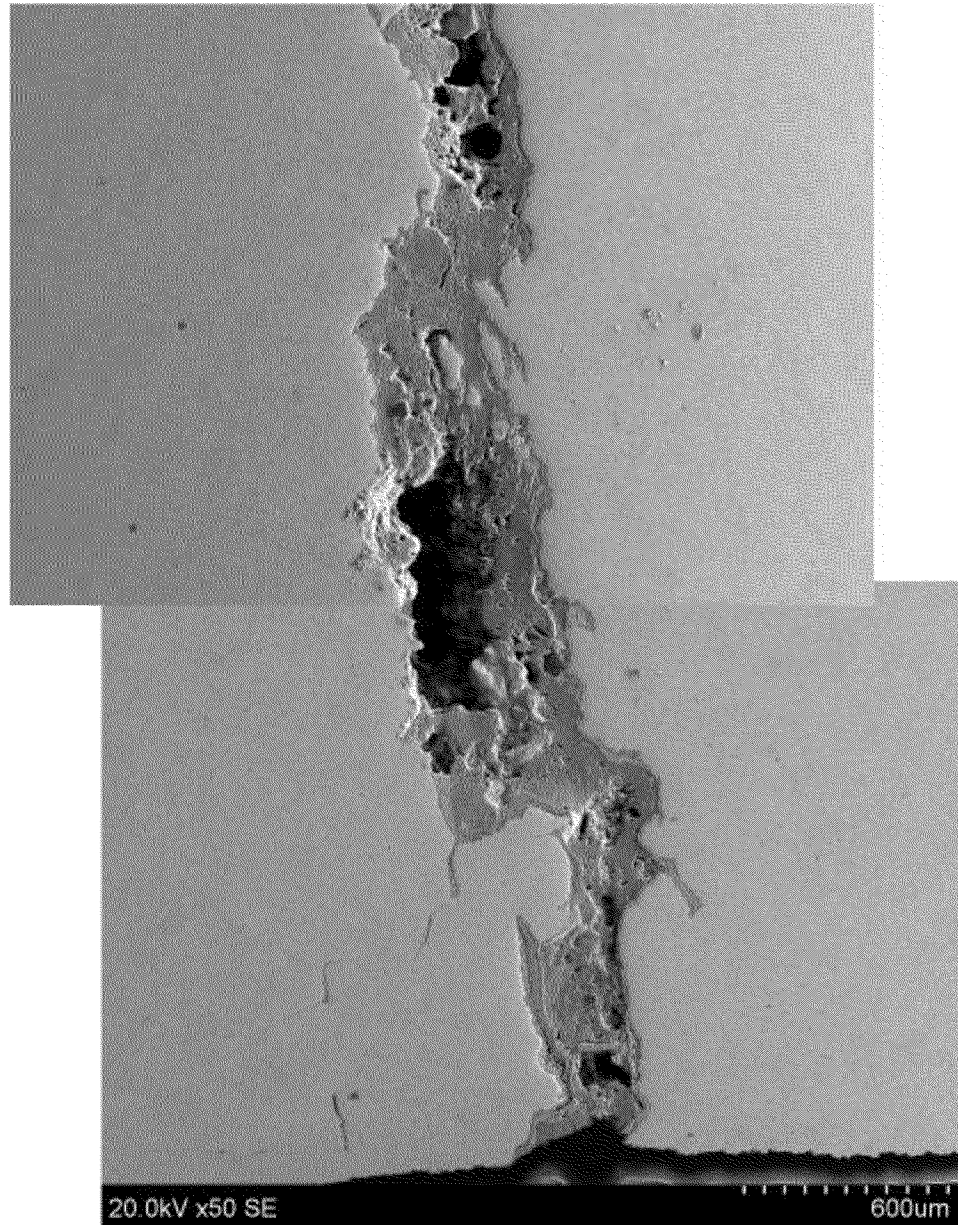
Anamet conducted SEM/EDS analysis of the unopened crack in a metallographic mount: originally Figure 20 in their September 6, 2013 report, shown here as Figure 15. Consistent with Exponent's analysis, Anamet determined that the crack was filled with iron oxide and contained appreciable amounts of sulfur.

Figure 15. Composite SEM micrograph of the metallographic mount prepared by Anamet. Image reproduced from the September 6, 2013 Anamet report with permission from Anamet.
