Report No. 5004.9268 Rev. 1

**METALLURGICAL EVALUATION OF A SECTION FROM
L-147 MP 2.2 BRITTAN AVE. AND ROGERS AVE., SAN CARLOS**

Report To: Pacific Gas & Electric Co.

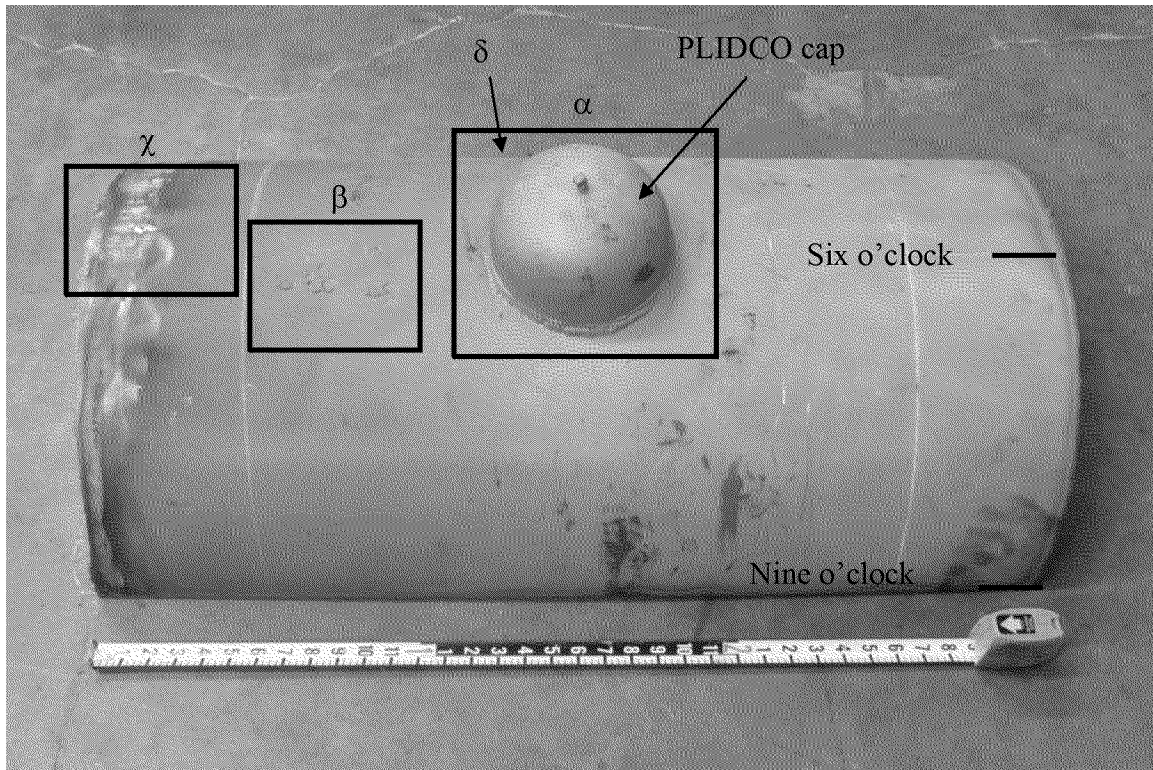
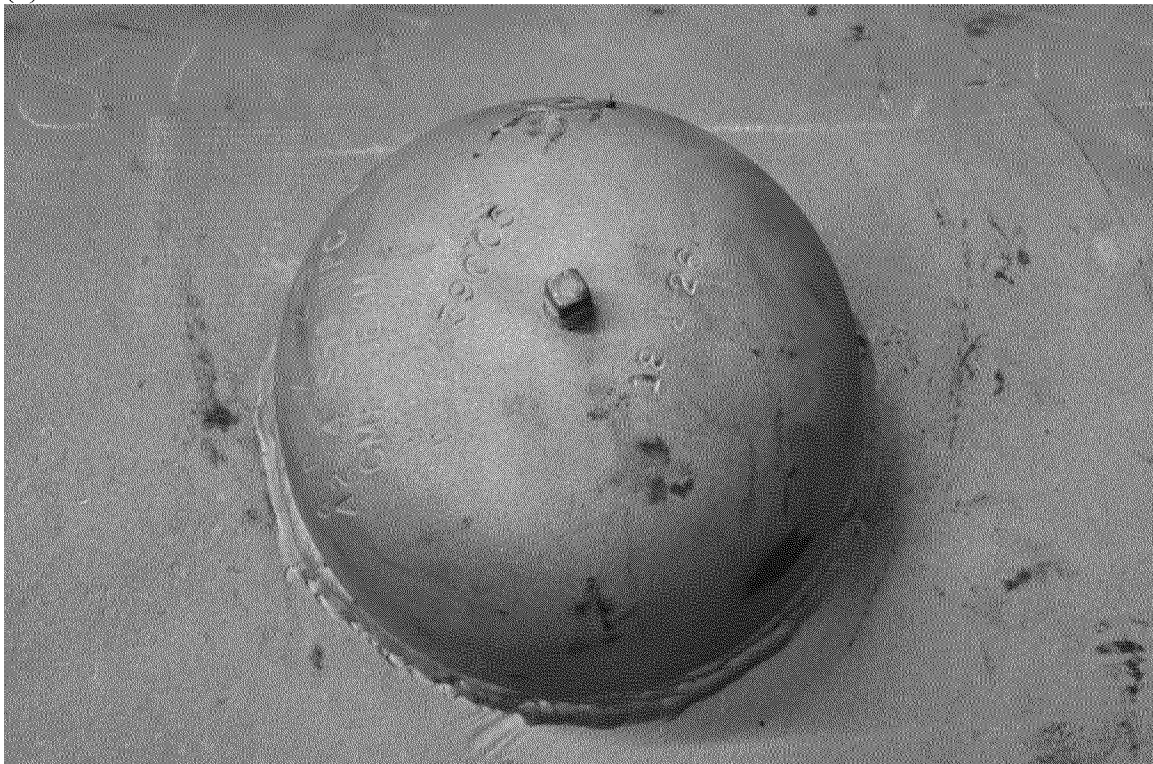
Figure 1 Photographs of the outside surface of sample half A as-received.

The subject sample of L-147 was received sectioned into two halves along the longitudinal axis, with the outside surface grit blasted, as shown in Figure 1 through Figure 5. The section half with the PLIDCO cap was arbitrarily labeled A and the other section was labeled B, in the laboratory. Based on the reported position of the cap, the longitudinal flame cuts were located at three o'clock and nine o'clock positions. Wall thickness measurements were made with a pointed anvil micrometer and the results are listed in Table 1. Small regions of weld metal and a few shallow hemispherical pits were present near the cap, as shown in Figure 2. Pits were also present just past the three o'clock position toward the cap, indicated in Figure 1. Pit depths were measured with a pit gage, and the results are listed in Table 2. No evidence of a leak location or repair was visible to the unaided eye on the inside surface of the pipe under the cap.

The appearance of the longitudinal seam was typical of A. O. Smith welds, a wide low-crowned cap on the outside surface and a narrow flash on the inside surface. A weld stop/start was visible on the outside surface.

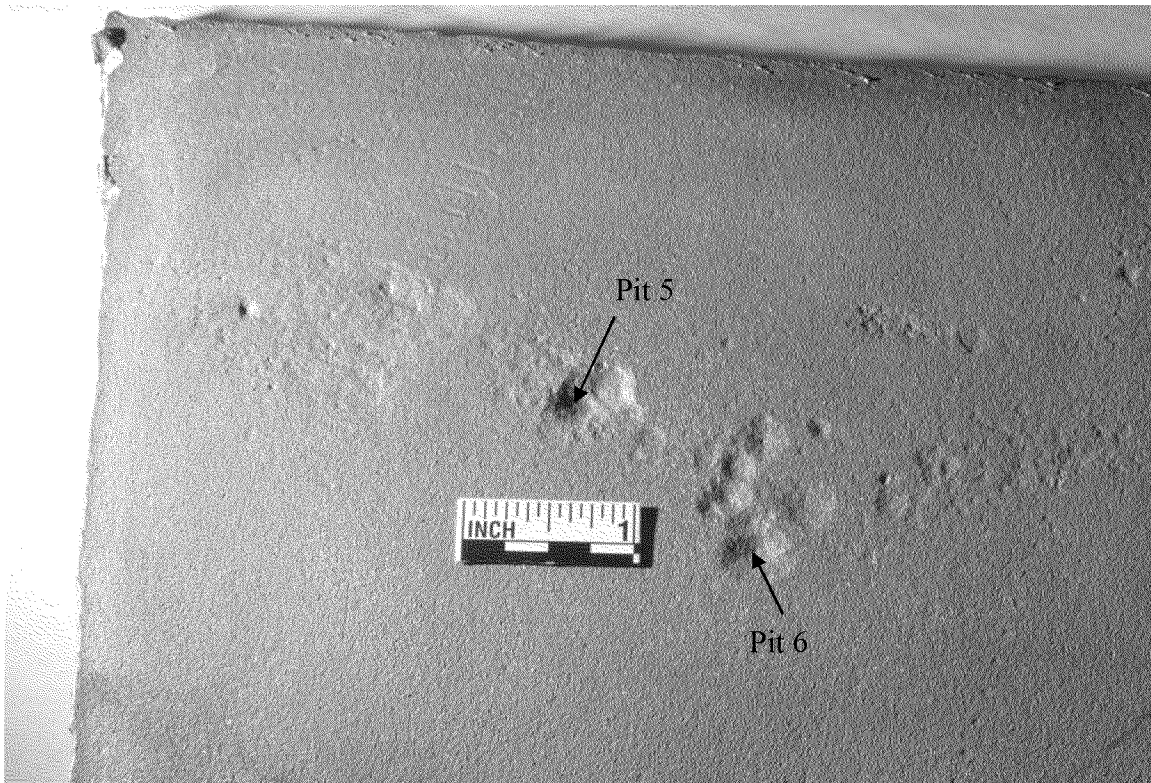
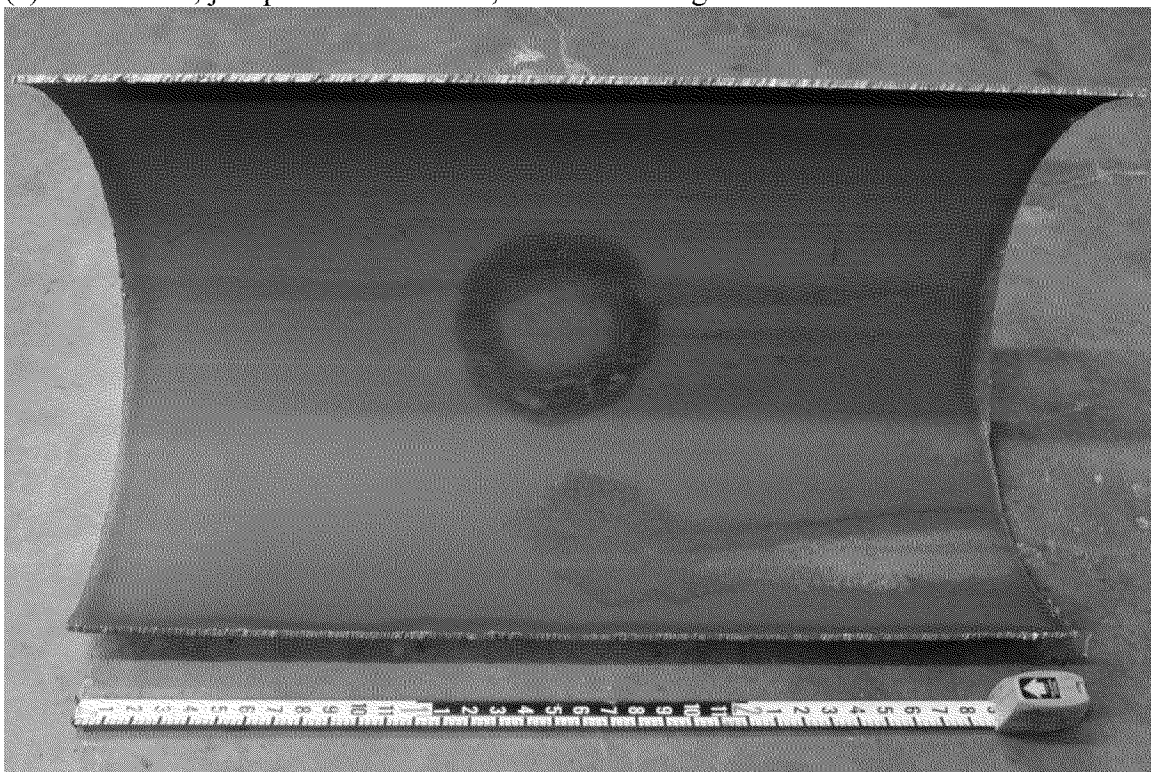
Figure 3 Photographs of pits on the outside surface and the inside surface of sample A.

(a) Location δ , just past three o'clock, indicated in Figure 1a

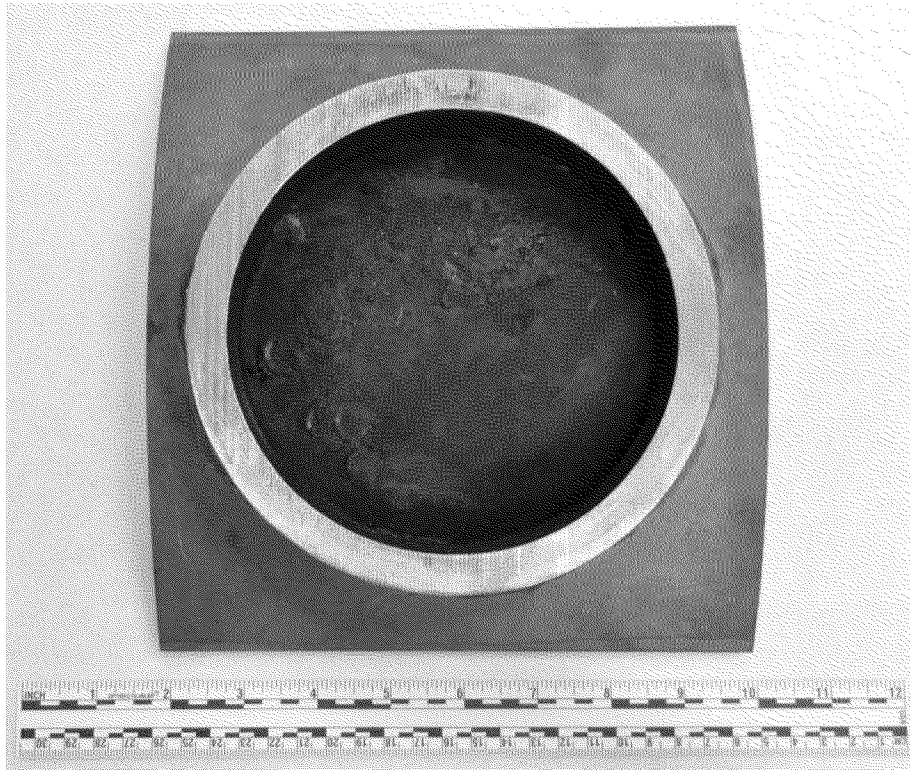
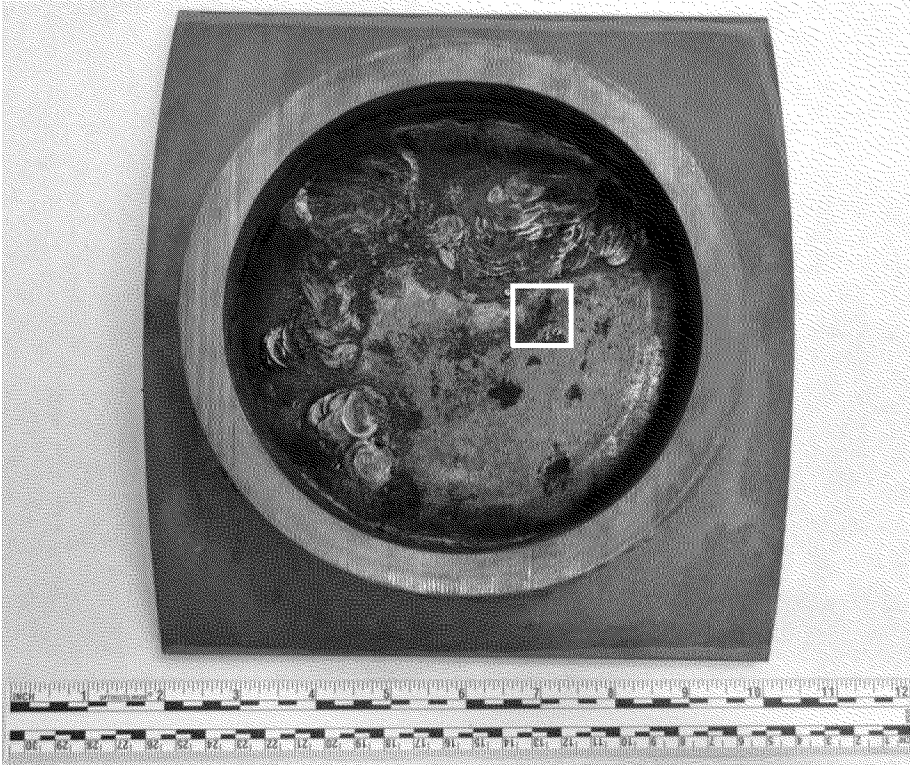
Figure 6 Photographs of the PLIDCO cap area after sectioning.

Both sides of the cap sample shown in Figure 6 were thoroughly cleaned with acetone and dried with compressed air. A liquid penetrant test was performed by applying developer to the inside surface, and penetrant was liberally applied to the outside surface in the area covered by the cap. After 1.5-hours, no indication of penetrant was visible on the inside surface.

A pressure test was performed by clamping a plate over the sectioned cap, sealed with a silicone gasket, and introducing 40-psig of compressed air. Snoop® liquid leak detector was applied to the inside surface. No leaks were detected. The compressed air was valved-off, and no pressure drop from 40-psig was detected after 45-minutes.

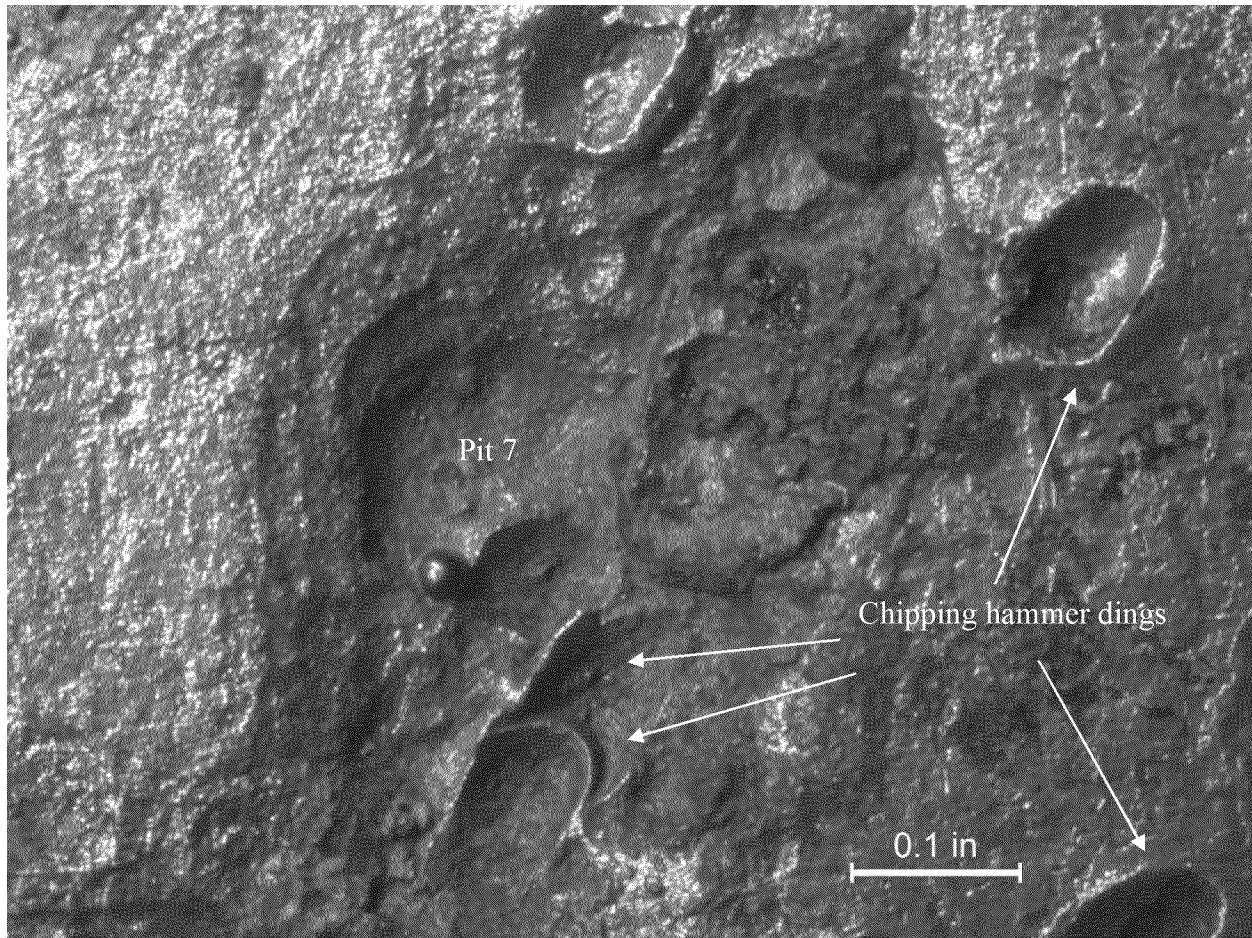
Figure 7 Macrograph of a pit under the PLIDCO cap, from the boxed area in Figure 6b.

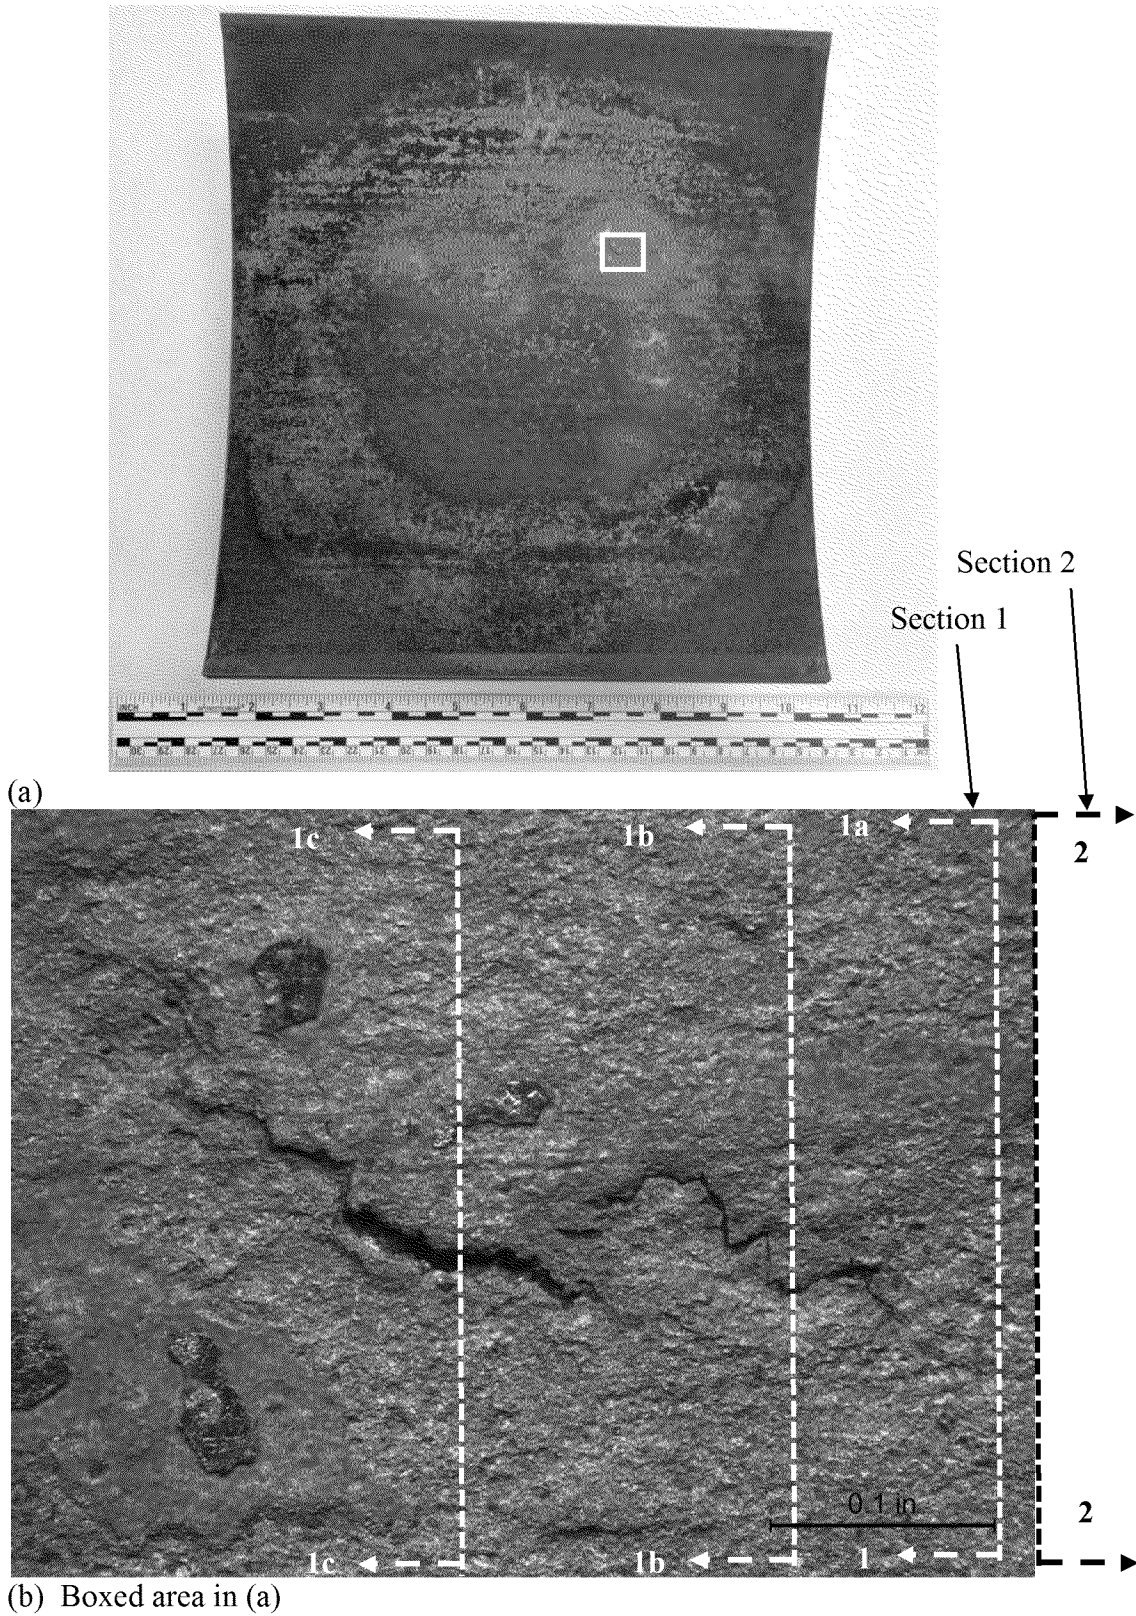
Figure 8 Photograph (a) and macrograph (b) of the inside surface of sample half A under the PLIDCO cap, after cleaning.

The region containing the PLIDCO cap was sectioned from sample A and the cap was cut off to expose the outside surface of the pipe wall. The outside surface was covered with rust and had a slightly oily feel. Both surfaces were cleaned with dilute Oakite® 33 and a wire brush. The outside surface is shown before and after cleaning in Figure 6. Several regions of weld metal were visible on the outside surface. Examination using low-power optical microscopy revealed a pit consistent with corrosion on the outside surface, indicated in Figure 7. The inside surface is shown after cleaning in Figure 8. Indications of heat exposure were visible on the inside surface, corresponding to the weld metal on the outside surface. No evidence of weld burn through was detected, and fine grooves typical of wrought steel surfaces were continuous across the region, which indicated that repairs did not extend to the inside surface. Examination using low-power optical microscopy revealed a crack-like feature on the inside surface within the heat affected zone of a weld deposit, as shown in Figure 8b.

The sample shown in Figure 6 was returned to PG&E for radiography. A digital radiograph of the sample is shown in Appendix A along with a photograph of the sample. A crack indication was found that corresponded to the crack-like feature detected visually on the inside surface, shown in Figure 8b.

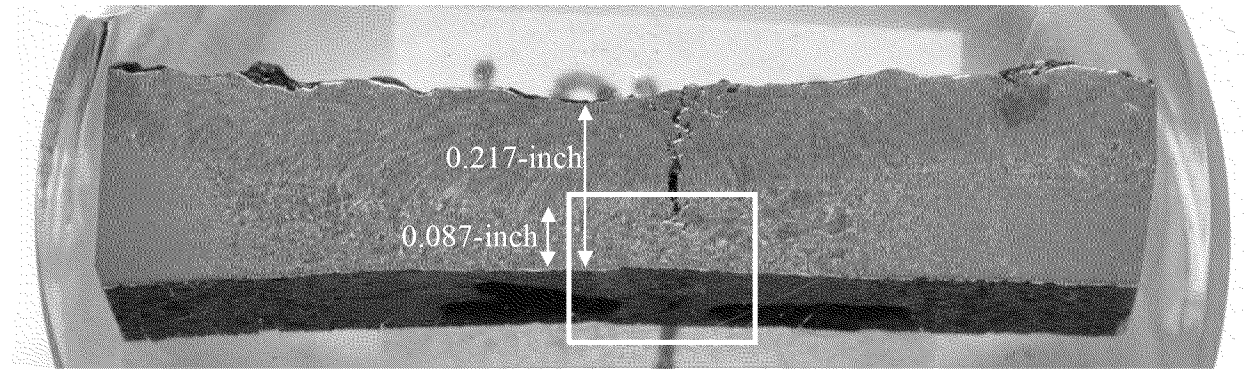
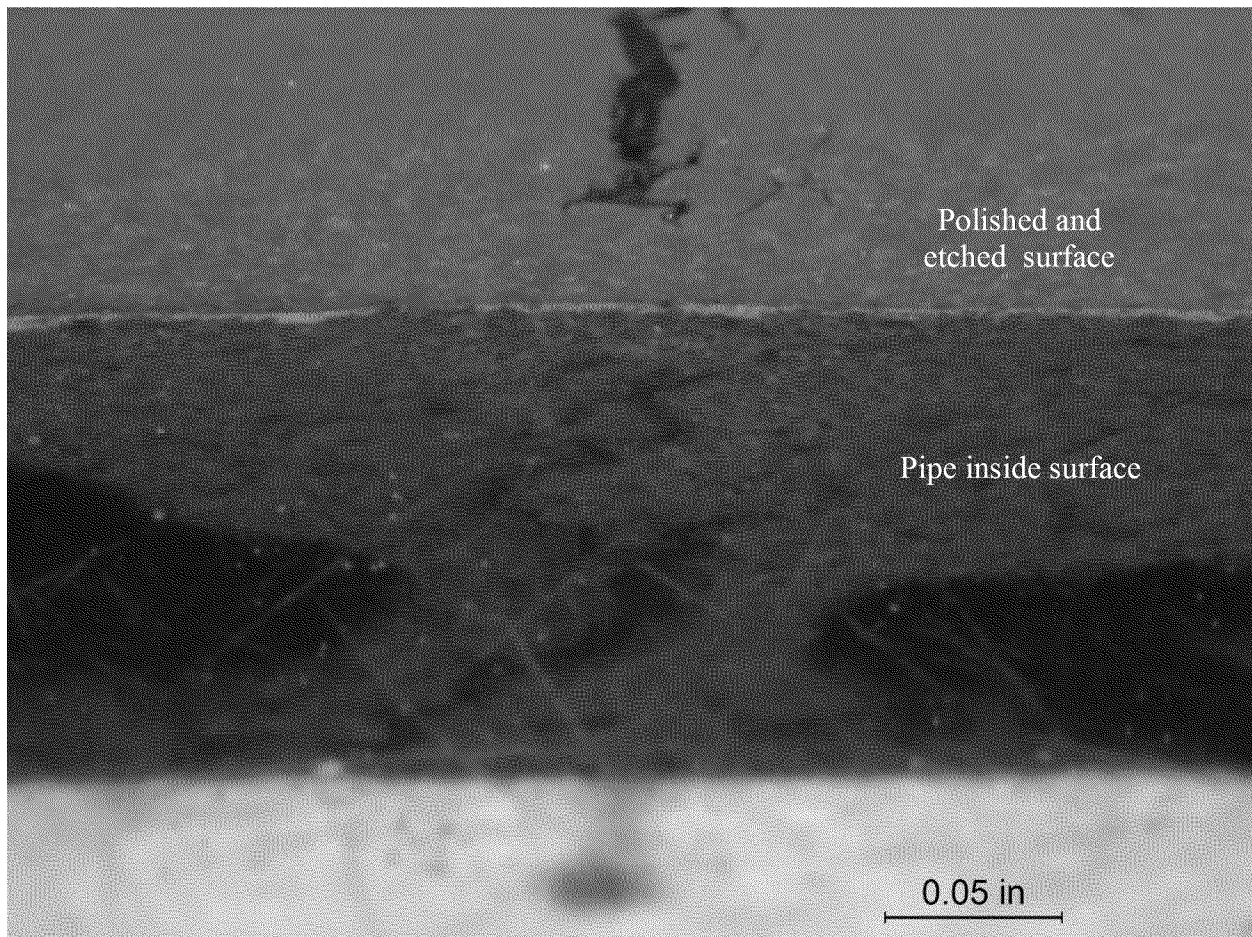
Figure 10 Images of the specimen prepared for metallography, section 1a. Etched with 2% nital.

Specimens were prepared for metallography from section 1 and 2 indicated in Figure 8b. Weld crater cracks and heat affected zone liquation cracks were present in the sections. Serial grinding and polishing was performed on section 1, referred to as sections 1a, 1b, and 1c. As shown in Figure 10 through Figure 20, a weld crater crack extended from the outside surface into the weld heat affected zone in section 1a, but did not penetrate through the wall at this location. Shrinkage porosity was present near the outside surface, and intergranular cracks consistent with grain boundary liquation were present in the heat affected zone.

Section 2 is shown in Figure 19. The fusion zone in this section had a profile that was more varied in depth than in sections 1a through 1c, which suggested the possibility that the weld metal was deposited to build-up locations where wall thickness had been reduced by external corrosion. Measurements of the minimum thickness of base metal beneath the weld metal are shown in Figure 10, Figure 13, Figure 16, and Figure 19.

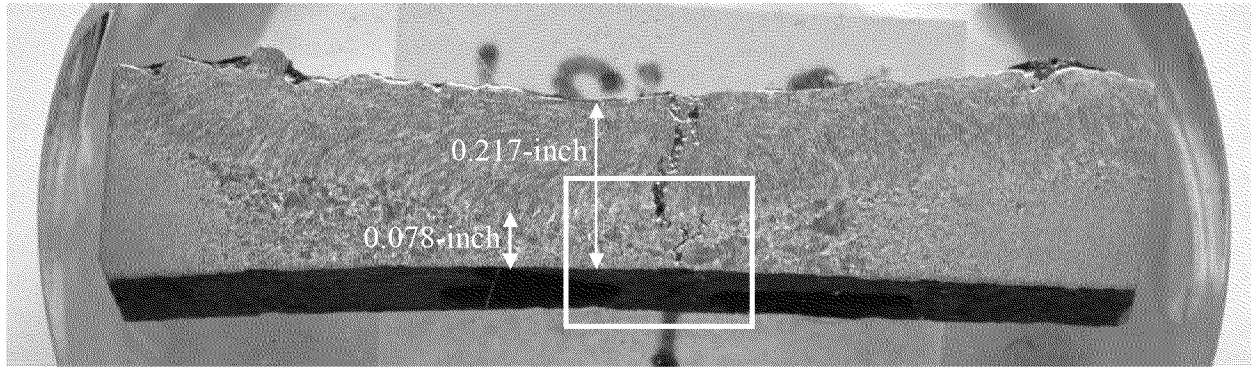
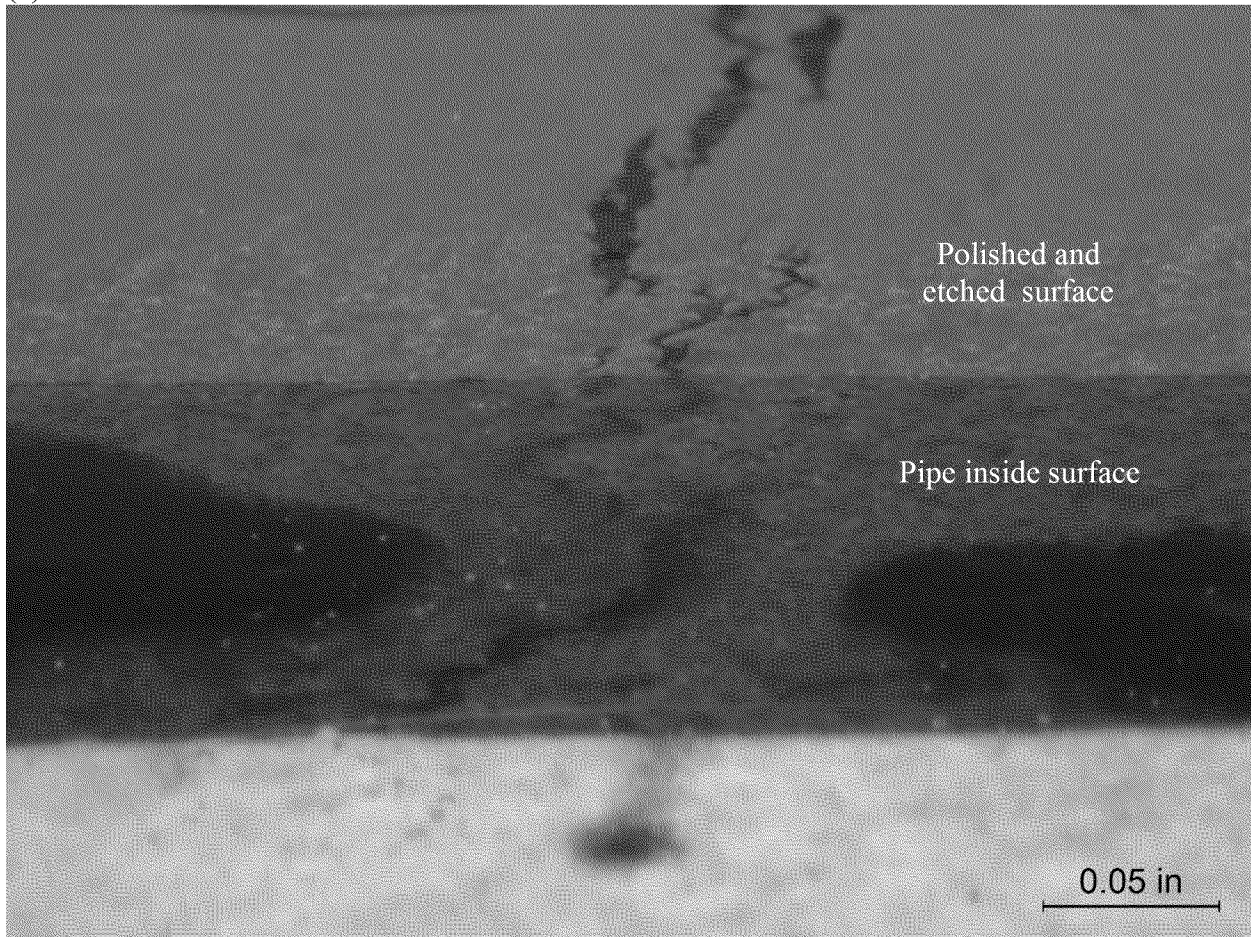
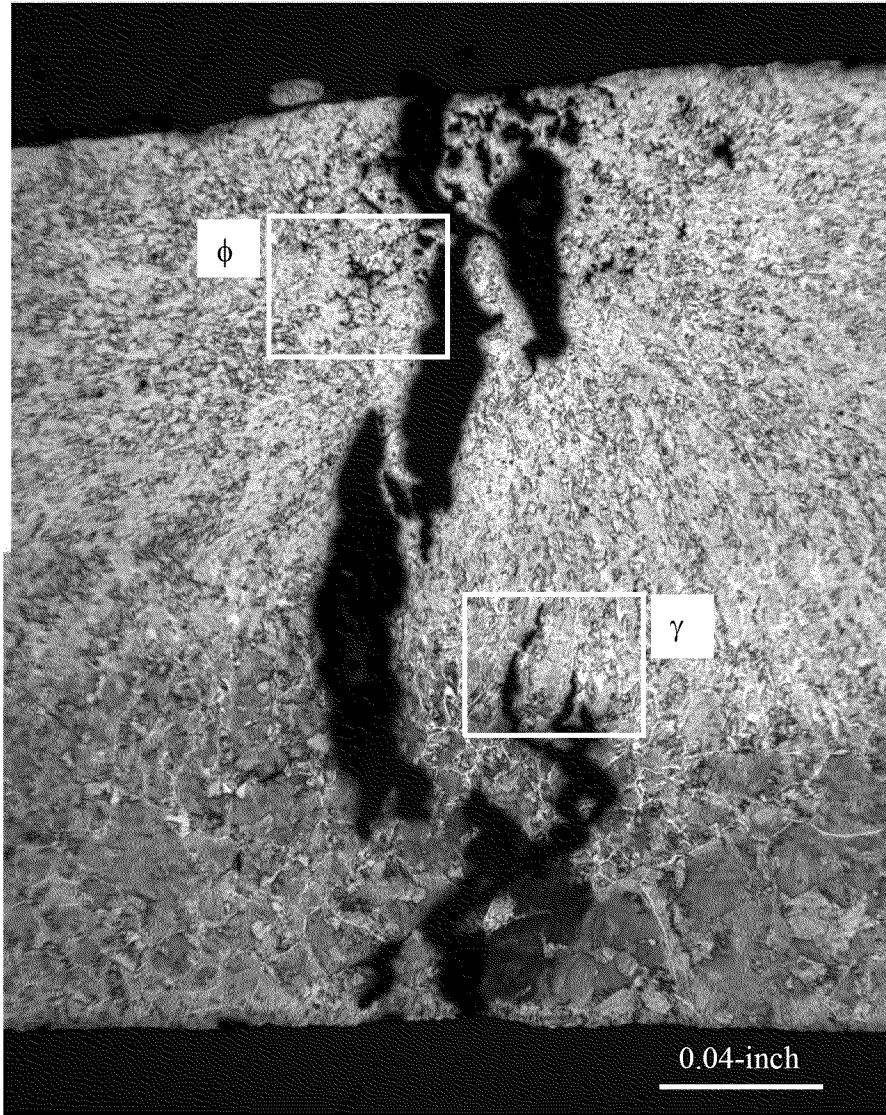
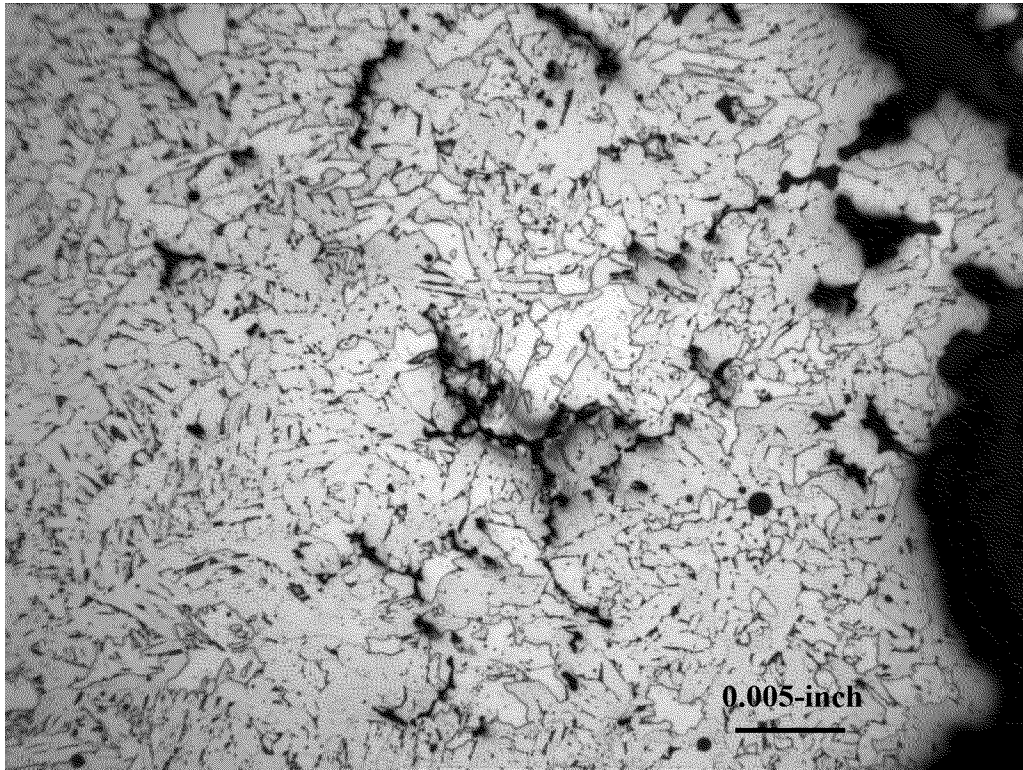
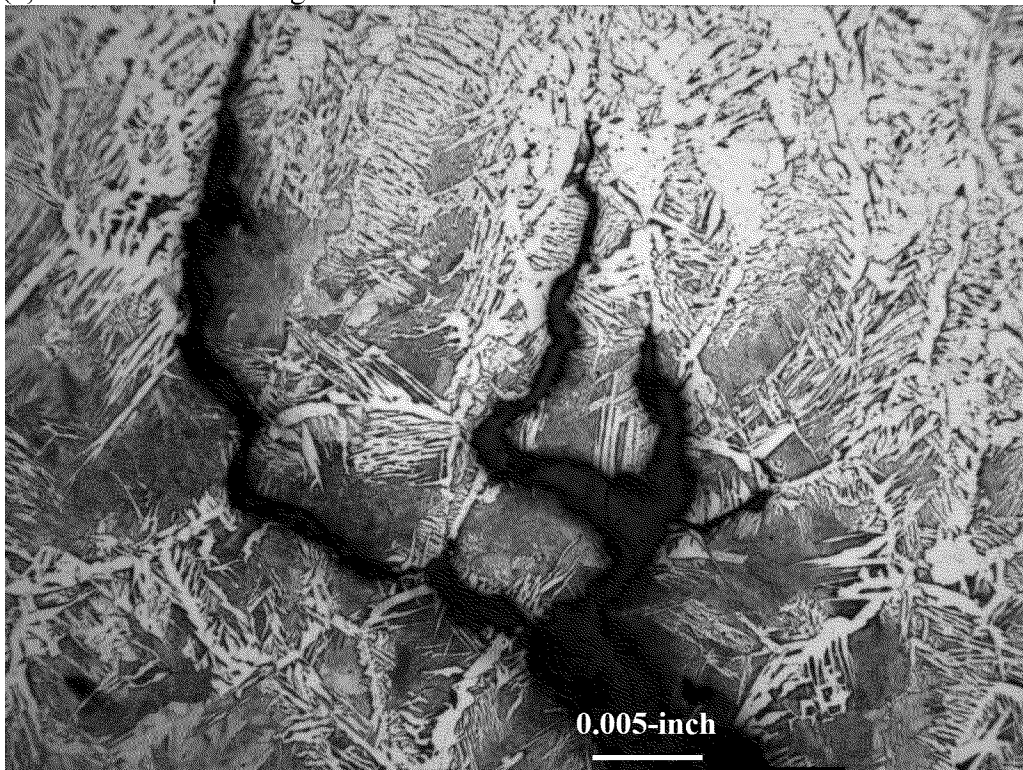
Figure 13 Images of the specimen prepared for metallography, section 1b. Etched with 2% nital.

In section 1b, shown in Figure 13 through Figure 15, cracks were present from the outside surface to the inside surface. Only a few small ligaments prevented the demonstration of a through-wall leak path. However, it is likely that a leak path existed between section 1a and 1b. The weld metal crack morphology was consistent with shrinkage, and the heat affected zone crack morphology was indicative of grain boundary liquation.

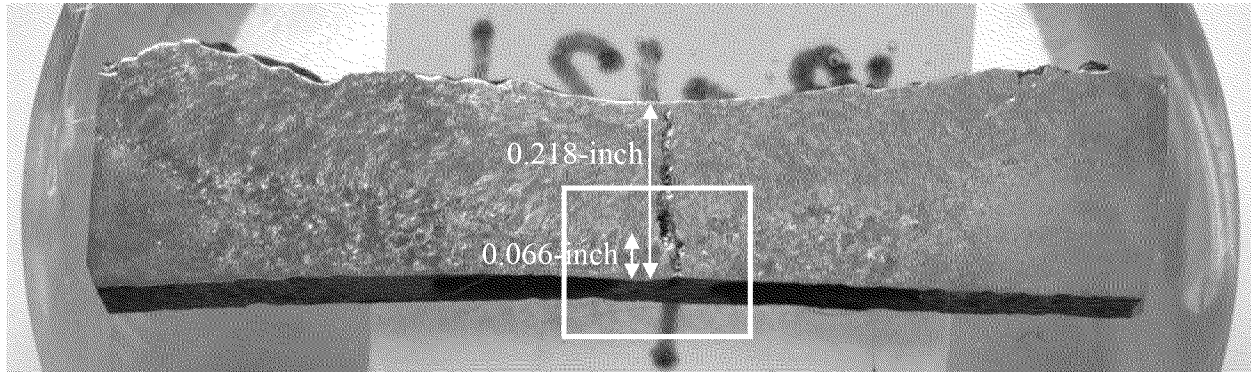
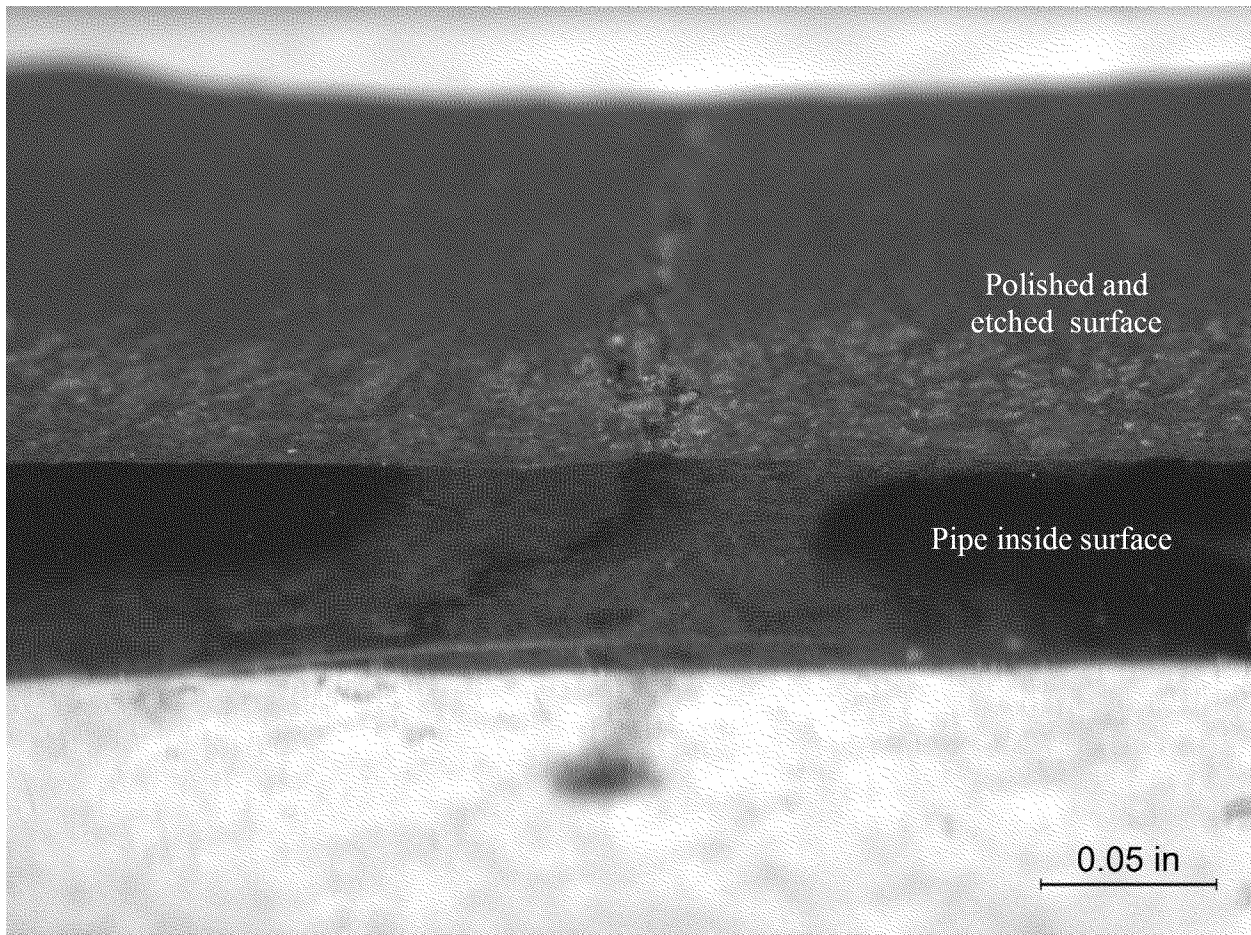
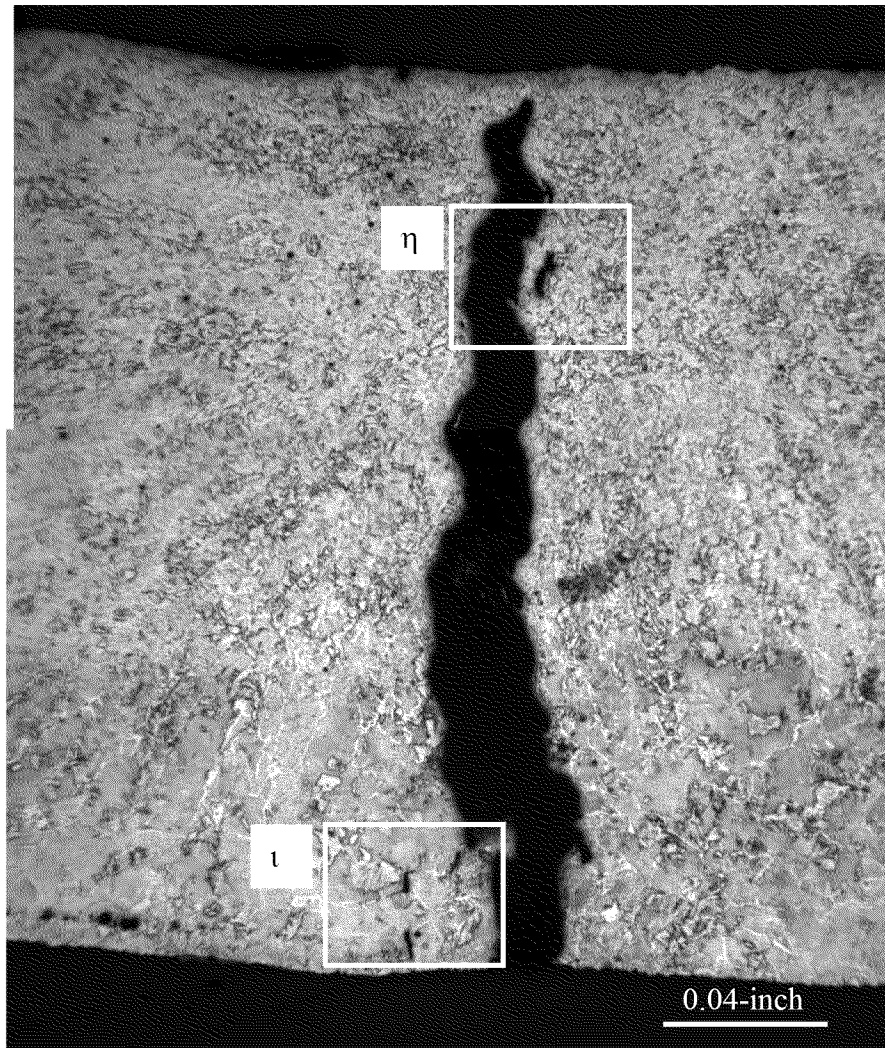
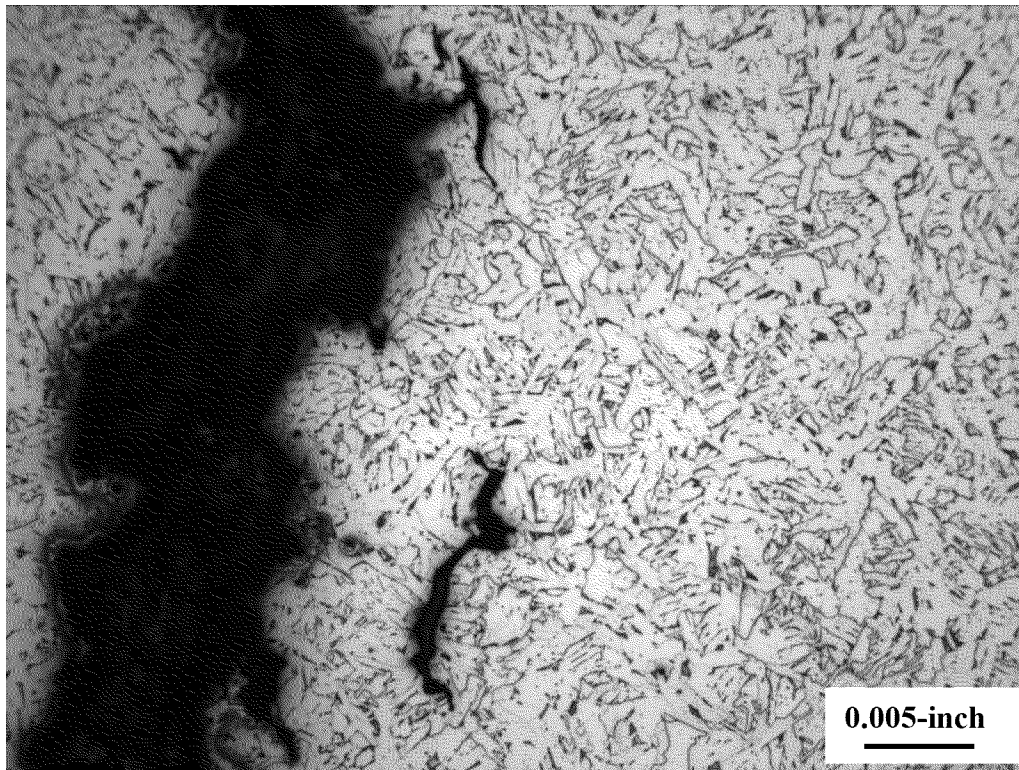
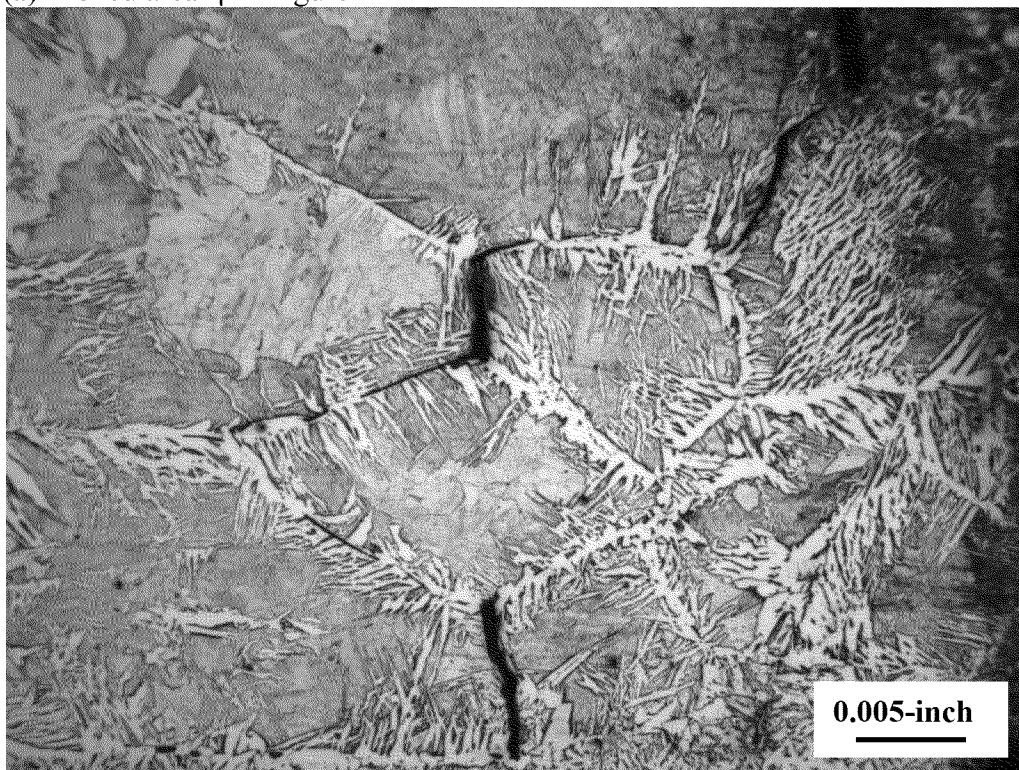
Figure 16 Images of the specimen prepared for metallography, section 1c. Etched with 2% nital.

In section 1c, shown in Figure 16 through Figure 18, one small ligament at the outside surface prevented demonstration of a through-wall leak path. Once again, the weld crack morphology was consistent with shrinkage and the heat affected zone crack morphology was consistent with grain boundary liquation. In all three sections of specimen 1, the weld fusion zone followed a smooth broad contour with no indications of external corrosion prior to welding.

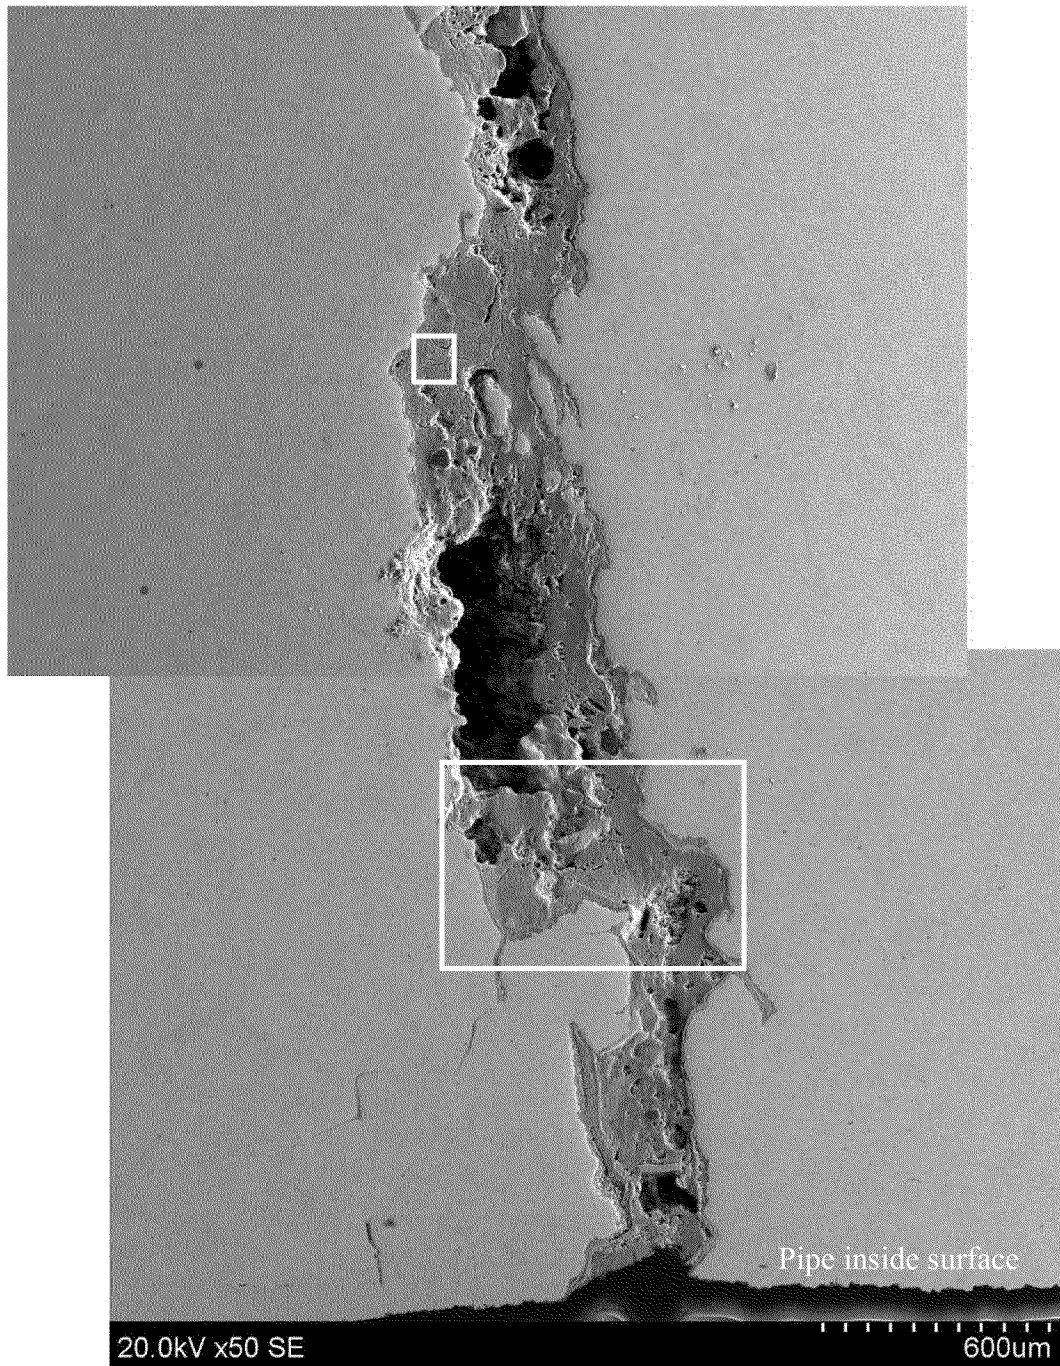
Figure 20 Composite SEM micrograph of the specimen prepared for metallography, section 1c.

Scanning electron microscopy (SEM) and energy dispersive X-ray spectroscopy² (EDS) was performed on the section 3 polished and etched surface. A composite SEM micrograph of the crack is shown in Figure 20. Much of the crack was filled with oxide, indicated by the morphology and chemical composition of primarily iron and oxygen, with sulfur present, likely from mercaptan in the gas stream.
