**Pipe Characterization and Weld Assessment  
San Carlos  
Line 147  
Mile Post 0.52**

**ATS Report #: 413.61-13.390**

**Gas Project: ICDA**

**Line 147 Mile Point 0.52 San Carlos**

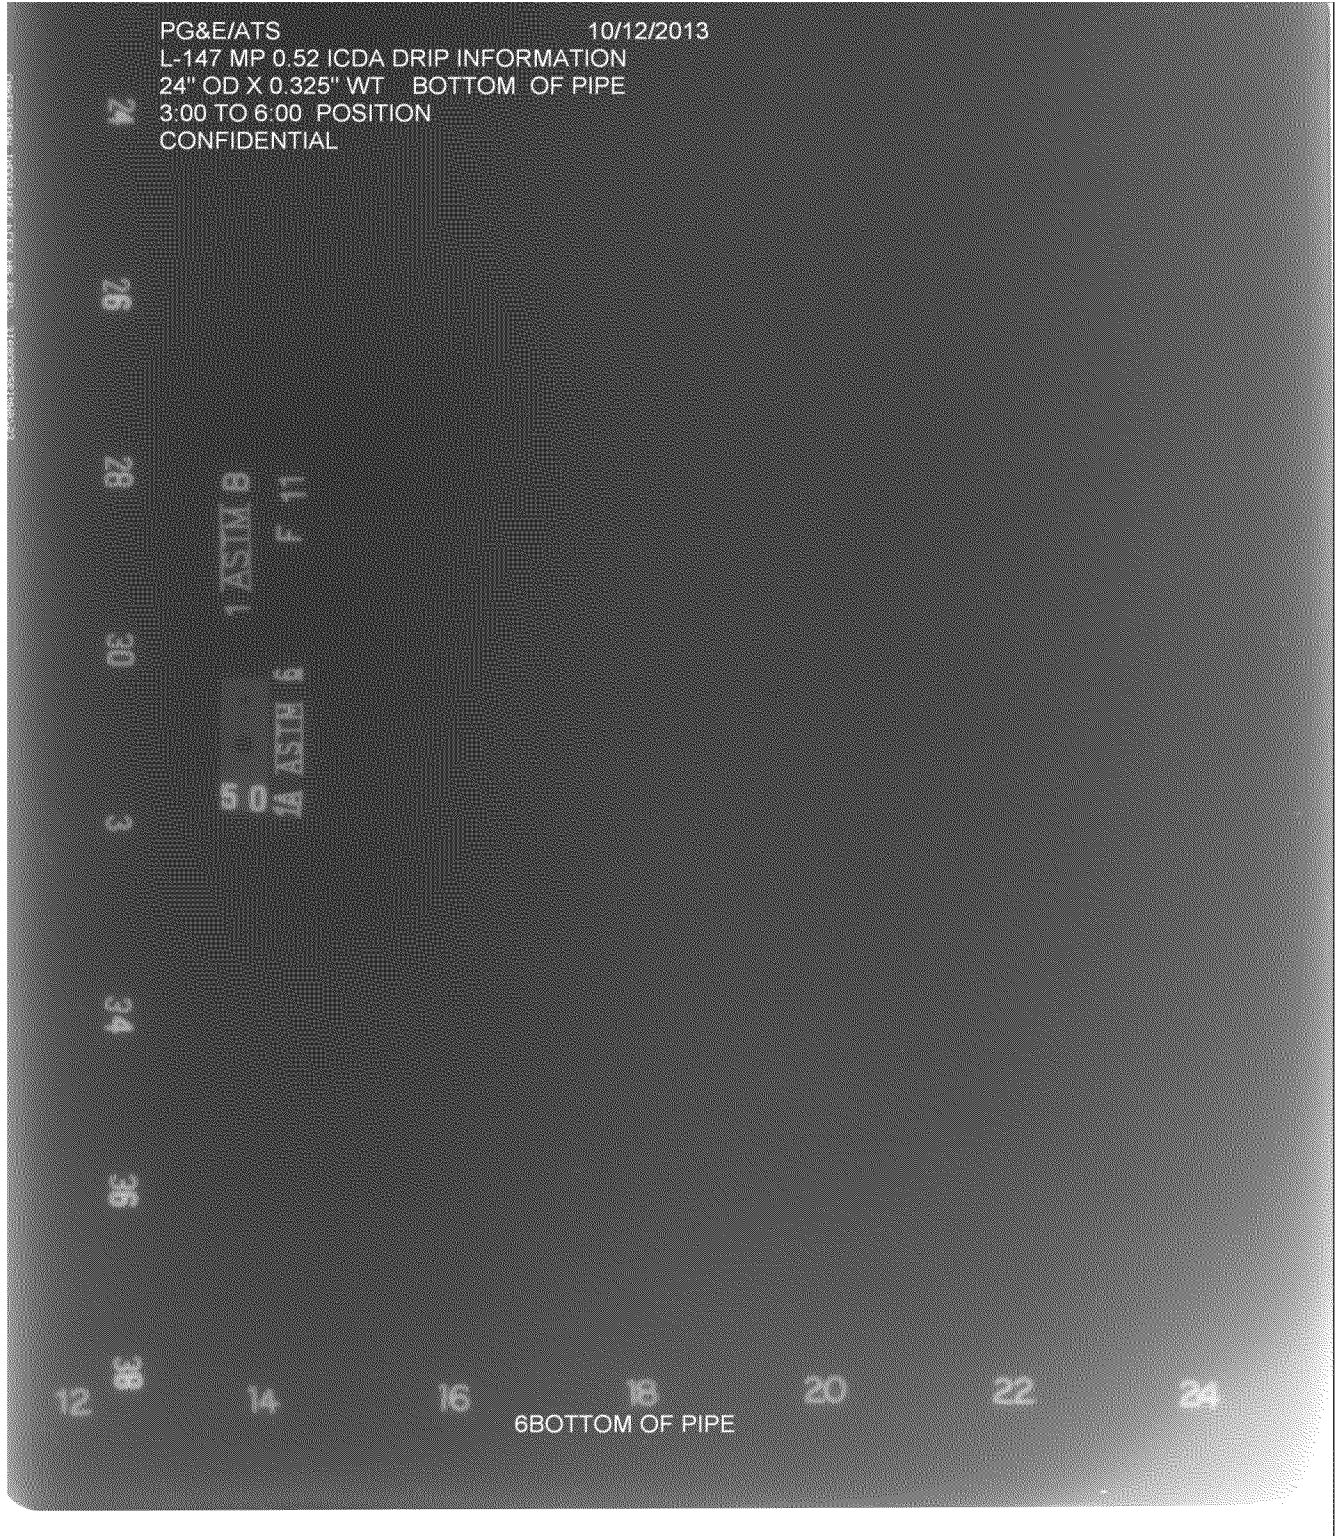
**Main Line:** ATS Radiographed from 3:00 to 9:00 the entire 8' exposed section of 24" pipe. No sign of internal corrosion, pitting, or debris were found. The 24" section of pipe has external corrosion cells on and around the reinforcement pad for the drip pot.

**Radiograph of the 24" main line showing no internal corrosion**

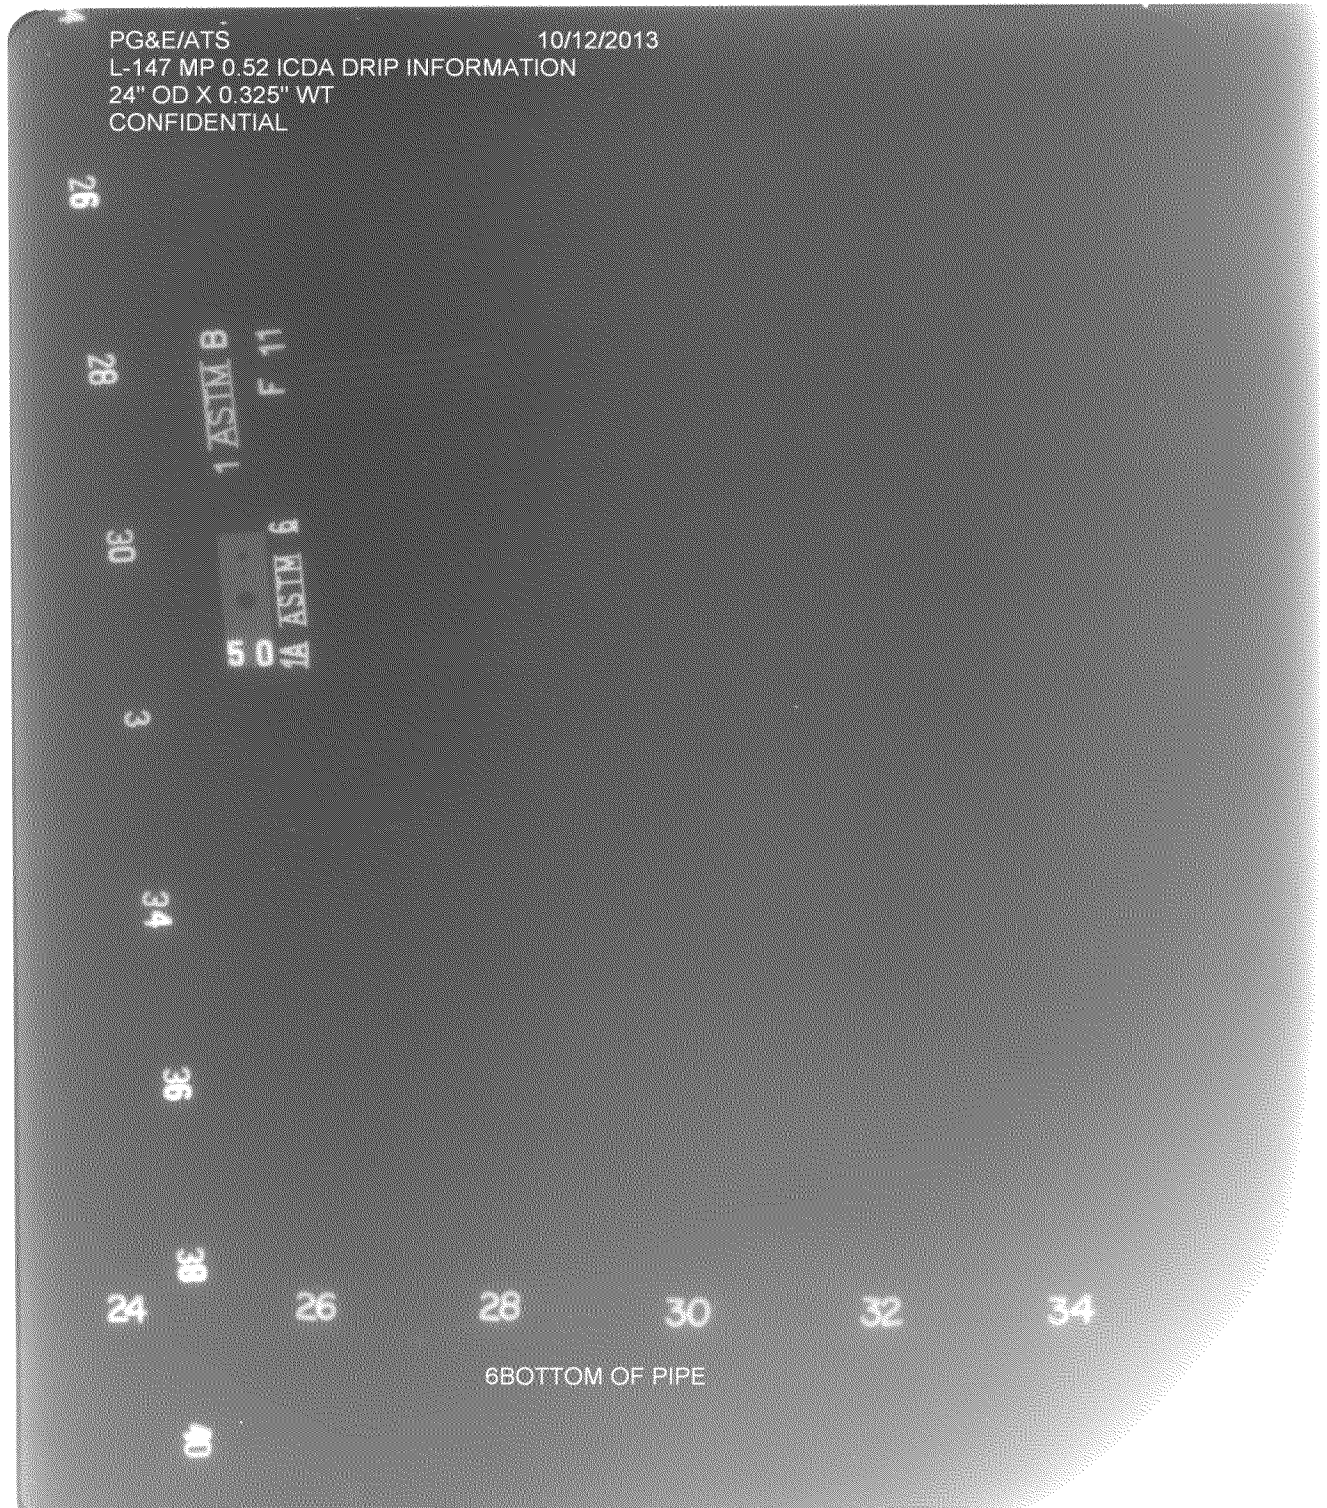
**Radiograph of the 24" main line showing no internal corrosion**

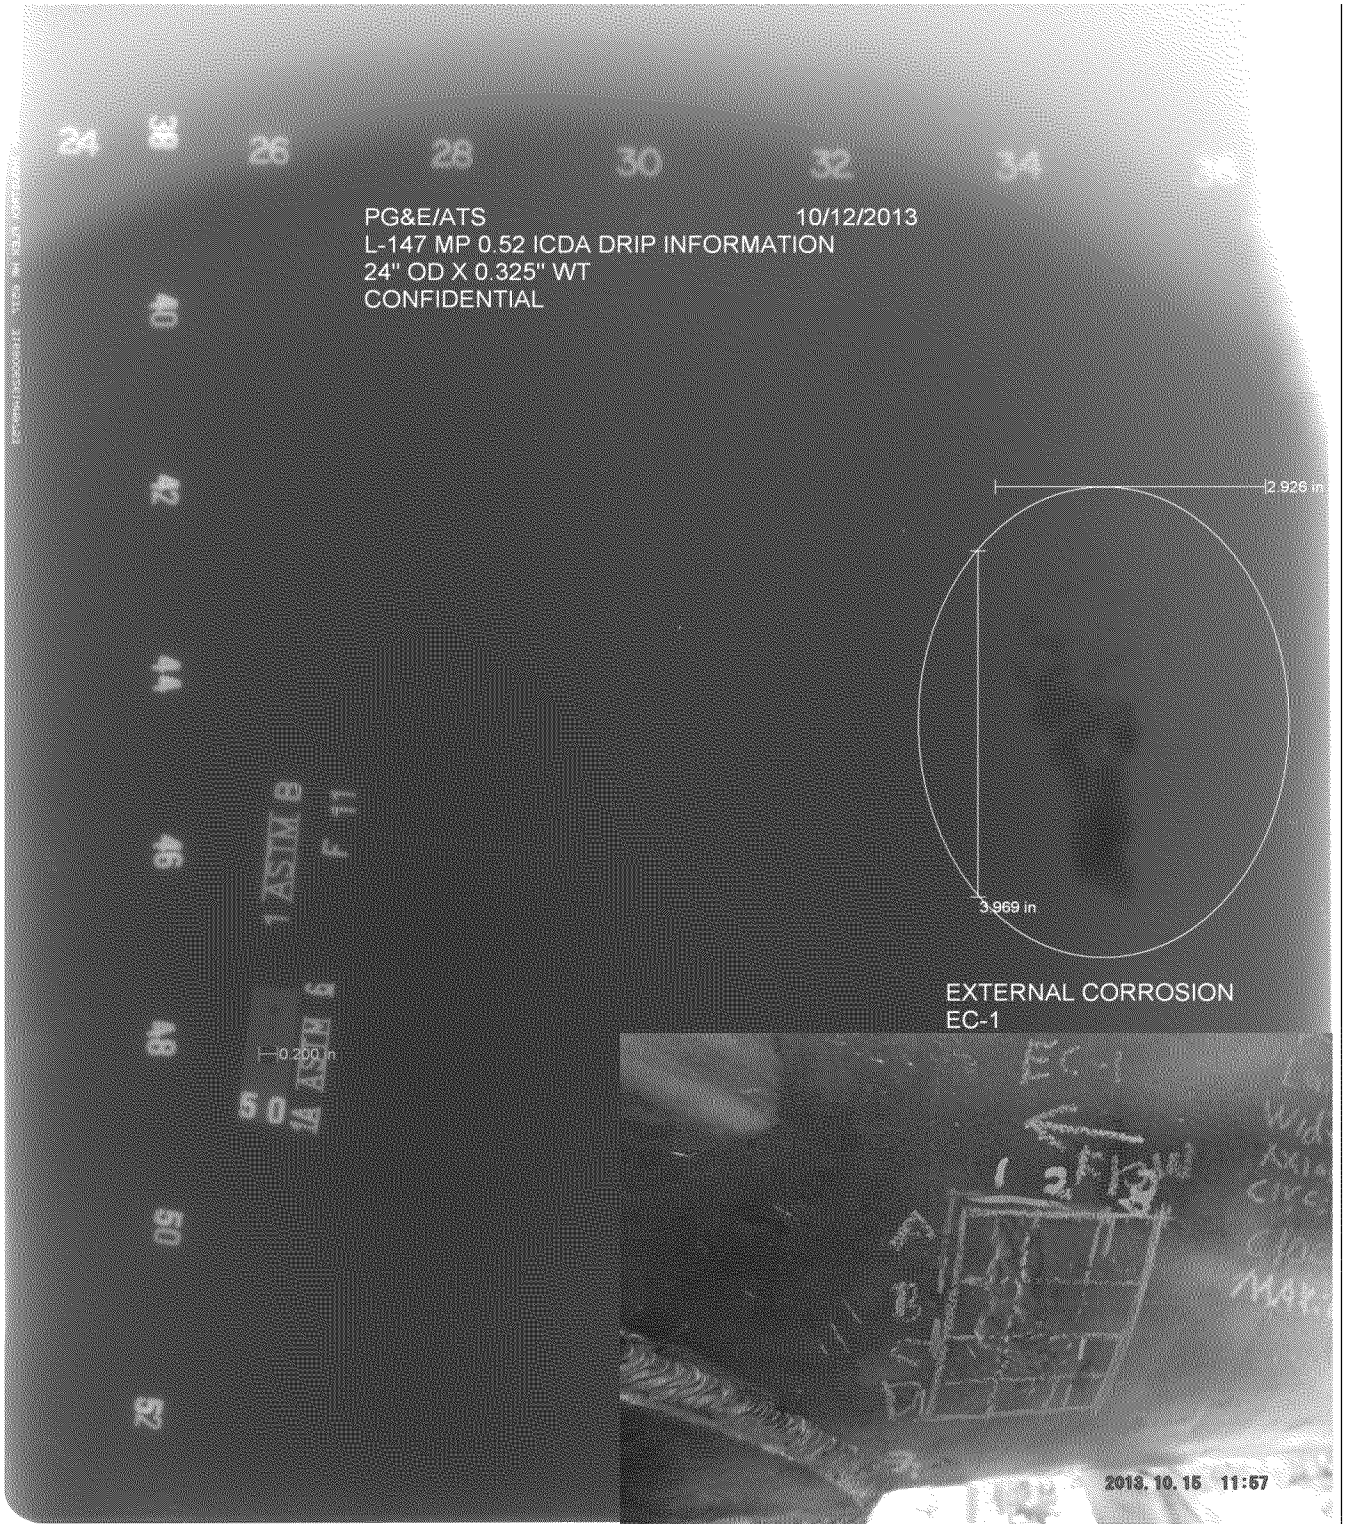
**EC-1:** Average Wall Thickness: 0.325", Min. 0.244" for 25% Wall Loss.

Radiograph of the 24" main line showing external corrosion cell (EC-1)

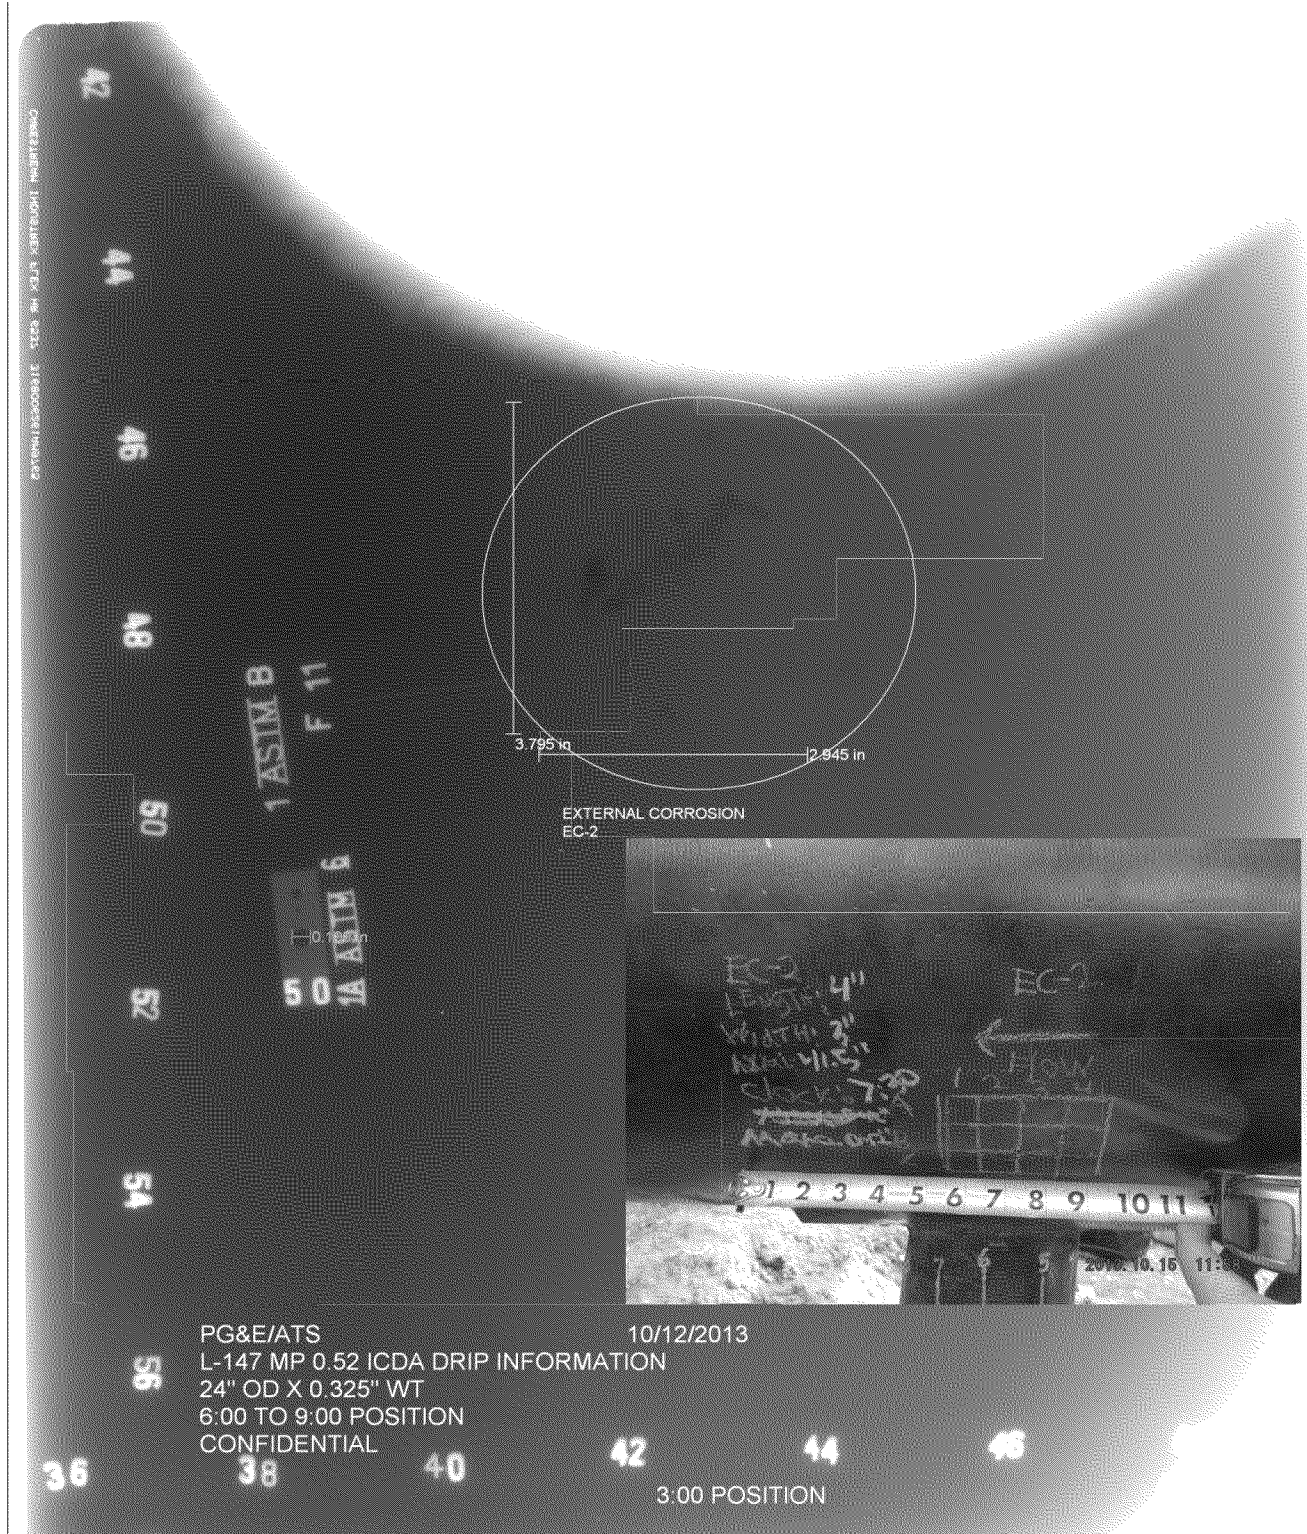
**EC-2 :** Average Wall Thickness: 0.325", Min. 0.283" for 13% Wall Loss.

Radiograph of the 24" main line showing external corrosion cell (EC-2)

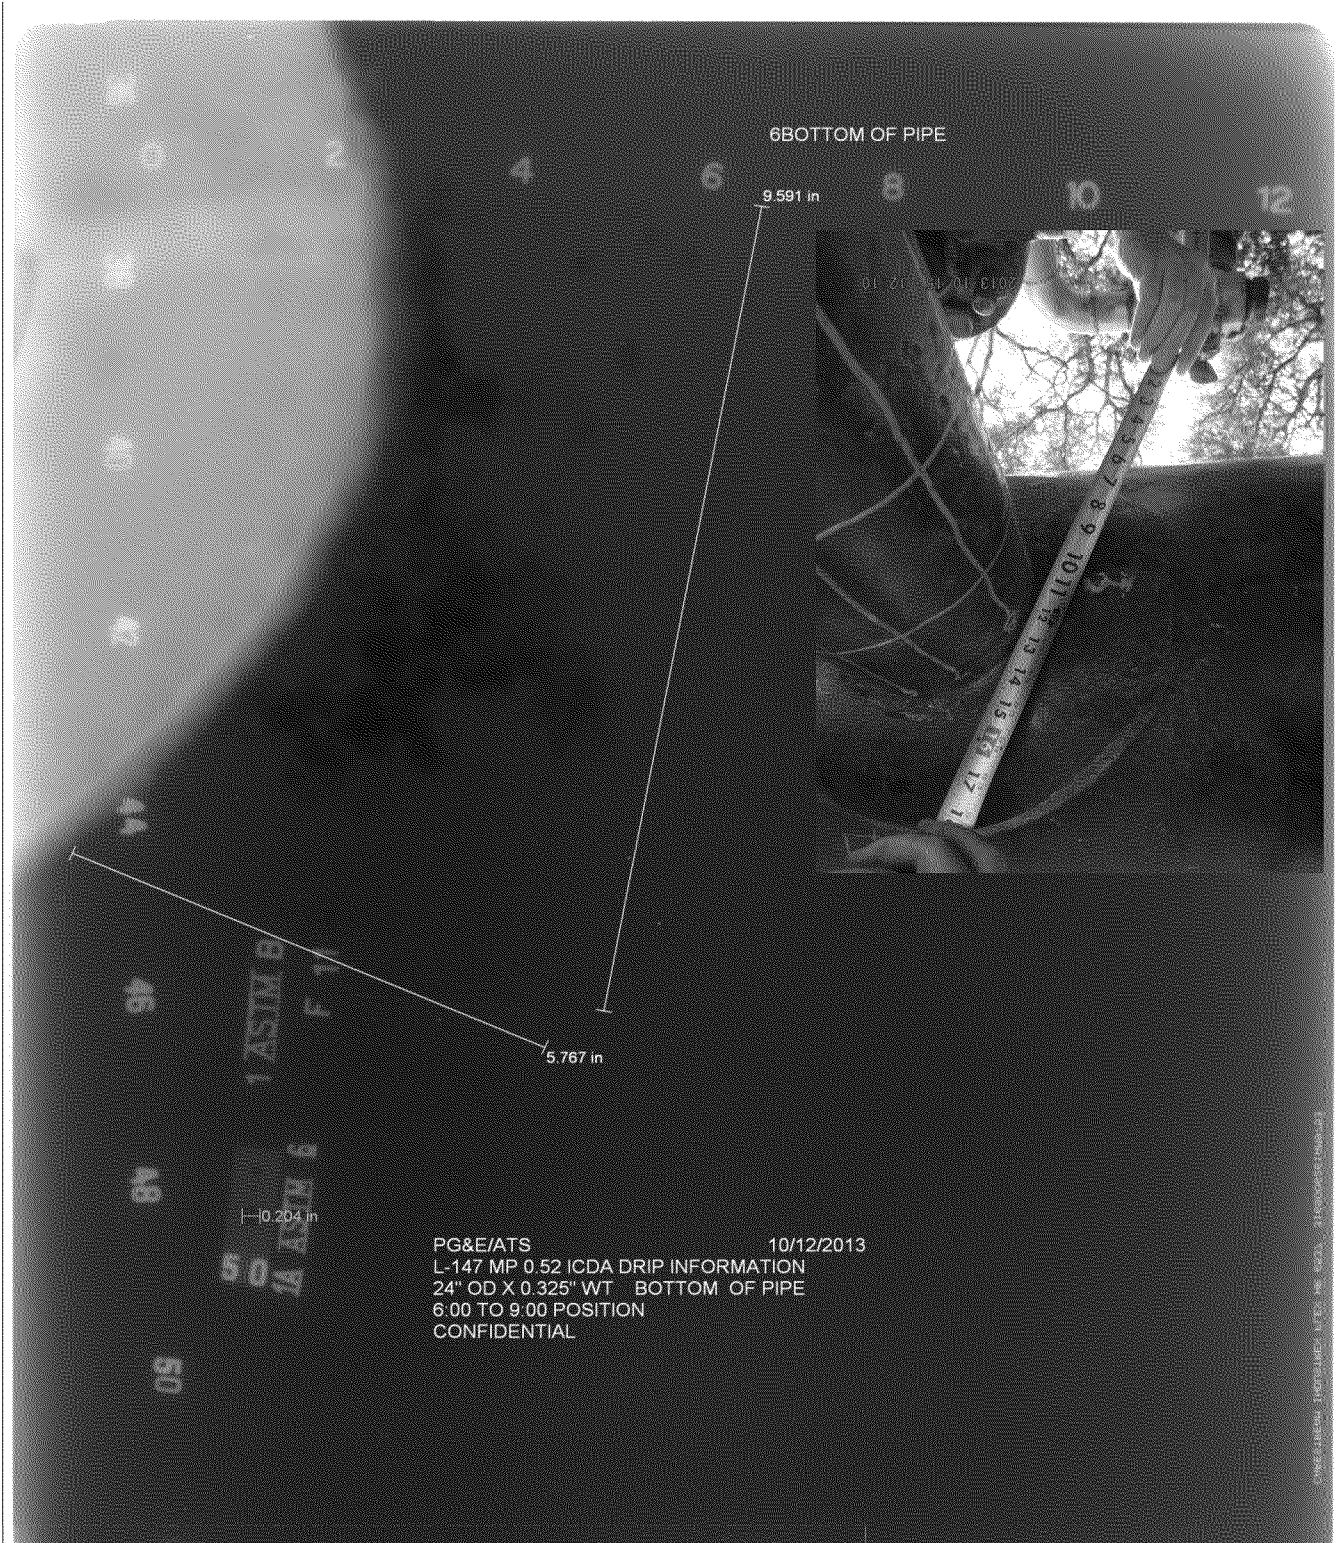
Radiograph of the 24" main line showing external corrosion cell (EC-3-1)

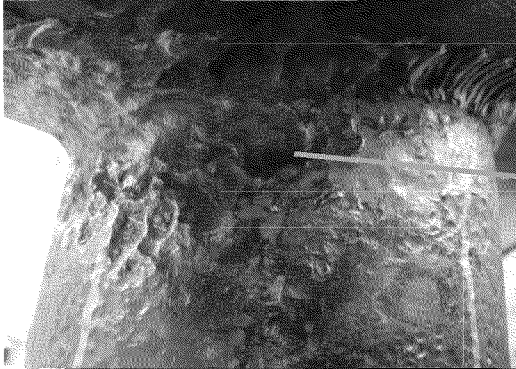
**6" Drip Pot:** ATS radiographed the drip pot and found it to be full of debris / sludge. Drip pot also has heavy external corrosion.

**2" pipe between drip pot and valve:** The 2" pipe is full of debris / sludge

Radiograph of the Drip Pot showing debris / sludge inside of the drip pot and 2" pipe between the drip pot and valve.

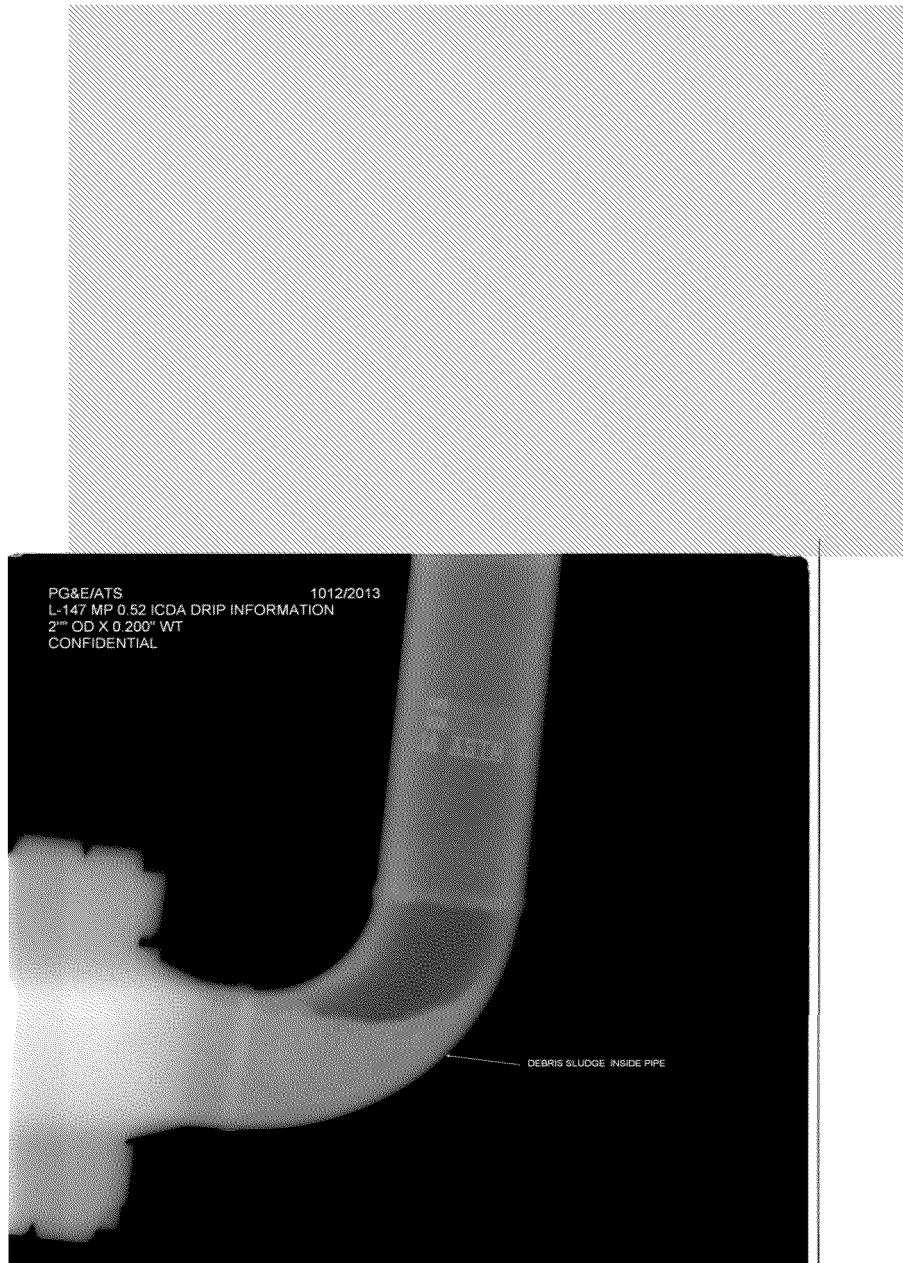
**2" Elbow past valve and 2" pipe running vertical:** The bottom elbow has debris / sludge that stops at the first girth weld running vertical. The vertical section of pipe has no debris / sludge. The top elbow has a small buildup of debris / sludge on the bottom.

**Radiograph of the 2" piping past the vavle showing debris / slugde in the bottom 90 and a small amount of debris / sludge on the bottom of the upper 90**

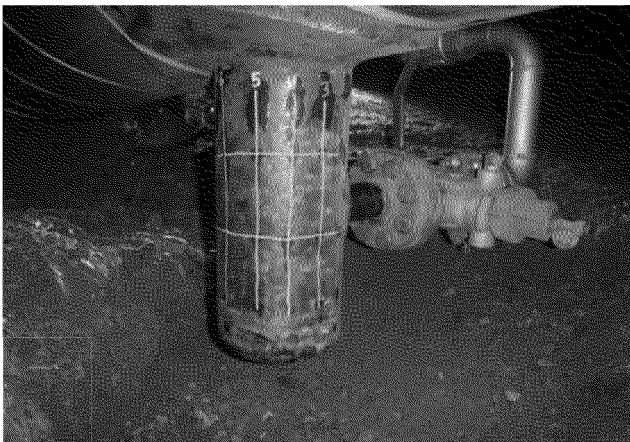
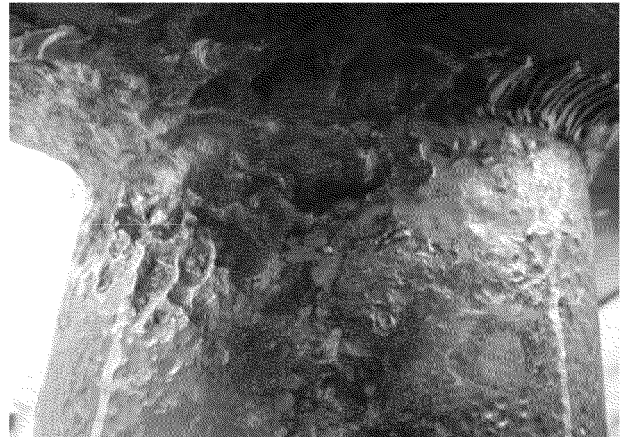
**EC 3-1 UT thickness survey of corrosion cell between the reinforcement pad and the drip pot using a pencil probe.**

Position	UT reading	Remaining wall
7:00	0.162	42.14%
plus 1"	0.179	36.07%
8:00	0.216	22.85%
plus 1"	0.185	33.92%
9:00	0.160	42.85%
<b>Average wall thickness for the drip pot:</b>		<b>0.280</b>

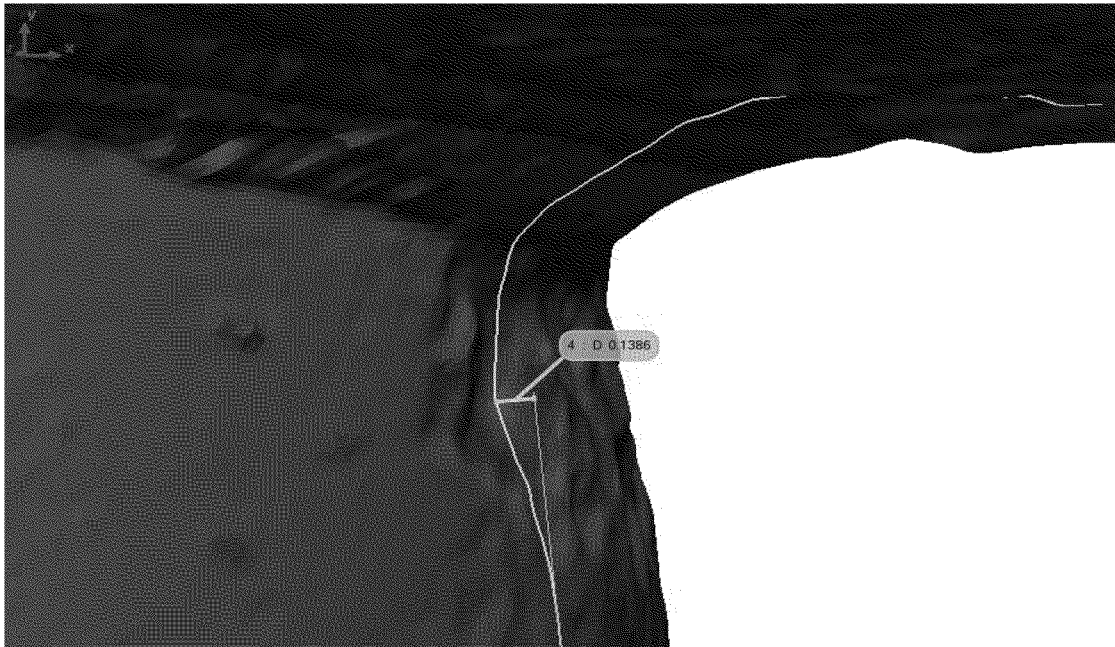
**EC-3:** Average Wall Thickness: 0.280", Min. 0.138" for 50.69% Wall Loss, (Per Laser Scanner see attached Report). an Impression Casting of the corroded weld, drip pot to saddle weld was difficult to obtain using multiple methods. This was: 4.00" width X 0.800" Long and approximately 0.150"-0.200" metal loss.

4 - D 0.1386

**View of deepest corrosion pit**

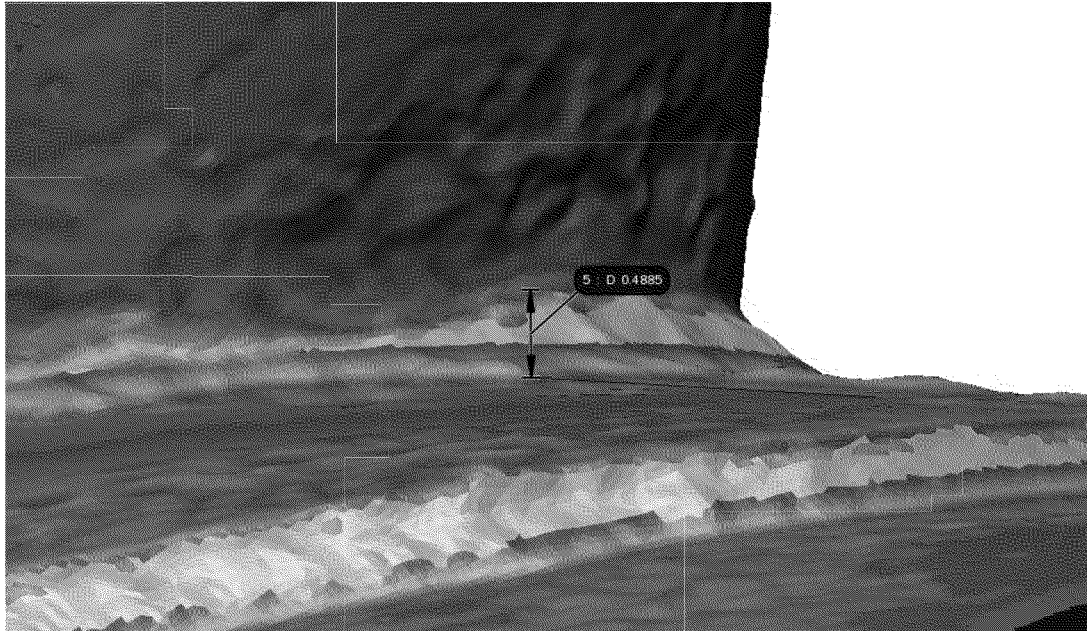
**Estimated weld leg size**

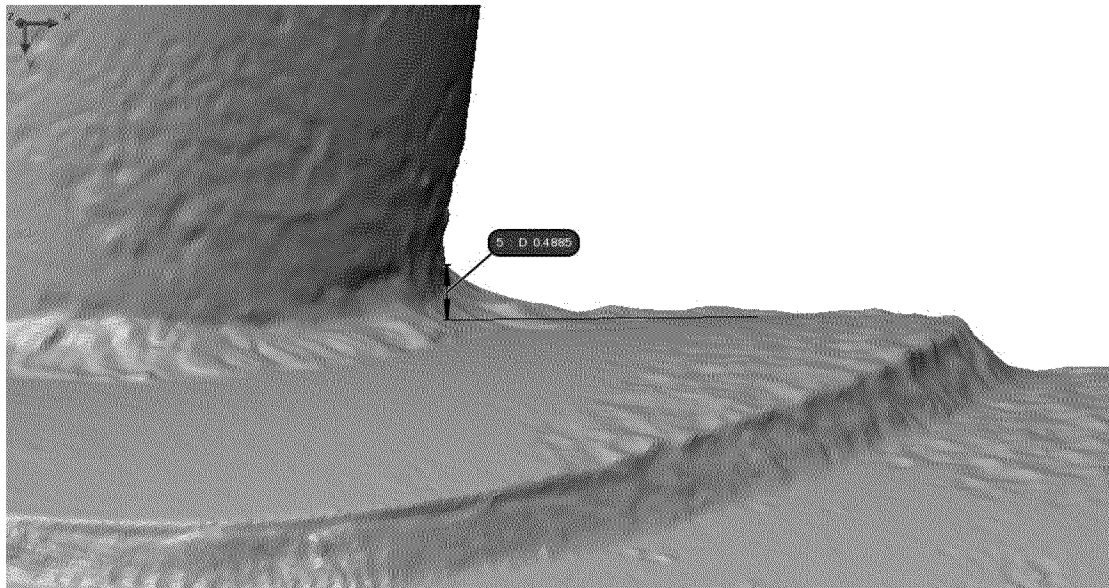
**Estimated weld leg size, without color map**

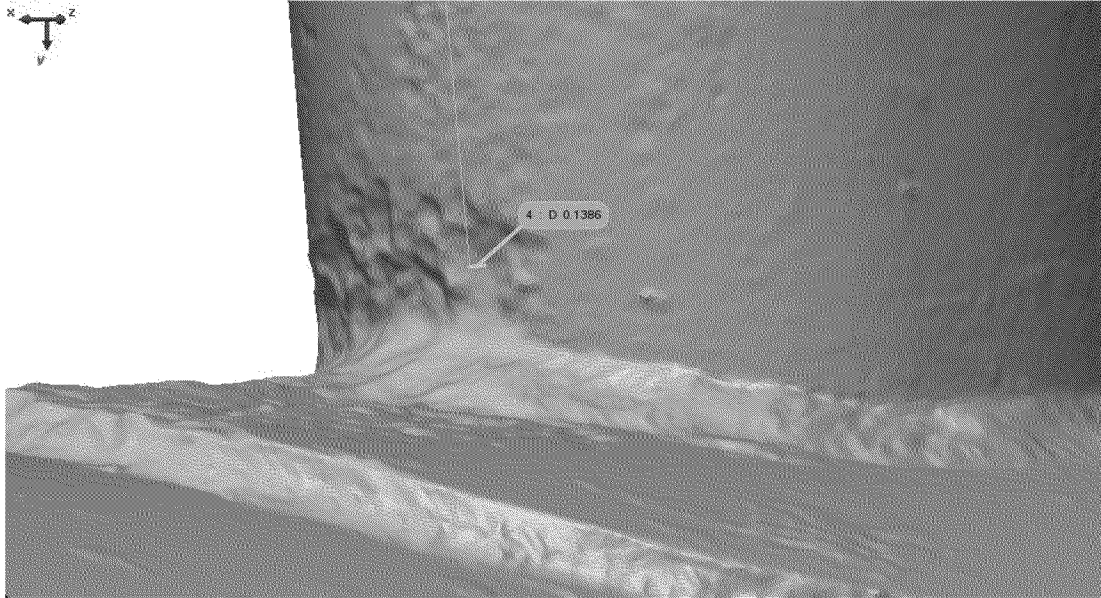
**View of deepest corrosion pit, without color map**

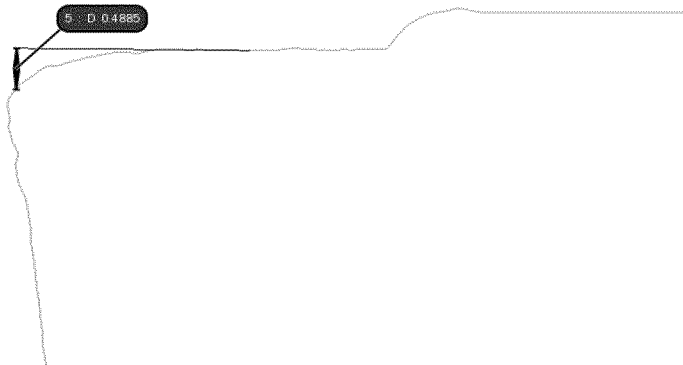
**Cross-section view of estimated weld leg size**

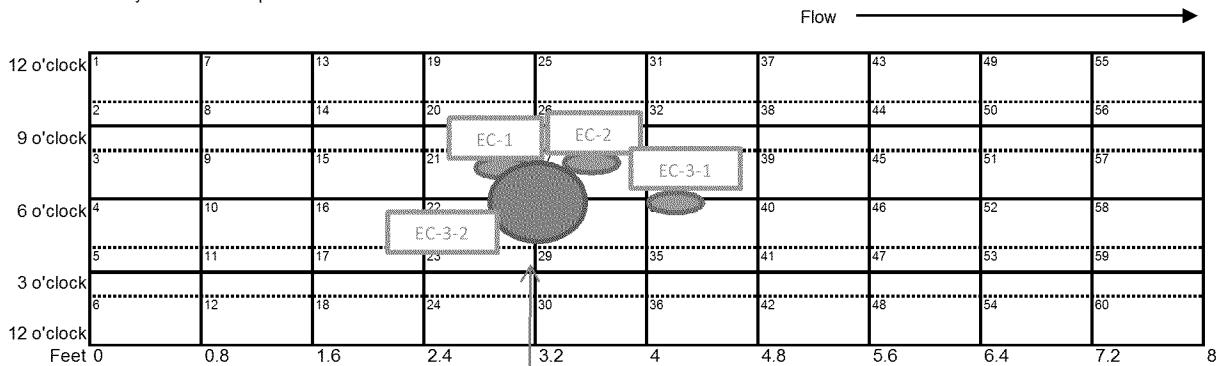
Drip Pot  
 EC-3-2 is the entire circumference of the 6" Dia Drip Pot
