**BEFORE THE PUBLIC UTILITIES COMMISSION
OF THE STATE OF CALIFORNIA**

**DECLARATION OF SUMEET SINGH SUPPLEMENTING THE VERIFIED
STATEMENT OF PACIFIC GAS AND ELECTRIC COMPANY'S VICE
PRESIDENT OF GAS TRANSMISSION MAINTENANCE AND CONSTRUCTION
IN RESPONSE TO RULING OF ASSIGNED COMMISSIONER AND ASSIGNED
ADMINISTRATIVE LAW JUDGE**

**PG&E Line 147 Britton
and Rogers Avenue Leak:
Metallurgical Analysis**

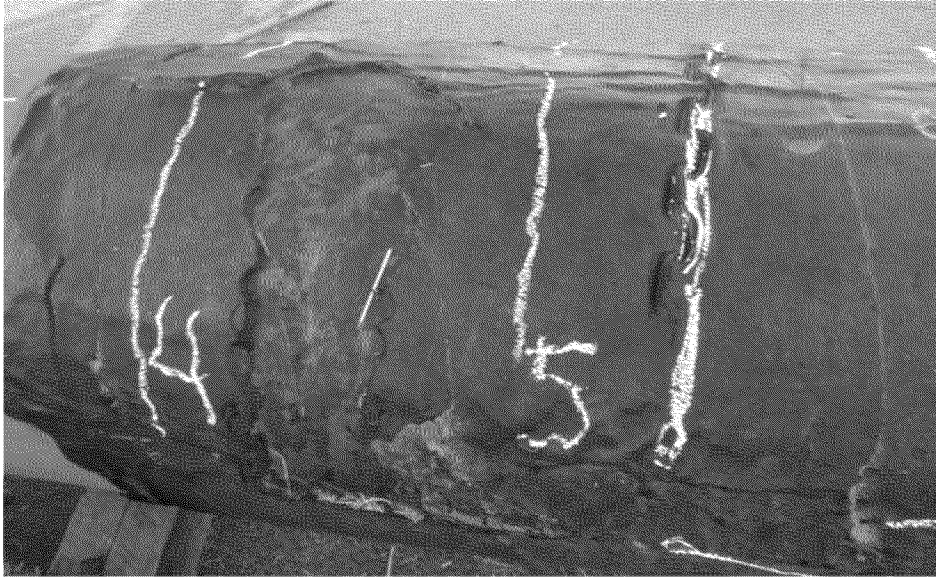
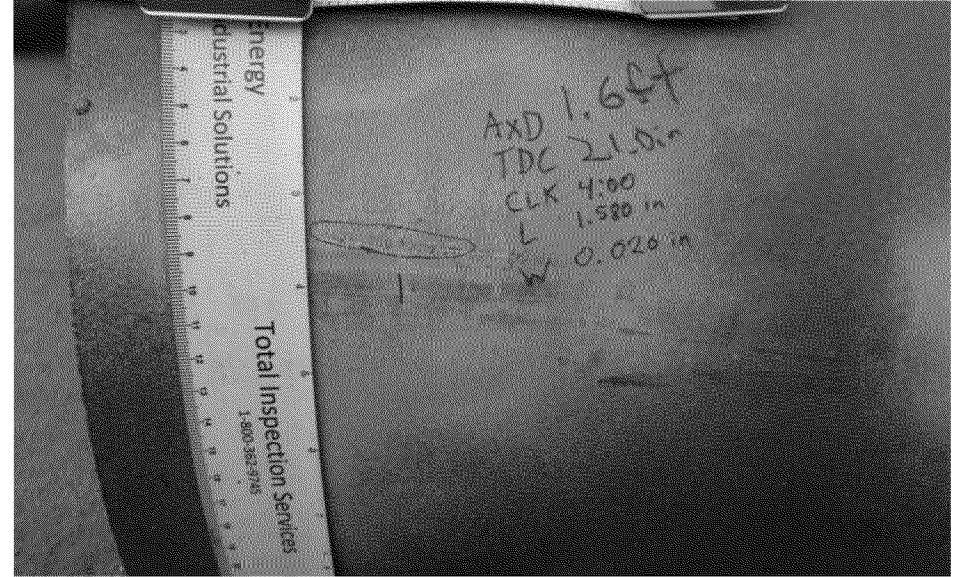
Coating damaged from removal process.

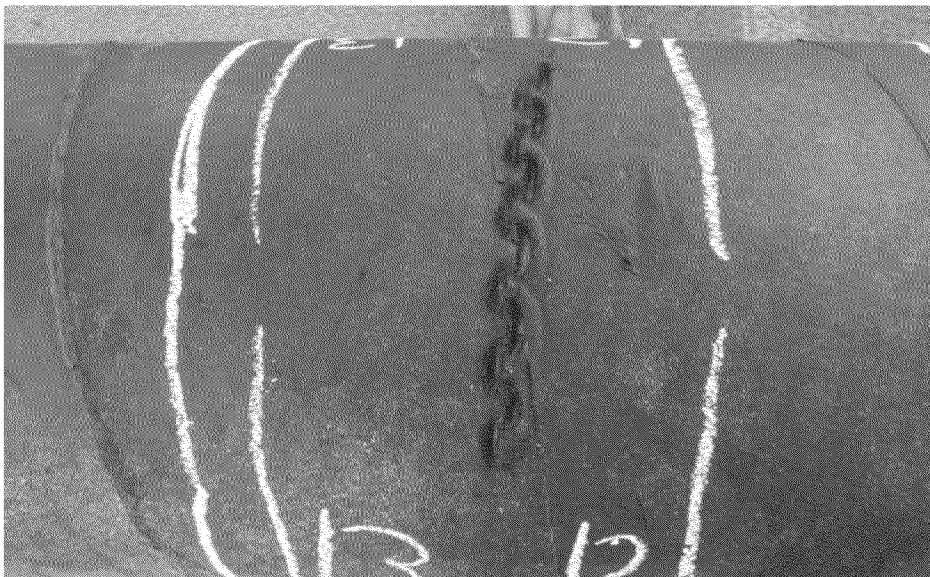
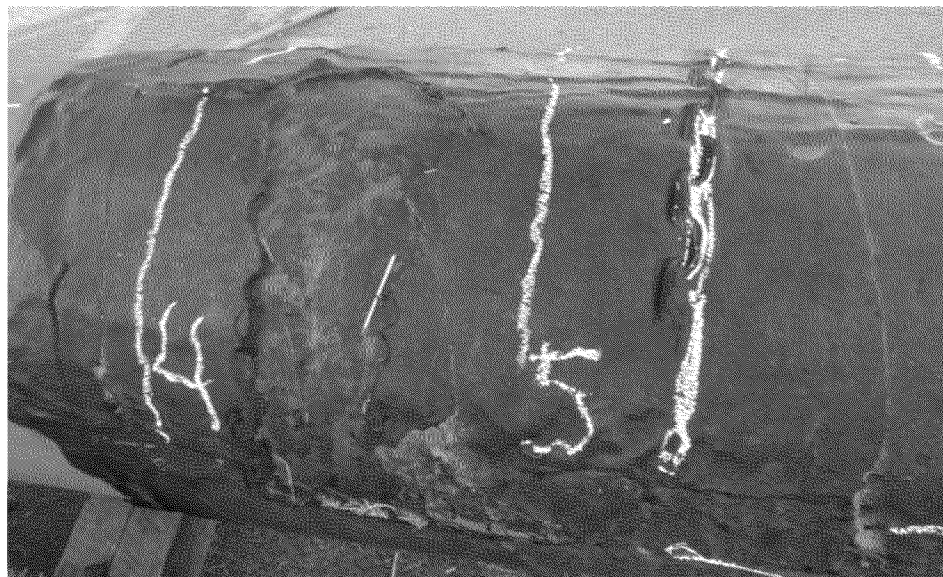
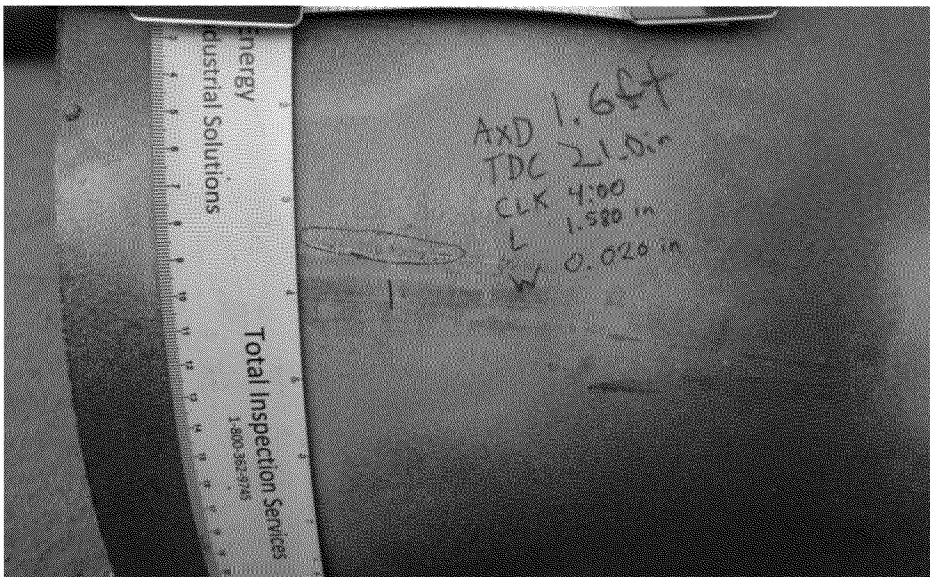
Coating damaged from removal process.

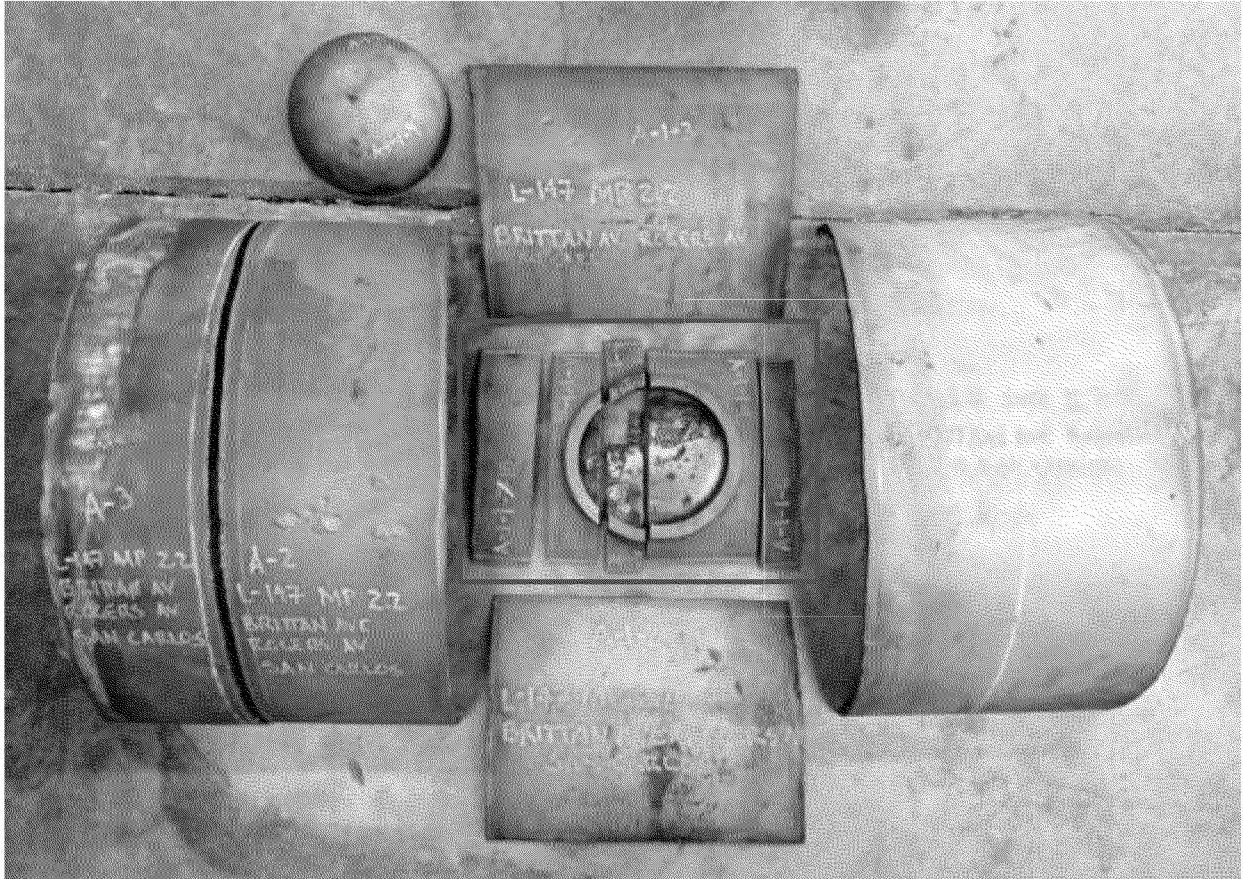
Figure 1. Photograph of the section of L-147 containing the crack and the PLIDCO cap welded over it to stop the gas leak. The red box shows the area magnified in Figure 3. Note the sectioning of the pipe and the yellow markings were made by Anamet.

The leak site was located in the area in the red box in Figure 1; enlarged in Figure 3. A PLIDCO cap had been welded onto the pipe to stop the leak until the subject pipe section could be removed. Beneath the cap, several weld repairs had been conducted. Anamet had sectioned the approximately 0.4-inch long crack into two pieces, then mounted, polished and etched the parts for analysis. The two metallurgical mounts are shown in Figure 4 as received from Anamet. Exponent retained Anamet's sample ID numbers, which for the metallurgical mounts are A-1-1-8 and A-1-1-7, left and right, respectively in Figure 4. As indicated in Anamet's report, these samples were subjected to serial grinding to evaluate different leak cross-sections. As such, portions of the leak that have been ground-away are no longer available for examination.

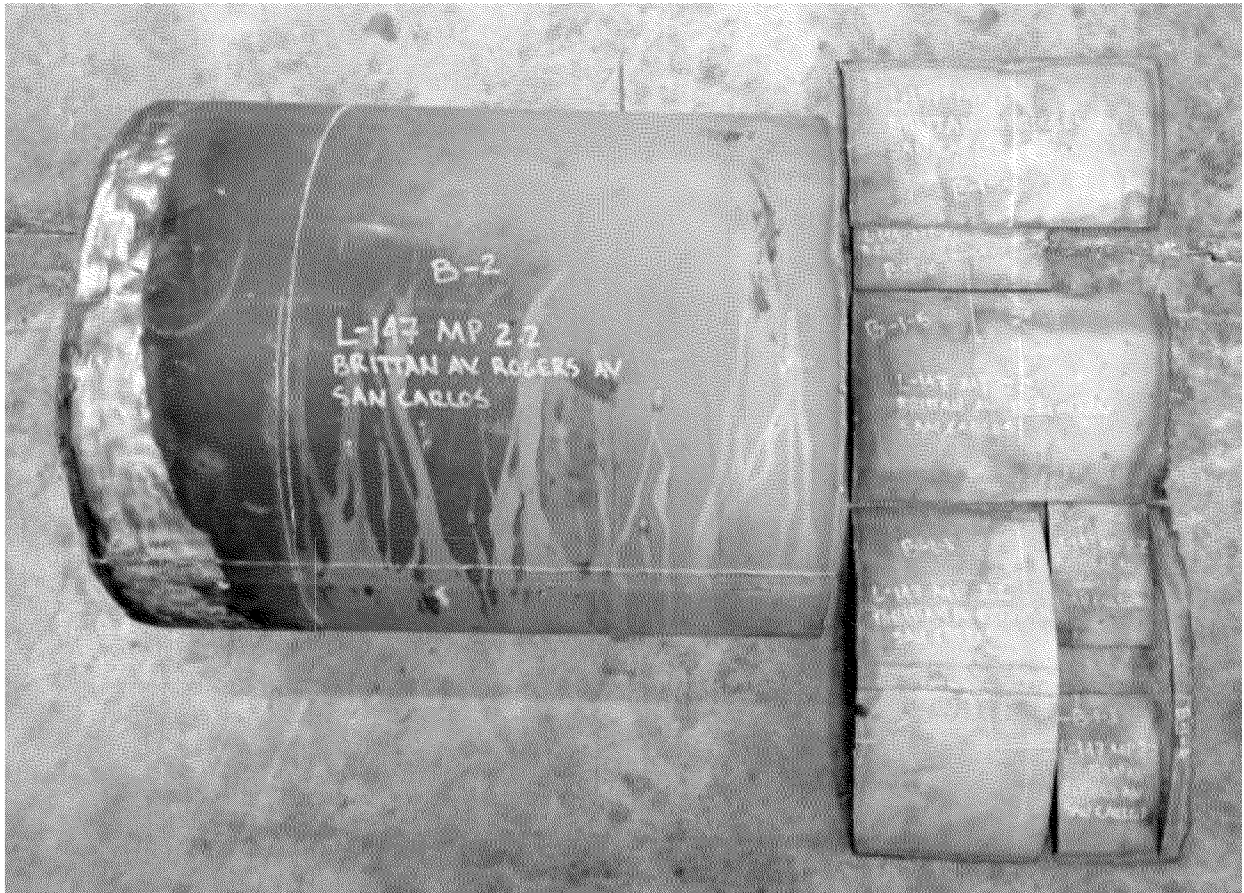
Figure 2. Photograph of a section of L-147 removed from the section of pipe containing the crack. Note the sectioning of the pipe and the yellow markings were made by Anamet.

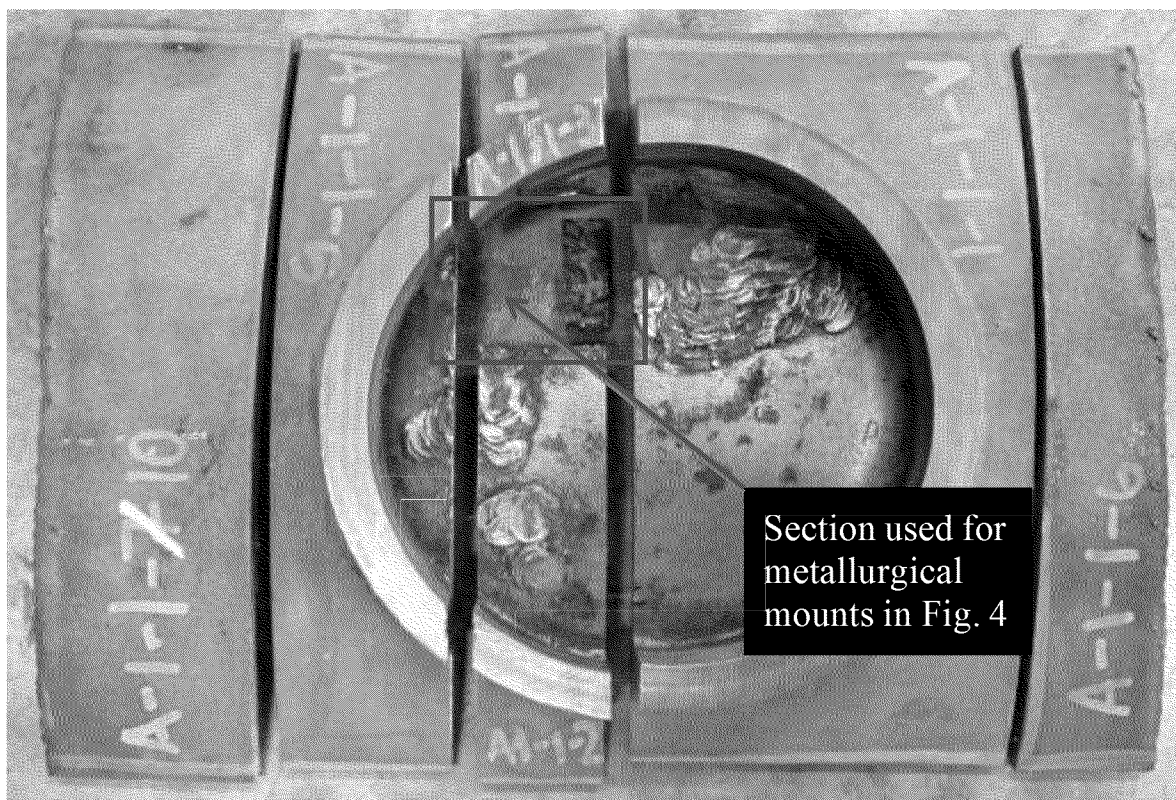
Figure 3. Photograph of the section of L-147 (boxed in red in Figure 1) containing the crack and the PLIDCO cap. Note the sectioning of the pipe and the yellow markings were made by Anamet.

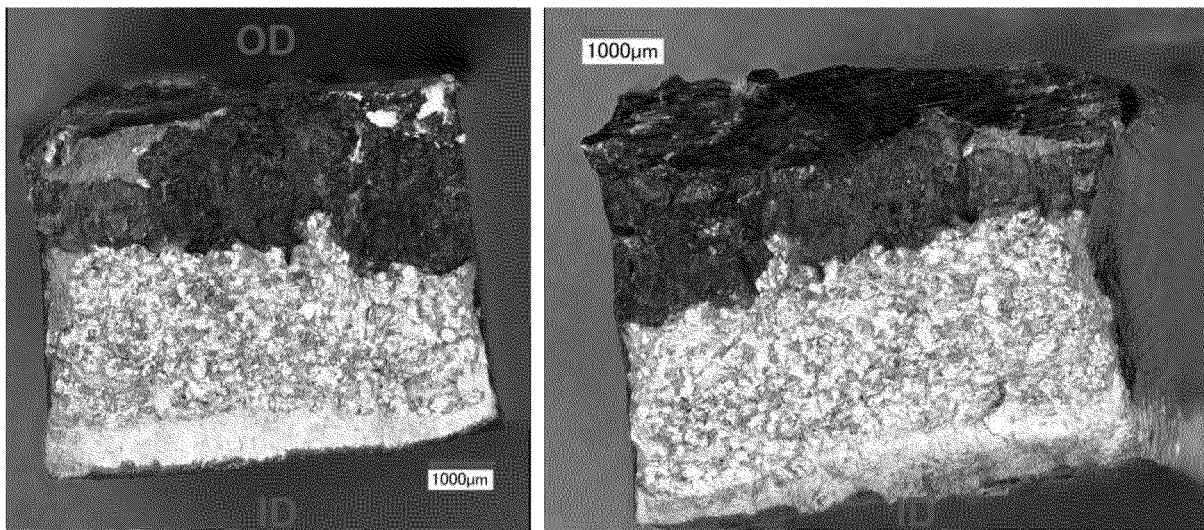
Figure 5. Optical micrographs of the leak surface after opening Anamet's A-1-1-8 metallurgical mount.

As shown in Figure 5, the pre-existing crack in Sample A-1-1-8 only extended from the OD approximately halfway through the pipe wall. The pre-existing crack A-1-1-7 extended from the ID nearly to the OD surface. While neither of these two samples display a clear ID-to-OD leak path, the pre-existing crack in Sample A-1-1-7 extends nearly through the pipe wall thickness. Based on the metallographic images in Anamet's report, as well as fractographic analysis of the remaining broken-open metallographic specimens, it is apparent that the through-wall (ID-to-OD) path for the subject leak was less than the 0.4 inch total length of the cracks.

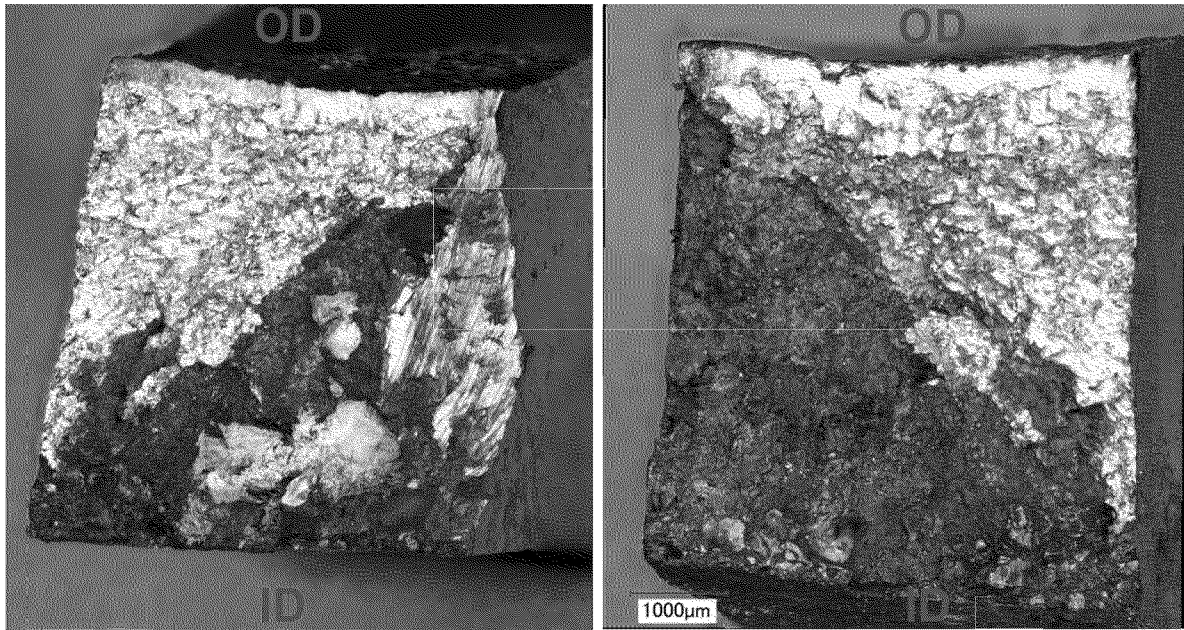
Figure 6. Optical micrographs of the leak surface after opening Anamet's A-1-1-7 metallurgical mount.

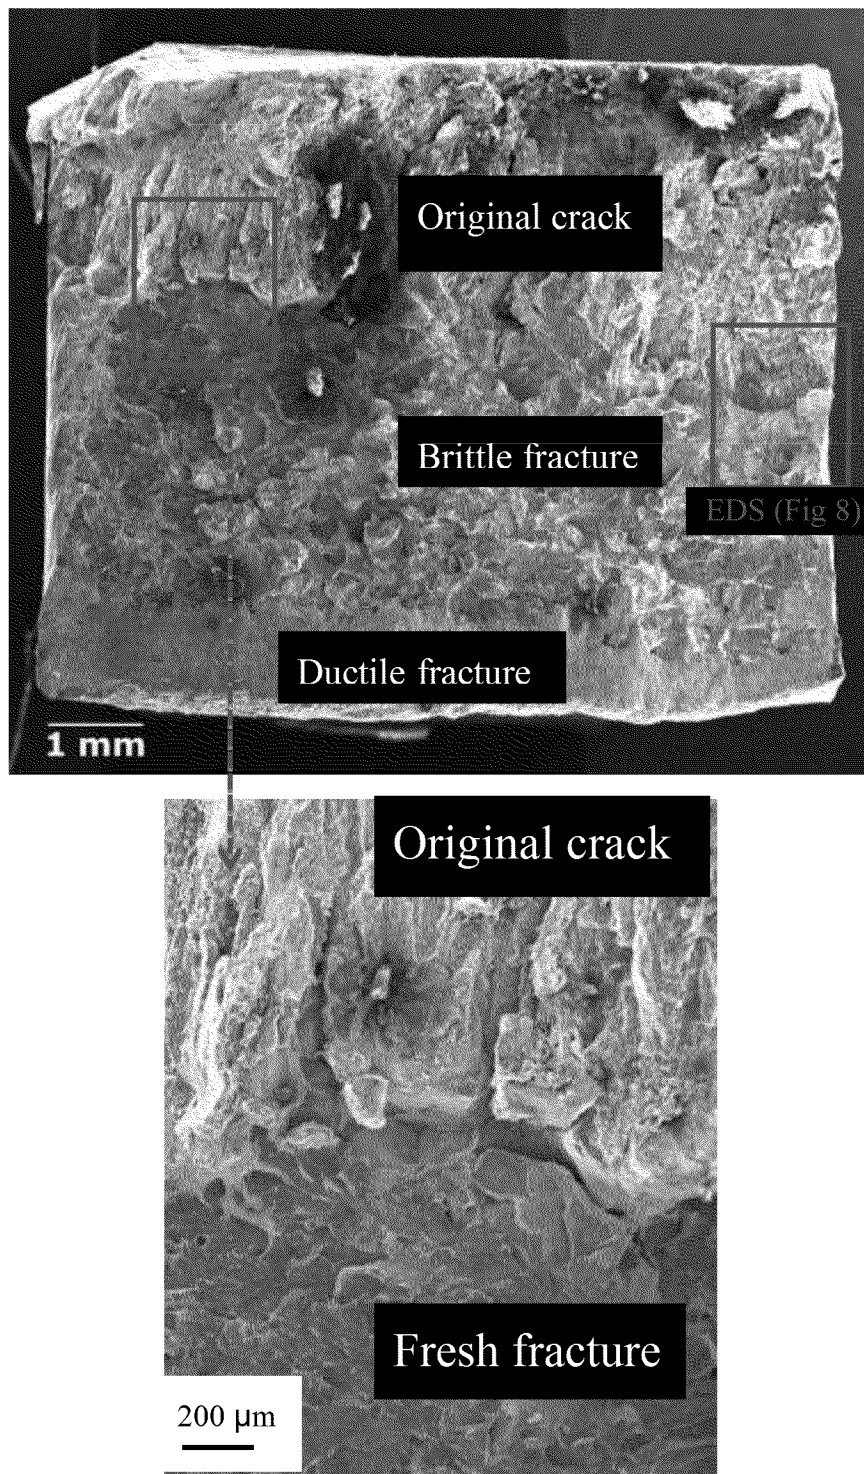
Figure 7. SEM images of Sample A-1-1-8 fracture surface (left side of Figure 5). Top image shows the entire surface with one red box magnified (bottom image) and another red box for the area analyzed with EDS in Figure 8.

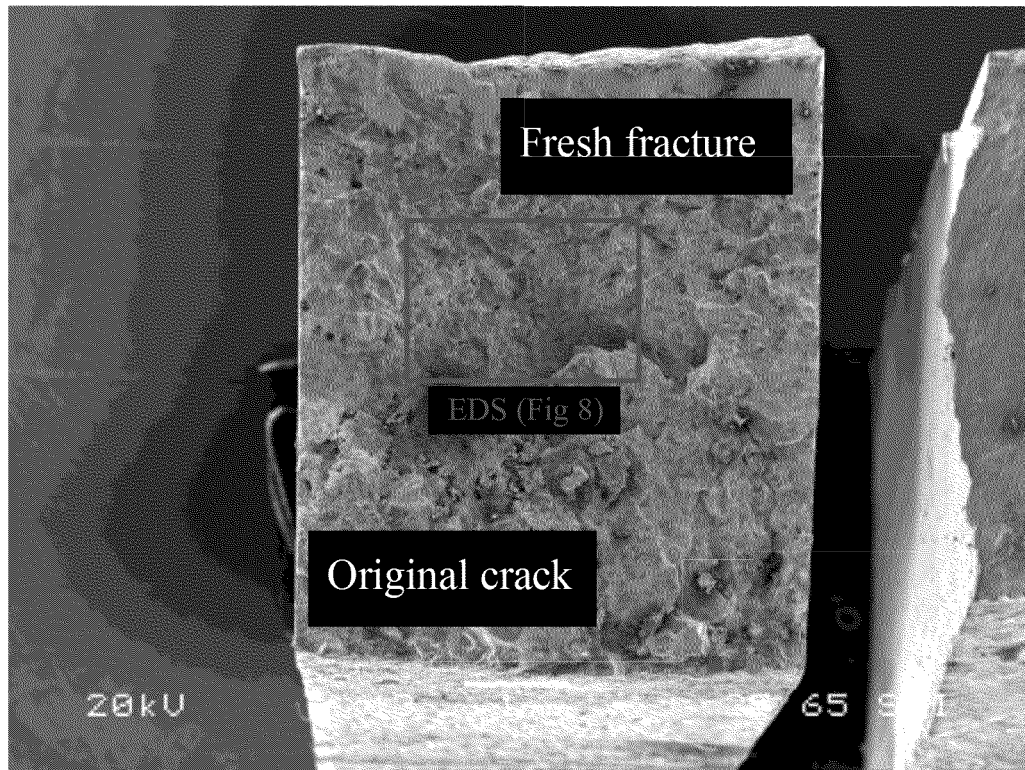
Similar SEM and EDS examination was performed on the Sample A-1-1-7 fracture surface faces, example images are shown in Figure 9 and Figure 10. The substantial oxide deposits on the original leak surface obscured much of fracture morphology in the original-cracked portion of Sample A-1-1-7, as shown in Figure 9. However, the transition between the original crack surface and the intentional brittle (cleavage) fracture area showed no evidence of progressive growth, also shown in Figure 9.

Figure 9. One side of the crack surface in Sample A-1-1-7 (right side of Figure 6). The red box shows the area analyzed with EDS in Figure 10.

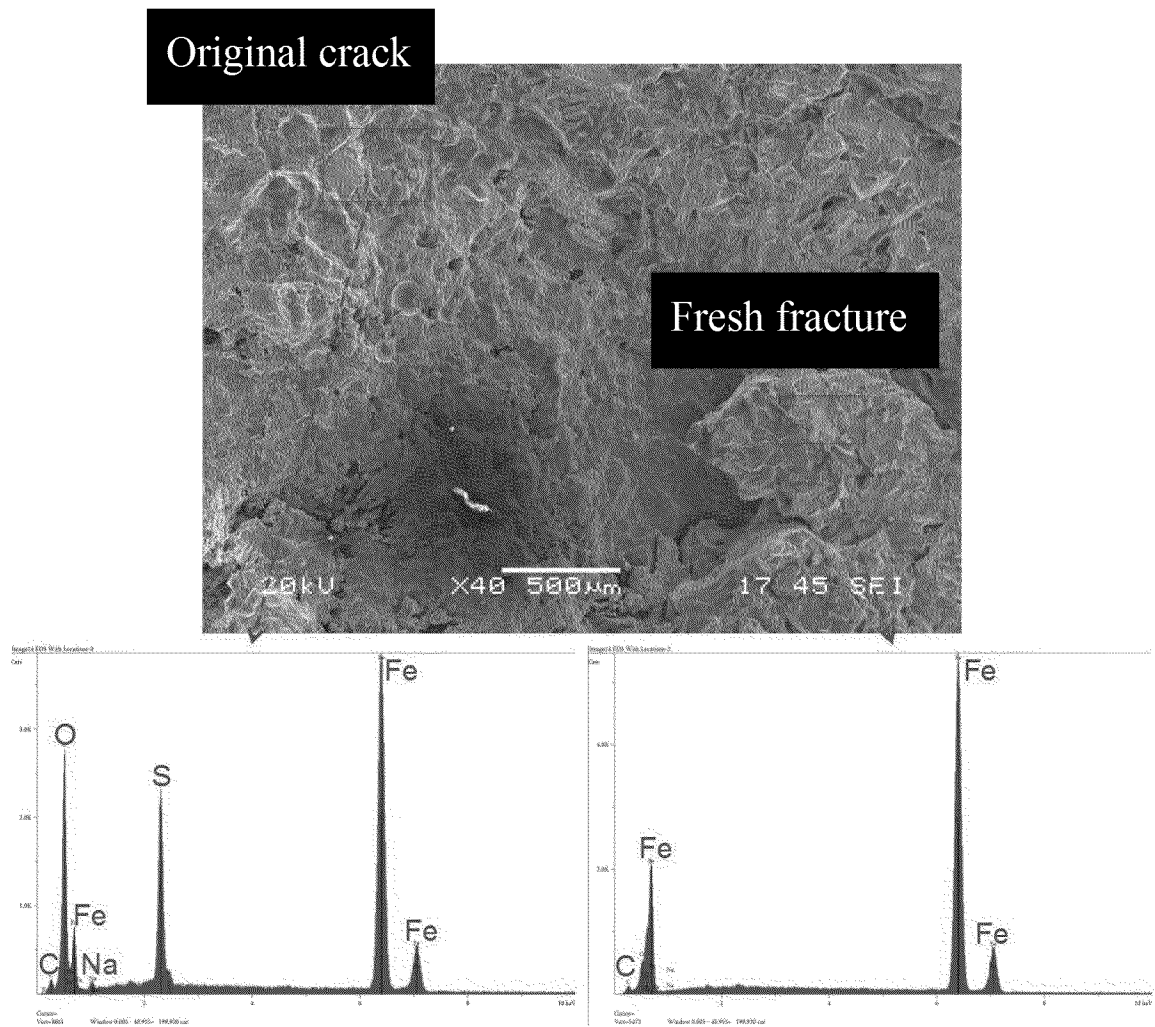
EDS analysis of the Sample A-1-1-7 fracture surface showed similar findings as exhibited in Sample A-1-1-8. The freshly-exposed brittle fracture surface showed primarily iron with a small amount of carbon, while the original leak surface exhibited significant amounts of carbon, oxygen, and sulfur, as shown in Figure 10.

Figure 10. EDS analysis of the area in the red box in the top image in Figure 9. The right side is the freshly cracked surface; the left side is the surface of the original crack composed of iron oxide with significant sulfur.

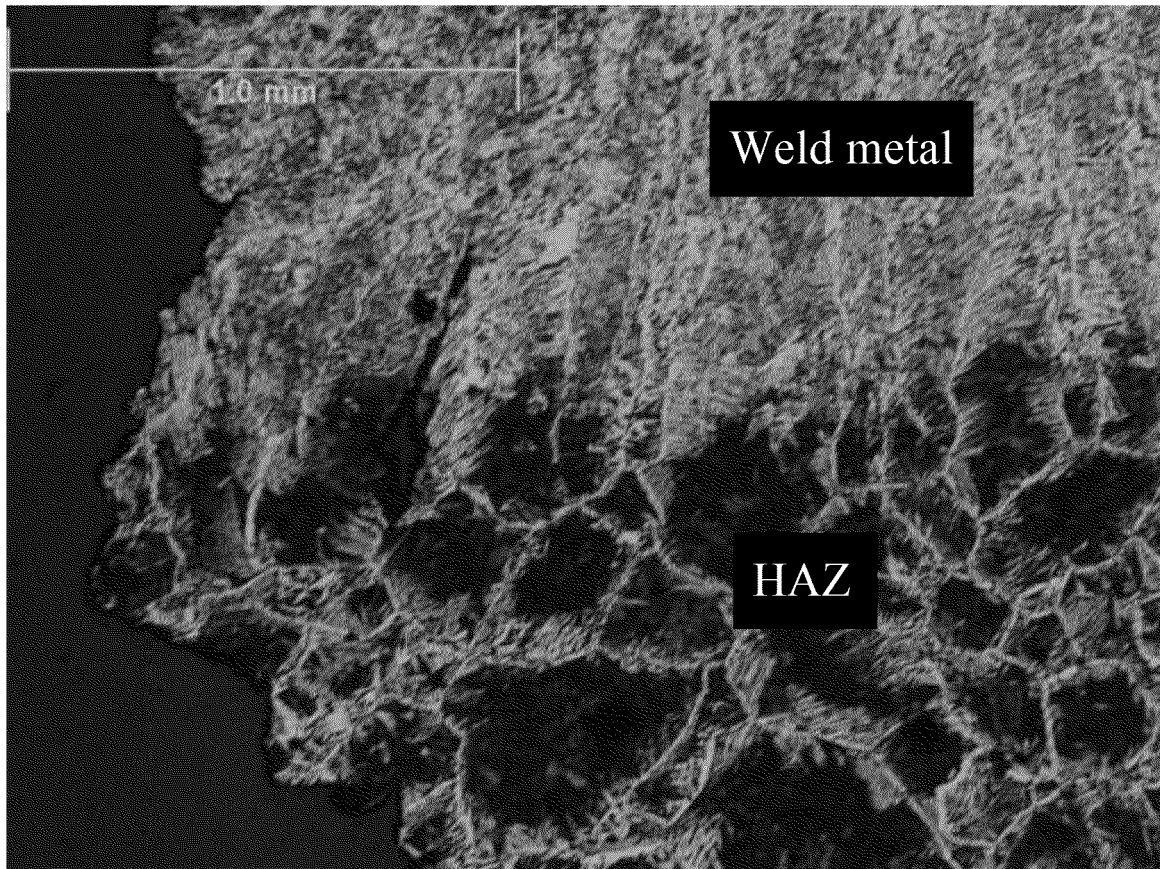
Figure 14. Metallographic image that shows significant grain coarsening beneath the weld in Sample A-1-1-8, with Widmanstatten ferrite at the prior-austenite grain boundaries in the heat-affected zone (HAZ).

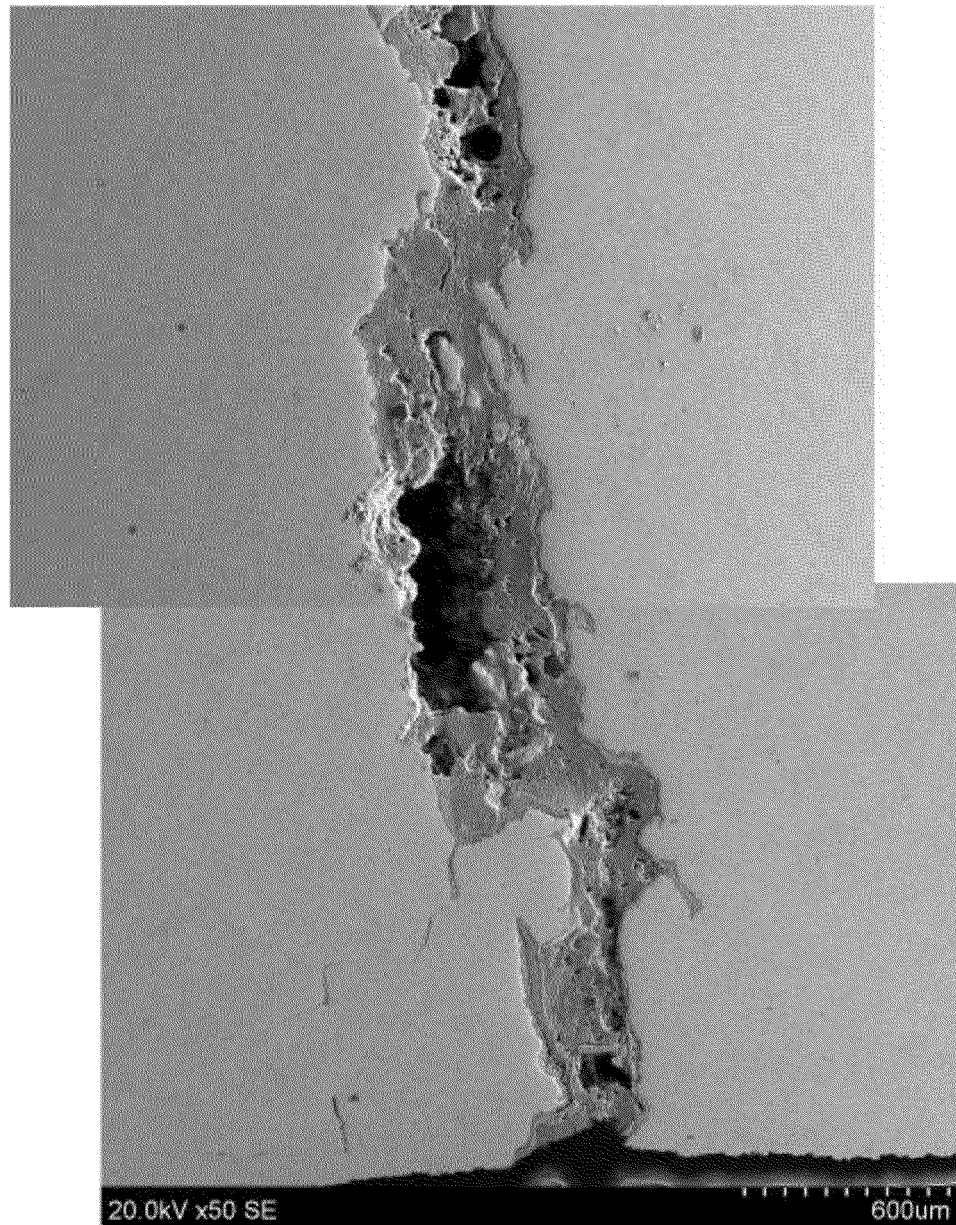
Anamet conducted SEM/EDS analysis of the unopened crack in a metallographic mount: originally Figure 20 in their September 6, 2013 report, shown here as Figure 15. Consistent with Exponent's analysis, Anamet determined that the crack was filled with iron oxide and contained appreciable amounts of sulfur.

Figure 15. Composite SEM micrograph of the metallographic mount prepared by Anamet. Image reproduced from the September 6, 2013 Anamet report with permission from Anamet.

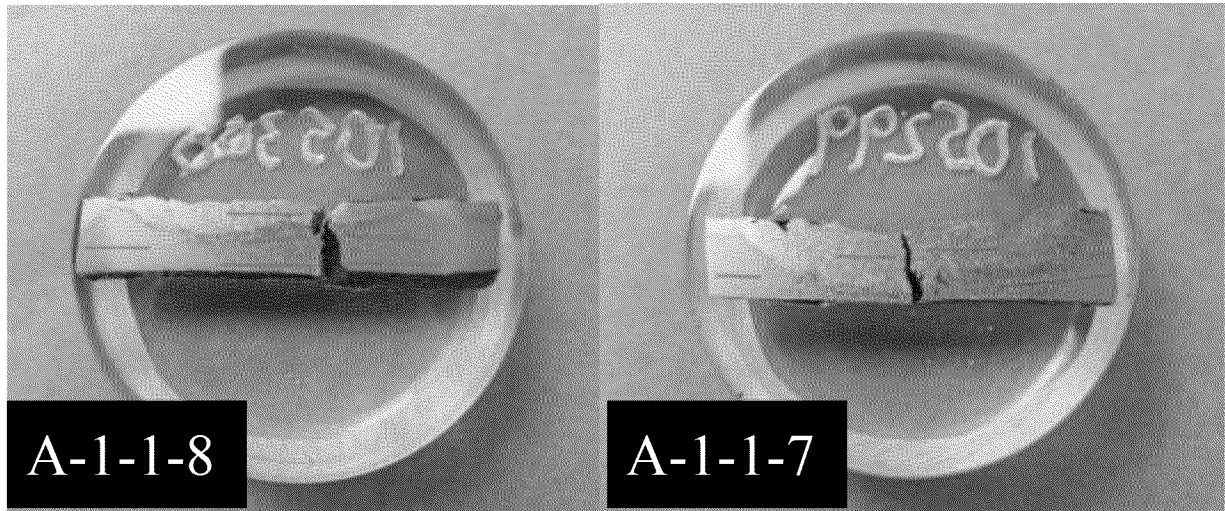
Vickers microhardness (HV) traverses were conducted over both metallographic mounts to assess hardness in the weld, HAZ, and base metal, shown by red lines in Figure 16. Each microhardness traverse and associated values are shown in Appendix B. Accounting for all testing samples, the base and weld metal exhibited average hardness values between 130-155 HV. The HAZ exhibited slightly higher hardness levels, between 155-190HV. However, it should be noted that the HAZ hardness levels are relatively low, consistent with the significant

grain coarsening observed. For carbon steels, a hardness of over 350HV would be considered excessive, and indicate a possible susceptibility to hydrogen cracking in the HAZ.^{4, 5}
