**Pipe Characterization and Weld Assessment
San Carlos
Line 147
Mile Post 0.52**

ATS Report #: 413.61-13.390

Gas Project: ICDA

Line 147 Mile Point 0.52 San Carlos

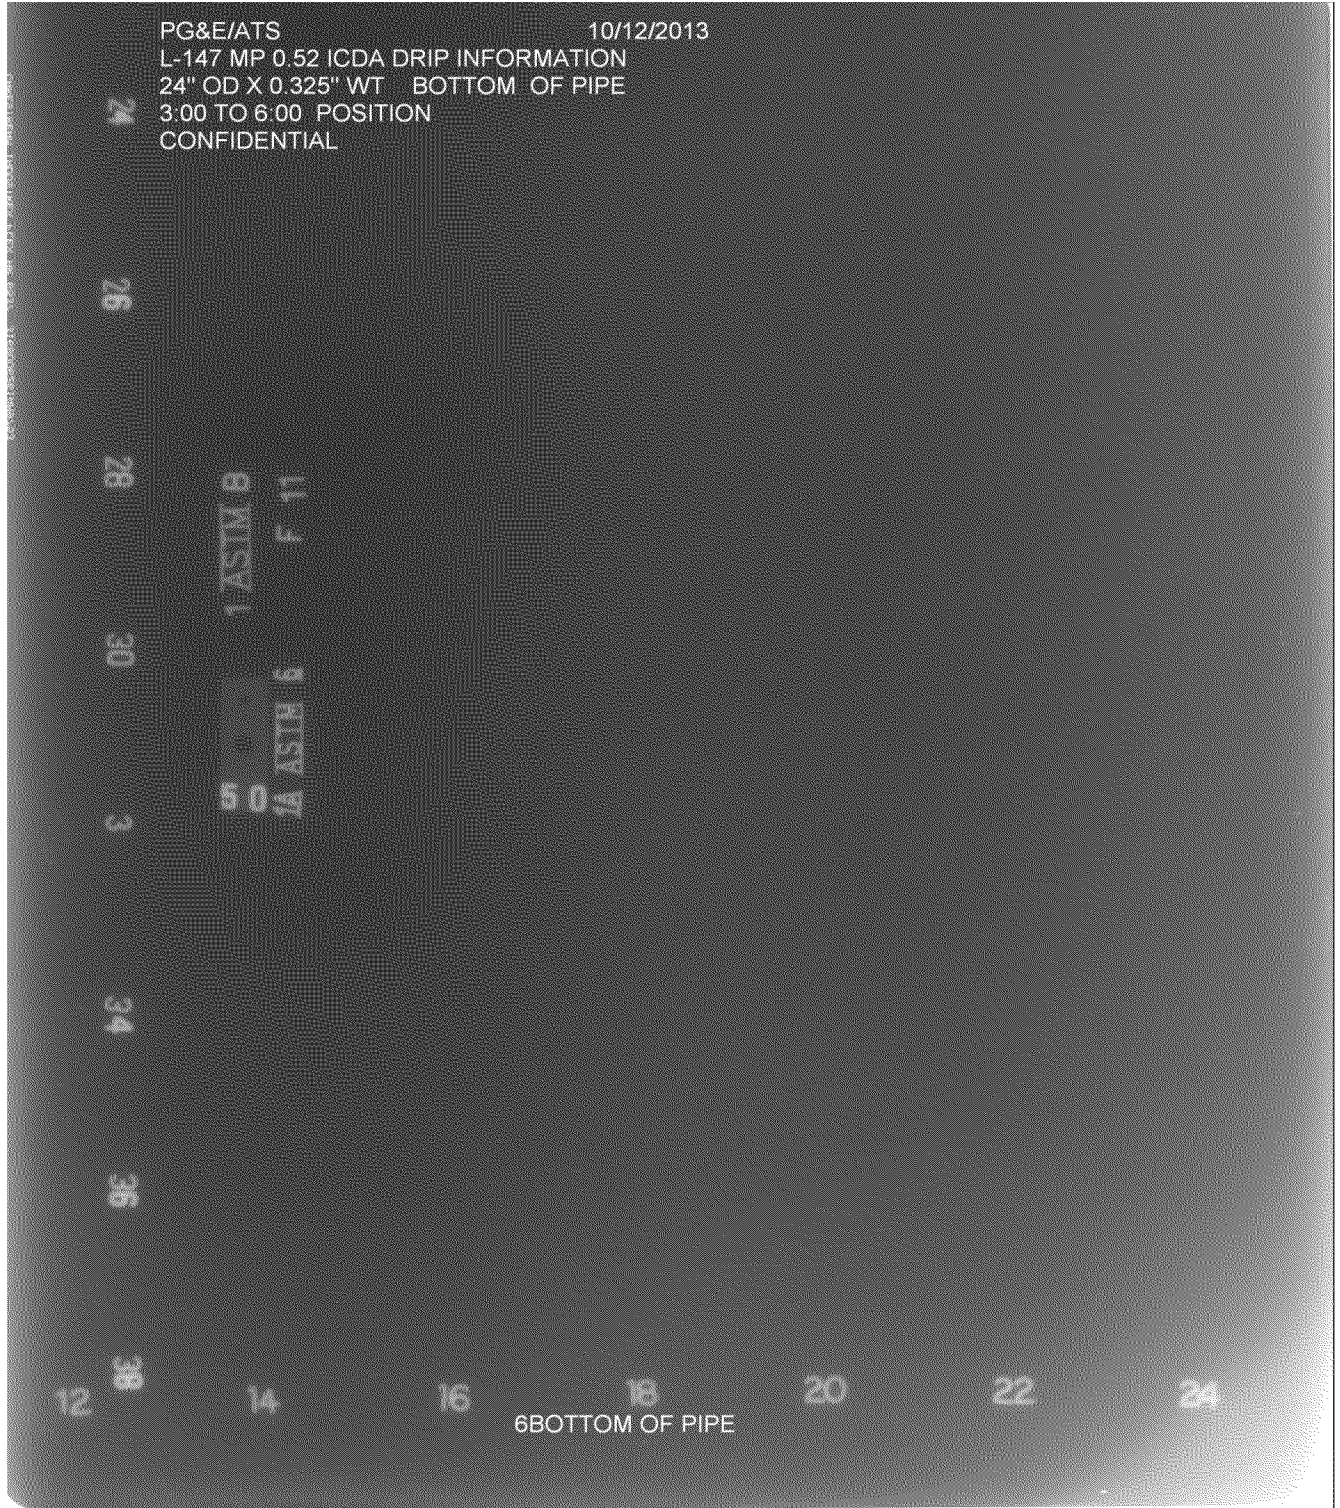
Radiograph of the 24" main line showing no internal corrosion

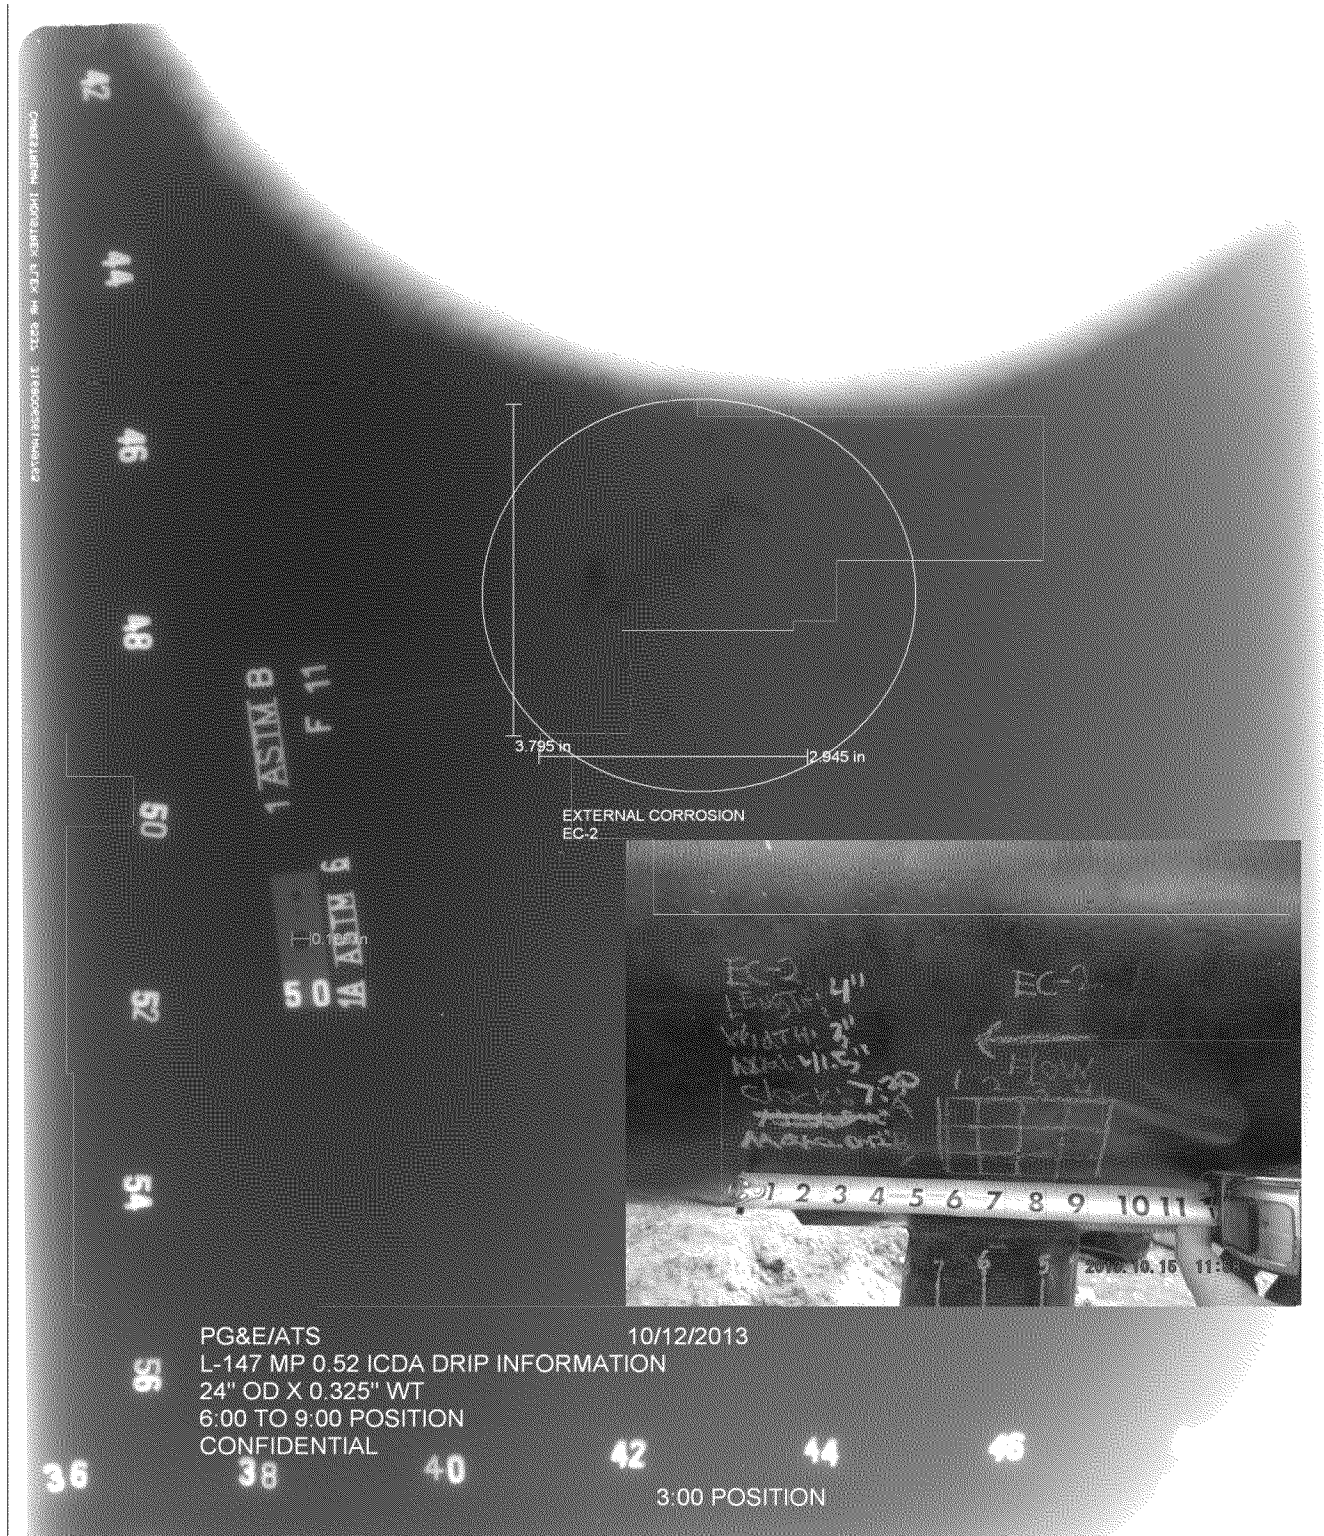
EC-2 : Average Wall Thickness: 0.325", Min. 0.283" for 13% Wall Loss.

Radiograph of the 24" main line showing external corrosion cell (EC-2)

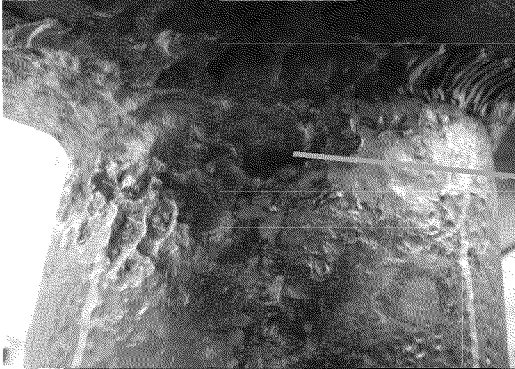
6" Drip Pot: ATS radiographed the drip pot and found it to be full of debris / sludge. Drip pot also has heavy external corrosion.

2" pipe between drip pot and valve: The 2" pipe is full of debris / sludge

Radiograph of the Drip Pot showing debris / sludge inside of the drip pot and 2" pipe between the drip pot and valve.

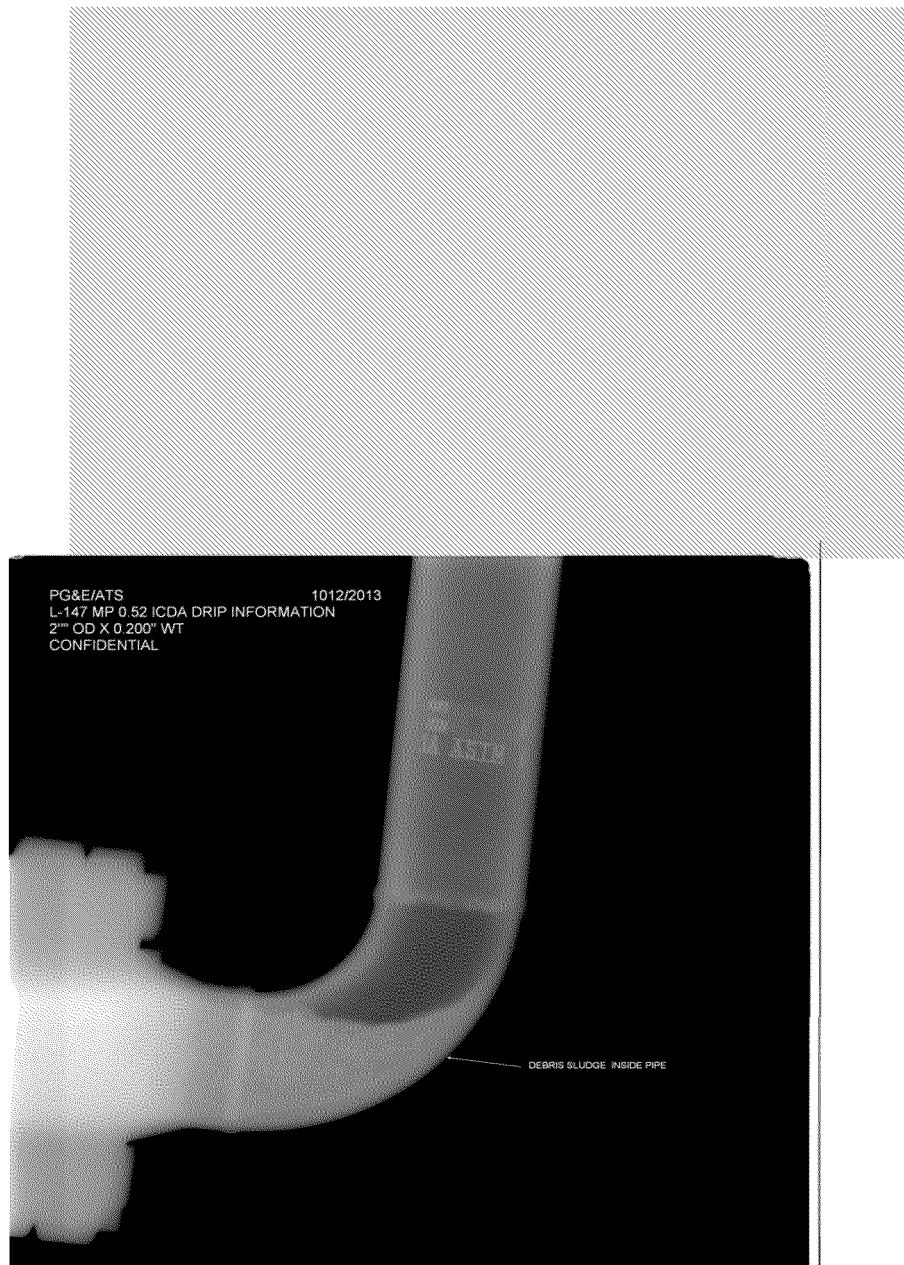
2" Elbow past valve and 2" pipe running vertical: The bottom elbow has debris / sludge that stops at the first girth weld running vertical. The vertical section of pipe has no debris / sludge. The top elbow has a small buildup of debris / sludge on the bottom.

Radiograph of the 2" piping past the vavle showing debris / slugde in the bottom 90 and a small amount of debris / sludge on the bottom of the upper 90

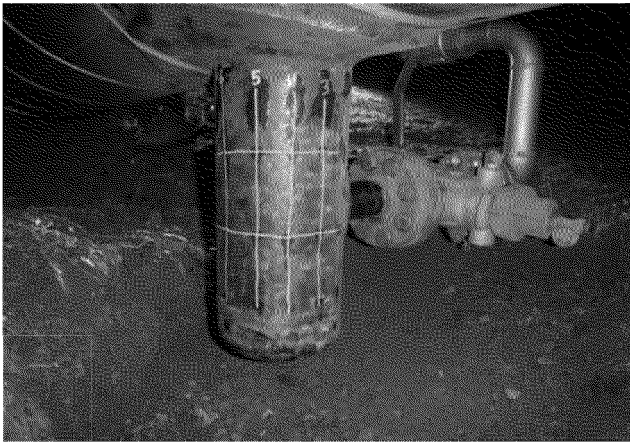
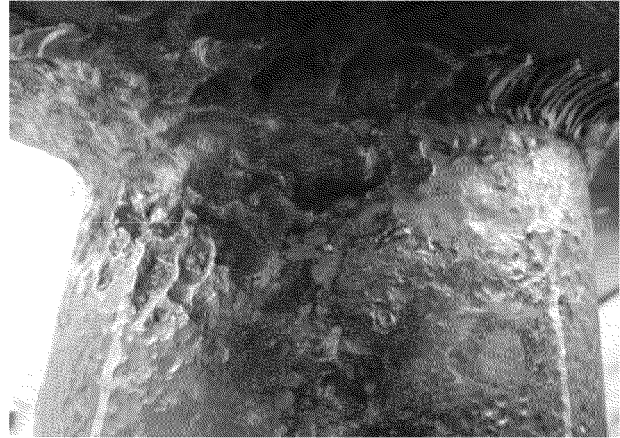
EC 3-1 UT thickness survey of corrosion cell between the reinforcement pad and the drip pot using a pencil probe.

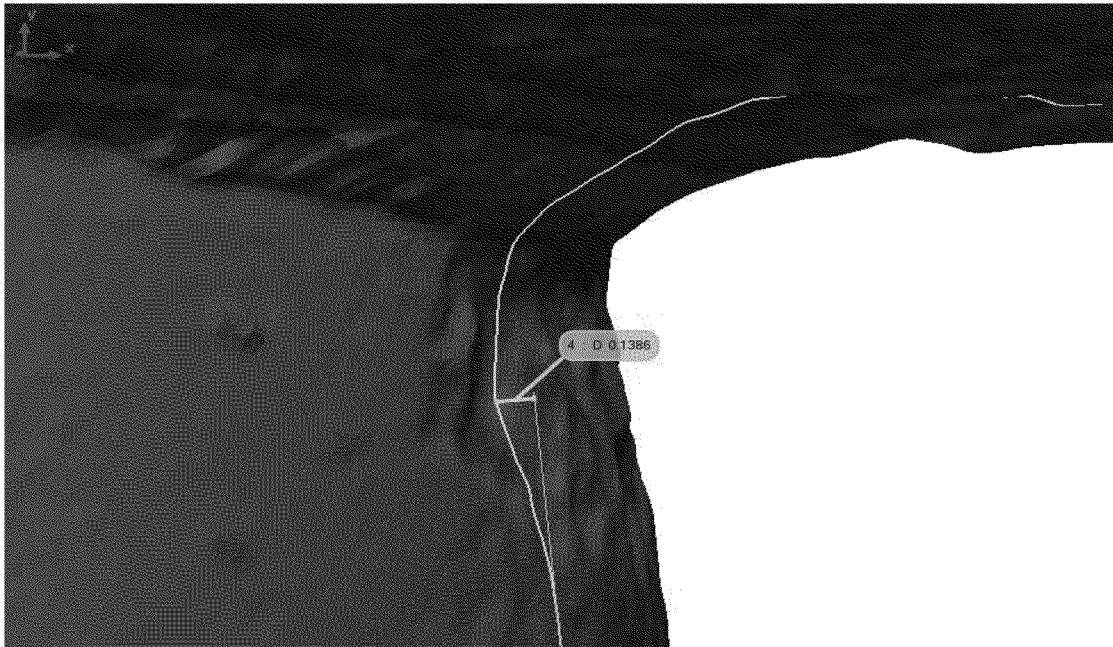
EC-3: Average Wall Thickness: 0.280", Min. 0.138" for 50.69% Wall Loss, (Per Laser Scanner see attached Report). an Impression Casting of the corroded weld, drip pot to saddle weld was difficult to obtain using multiple methods. This was: 4.00" width X 0.800" Long and approximately 0.150"-0.200" metal loss.

View of deepest corrosion pit

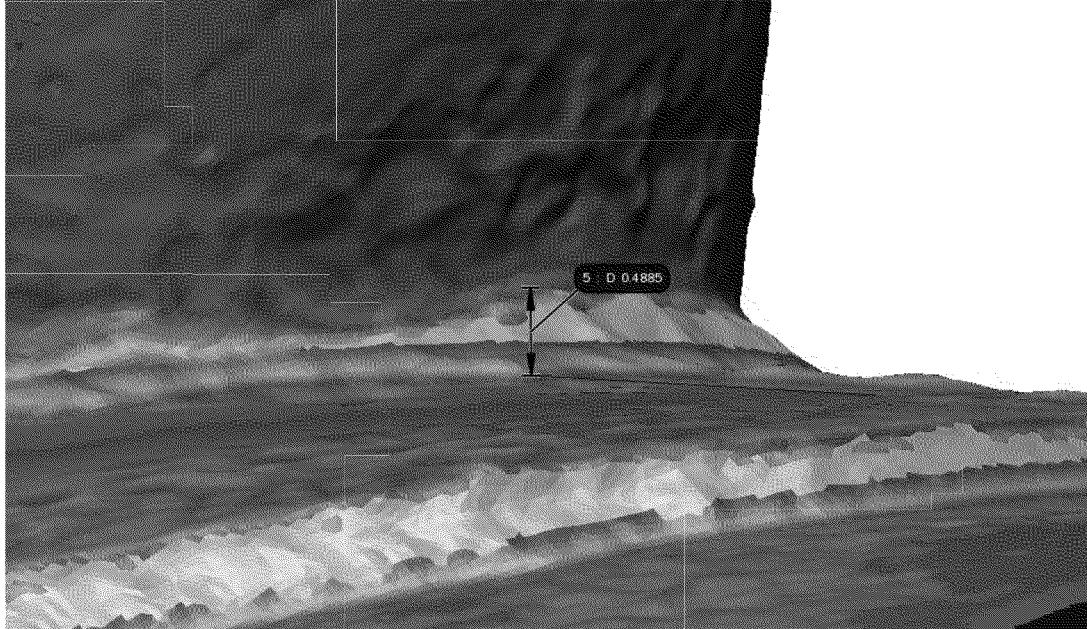
Estimated weld leg size

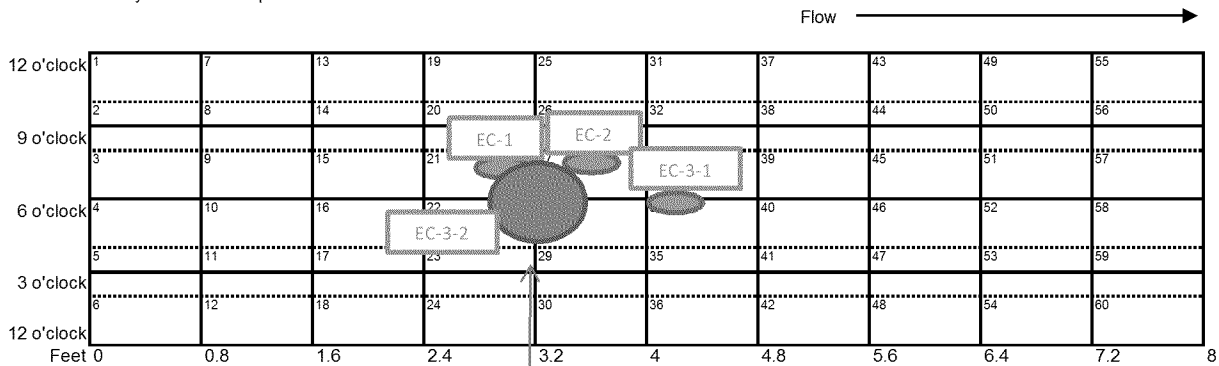
Drip Pot
 EC-3-2 is the entire circumference of the 6" Dia Drip Pot
