**Pipe Characterization and Weld Assessment
San Carlos
Line 147
Mile Post 0.52**

ATS Report #: 413.61-13.390

Gas Project: ICDA

Line 147 Mile Point 0.52 San Carlos

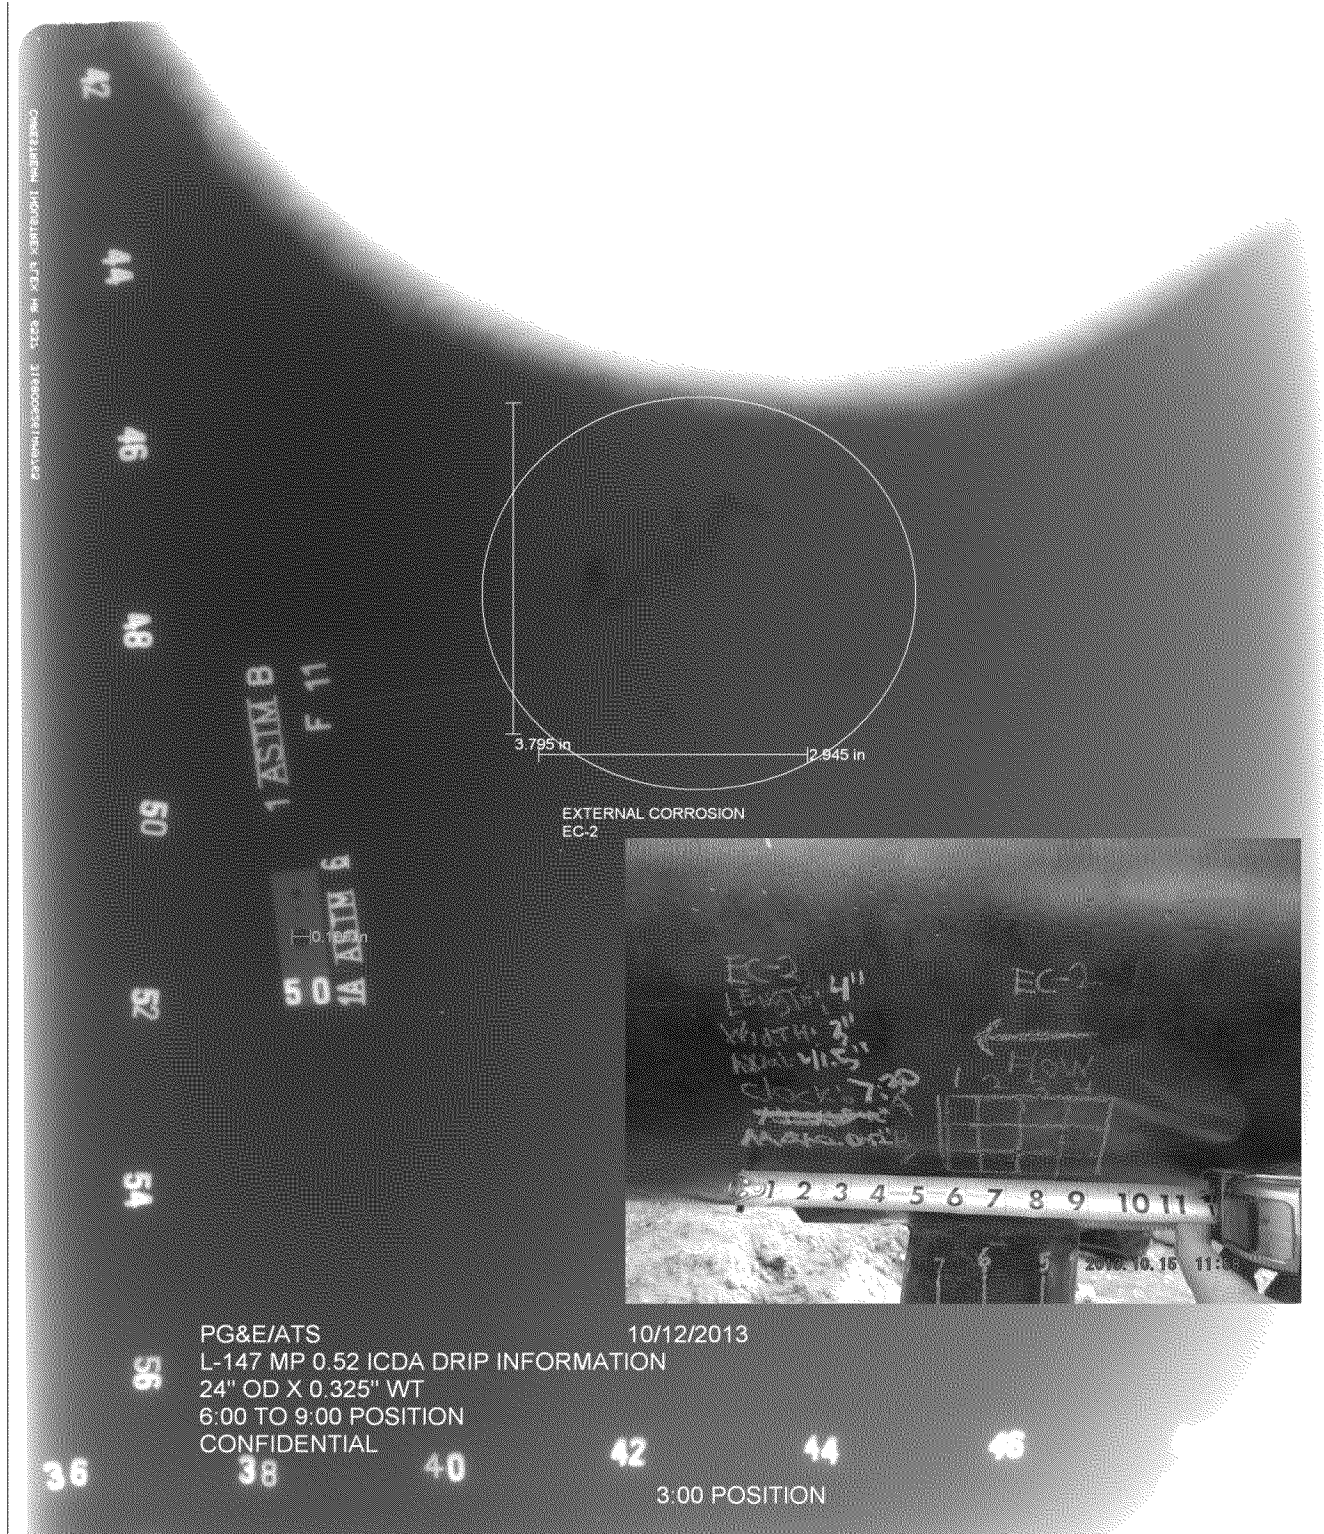
Radiograph of the 24" main line showing external corrosion cell (EC-3-1)

EC 3-1 UT thickness survey of corrosion cell between the reinforcement pad and the drip pot using a pencil probe.

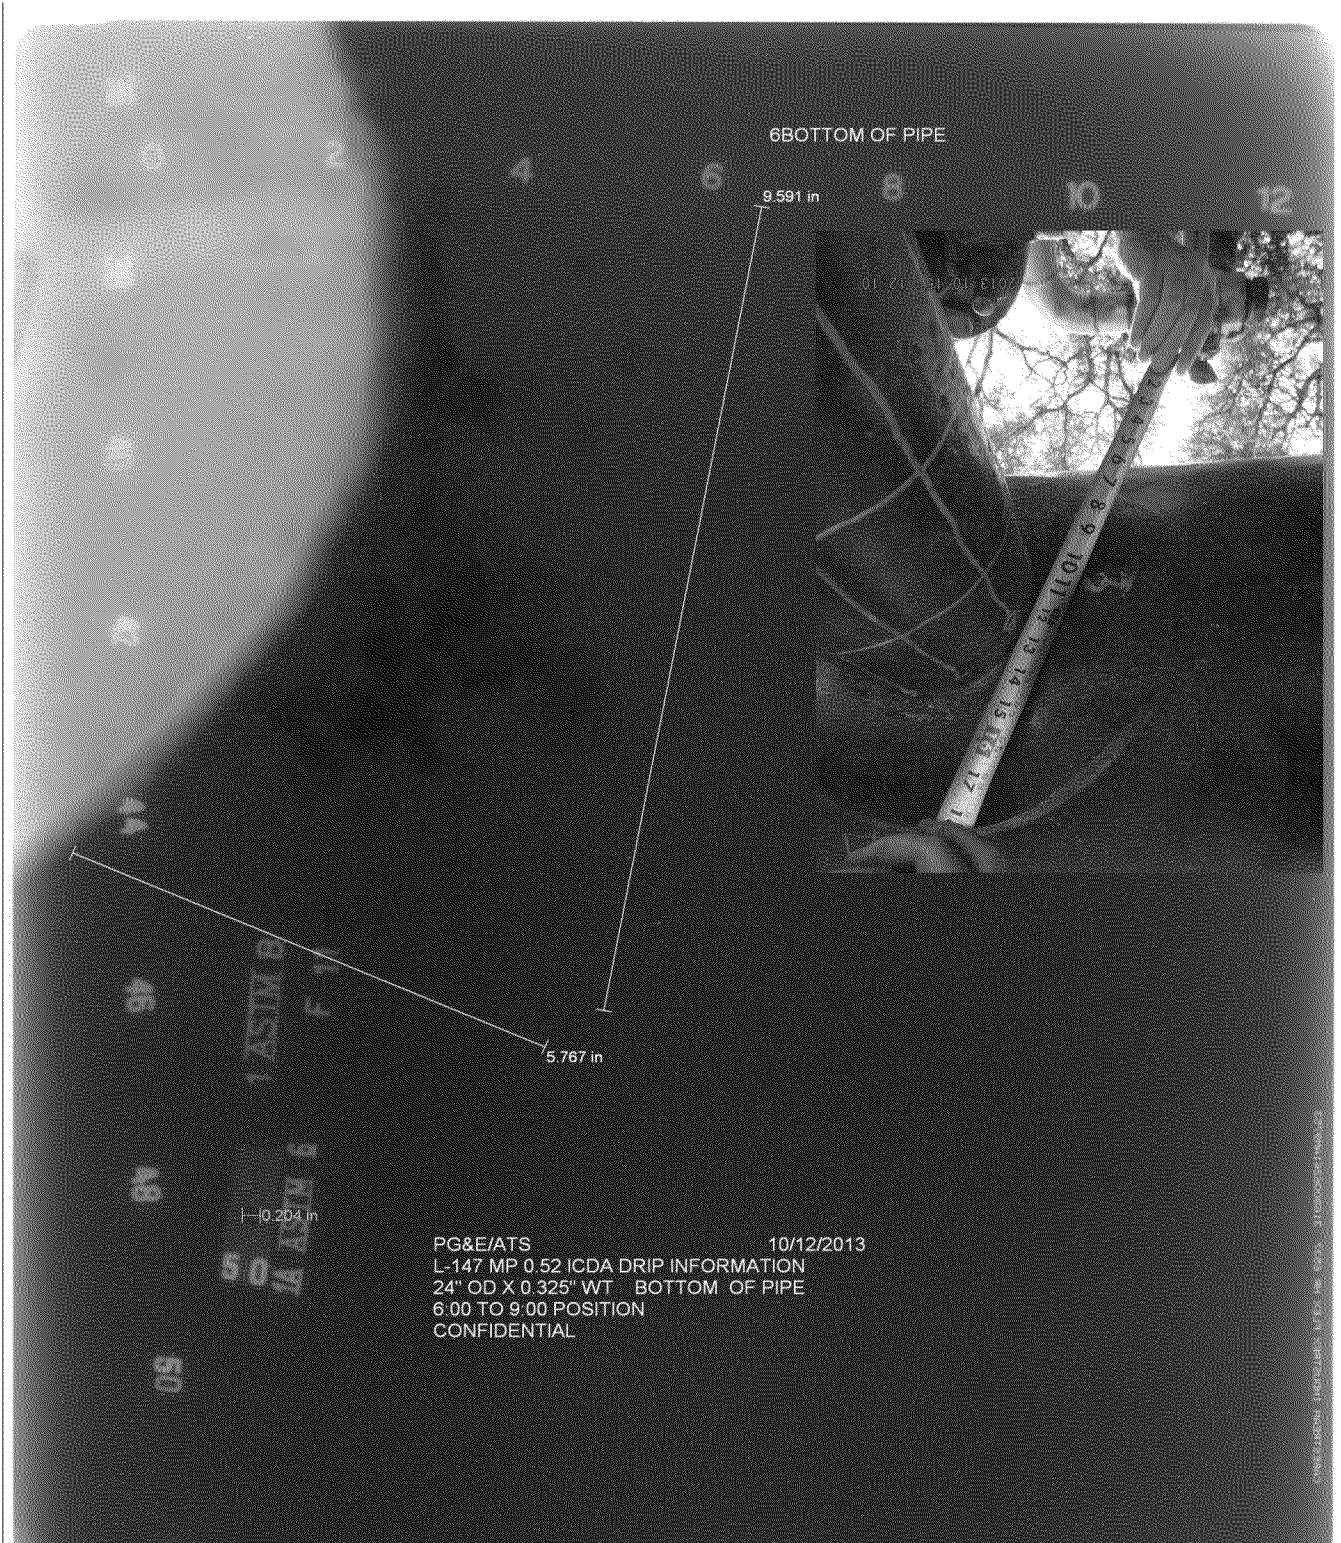
6" Drip Pot: ATS radiographed the drip pot and found it to be full of debris / sludge. Drip pot also has heavy external corrosion.

Radiograph of the Drip Pot showing debris / sludge inside of the drip pot and 2" pipe between the drip pot and valve.

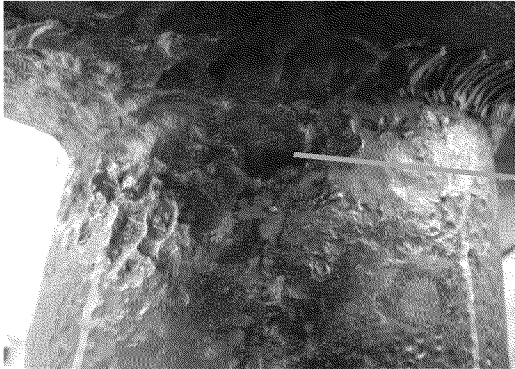
Picture showing the external corrosion

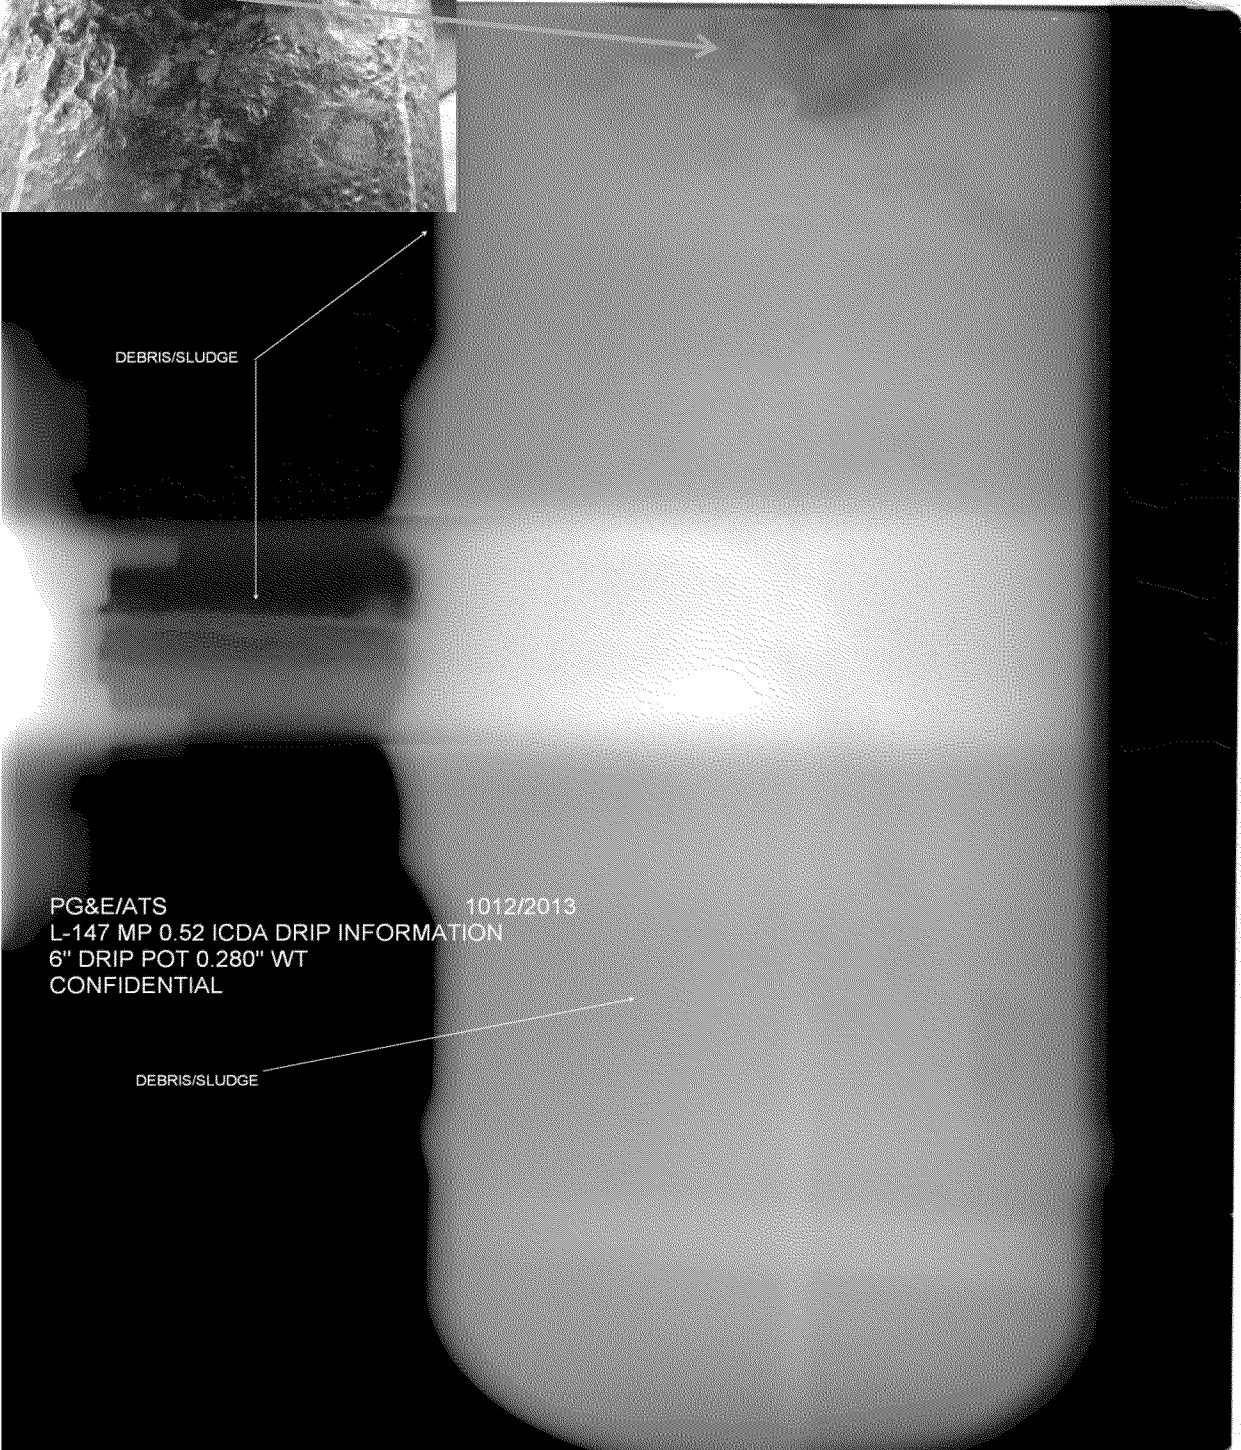
2" pipe between drip pot and valve: The 2" pipe is full of debris / sludge

DEBRIS/SLUDGE

Radiograph of the 2" pipe between the drip pot and valve in the 90° position

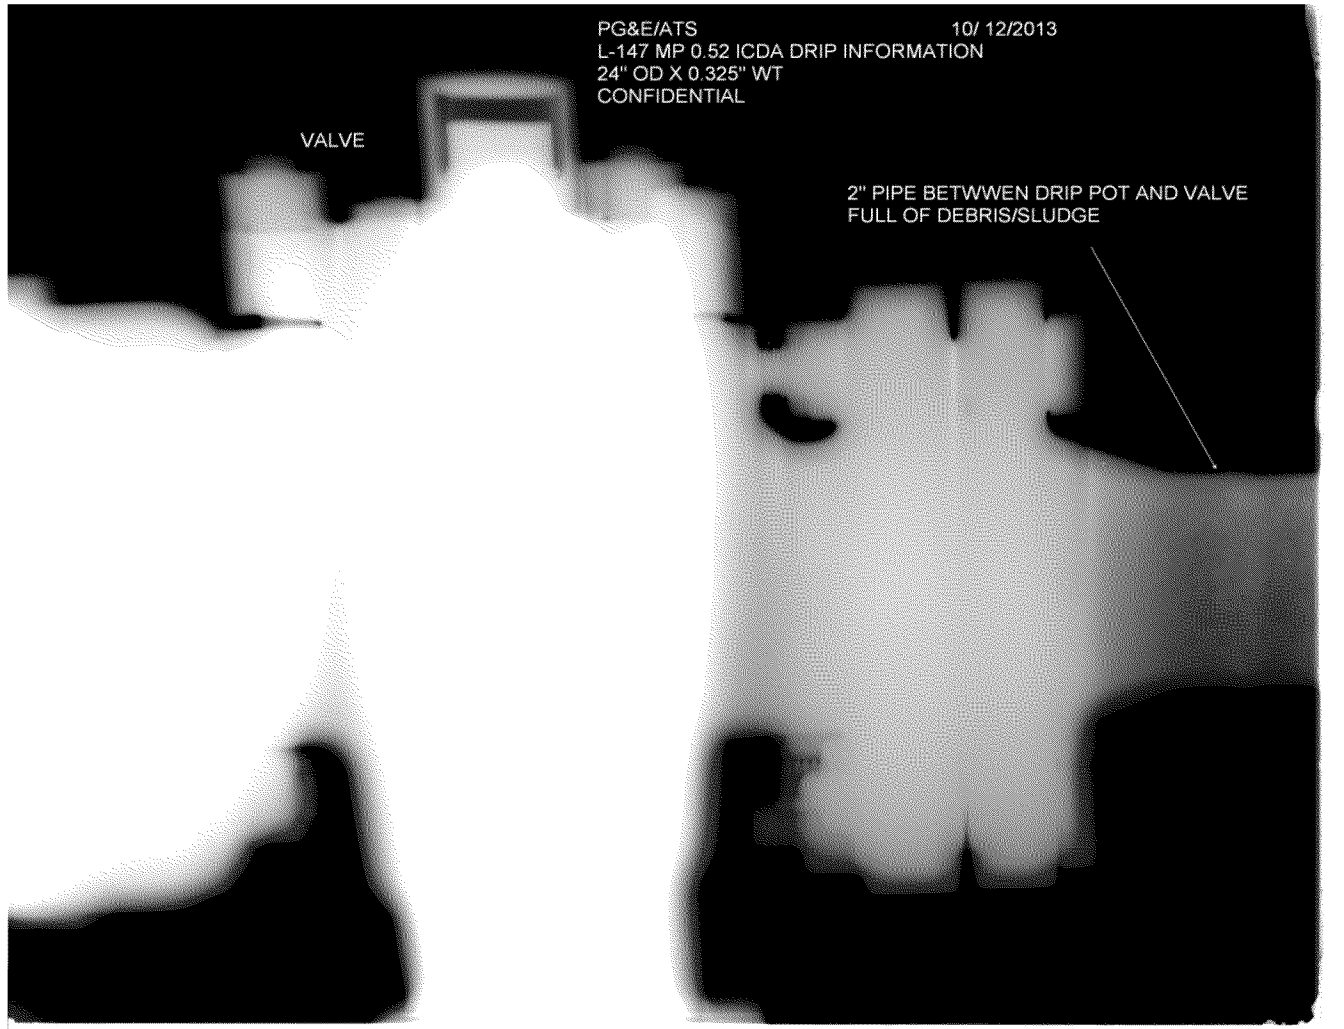
2" Elbow past valve and 2" pipe running vertical: The bottom elbow has debris / sludge that stops at the first girth weld running vertical. The vertical section of pipe has no debris / sludge. The top elbow has a small buildup of debris / sludge on the bottom.

Radiograph of the 2" piping past the vavle showing debris / slugde in the bottom 90 and a small amount of debris / sludge on the bottom of the upper 90

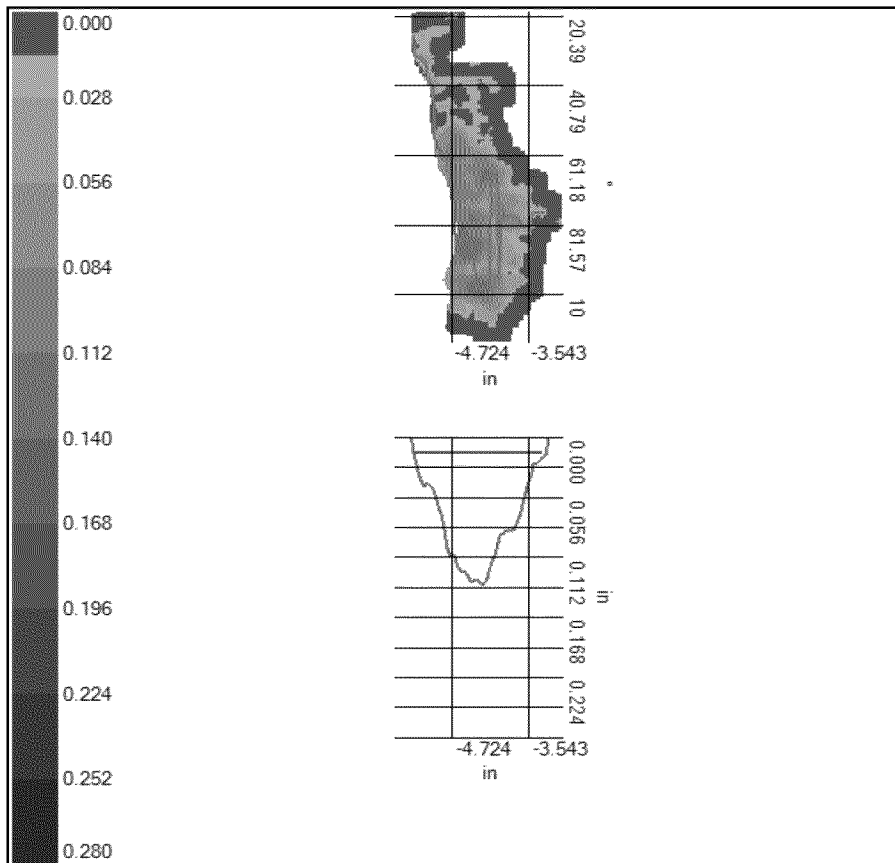
EC-3: Average Wall Thickness: 0.280", Min. 0.138" for 50.69% Wall Loss, (Per Laser Scanner see attached Report). an Impression Casting of the corroded weld, drip pot to saddle weld was difficult to obtain using multiple methods. This was: 4.00" width X 0.800" Long and approximately 0.150"-0.200" metal loss.

Axial Start	-5.354 in
Axial End	-3.268 in
Axial Length	2.087 in
Circ. Start	23.090 °
Circ. End	111.400 °
Circ. Length	88.300 °
Max. Depth	0.138 in
Axial Pos.	-4.272 in
Circ. Pos.	100.190 °

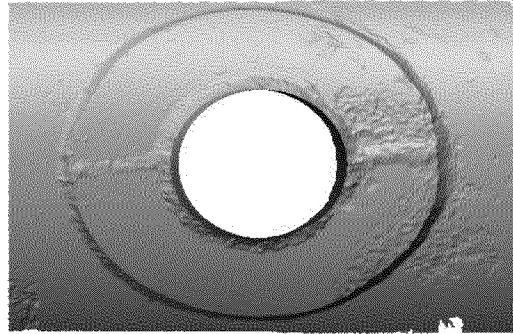
Over View of L-147 MP 0.52 drip pot and weld pad

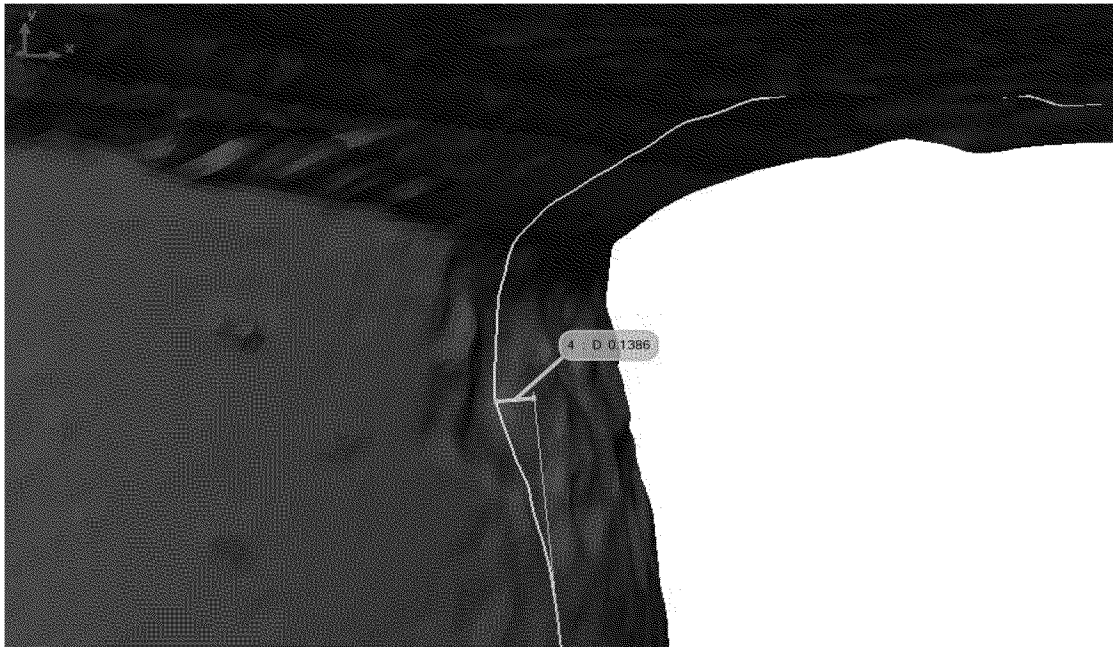
View of deepest corrosion pit

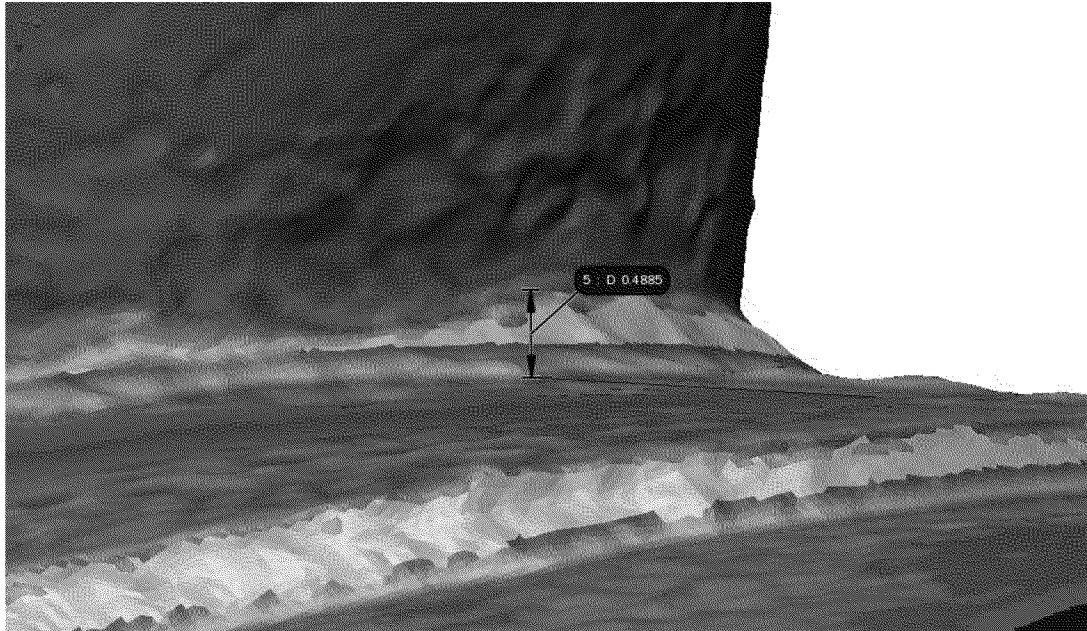
Estimated weld leg size

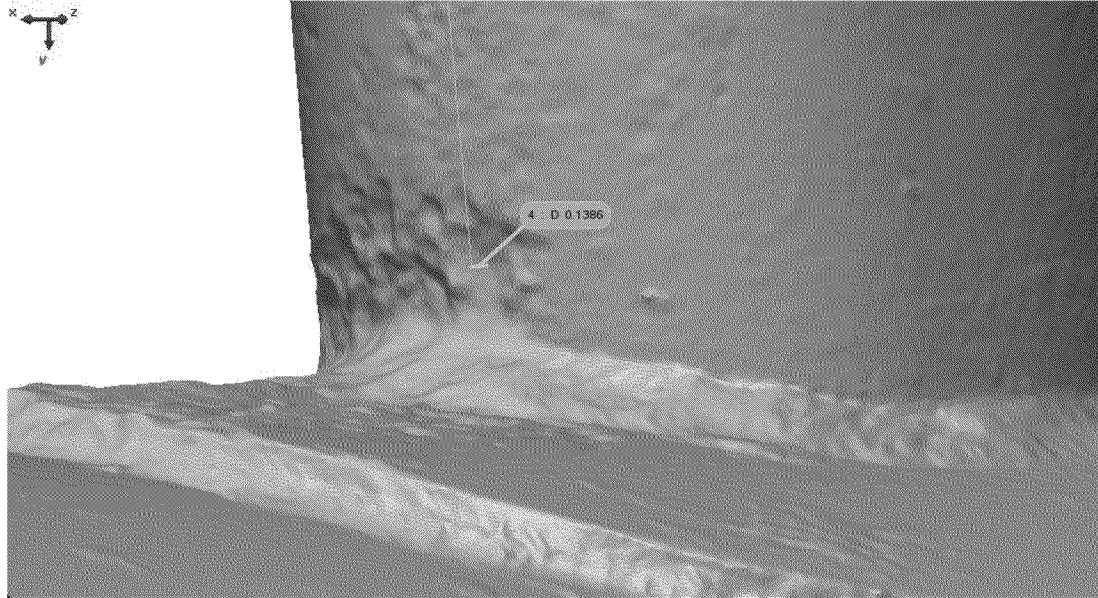
View of deepest corrosion pit, without color map

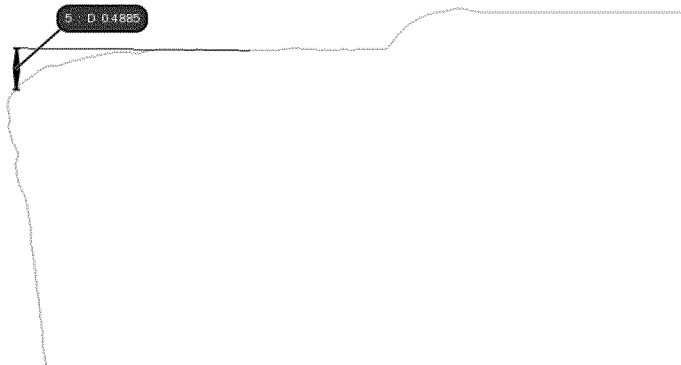
Cross-section view of estimated weld leg size

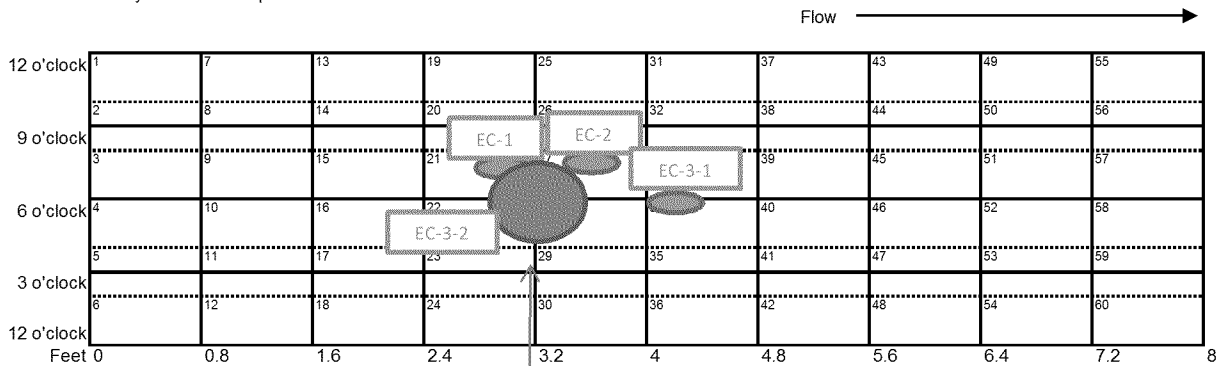
Drip Pot
 EC-3-2 is the entire circumference of the 6" Dia Drip Pot
