Pipe Characterization and Weld Assessment
San Carlos
Line 147
Mile Post 0.52

ATS Report #: 413.61-13.390

Gas Project: ICDA

Line 147 Mile Point 0.52 San Carlos

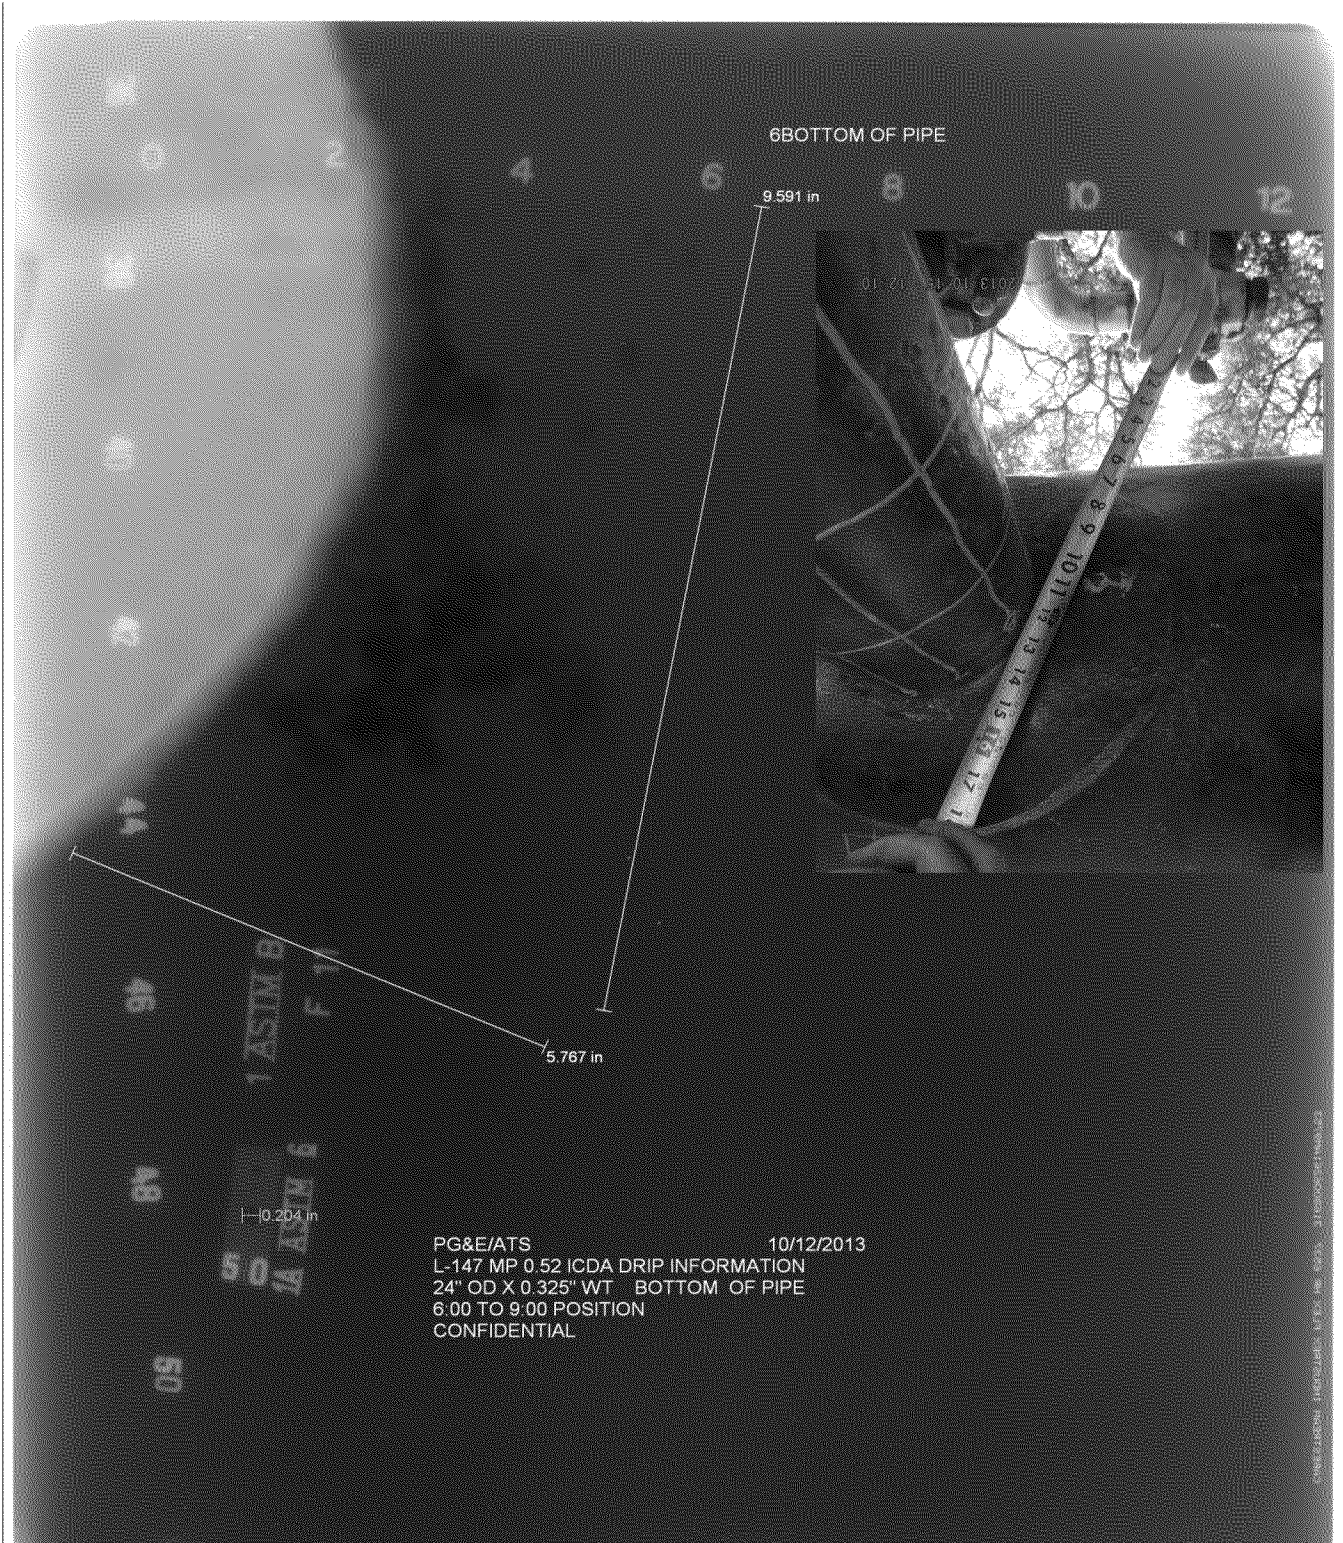
Radiograph of the 24" main line showing external corrosion cell (EC-3-1)

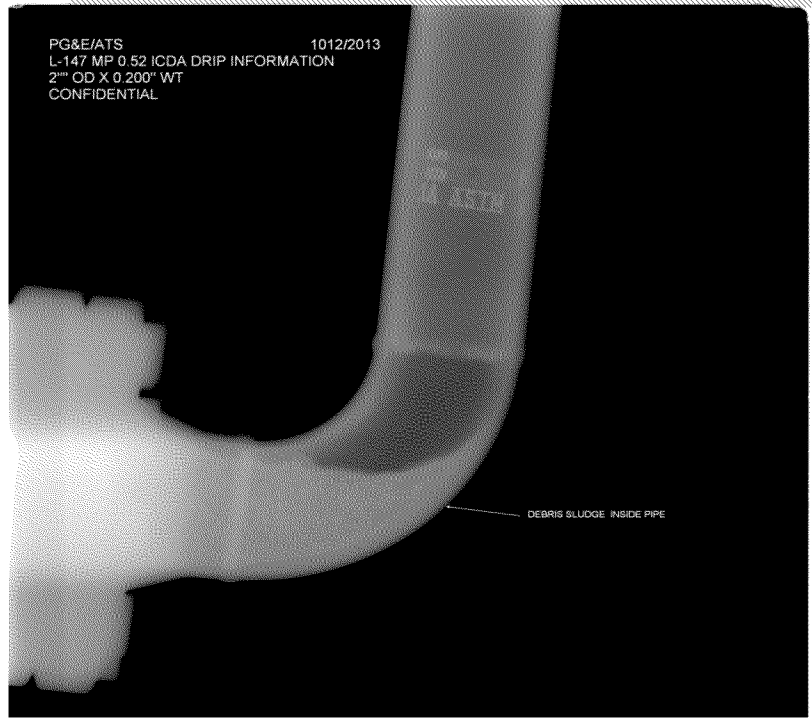
2" Elbow past valve and 2" pipe running vertical: The bottom elbow has debris / sludge that stops at the first girth weld running vertical. The vertical section of pipe has no debris / sludge. The top elbow has a small buildup of debris / sludge on the bottom.

Radiograph of the 2" piping past the vavle showing debris / slugde in the bottom 90 and a small amount of debris / sludge on the bottom of the upper 90

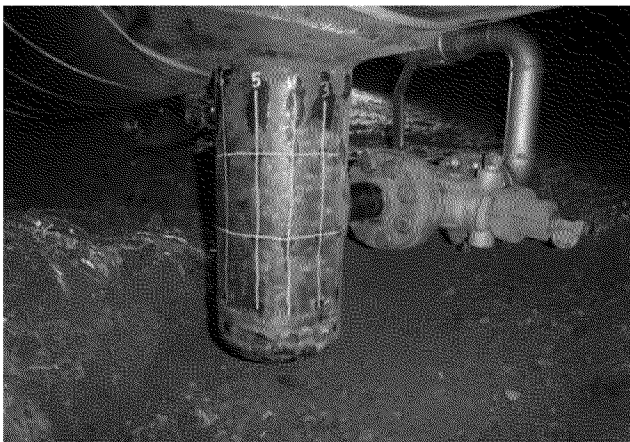
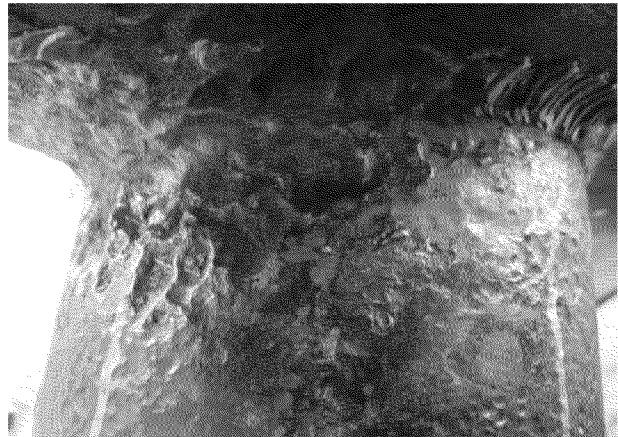
EC 3-1 UT thickness survey of corrosion cell between the reinforcement pad and the drip pot using a pencil probe.

Position	UT reading	Remaining wall
7:00	0.162	42.14%
plus 1"	0.179	36.07%
8:00	0.216	22.85%
plus 1"	0.185	33.92%
9:00	0.160	42.85%
Average wall thickness for the drip pot:		0.280

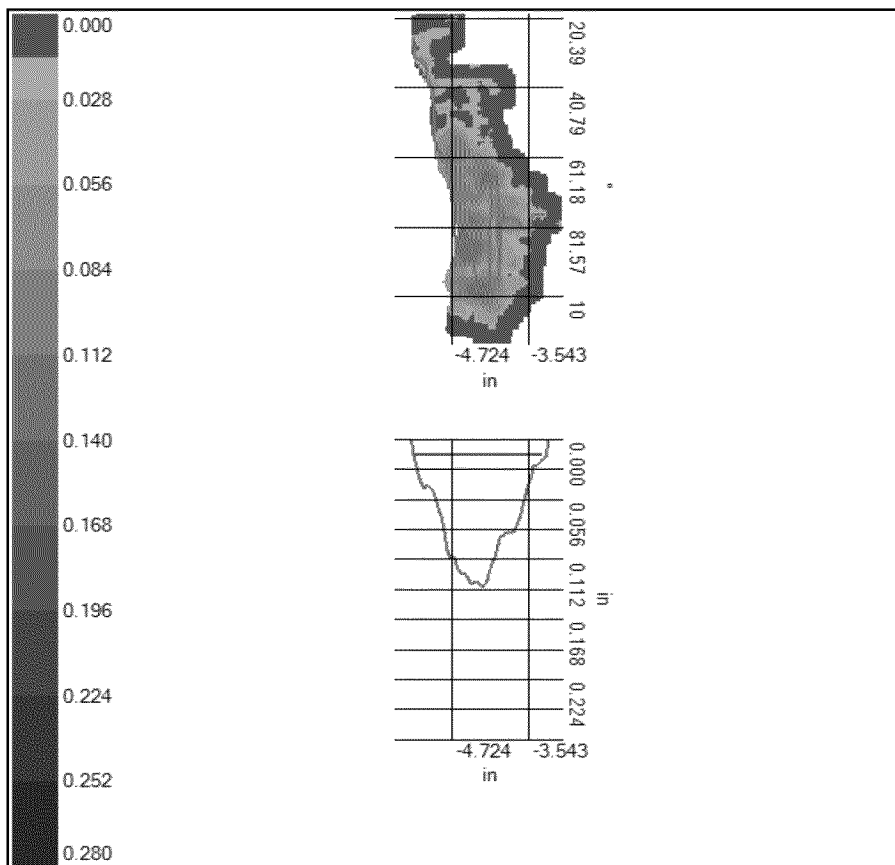
EC-3: Average Wall Thickness: 0.280", Min. 0.138" for 50.69% Wall Loss, (Per Laser Scanner see attached Report). an Impression Casting of the corroded weld, drip pot to saddle weld was difficult to obtain using multiple methods. This was: 4.00" width X 0.800" Long and approximately 0.150"-0.200" metal loss.

Results for Feature 1

Axial Start	-5.354 in
Axial End	-3.268 in
Axial Length	2.087 in
Circ. Start	23.090 °
Circ. End	111.400 °
Circ. Length	88.300 °
Max. Depth	0.138 in
Axial Pos.	-4.272 in
Circ. Pos.	100.190 °

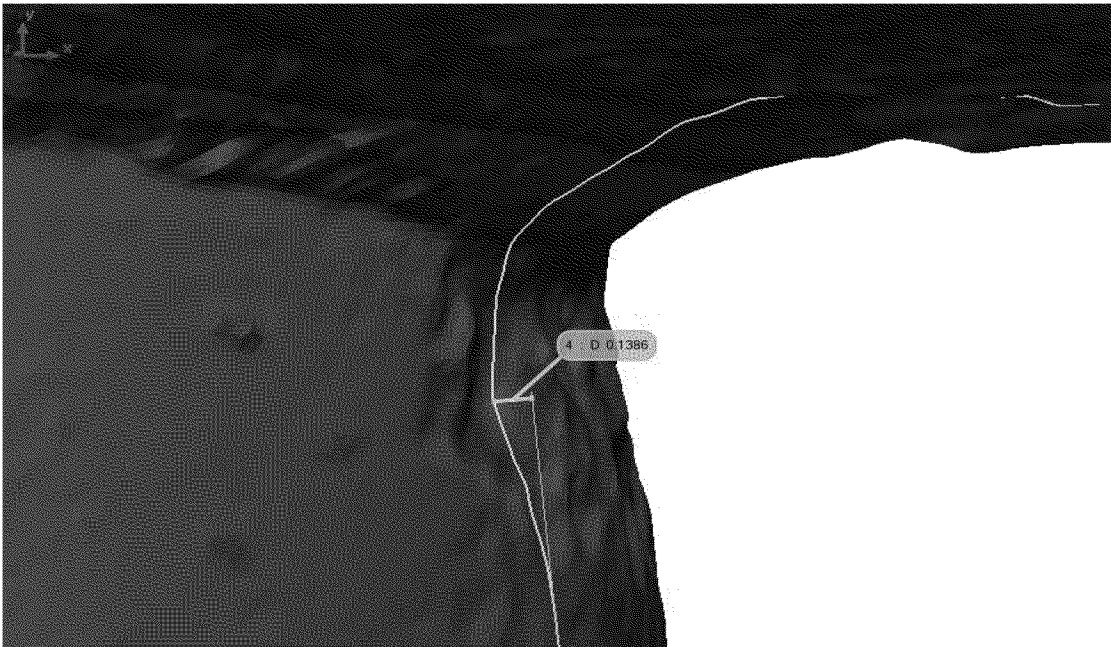
View of deepest corrosion pit

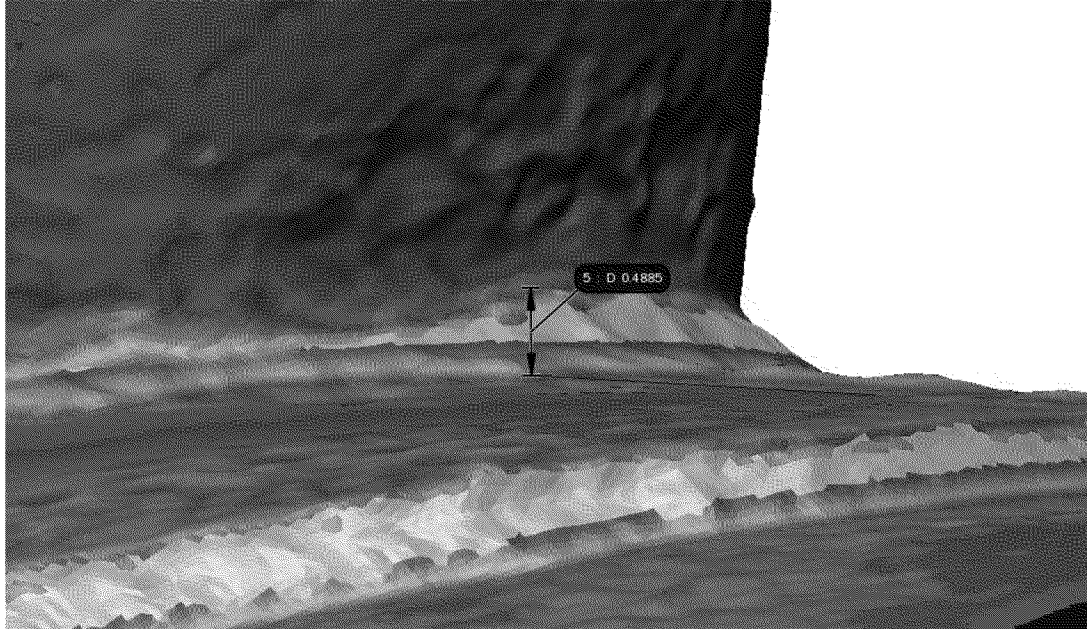
Estimated weld leg size
