**Pacific Gas & Electric Company**

**Hydrostatic Test Dig from October 7, 2011 to November 5, 2011**

**T43A/B\_L147\_B** [Redacted]

Date: December 2, 2011

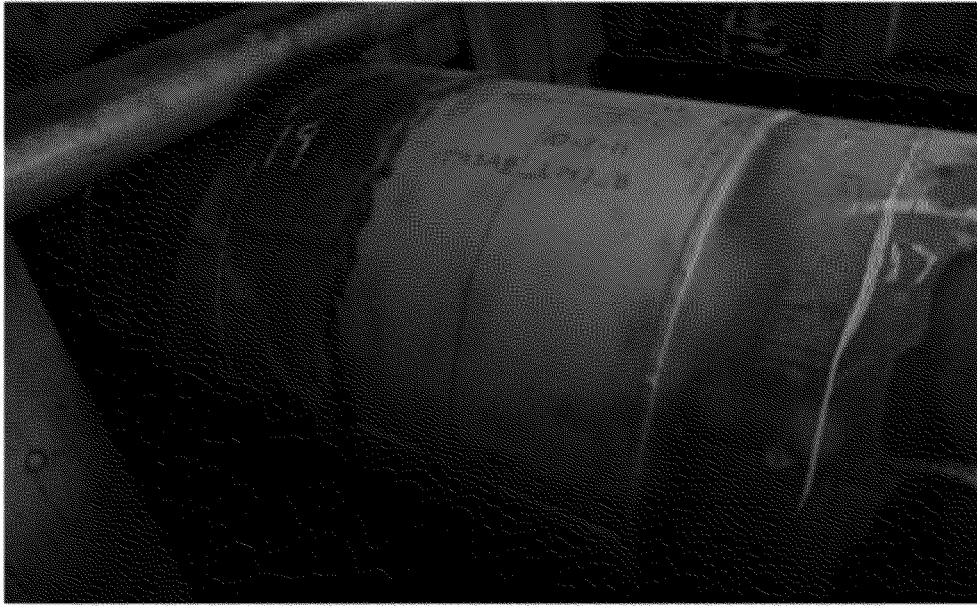
Overview of coating condition 17ft to 20ft, 900 position

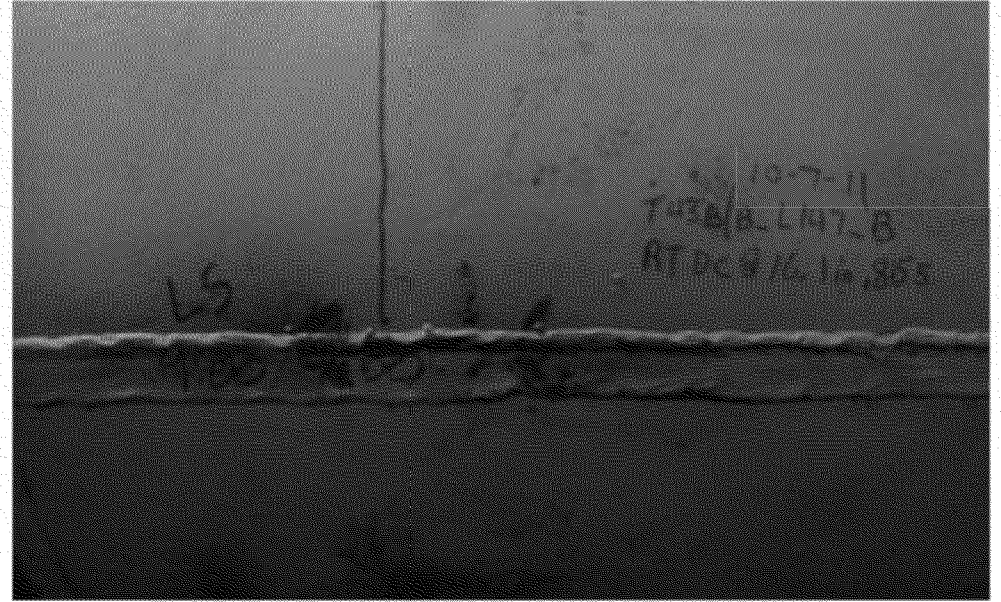
Overview of feature joint long seam @ 8:55

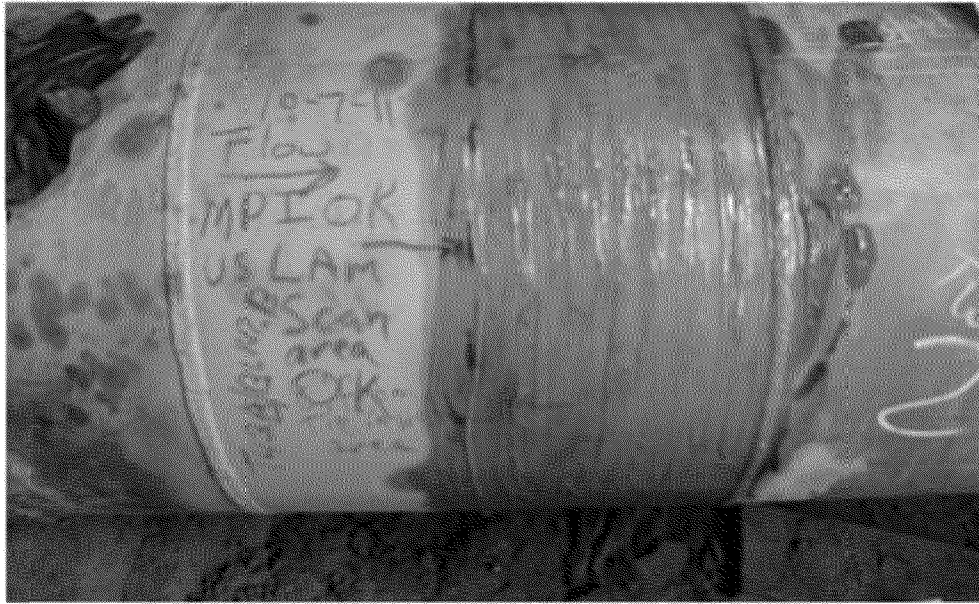
Overview of US MPIOK and Lamination scan OK.

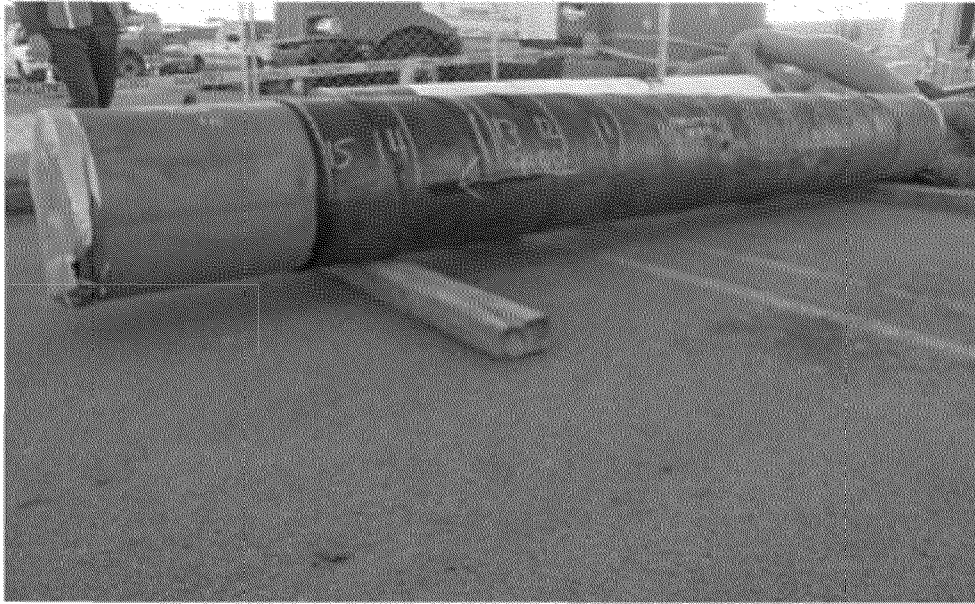
Comments: Coating removed & tie in weld areas blasted. Pipe section removed and test pipes installed. Removed pipe section was also assessed and was in good condition except for coating damage from removal and transportation. See comments page 10.

Removed pipe section coating assesment 9:00

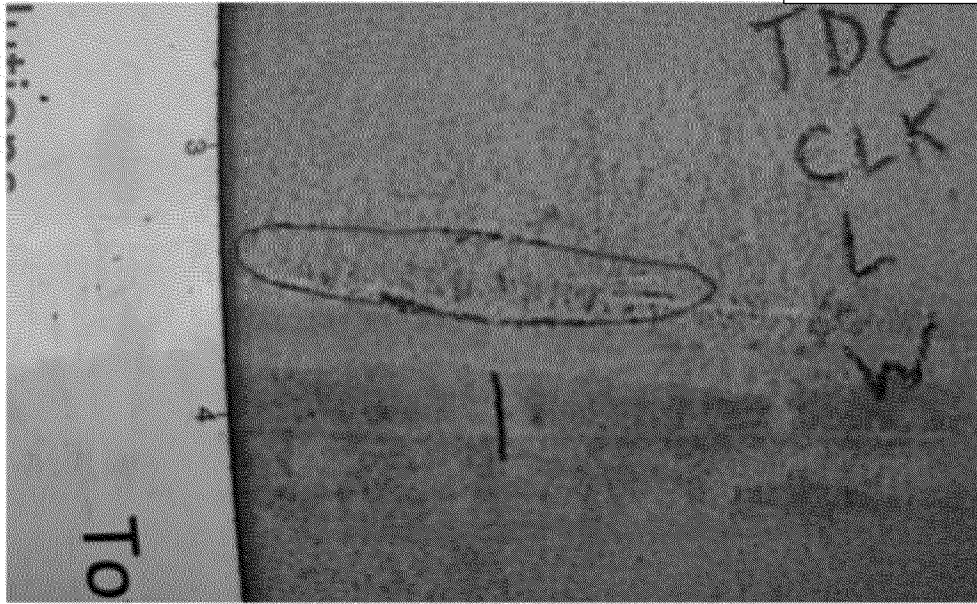
Close-up of MT Indications of LIN-01

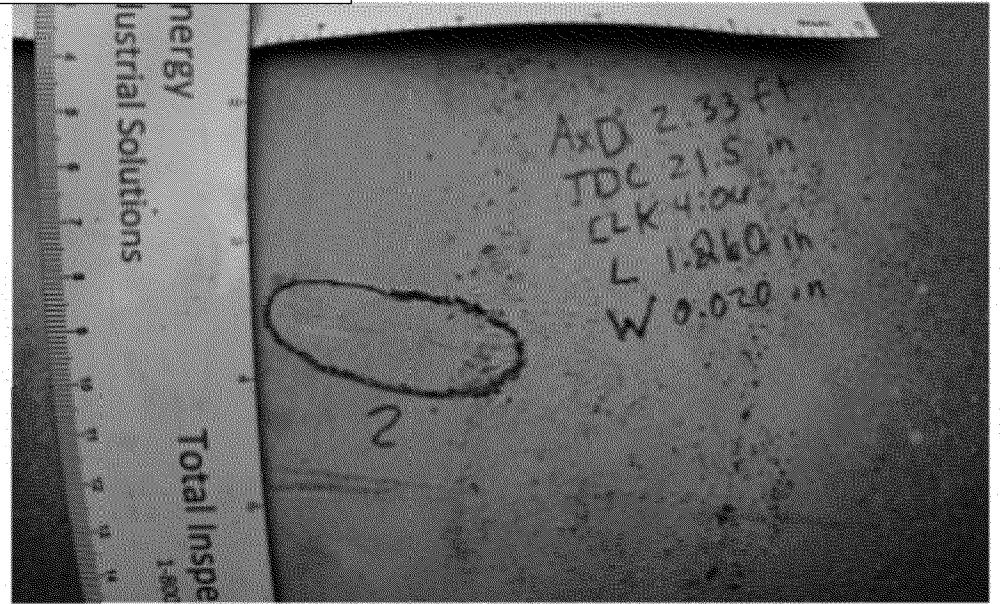
2.6 Wet Fluorescent Mag. Part. Is Required. Comments: 2 linear indications on the removed pipe section. See MT & Photo report.  
 Were there any linear indications?  Yes  No If Yes, attach NDE report electronically as part of the H-Form. Report to include black light and white light photos of indications.

Removed pipe section linear indication-02

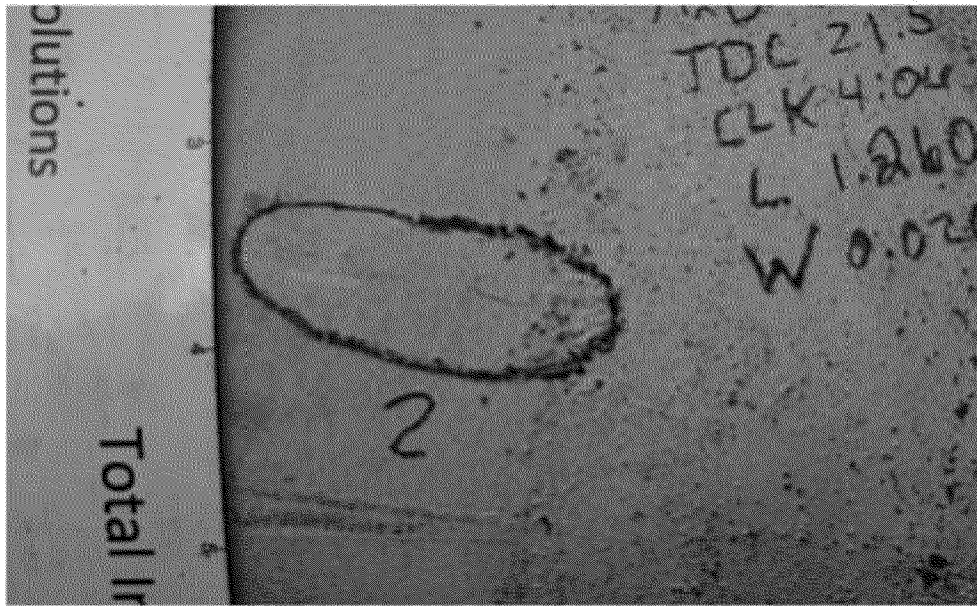
Close-up of MT Indications of LIN-02
