Pipe Characterization and Weld Assessment
San Carlos
Line 147
Mile Post 0.52

ATS Report #: 413.61-13.390

Gas Project: Internal Corrosion Verification

Line 147 Mile Point 0.52 San Carlos

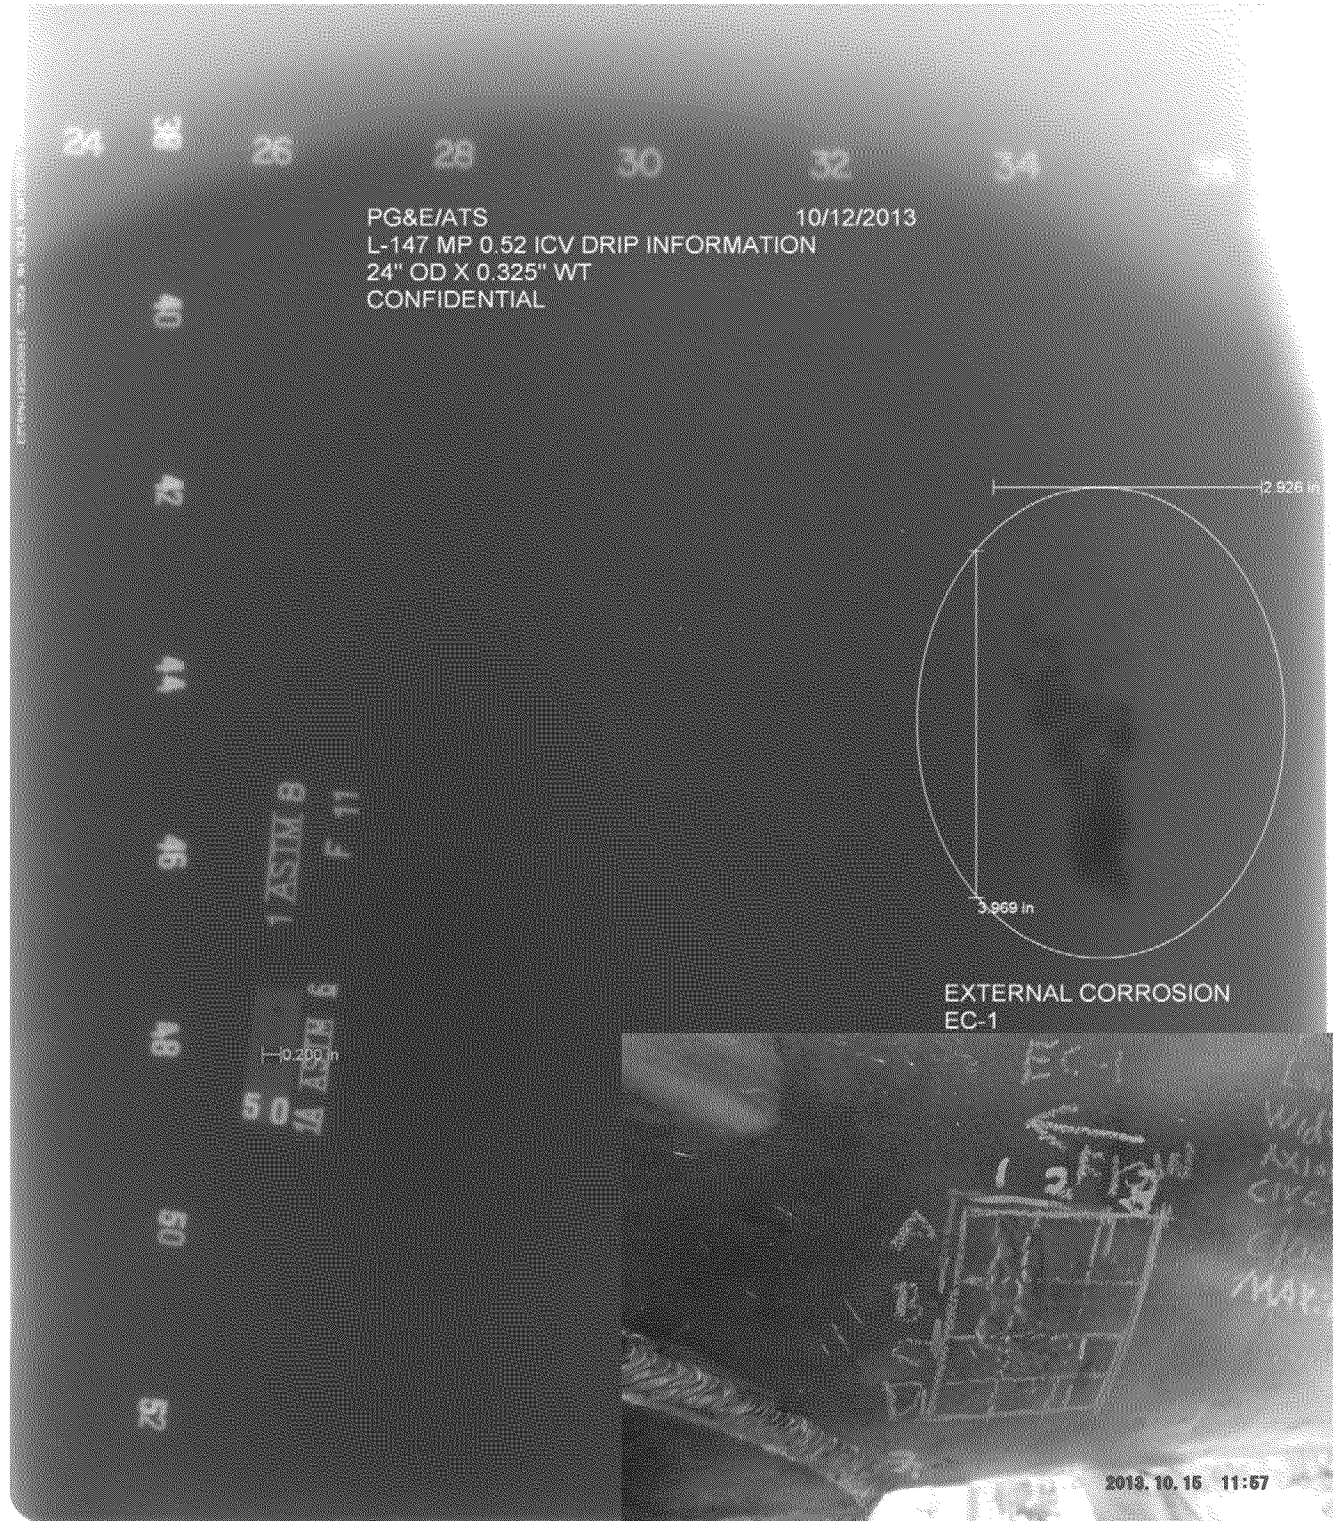
EC-1: Average Wall Thickness: 0.325", Min. 0.244" for 25% Wall Loss.

Radiograph of the 24" main line showing external corrosion cell (EC-1)

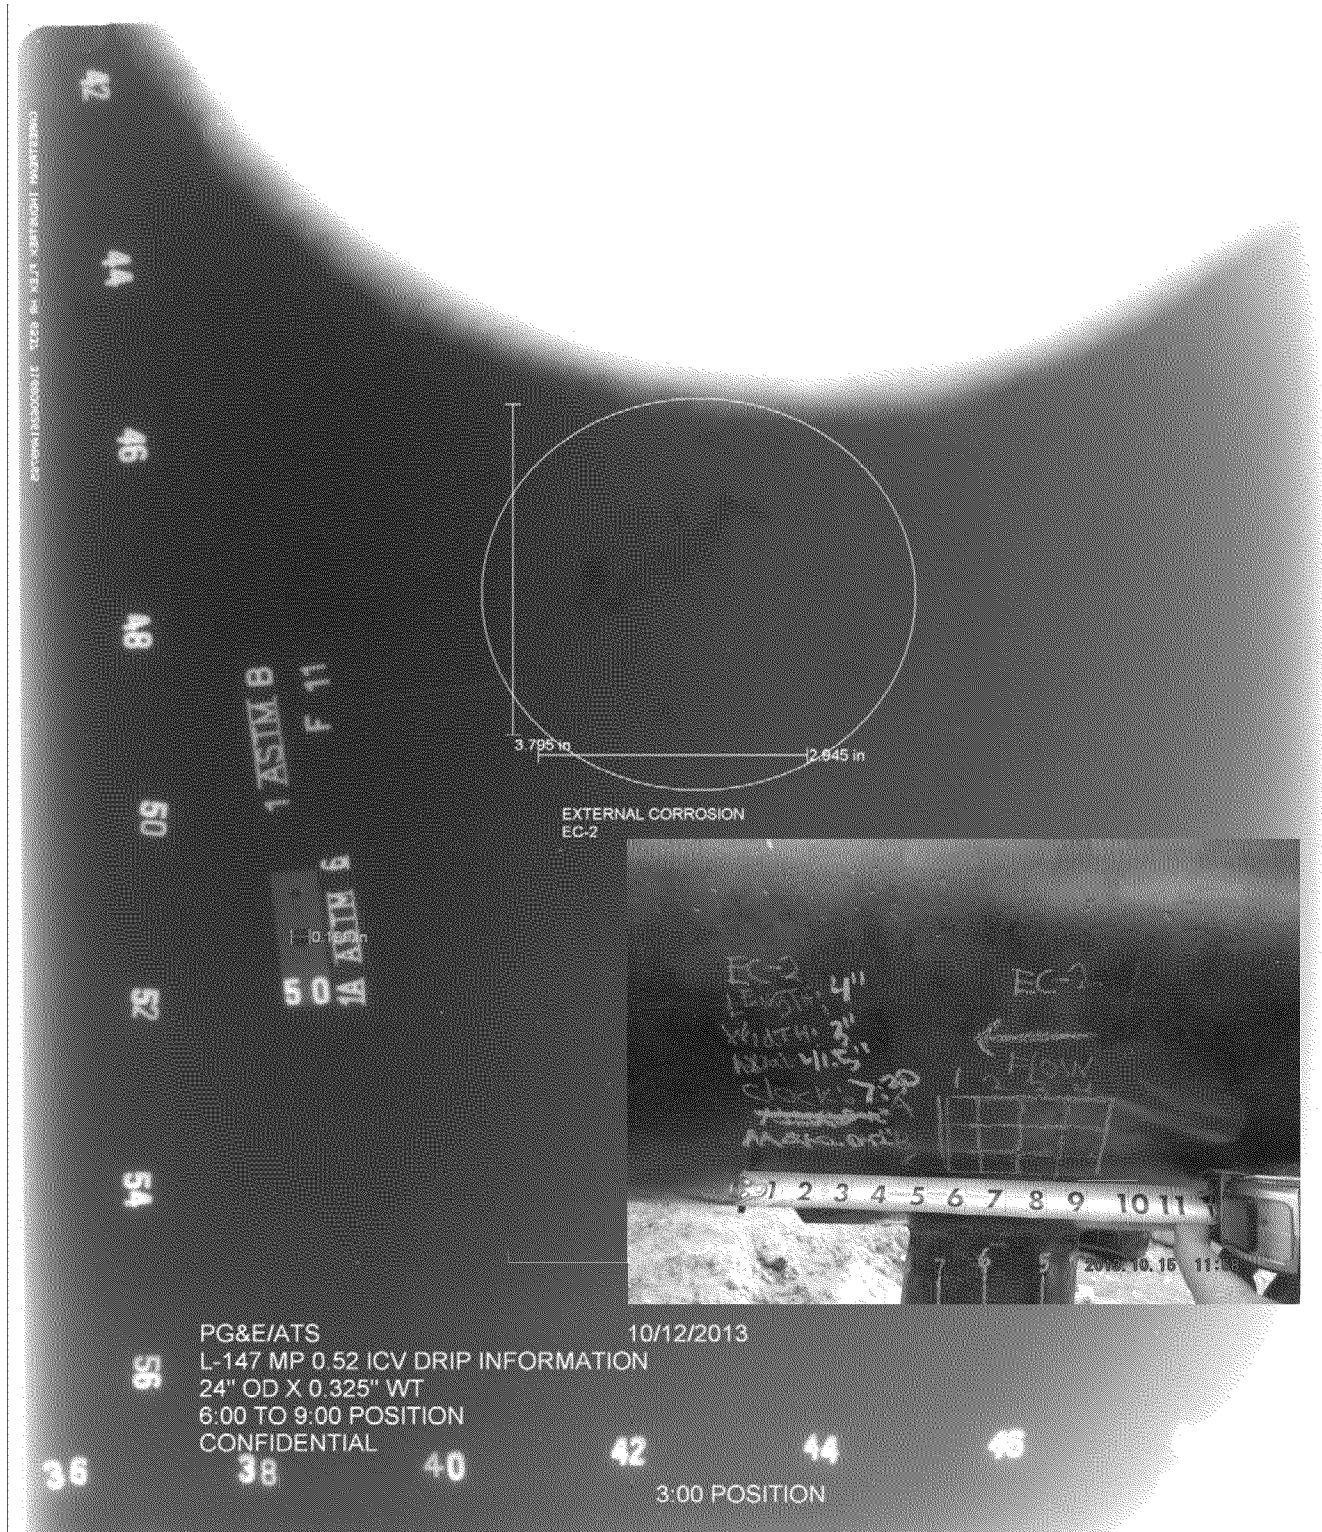
EC-2 : Average Wall Thickness: 0.325", Min. 0.283" for 13% Wall Loss.

Radiograph of the 24" main line showing external corrosion cell (EC-2)

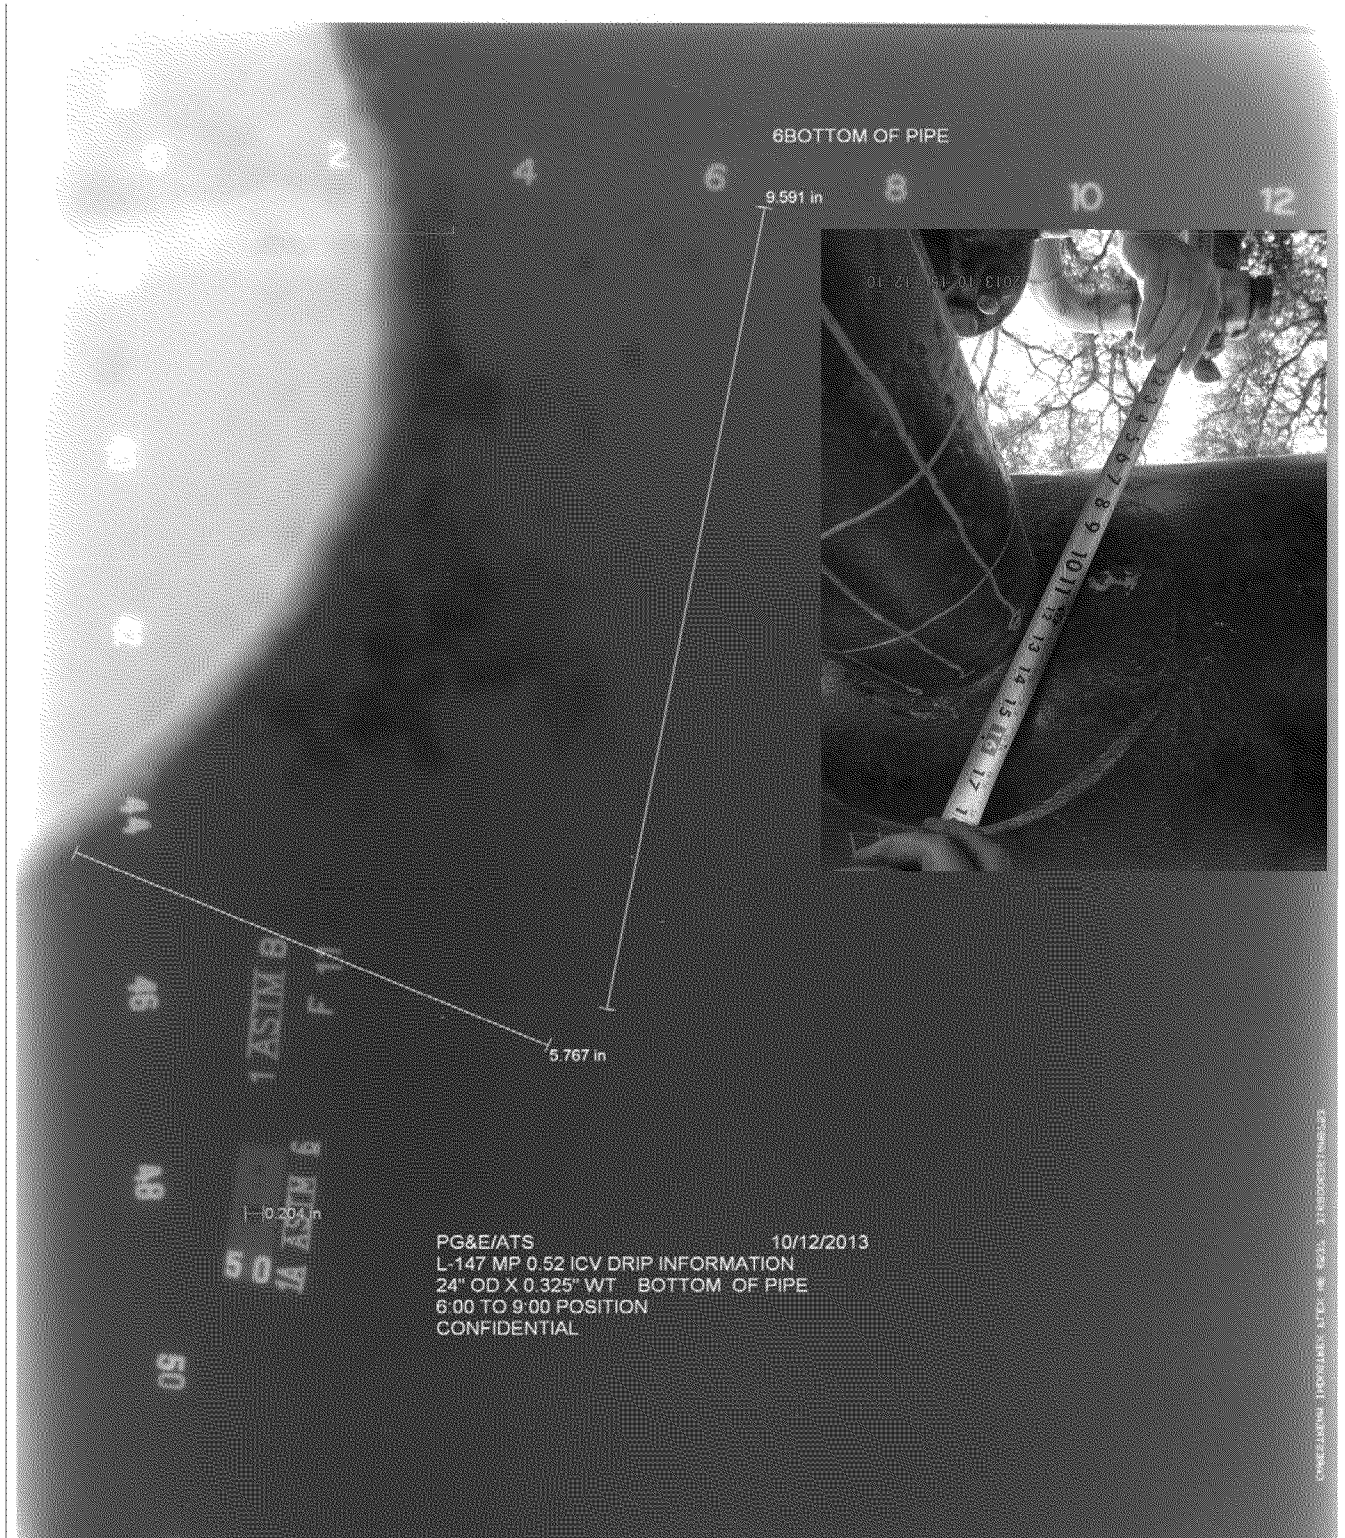
Radiograph of the 24" main line showing external corrosion cell (EC-3-1)

degree elbow that goes North into a Vaccing fitting. There were 4 Corrosion cells that were manually gridded, the most severe of these corrosion cells was
EC-3-1 (73 mils Depth).

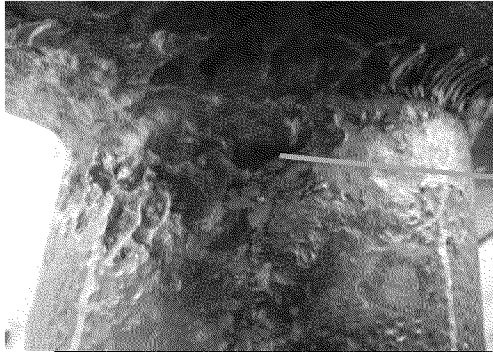
6" Drip Pot: ATS radiographed the drip pot and found it to be full of debris / sludge. Drip pot also has heavy external corrosion.

Radiograph of the Drip Pot showing debris / sludge inside of the drip pot and 2" pipe between the drip pot and valve.

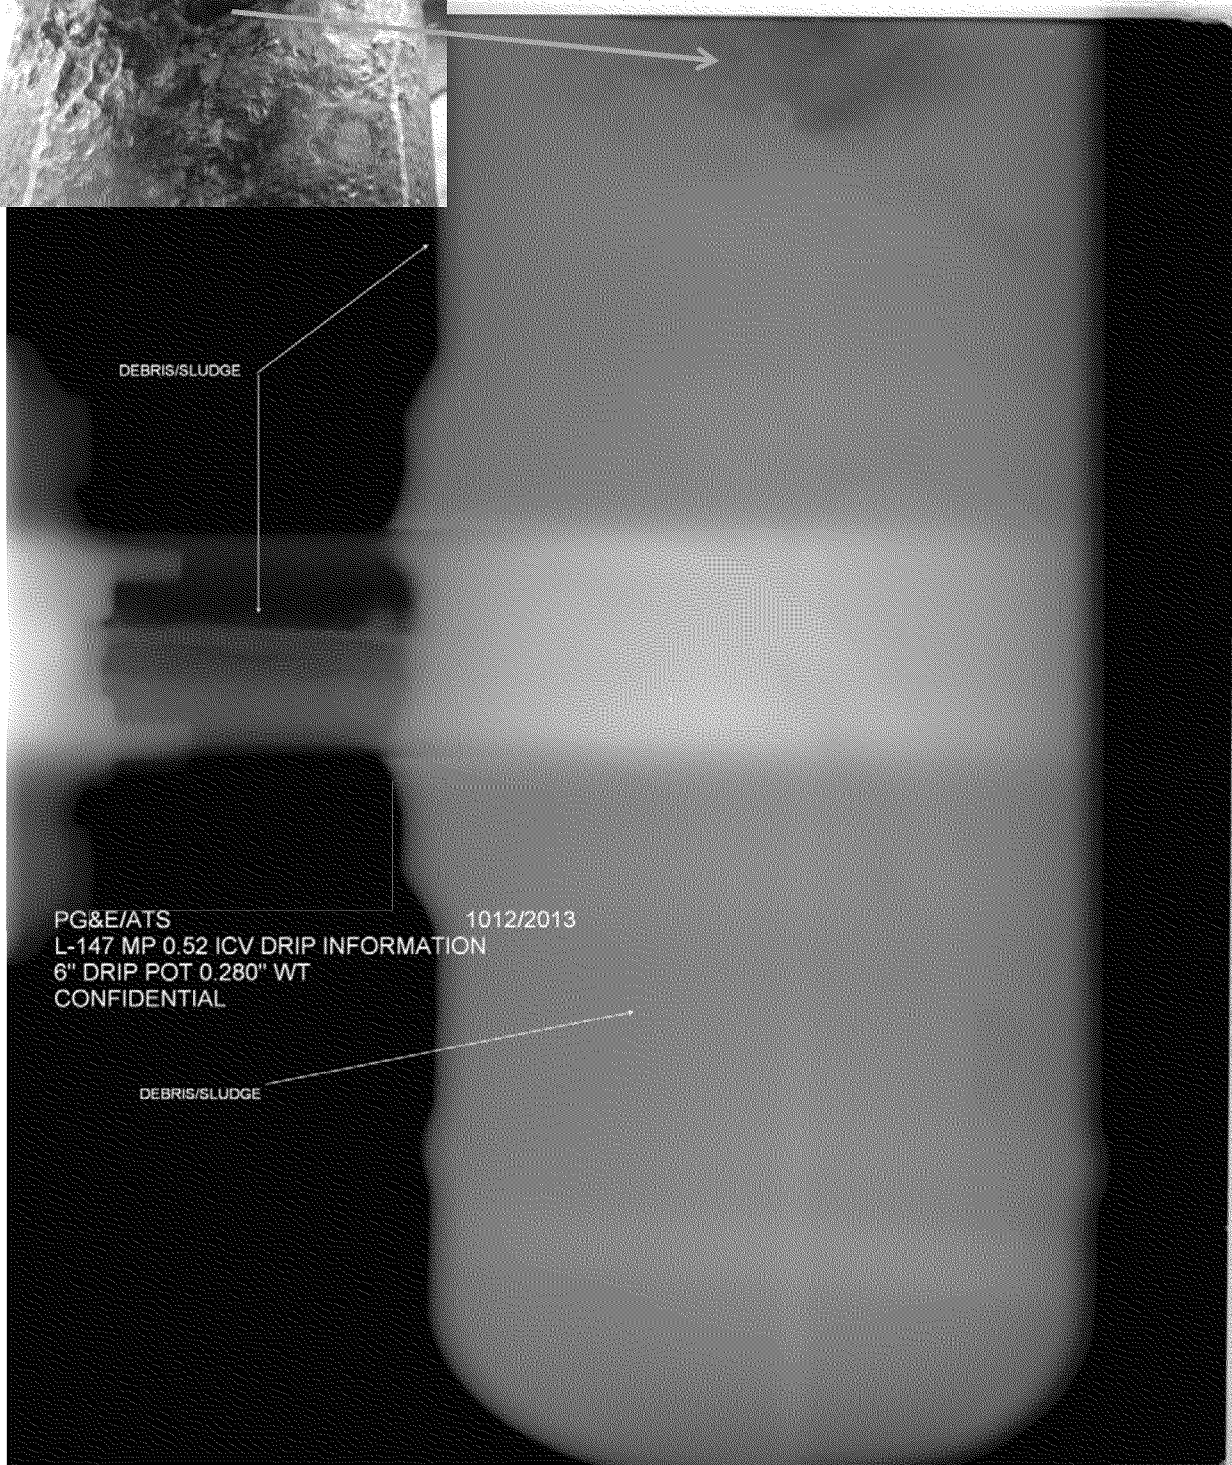
Picture showing the external corrosion

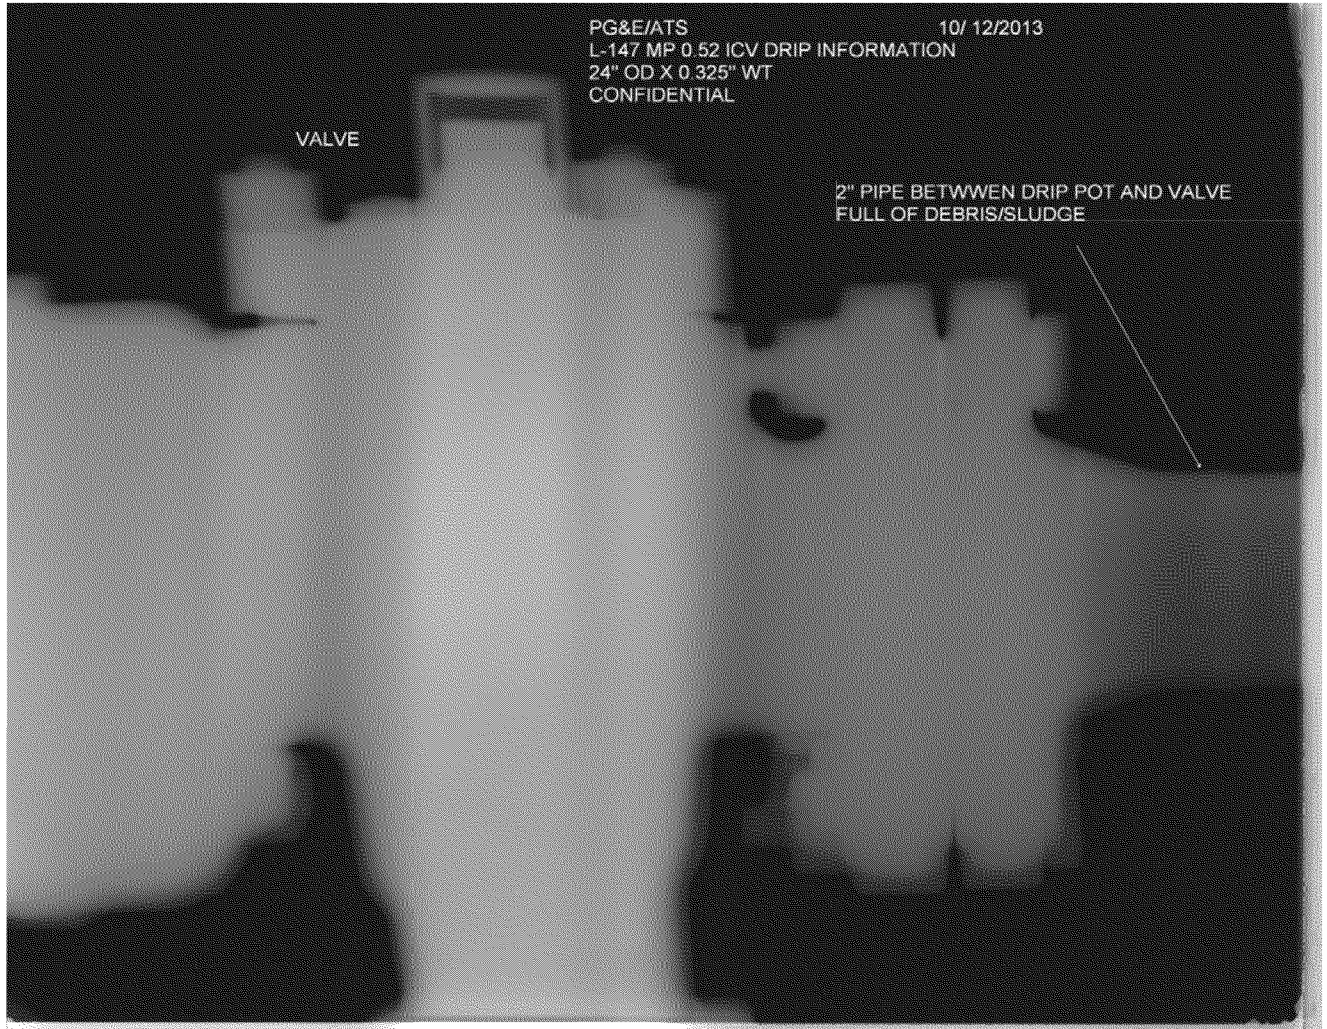
2" pipe between drip pot and valve: The 2" pipe is full of debris / sludge

Radiograph of the 2" pipe between the drip pot and valve in the 90° position

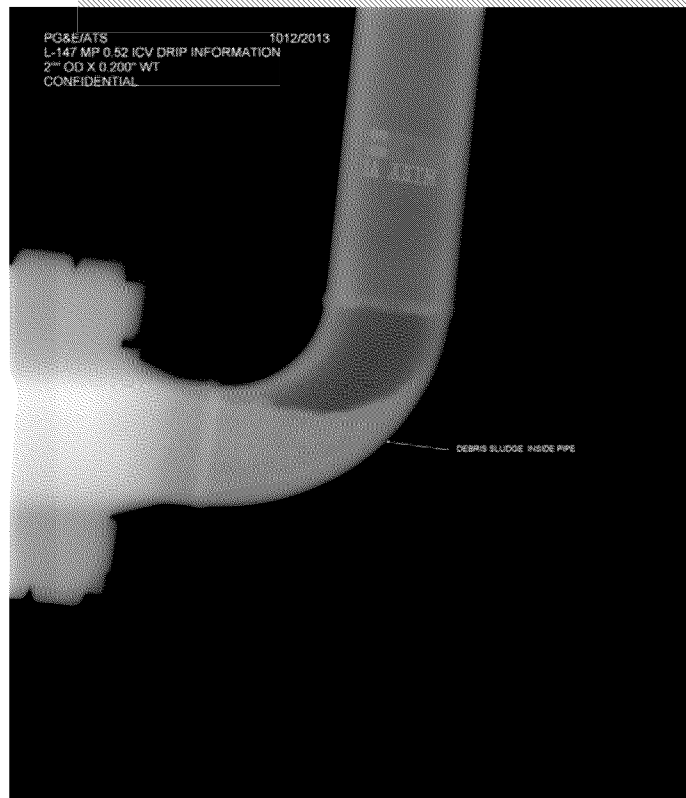
2" Elbow past valve and 2" pipe running vertical: The bottom elbow has debris / sludge that stops at the first girth weld running vertical. The vertical section of pipe has no debris / sludge. The top elbow has a small buildup of debris / sludge on the bottom.

Radiograph of the 2" piping past the vavle showing debris / sludge in the bottom 90 and a small amount of debris / sludge on the bottom of the upper 90

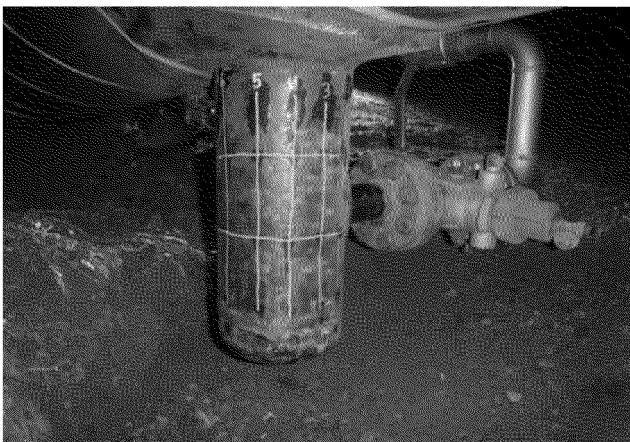
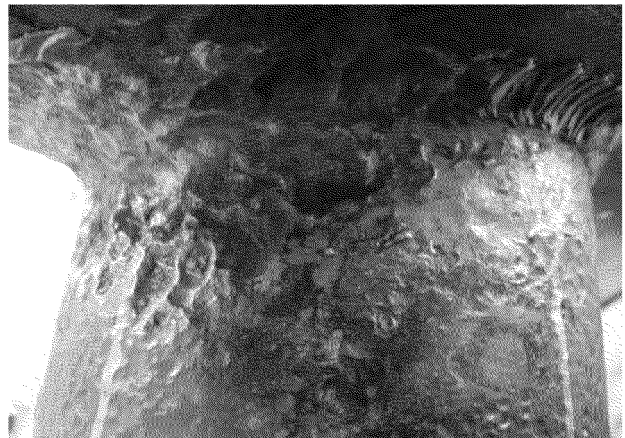
UT thickness survey of corrosion cell between the reinforcement pad and the drip pot using a pencil probe.

Position	UT reading	Remaining wall
7:00	0.162	42.14%
plus 1"	0.179	36.07%
8:00	0.216	22.85%
plus 1"	0.185	33.92%
9:00	0.160	42.85%
<hr/>		
Average wall thickness for the drip pot:		0.280

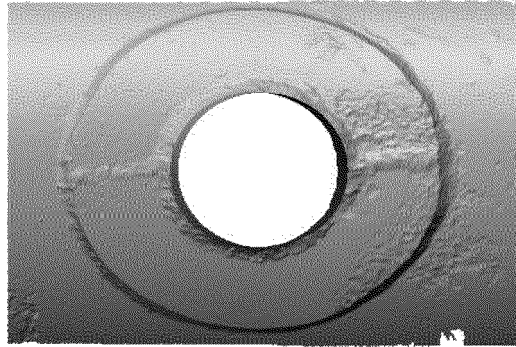
Over View of L-147 MP 0.52 drip pot and weld pad

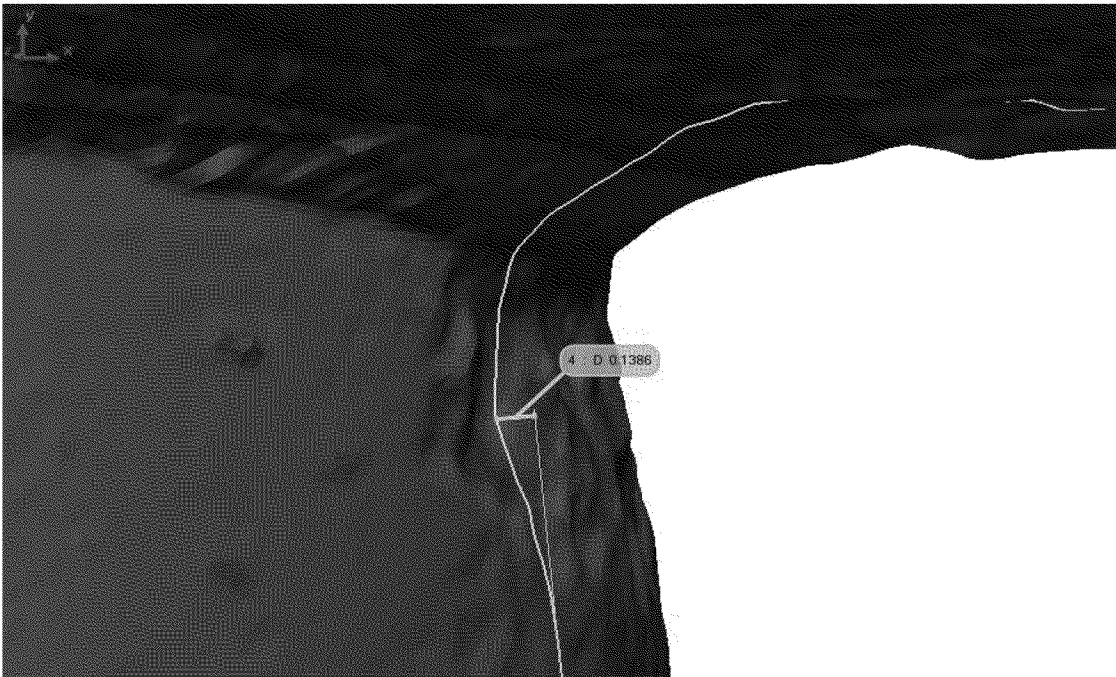
EC-3: Average Wall Thickness: 0.280", Min. 0.138" for 50.69% Wall Loss (Per Laser Scanner see attached Report) Impression Casting of the corroded weld (IC 3-3 area) which was difficult to obtain using multiple methods was: 4.00" width X 0.800" Long and approximately 0.150"-0.200" metal loss.

View of deepest corrosion pit

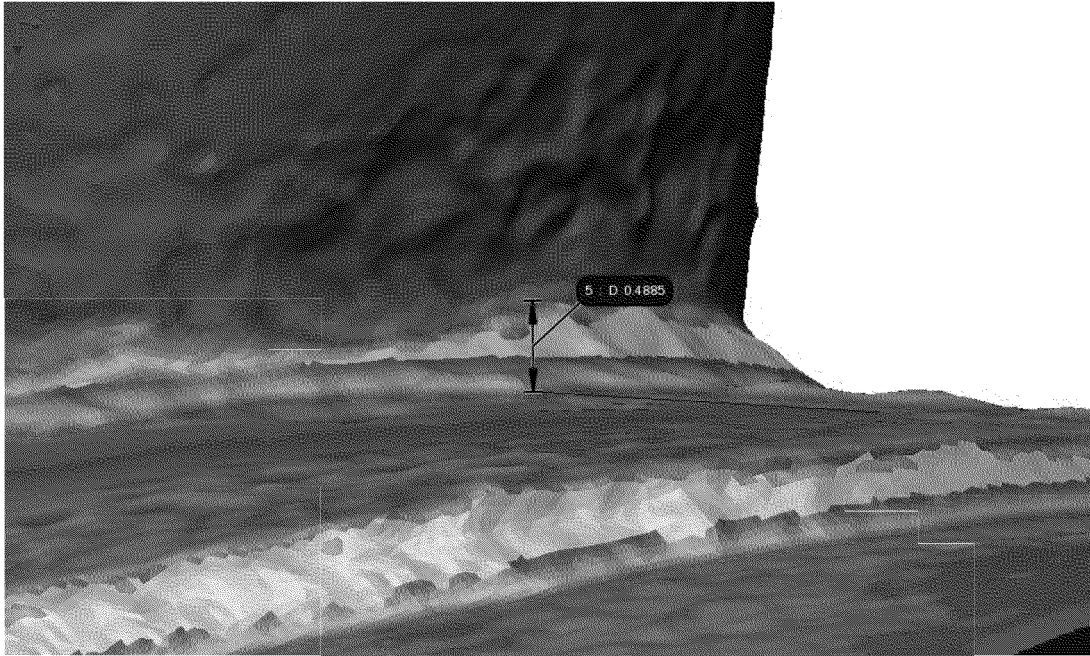
Estimated weld leg size

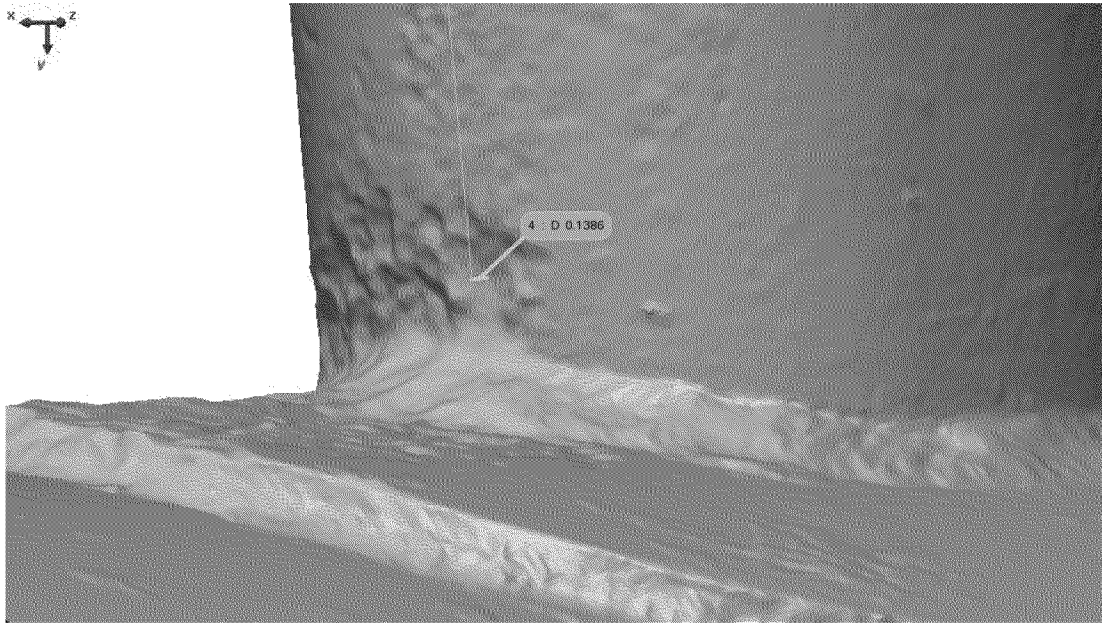
View of deepest corrosion pit, without color map

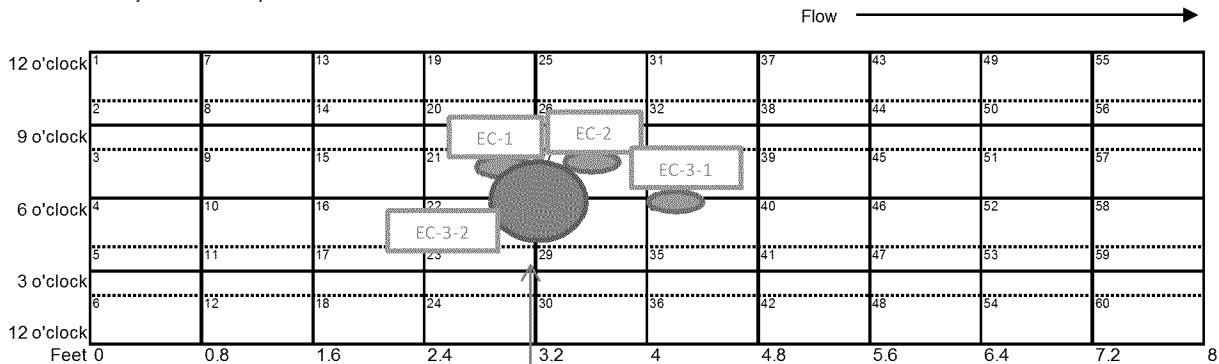
EC-3-3: Average Wall Thickness: 0.280", Min. 0.207" for 26.1% Wall Loss.

Drip Pot
 EC-3-2 is the entire circumference of the 6" Dia Drip Pot
