Form H: Direct Examination Data Sheet
Event 72298 on L-147 @97+70 M-147

PG&E

Route Number/MP	L-147 @97+70 M-147	N-Segment	147	ILI Log Distance (ft.)	0.000 Feet
Examination Date	11/4/2013	IMA Number	N/A	RMP-11 Ref. Section	N/A
Exam Performed By	Redacted	Region Number	1	Reference Girth Weld	N
Project Manager		Sub # (ICDA)	N/A	Dist. From Girth Weld (ft.)	0.000 Feet
Order Number	41976828	Stationing	97+70

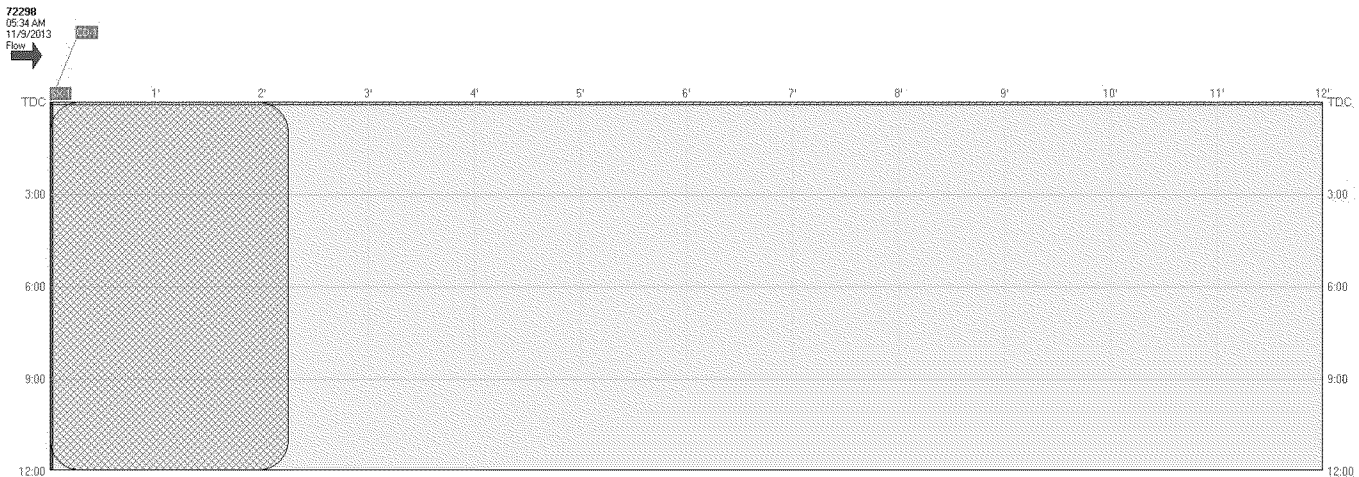
Map of Coating Degradation

Sample pH **0.000**
 Coating Conditions **Fair - Coating Partially Disbonded or Degraded**
 Coating Condition Comments **There were 2 types of existing coating found, HAA and Powercrete J. The HAA was in fair condition with one holiday noted in the report. The Powercrete J was in good condition with no holidays found.**
 Coating Degradation Map **Upstream Edge of Coating** Photos Taken **Y**
 Zero Reference Point **Removal**
 Coating Sample Taken **Y** Location of Coating Sample **3:00, U/S edge of coating removal.**
 Liquid Underneath Coating **N** If Yes, pH of Liquid **0.000**
 Corrosion Product Present **N** If Yes, Corrosion Sample Taken **N**
 Comments **No corrosion product present at the time of inspection.**
 Soil pH (Sb Electrode) U/S **5.500** Soil pH (Sb Electrode) D/S **5.500**

ID	Axial Location (Inches from Ref.)	Circ. Location (Inches from TDC)	Damage Type	Length (Inches)	Width (Inches)	Description/Notes	Image Link
CD-001	0.00	0 12:00	Rock Impression	27.00	63.50	The rock impression extended from 0" to 27" D/S of reference, full circumference.

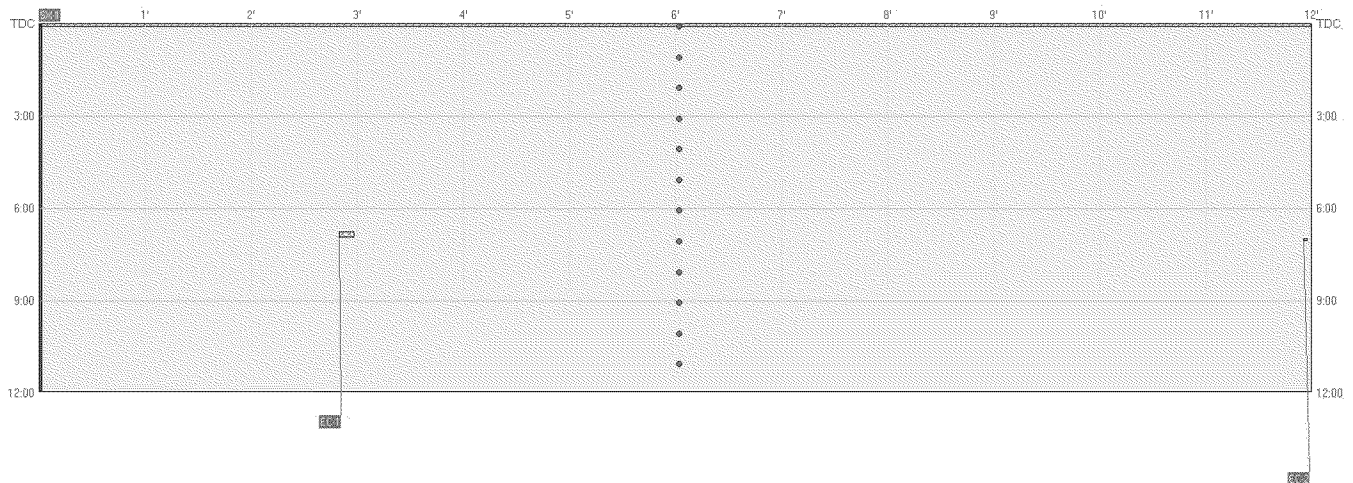
Map of Corroded Area

ID	Axial Location (Inches from Ref.)	Circ. Location (Inches from TDC)	Type	Length (Inches)	Width (Inches)	Max Depth (Inches)	Description/Notes	Image Link
EC-001	34.00	35.78 6:45	Localized	1.75	1.00	0.062	Maximum wall loss is 24.71%	
EC-002	143.00	37.04 7:00	Localized	0.50	0.50	0.036	Maximum wall loss is 13.432%

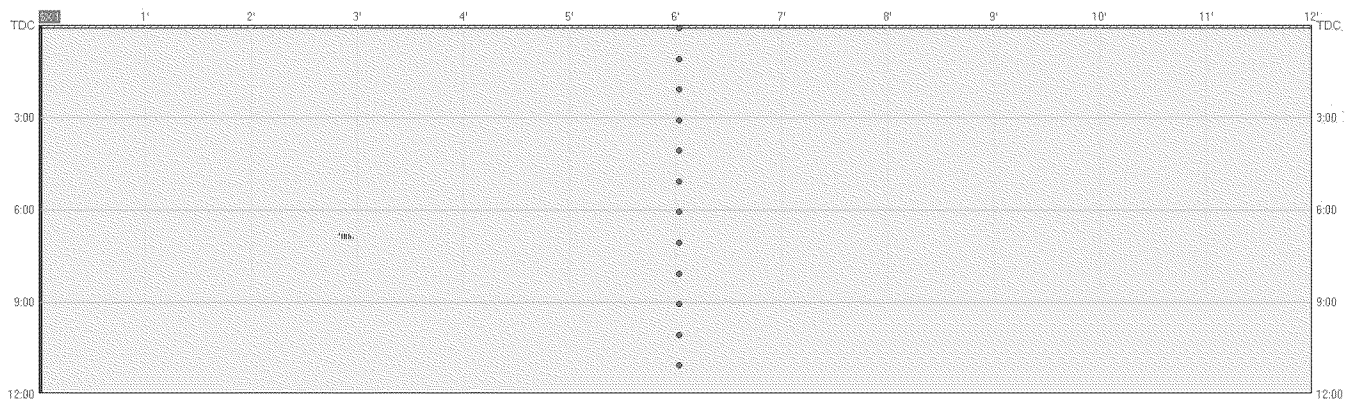
External Pit Depth Measurement Grids

EC-001	From TDC	1	2	3	4	5	6	7
A	35.78	.013	-	-	-	-	-	-

B	36.03	.011	.010	.038	.023	.002	-	-
C	36.28	-	.021	.062	.014	.012	.001	-
D	36.53	-	.004	.028	.007	.001	.002	.001

EC-002	Explanation
Details Not Provided - Max Depth: 0.036	Maximum wall loss is 13.432%

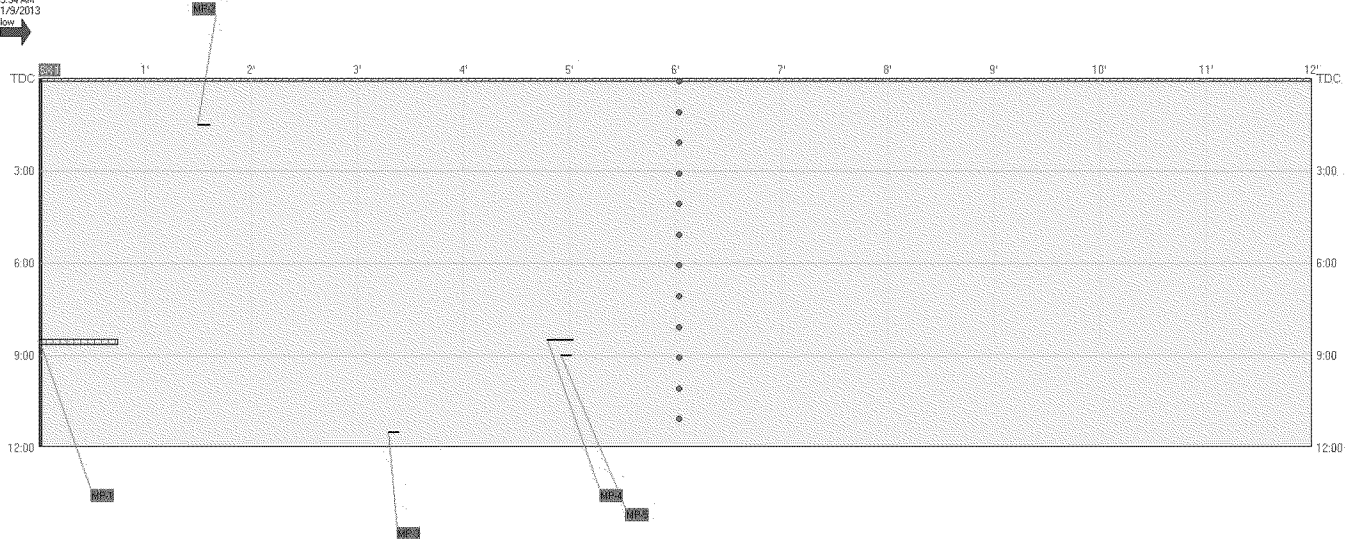
Ind. ID	Axial Location (Inches from Ref.)	Circ. Location (Inches from TDC)	Indication	Length (Inches)	Width (Inches)	Local Min. UTT (Inches)	Description/Notes	Image Link
MP-001	0.00	44.97 8:30	Singular	9.00	1.00	0.263	indication extends into existing coating. indication was removed up to existing coating.	
MP-002	18.00	7.93 1:30	Singular	1.50	0.25	0.260	indication was successfully removed	
MP-003	39.50	60.85 11:30	Singular	1.25	0.25	0.265	indication was successfully removed	
MP-004	57.50	44.97 8:30	Singular	3.00	0.25	0.251	indication was successfully removed	
MP-005	59.00	47.65 9:00	Singular	1.25	0.25	0.254	indication was successfully removed

Comments WFMT was performed on the 12' of exposed pipe, full circumference. 5 Linear Indications were found and noted in the report.

Repair Made	Y	Number of Repairs Made	5
Repair Type	Other	Damage Repaired	Other
Misc. Comments/Information	5 Linear Indications were removed via buffing.
