Pacific Gas & Electric Company

Hydrostatic Test Dig from October 7, 2011 to November 5, 2011

T43A/B_L147_B

Photo Report of T43A/B_L147_B

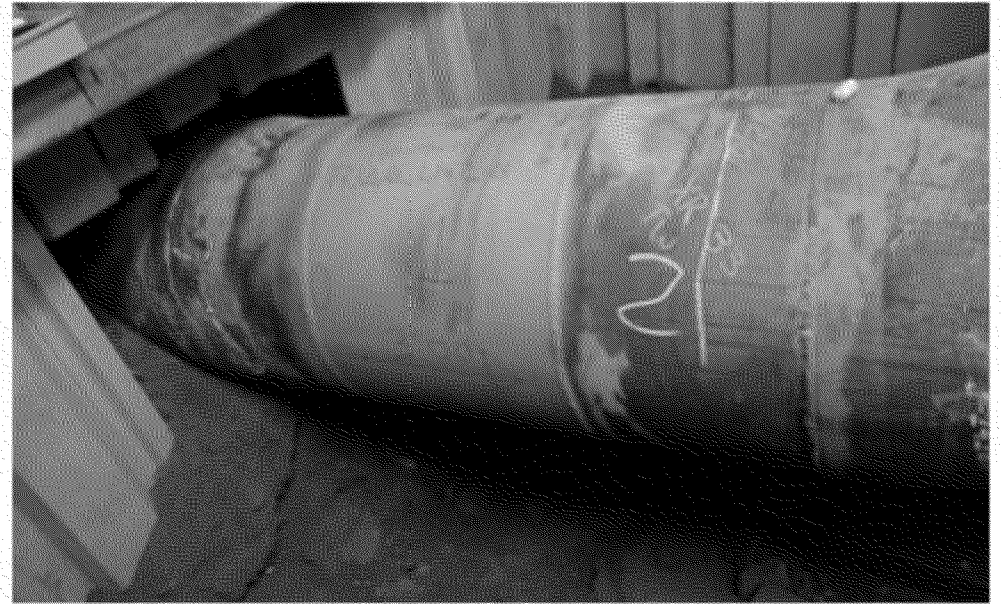
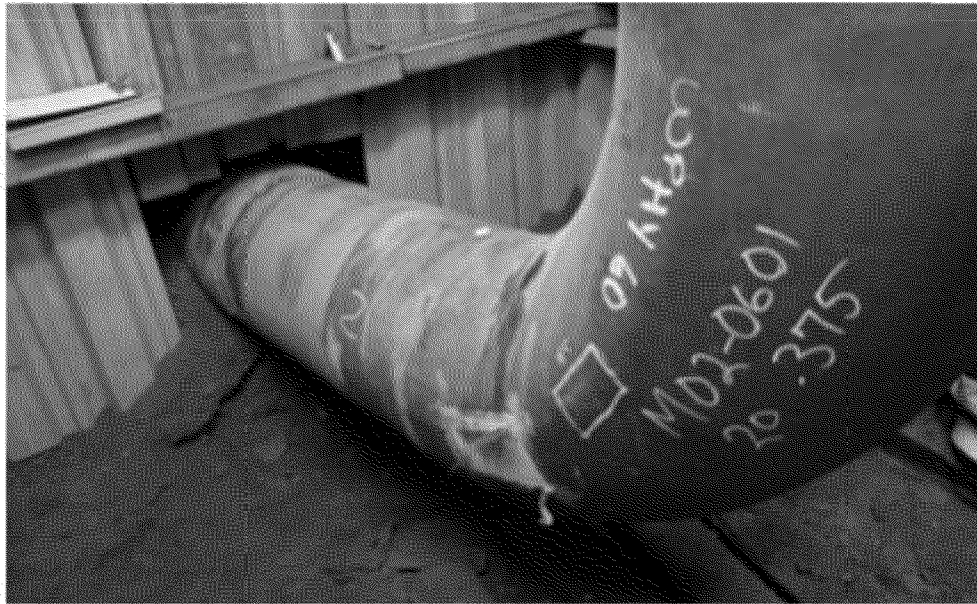
Overview of coating condition -1ft to 2ft, 3:00 position

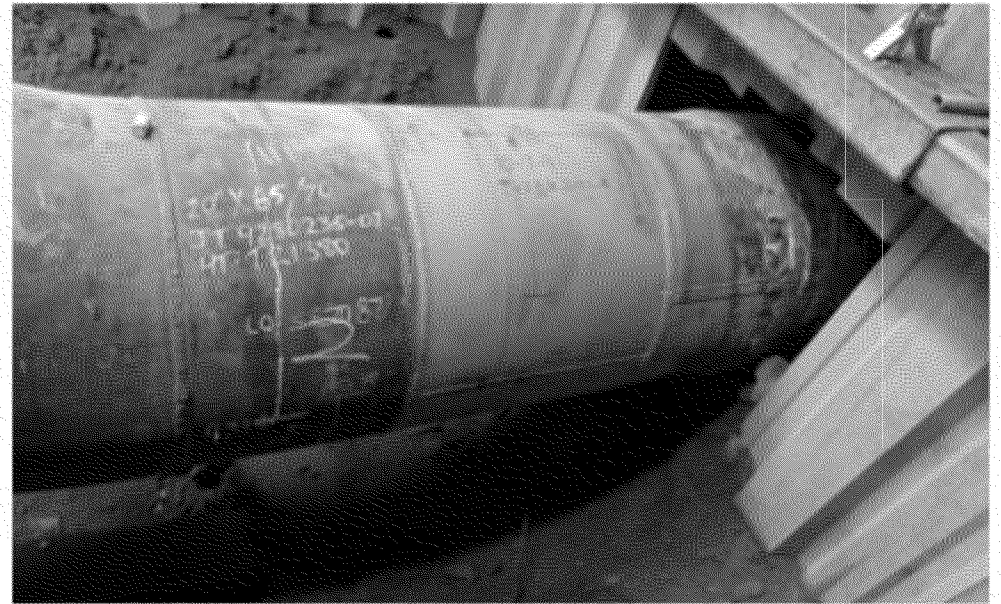
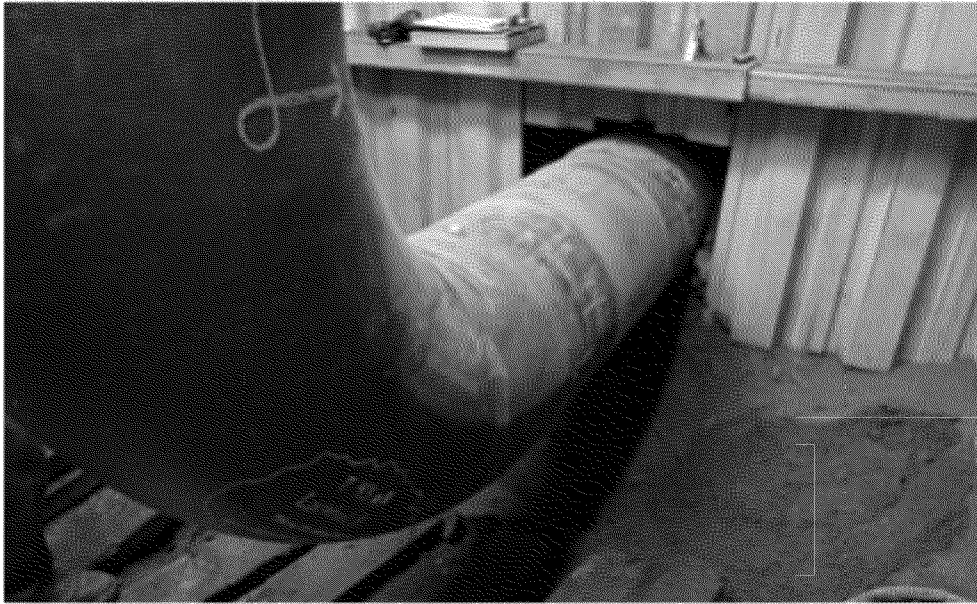
Overview of coating condition -1ft to 2ft, 9:00 position

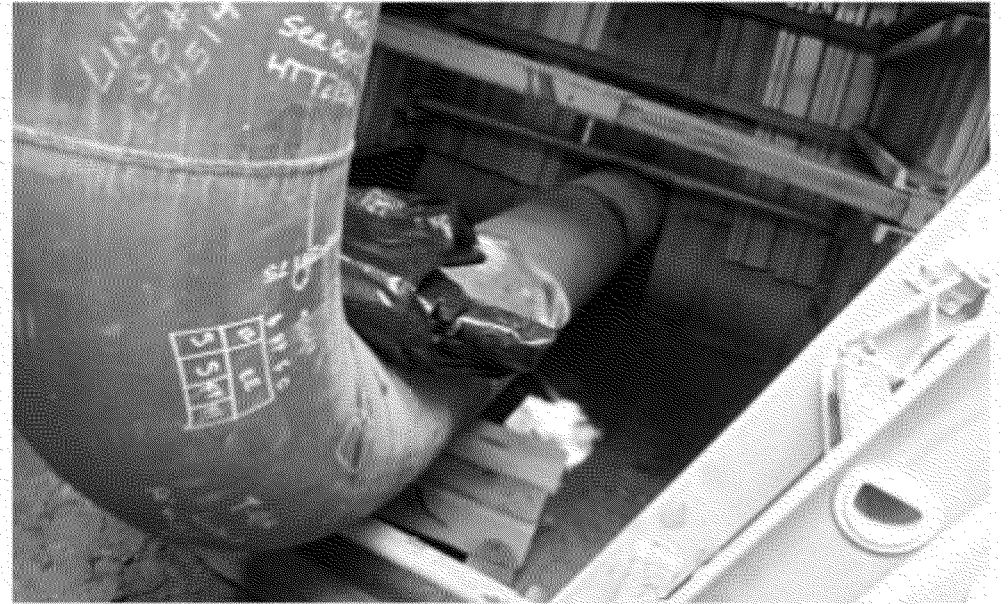
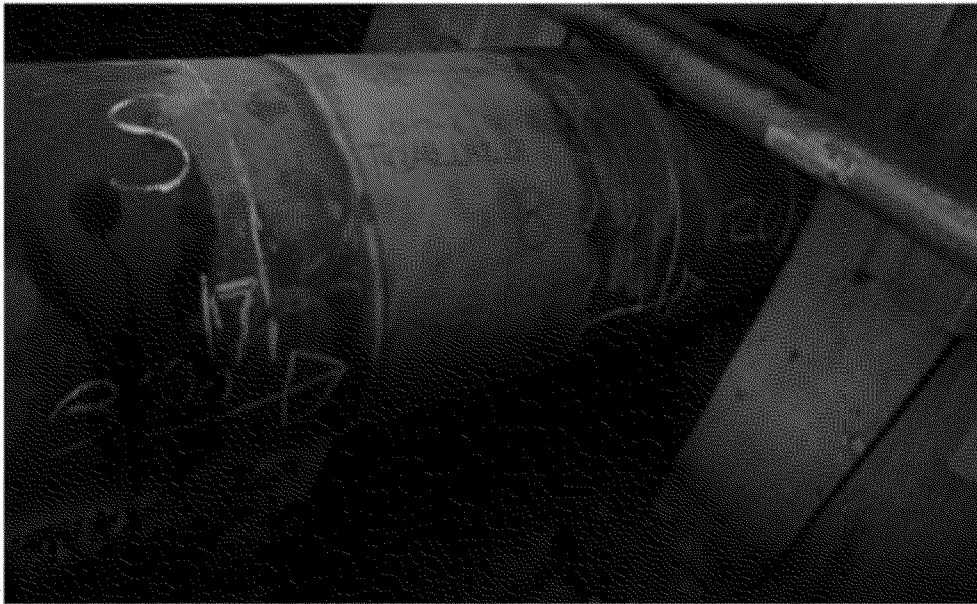
Overview of coating condition 17ft to 20ft, 3:00 position

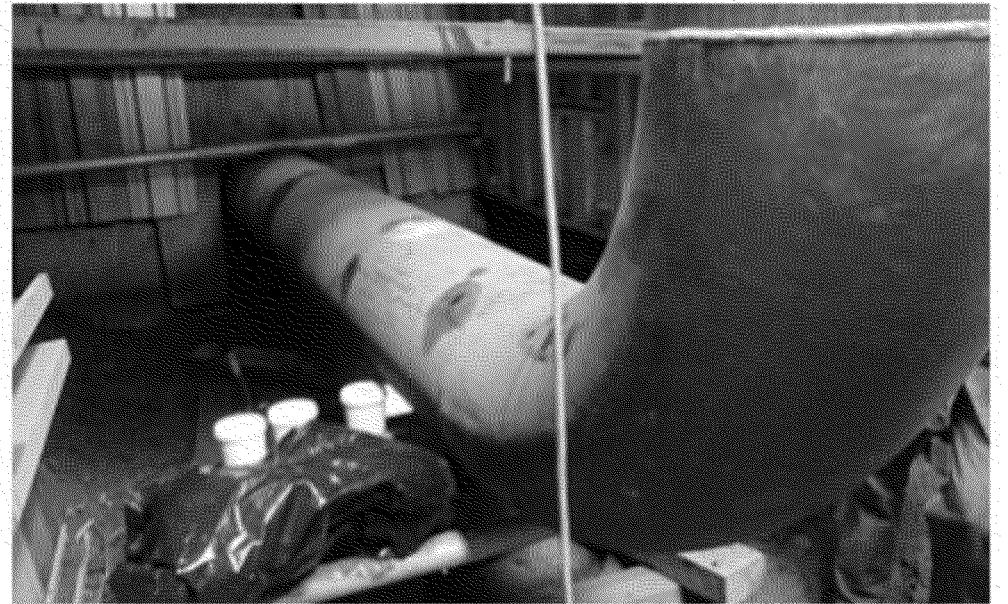
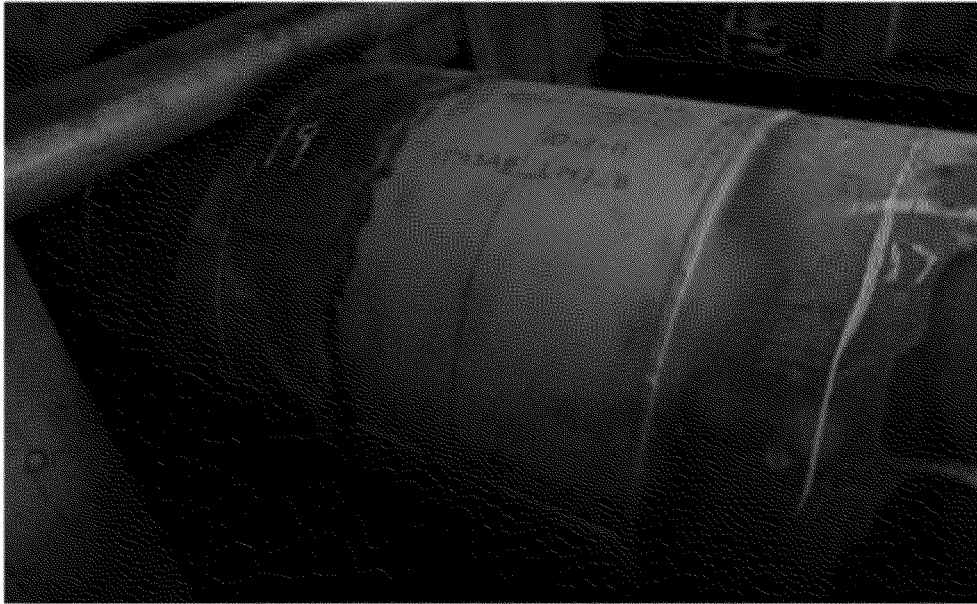
Overview of coating condition 17ft to 20ft, 9:00 position

Overview of coating condition 17ft to 20ft, 900 position

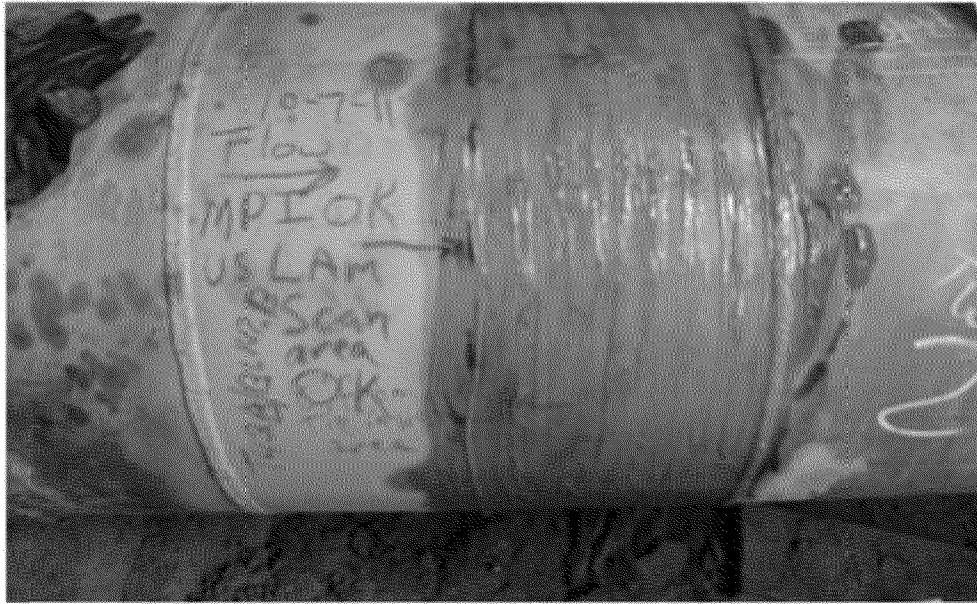
Overview of US MPI OK and Lamination scan OK.

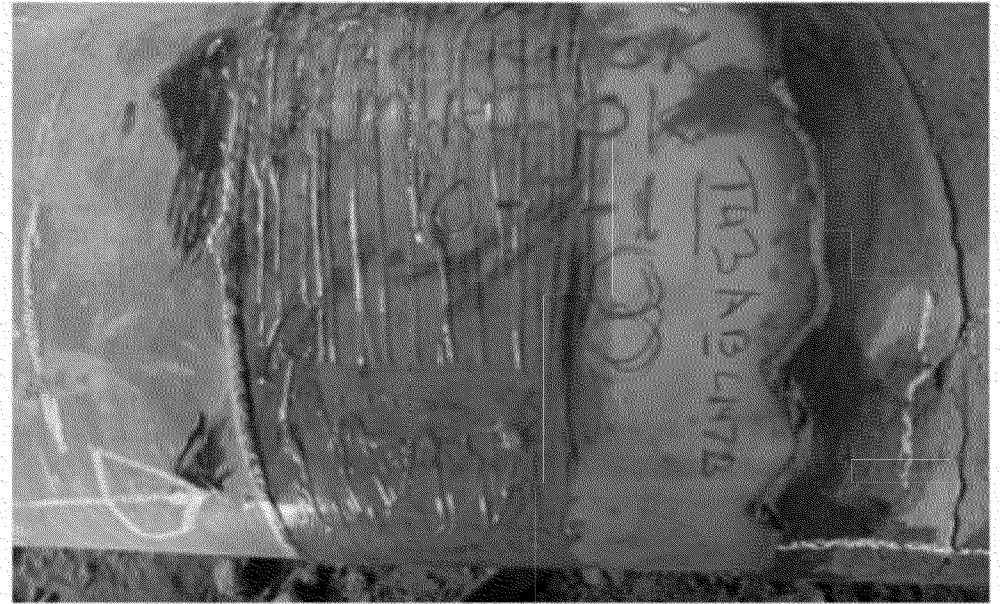
Overview DS of MPI OK and Lamination scan OK.

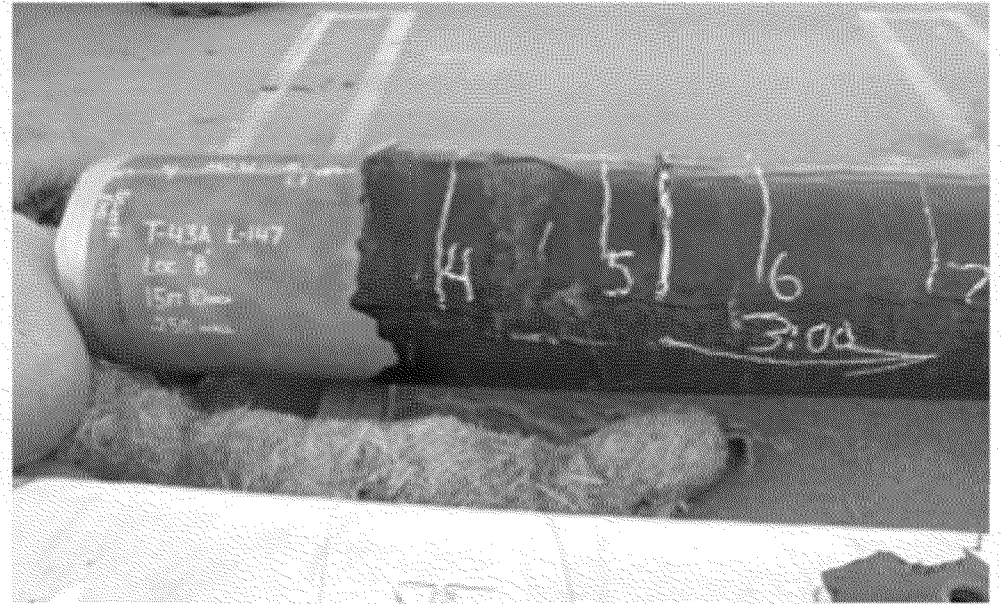
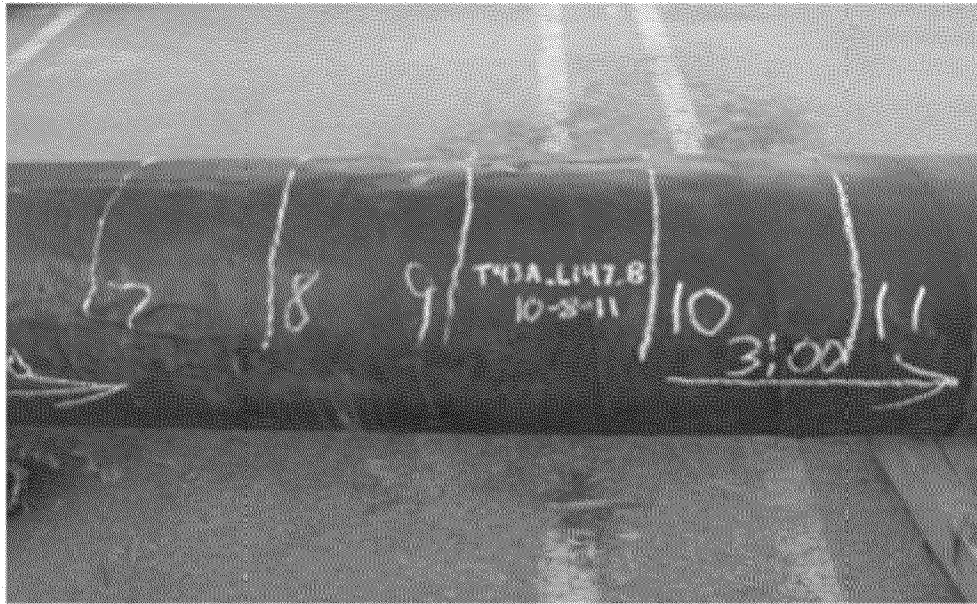
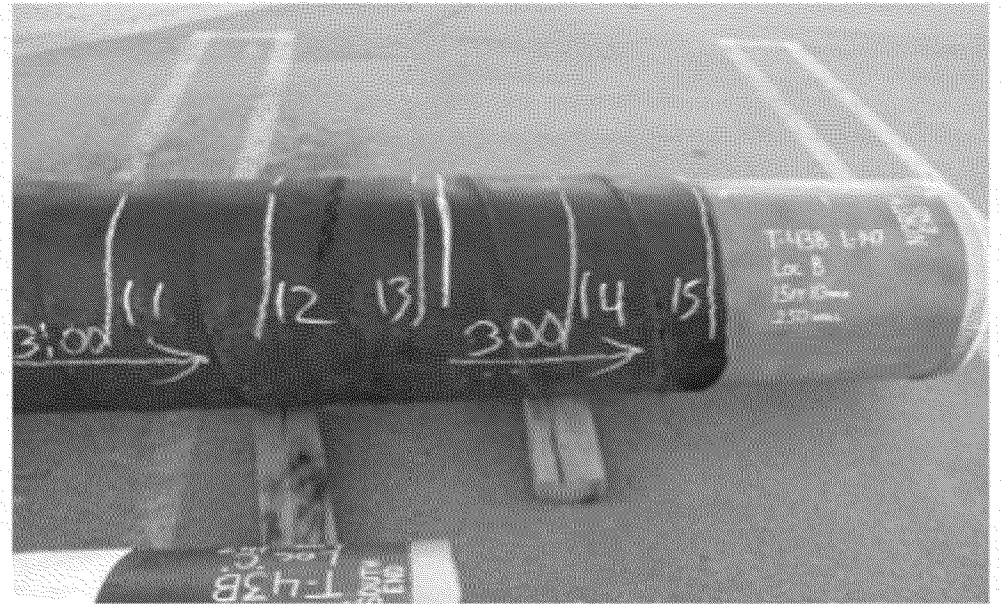
Removed pipe section coating assesment 3:00

Comments: Coating removed & tie in weld areas blasted. Pipe section removed and test pipes installed. Removed pipe section was also assessed and was in good condition except for coating damage from removal and transportation. See comments page 10.

Overview of coating condition 300 position

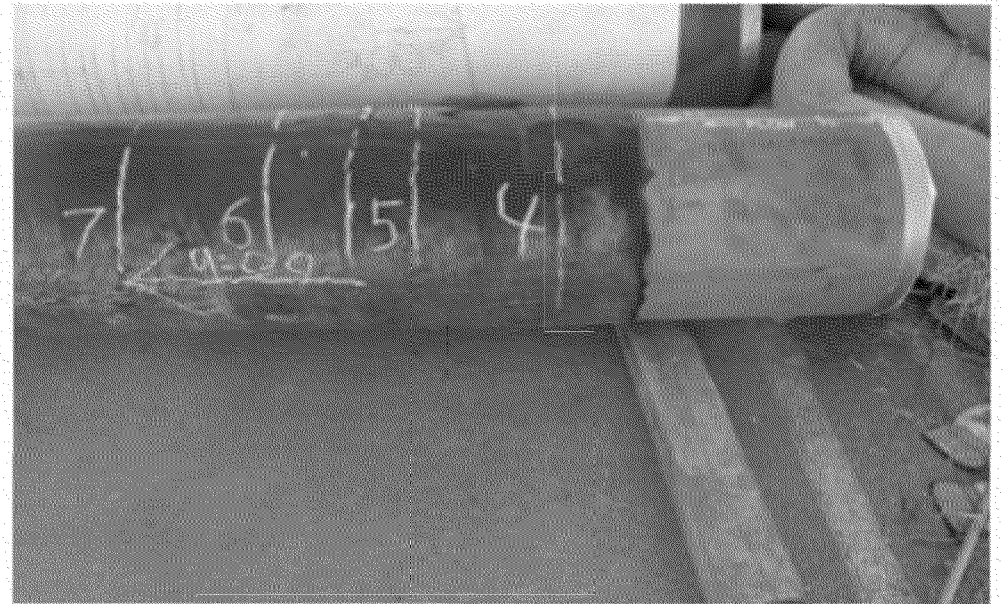
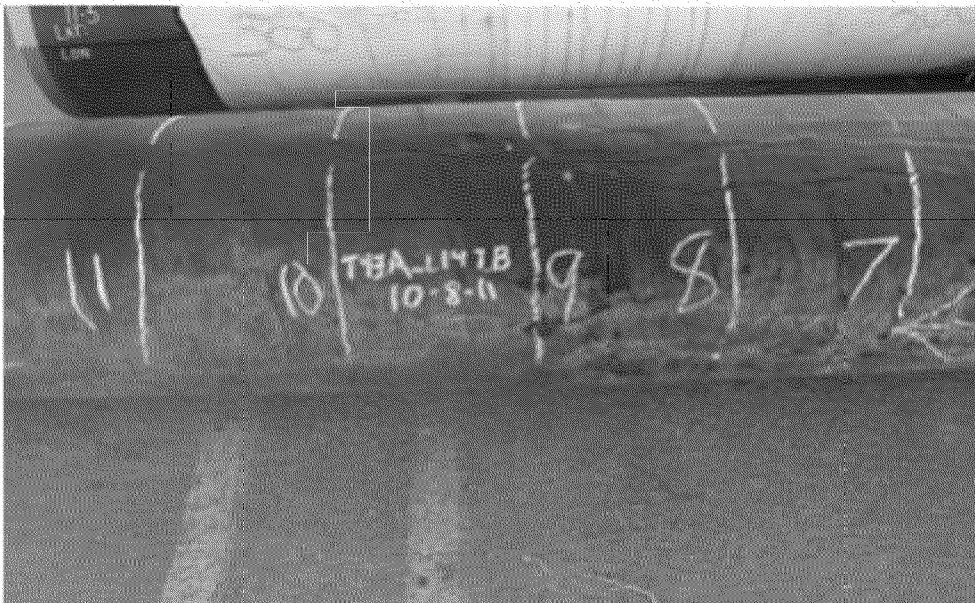
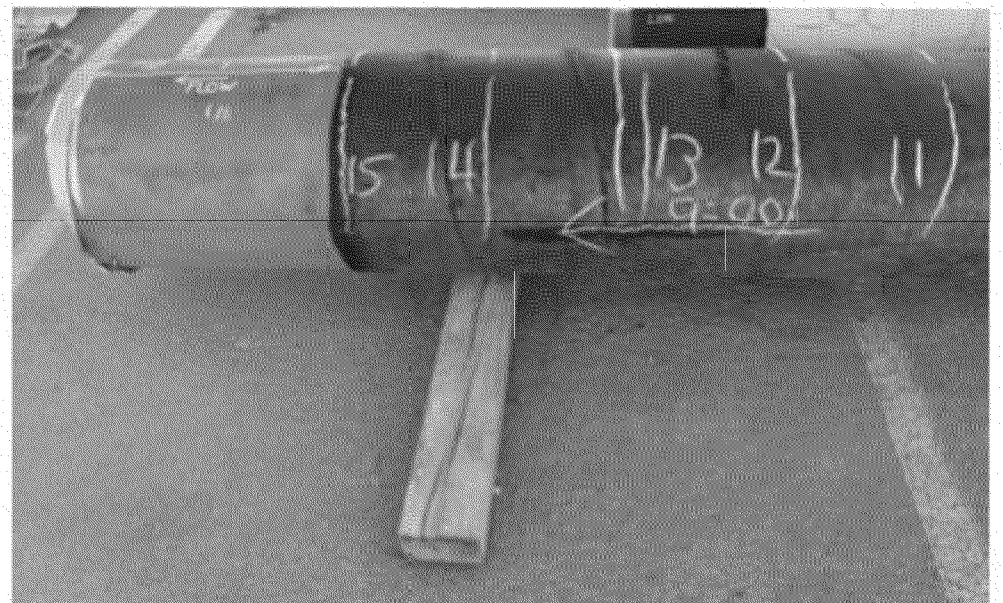
Removed pipe section coating assesment 9:00

Overview of coating condition 9:00 position

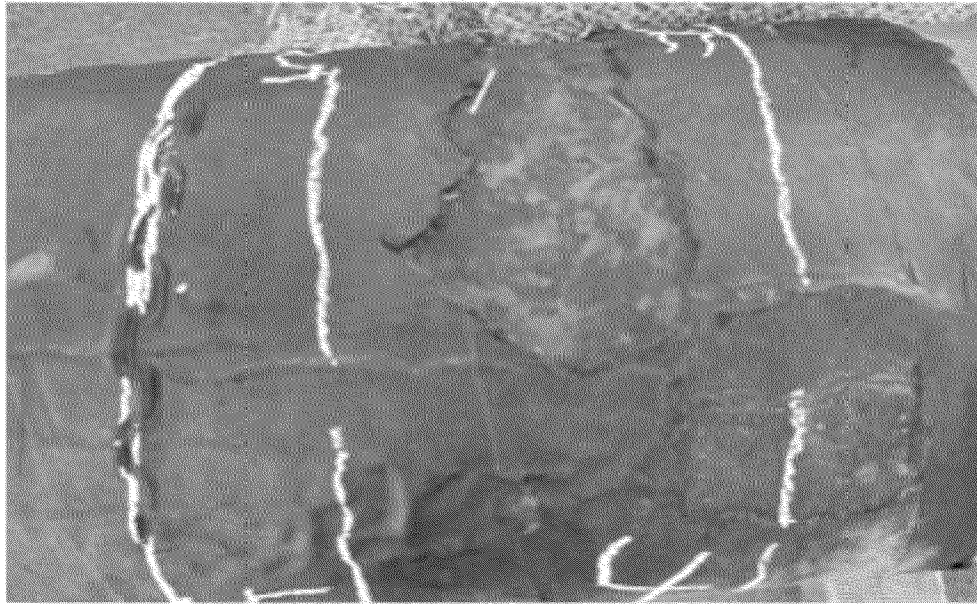
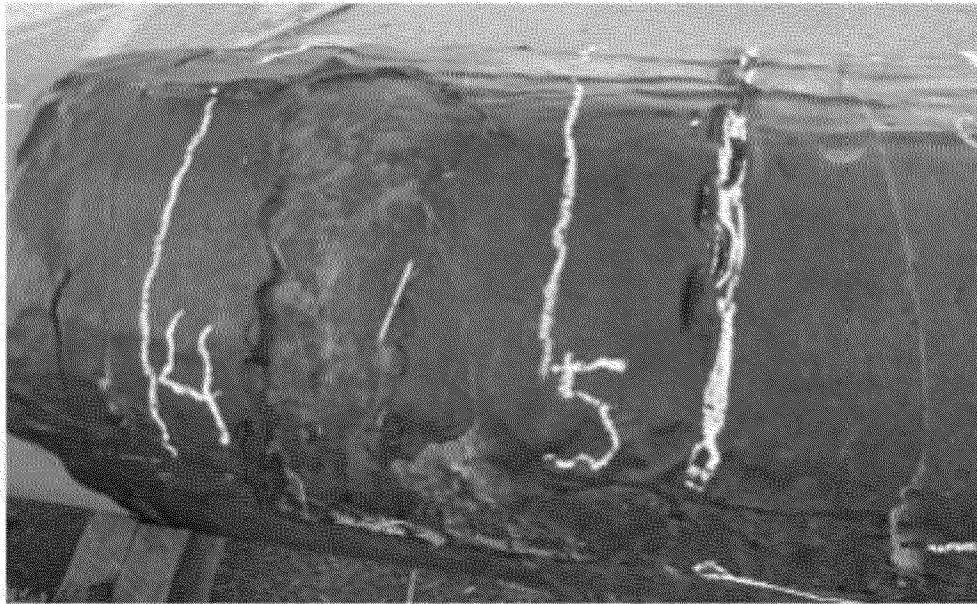
Coating damaged from removal process.

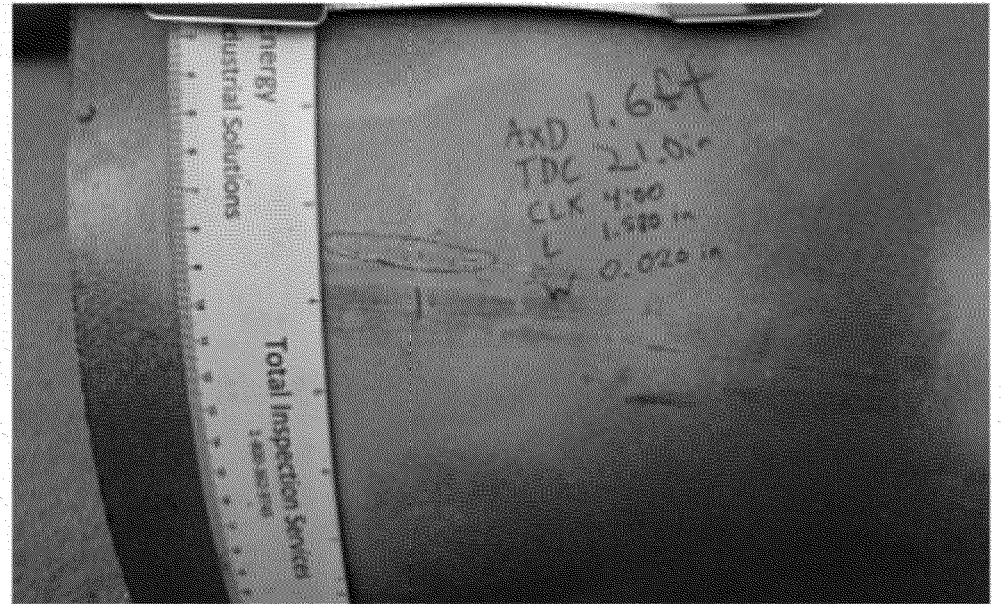
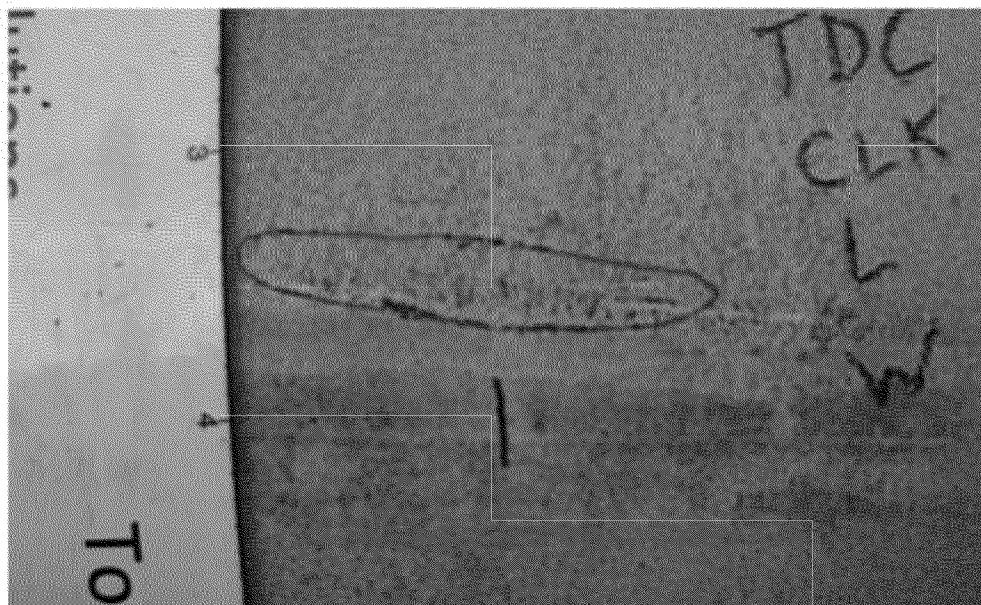
2.6 Wet Fluorescent Mag. Part. Is Required. Comments: 2 linear indications on the removed pipe section. See MT & Photo report.
 Were there any linear indications? Yes No
 If Yes, attach NDE report electronically as part of the H-Form. Report to include black light and white light photos of indications.

Removed pipe section linear indication-01.

Close up of MT Indications of LIN-01

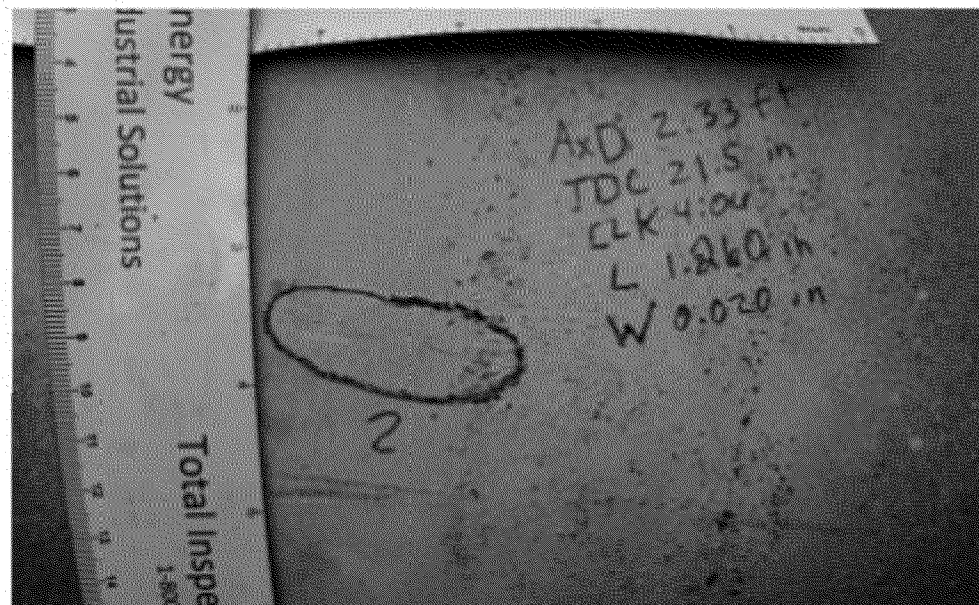
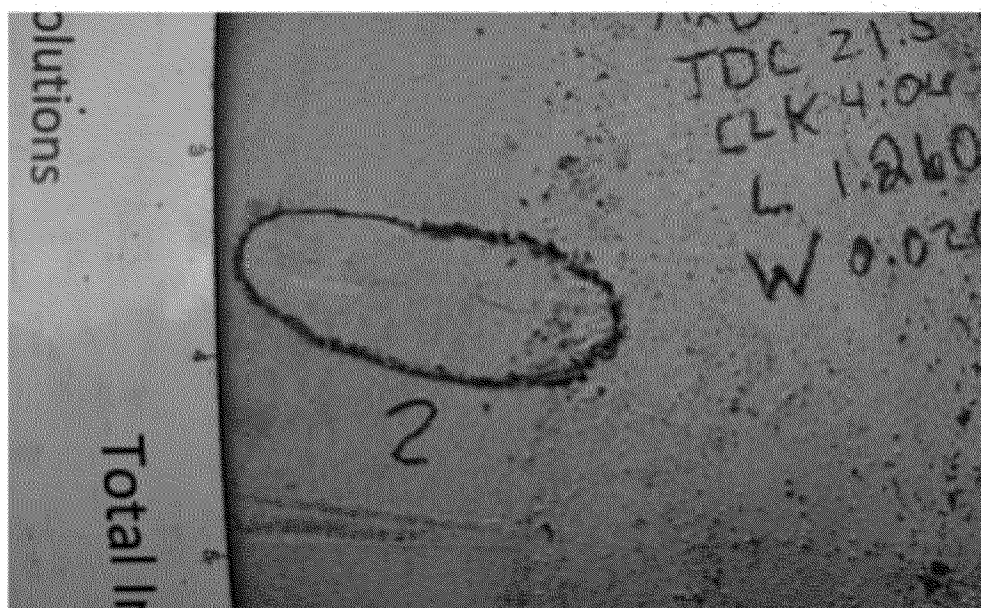
Removed pipe section linear indication-02

Close up of MT Indications of LIN-02

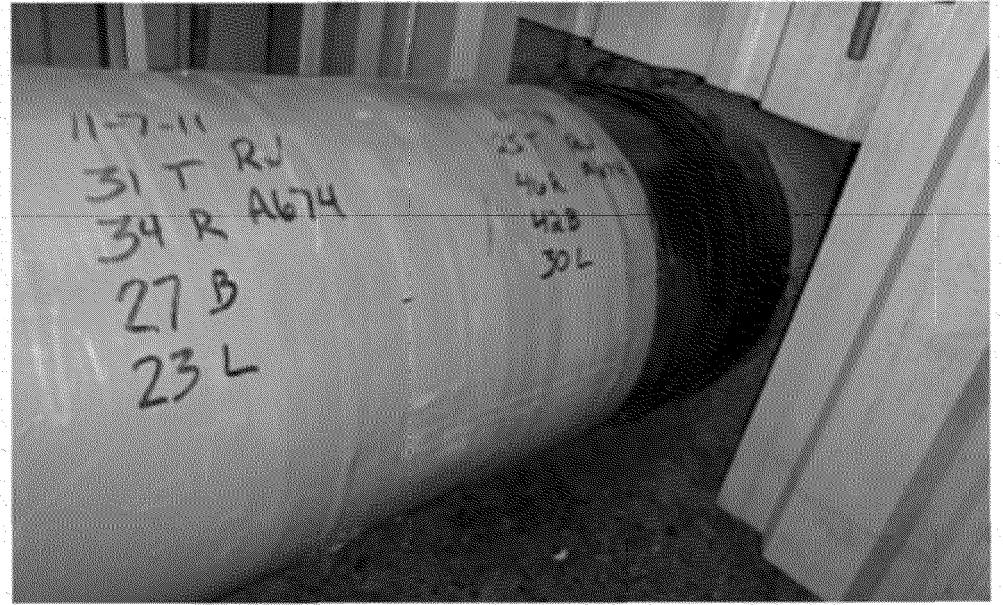
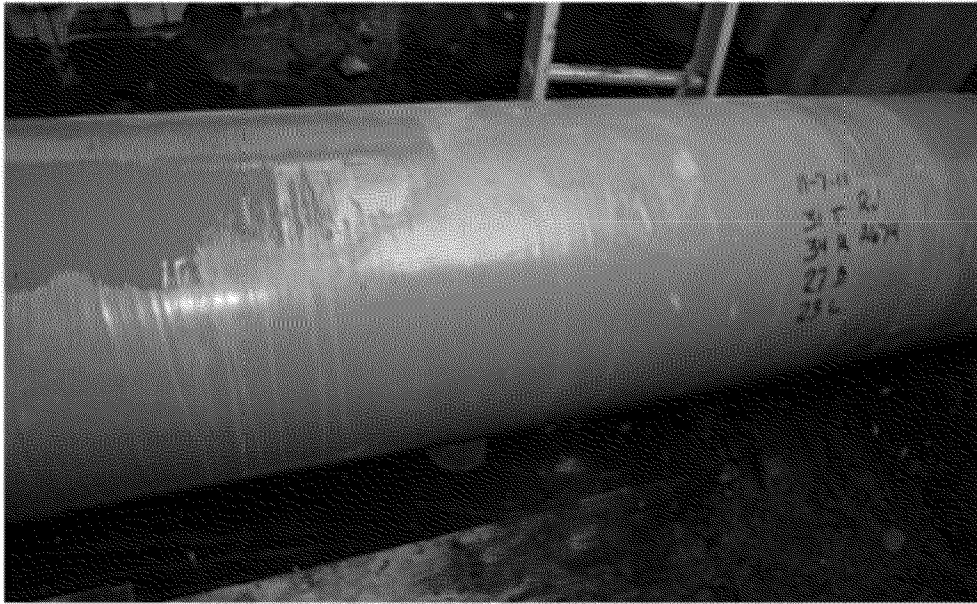
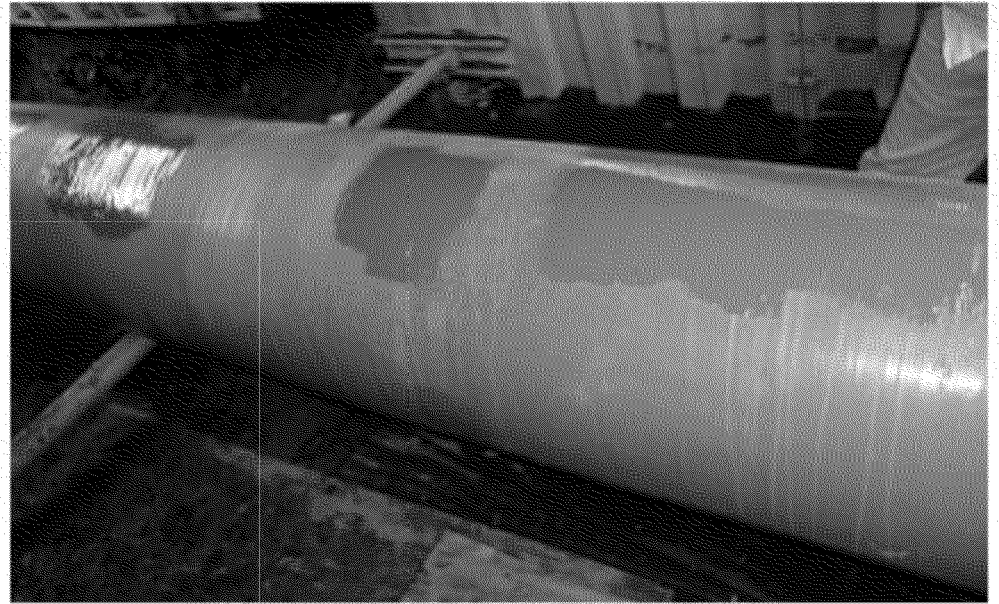
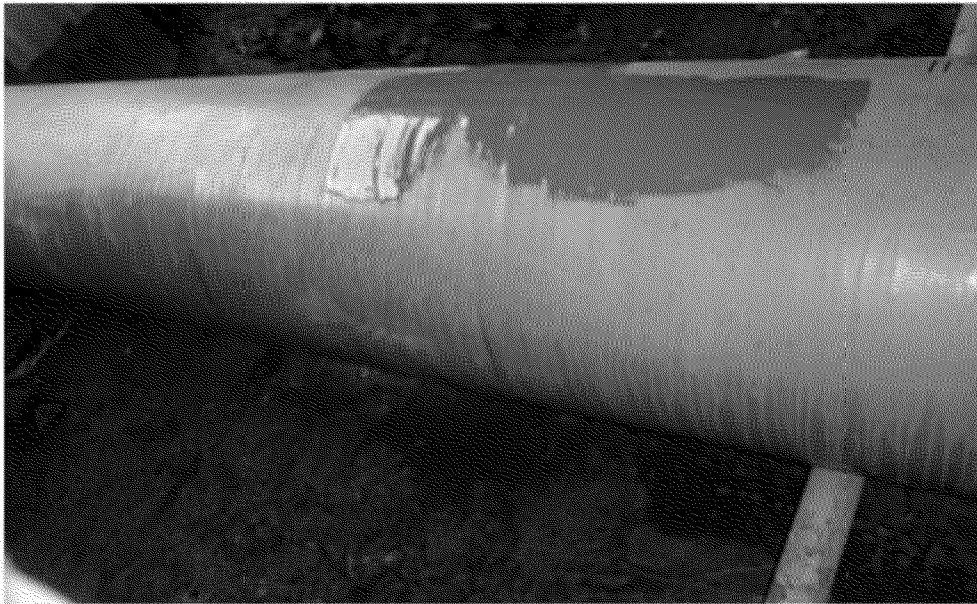
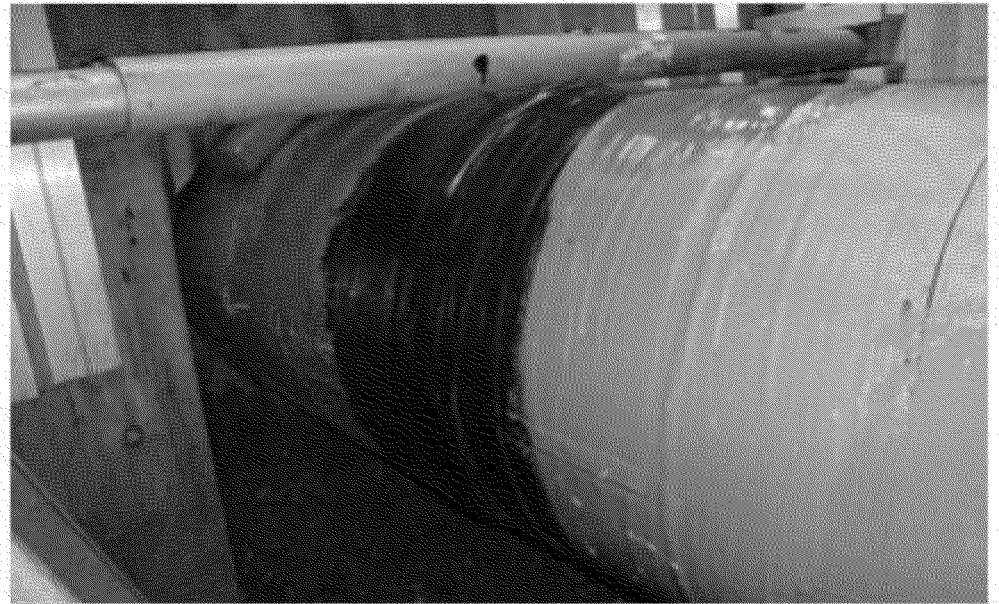
Overview of final coating condition US 300

Overview of final coating condition 3:00

Overview of final coating condition US 3:00
