Pipe Characterization and Weld Assessment
San Carlos
Line 147
Mile Post 0.52

ATS Report #: 413.61-13.390

Gas Project: Internal Corrosion Verification

Line 147 Mile Point 0.52 San Carlos

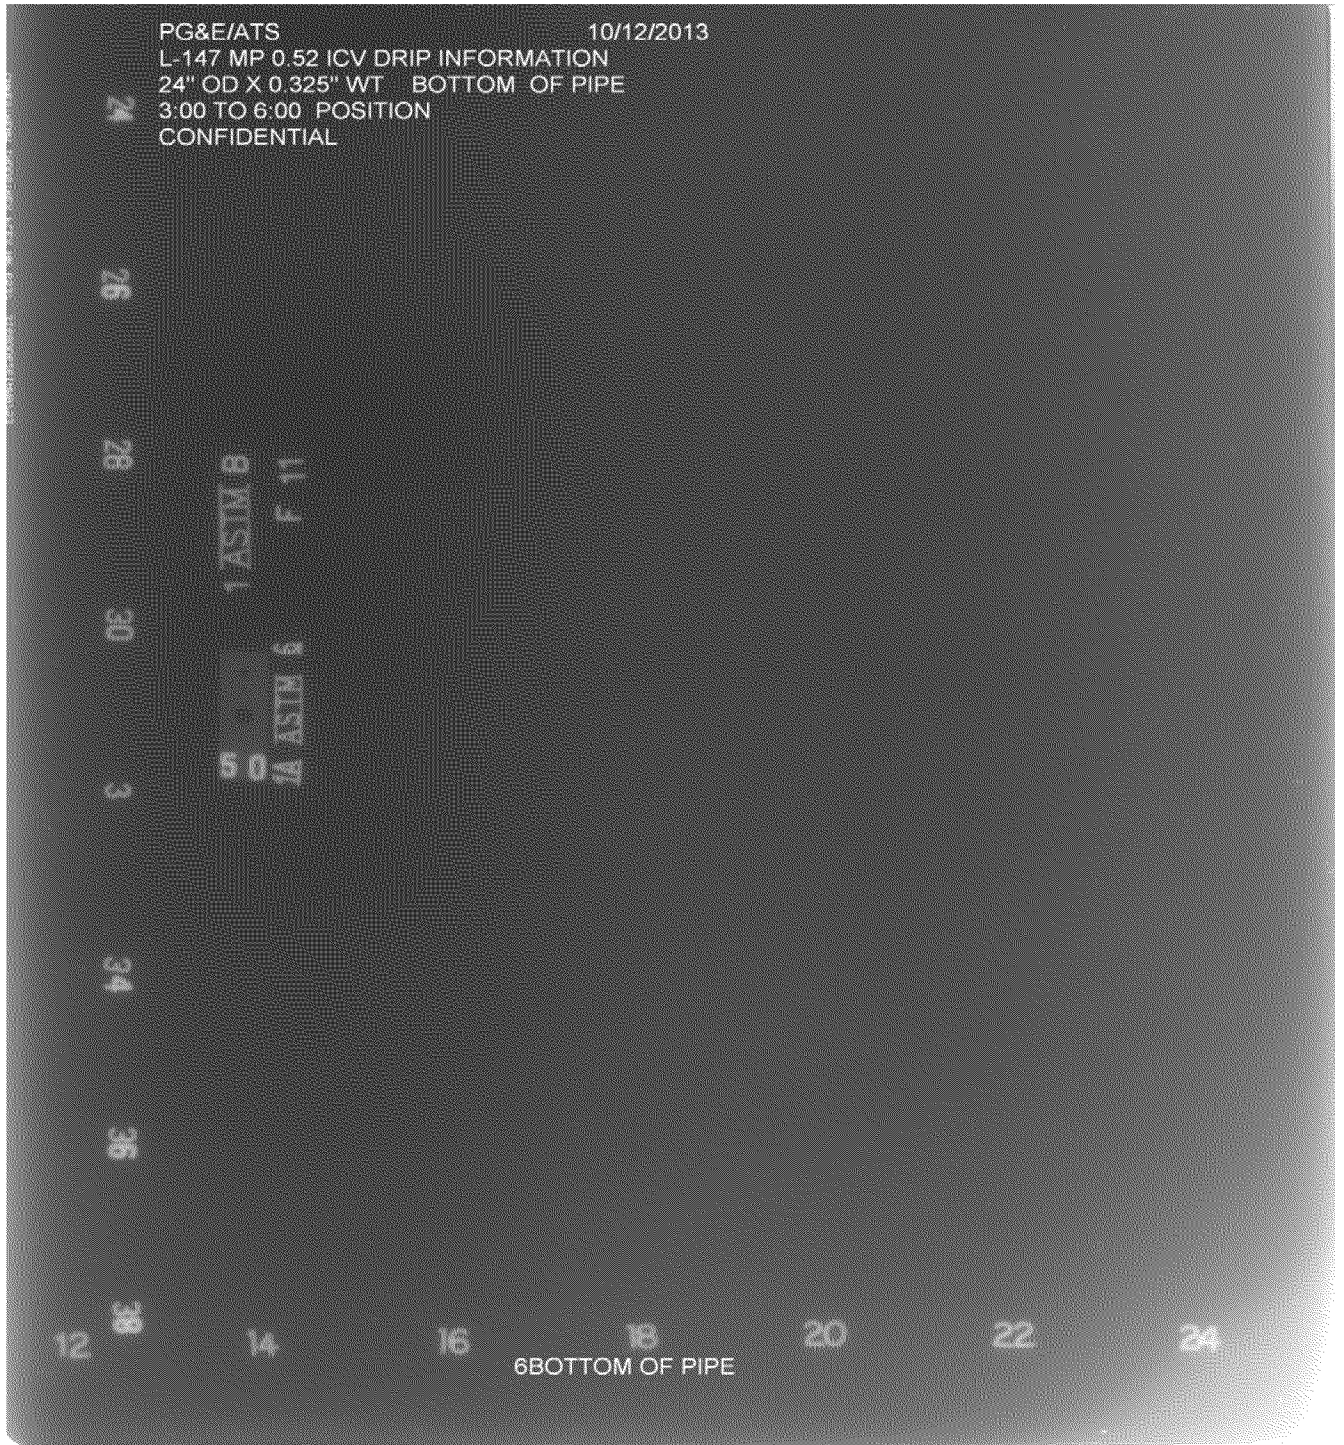
Main Line: ATS Radiographed from 3:00 to 9:00 the entire 8' exposed section of 24" pipe. No sign of internal corrosion, pitting, or debris were found. The 24" section of pipe has external corrosion cells on and around the reinforcement pad for the drip pot.

Radiograph of the 24" main line showing no internal corrosion

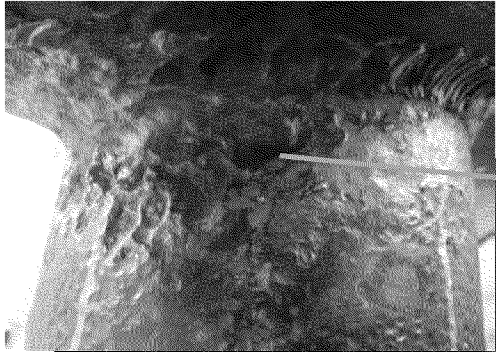
6" Drip Pot: ATS radiographed the drip pot and found it to be full of debris / sludge. Drip pot also has heavy external corrosion.

2" pipe between drip pot and valve: The 2" pipe is full of debris / sludge

Radiograph of the Drip Pot showing debris / sludge inside of the drip pot and 2" pipe between the drip pot and valve.

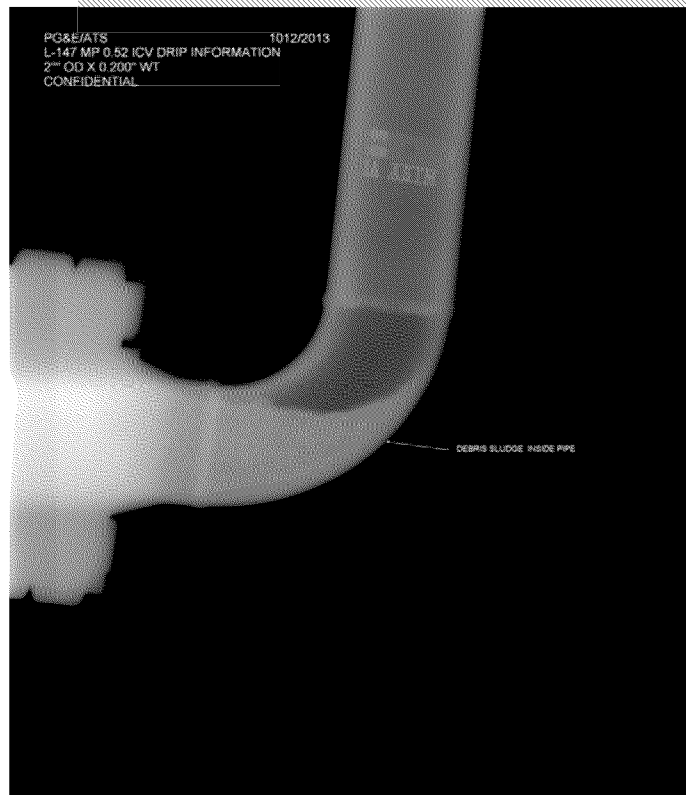
2" Elbow past valve and 2" pipe running vertical: The bottom elbow has debris / sludge that stops at the first girth weld running vertical. The vertical section of pipe has no debris / sludge. The top elbow has a small buildup of debris / sludge on the bottom.

Radiograph of the 2" piping past the vavle showing debris / sludge in the bottom 90 and a small amount of debris / sludge on the bottom of the upper 90

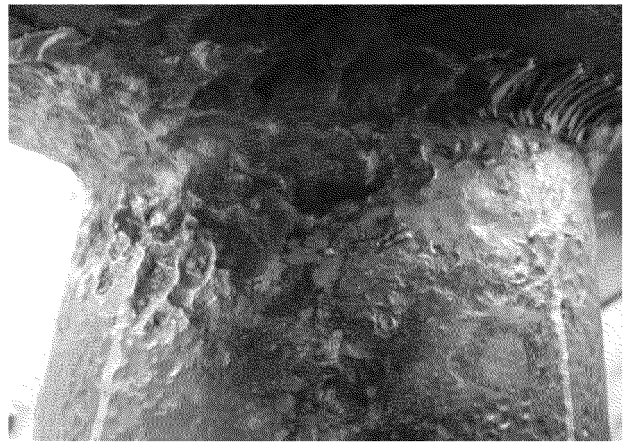
UT thickness survey of corrosion cell between the reinforcement pad and the drip pot using a pencil probe.

Position	UT reading	Remaining wall
7:00	0.162	42.14%
plus 1"	0.179	36.07%
8:00	0.216	22.85%
plus 1"	0.185	33.92%
9:00	0.160	42.85%
<hr/>		
Average wall thickness for the drip pot:		0.280

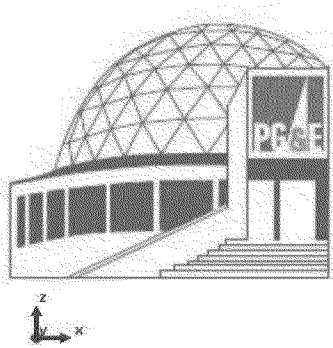
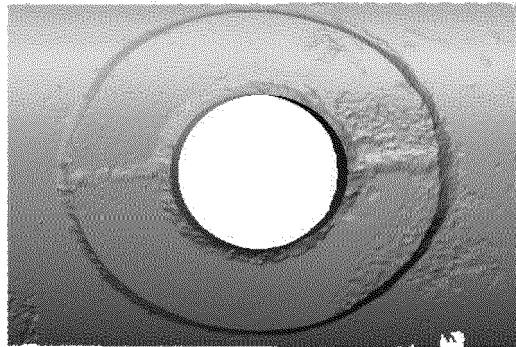
San carlos I-147 mp 0.52.stl

Over View of L-147 MP 0.52 drip pot and weld pad

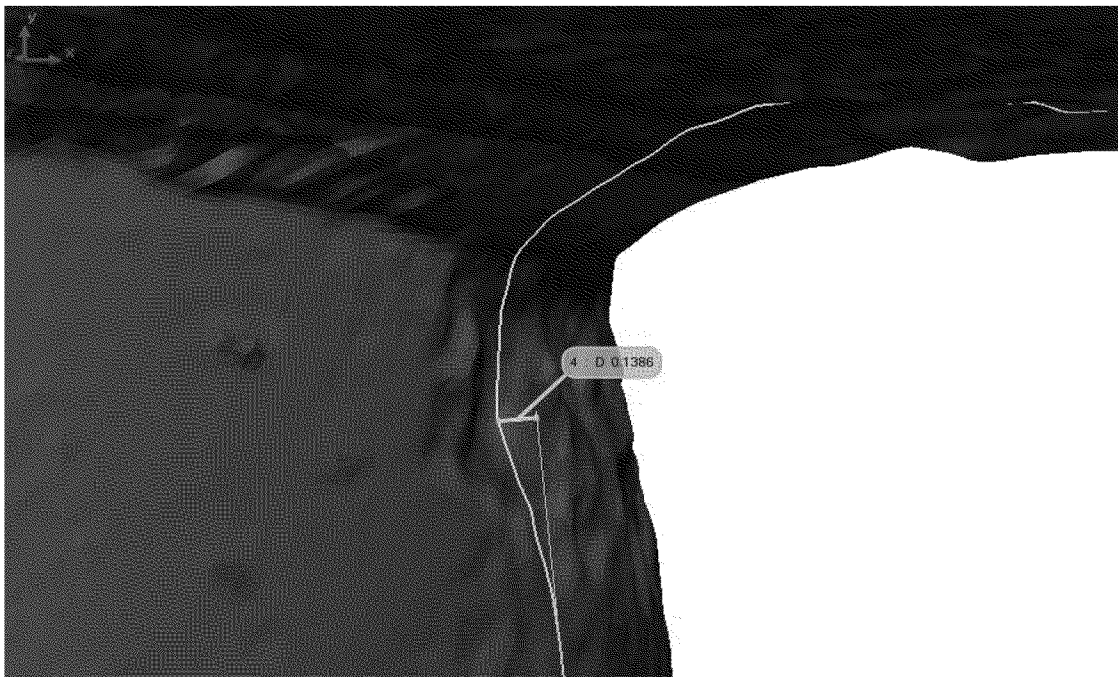
EC-3: Average Wall Thickness: 0.280", Min. 0.138" for 50.69% Wall Loss (Per Laser Scanner see attached Report) Impression Casting of the corroded weld (IC 3-3 area) which was difficult to obtain using multiple methods was: 4.00" width X 0.800" Long and approximately 0.150"-0.200" metal loss.

View of deepest corrosion pit

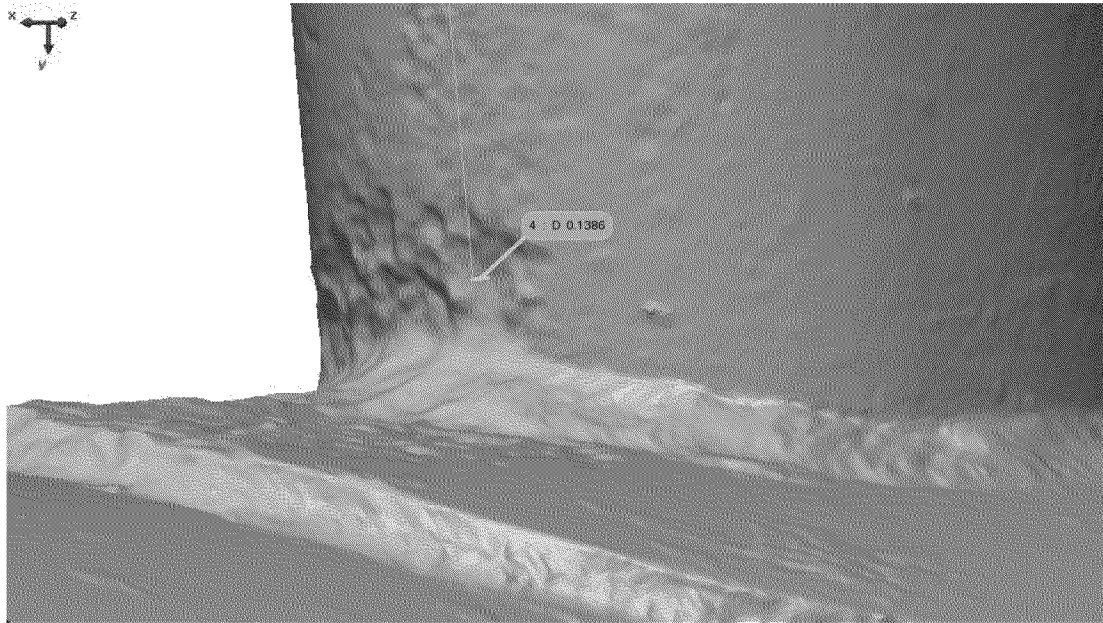
View of deepest corrosion pit, without color map
