**Form H: Direct Examination Data Sheet**  
**Event 72298 on L-147 @97+70 M-147**

Route Number/MP Examination Date	L-147 @97+70 M-147 11/4/2013	N-Segment	147	ILI Log Distance (ft.)	0.000 Feet
Exam Performed By	Redacted	IMA Number	N/A	RMP-11 Ref. Section	N/A
Project Manager		Region Number	1	Reference Girth Weld	N
Order Number	41976828	Sub # (ICDA)	N/A	Dist. From Girth Weld (ft.)	0.000 Feet
		Stationing	97+70

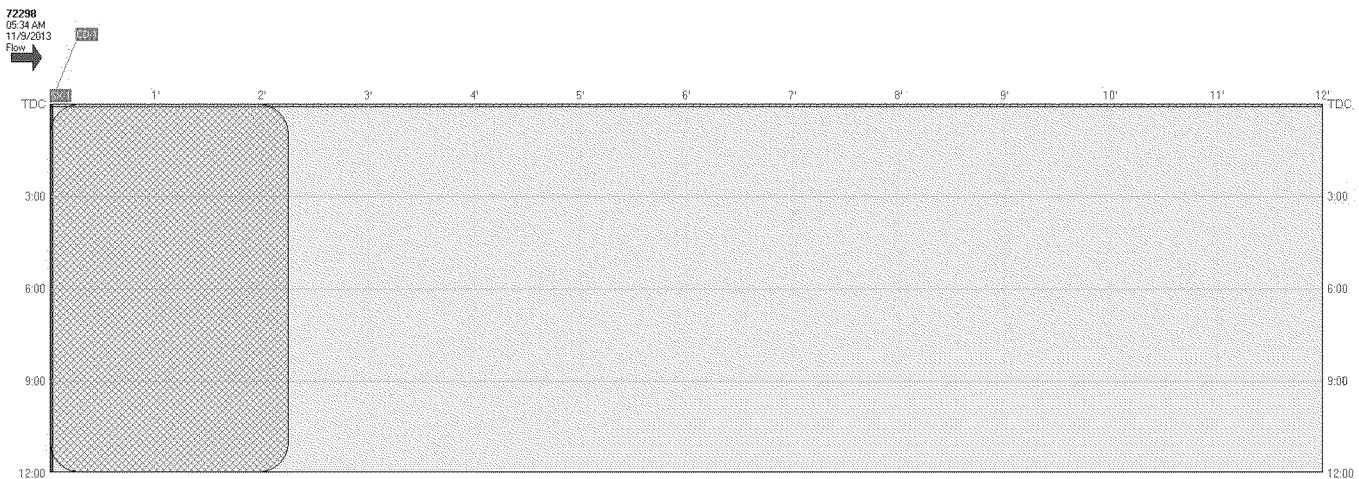
**Map of Coating Degradation**

Sample pH **0.000**  
 Coating Conditions **Fair - Coating Partially Disbonded or Degraded**  
 Coating Condition Comments **There were 2 types of existing coating found, HAA and Powercrete J. The HAA was in fair condition with one holiday noted in the report. The Powercrete J was in good condition with no holidays found.**  
 Coating Degradation Map **Upstream Edge of Coating** Photos Taken **Y**  
 Zero Reference Point **Removal**  
 Coating Sample Taken **Y** Location of Coating Sample **3:00, U/S edge of coating removal.**  
 Liquid Underneath Coating **N** If Yes, pH of Liquid **0.000**  
 Corrosion Product Present **N** If Yes, Corrosion Sample Taken **N**  
 Comments **No corrosion product present at the time of inspection.**  
 Soil pH (Sb Electrode) U/S **5.500** Soil pH (Sb Electrode) D/S **5.500**

ID	Axial Location (Inches from Ref.)	Circ. Location (Inches from TDC)	Damage Type	Length (Inches)	Width (Inches)	Description/Notes	Image Link
CD-001	0.00	0 12:00	Rock Impression	27.00	63.50	The rock impression extended from 0" to 27" D/S of reference, full circumference.

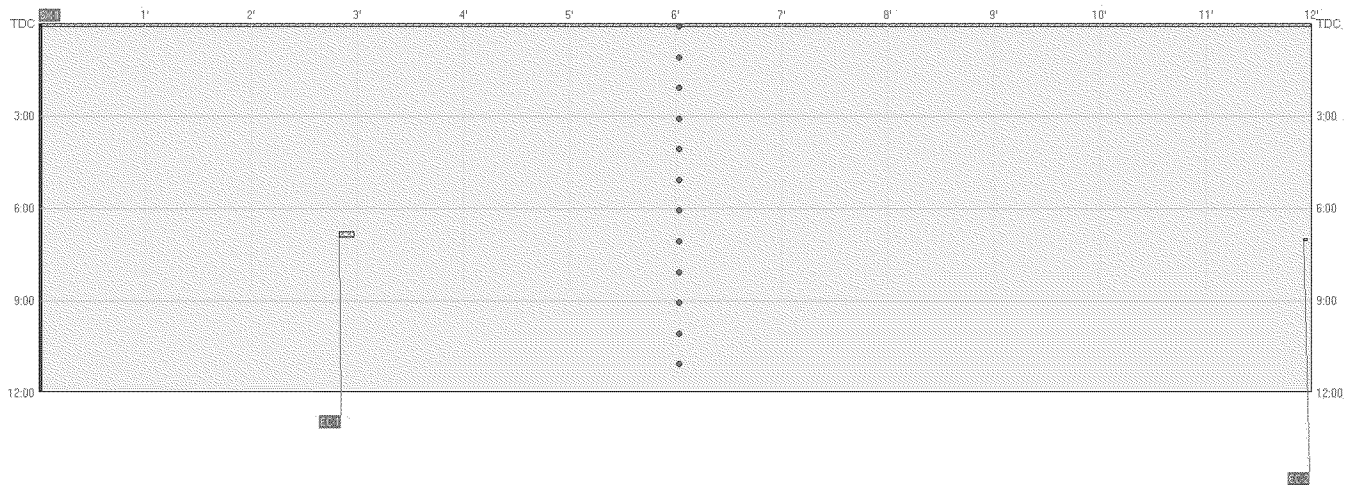
**Map of Corroded Area**

ID	Axial Location (Inches from Ref.)	Circ. Location (Inches from TDC)	Type	Length (Inches)	Width (Inches)	Max Depth (Inches)	Description/Notes	Image Link
EC-001	34.00	35.78 6:45	Localized	1.75	1.00	0.062	Maximum wall loss is 24.71%	
EC-002	143.00	37.04 7:00	Localized	0.50	0.50	0.036	Maximum wall loss is 13.432%

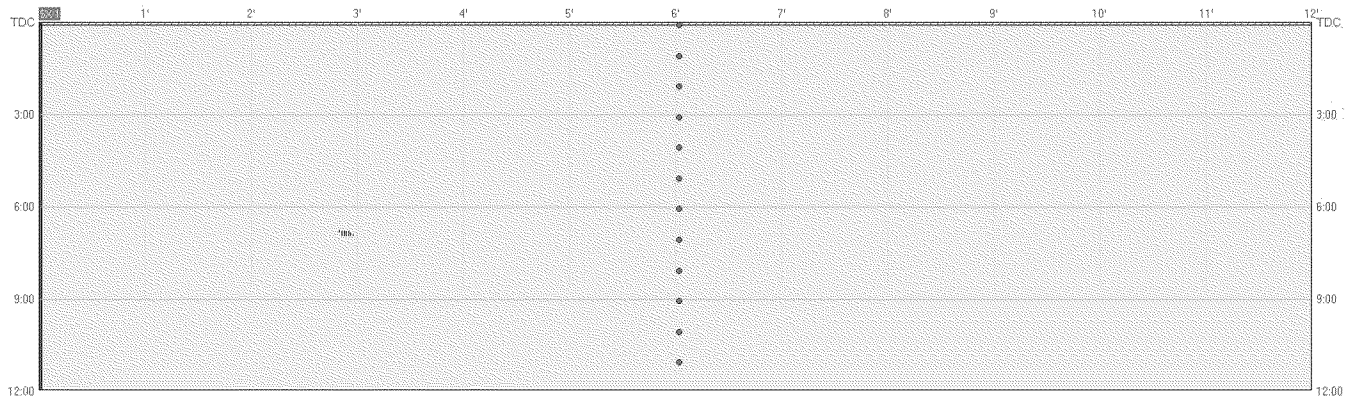
### External Pit Depth Measurement Grids

EC-001	From TDC	1	2	3	4	5	6	7
A	35.78	.013	-	-	-	-	-	-

B	36.03	.011	.010	.038	.023	.002	-	-
C	36.28	-	.021	.062	.014	.012	.001	-
D	36.53	-	.004	.028	.007	.001	.002	.001

EC-002	Explanation
Details Not Provided - Max Depth: 0.036	Maximum wall loss is 13.432%

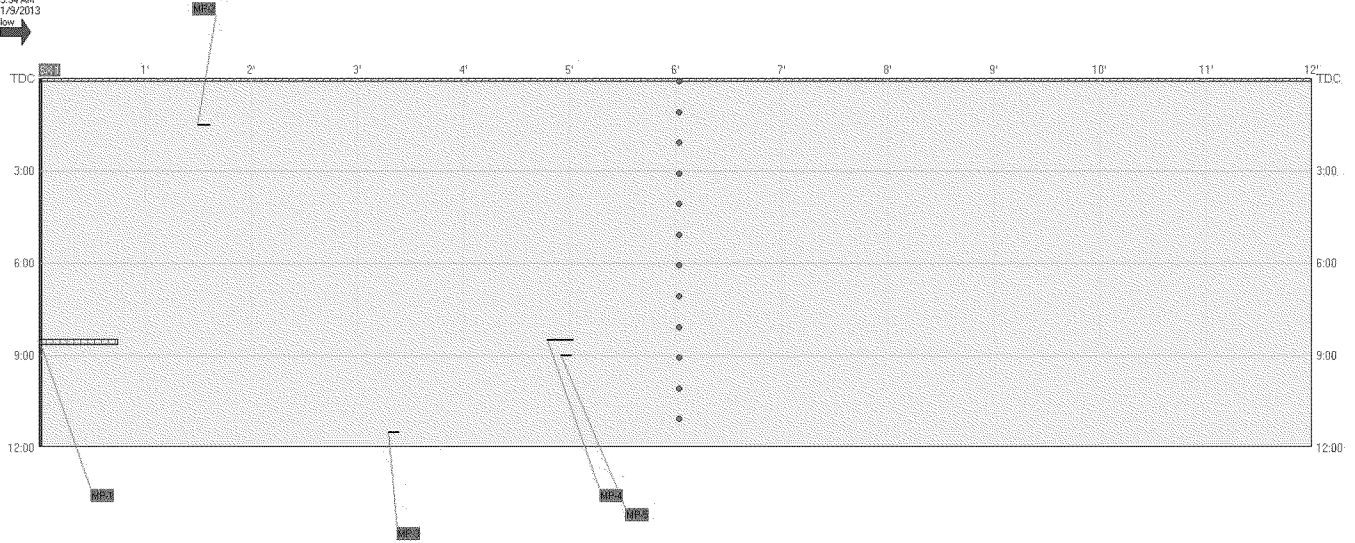
Ind. ID	Axial Location (Inches from Ref.)	Circ. Location (Inches from TDC)	Indication	Length (Inches)	Width (Inches)	Local Min. UTT (Inches)	Description/Notes	Image Link
MP-001	0.00	44.97 8:30	Singular	9.00	1.00	0.263	indication extends into existing coating. indication was removed up to existing coating.	
MP-002	18.00	7.93 1:30	Singular	1.50	0.25	0.260	indication was successfully removed	
MP-003	39.50	60.85 11:30	Singular	1.25	0.25	0.265	indication was successfully removed	
MP-004	57.50	44.97 8:30	Singular	3.00	0.25	0.251	indication was successfully removed	
MP-005	59.00	47.65 9:00	Singular	1.25	0.25	0.254	indication was successfully removed

Comments WFMT was performed on the 12' of exposed pipe, full circumference. 5 Linear Indications were found and noted in the report.

Repair Made	Y	Number of Repairs Made	5
Repair Type	Other	Damage Repaired	Other
Misc. Comments/Information	5 Linear Indications were removed via buffing.
