Pipe Characterization and Weld Assessment
San Carlos
Line 147
Mile Post 0.52

ATS Report #: 413.61-13.390

Gas Project: Internal Corrosion Verification

Line 147 Mile Point 0.52 San Carlos

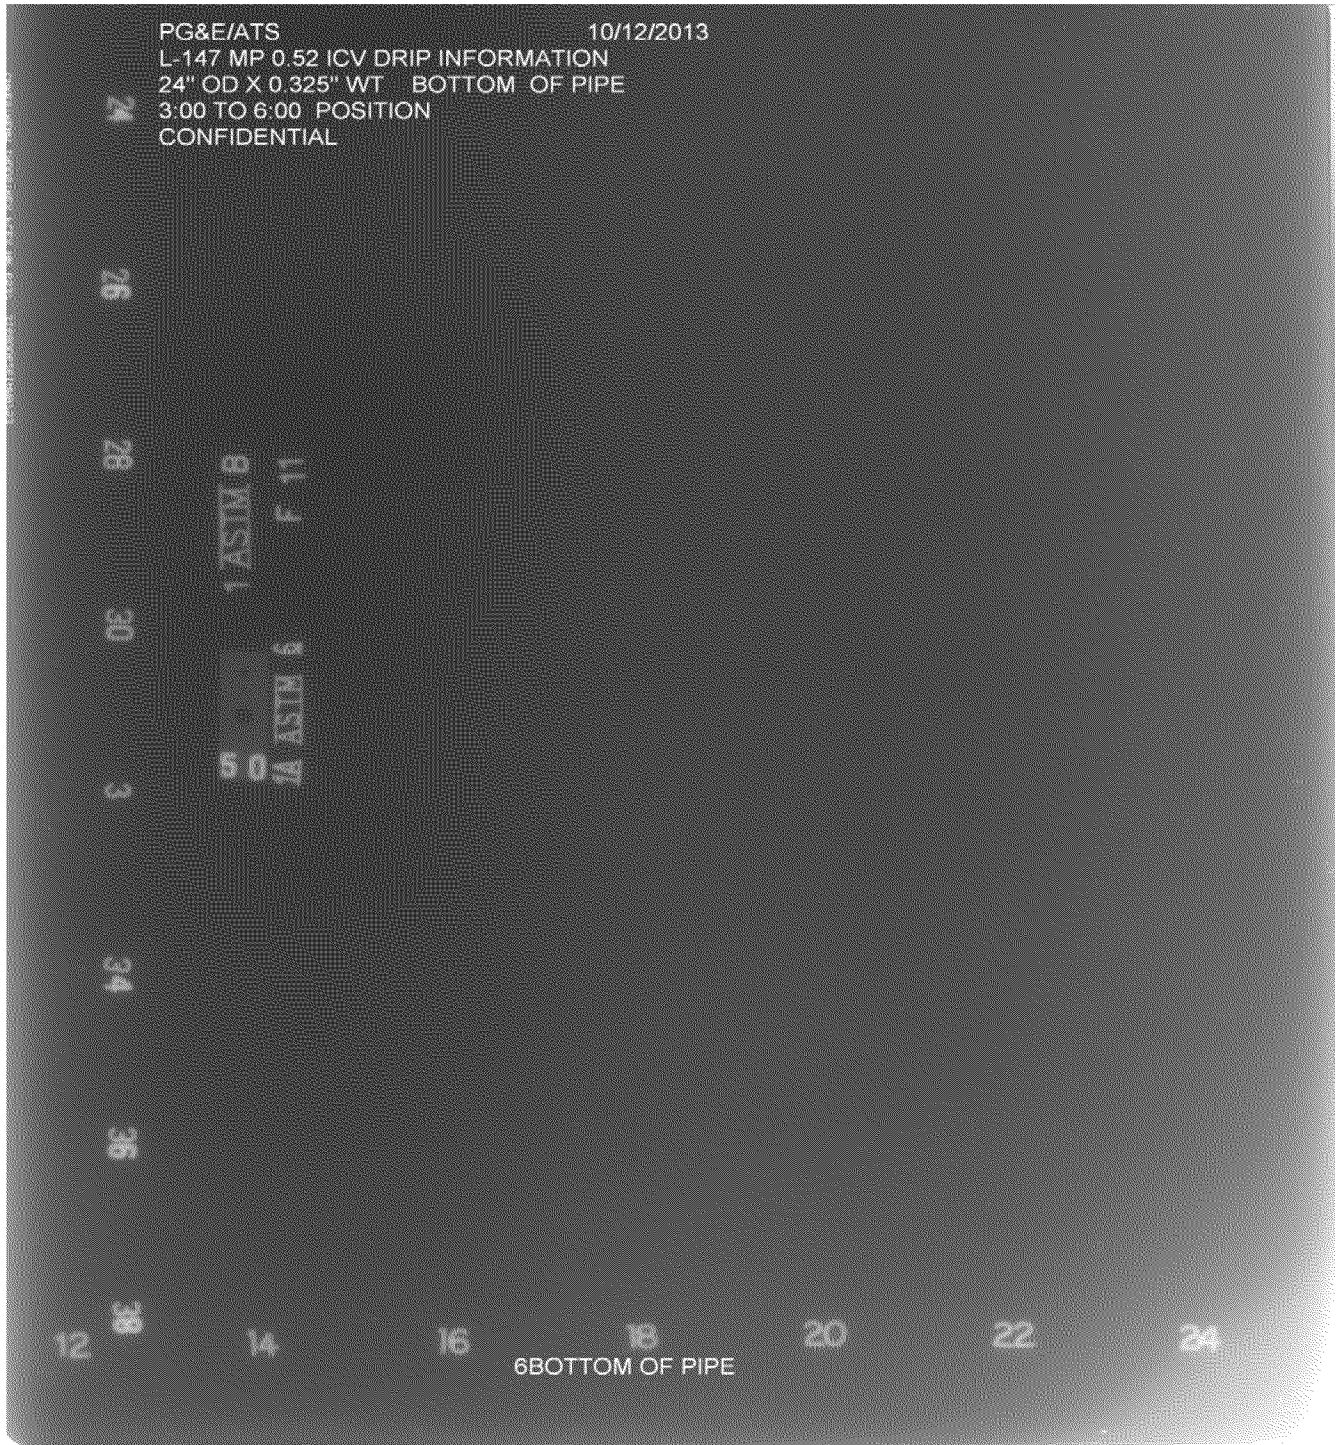
Main Line: ATS Radiographed from 3:00 to 9:00 the entire 8' exposed section of 24" pipe. No sign of internal corrosion, pitting, or debris were found. The 24" section of pipe has external corrosion cells on and around the reinforcement pad for the drip pot.

Radiograph of the 24" main line showing no internal corrosion

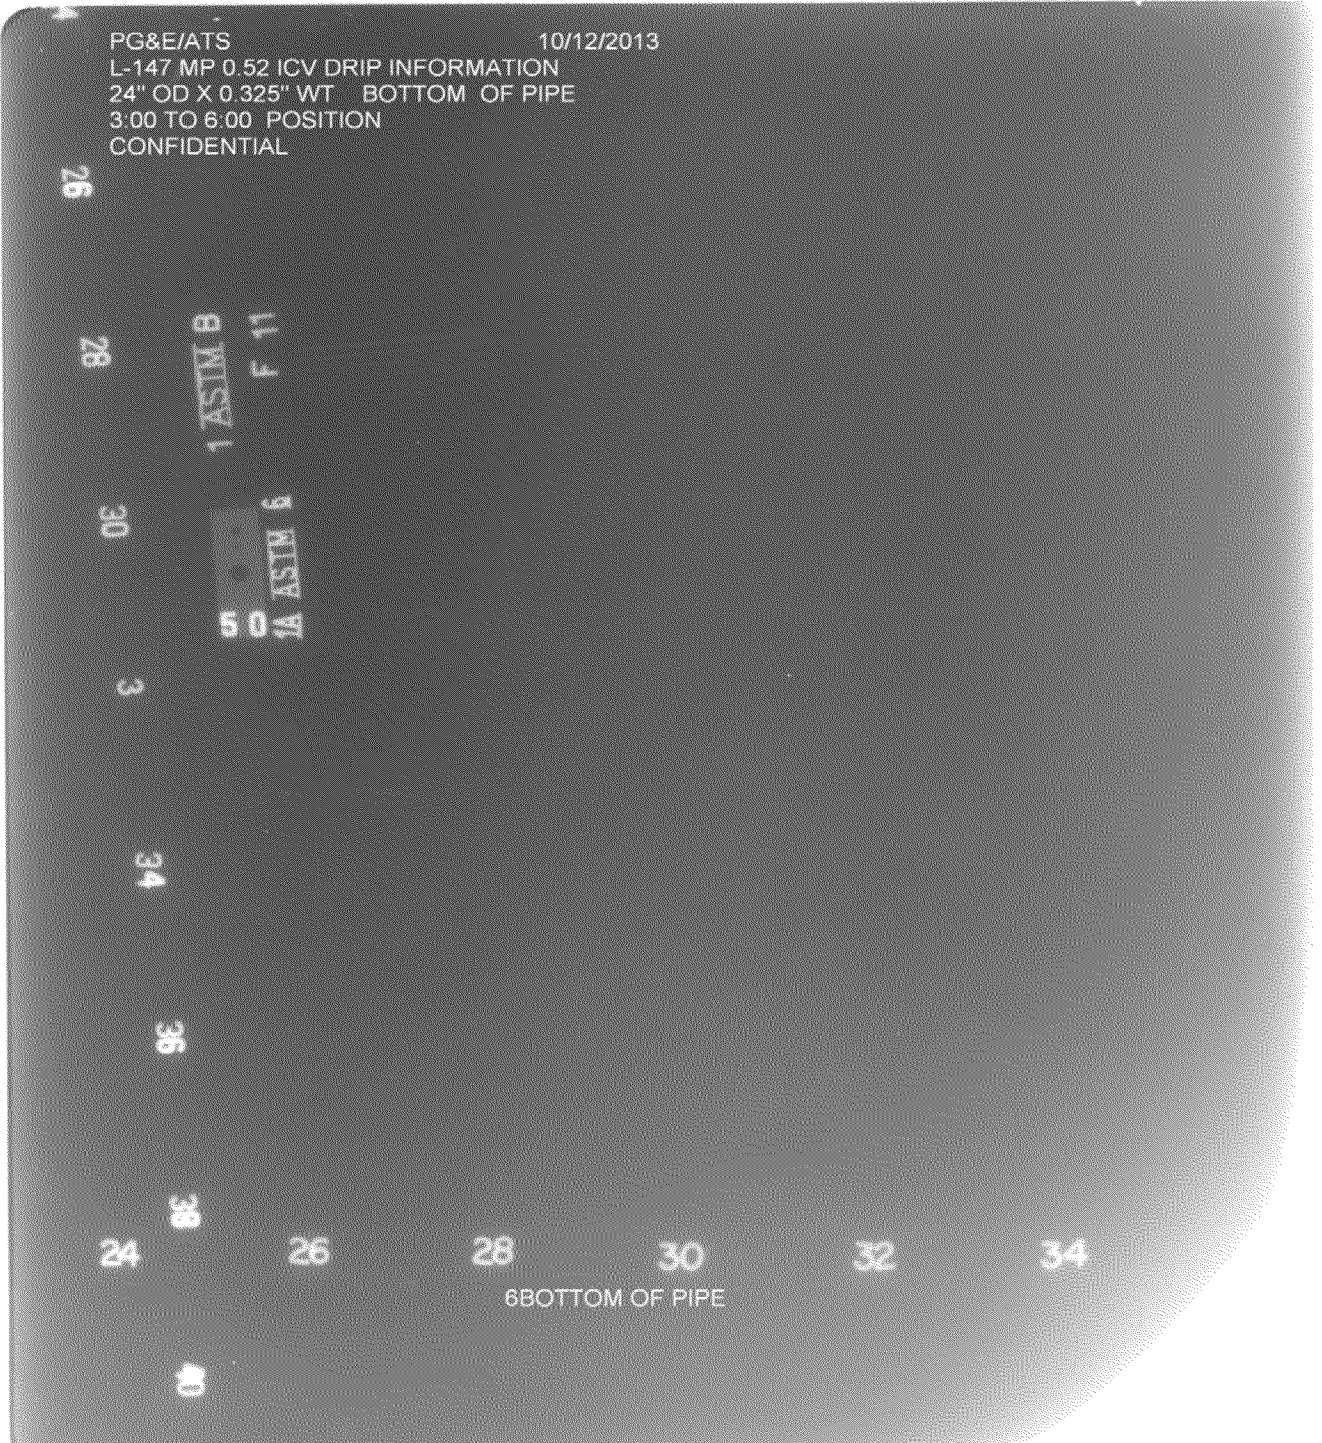
Radiograph of the 24" main line showing no internal corrosion

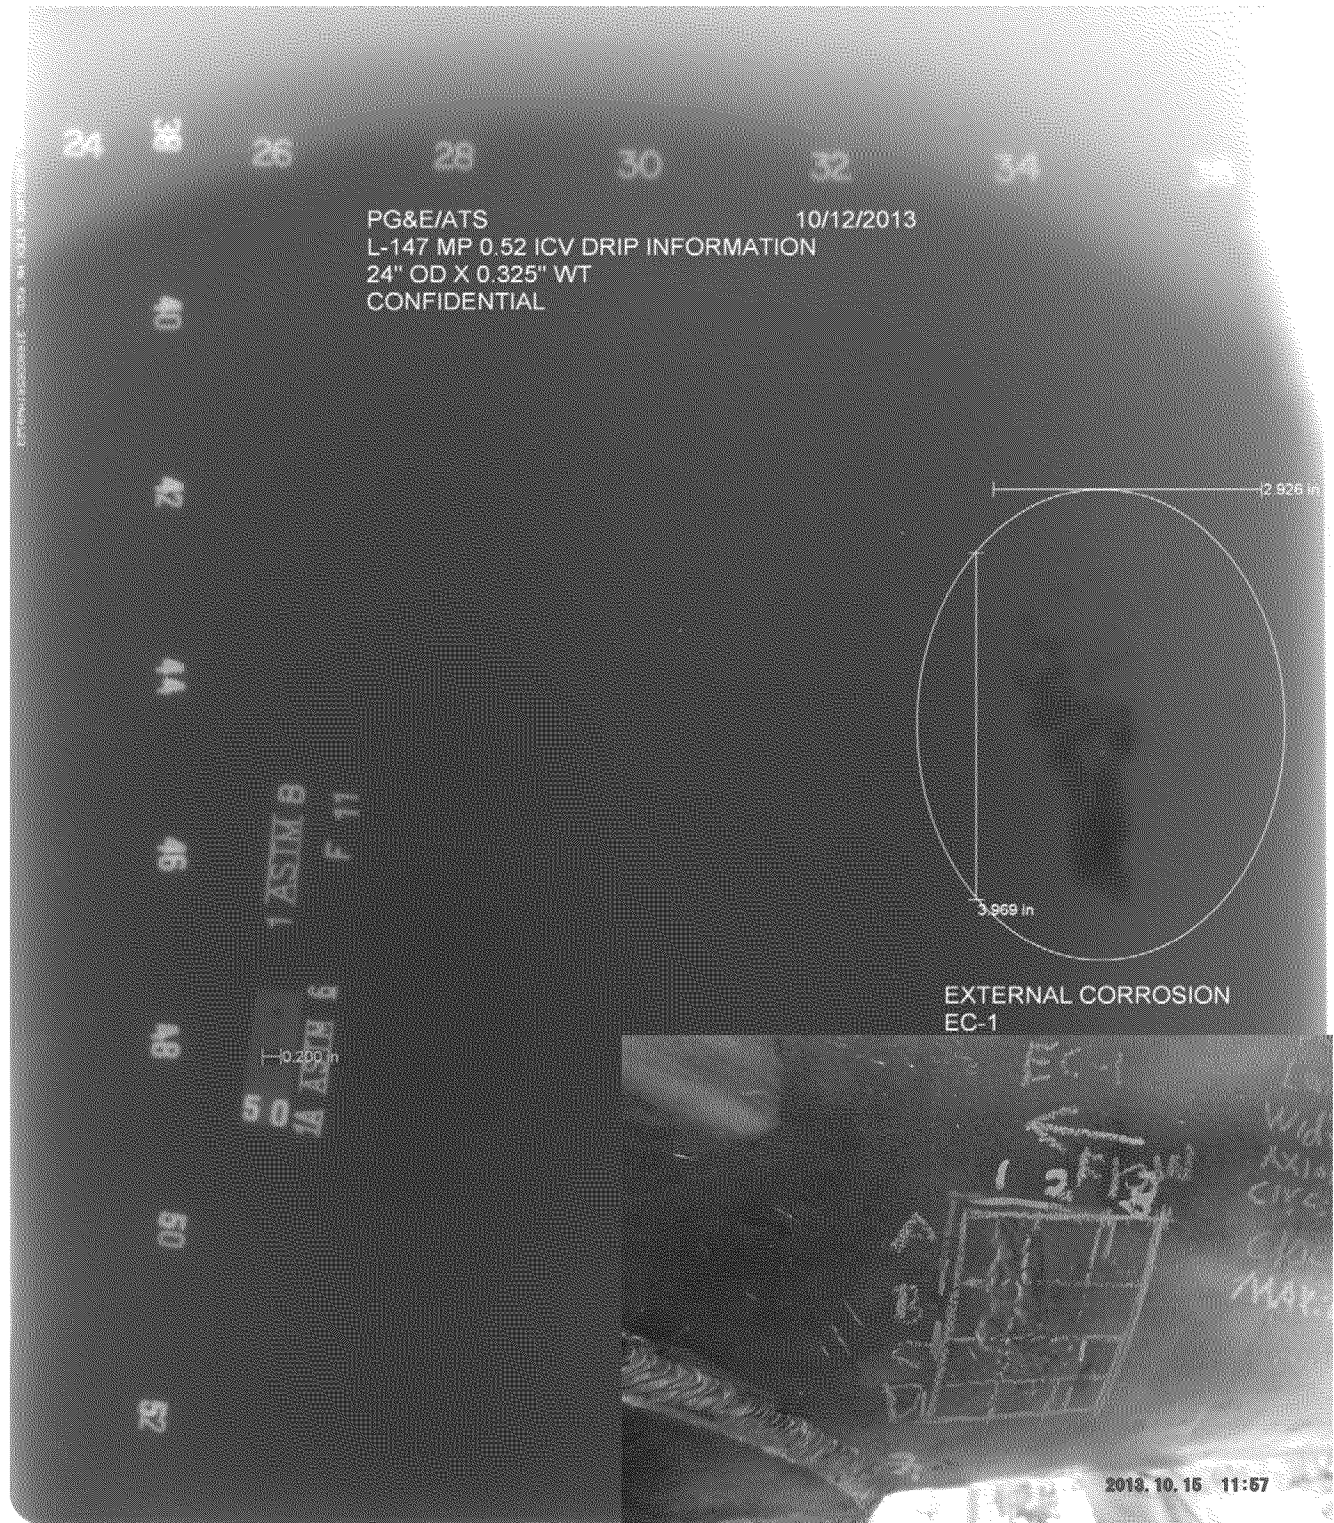
EC-1: Average Wall Thickness: 0.325", Min. 0.244" for 25% Wall Loss.

Radiograph of the 24" main line showing external corrosion cell (EC-1)

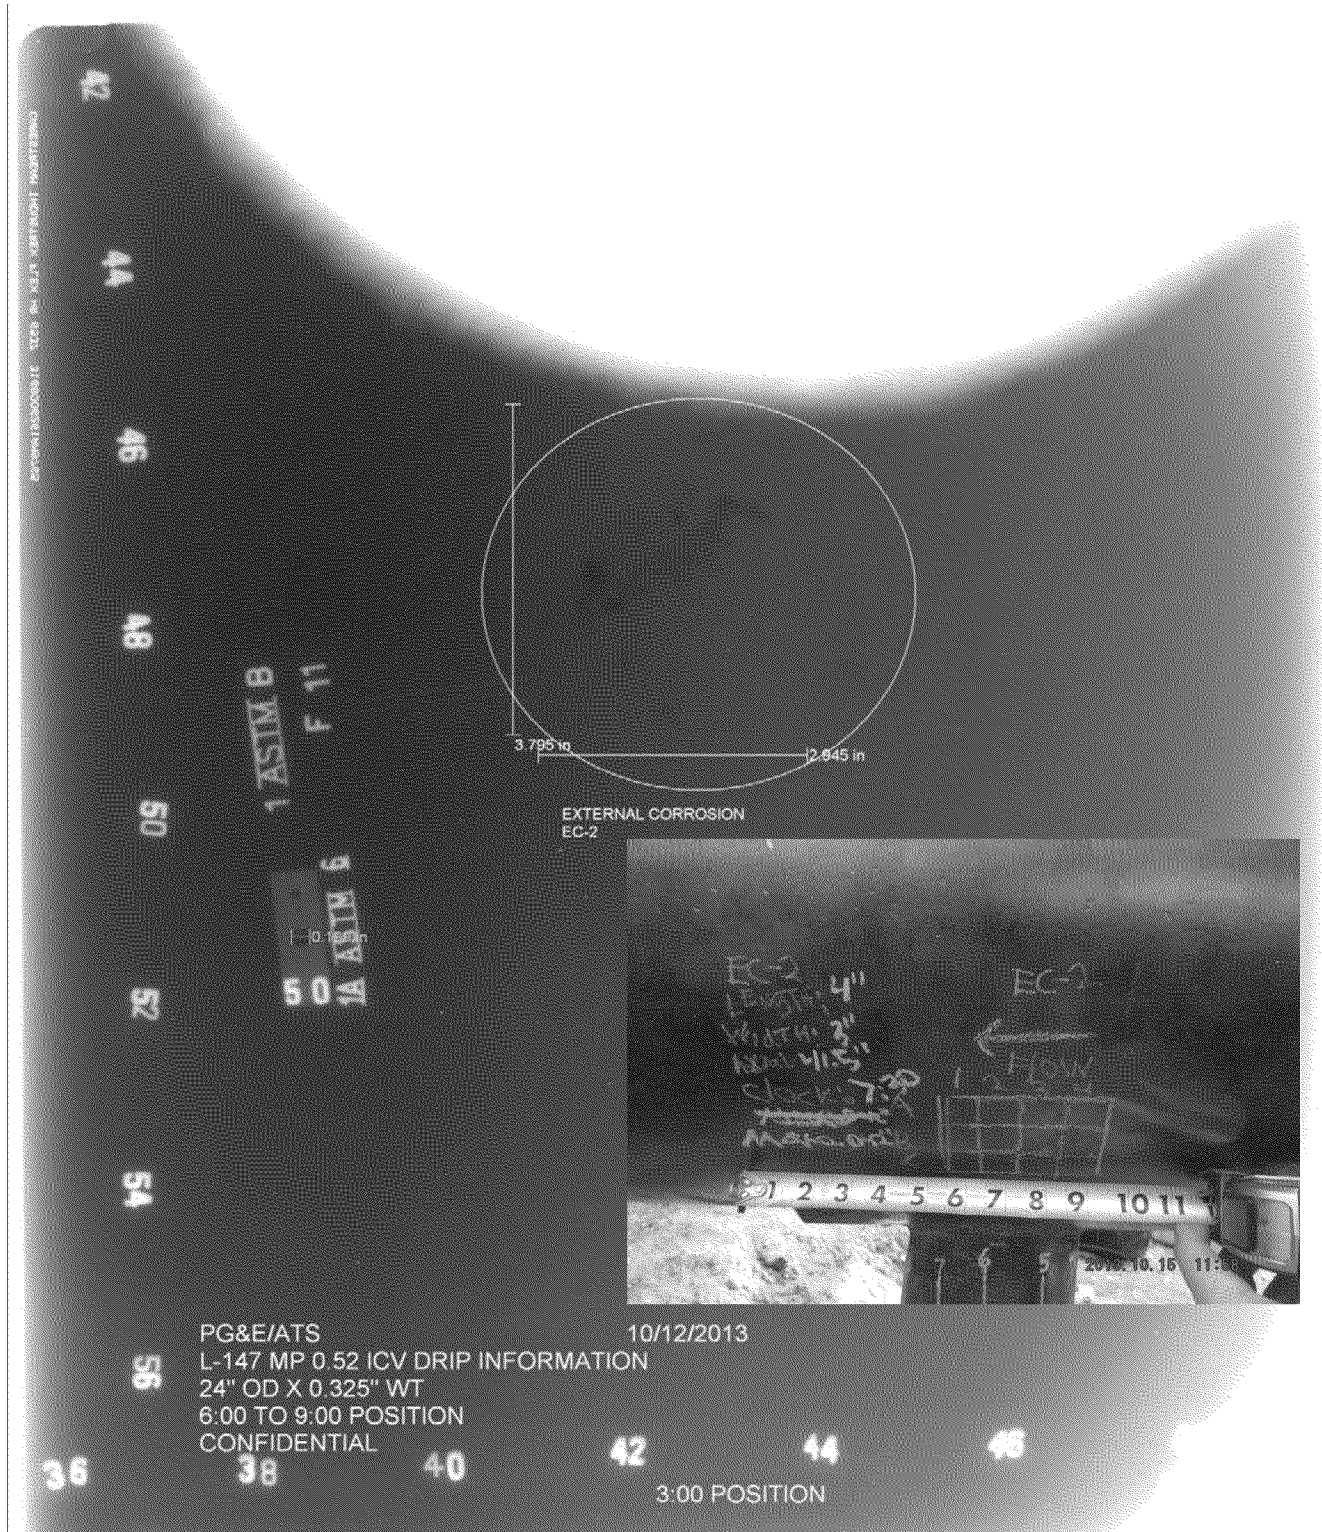
EC-2 : Average Wall Thickness: 0.325", Min. 0.283" for 13% Wall Loss.

Radiograph of the 24" main line showing external corrosion cell (EC-2)

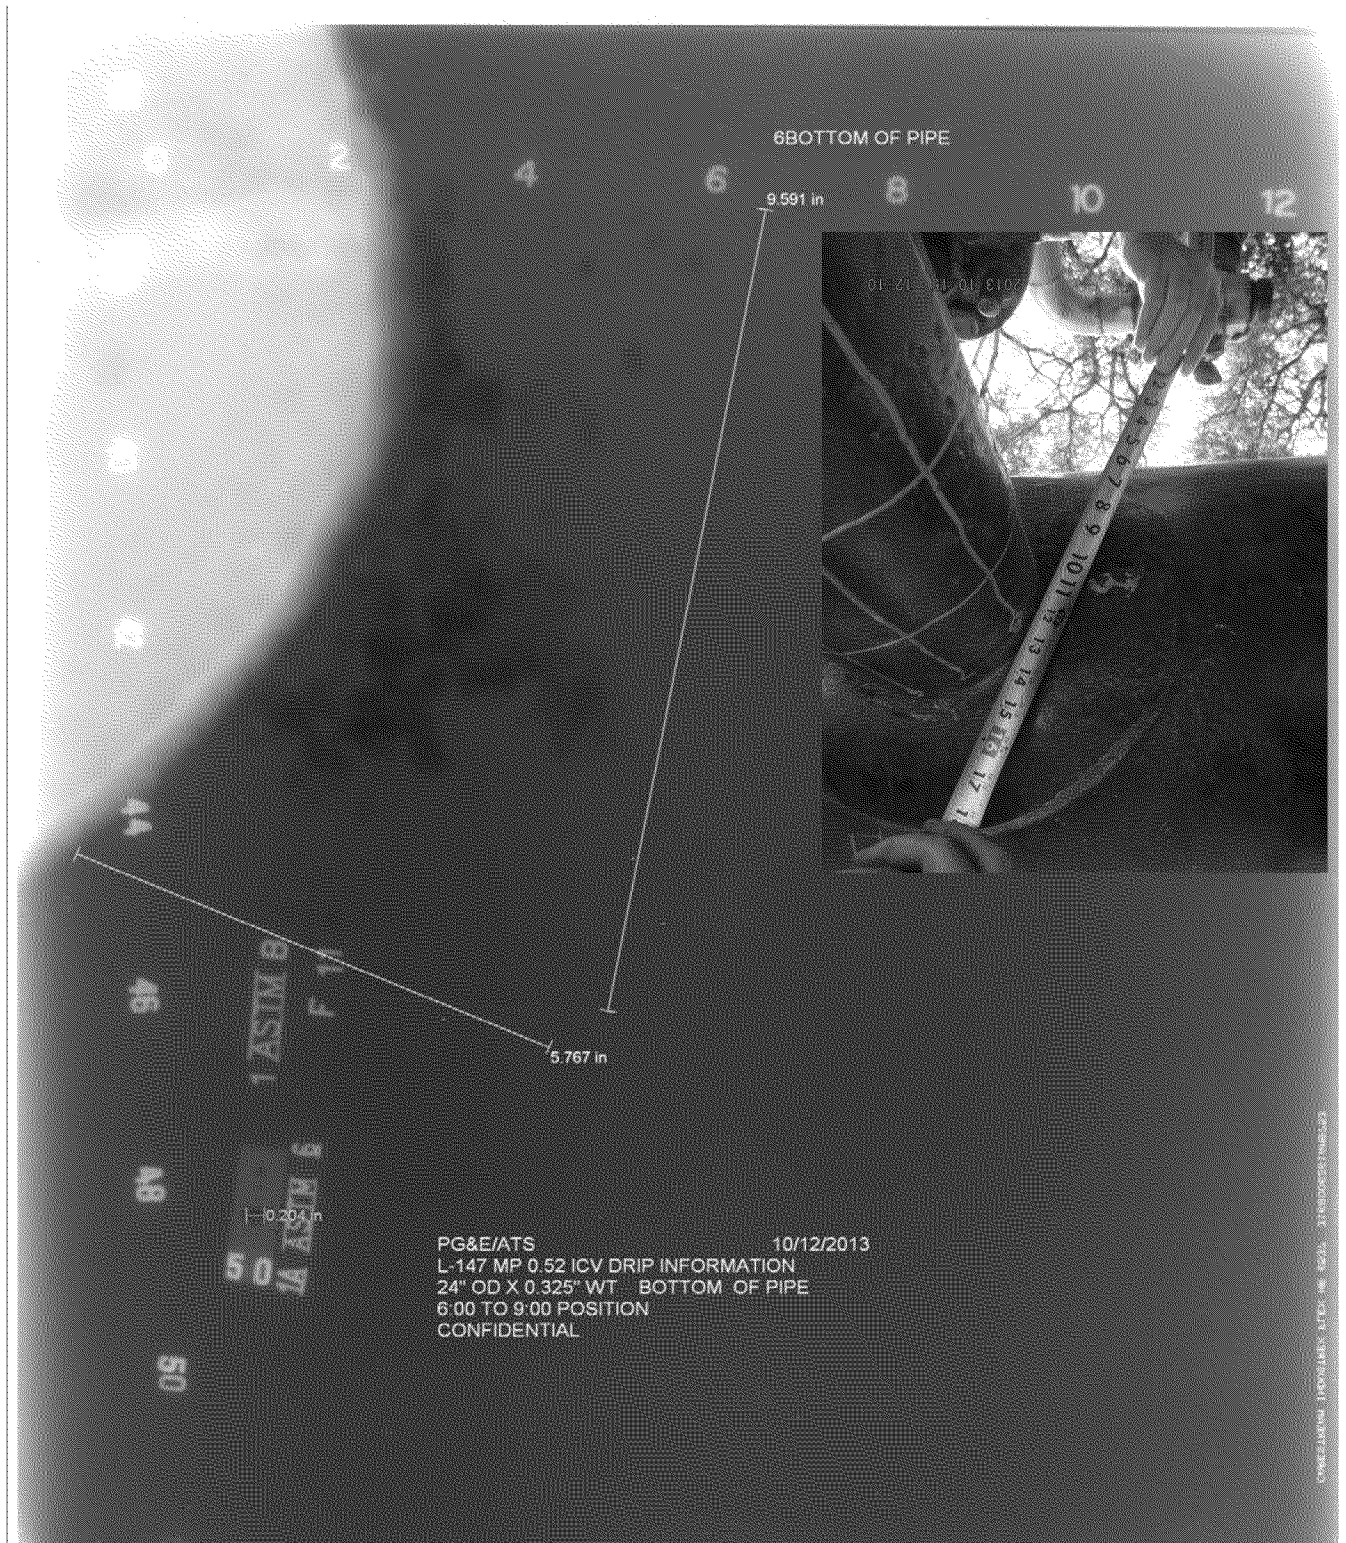
Radiograph of the 24" main line showing external corrosion cell (EC-3-1)

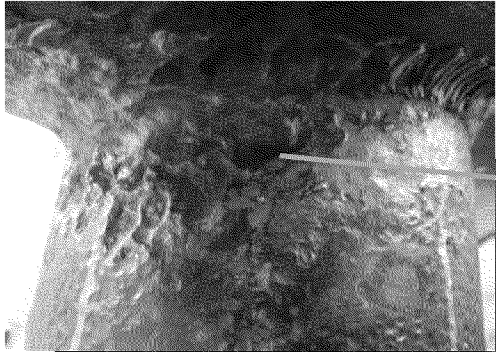
6" Drip Pot: ATS radiographed the drip pot and found it to be full of debris / sludge. Drip pot also has heavy external corrosion.

Radiograph of the Drip Pot showing debris / sludge inside of the drip pot and 2" pipe between the drip pot and valve.

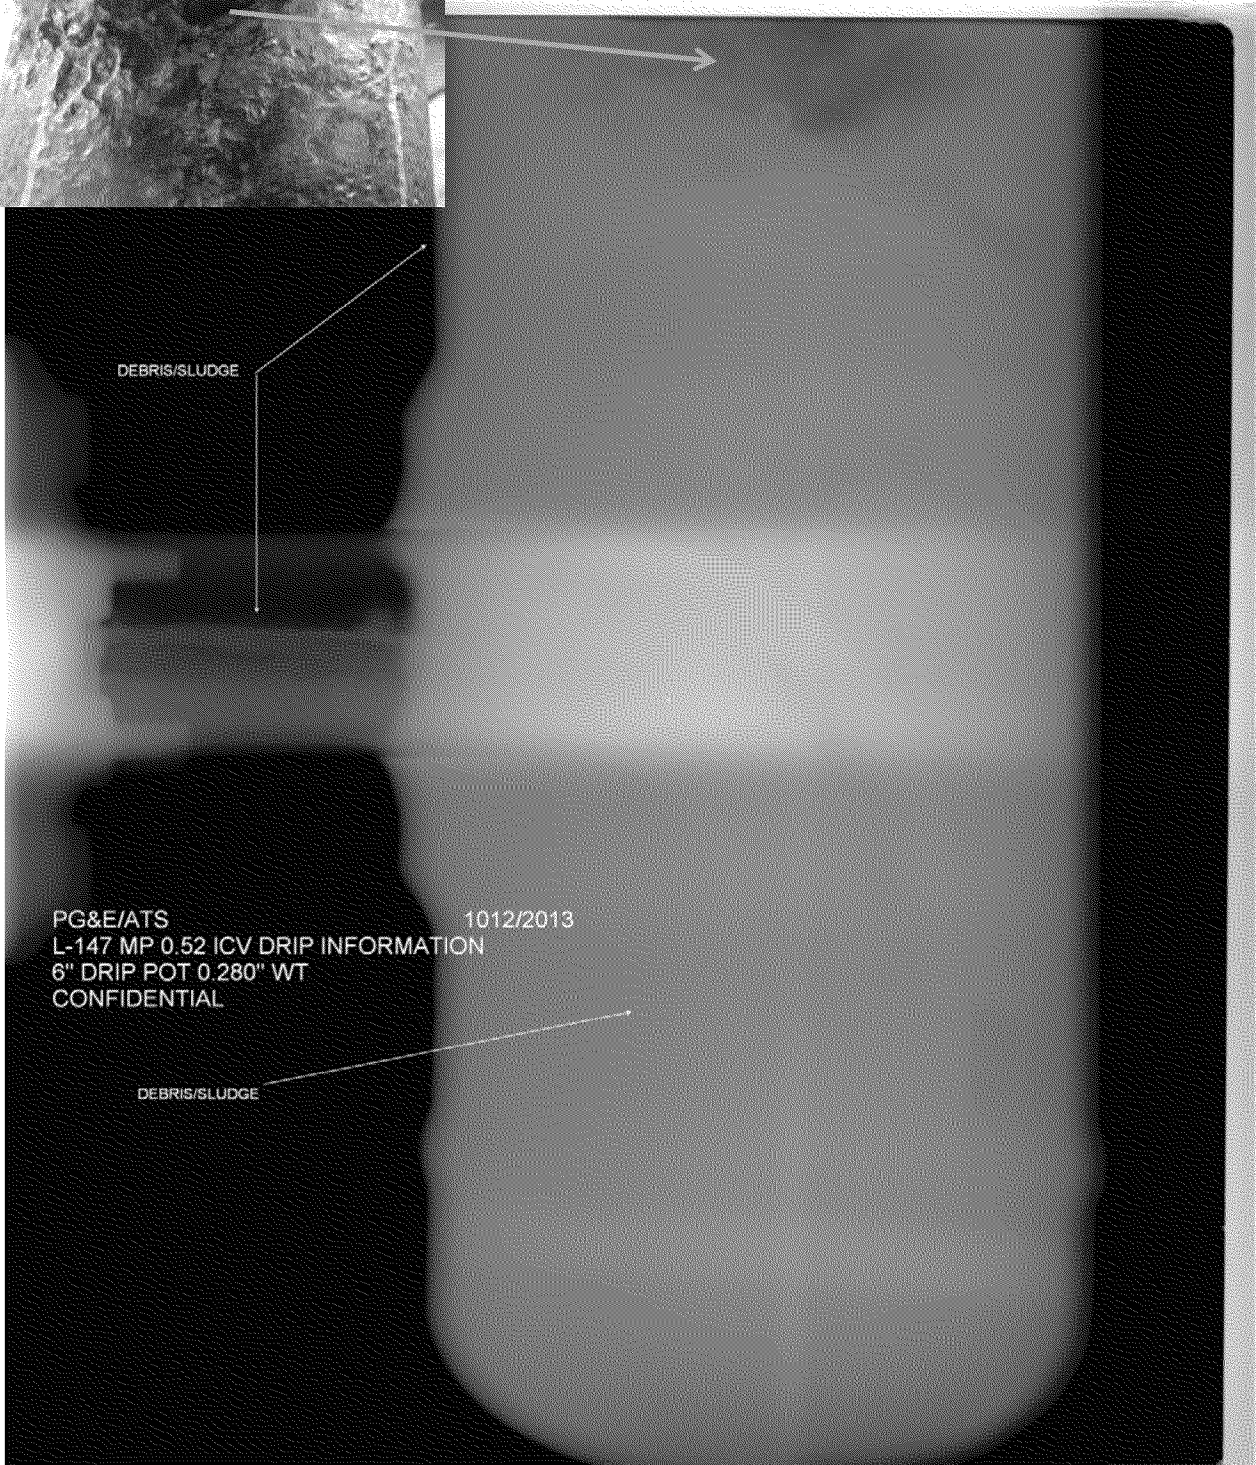
Picture showing the external corrosion

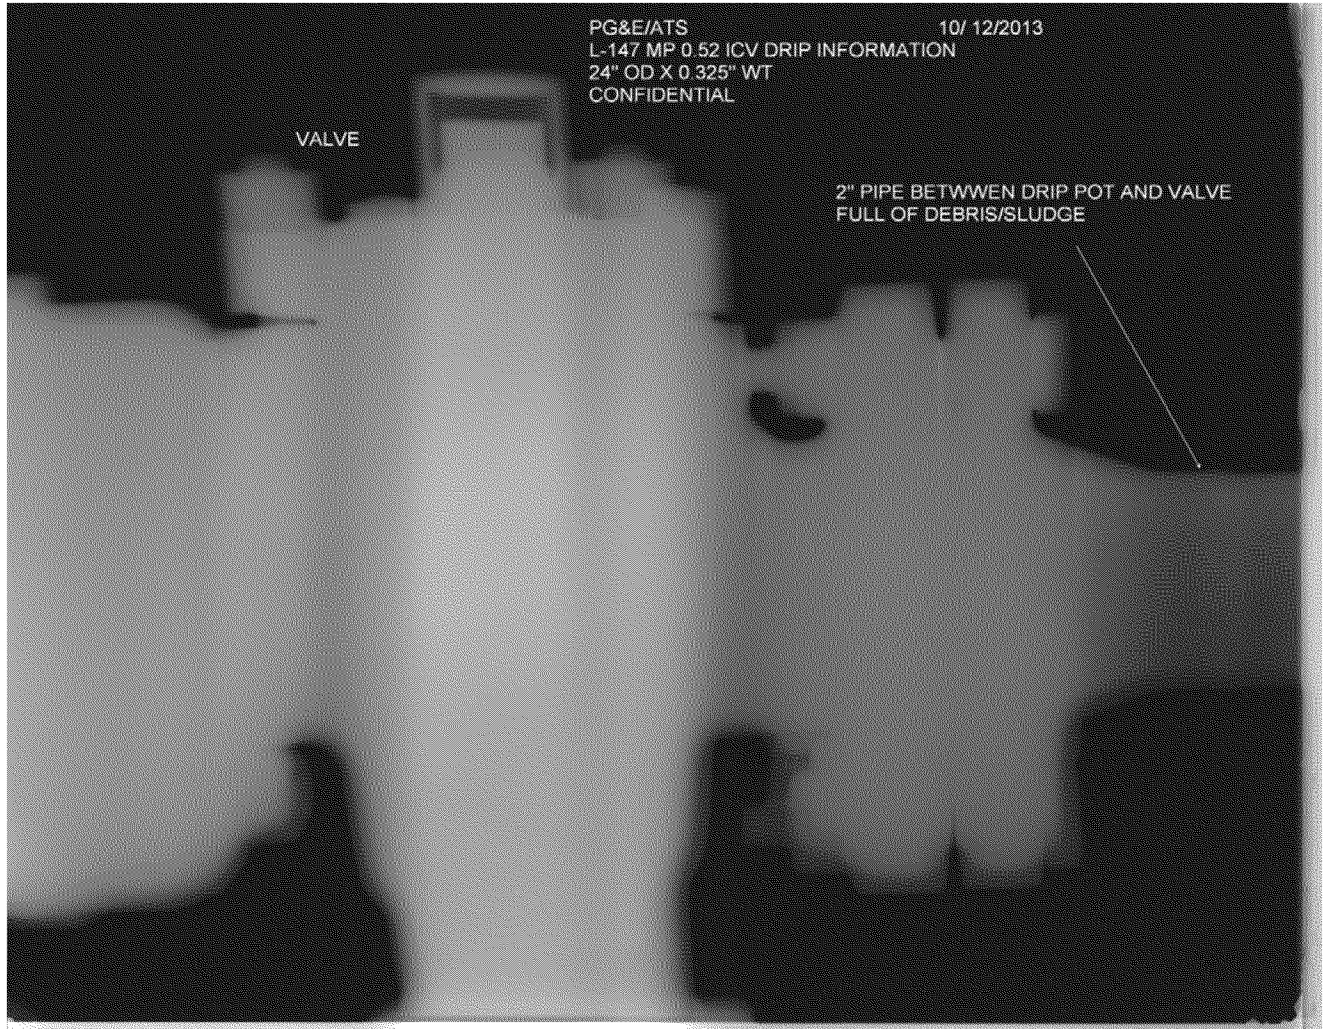
2" pipe between drip pot and valve: The 2" pipe is full of debris / sludge

Radiograph of the 2" pipe between the drip pot and valve in the 90° position

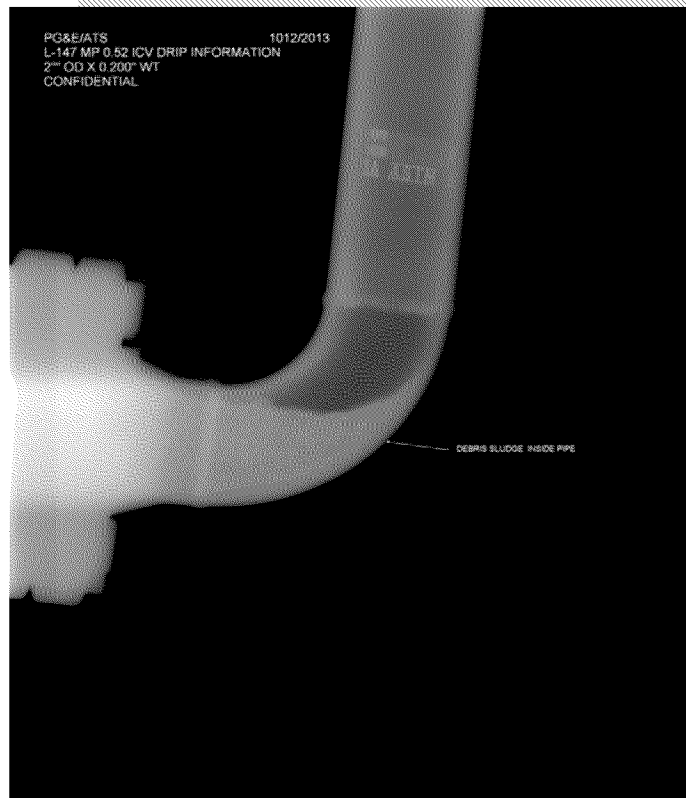
2" Elbow past valve and 2" pipe running vertical: The bottom elbow has debris / sludge that stops at the first girth weld running vertical. The vertical section of pipe has no debris / sludge. The top elbow has a small buildup of debris / sludge on the bottom.

Radiograph of the 2" piping past the vavle showing debris / slugde in the bottom 90 and a small amount of debris / sludge on the bottom of the upper 90

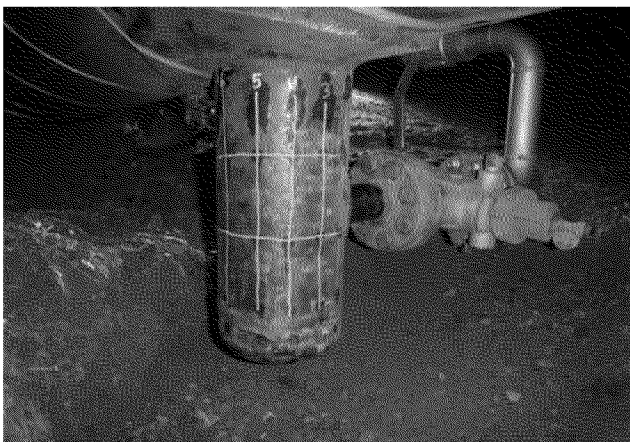
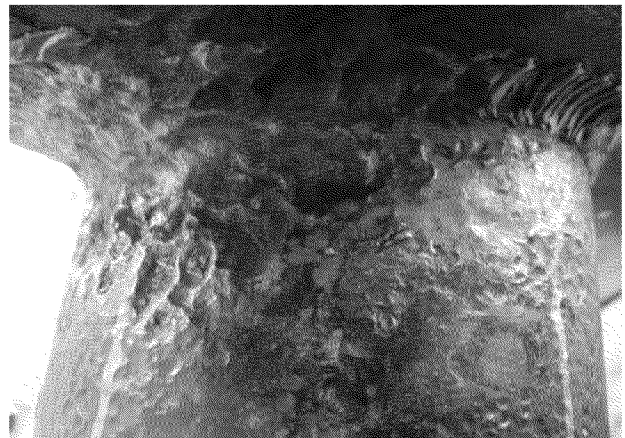
UT thickness survey of corrosion cell between the reinforcement pad and the drip pot using a pencil probe.

Position	UT reading	Remaining wall
7:00	0.162	42.14%
plus 1"	0.179	36.07%
8:00	0.216	22.85%
plus 1"	0.185	33.92%
9:00	0.160	42.85%
Average wall thickness for the drip pot:		0.280

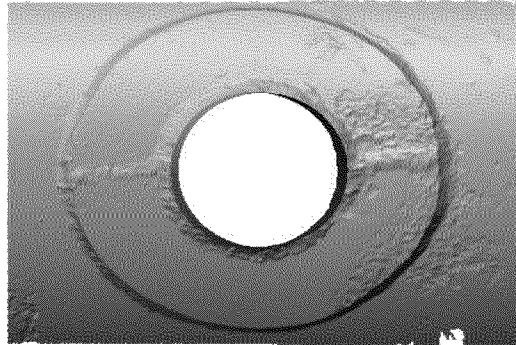
San carlos.l-147.mp.0.52.stl

Over View of L-147 MP 0.52 drip pot and weld pad

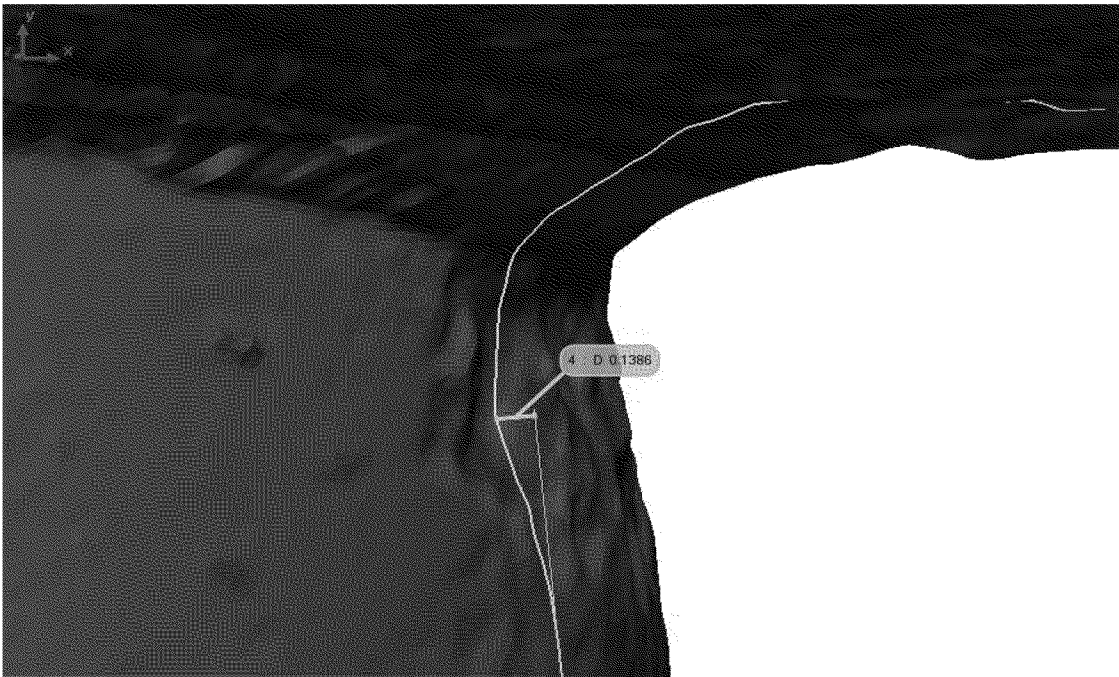
EC-3: Average Wall Thickness: 0.280", Min. 0.138" for 50.69% Wall Loss (Per Laser Scanner see attached Report) Impression Casting of the corroded weld (IC 3-3 area) which was difficult to obtain using multiple methods was: 4.00" width X 0.800" Long and approximately 0.150"-0.200" metal loss.

View of deepest corrosion pit

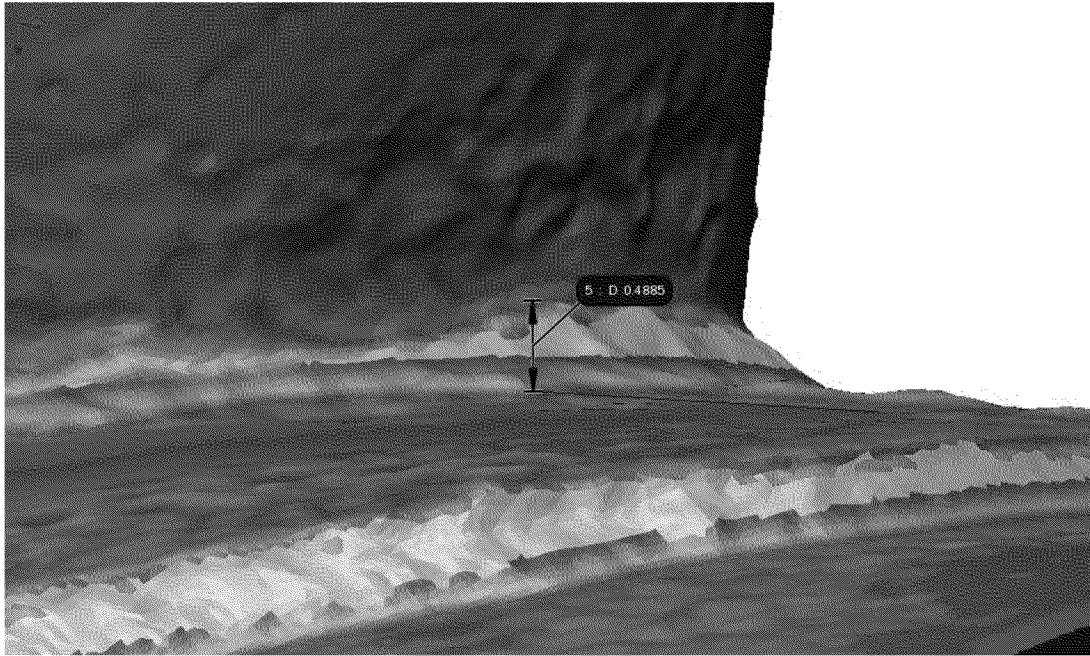
Estimated weld leg size

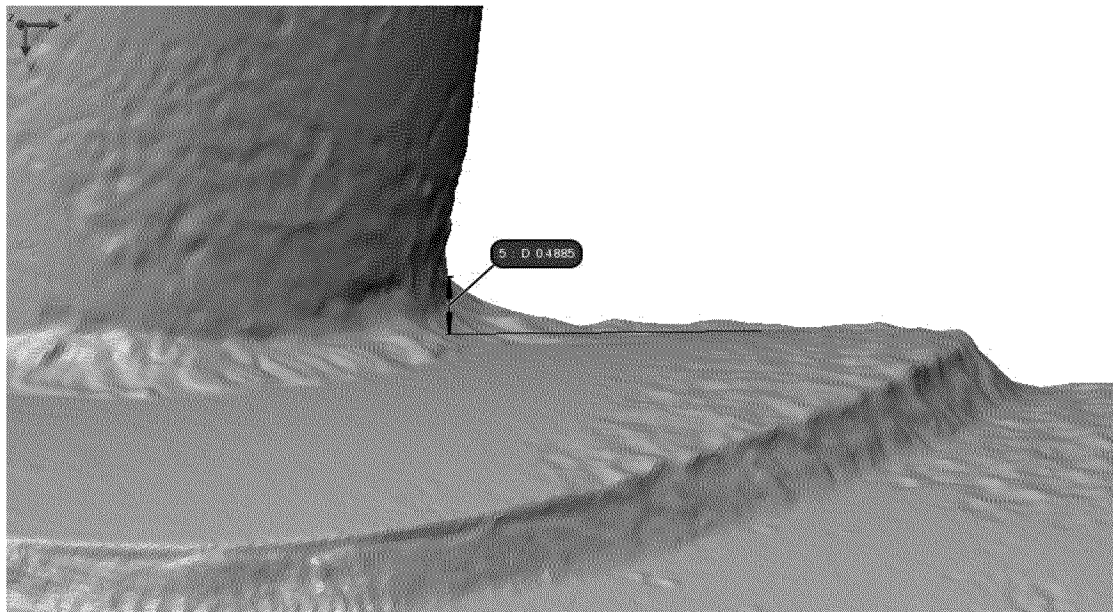
Estimated weld leg size, without color map

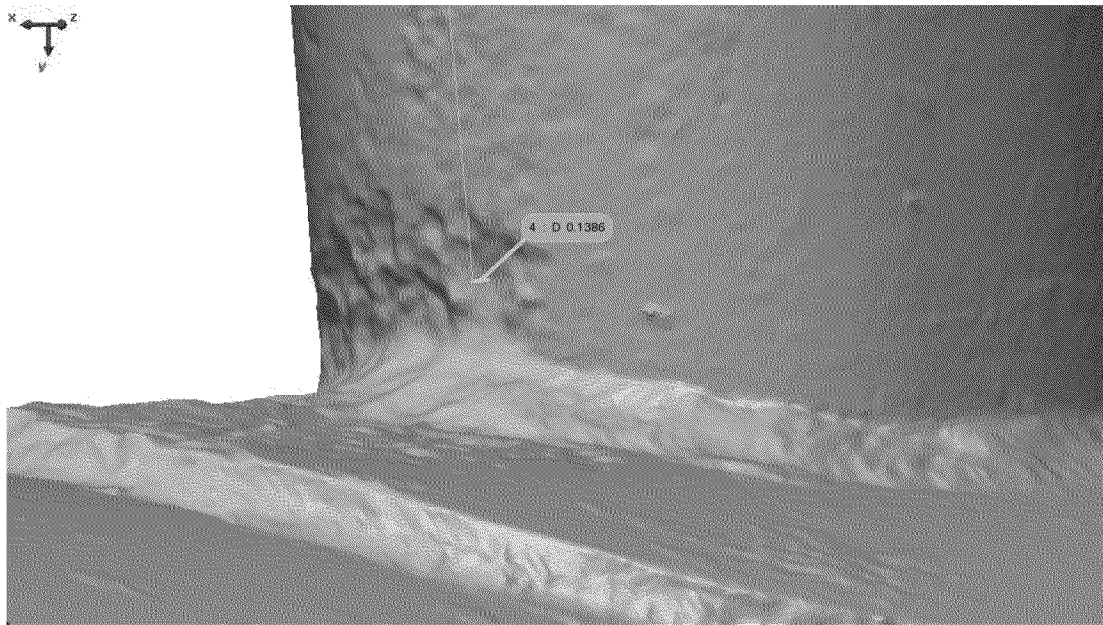
View of deepest corrosion pit, without color map

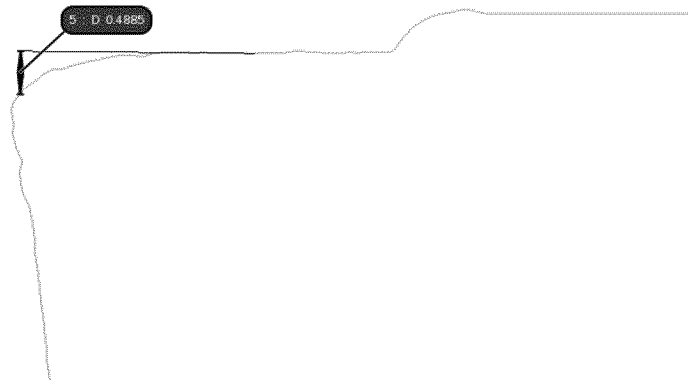
Cross-section view of estimated weld leg size

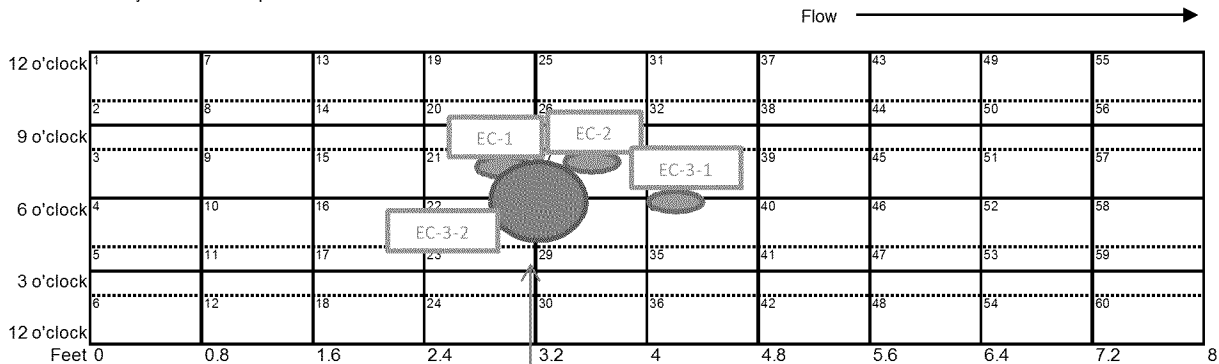
Drip Pot
 EC-3-2 is the entire circumference of the 6" Dia Drip Pot
