**Form H: Direct Examination Data Sheet**  
**Event 72298 on L-147 @97+70 M-147**

Route Number/MP	L-147 @97+70 M-147	N-Segment	147	ILI Log Distance (ft.)	0.000 Feet
Examination Date	11/4/2013	IMA Number	N/A	RMP-11 Ref. Section	N/A
Exam Performed By	Redacted	Region Number	1	Reference Girth Weld	N
Project Manager		Sub # (ICDA)	N/A	Dist. From Girth Weld (ft.)	0.000 Feet
Order Number	41976828	Stationing	97+70

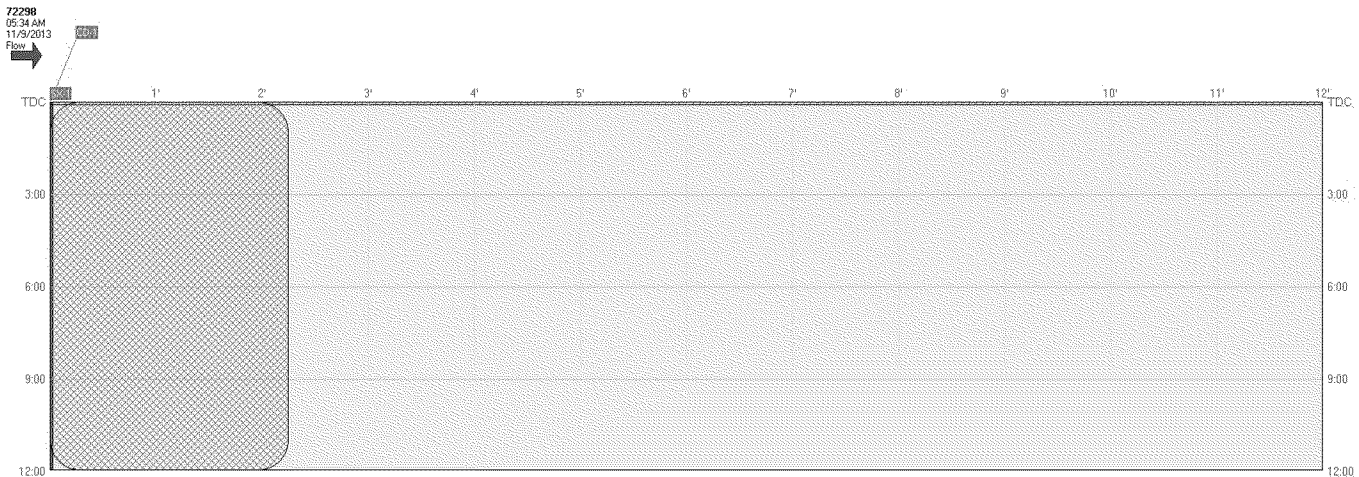
**Map of Coating Degradation**

Sample pH **0.000**  
 Coating Conditions **Fair - Coating Partially Disbonded or Degraded**  
 Coating Condition Comments **There were 2 types of existing coating found, HAA and Powercrete J. The HAA was in fair condition with one holiday noted in the report. The Powercrete J was in good condition with no holidays found.**  
 Coating Degradation Map **Upstream Edge of Coating** Photos Taken **Y**  
 Zero Reference Point **Removal**  
 Coating Sample Taken **Y** Location of Coating Sample **3:00, U/S edge of coating removal.**  
 Liquid Underneath Coating **N** If Yes, pH of Liquid **0.000**  
 Corrosion Product Present **N** If Yes, Corrosion Sample Taken **N**  
 Comments **No corrosion product present at the time of inspection.**  
 Soil pH (Sb Electrode) U/S **5.500** Soil pH (Sb Electrode) D/S **5.500**

ID	Axial Location (Inches from Ref.)	Circ. Location (Inches from TDC)	Damage Type	Length (Inches)	Width (Inches)	Description/Notes	Image Link
CD-001	0.00	0 12:00	Rock Impression	27.00	63.50	The rock impression extended from 0" to 27" D/S of reference, full circumference.

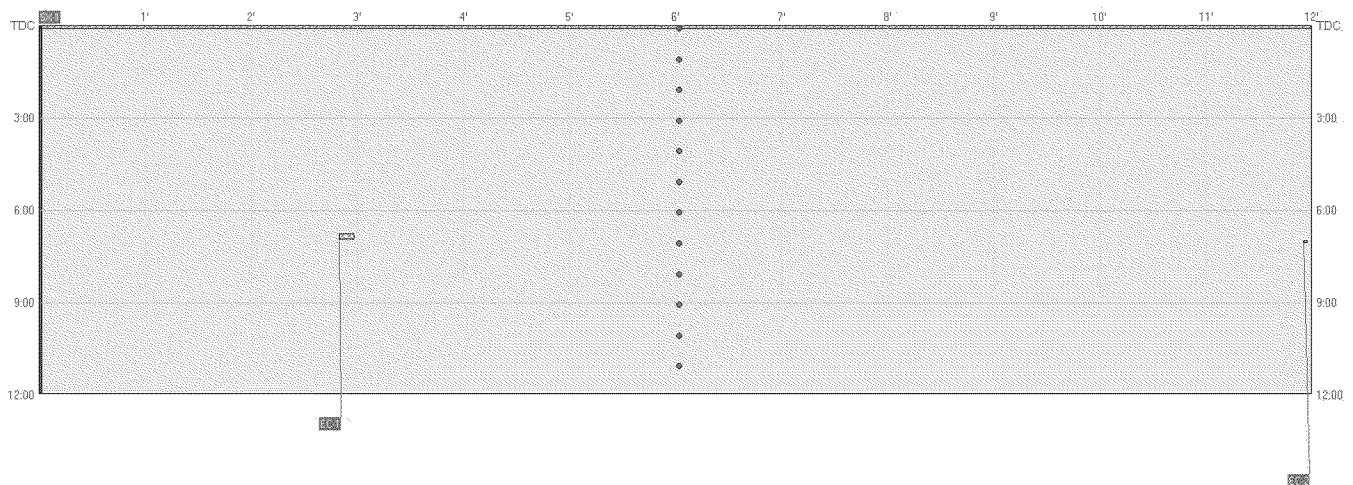
**Map of Corroded Area**

ID	Axial Location (Inches from Ref.)	Circ. Location (Inches from TDC)	Type	Length (Inches)	Width (Inches)	Max Depth (Inches)	Description/Notes	Image Link
EC-001	34.00	35.78 6:45	Localized	1.75	1.00	0.062	Maximum wall loss is 24.71%	
EC-002	143.00	37.04 7:00	Localized	0.50	0.50	0.036	Maximum wall loss is 13.432%

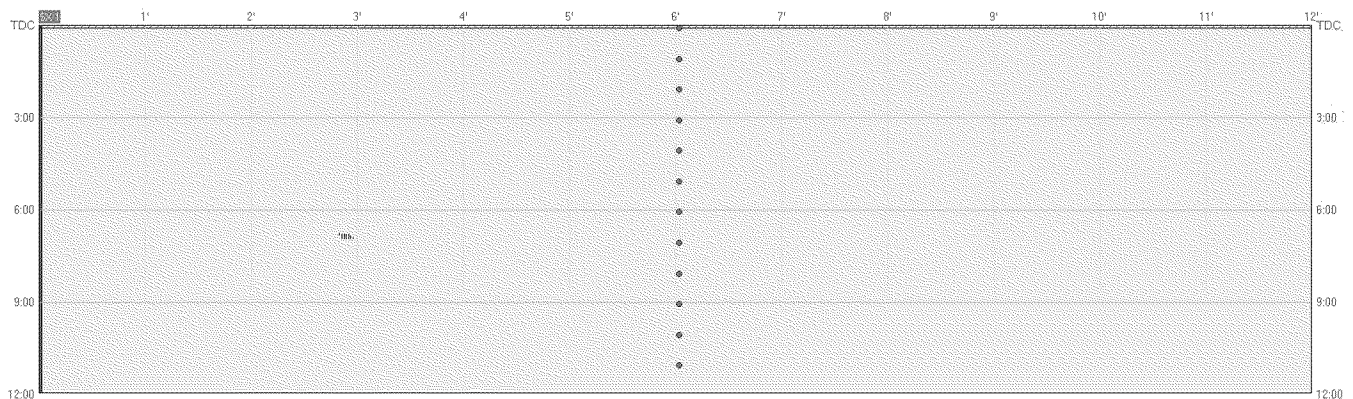
### External Pit Depth Measurement Grids

EC-001	From TDC	1	2	3	4	5	6	7
A	35.78	.013	-	-	-	-	-	-

B	36.03	.011	.010	.038	.023	.002	-	-
C	36.28	-	.021	.062	.014	.012	.001	-
D	36.53	-	.004	.028	.007	.001	.002	.001

EC-002	Explanation
Details Not Provided - Max Depth: 0.036	Maximum wall loss is 13.432%

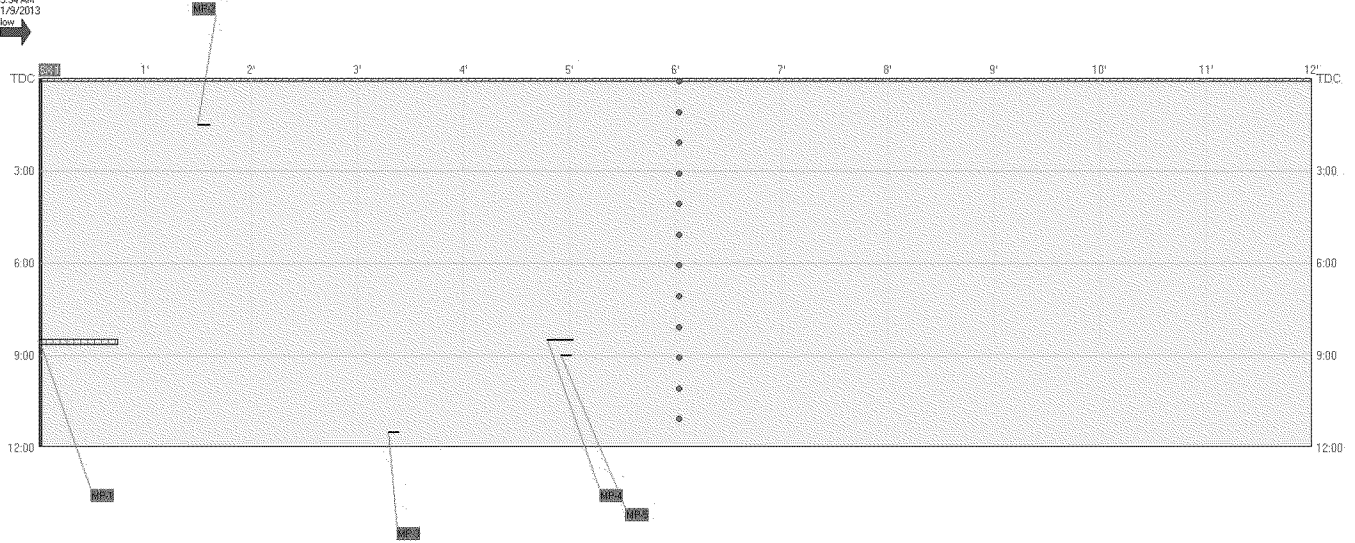
Ind. ID	Axial Location (Inches from Ref.)	Circ. Location (Inches from TDC)	Indication	Length (Inches)	Width (Inches)	Local Min. UTT (Inches)	Description/Notes	Image Link
MP-001	0.00	44.97 8:30	Singular	9.00	1.00	0.263	indication extends into existing coating. indication was removed up to existing coating.	
MP-002	18.00	7.93 1:30	Singular	1.50	0.25	0.260	indication was successfully removed	
MP-003	39.50	60.85 11:30	Singular	1.25	0.25	0.265	indication was successfully removed	
MP-004	57.50	44.97 8:30	Singular	3.00	0.25	0.251	indication was successfully removed	
MP-005	59.00	47.65 9:00	Singular	1.25	0.25	0.254	indication was successfully removed

Comments WFMT was performed on the 12' of exposed pipe, full circumference. 5 Linear Indications were found and noted in the report.

Repair Made **Y** Number of Repairs Made **5**  
Repair Type **Other** Damage Repaired **Other**  
Misc. Comments/Information **5 Linear Indications were removed via buffing.**
