IN-FIELD SERVICES
GEIS Pipeline Integrity Team NDE

Pacific Gas & Electric Company

Hydrostatic Test Dig from October 7, 2011 to November 5, 2011

T43A/B_L147_B [Redacted]

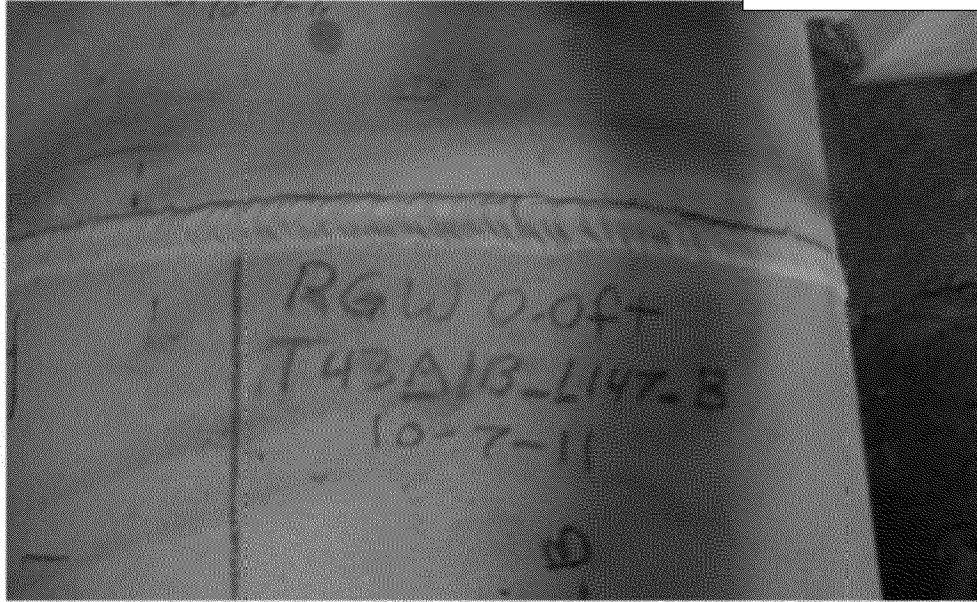
Overview of Reference Girth Weld measurements were taken from.

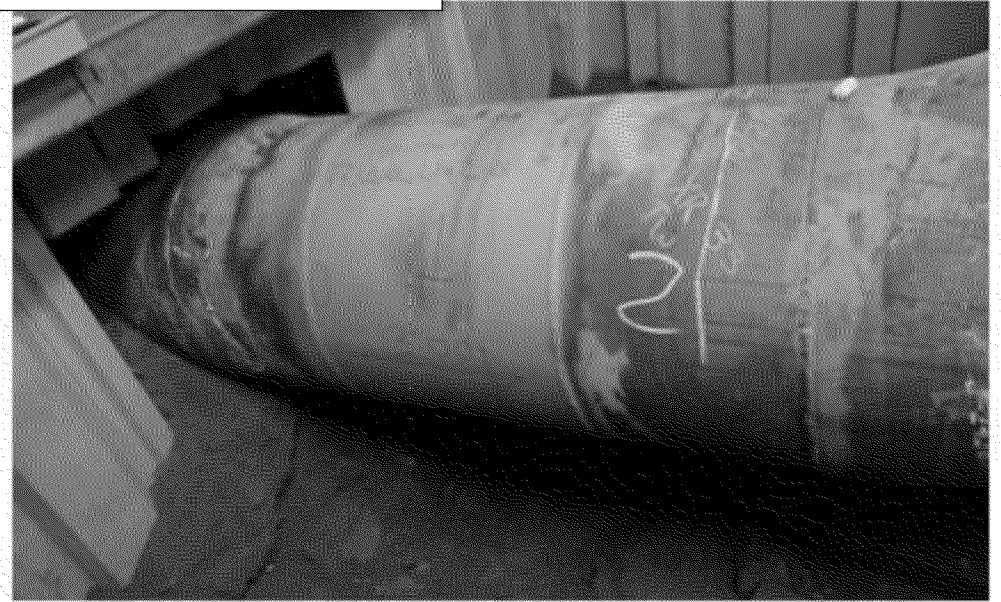
Overview of coating condition -1ft to 2ft, 3:00 position

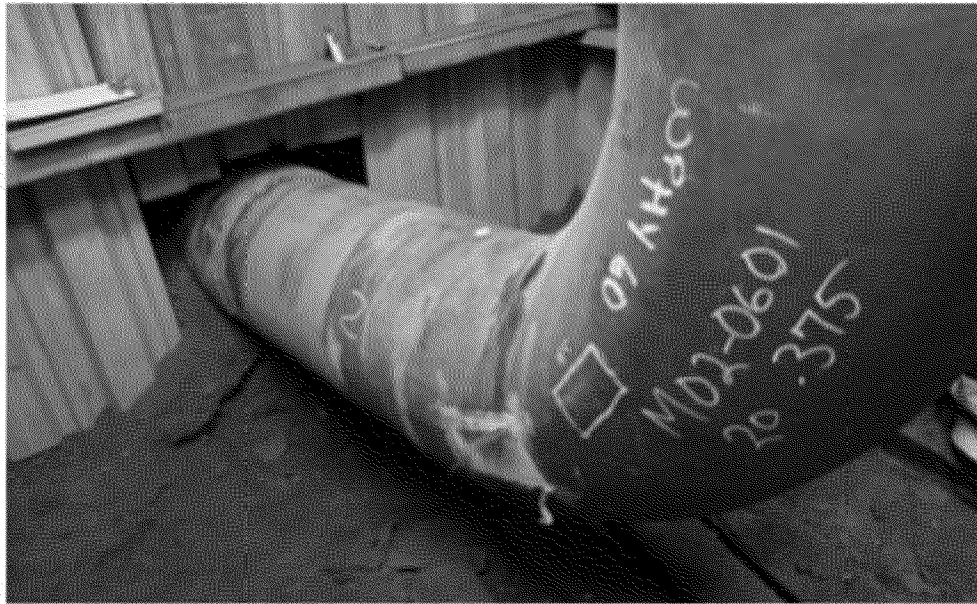
Overview of coating condition -1ft to 2ft, 3:00 position

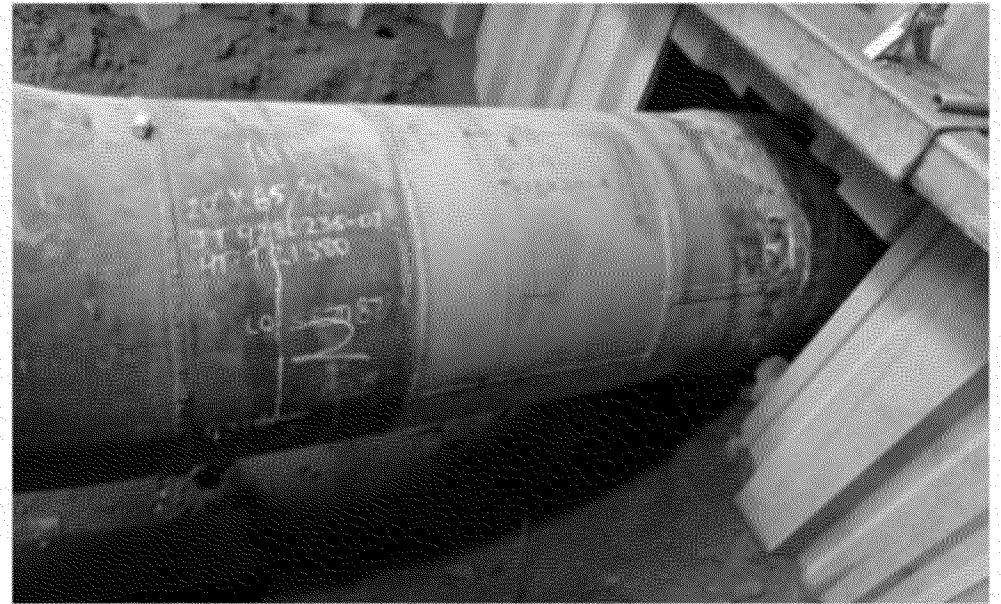
Overview of coating condition -1ft to 2ft, 9:00 position

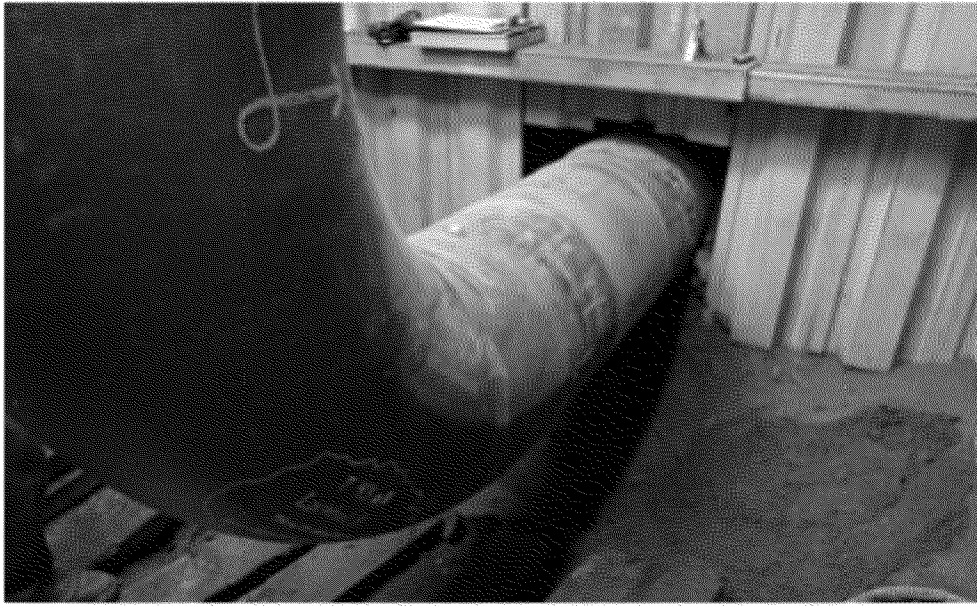
Overview of coating condition -1ft to 2ft, 9:00 position

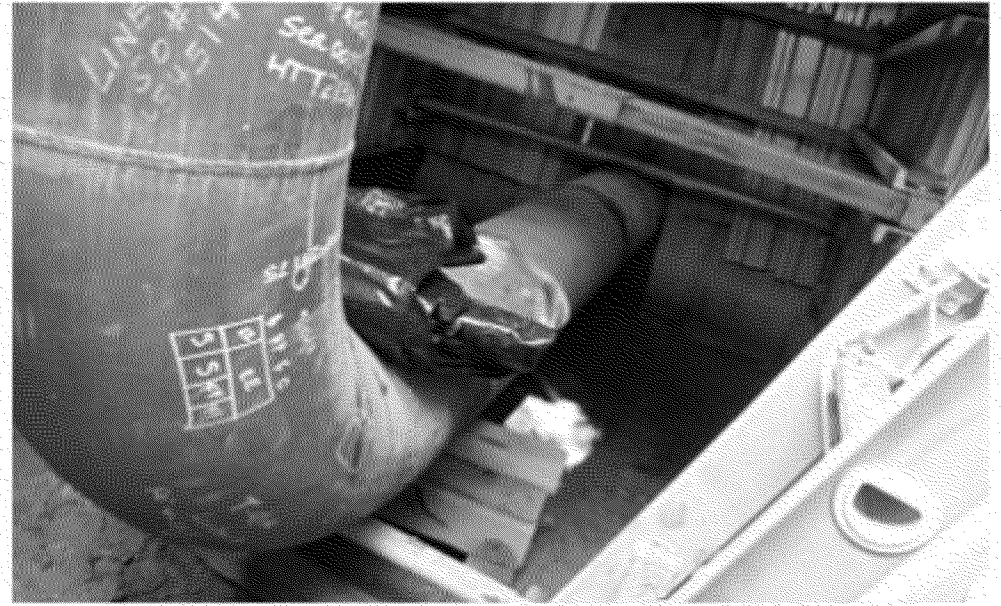
Overview of coating condition 17ft to 20ft, 3:00 position

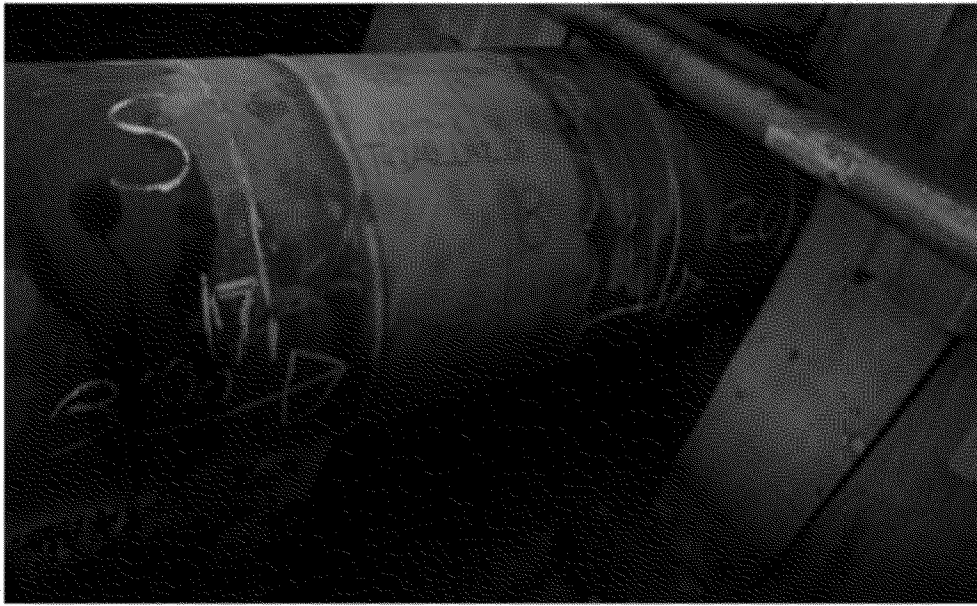
Overview of coating condition 17ft to 20ft, 3:00 position

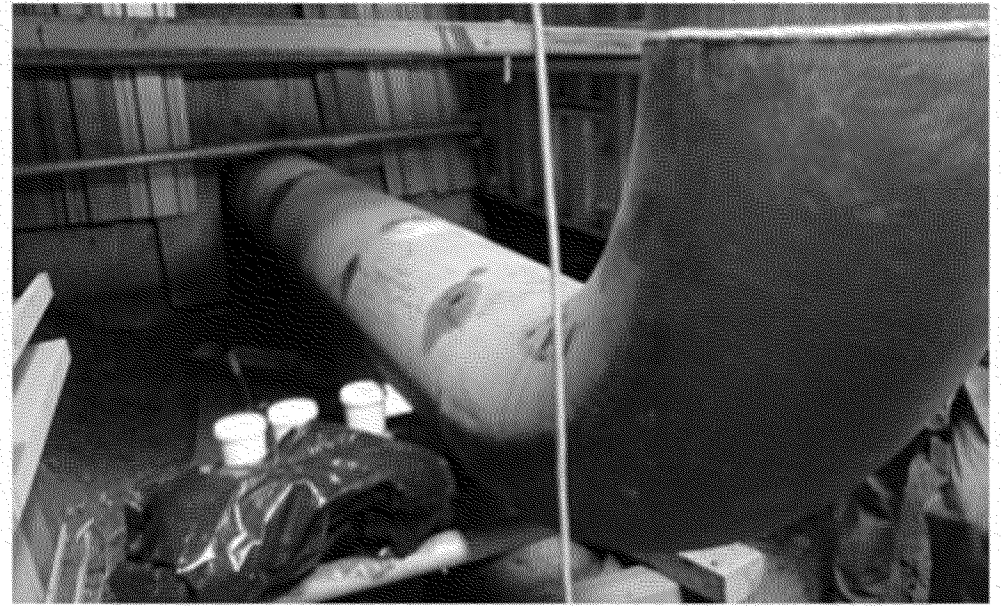
Overview of coating condition 17ft to 20ft, 9:00 position

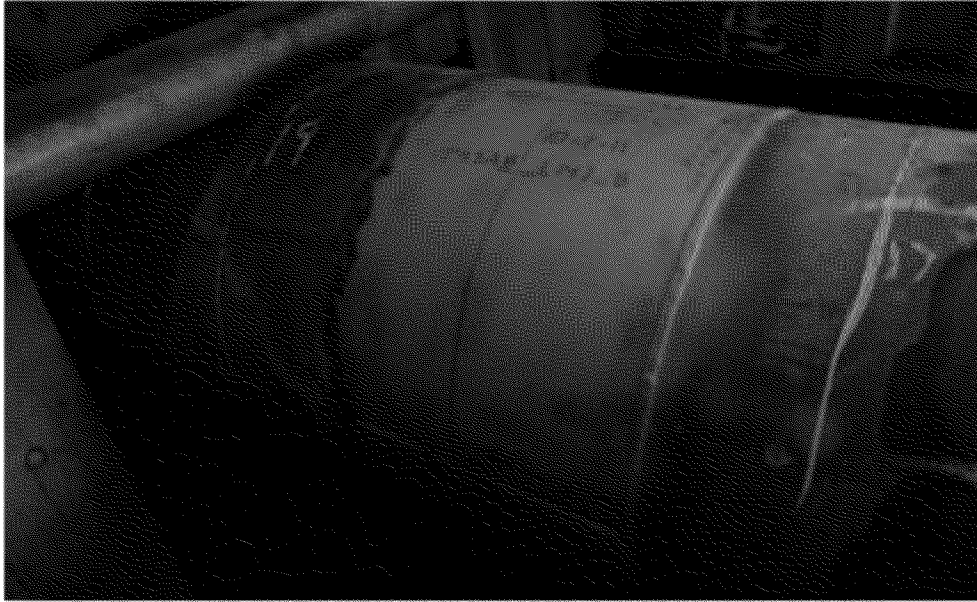
Overview of coating condition 17ft to 20ft, 900 position

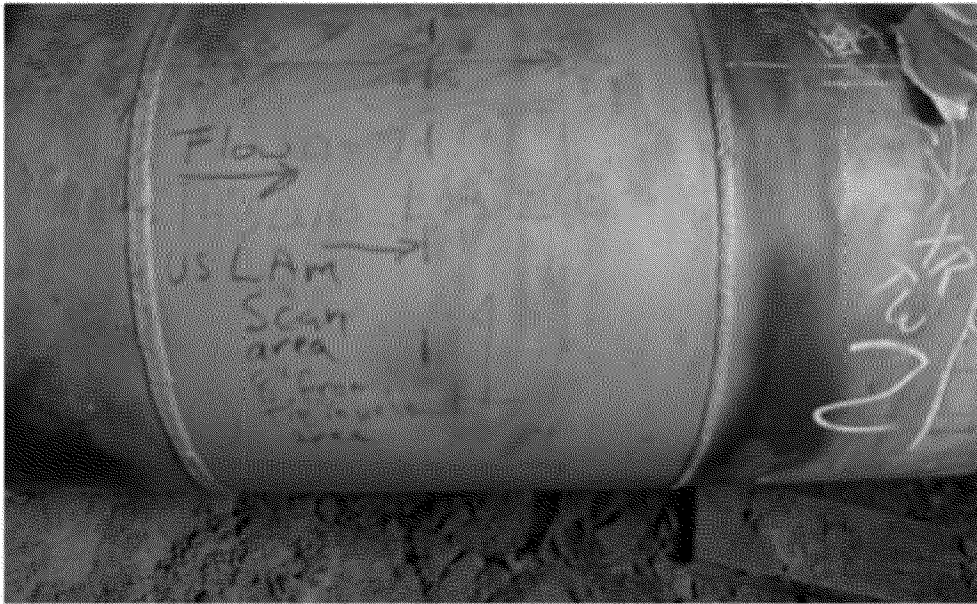
Overview of US lamination scan area.

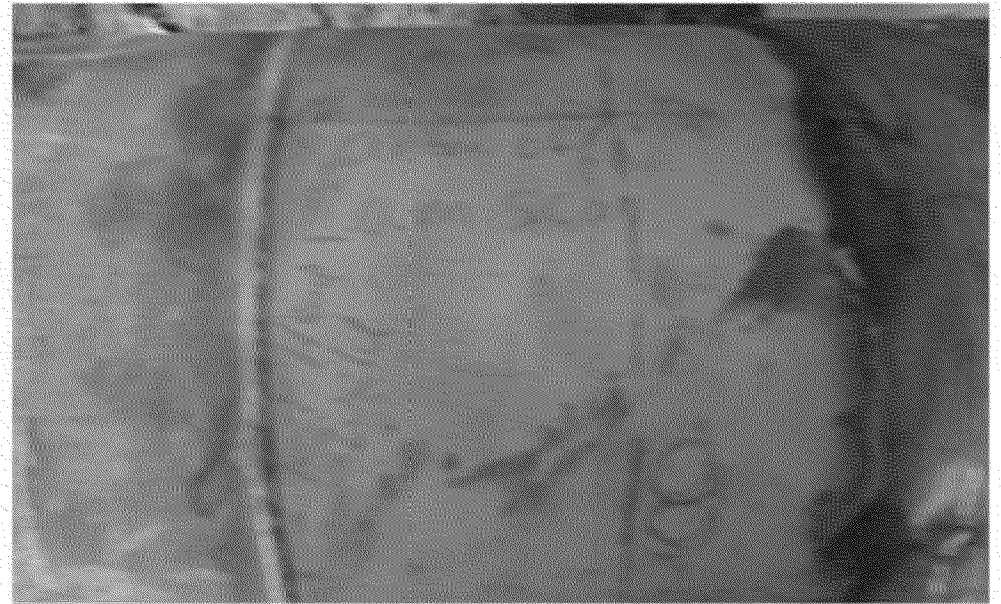
Overview of DS lamination scan area.

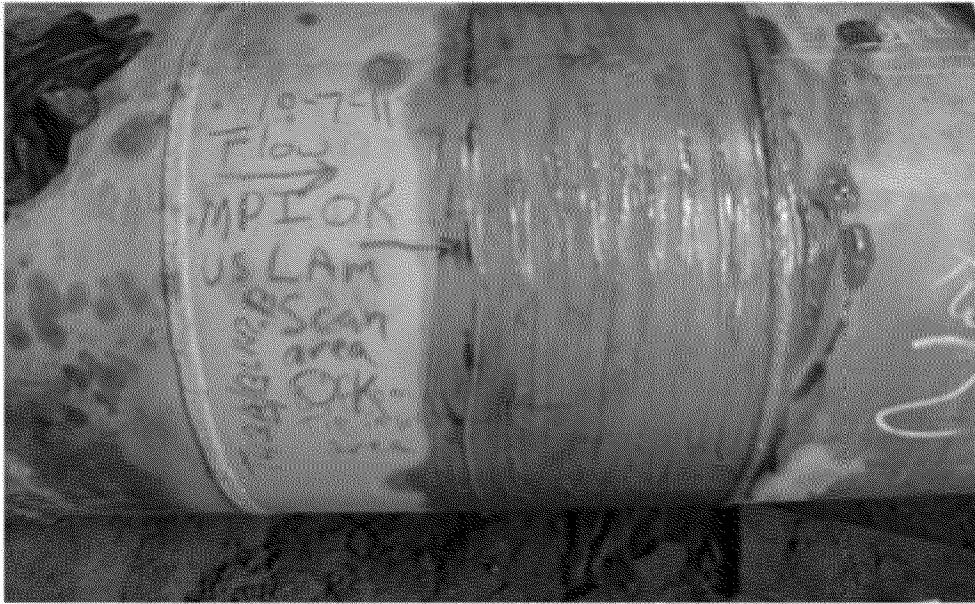
Overview of US MPIOK and Lamination scan OK.

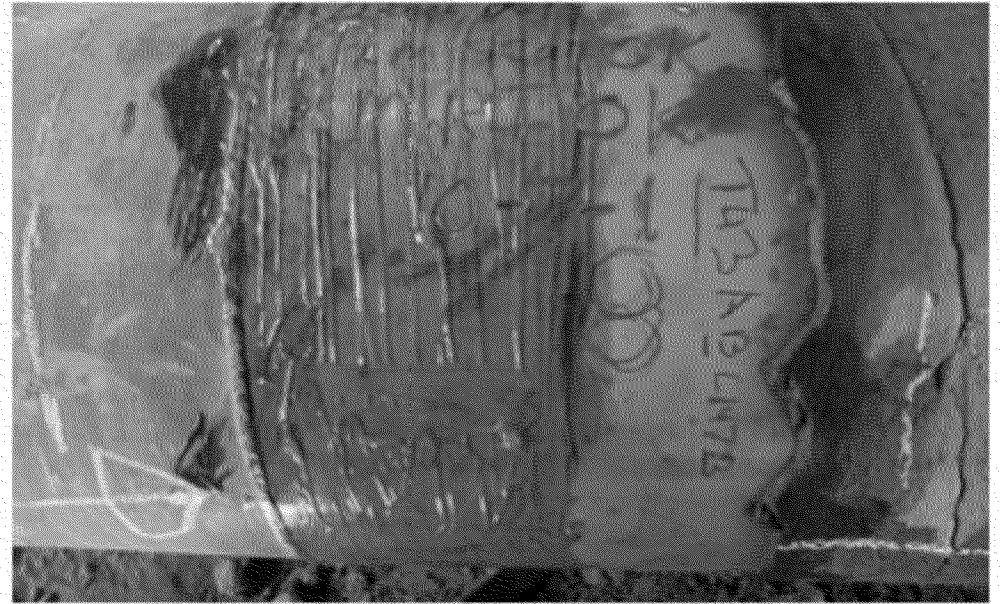
Overview DS of MPIOK and Lamination scan OK.

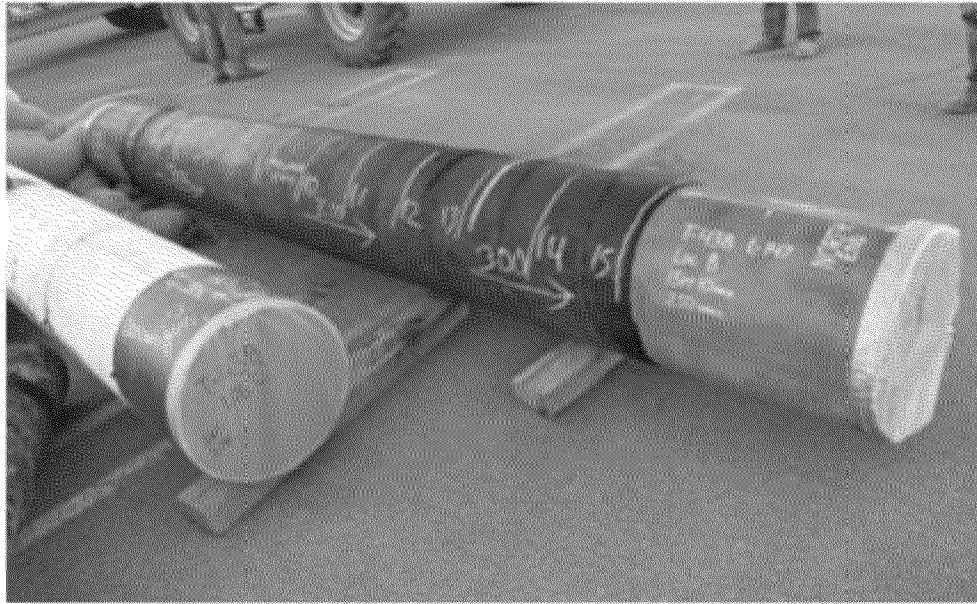
1.8 Coating Condition: Good - Adhered to Pipe Fair - Coating Partially Disbonded or Degraded
 Poor - Coating Significantly Disbonded or Missing
 Comments: Coating removed & tie in weld areas blasted. Pipe section removed and test pipes installed. Removed pipe section was also assessed and was in good condition except for coating damage from removal and transportation. See comments page 10.

Removed pipe section coating assesment 3:00

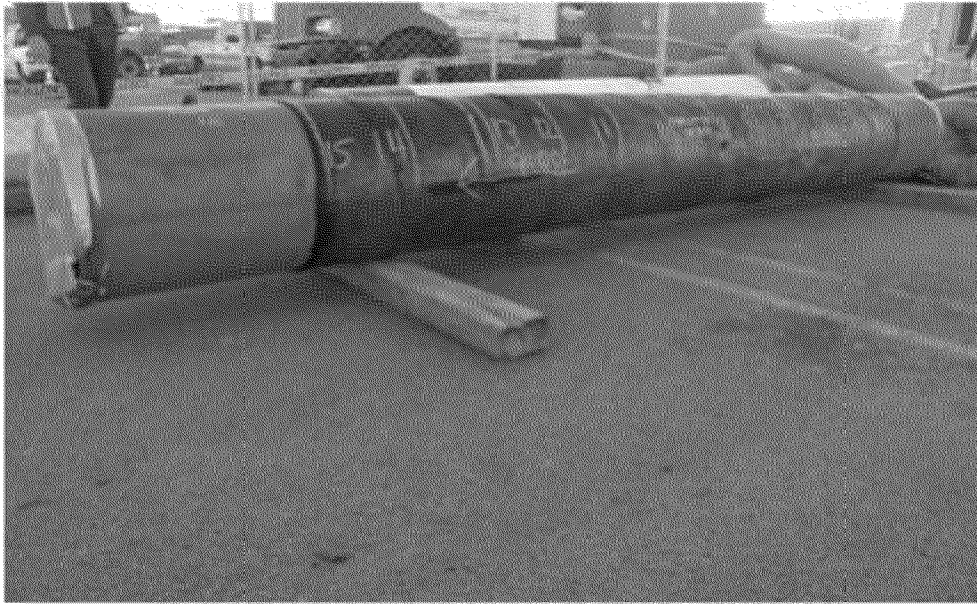
Removed pipe section coating assesment 9:00

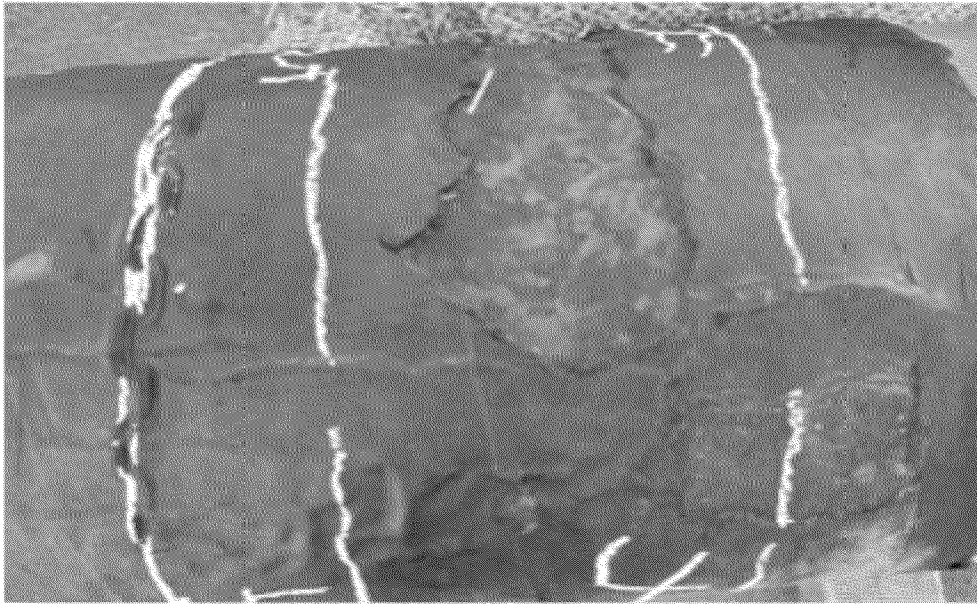
Coating damaged from removal process.

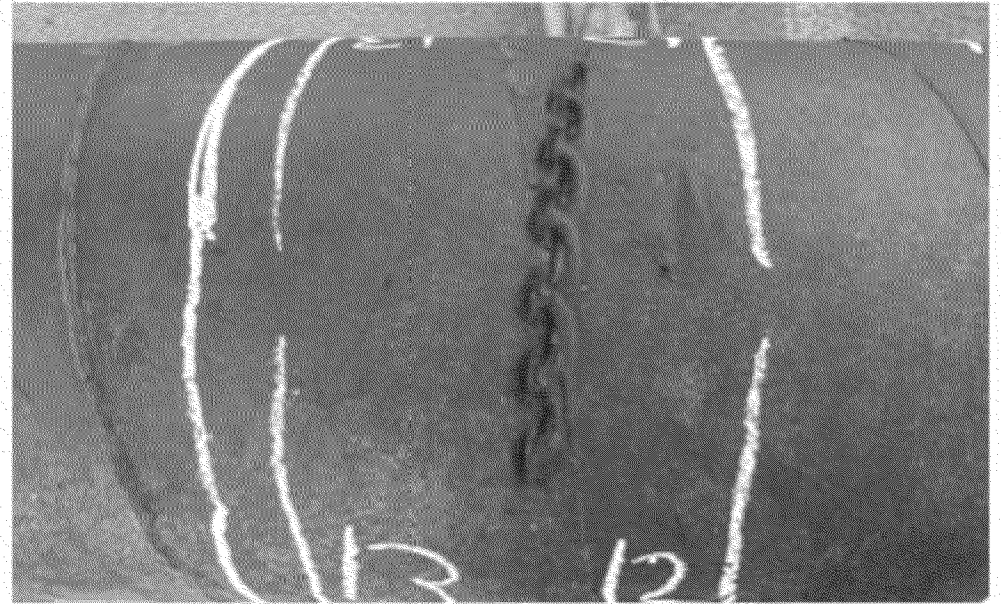
Coating damaged from removal process.

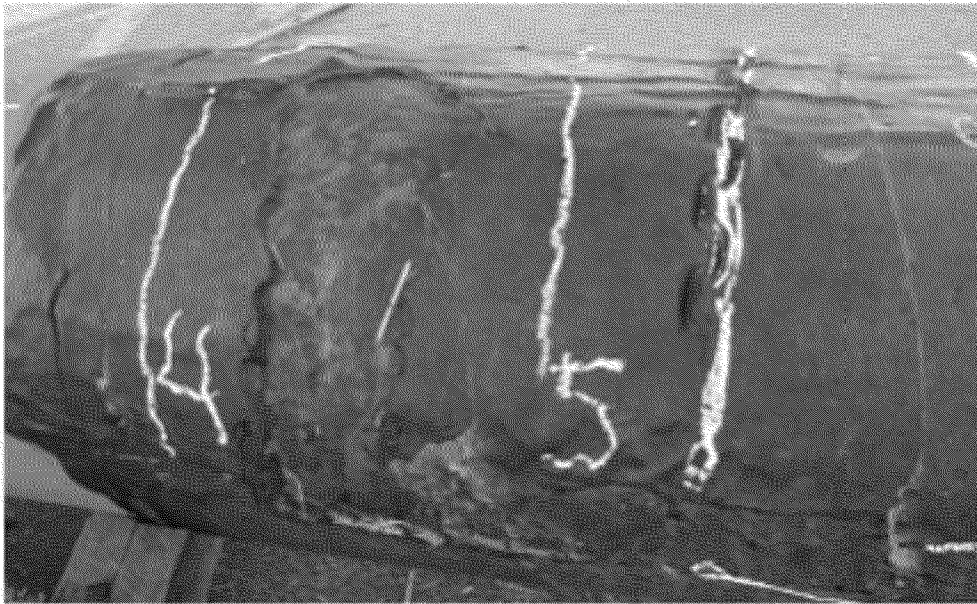
Coating damaged from removal process.

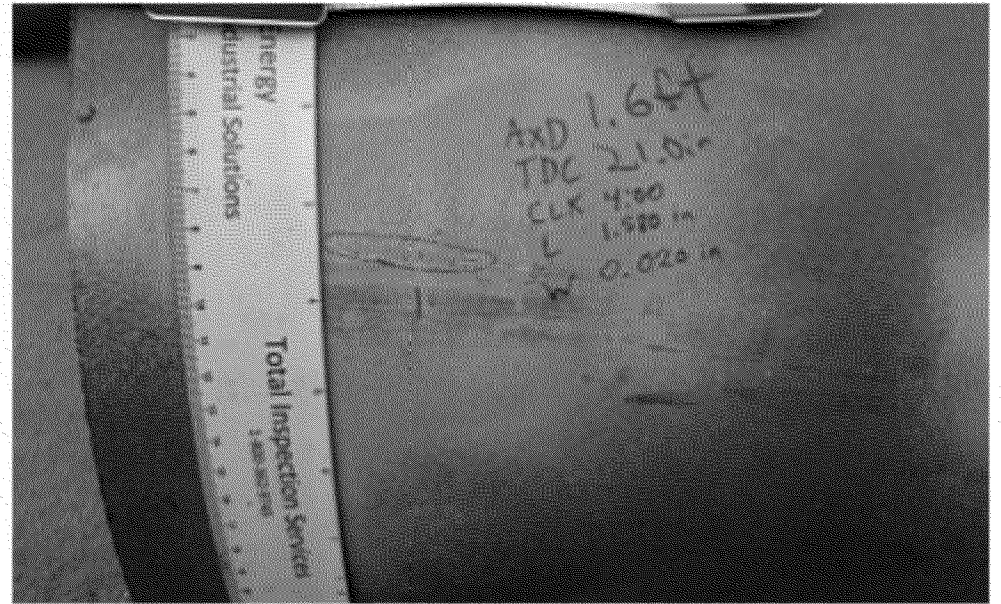
2.6 Wet Fluorescent Mag. Part. Is Required. Comments: 2 linear indications on the removed pipe section. See MT & Photo report.
 Were there any linear indications? Yes No If Yes, attach NDE report electronically as part of the H-Form. Report to include black light and white light photos of indications.

Removed pipe section linear indication-01.

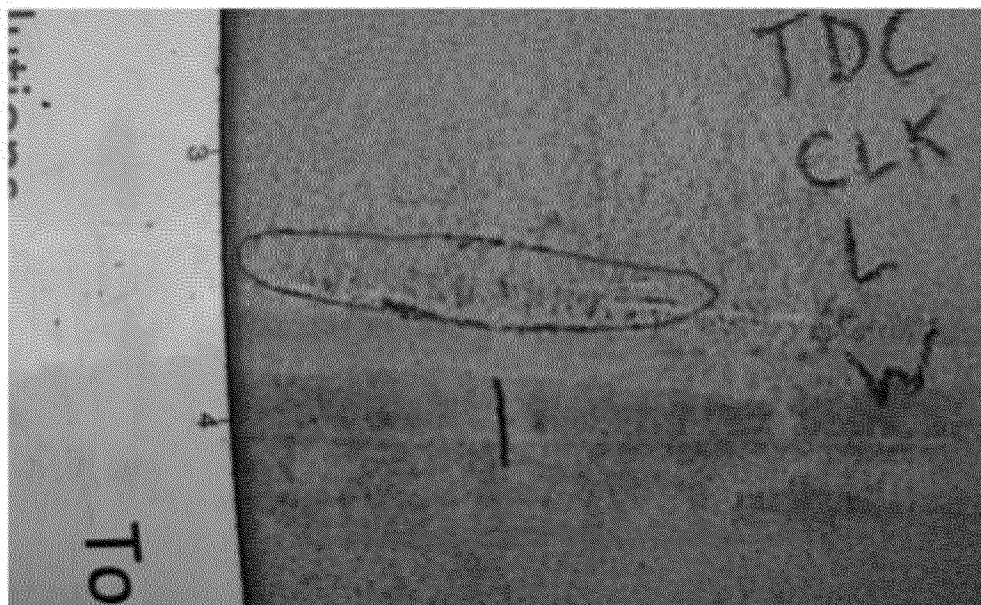
Close-up of MT Indications of LIN-01

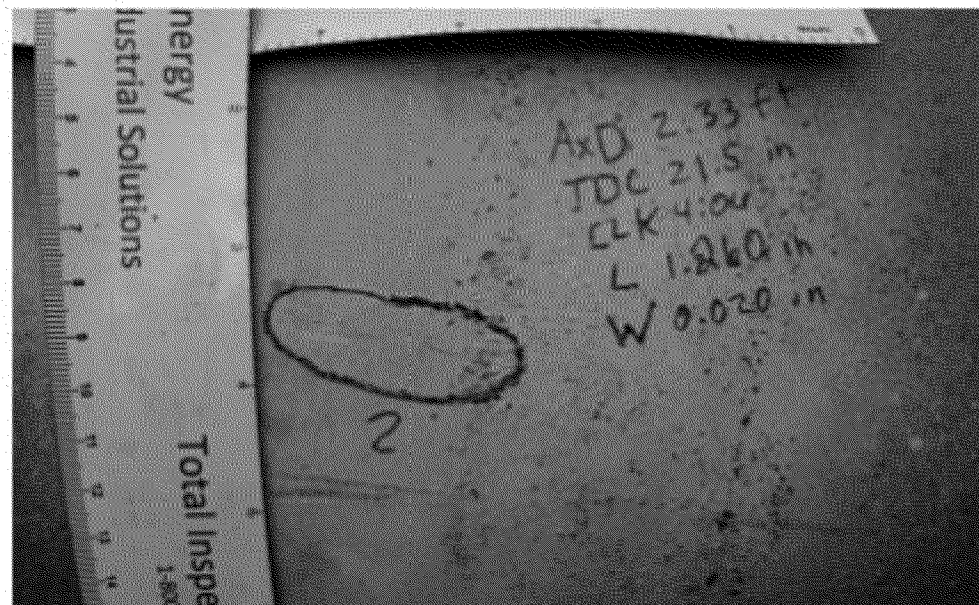
Removed pipe section linear indication-02

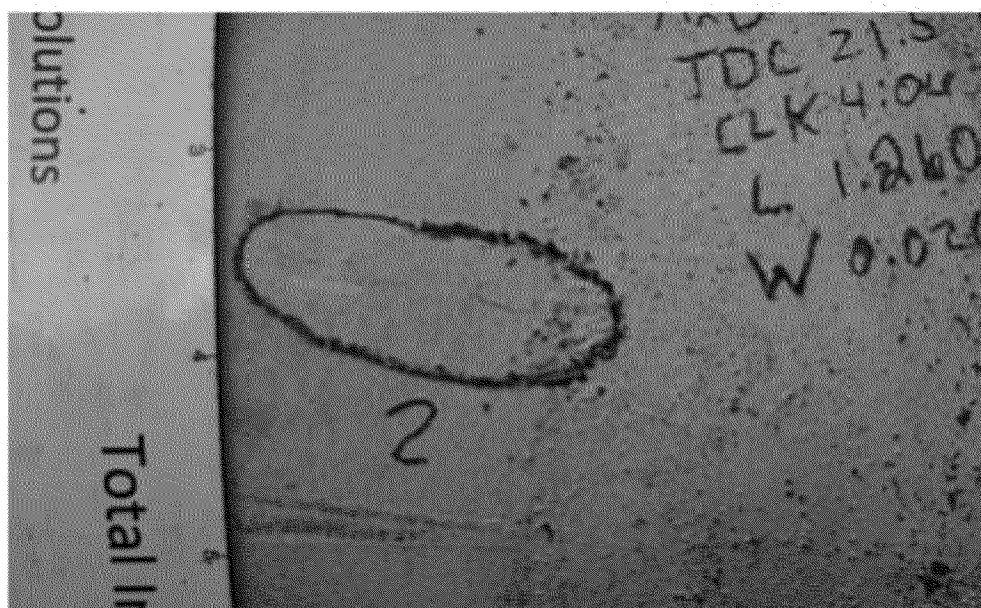
Close-up of MT Indications of LIN-02

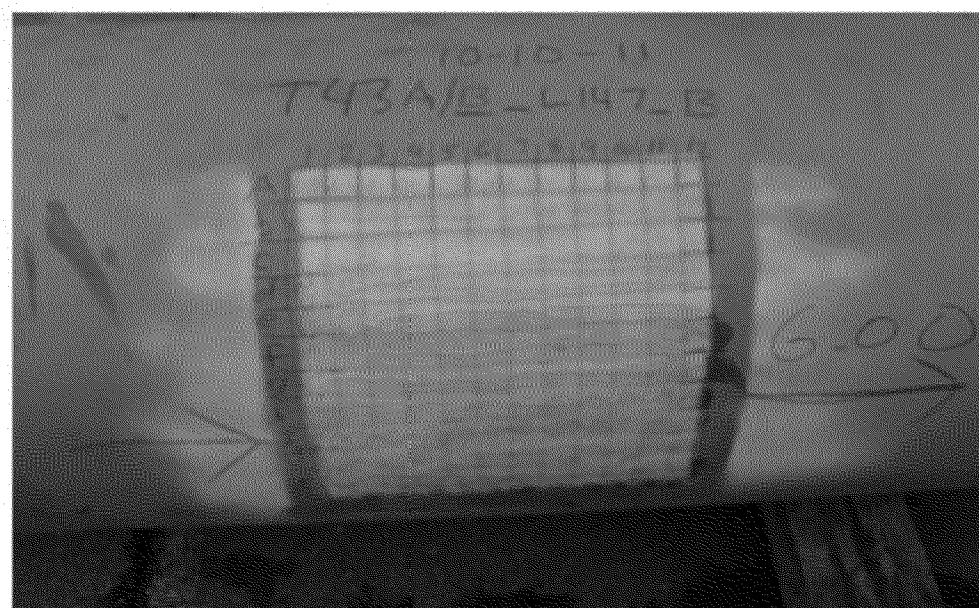
12" x 12" (1"x1" grid) at a random 6:00 position on the pipe.				- No relevant indications @ time of inspection.				
12" lamination scans at cut-line locations.				- No relevant indications @ time of inspection.				
Thickness readings US & DS inspection areas at the clock positions.								
Copy To: Pacific Gas & Electric Company GE Inspection Services (Los Angeles)				Requested By: Redacted		Reported By / Technician: Redacted		
				<input checked="" type="checkbox"/> Customer Specifications <input checked="" type="checkbox"/> Accept <input type="checkbox"/> Reject		NDT Supervisor: Redacted

Overview of UT Grid

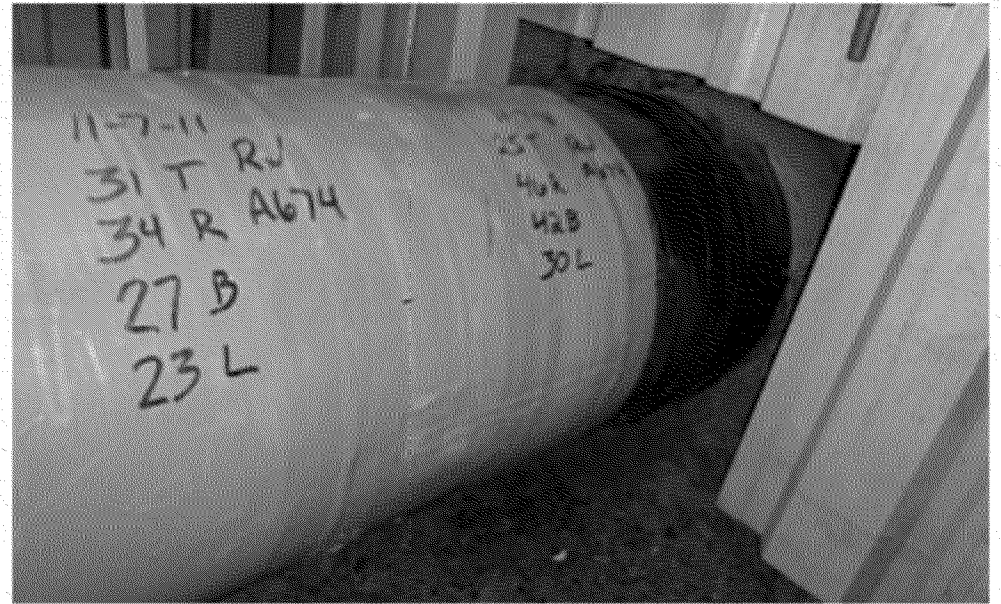
Overview of final coating condition US 300

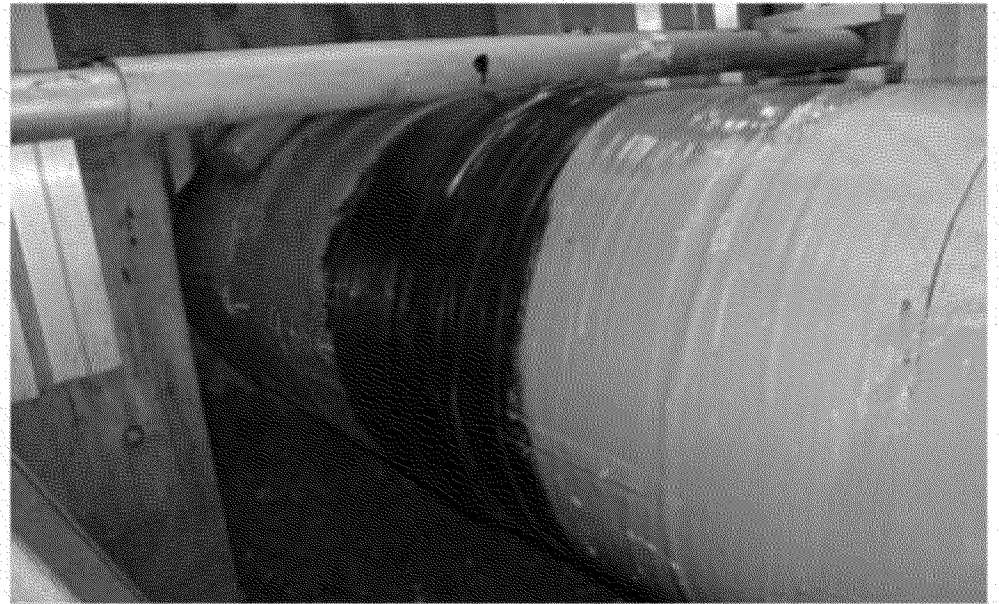
Overview of final coating condition US 3:00
