Final Report

Pipe Characterization and Weld Assessment
San Carlos
Line 147
Mile Post 0.52

ATS Report #: 413.61-13.390

Gas Project: Internal Corrosion Verification

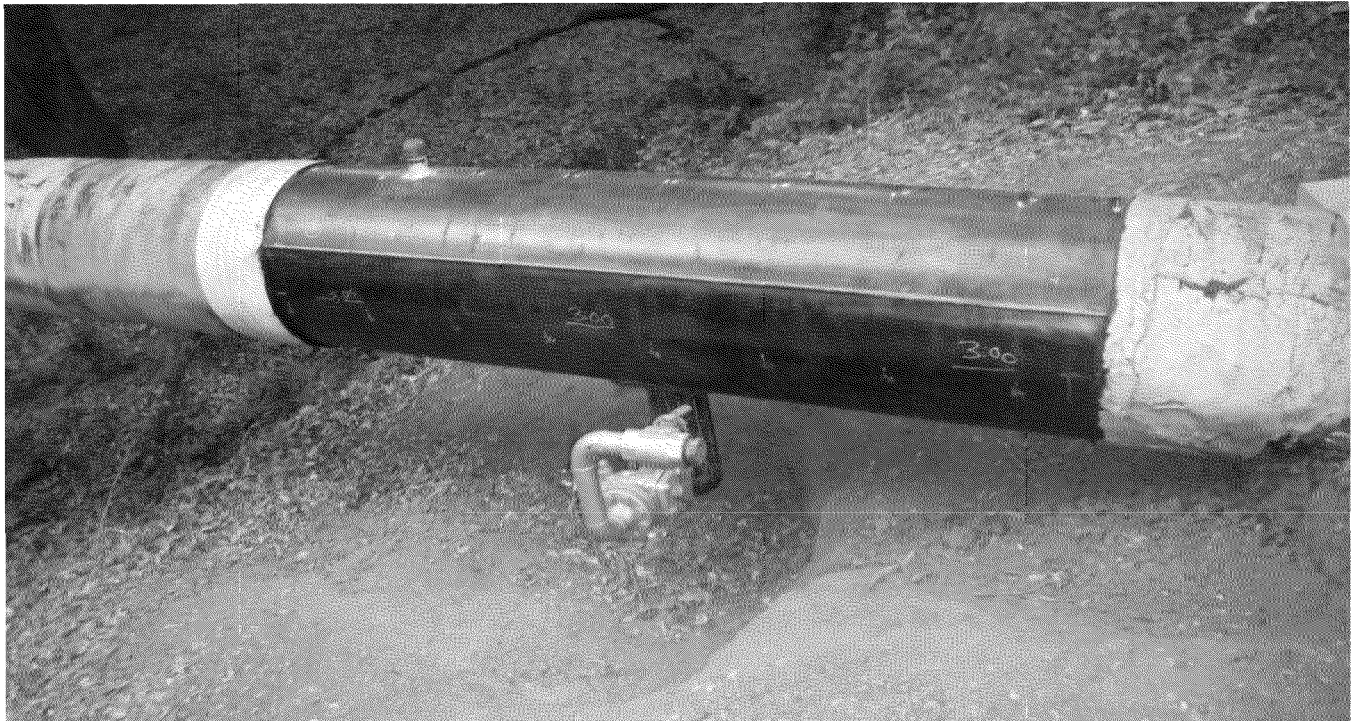
Main Line: ATS Radiographed from 3:00 to 9:00 the entire 8' exposed section of 24" pipe. No sign of internal corrosion, pitting, or debris were found. The 24" section of pipe has external corrosion cells on and around the reinforcement pad for the drip pot.

Radiograph of the 24" main line showing no internal corrosion

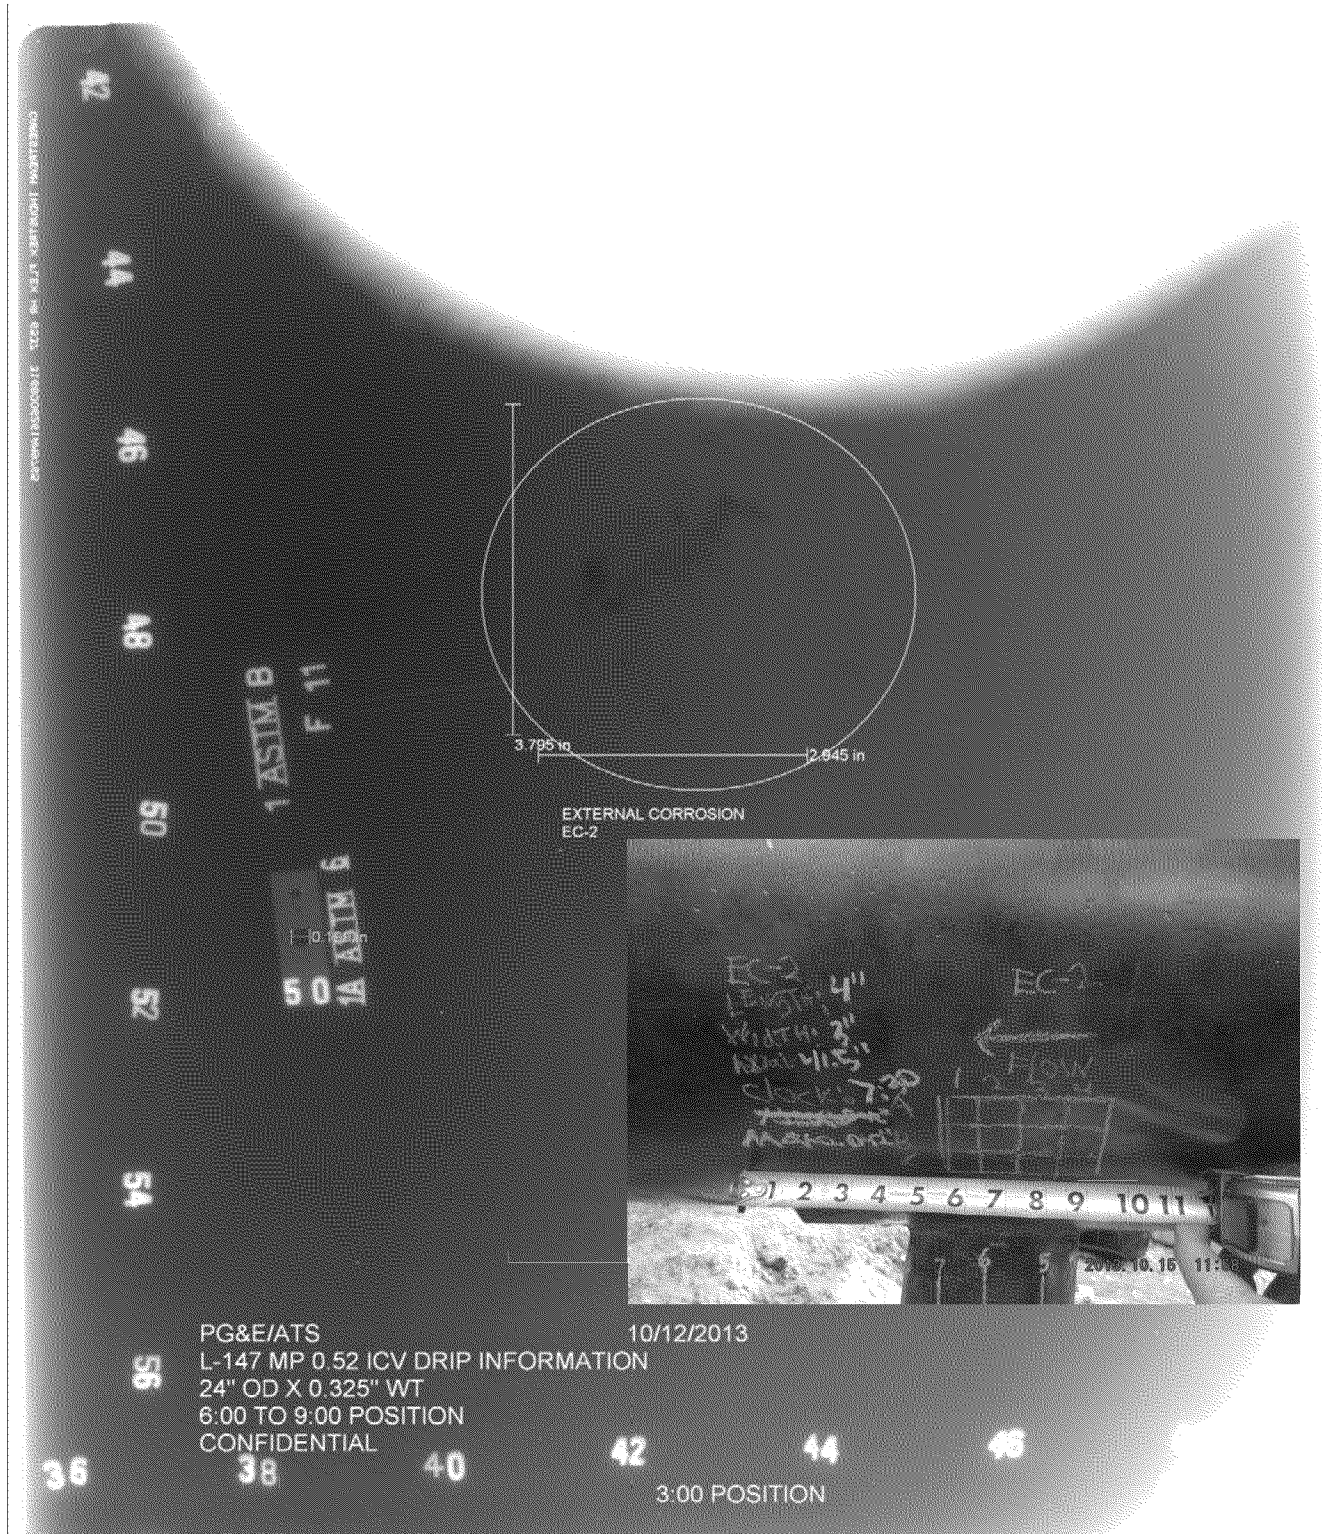
Radiograph of the 24" main line showing external corrosion cell (EC-3-1)

degree elbow that goes North into a Vaccing fitting. There were 4 Corrosion cells that were manually gridded, the most severe of these corrosion cells was
EC-3-1 (73 mils Depth).

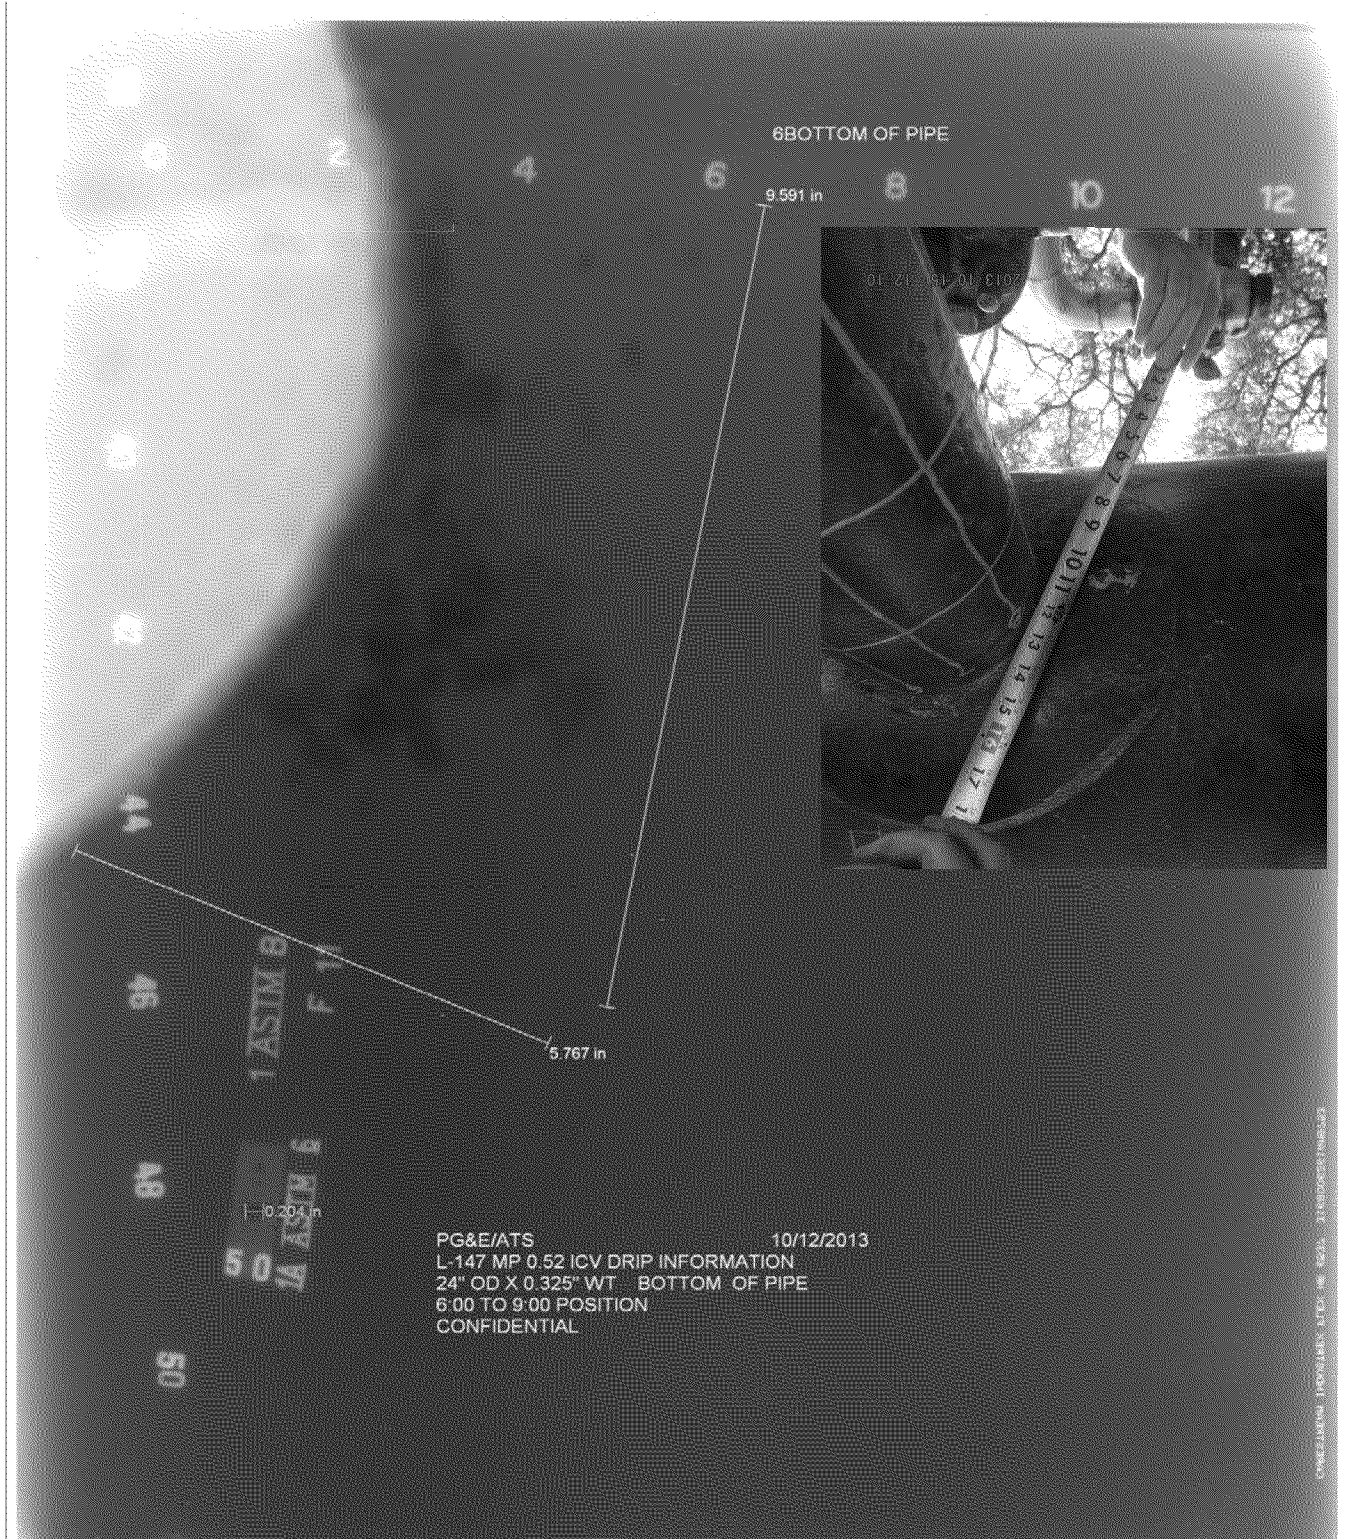
6" Drip Pot: ATS radiographed the drip pot and found it to be full of debris / sludge. Drip pot also has heavy external corrosion.

2" pipe between drip pot and valve: The 2" pipe is full of debris / sludge

Radiograph of the Drip Pot showing debris / sludge inside of the drip pot and 2" pipe between the drip pot and valve.

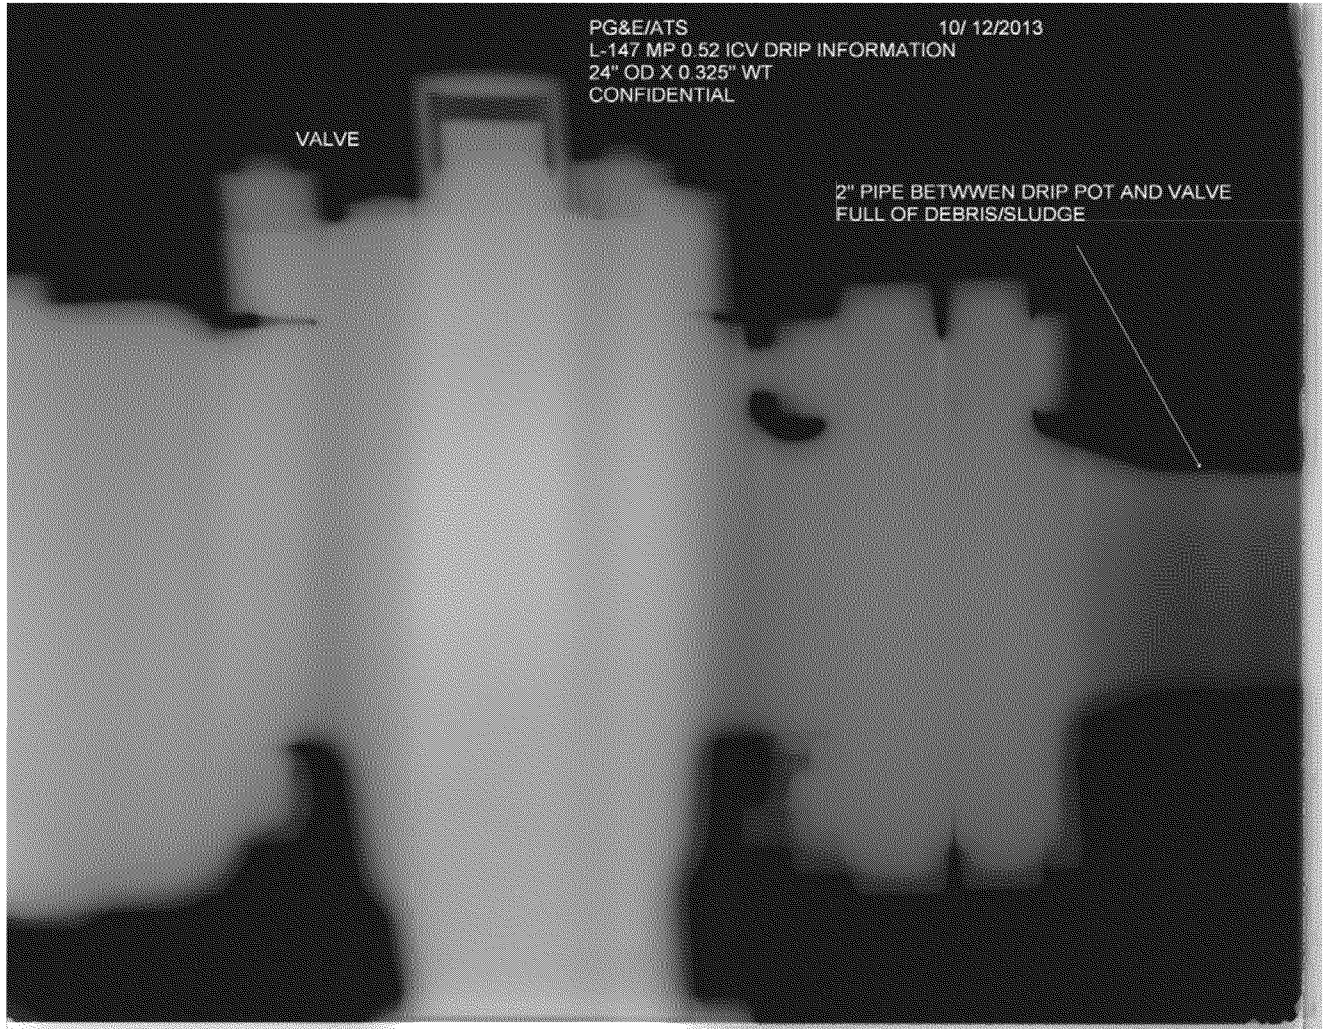
2" Elbow past valve and 2" pipe running vertical: The bottom elbow has debris / sludge that stops at the first girth weld running vertical. The vertical section of pipe has no debris / sludge. The top elbow has a small buildup of debris / sludge on the bottom.

Radiograph of the 2" piping past the vavle showing debris / sludge in the bottom 90 and a small amount of debris / sludge on the bottom of the upper 90

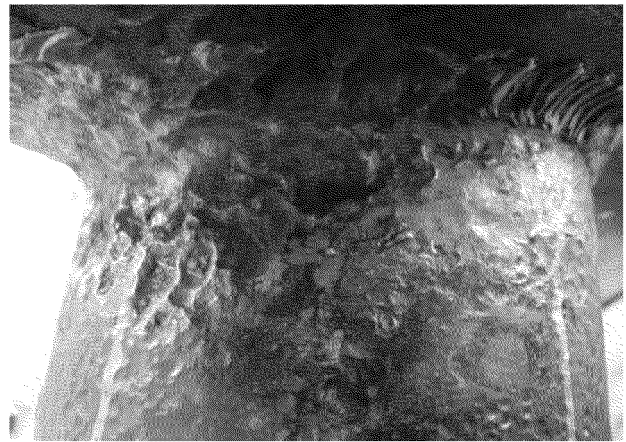
UT thickness survey of corrosion cell between the reinforcement pad and the drip pot using a pencil probe.

Position	UT reading	Remaining wall
7:00	0.162	42.14%
plus 1"	0.179	36.07%
8:00	0.216	22.85%
plus 1"	0.185	33.92%
9:00	0.160	42.85%
<hr/>		
Average wall thickness for the drip pot:		0.280

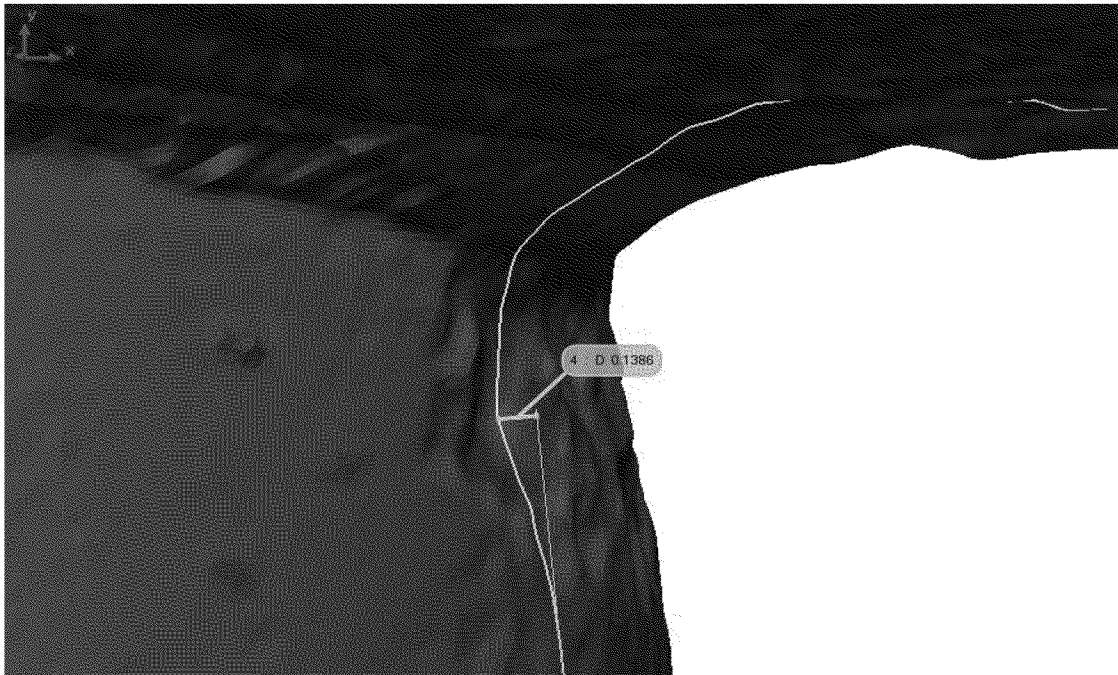
EC-3: Average Wall Thickness: 0.280", Min. 0.138" for 50.69% Wall Loss (Per Laser Scanner see attached Report) Impression Casting of the corroded weld (IC 3-3 area) which was difficult to obtain using multiple methods was: 4.00" width X 0.800" Long and approximately 0.150"-0.200" metal loss.

View of deepest corrosion pit

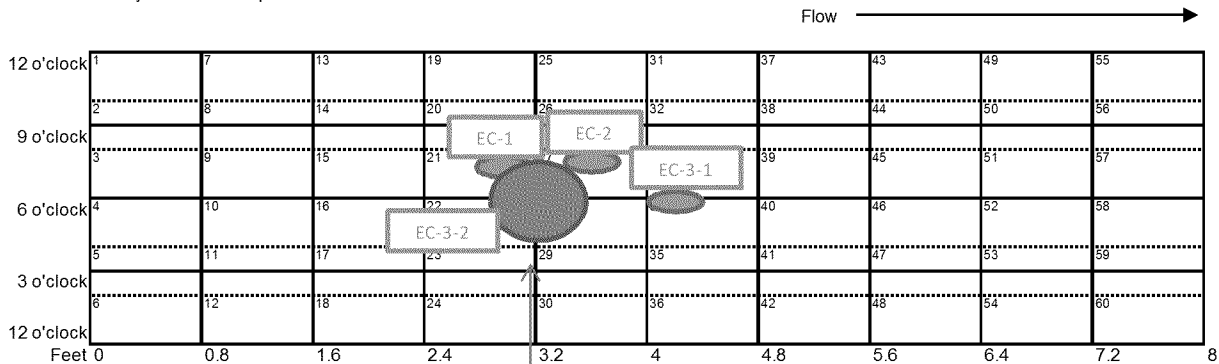
EC-3-3: Average Wall Thickness: 0.280", Min. 0.207" for 26.1% Wall Loss.

Drip Pot
 EC-3-2 is the entire circumference of the 6" Dia Drip Pot
