Form H: Direct Examination Data Sheet
Event 72298 on L-147 @97+70 M-147

PG&E

Route Number/MP Examination Date	L-147 @97+70 M-147 11/4/2013	N-Segment	147	ILI Log Distance (ft.)	0.000 Feet
Exam Performed By	Redacted	IMA Number	N/A	RMP-11 Ref. Section	N/A
Project Manager	Redacted	Region Number	1	Reference Girth Weld	N
Order Number	41976828	Sub # (ICDA)	N/A	Dist. From Girth Weld (ft.)	0.000 Feet
		Stationing	97+70

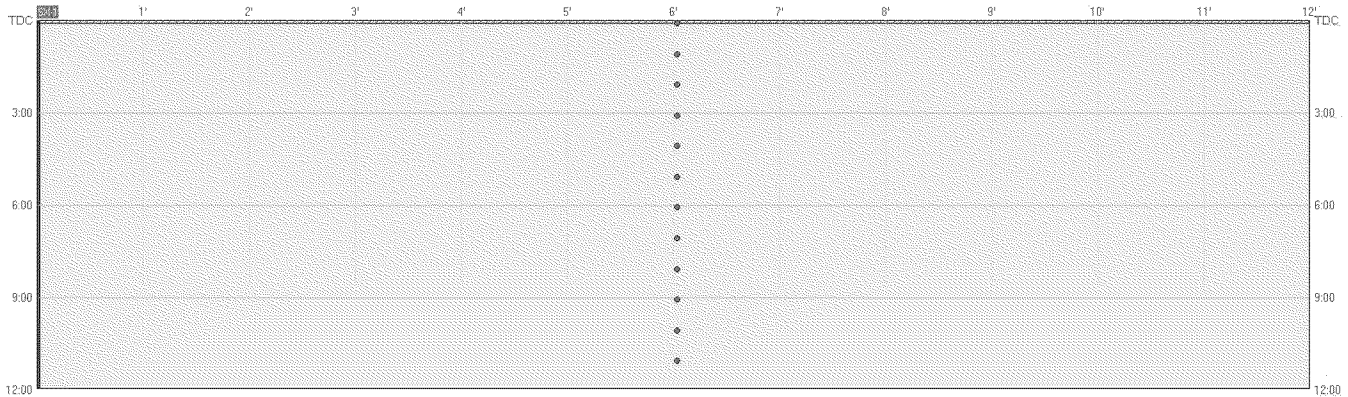
Map of Mechanical Damage

ID	Axial Location (Inches from Ref.)	Circ. Location (Inches from TDC)	Damage Type	Length (Inches)	Width (Inches)	Max Depth (Inches)	Description/Notes	Image Link
N/A	N/A	N/A	N/A	N/A	N/A	N/A	N/A	N/A

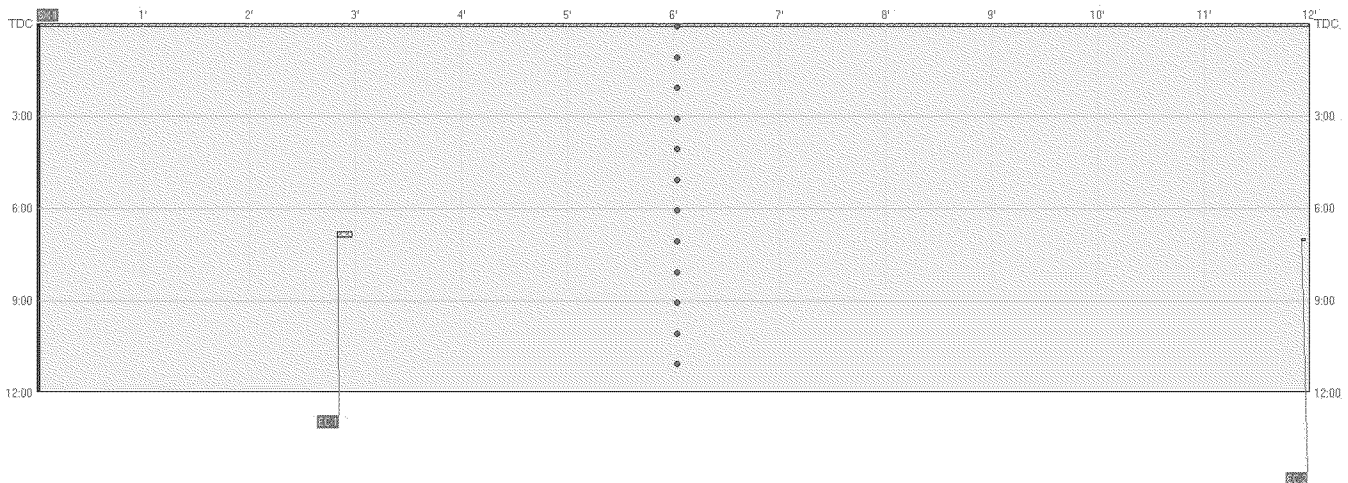
Map of Corroded Area

ID	Axial Location (Inches from Ref.)	Circ. Location (Inches from TDC)	Type	Length (Inches)	Width (Inches)	Max Depth (Inches)	Description/Notes	Image Link
EC-001	34.00	35.78 6:45	Localized	1.75	1.00	0.062	Maximum wall loss is 24.71%	
EC-002	143.00	37.04 7:00	Localized	0.50	0.50	0.036	Maximum wall loss is 13.432%

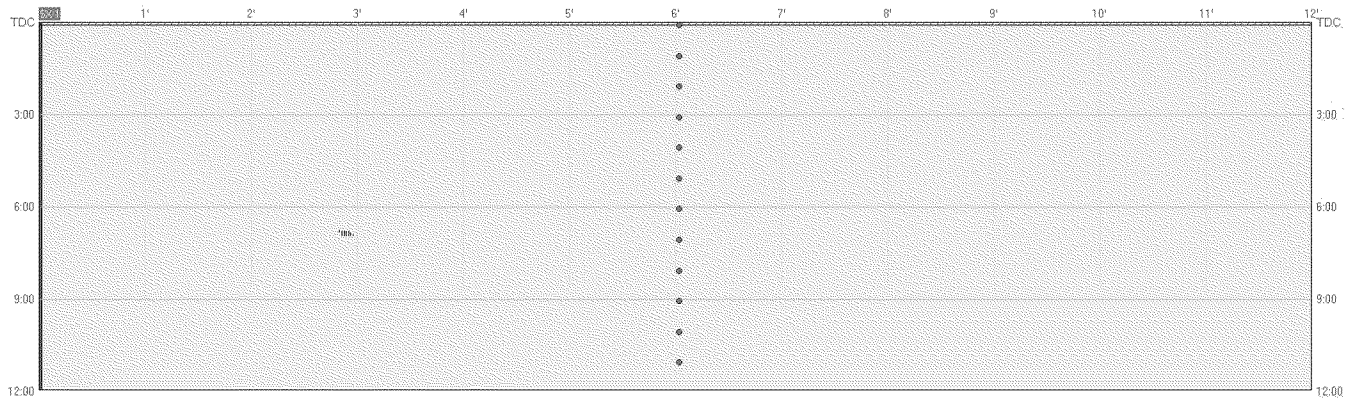
External Pit Depth Measurement Grids

EC-001	From TDC	1	2	3	4	5	6	7
A	35.78	.013	-	-	-	-	-	-

B	36.03	.011	.010	.038	.023	.002	-	-
C	36.28	-	.021	.062	.014	.012	.001	-
D	36.53	-	.004	.028	.007	.001	.002	.001

EC-002	Explanation
Details Not Provided - Max Depth: 0.036	Maximum wall loss is 13.432%

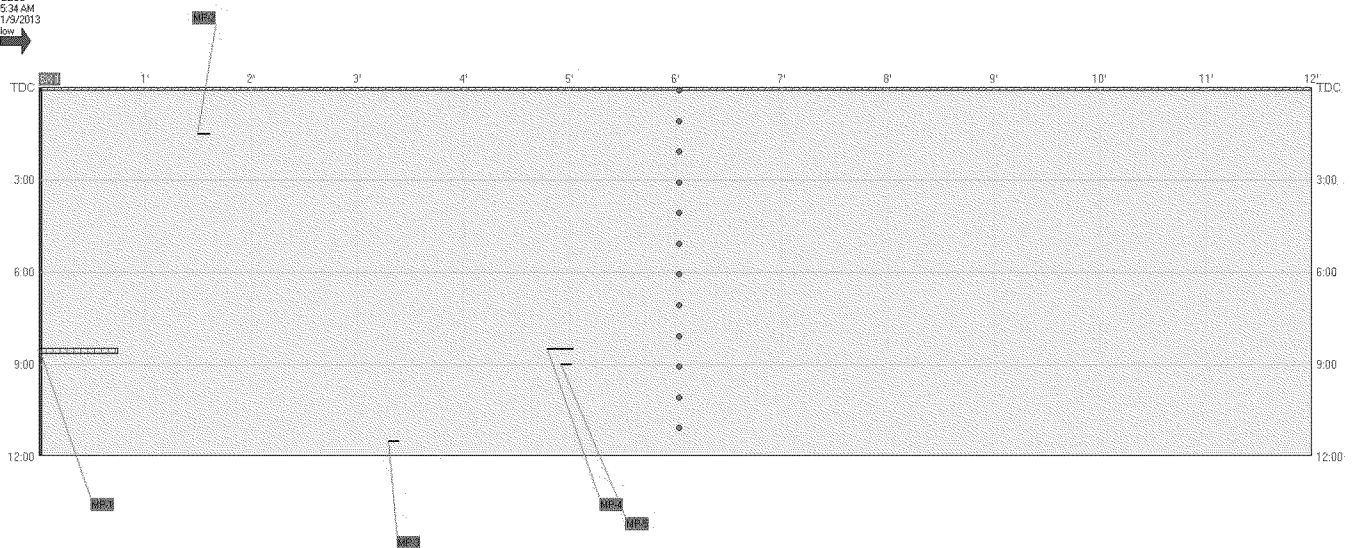
Ind. ID	Axial Location (Inches from Ref.)	Circ. Location (Inches from TDC)	Indication	Length (Inches)	Width (Inches)	Local Min. UTT (Inches)	Description/Notes	Image Link
MP-001	0.00	44.97 8:30	Singular	9.00	1.00	0.263	indication extends into existing coating. indication was removed up to existing coating.	
MP-002	18.00	7.93 1:30	Singular	1.50	0.25	0.260	indication was successfully removed	
MP-003	39.50	60.85 11:30	Singular	1.25	0.25	0.265	indication was successfully removed	
MP-004	57.50	44.97 8:30	Singular	3.00	0.25	0.251	indication was successfully removed	
MP-005	59.00	47.65 9:00	Singular	1.25	0.25	0.254	indication was successfully removed

Comments WFMT was performed on the 12' of exposed pipe, full circumference. 5 Linear Indications were found and noted in the report.

Repair Made **Y** Number of Repairs Made **5**
 Repair Type **Other** Damage Repaired **Other**
 Misc. Comments/Information **5 Linear Indications were removed via buffing.**
