**Pacific Gas & Electric Company**

**Hydrostatic Test Dig from October 7, 2011 to November 5, 2011**

**T43A/B\_L147\_B**

Photo Report of T43A/B\_L147\_B

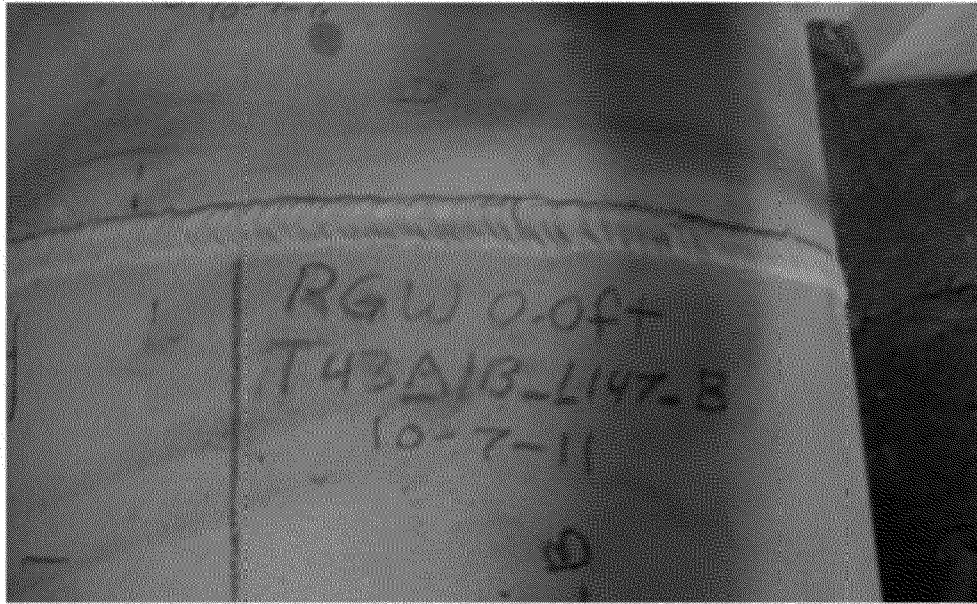
Overview of Reference Girth Weld measurements were taken from.

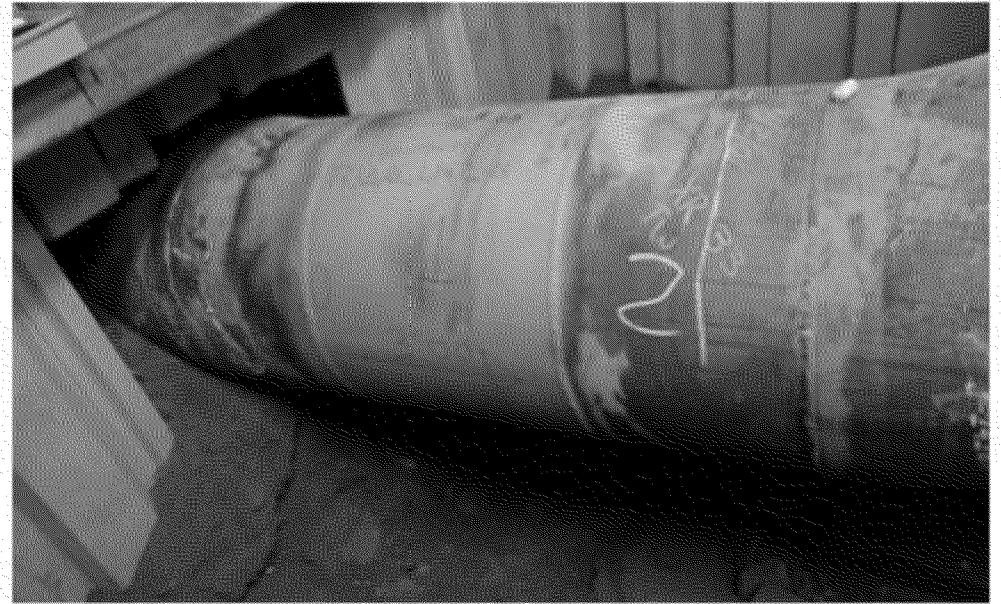
Overview of coating condition -1ft to 2ft, 3:00 position

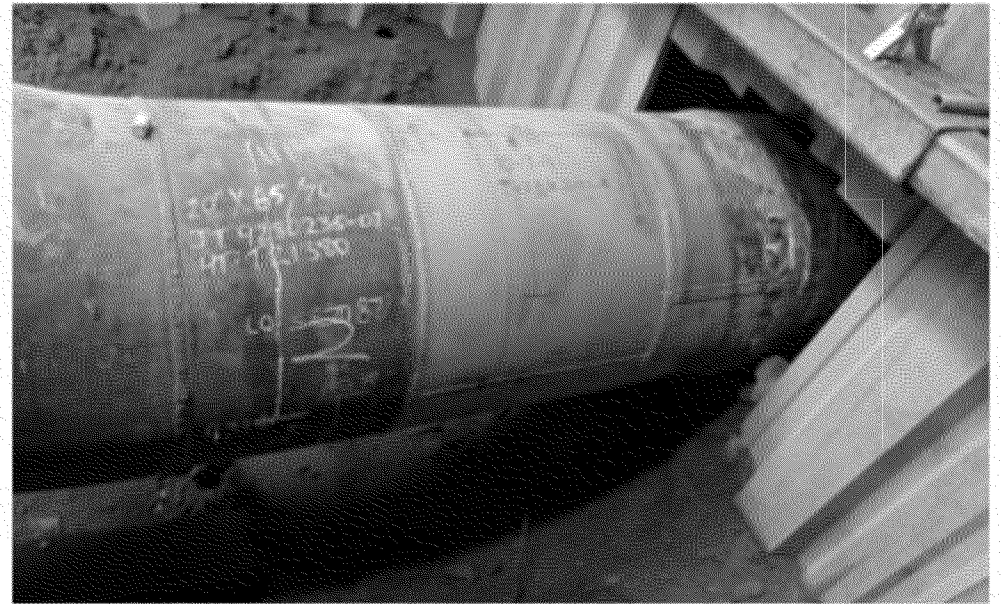
Overview of coating condition -1ft to 2ft, 9:00 position

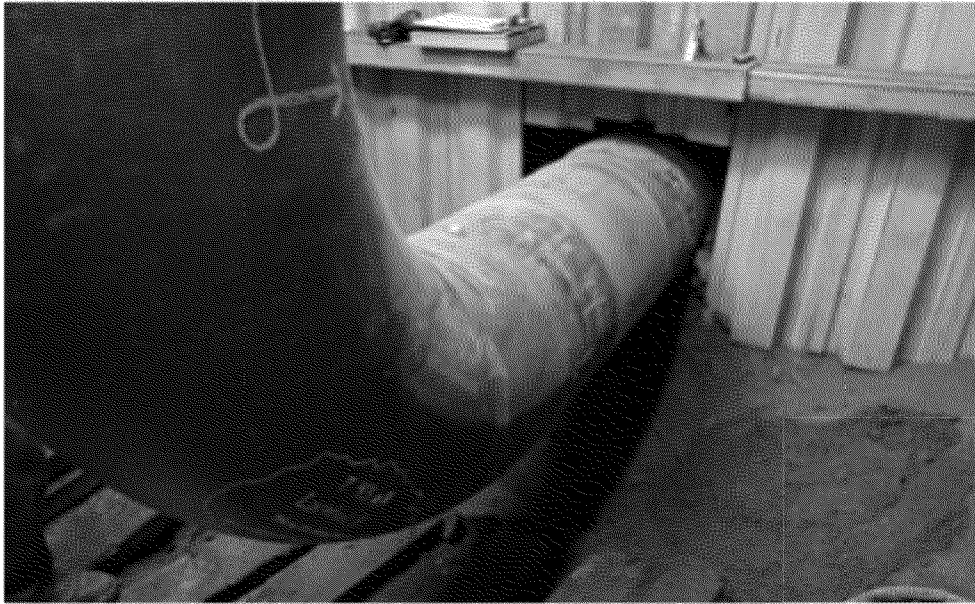
Overview of coating condition -1ft to 2ft, 9:00 position

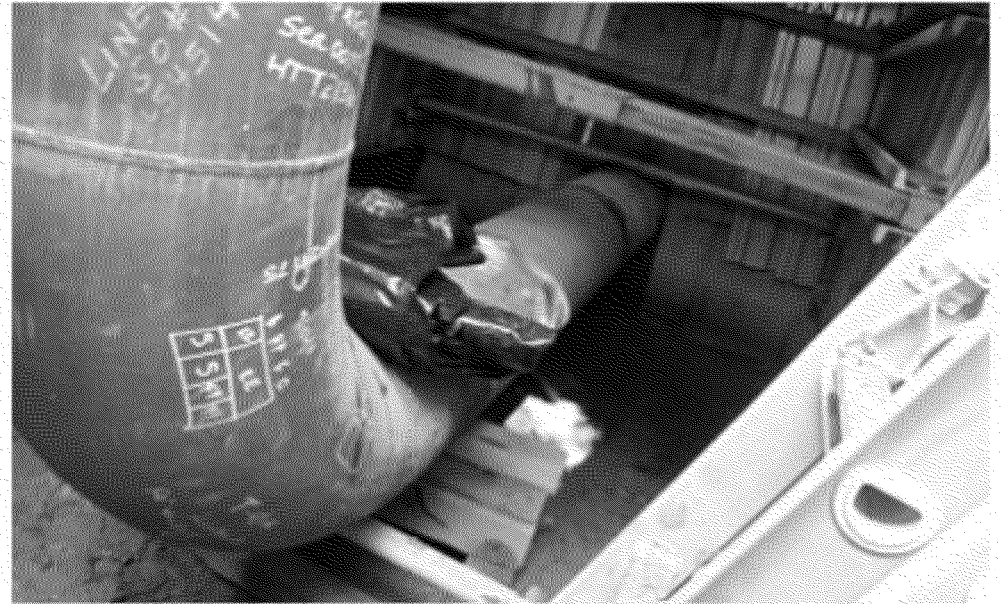
Overview of coating condition 17ft to 20ft, 3:00 position

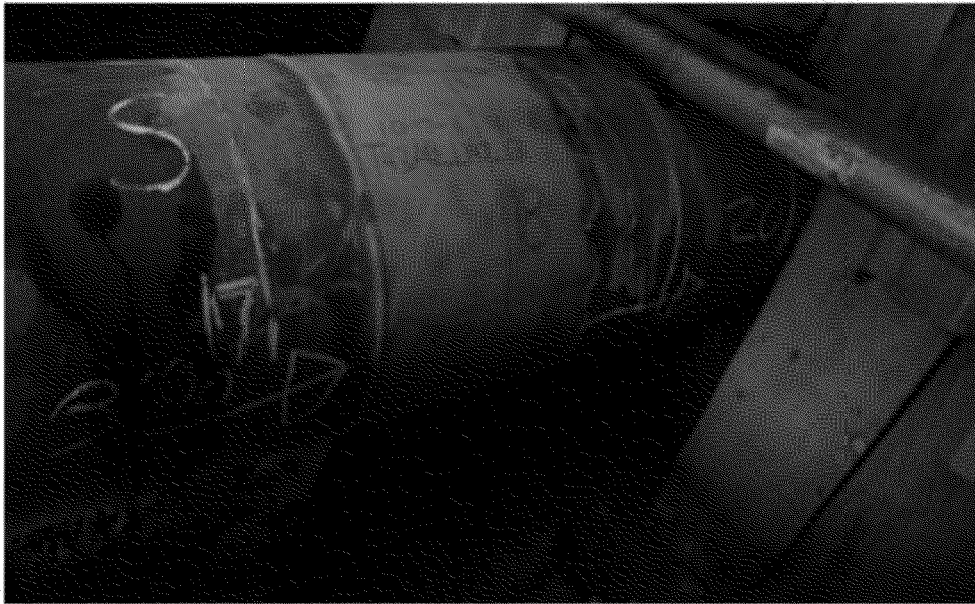
Overview of coating condition 17ft to 20ft, 3:00 position

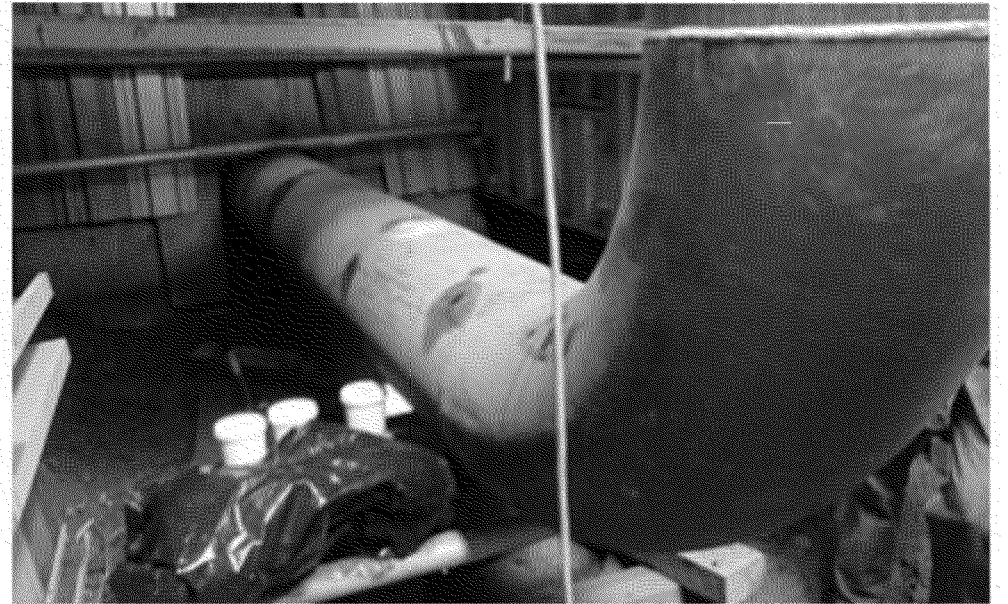
Overview of coating condition 17ft to 20ft, 9:00 position

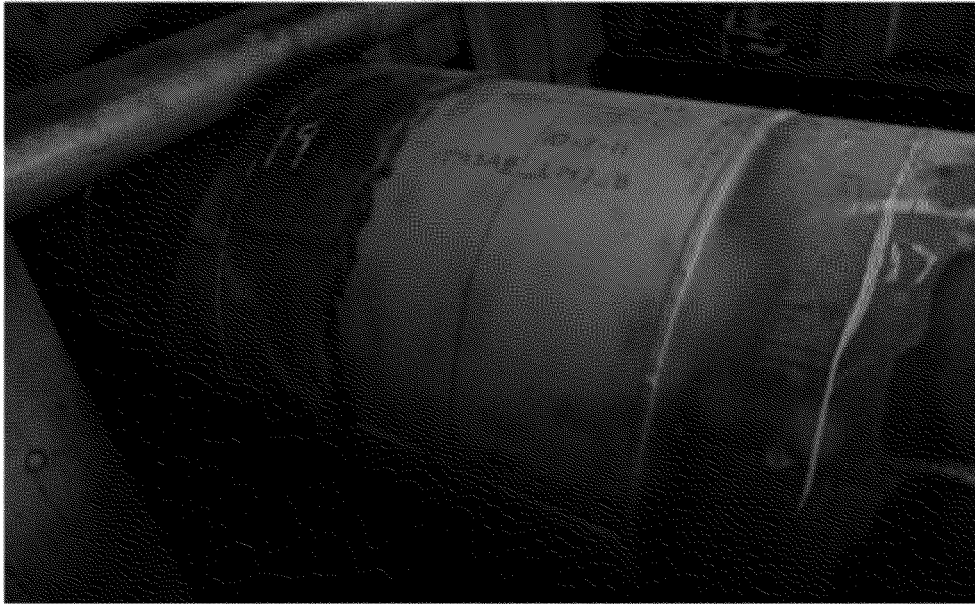
Overview of coating condition 17ft to 20ft, 9:00 position

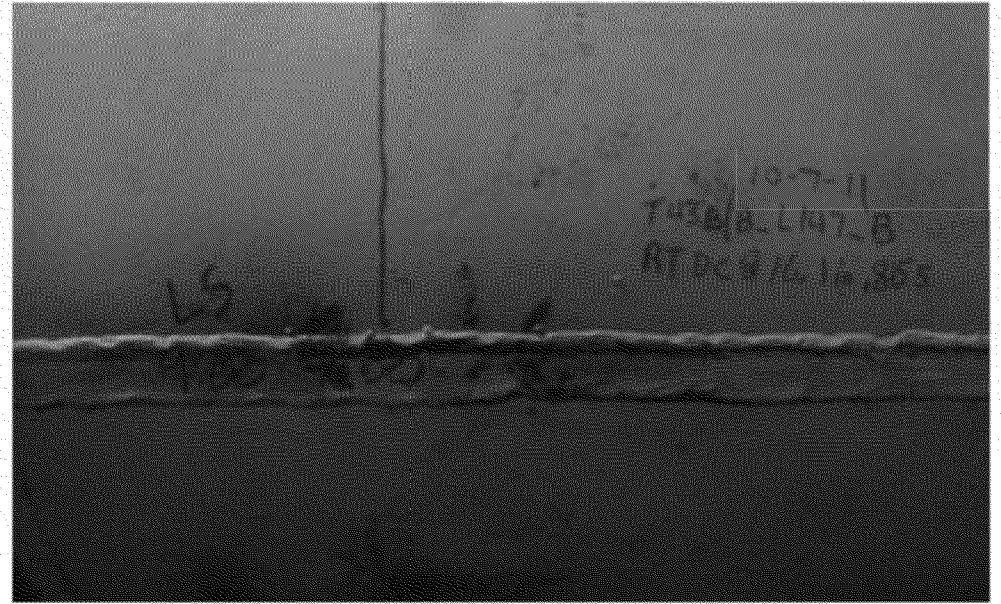
Overview of feature joint long seam @ 8:55.

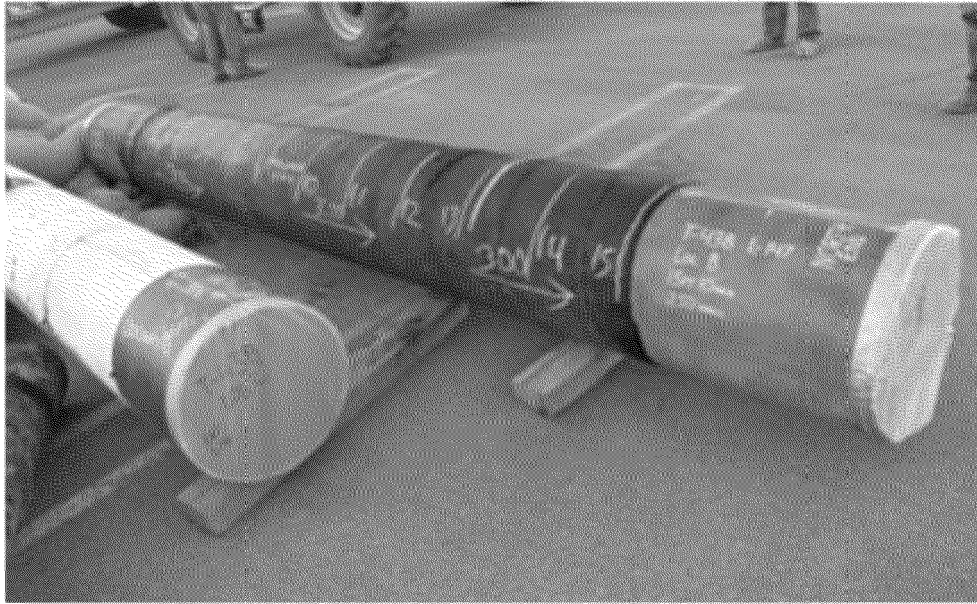
Comments: Coating removed & tie in weld areas blasted. Pipe section removed and test pipes installed. Removed pipe section was also assessed and was in good condition except for coating damage from removal and transportation. See comments page 10.

Removed pipe section coating assesment 3:00

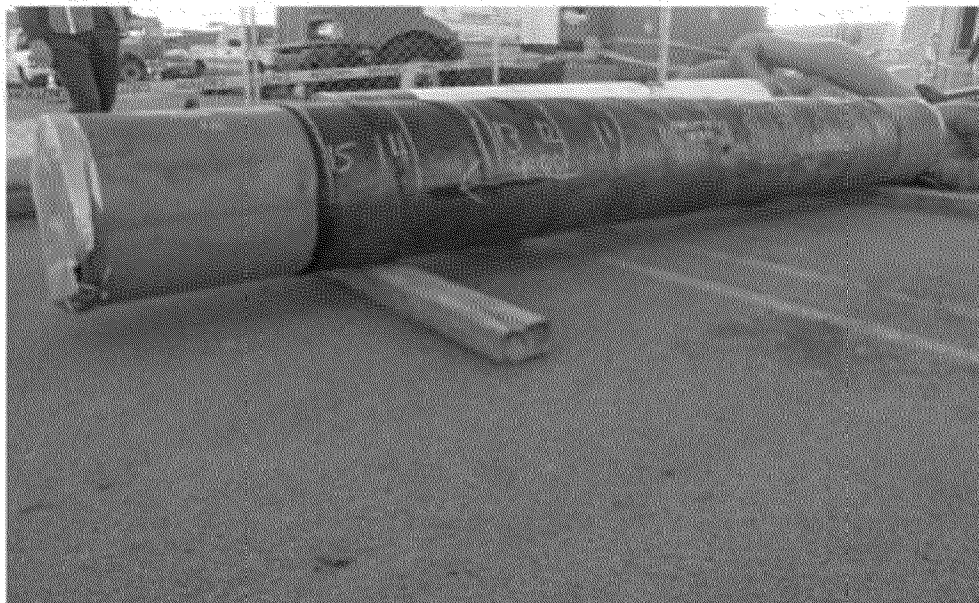
Removed pipe section coating assesment 9:00

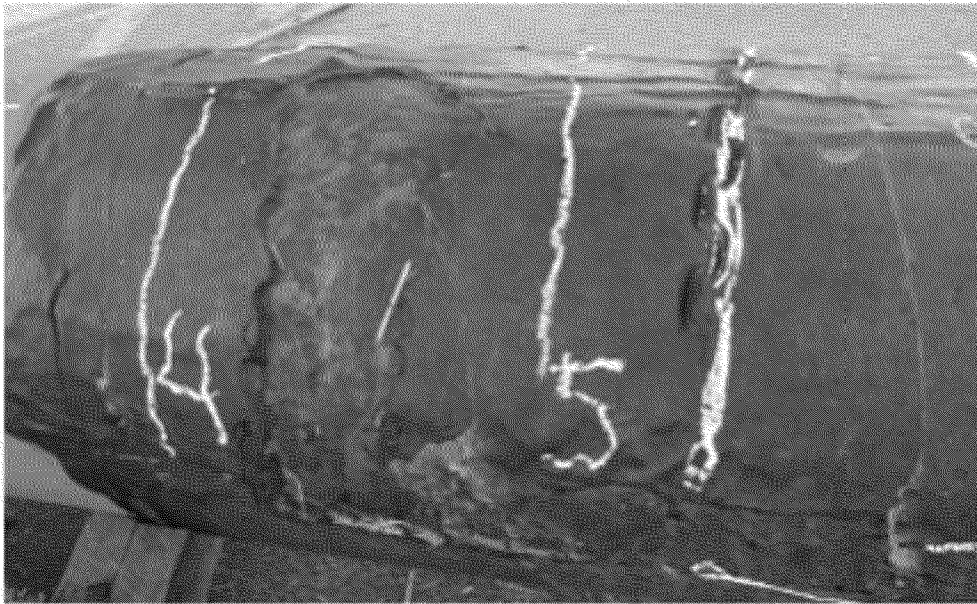
Coating damaged from removal process.

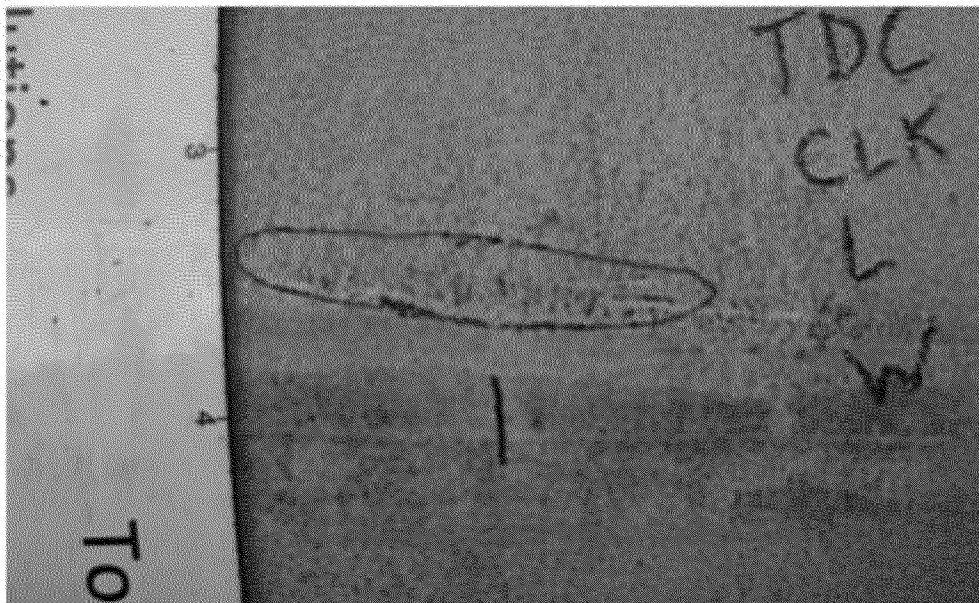
2.6 Wet Fluorescent Mag. Part. Is Required. Comments: 2 linear indications on the removed pipe section. See MT & Photo report.  
 Were there any linear indications?  Yes  No If Yes, attach NDE report electronically as part of the H-Form. Report to include black light and white light photos of indications.

Close-up of MT Indications of LIN-01

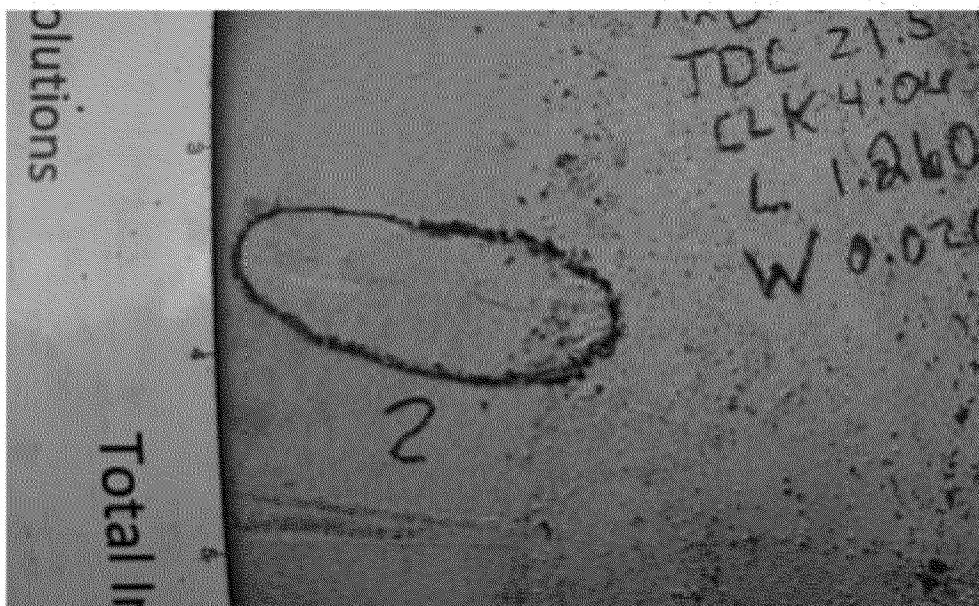
Close-up of MT Indications of LIN-02

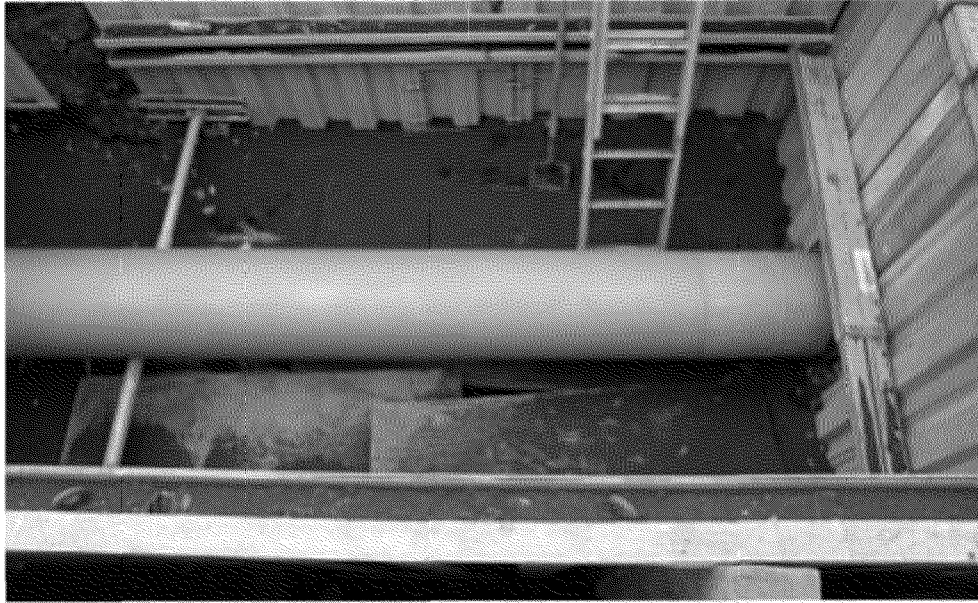
Overview of clean blasted inspection area prior to recoat activities

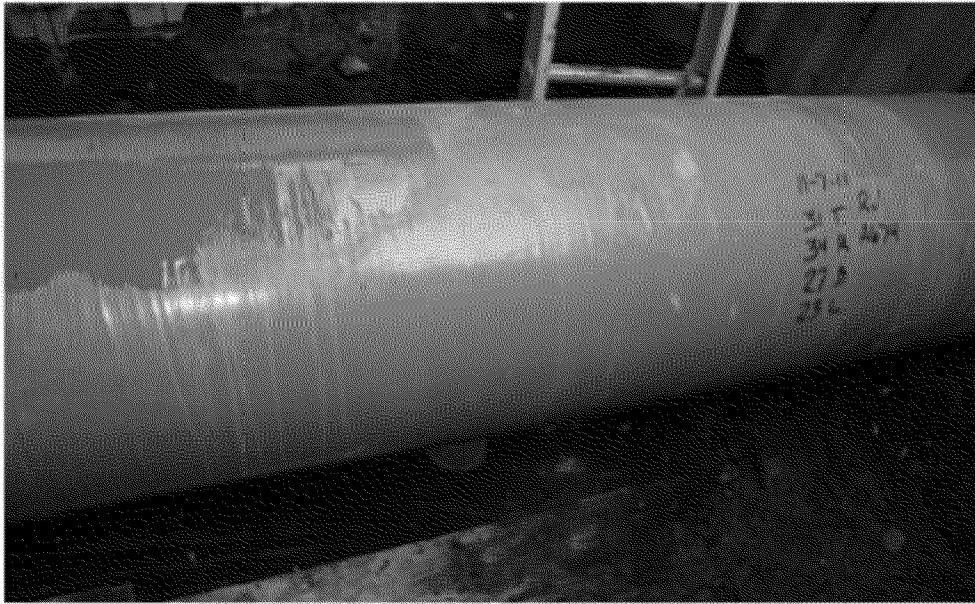
Overview of final coating condition 3:00
