Re: Update - Oakland Incident of December 10, 2013

Investigation Status Update
12/16/2013

Exponent[®]
Failure Analysis Associates[®]

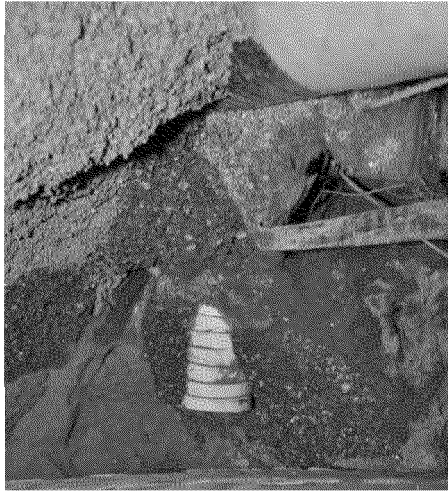
4" gas main and water line

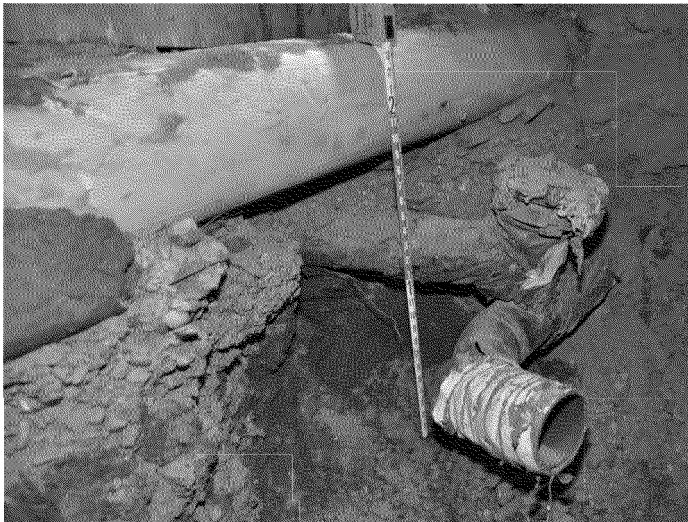
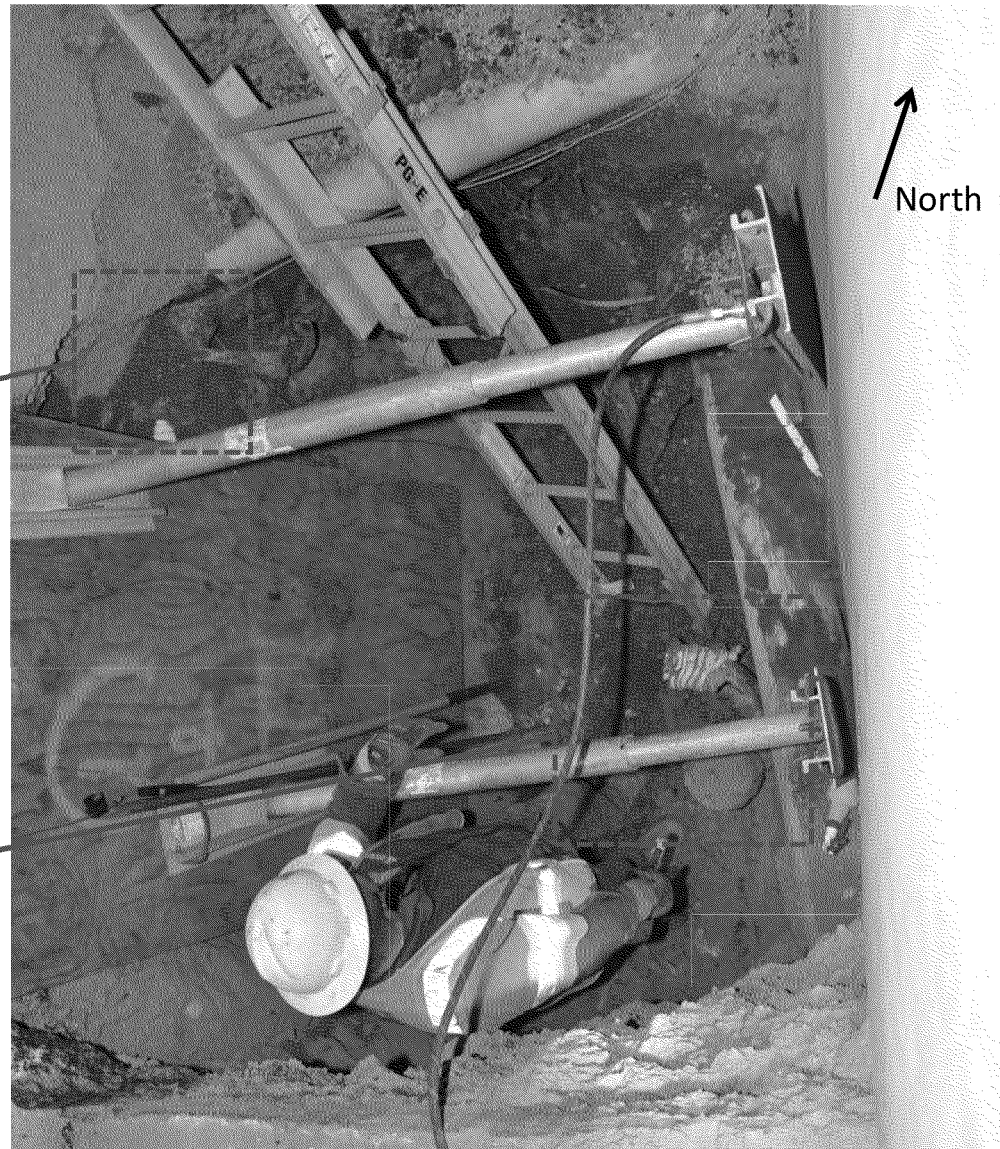
3" and 4" gas mains and sewer line

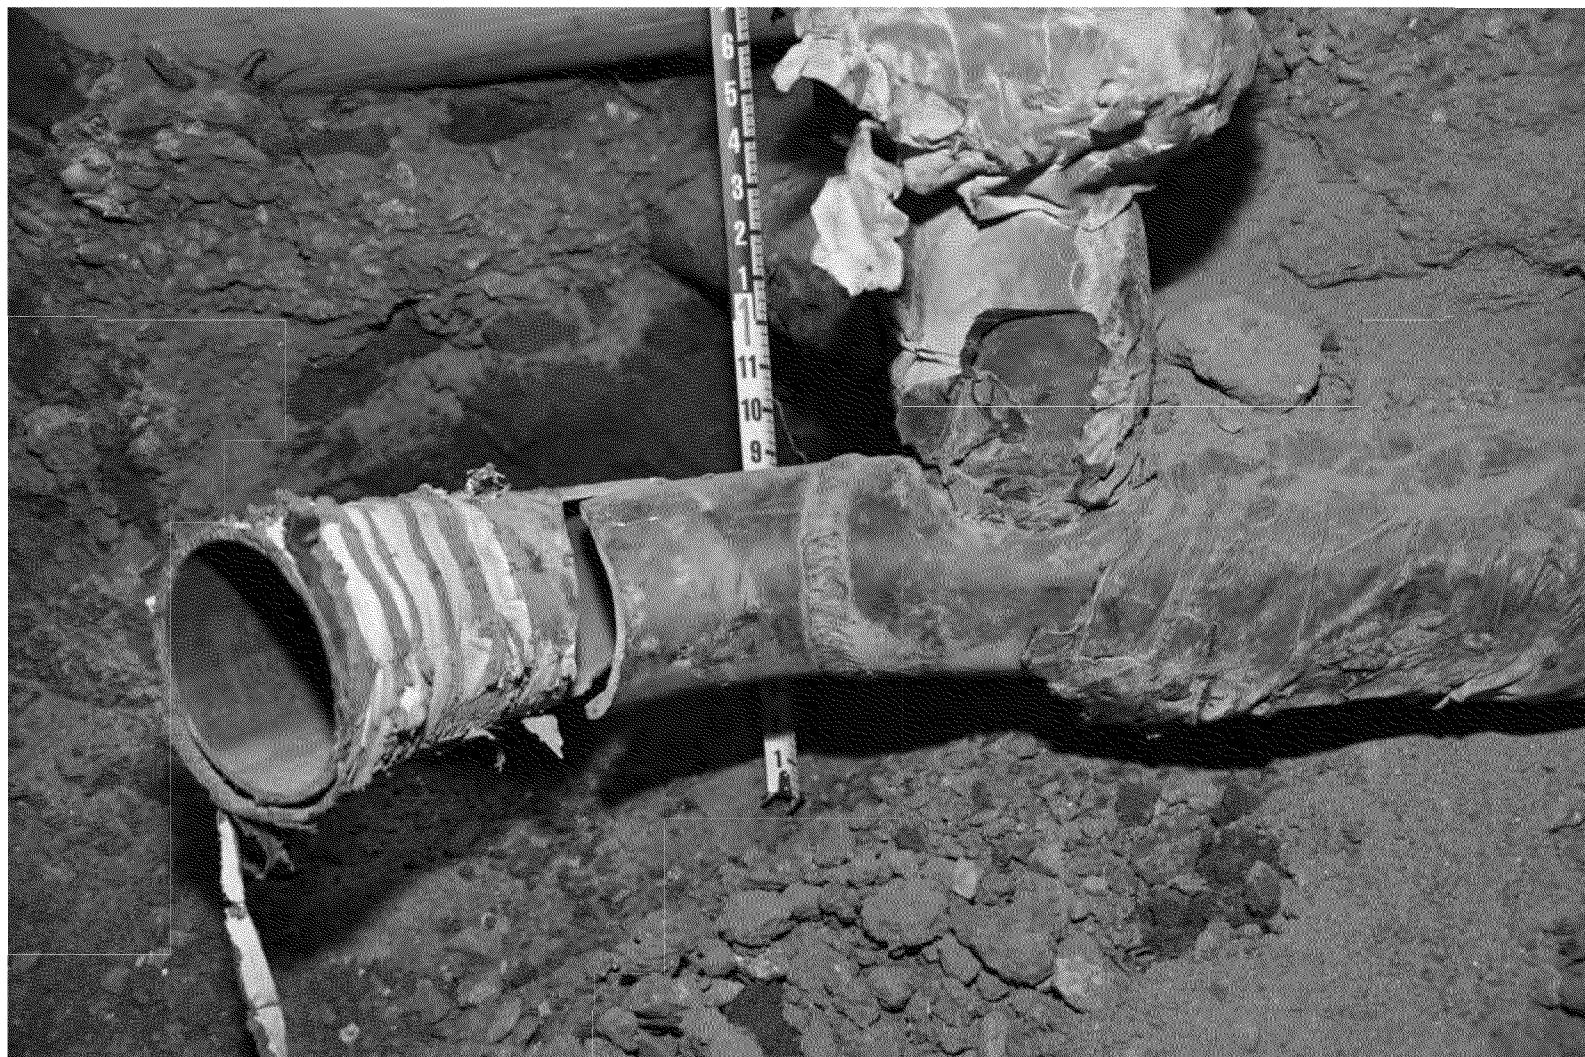
Failed Elbow Before Removal

- The failure of the 4-inch steel elbow resulted from a single, significant external force to the pipeline. The elbow failed at the inner radius due to an external load to the pipe. The cause of the external force is not known at this time. The elbow failed in a brittle failure mode with no indications of yielding or fatigue. Yielding is the point where a material starts to deform due to the loading. In this case, the steel fractured with no indications of deformation.

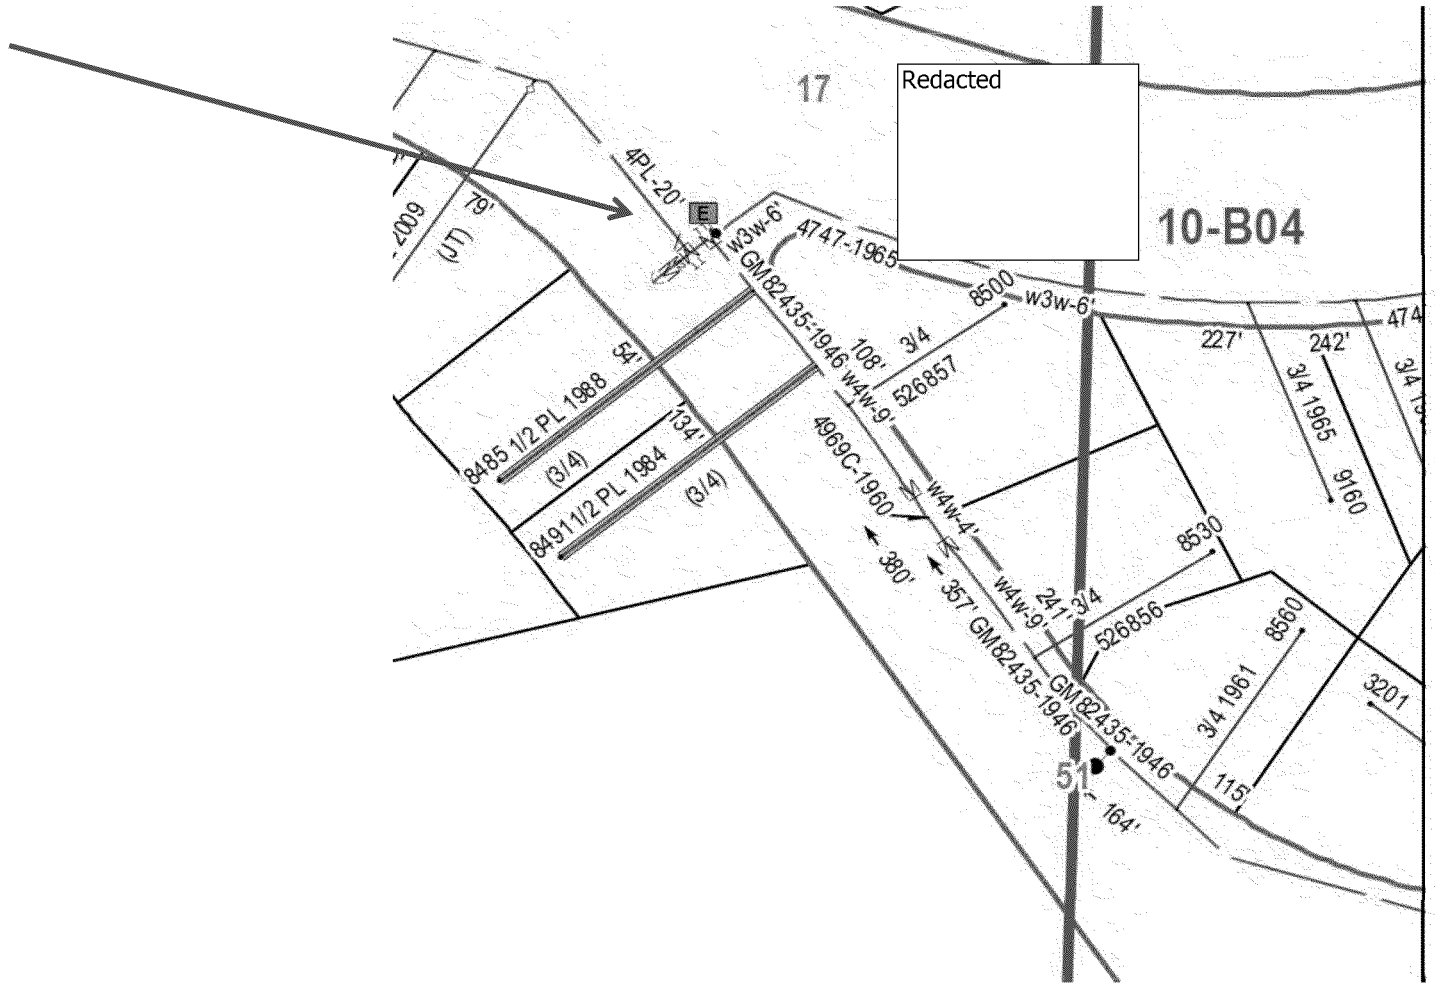
Distribution Plat

- D-Plat 10B-03 shows area of leak
- Indicates three jobs installed mains in the immediate area of the leak

Area of leak

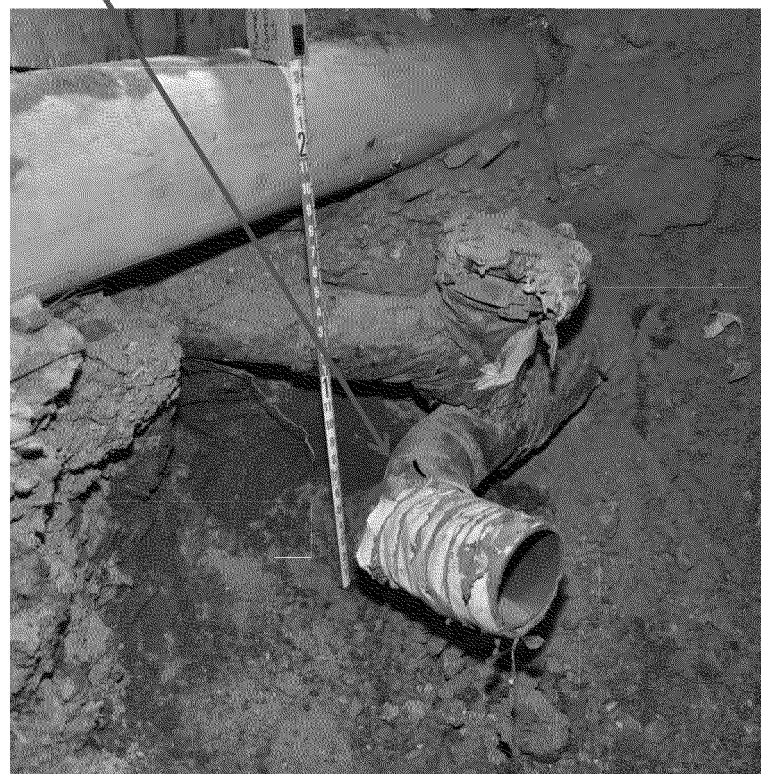
G.M.G. 82435 (1946)

- The 1946 construction drawing shows the installation of 4" 90° elbows and a steel distribution line
- Detail A is consistent with the intersection of Redacted and Redacted
- The location of the 4" 90° elbows is consistent with "existing" features shown in later construction drawings

Installed 4" elbow and 4" main (1946)

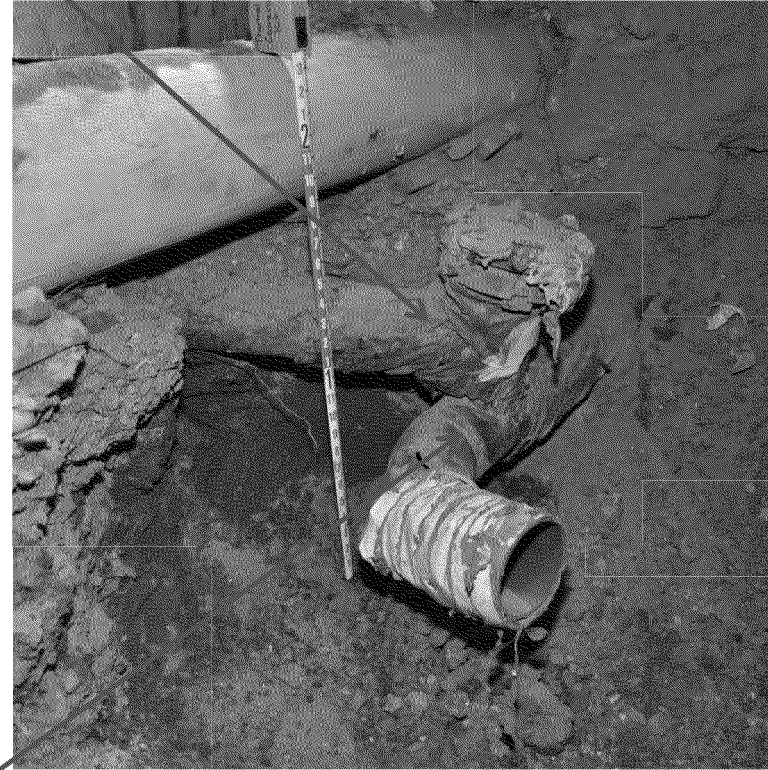
W.O. 4747 (1965)

Installed 3" flanged tee and 3" main (1965)

Existing 4" main (1946)

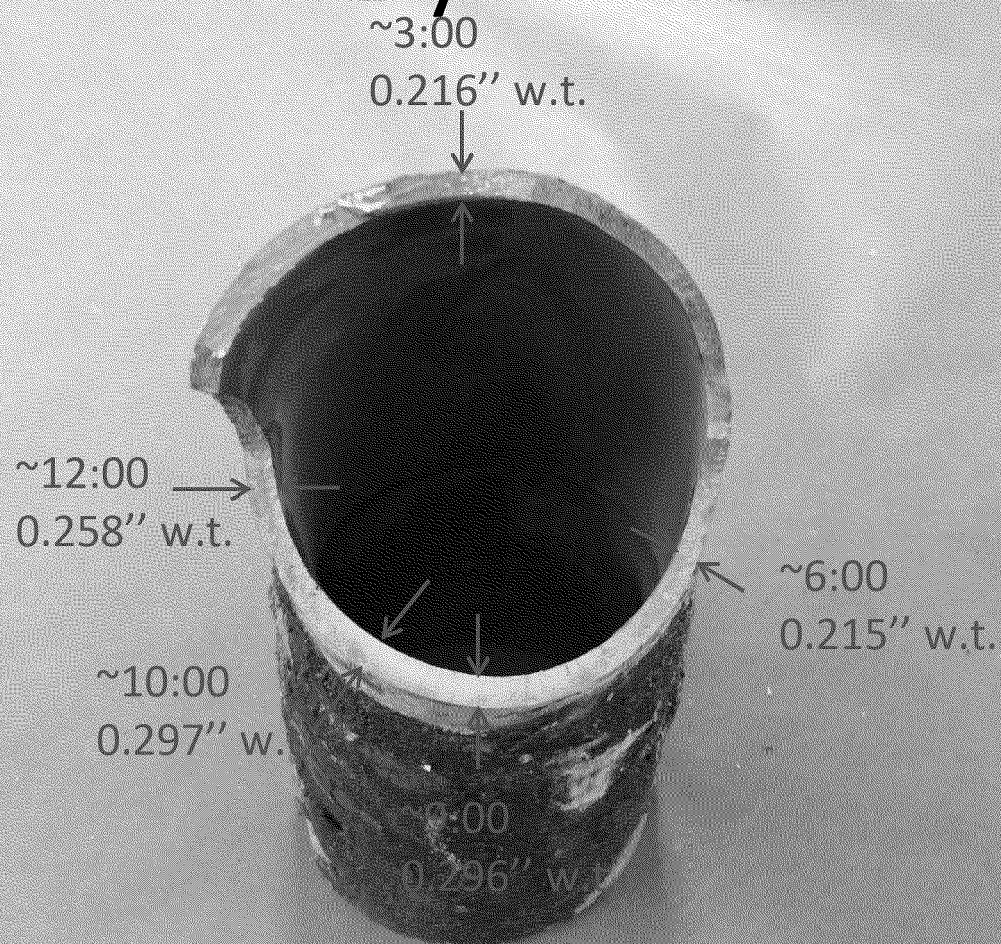
Dimensional Analysis: Wall Thickness

- The affected pipe was installed in 1946 with a Maximum Allowable Operating Pressure of 54 psig and a Normal Operating Pressure of 48 psig. The elbow is seamless and showed limited evidence of corrosion or prior mechanical damage, neither of which contributed to the failure. The materials and configuration of the pipelines in the exposed area are consistent with our as-built records of the pipe installed at the location.

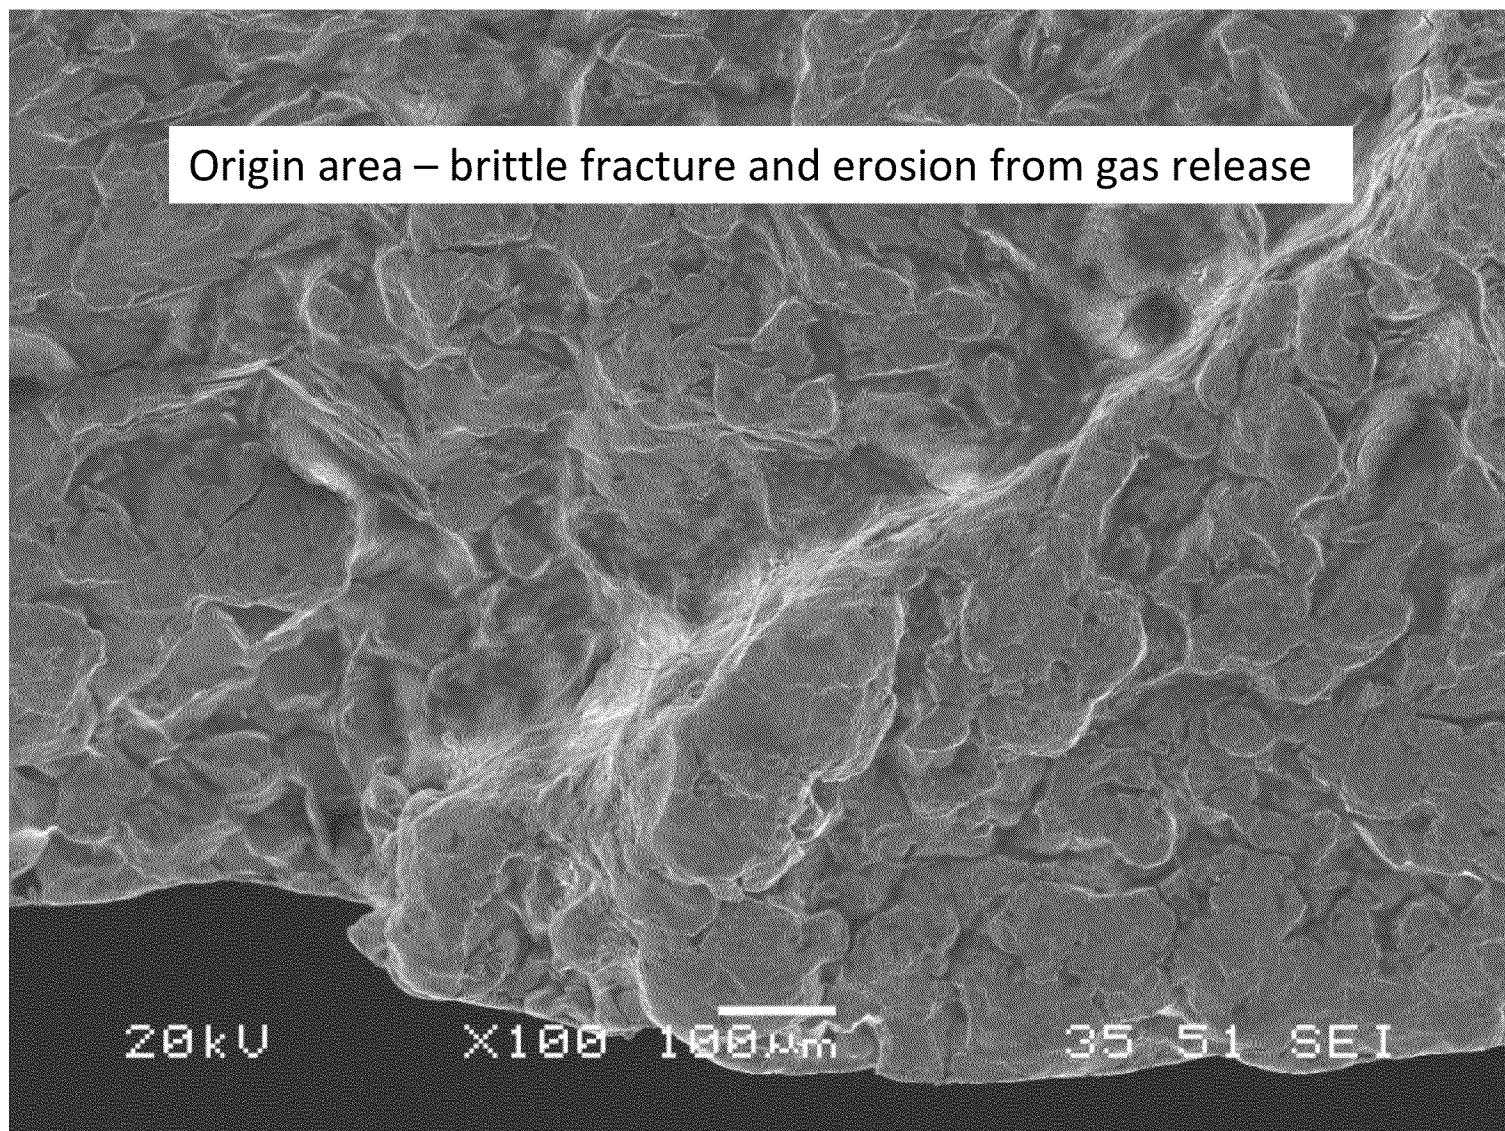
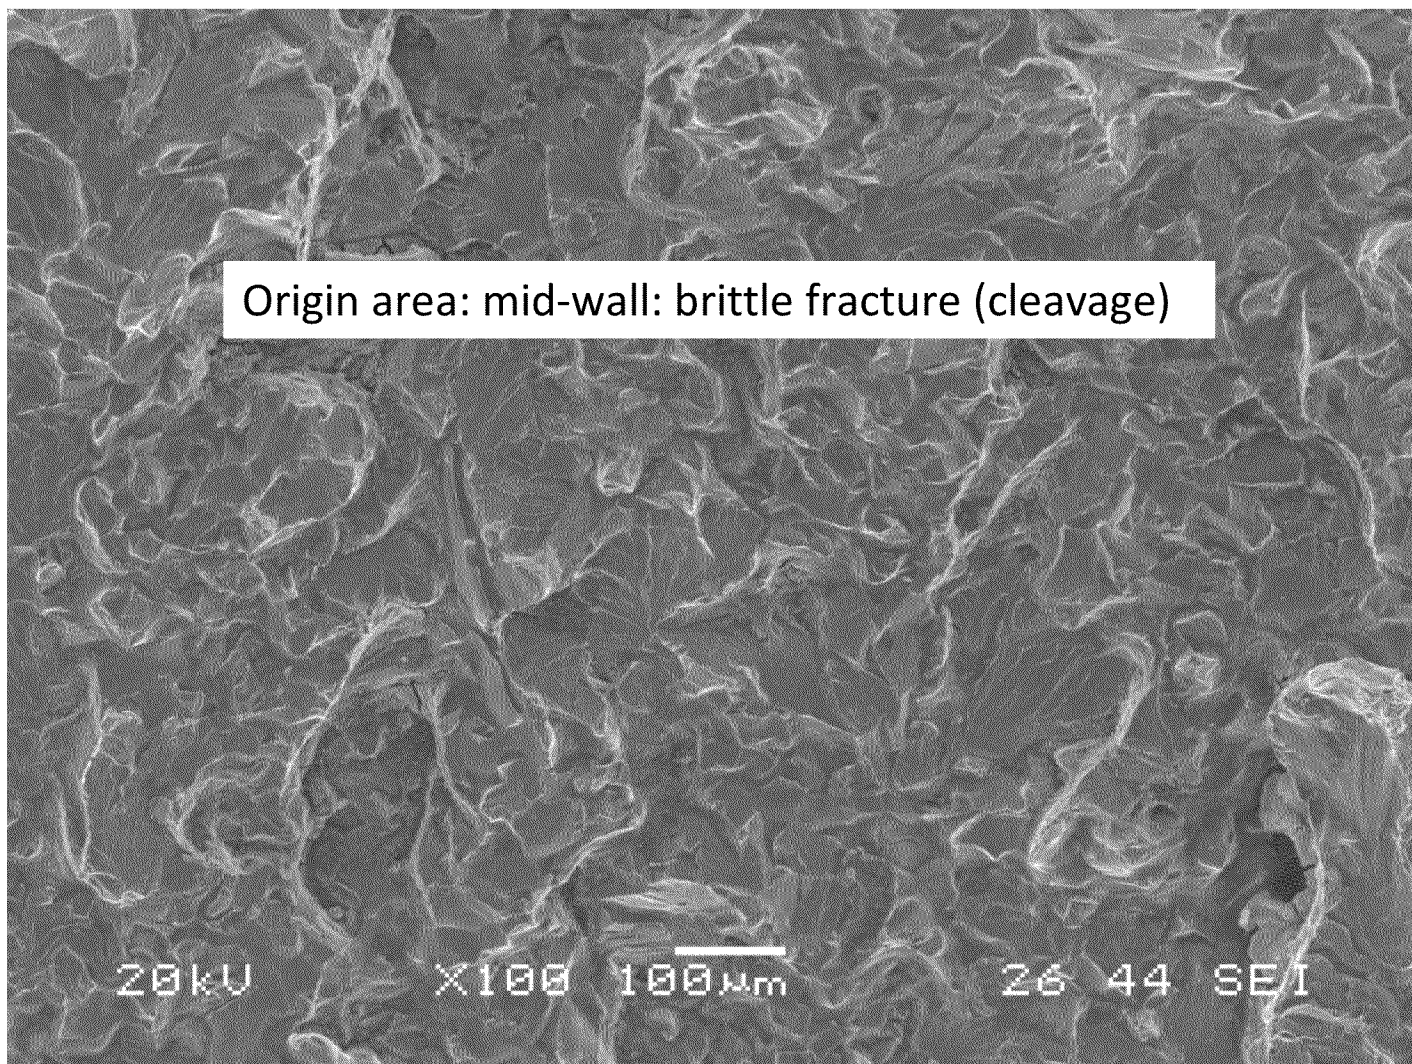
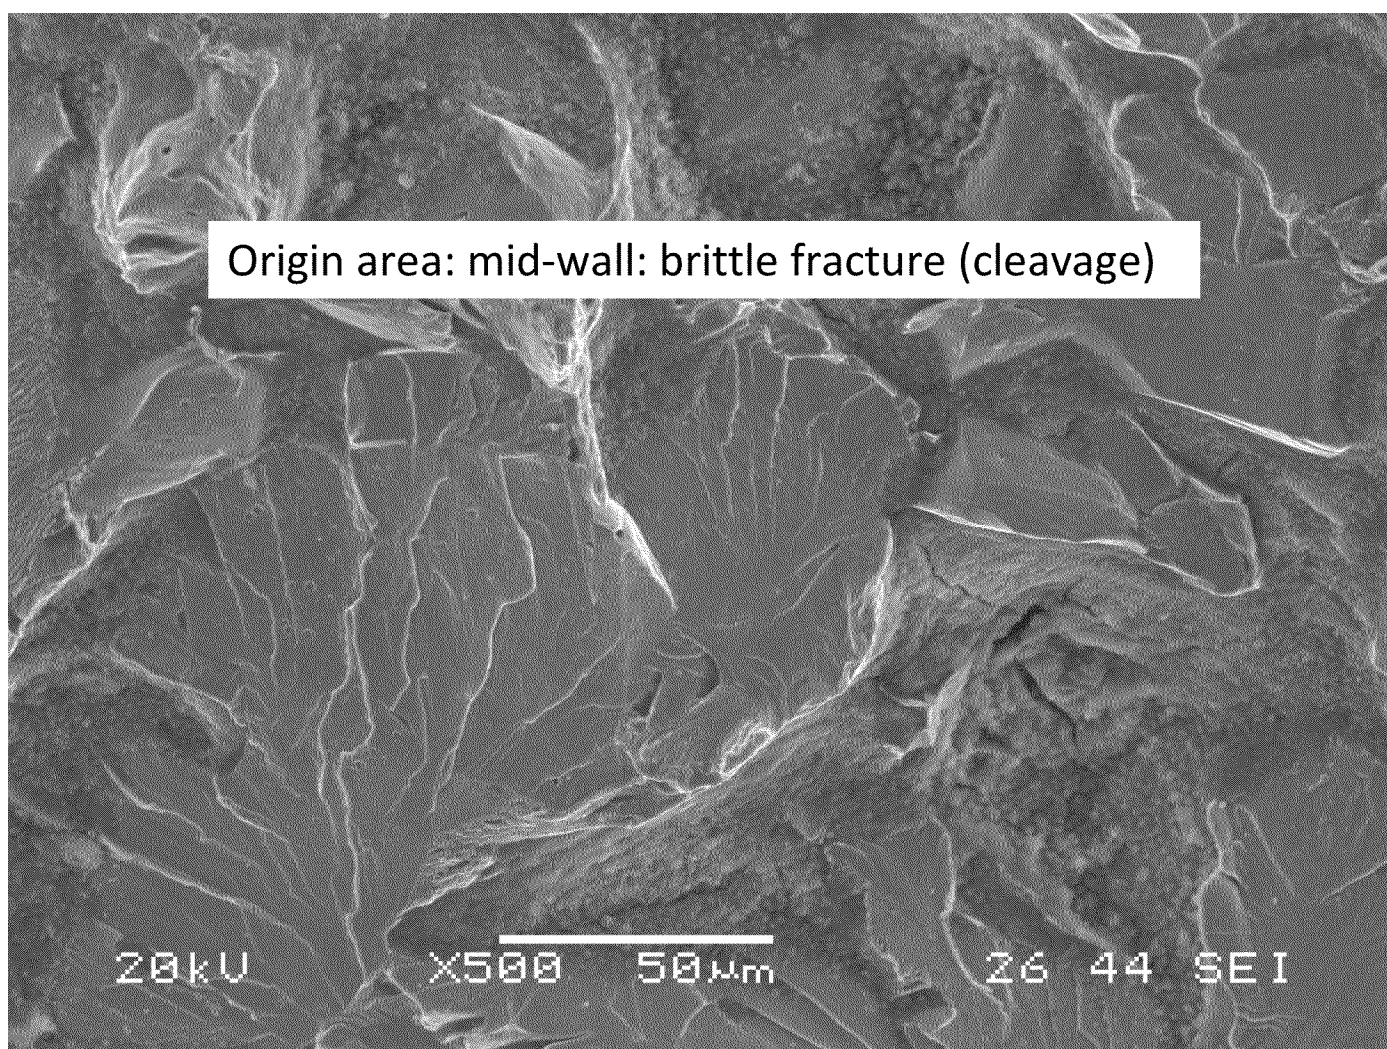
- External forces acting on the pipeline resulted in stresses that exceeded the subject elbow's tensile strength, resulting in its fracture
- The source of these external forces is currently being investigated
- Brittle (cleavage) fracture morphology was observed
- No evidence of progressive fracture (such as fatigue or stress corrosion cracking) was observed
- The fracture was not associated with a mechanical, corrosion-induced, or metallurgical defect
- The elbow exhibited the expected "ferrite-pearlite" microstructure
- The elbow hardness was measured to be 193 HV, roughly equivalent to a UTS of 92 ksi
