Re: Update - Oakland Incident of December 10, 2013

Investigation Status Update
12/16/2013

Exponent[®]
Failure Analysis Associates[®]

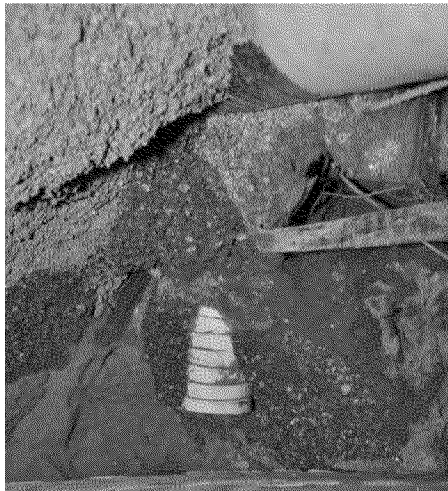
4" gas main and water line

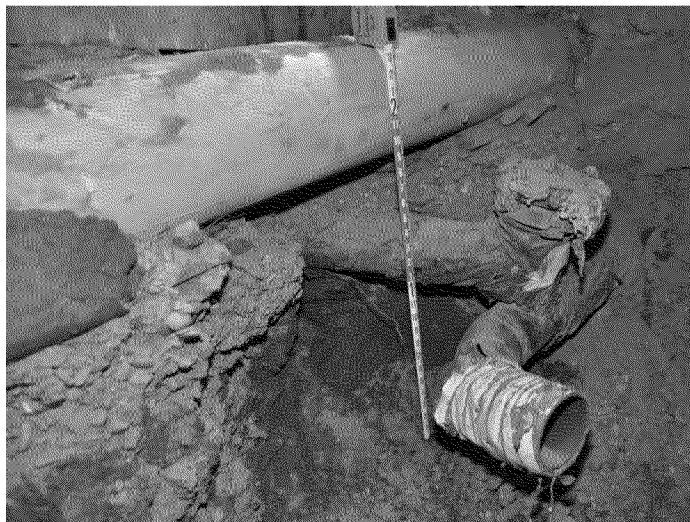
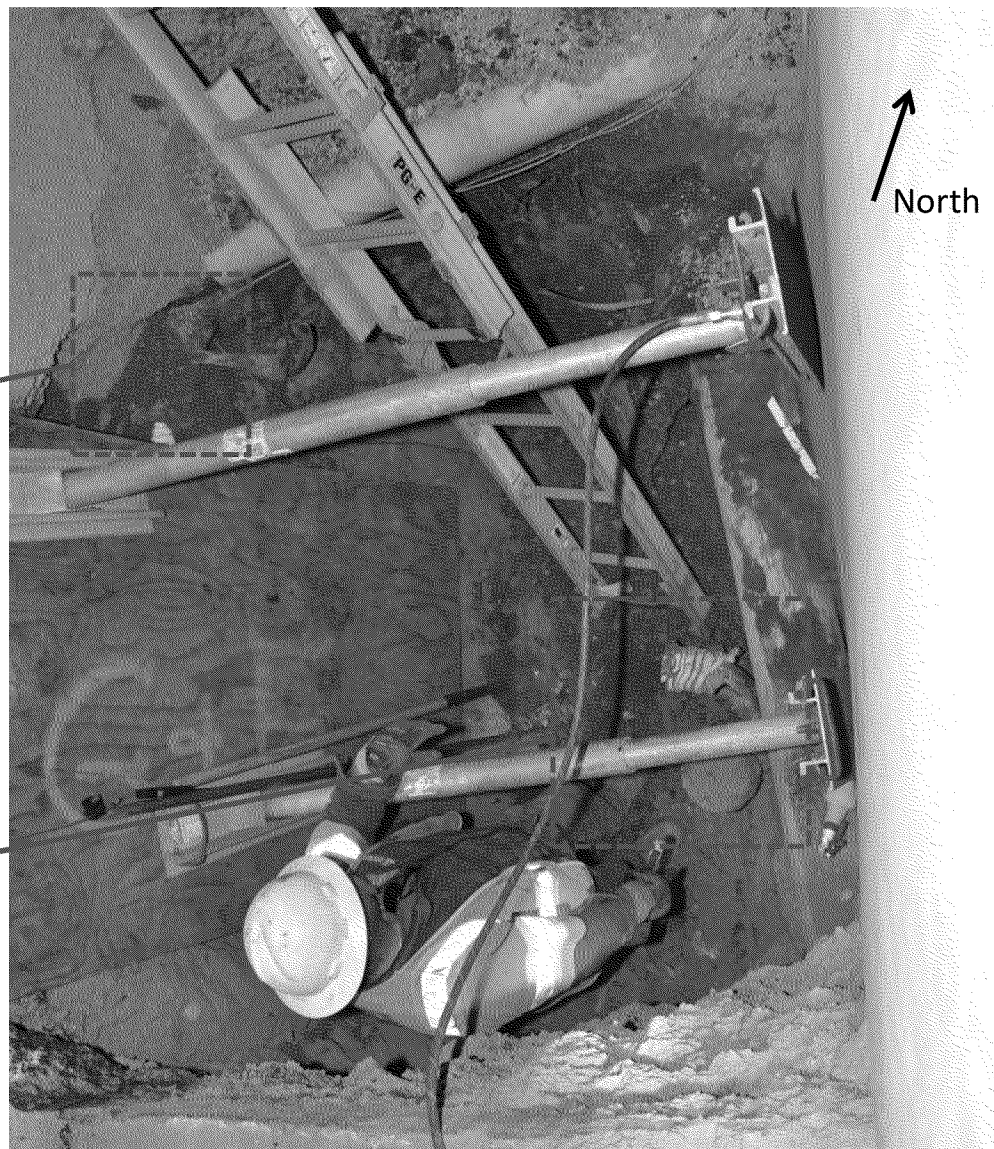
3" and 4" gas mains and sewer line

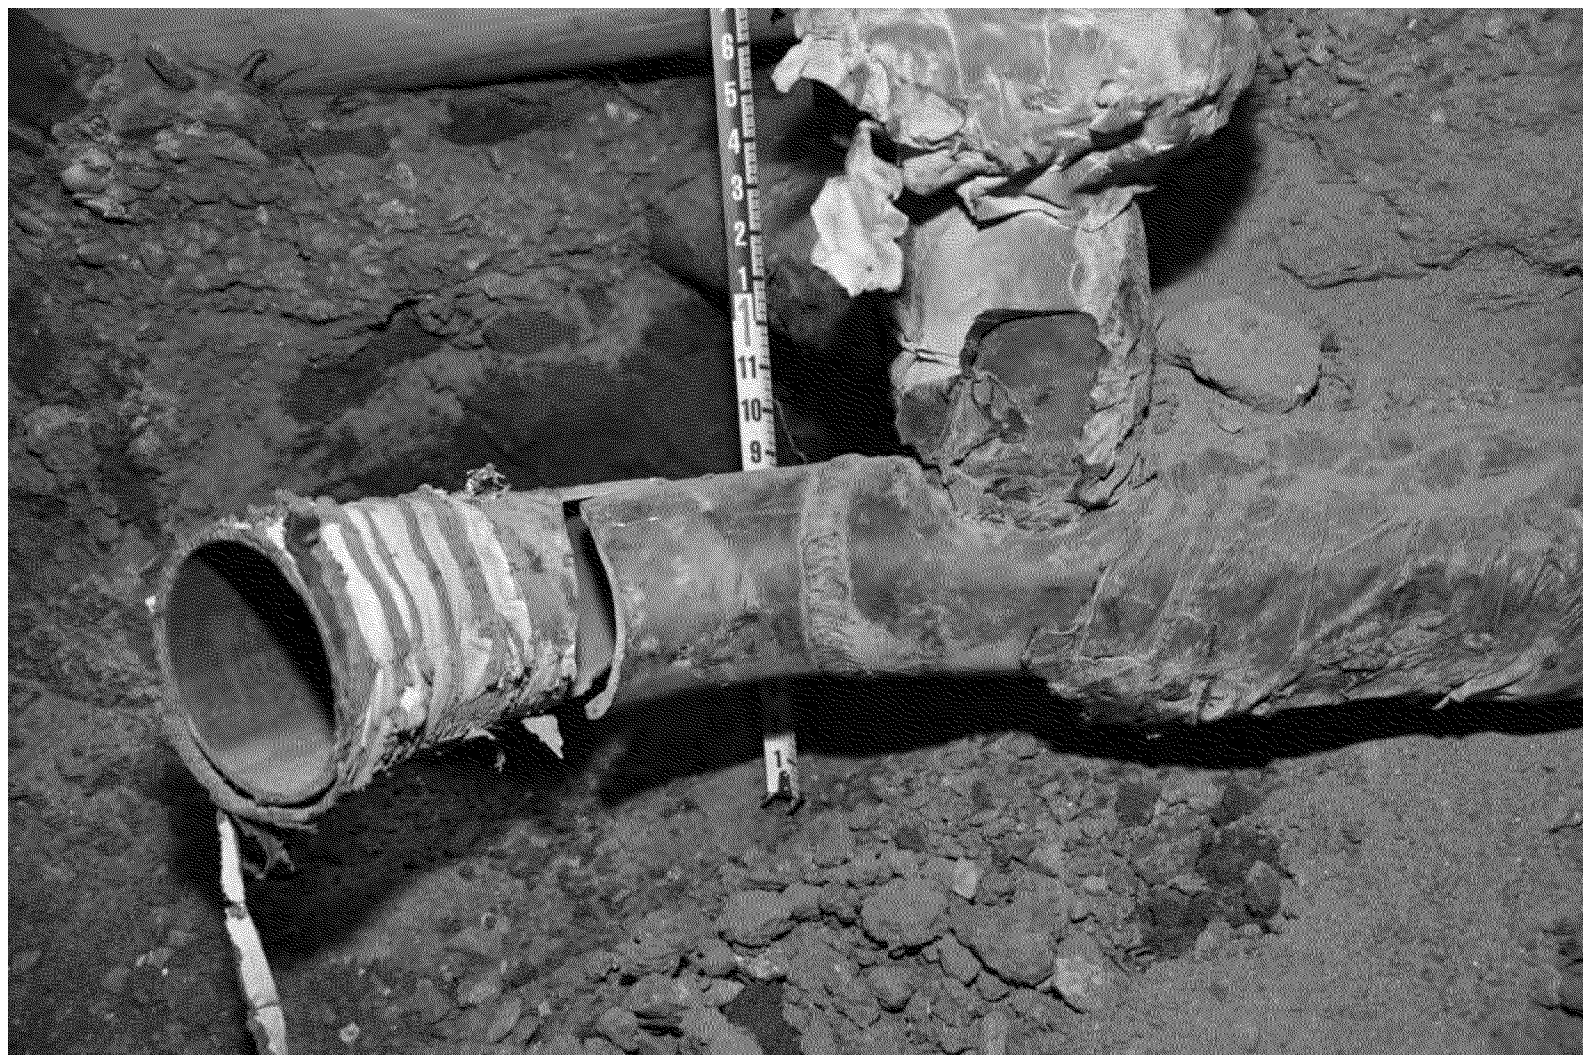
- The failure of the 4-inch steel elbow resulted from a single, significant external force to the pipeline. The elbow failed at the inner radius due to an external load to the pipe. The cause of the external force is not known at this time. The elbow failed in a brittle failure mode with no indications of yielding or fatigue. Yielding is the point where a material starts to deform due to the loading. In this case, the steel fractured with no indications of deformation.

Failed Elbow Before Removal

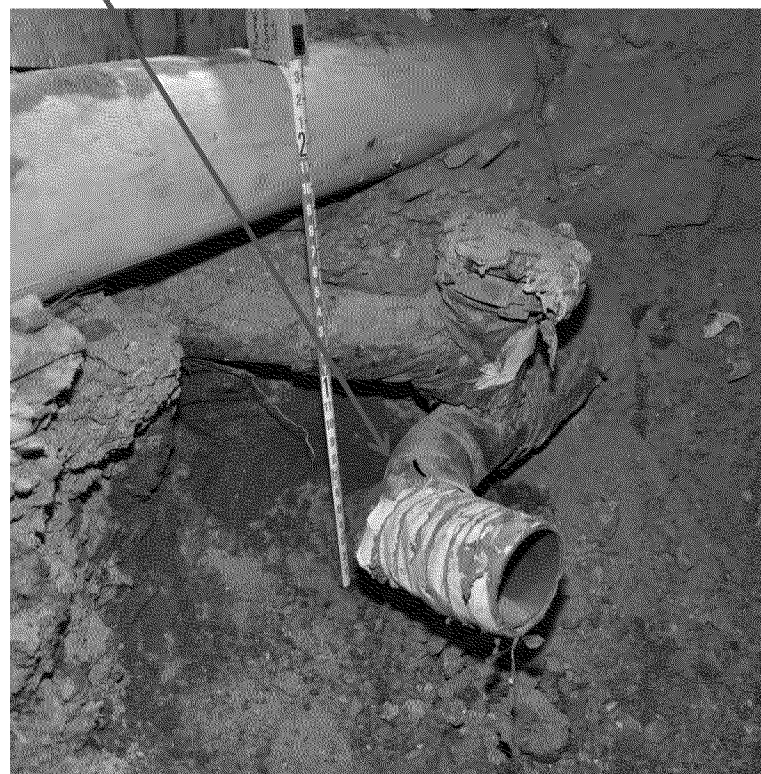
G.M.G. 82435 (1946)

- The 1946 construction drawing shows the installation of 4" 90° elbows and a steel distribution line
- Detail A is consistent with the intersection of Redacted and Redacted
- The location of the 4" 90° elbows is consistent with "existing" features shown in later construction drawings

Installed 4" elbow and 4" main (1946)

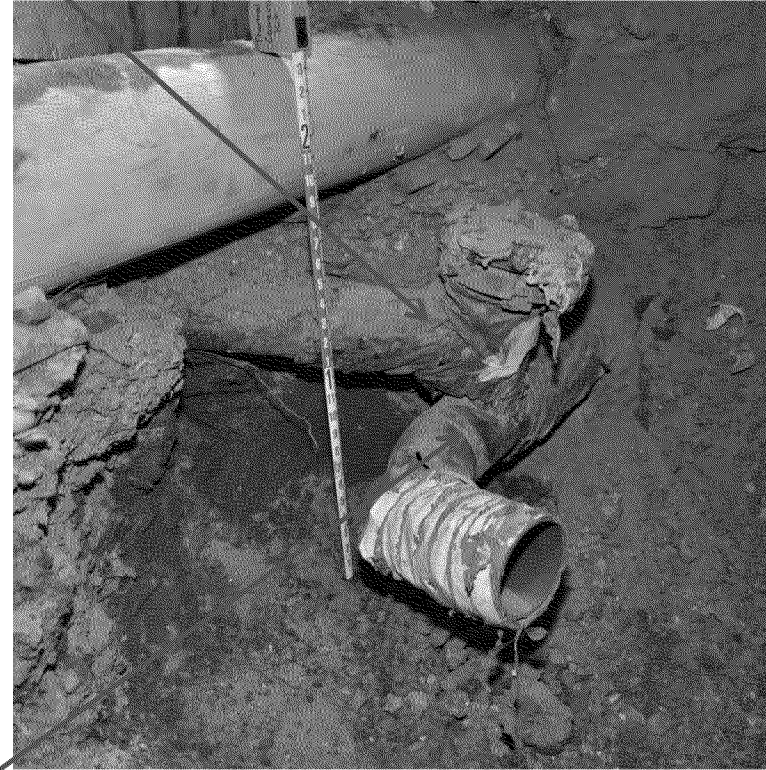
W.O. 4747 (1965)

Installed 3" flanged tee and 3" main (1965)

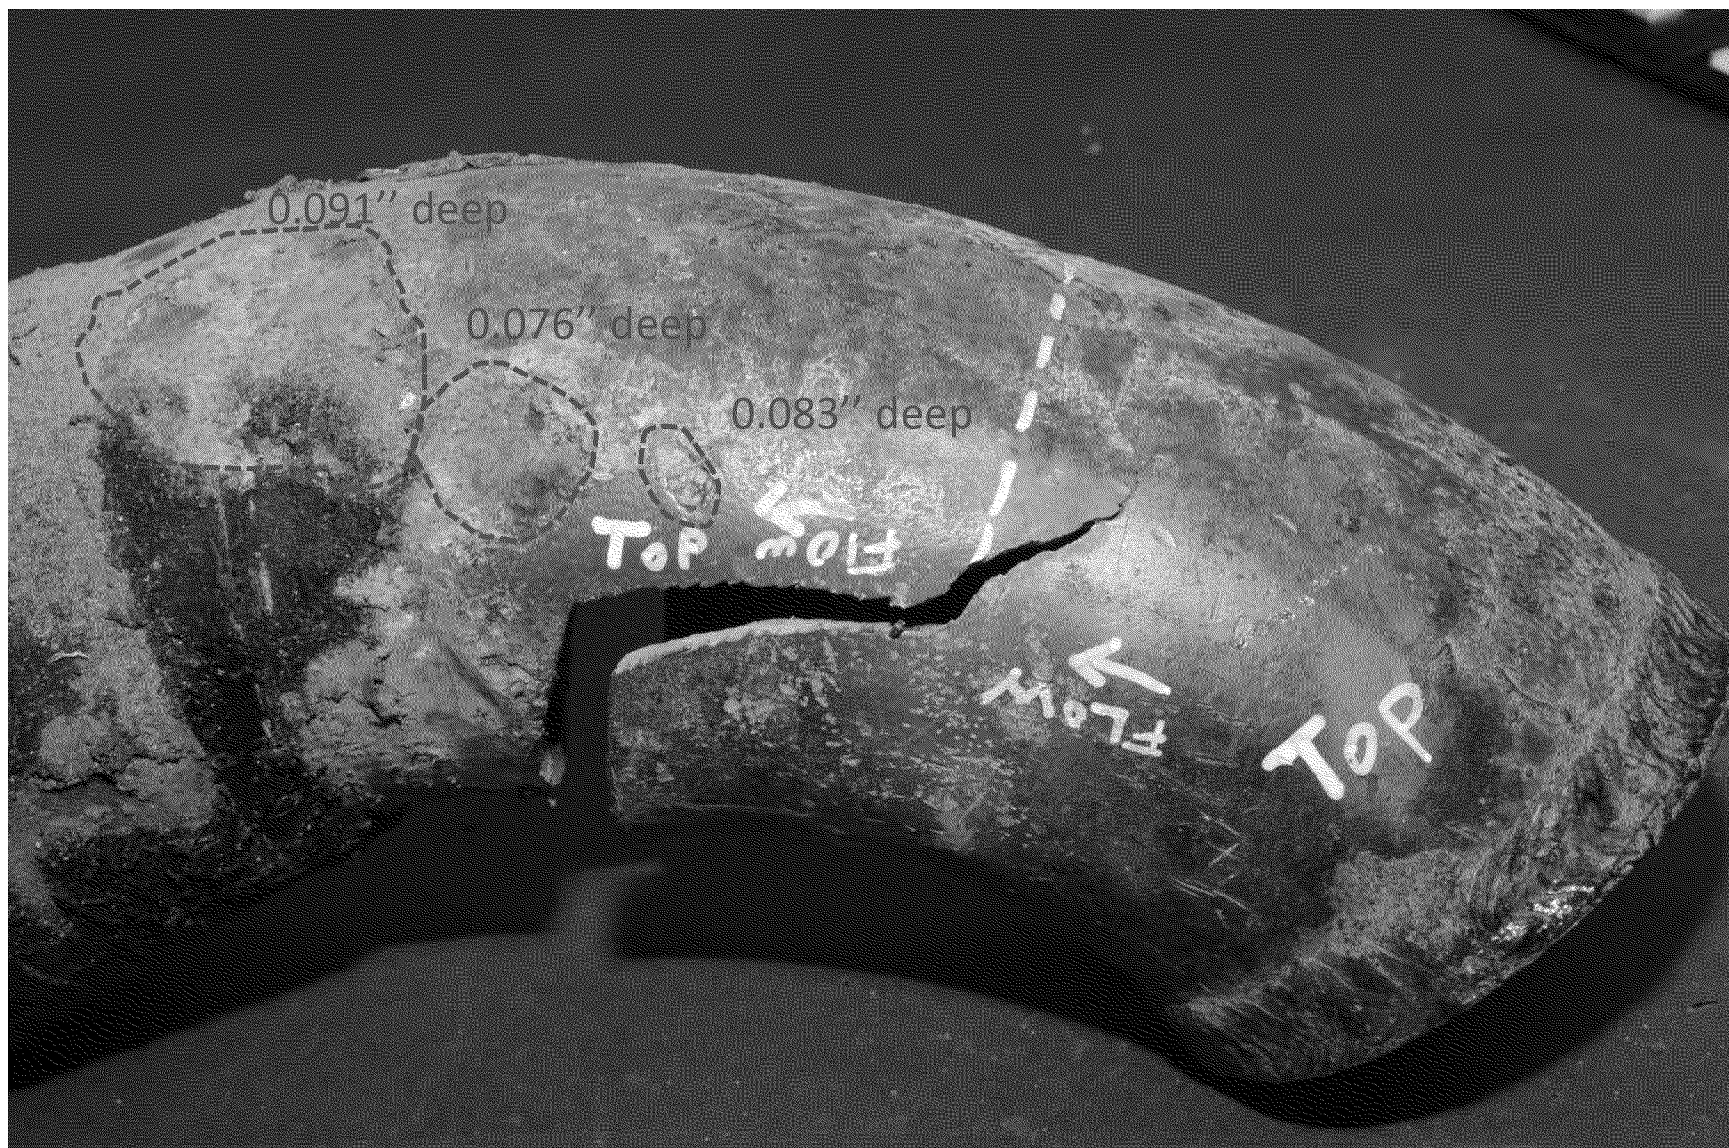
Dimensional Analysis: Corrosion

- The affected pipe was installed in 1946 with a Maximum Allowable Operating Pressure of 54 psig and a Normal Operating Pressure of 48 psig. The elbow is seamless and showed limited evidence of corrosion or prior mechanical damage, neither of which contributed to the failure. The materials and configuration of the pipelines in the exposed area are consistent with our as-built records of the pipe installed at the location.

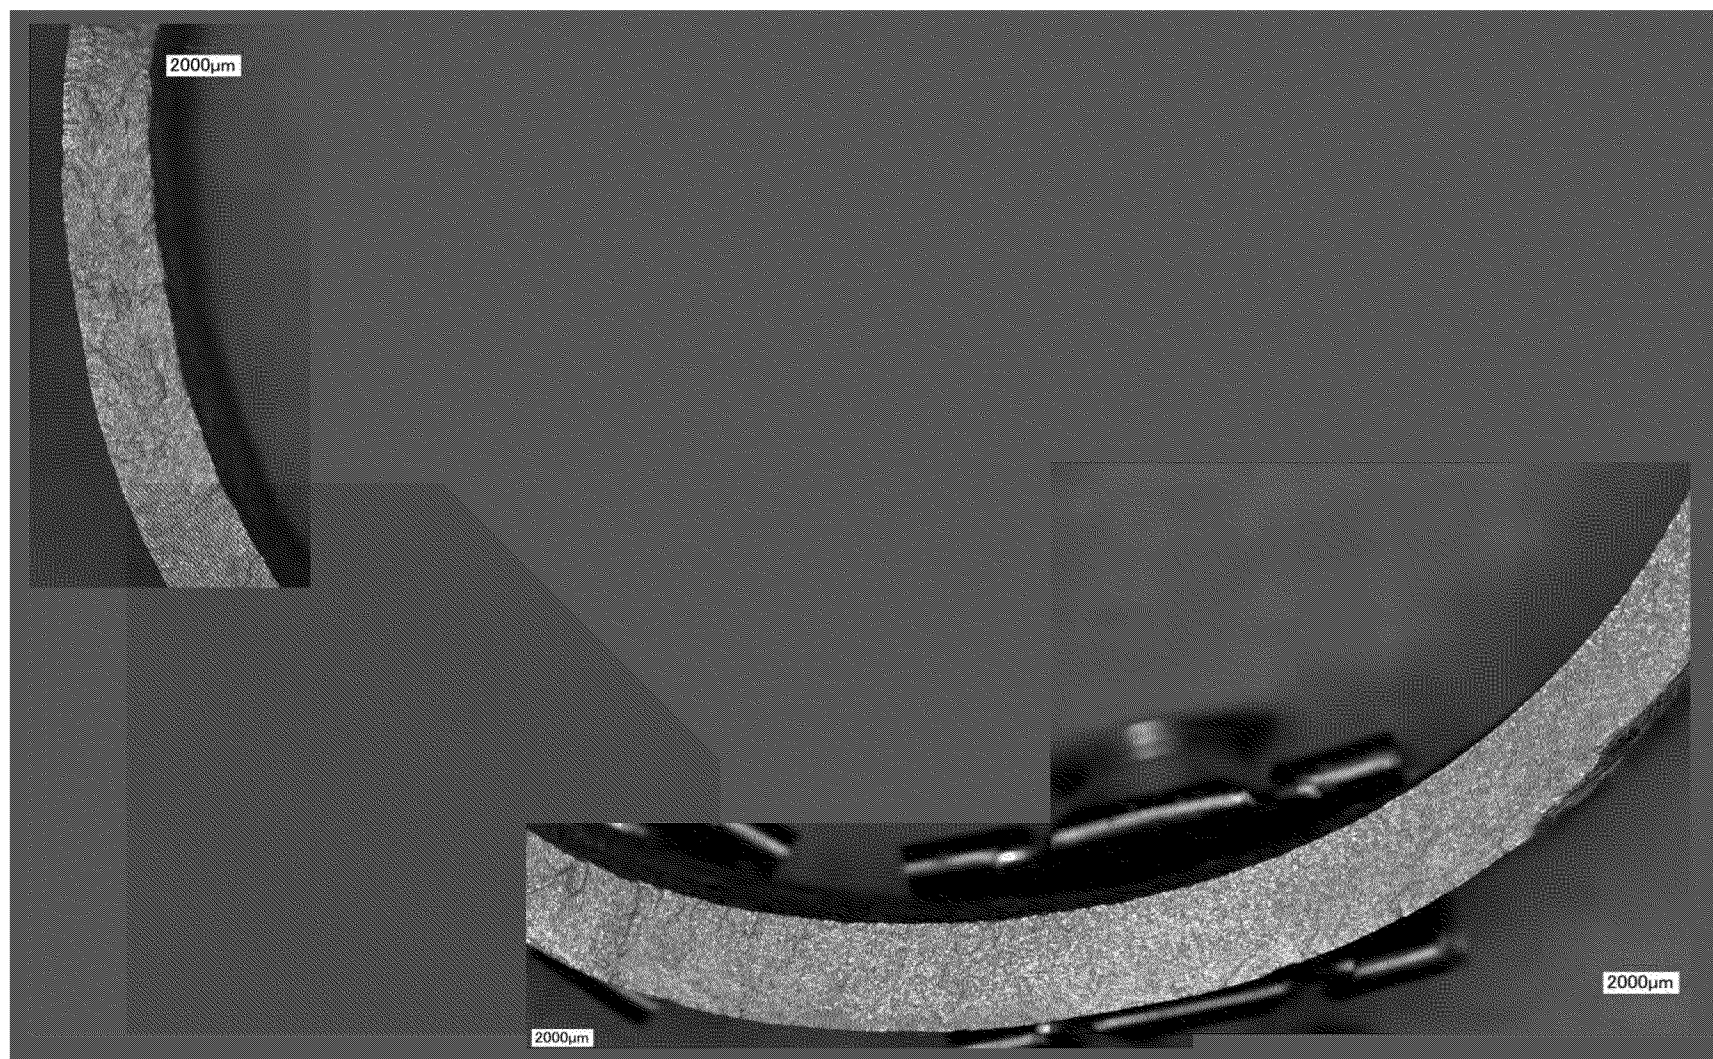
Optical Microscopy

Fracture Origin

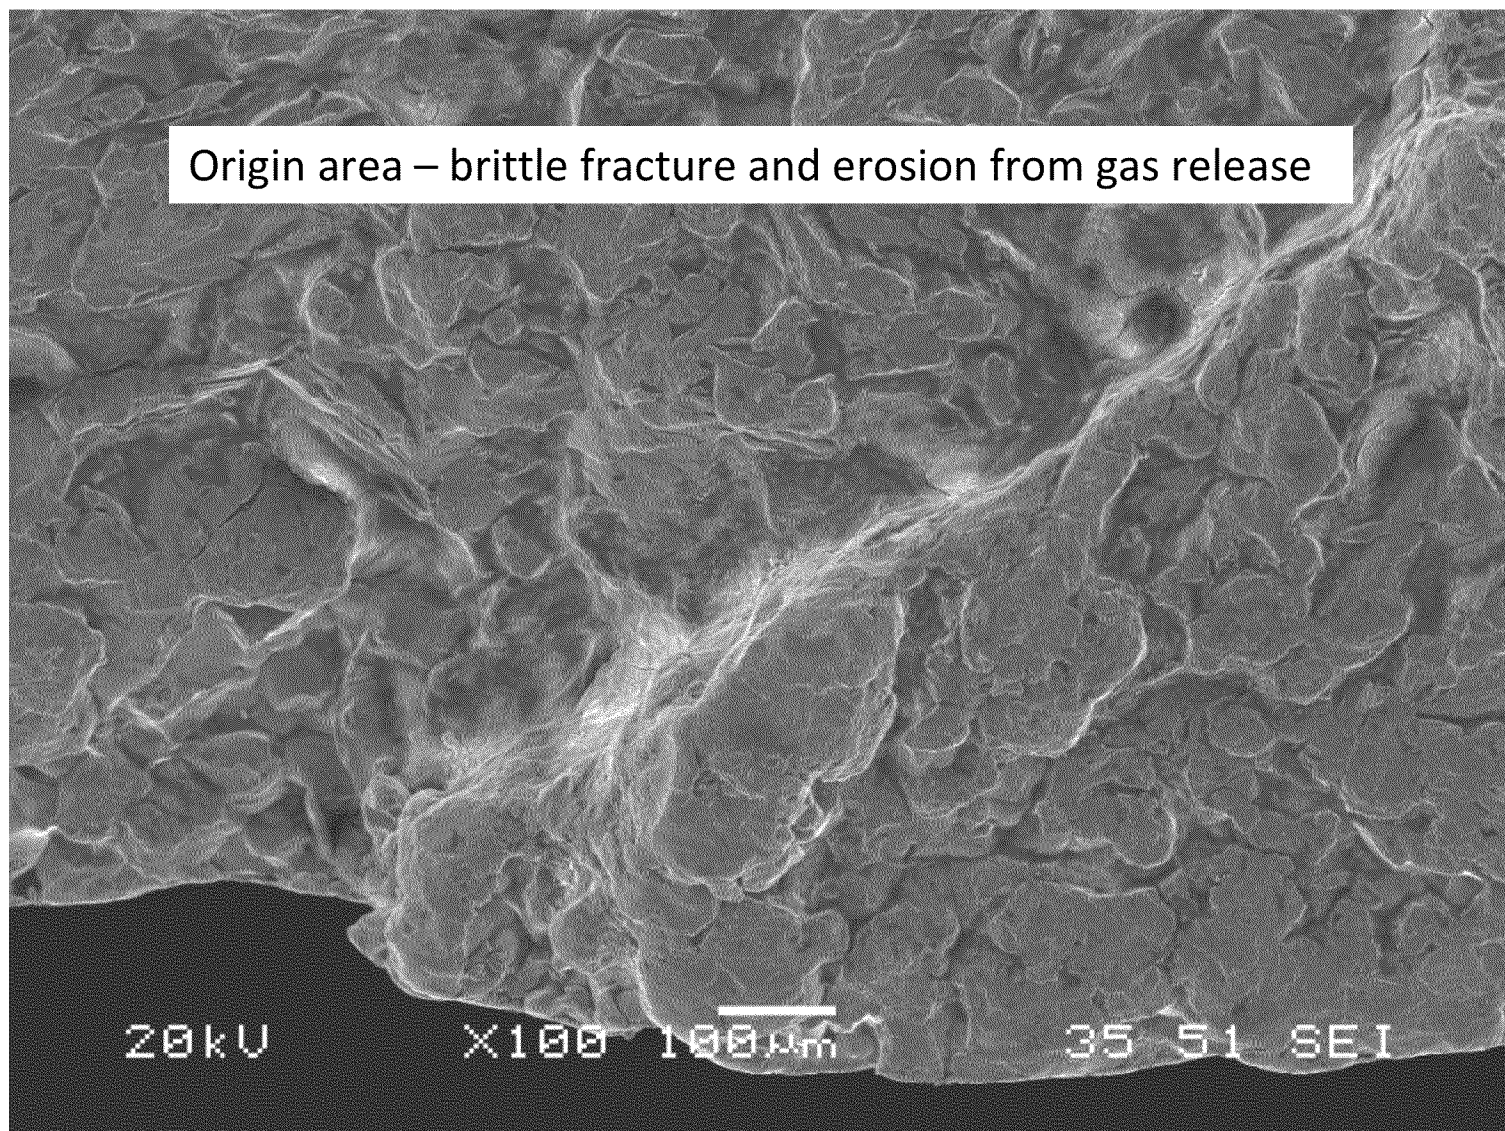
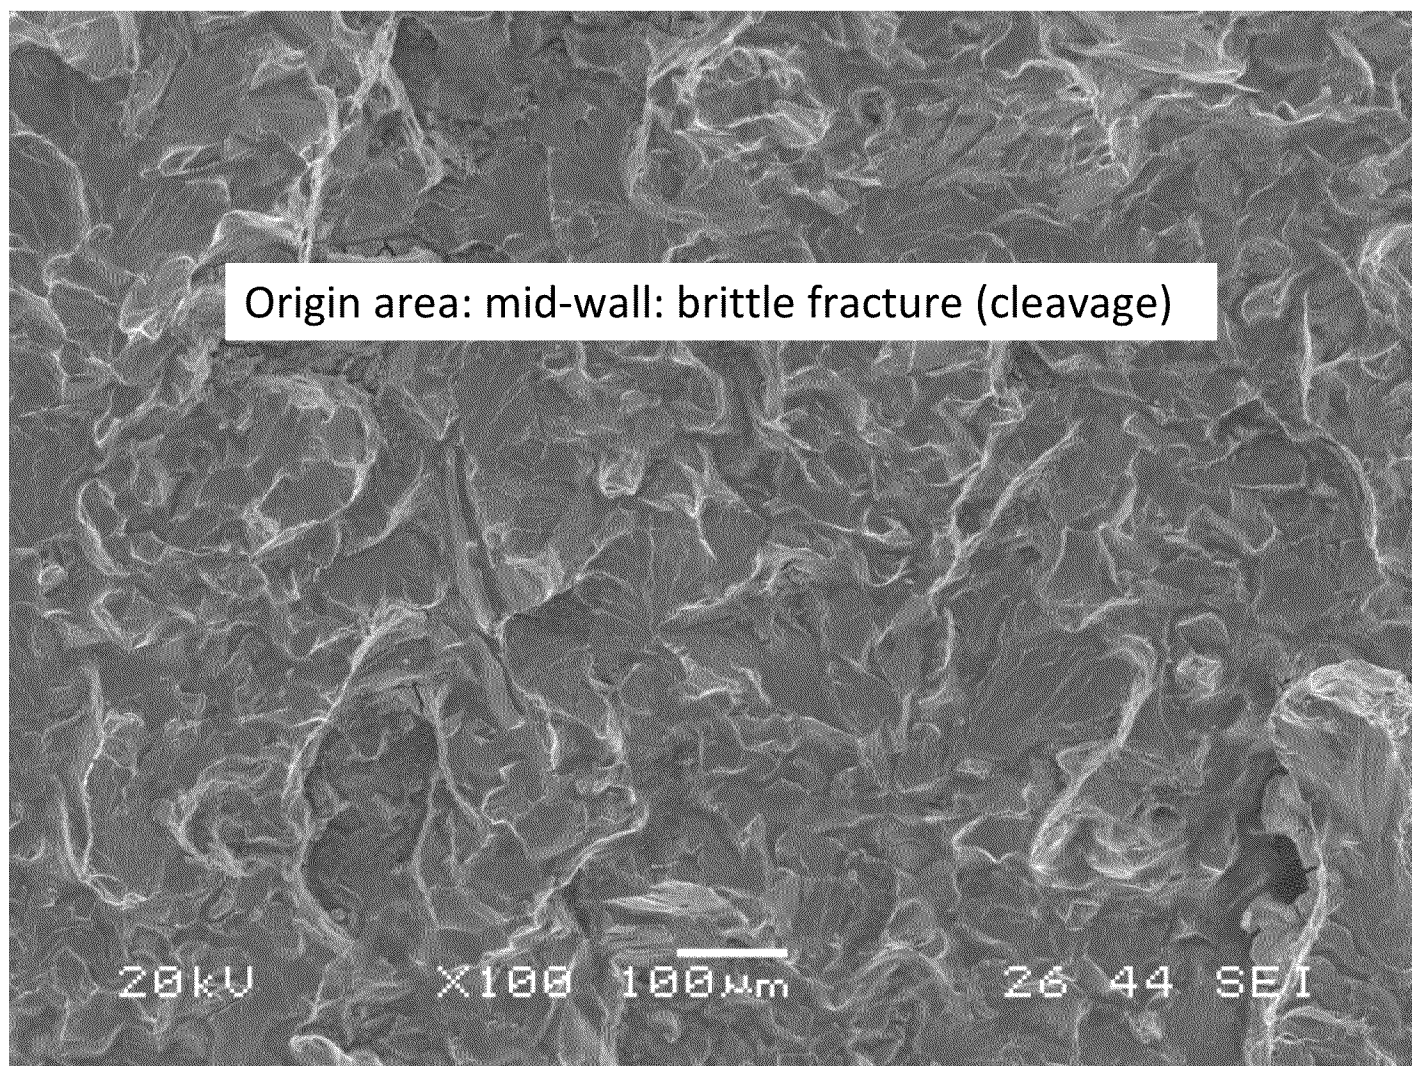
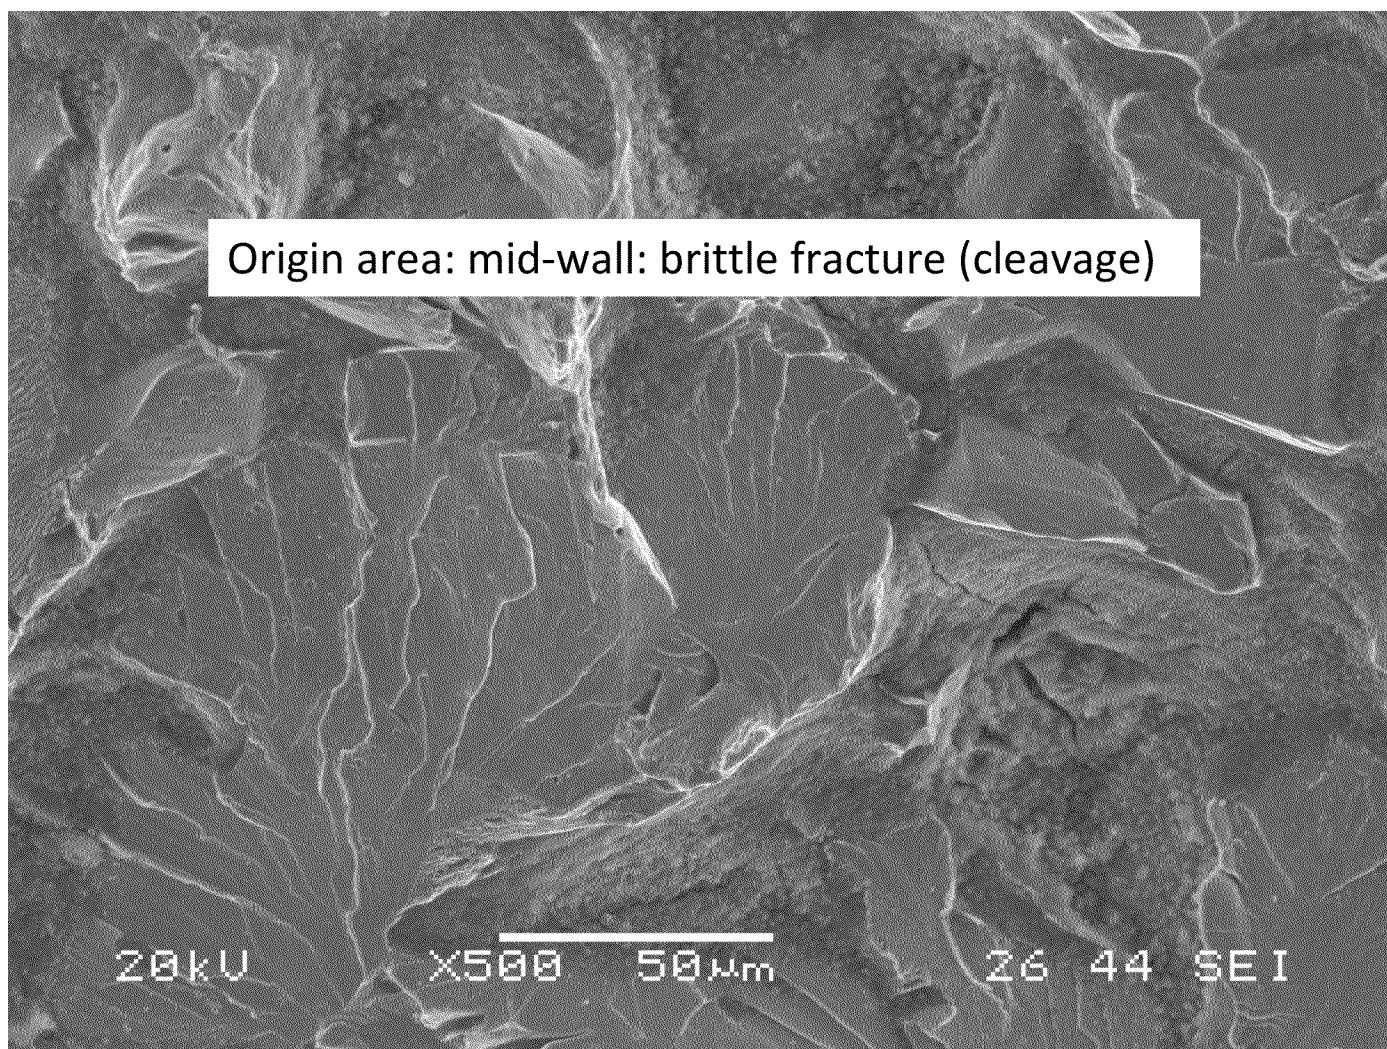
Scanning Electron Microscopy

- External forces acting on the pipeline resulted in stresses that exceeded the subject elbow's tensile strength, resulting in its fracture
- The source of these external forces is currently being investigated
- Brittle (cleavage) fracture morphology was observed
- No evidence of progressive fracture (such as fatigue or stress corrosion cracking) was observed
- The fracture was not associated with a mechanical, corrosion-induced, or metallurgical defect
- The elbow exhibited the expected "ferrite-pearlite" microstructure
- The elbow hardness was measured to be 193 HV, roughly equivalent to a UTS of 92 ksi

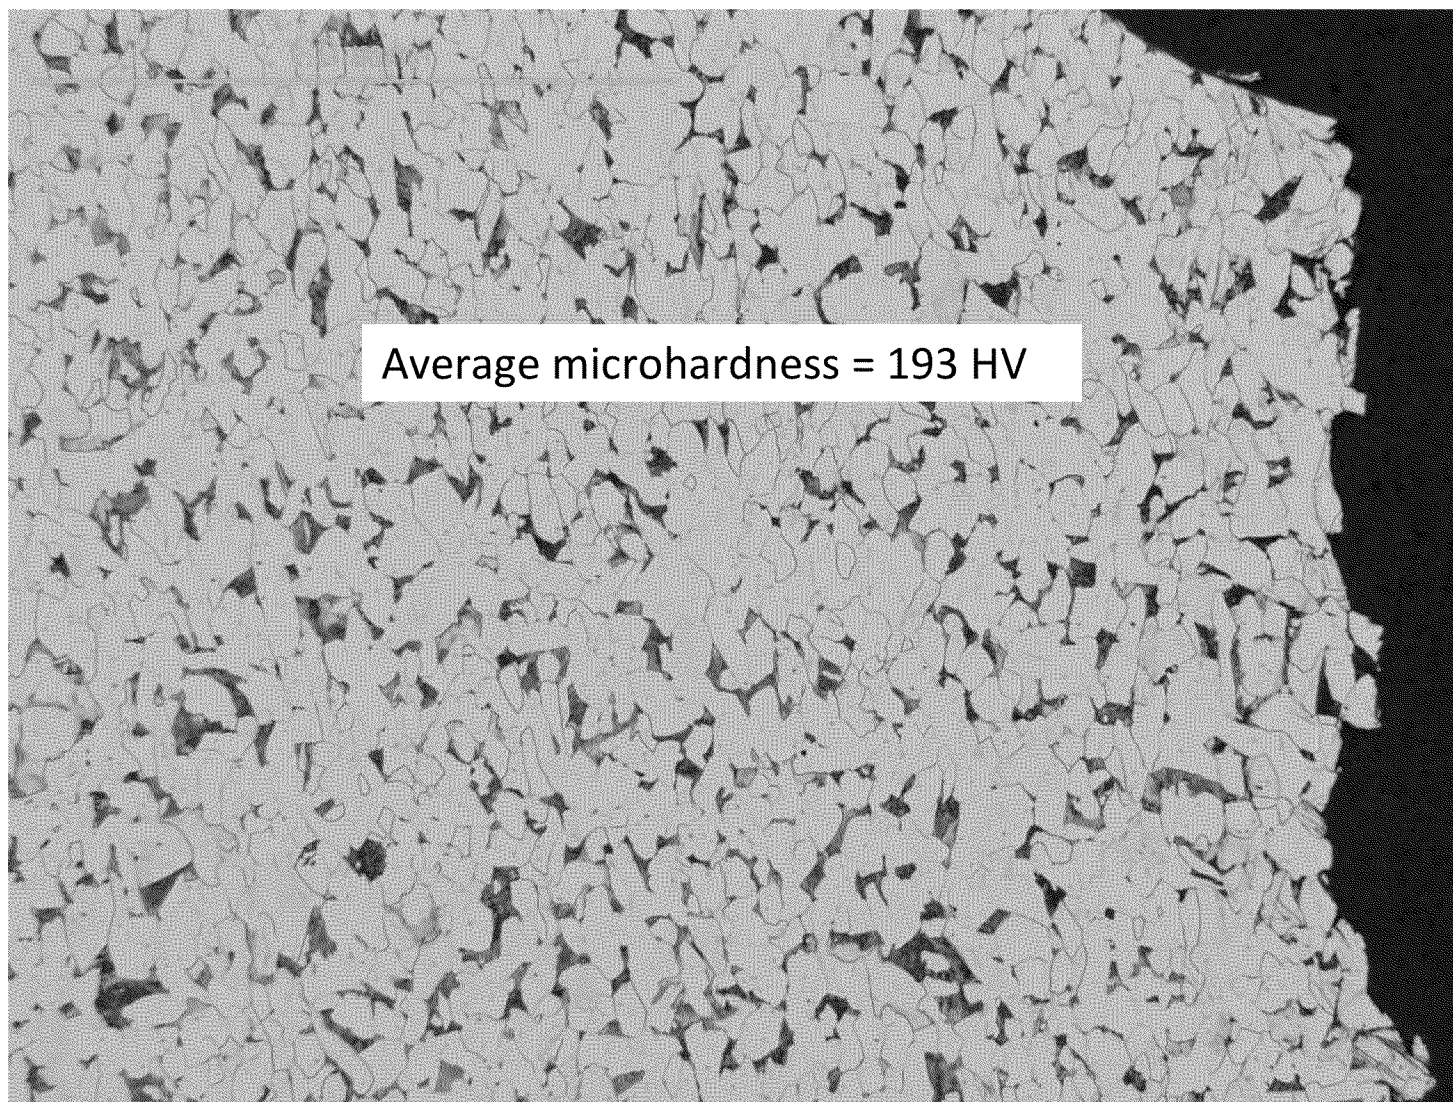
Metallography

Average microhardness = 193 HV
