Re: Update - Oakland Incident of December 10, 2013

PG&E Golf Links Road Release

Investigation Status Update

Exponent[®]
Failure Analysis Associates[®]

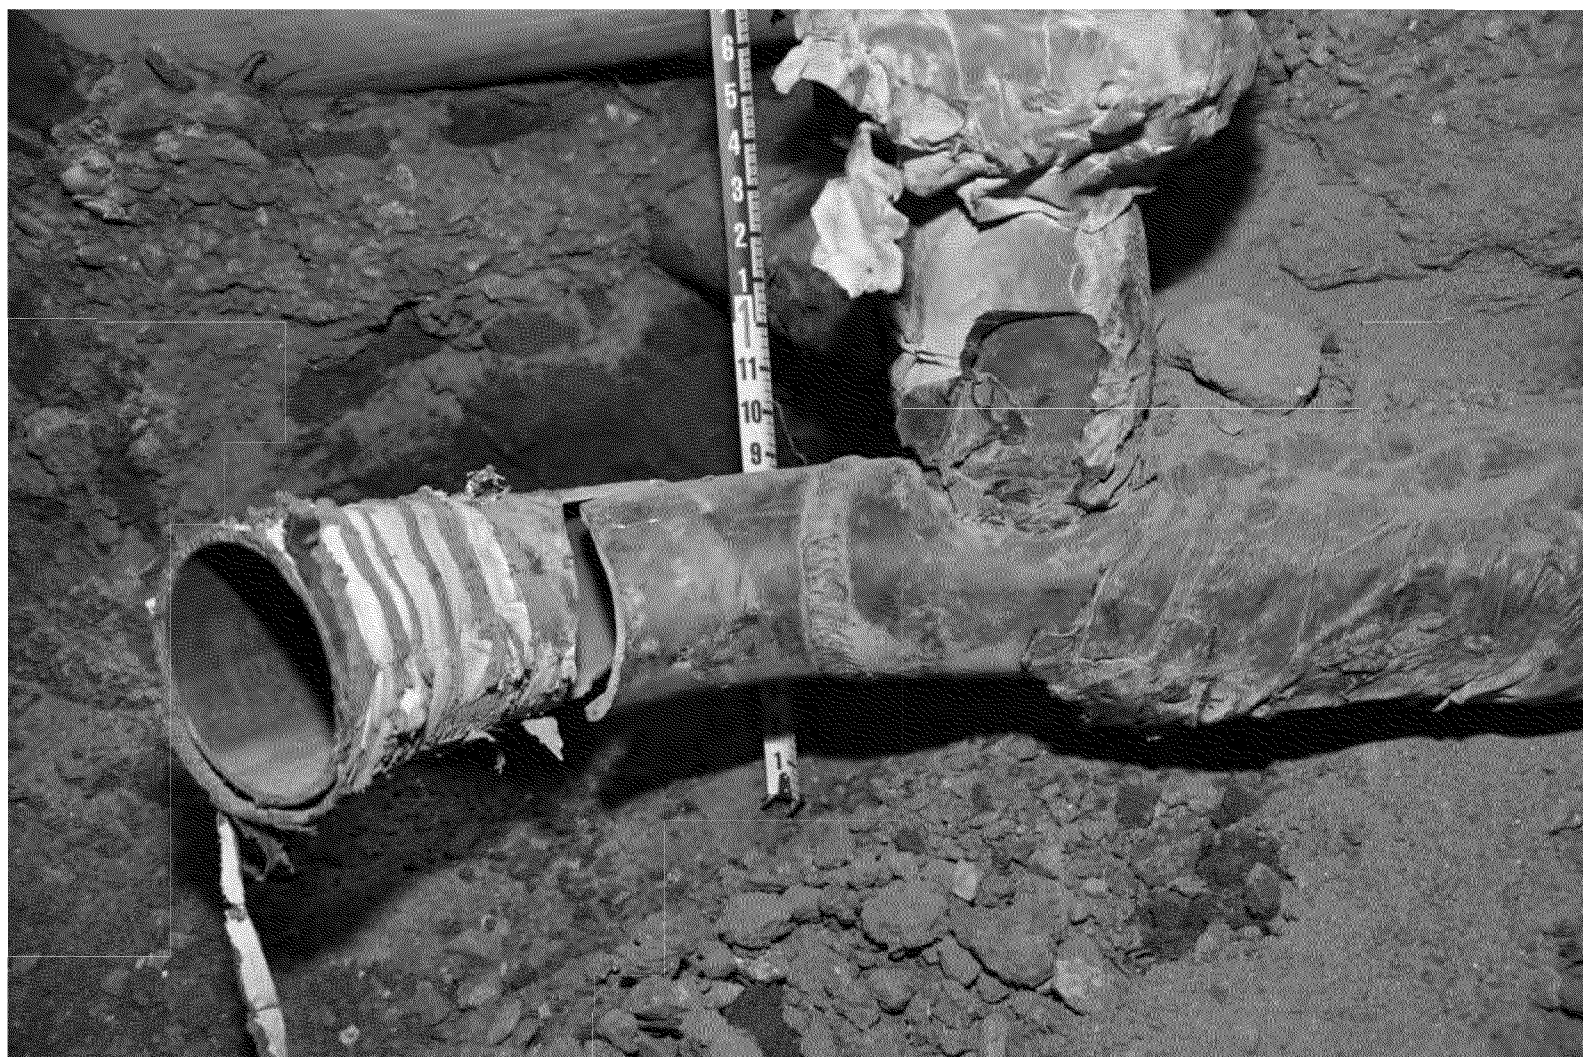
Failed Elbow Before Removal

- The failure of the 4-inch steel elbow resulted from a single, significant external force to the pipeline. The elbow failed at the inner radius due to an external load to the pipe. The cause of the external force is not known at this time. The elbow failed in a brittle failure mode with no indications of yielding or fatigue. Yielding is the point where a material starts to deform due to the loading. In this case, the steel fractured with no indications of deformation.

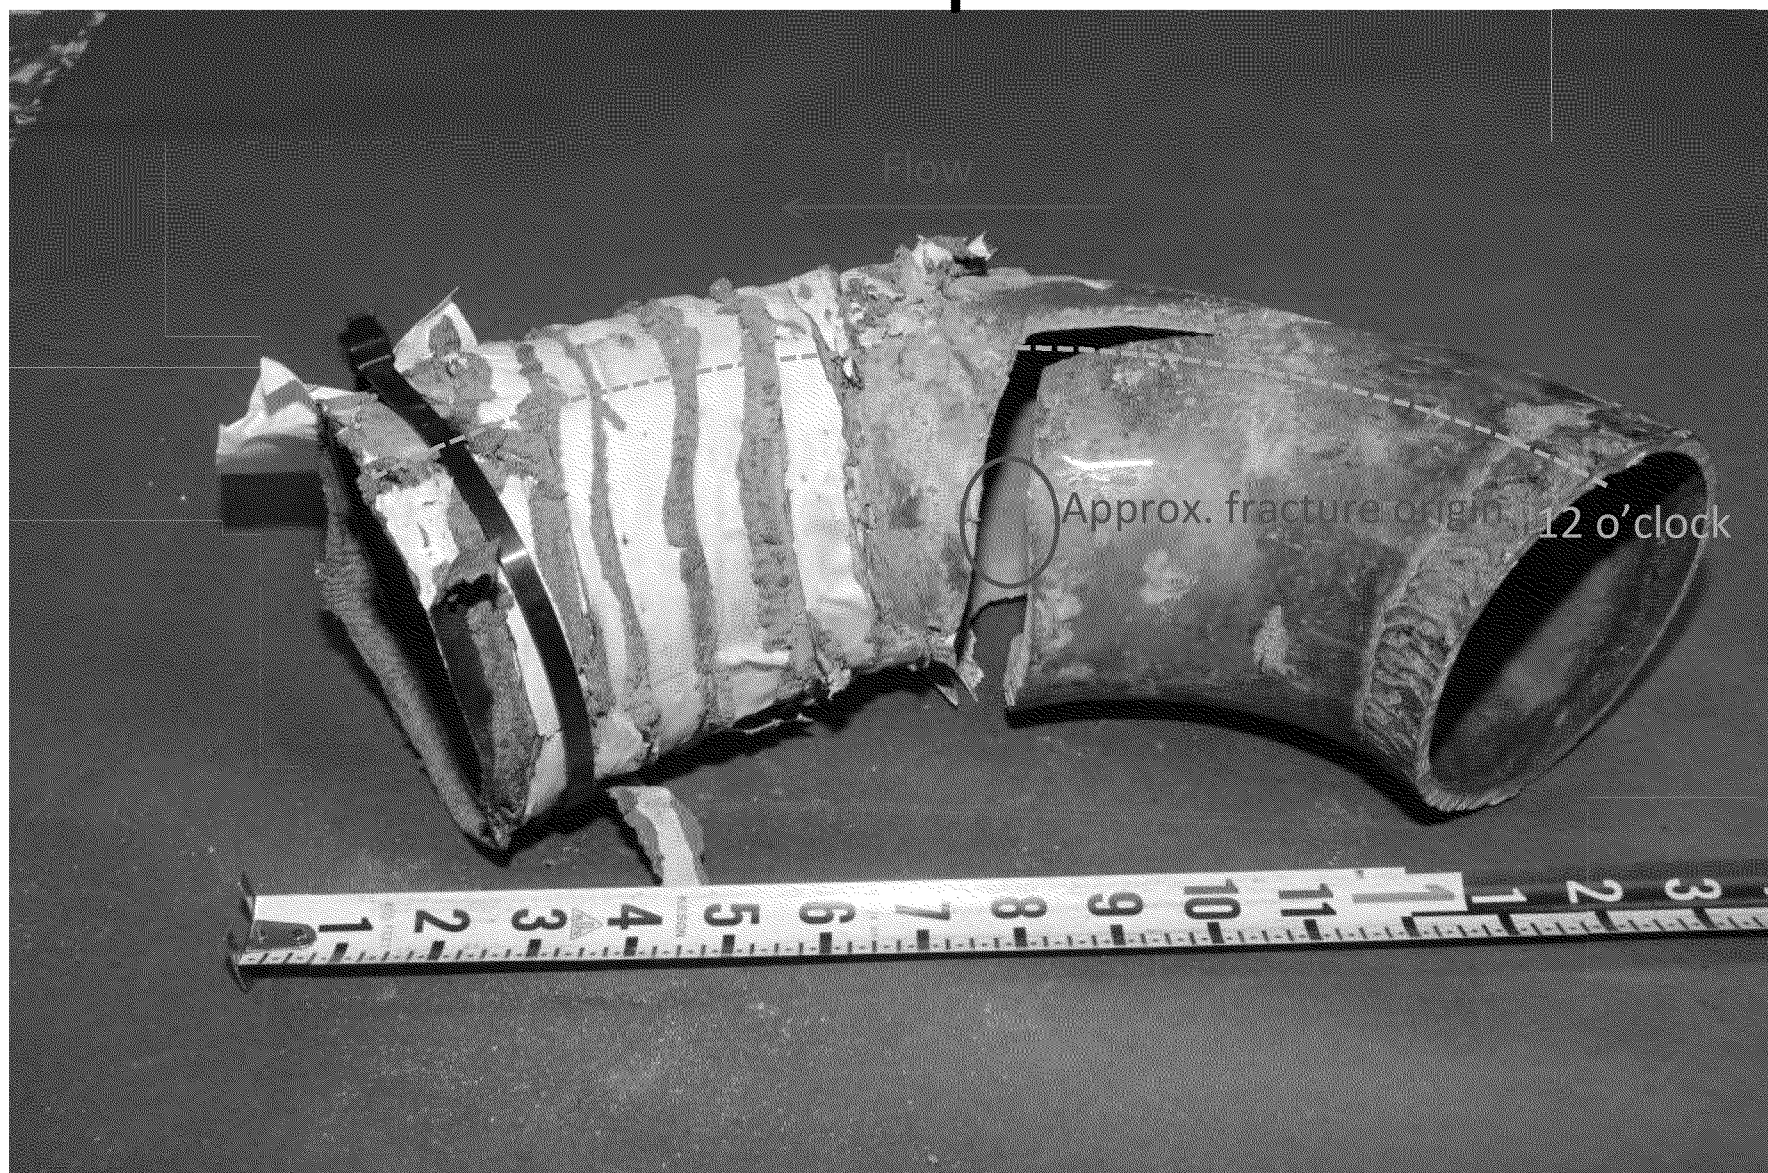
Visual Inspection

- External forces acting on the pipeline resulted in stresses that exceeded the subject elbow's tensile strength, resulting in its fracture
- The source of these external forces is currently being investigated
- Brittle (cleavage) fracture morphology was observed
- No evidence of progressive fracture (such as fatigue or stress corrosion cracking) was observed
- The fracture was not associated with a mechanical, corrosion-induced, or metallurgical defect
- The elbow exhibited the expected "ferrite-pearlite" microstructure
- The elbow hardness was measured to be 193 HV, roughly equivalent to a UTS of 92 ksi
